INSPECTION REPORT  
5341 Lanai St  
Long Beach CA 90808

INSPECTED BY  
Christopher Vella  
Professional  
Inspection  
Network

INSPECTION DATE  
📅 10/2/2025  
🕒 09:00 AM

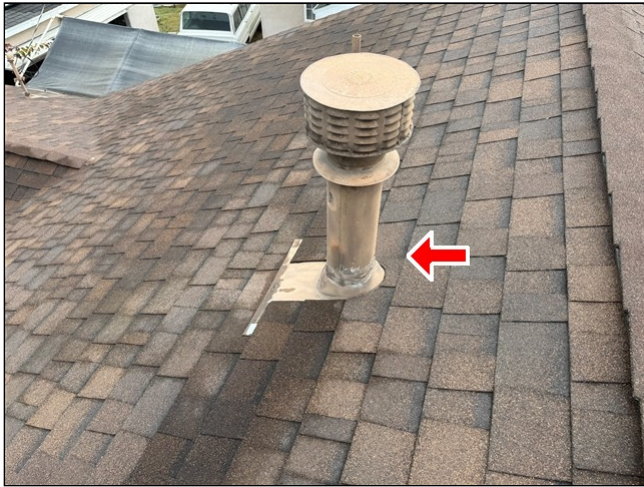
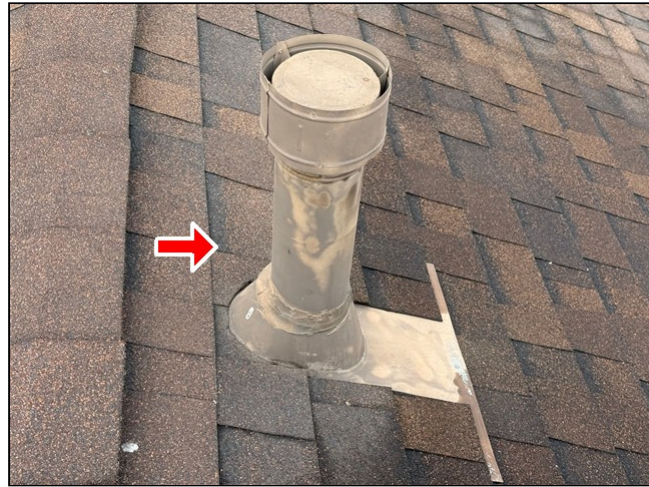
Item 1 - Item 1 (Picture) Roofing

- 1. Repair or Replace:** The metal exhaust vents lack storm collars. This component is typically required to prevent water from entering the vent system during adverse weather conditions. Without a storm collar, there is an increased risk of water intrusion into the exhaust system, which can lead to corrosion, reduced efficiency, and potential damage to the heater. Additionally, moisture ingress could compromise the integrity of the surrounding structures and lead to mold growth. It is recommended to install a storm collar on the exhaust vent to enhance the protection against water intrusion. A qualified HVAC technician should be consulted to ensure that the storm collar is properly fitted and installed according to manufacturer specifications and local building codes.

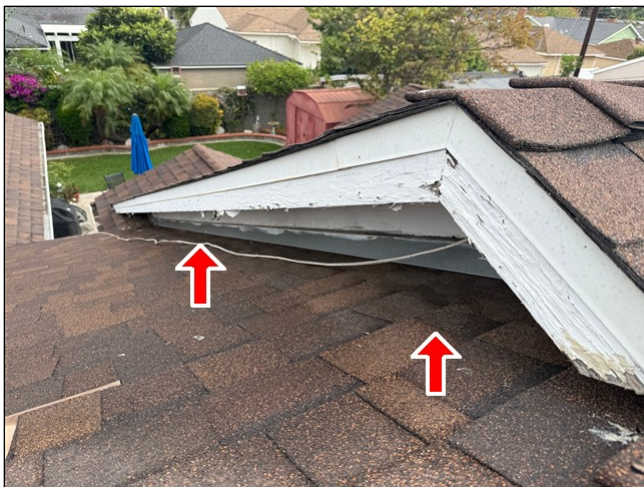
Item 2 - Item 1 (Picture) Exterior

- 2. Repair or Replace:** There is wood deterioration observed at the fascia boards in one or more locations. This deterioration can be caused by various factors such as moisture, pests, or age-related wear and tear. It is important to address this issue to prevent further damage. Due to the presence of wood deterioration, it is advisable to have a pest control company inspect the area for any signs of pest activity or infestation. Certain pests can cause significant damage to wood structures. A professional inspection will help determine if pests are present and if further treatment is necessary. It is recommended to hire a licensed contractor experienced in wood repairs and replacements. They will assess the extent of the wood deterioration and provide appropriate recommendations. Depending on the severity of the damage, the contractor may suggest repair techniques such as wood patching, reinforcement, or complete replacement of deteriorated wood components. Please be aware that this report is based on a visual inspection, and it is essential to consult a qualified professional, such as a licensed contractor and a pest control company, for a comprehensive assessment and appropriate repairs.

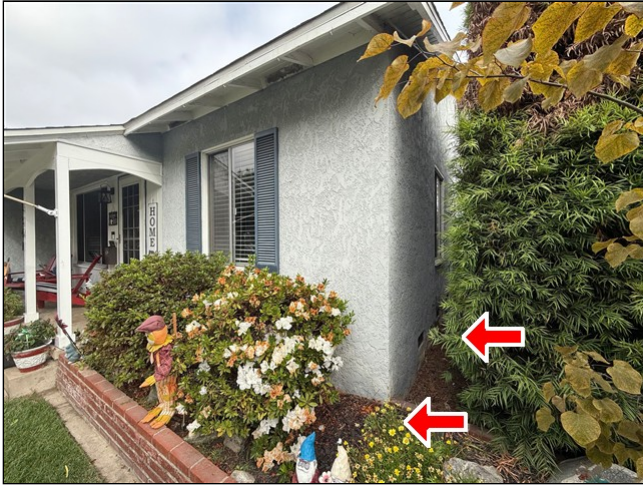
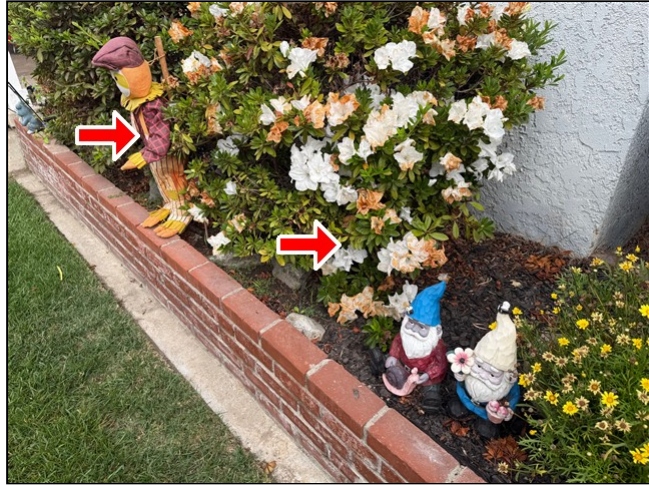
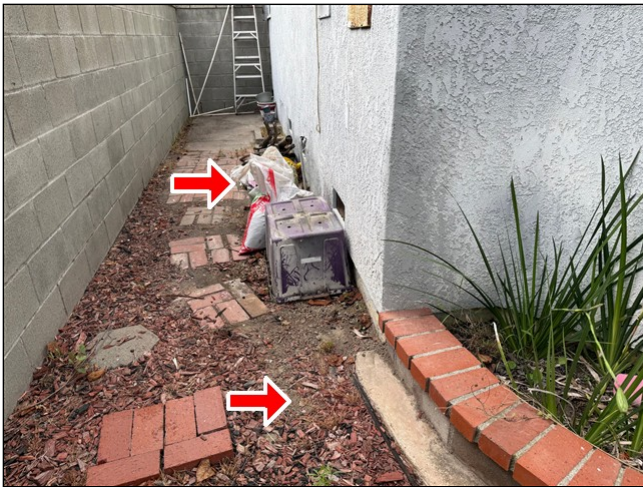
Item 3 - Item 1 (Picture) Exterior

- 3. (2) Improve:** There is a noticeable negative slope and several flat areas towards the home in various locations around the property. During periods of rain or extended irrigation, water tends to accumulate and pond near the foundation. This improper grading can contribute to various structural and moisture-related problems over time. Continuous water ponding near the foundation can lead to erosion and weakening of the foundation materials, potentially resulting in cracks and settling. It is advisable to engage a professional landscaping or civil engineering service to regrade the affected areas. The ground should be sloped away from the home at a minimum gradient (typically at least 5% or 6 inches drop over 10 feet) to ensure effective runoff away from the foundation.

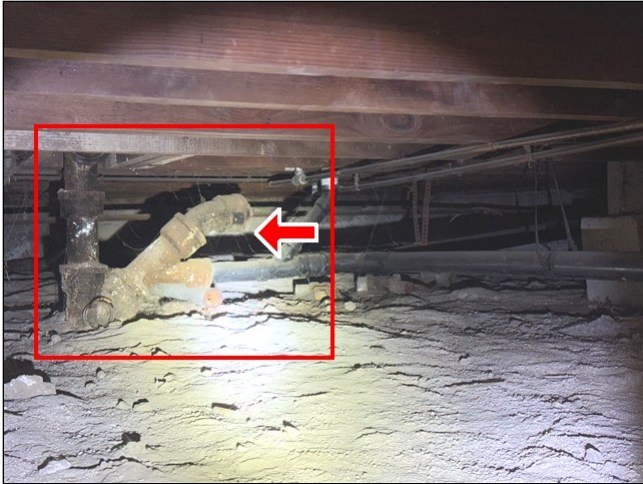
Item 5 - Item 1 (Picture) Plumbing System

5. (2) **Repair or Replace:** The older cast iron drain pipes throughout the crawl space of the home show

signs of corrosion. The older cast iron drain piping is prone to unexpected problems. The corrosion indicates potential issues and raises concerns about the longevity and reliability of the drain system. Corroded drain pipes can weaken the integrity of the drain pipes, making it more susceptible to leaks or further deterioration. It is recommended to have a qualified plumber assess the condition of the drain pipes and replace the corroded sections. This proactive measure will help prevent future leaks and ensure the proper functioning of the drainage system. By addressing the corroded drain pipes now, you can mitigate the risk of water damage, potential mold growth, and further deterioration of the plumbing system. A qualified plumber will be able to provide the necessary expertise and replace the corroded components with new, reliable materials, ensuring the long-term integrity of the drain system.

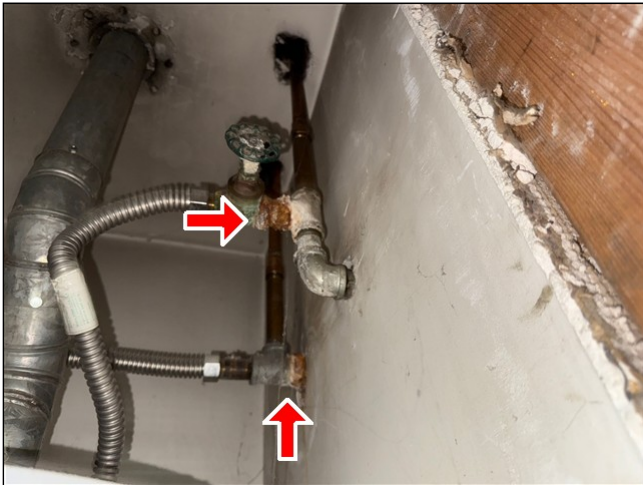
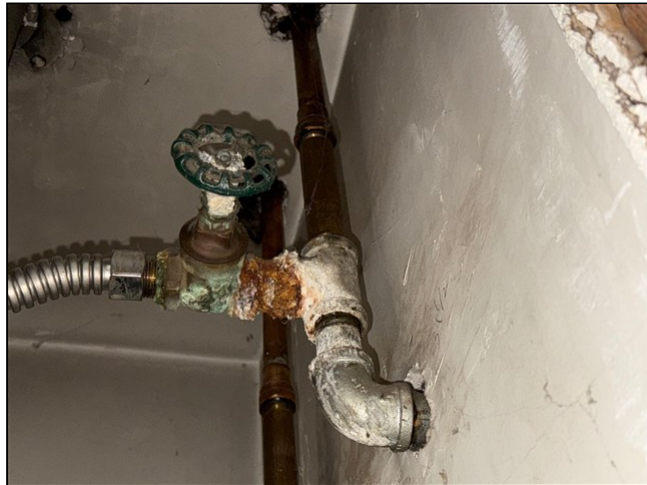
Item 6 - Item 1 (Picture) Plumbing System

6. (1) **Repair or Replace:** The exposed galvanized water supply pipes located at the water heater closet are older pipes that show visible corrosion and signs of leakage. Galvanized piping is prone to rust, internal buildup, and deterioration, which can reduce water flow and increase the risk of leaks or failure. Further evaluation and repair or replacement by a licensed plumbing contractor are recommended. Replacement of the older galvanized piping with approved modern materials (such as copper or PEX) should be considered to restore reliability and prevent further leakage.

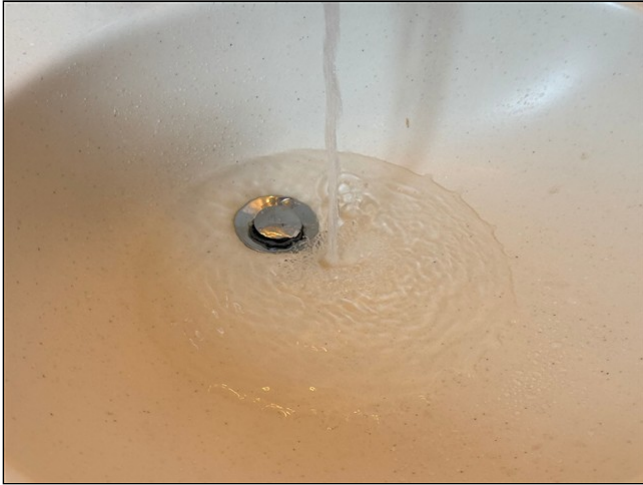
Item 7 - Item 1 (Picture) Plumbing System

7. (2) **Repair or Replace:** Low water flow and a noticeable drop in water flow were observed when multiple fixtures were operated simultaneously. The home's water supply piping is composed of older galvanized steel, and galvanized piping was visible in one or more areas. Galvanized piping is prone to internal corrosion and mineral buildup, which restricts water flow and can result in leaks or pipe failure over time. Further evaluation by a licensed plumbing contractor is recommended. Replacement of the older galvanized water supply piping with approved modern materials (such as copper or PEX) should be considered to restore proper water flow, improve efficiency, and reduce the risk of future leakage.

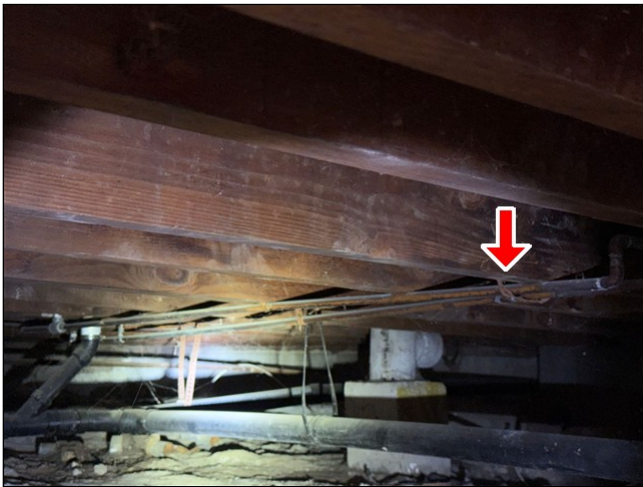
Item 8 - Item 1 (Picture) Plumbing System

8. (3) **Repair or Replace:** The copper water supply pipes throughout the crawl space of the home are being supported with galvanized straps/metal. These two types of metal (copper to galvanized) are dissimilar and should not be in contact with each other. Corrosion of the metals can occur if not corrected. Suggest replacement with conforming and compatible hangers by a qualified professional.

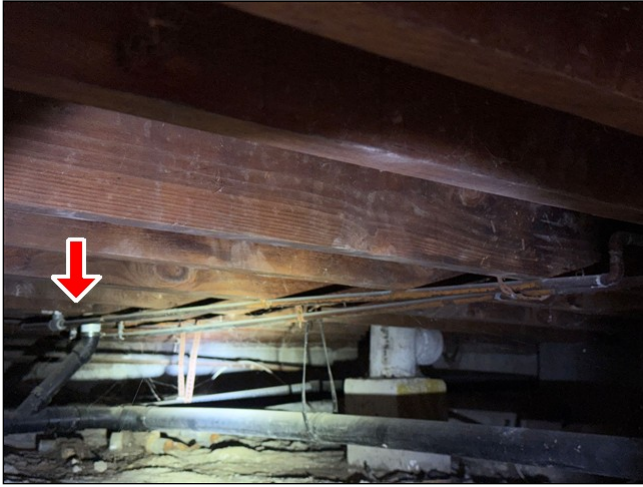
Item 9 - Item 1 (Picture) Plumbing System

9. (4) **Repair or Replace:** There are dielectric unions between copper and galvanized pipes at the crawl space. A dielectric union is a plumbing fitting that is used to join two different types of metal pipes, such as copper and galvanized pipes, while preventing the metals from coming into direct contact with each other. When different metals are in contact with each other, a process called galvanic corrosion can occur, which can result in leaks, corrosion, and other plumbing problems. If there is no dielectric union between a copper and galvanized pipe, it can result in galvanic corrosion, which can damage the pipes and compromise the plumbing system. Over time, the corrosion can cause leaks and reduce the efficiency and lifespan of the plumbing system.

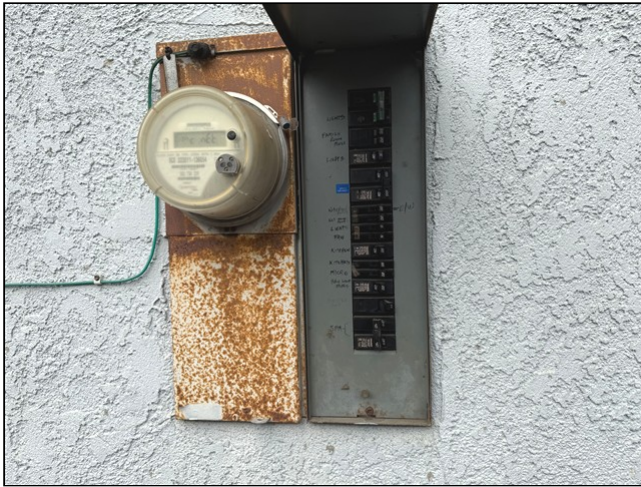
Item 13 - Item 1 (Picture) Electrical System

- 13. Safety Issue:** The electrical panel is manufactured by Challenger. Challenger panels are known to have design and manufacturing defects, including breakers that may fail to trip under overload or short-circuit conditions. This creates a potential fire and electrical safety hazard. Further evaluation by a licensed electrician is recommended. Due to the known safety concerns associated with Challenger panels, replacement of the panel should be strongly considered to ensure a safe and reliable electrical system.

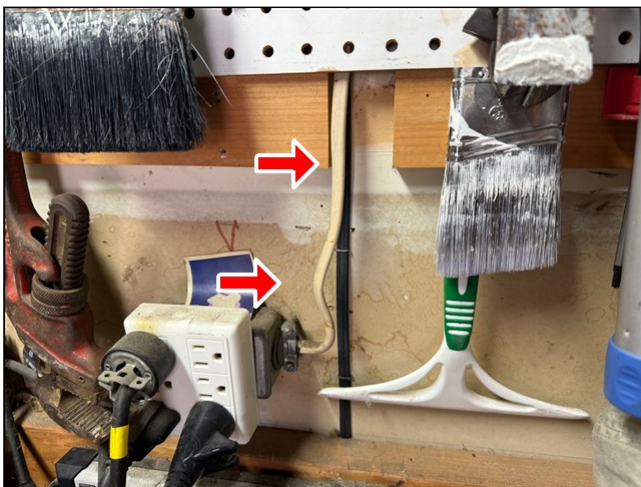
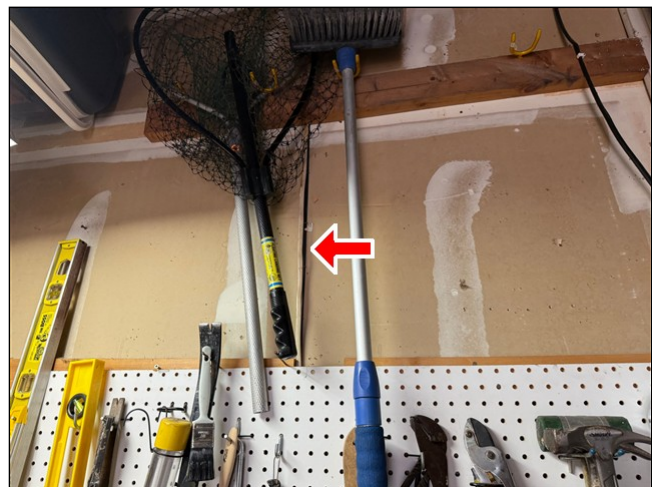
Item 14 - Item 1 (Picture) Electrical System

- 14. (1) Safety Issue:** Exposed Romex wiring was observed at the garage in various locations. Romex wiring or any type of exposed wiring should not be accessible. It is suggested that the wiring be covered by a qualified professional.

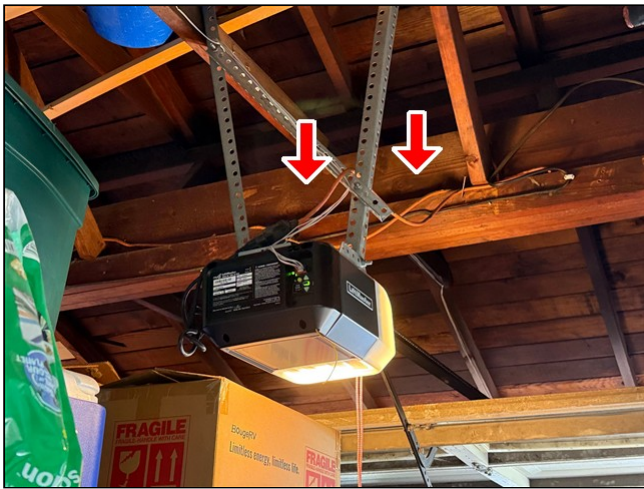
Item 15 - Item 1 (Picture) Electrical System

- 15. (2) Repair or Replace:** Extension cord wiring such as the one being used at the garage should not be used as permanent wiring. Suggest the installation of a dedicated outlet within 3 feet from the garage

door opener by a qualified electrician.

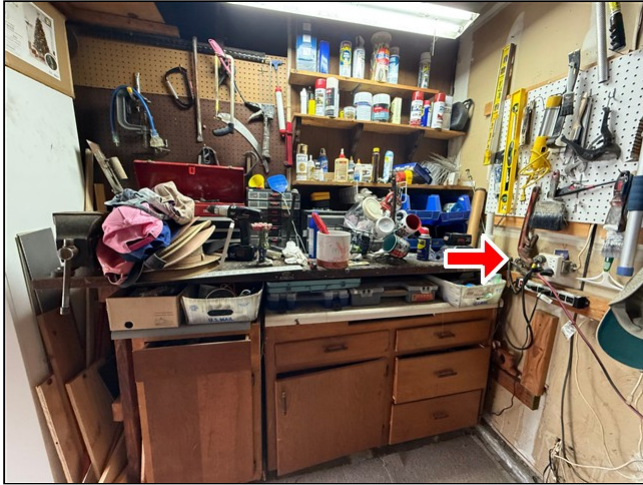
Item 17 - Item 1 (Picture) Electrical System

- 17. Safety Issue:** The electrical outlets in the garage lack Ground Fault Circuit Interrupter (GFCI) protection. GFCI outlets are designed to protect against electrical shocks and are typically required in areas where water and moisture are present, such as garages, bathrooms, kitchens, and outdoor locations. Since garages are susceptible to damp or wet conditions, the absence of GFCI protection in this area poses potential electrical hazards, especially if electrical equipment or tools are used in close proximity to water sources. The absence of GFCI protection in the garage electrical outlets poses potential electrical hazards, especially in damp or wet conditions. To enhance the safety of the garage's electrical system, it is strongly recommended to install GFCI outlets or provide GFCI protection at the circuit level. Hiring a qualified electrician to perform the installation and ensure proper wiring is essential for maintaining a safe and compliant electrical system in the garage. Regular maintenance and awareness of safety measures will help prevent electrical accidents and create a secure environment for everyone using the garage area.

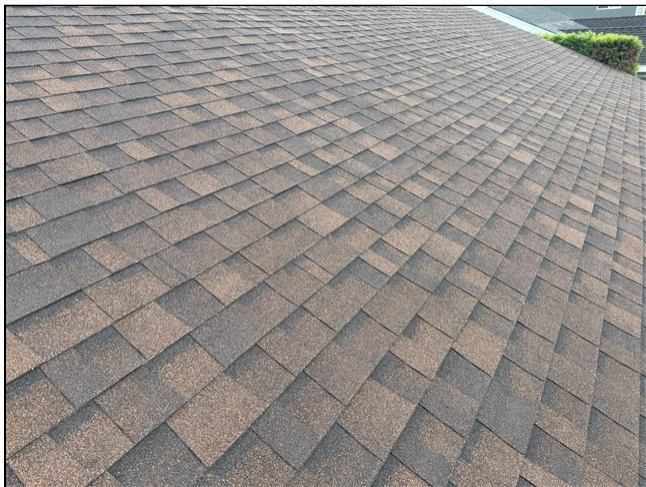
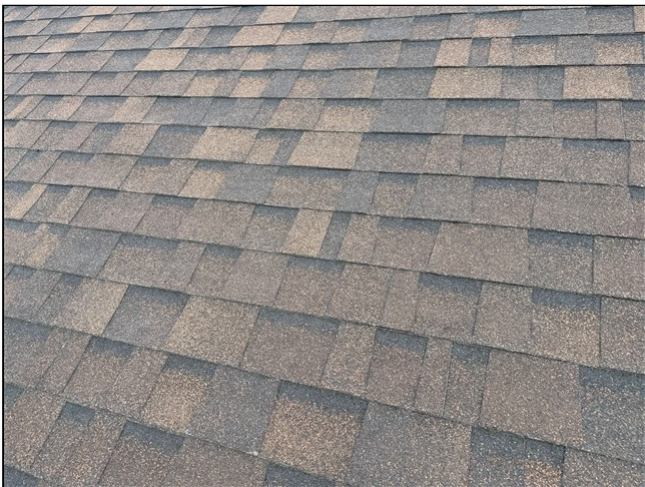
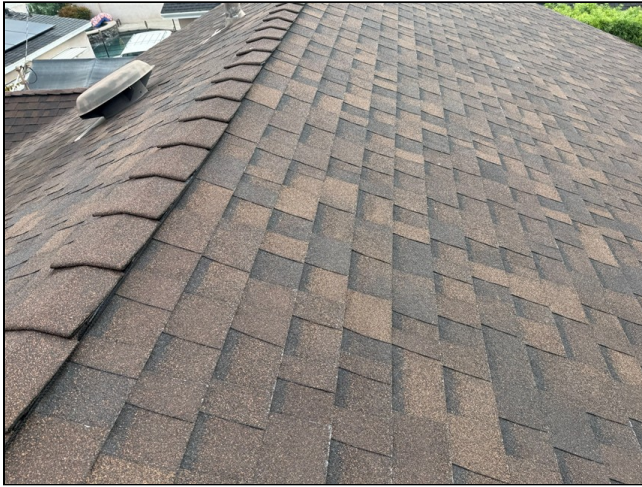
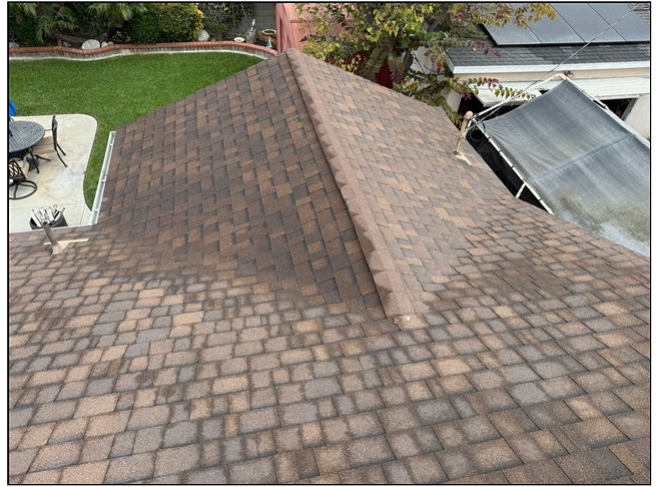
1.0 Item 1 (Picture) Roofing

**Monitor:** During the home inspection, it was observed that the composition shingle roofing is currently in good condition. However, it is important to note that accurately determining the remaining serviceable lifespan of the roofing is challenging. To ensure the longevity and proper maintenance of the roof, periodic reviews by a licensed roof contractor are highly recommended. The composition shingle roofing of the property is currently in good condition, exhibiting no visible signs of significant damage or deterioration during the home inspection. However, it is important to note that accurately predicting the exact remaining serviceable lifespan of the roofing is difficult due to various factors such as weather conditions, installation quality, and maintenance history. As with any roof, it is advised to engage the services of a licensed roof contractor for periodic evaluations and necessary repairs. This proactive approach will help identify any potential issues or areas requiring attention and ensure the longevity and integrity of the roofing system.

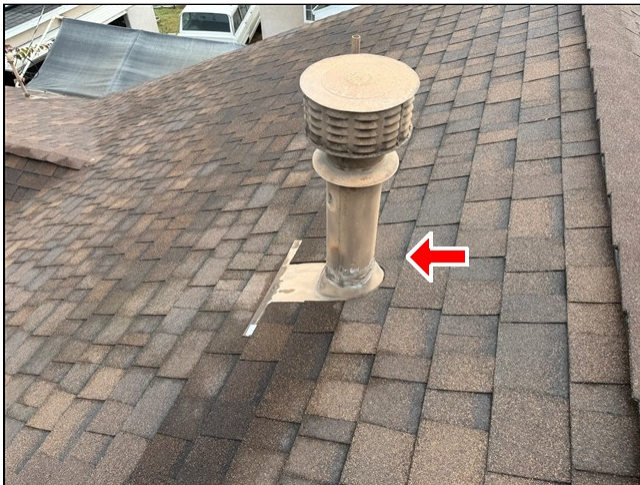
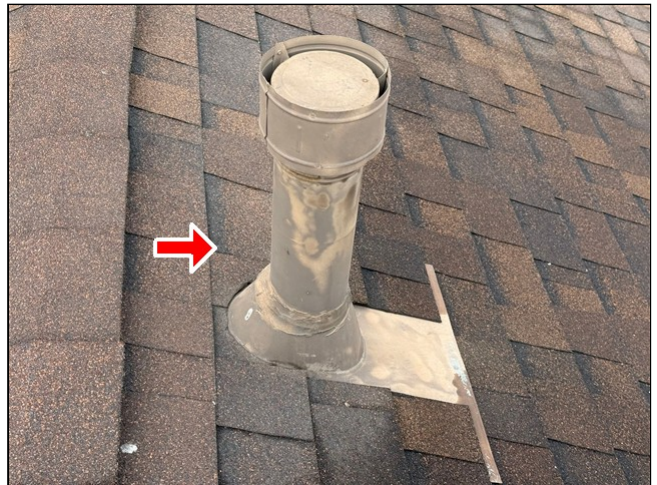
1.1 Item 1 (Picture) Roofing

**Repair or Replace:** The metal exhaust vents lack storm collars. This component is typically required to prevent water from entering the vent system during adverse weather conditions. Without a storm collar, there is an increased risk of water intrusion into the exhaust system, which can lead to corrosion, reduced efficiency, and potential damage to the heater. Additionally, moisture ingress could compromise the integrity of the surrounding structures and lead to mold growth. It is recommended to install a storm collar on the exhaust vent to enhance the protection against water intrusion. A qualified HVAC technician should be consulted to ensure that the storm collar is properly fitted and installed according to manufacturer specifications and local building codes.

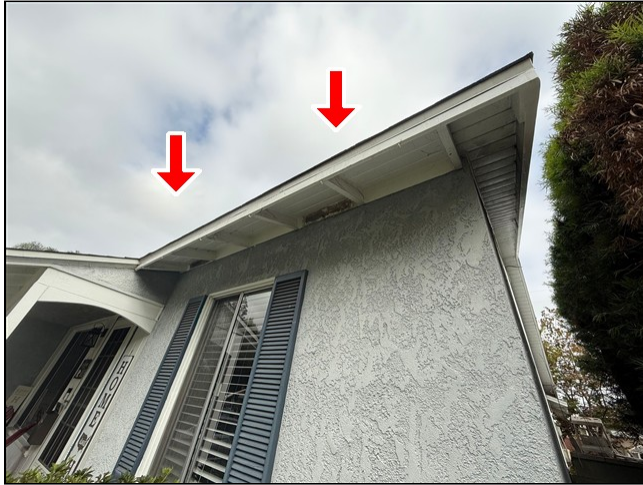
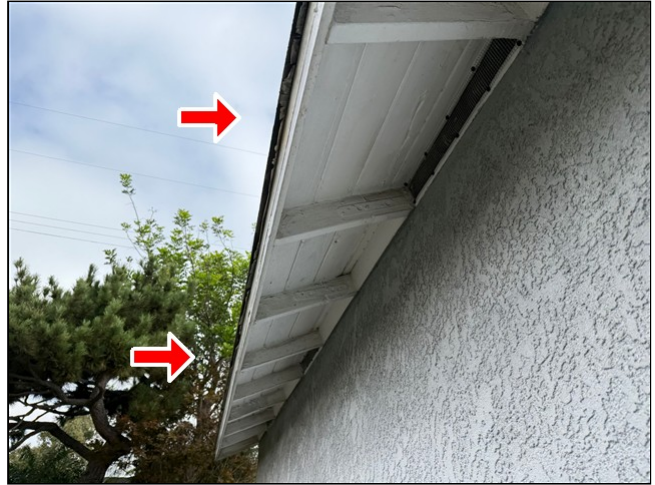
1.3 Item 1 (Picture) Roofing

channeling rainwater away from the foundation of the home. Without them, rainwater can accumulate around the perimeter of the property, potentially causing soil erosion, foundation settlement, and structural damage over time. The absence of gutters and downspouts can result in water cascading directly down the exterior walls during rainfall. This continuous exposure to moisture can lead to deterioration of siding materials, paint damage, and potential water intrusion into the building envelope. To address these concerns, it is recommended that gutters and downspouts be installed throughout the roof of the home. This will effectively collect rainwater and direct it away from critical areas, mitigating the risk of foundation damage, exterior wall deterioration, and landscape issues.

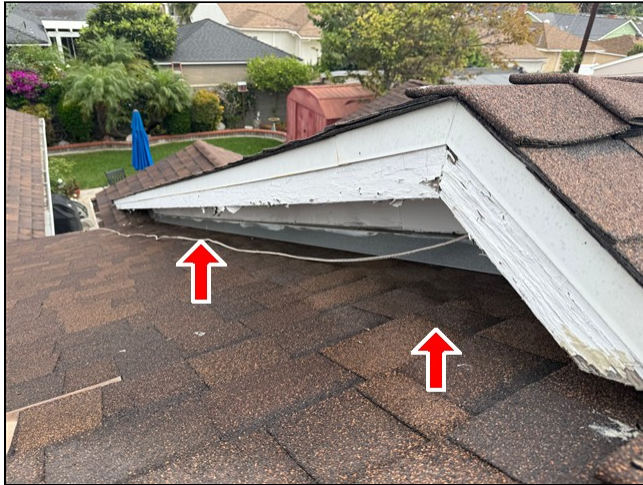
2.0 Item 1 (Picture) Exterior

structures. A professional inspection will help determine if pests are present and if further treatment is necessary. It is recommended to hire a licensed contractor experienced in wood repairs and replacements. They will assess the extent of the wood deterioration and provide appropriate recommendations. Depending on the severity of the damage, the contractor may suggest repair techniques such as wood patching, reinforcement, or complete replacement of deteriorated wood components. Please be aware that this report is based on a visual inspection, and it is essential to consult a qualified professional, such as a licensed contractor and a pest control company, for a comprehensive assessment and appropriate repairs.

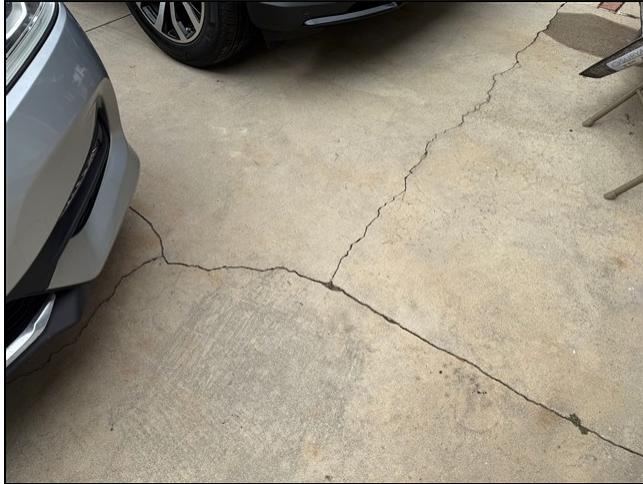
2.3 Item 1 (Picture) Exterior

(1) **Repair/Replace/Monitor:** During the home inspection, it was observed that the concrete driveway shows signs of common cracking in various locations. Cracking in concrete driveways is a common issue that can occur over time due to various factors. It is essential to assess the severity of the cracks and take appropriate measures to address them. Filling small cracks, repairing larger ones, and resealing the driveway will help protect it from further damage and extend its lifespan. Engaging professional contractors for repairs and addressing underlying issues will contribute to maintaining a safe and durable concrete driveway within the property.

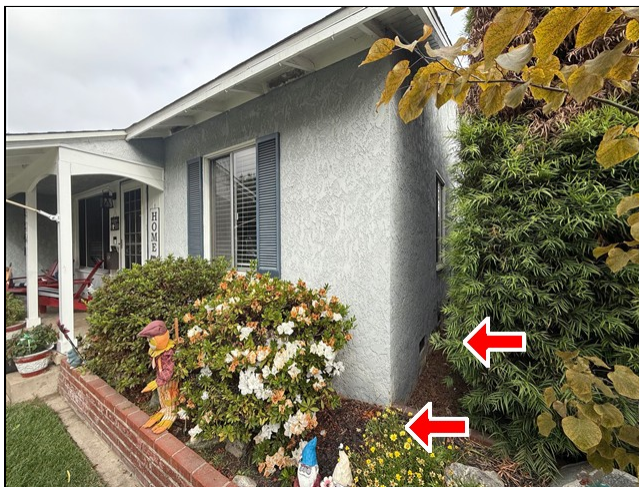
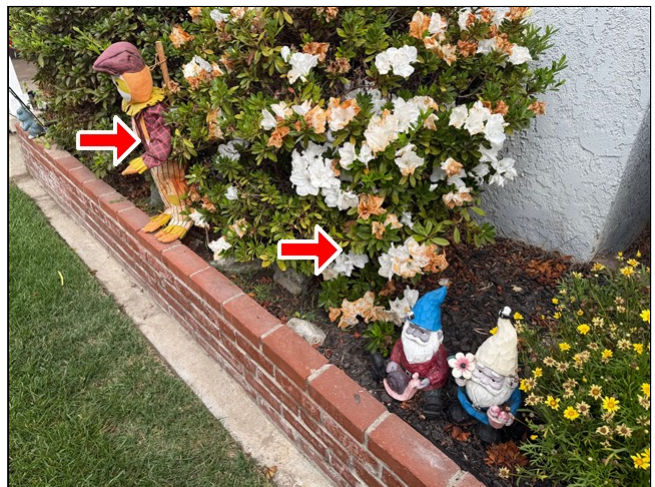
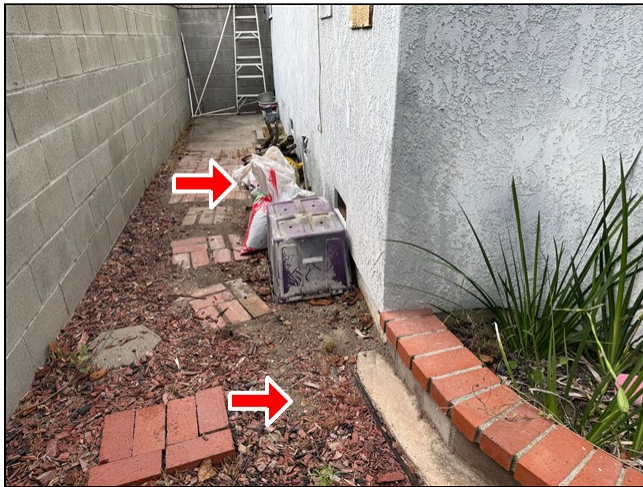
2.3 Item 2 (Picture) Exterior

(2) **Improve:** There is a noticeable negative slope and several flat areas towards the home in various locations around the property. During periods of rain or extended irrigation, water tends to accumulate and pond near the foundation. This improper grading can contribute to various structural and moisture-related problems over time. Continuous water ponding near the foundation can lead to erosion and weakening of the foundation materials, potentially resulting in cracks and settling. It is advisable to engage a professional landscaping or civil engineering service to regrade the affected areas. The ground should be sloped away from the home at a minimum gradient (typically at least 5% or 6 inches drop over 10 feet) to ensure effective runoff away from the foundation.

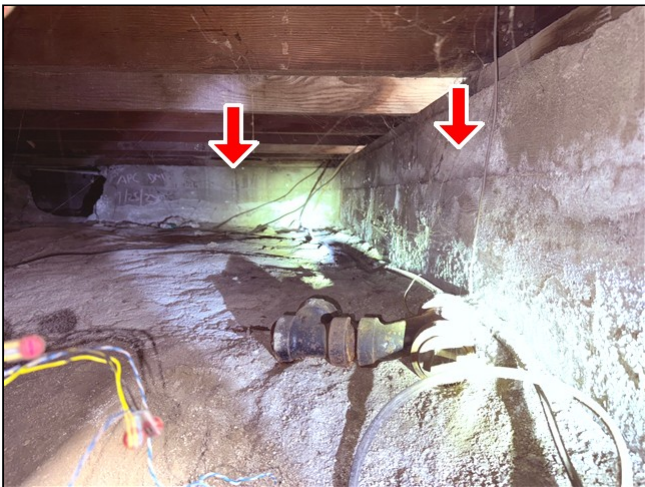
3.0 Item 1 (Picture) Structural Components

(1) **Improve/Monitor:** Efflorescence, a whitish, fuzzy material, is visible on portions of the concrete foundation walls or slab. This occurs when moisture in the concrete evaporates, leaving behind mineral deposits. The presence of efflorescence often indicates excess moisture on the outside of the foundation. To address this, ensure proper surface drainage by grading the landscape away from the foundation. Downspouts should direct water well away from the building, and landscape watering should be limited to short durations and directed away from the structure. If efflorescence continues to appear, further evaluation by a contractor or foundation specialist may be necessary to implement additional moisture management solutions. Maintaining drainage systems and minimizing exterior moisture are essential steps to protect the foundation.

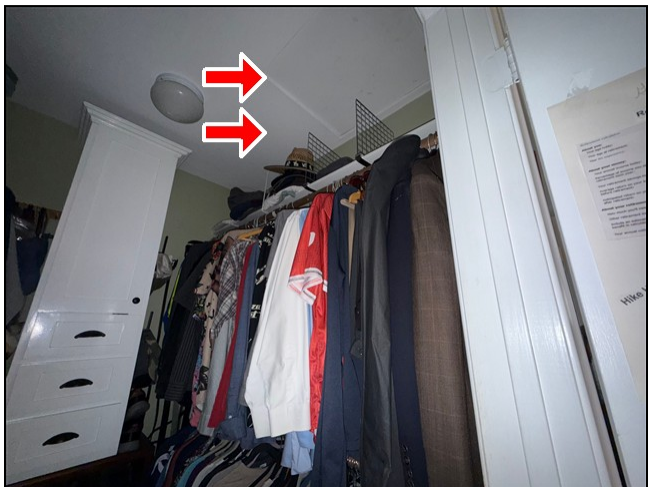
3.3 Item 1 (Picture) Structural Components

**Monitor:** The occupants' belongings in the primary closet prevented access to the attic space. As a result, the attic and its components-including the forced-air heater, roofing structure, insulation levels, wiring, and other elements-could not be inspected. The condition of these components remains unknown. Access should be made available for a complete evaluation. Once cleared, further inspection of the attic space is recommended to assess the condition of the HVAC equipment, insulation, roof framing, and electrical systems.

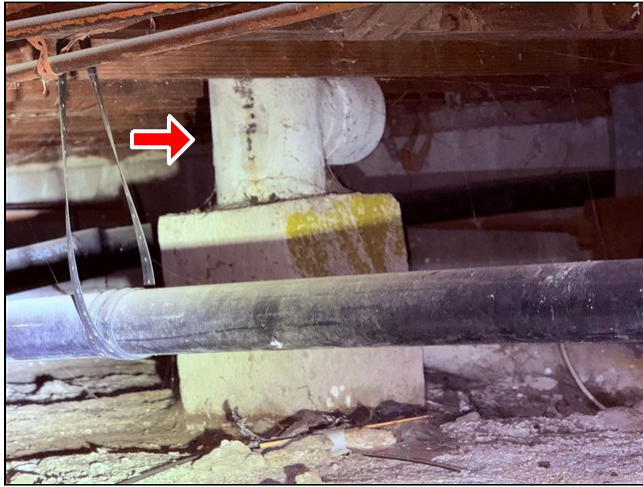
4.3 Item 1 (Picture) Heating/Central Air

**Monitor:** The older ceramic exhaust flue at the crawl space no longer in use may contain Asbestos. This can only be verified by laboratory analysis. The Environmental Protection Agency (E.P.A.) reports that asbestos represents a health hazard if "friable" (damaged, crumbling, or in any state that allows the release of fibers). Suggest further review, testing and removal by a qualified professional.

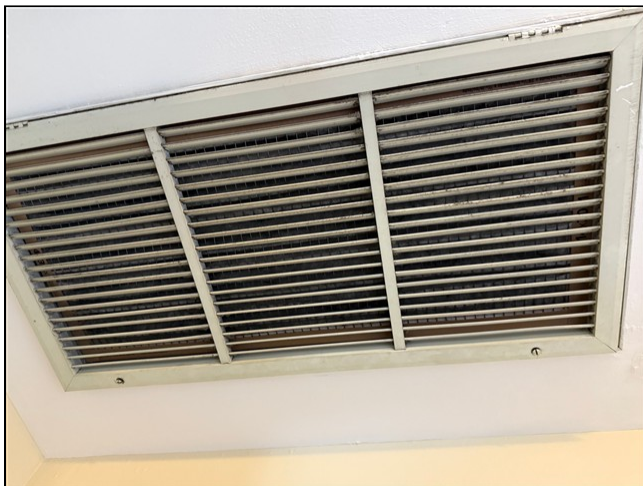
4.5 Item 1 (Picture) Heating/Central Air

**Improve:** The air filter for the HVAC system is dirty and requires replacement. A clogged or dirty air filter can reduce system efficiency, restrict airflow, and negatively impact indoor air quality. Prolonged use of a dirty filter may also put strain on the HVAC system, potentially leading to increased energy costs and premature wear. Replace the air filter with a clean, appropriately sized filter to improve airflow and maintain system efficiency. Regularly check and replace air filters, typically every 1-3 months, depending on usage and manufacturer recommendations, to ensure optimal performance and indoor air quality.

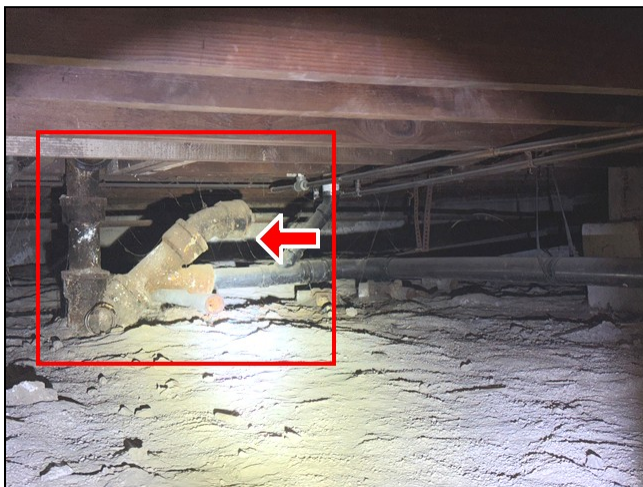
5.0 Item 2 (Picture) Plumbing System

(2) **Repair or Replace:** The older cast iron drain pipes throughout the crawl space of the home show signs of corrosion. The older cast iron drain piping is prone to unexpected problems. The corrosion indicates potential issues and raises concerns about the longevity and reliability of the drain system. Corroded drain pipes can weaken the integrity of the drain pipes, making it more susceptible to leaks or further deterioration. It is recommended to have a qualified plumber assess the condition of the drain pipes and replace the corroded sections. This proactive measure will help prevent future leaks and ensure the proper functioning of the drainage system. By addressing the corroded drain pipes now, you can mitigate the risk of water damage, potential mold growth, and further deterioration of the plumbing system. A qualified plumber will be able to provide the necessary expertise and replace the corroded components with new, reliable materials, ensuring the long-term integrity of the drain system.

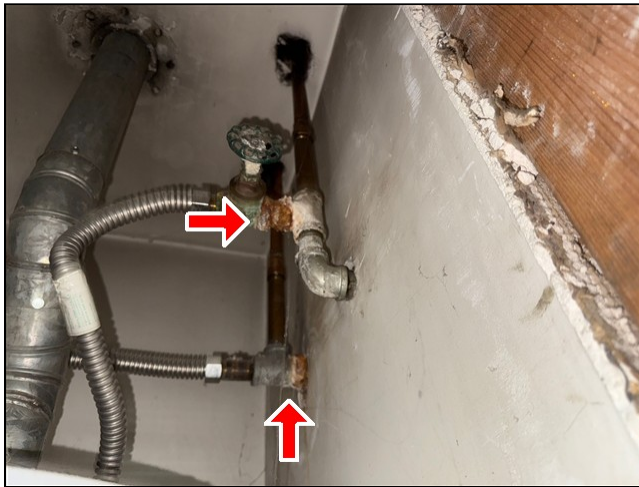
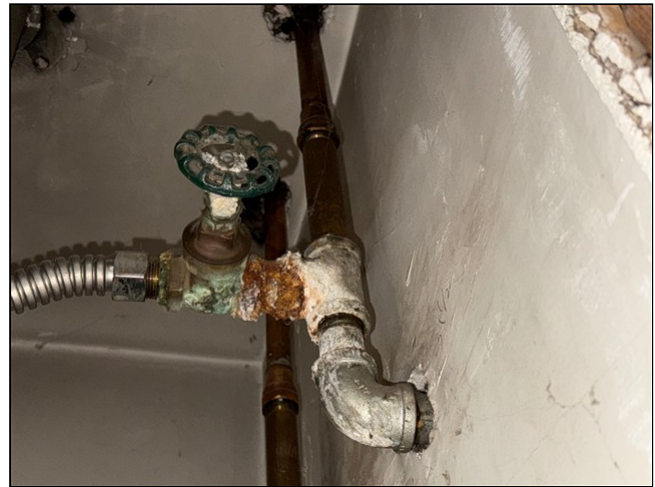
5.1 Item 1 (Picture) Plumbing System

(1) **Repair or Replace:** The exposed galvanized water supply pipes located at the water heater closet are older pipes that show visible corrosion and signs of leakage. Galvanized piping is prone to rust, internal buildup, and deterioration, which can reduce water flow and increase the risk of leaks or failure. Further evaluation and repair or replacement by a licensed plumbing contractor are recommended. Replacement of the older galvanized piping with approved modern materials (such as copper or PEX) should be considered to restore reliability and prevent further leakage.

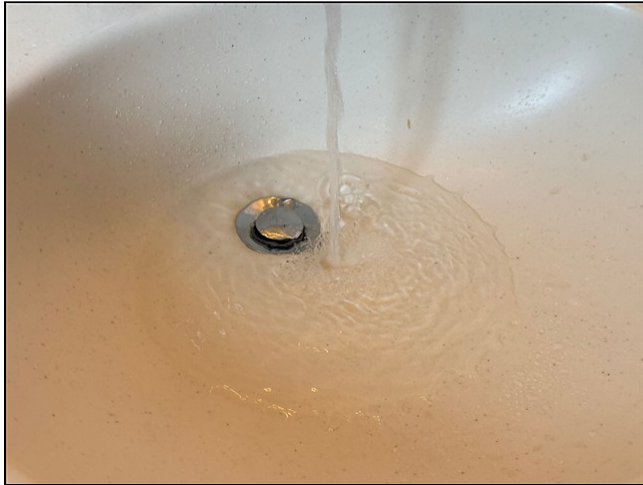
5.1 Item 3 (Picture) Plumbing System

(2) **Repair or Replace:** Low water flow and a noticeable drop in water flow were observed when multiple fixtures were operated simultaneously. The home's water supply piping is composed of older galvanized steel, and galvanized piping was visible in one or more areas. Galvanized piping is prone to internal corrosion and mineral buildup, which restricts water flow and can result in leaks or pipe failure over time. Further evaluation by a licensed plumbing contractor is recommended. Replacement of the older galvanized water supply piping with approved modern materials (such as copper or PEX) should be considered to restore proper water flow, improve efficiency, and reduce the risk of future leakage.

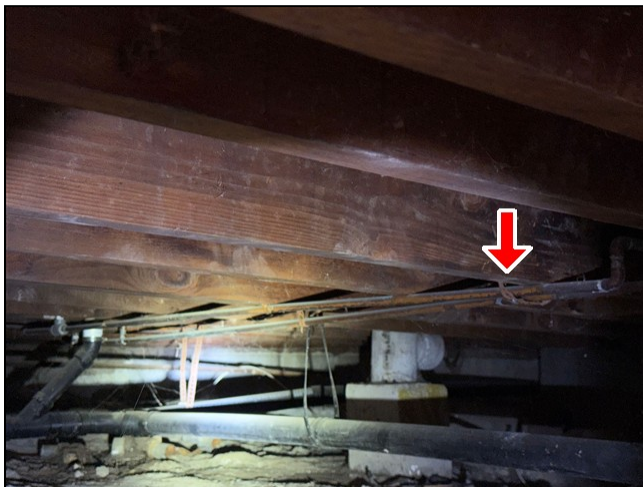
5.1 Item 4 (Picture) Plumbing System

(3) **Repair or Replace:** The copper water supply pipes throughout the crawl space of the home are being supported with galvanized straps/metal. These two types of metal (copper to galvanized) are dissimilar and should not be in contact with each other. Corrosion of the metals can occur if not corrected. Suggest replacement with conforming and compatible hangers by a qualified professional.

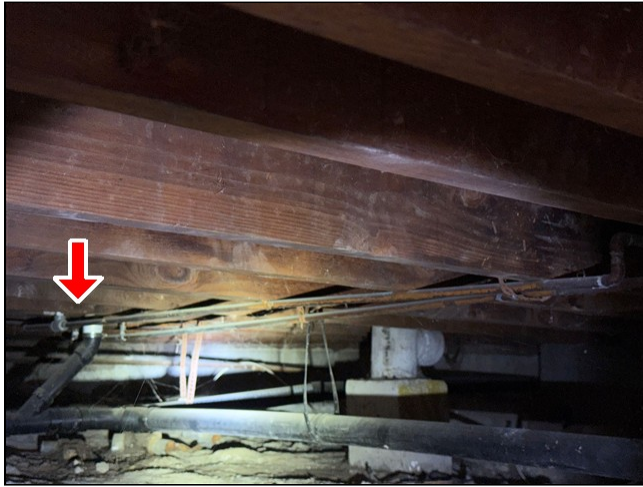
5.1 Item 5 (Picture) Plumbing System

called galvanic corrosion can occur, which can result in leaks, corrosion, and other plumbing problems. If there is no dielectric union between a copper and galvanized pipe, it can result in galvanic corrosion, which can damage the pipes and compromise the plumbing system. Over time, the corrosion can cause leaks and reduce the efficiency and lifespan of the plumbing system.

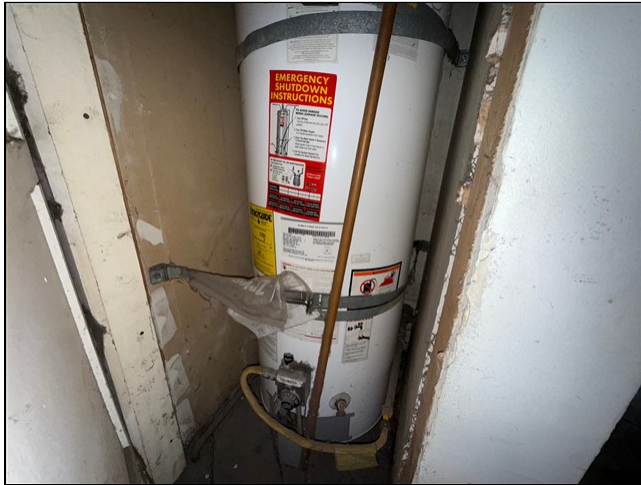
5.2 Item 2 (Picture) Plumbing System

(4) **Note/Monitor:** The water heater was operational and produced hot water at time of inspection.

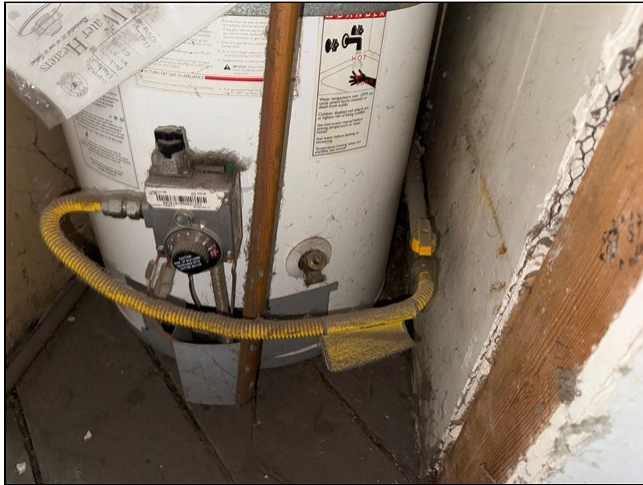
5.4 Item 1 (Picture) Plumbing System

(1) **Improve:** The gas supply pipe at the water heater lacks a sediment trap. A sediment trap, also known as a dirt leg or drip leg, is a vertical pipe section with a capped end that is installed on the gas supply line before it connects to the water heater flexible connector. The purpose of the sediment trap is to collect any debris, sediment, or moisture that may be present in the gas supply line. The sediment trap helps to prevent these contaminants from reaching and potentially damaging the internal components of the water heater, such as the gas valve or burner assembly. It also helps to ensure the smooth and efficient operation of the unit. Local building codes and regulations may vary, so it's important to consult the specific requirements in your area. In many jurisdictions, including the United States, a sediment trap is commonly required for gas-fired appliances, including water heaters. It is recommended to have a qualified professional, such as a licensed plumber or gas technician, install the sediment trap according to the manufacturer's instructions and local code requirements to ensure proper operation and safety of the water heater.

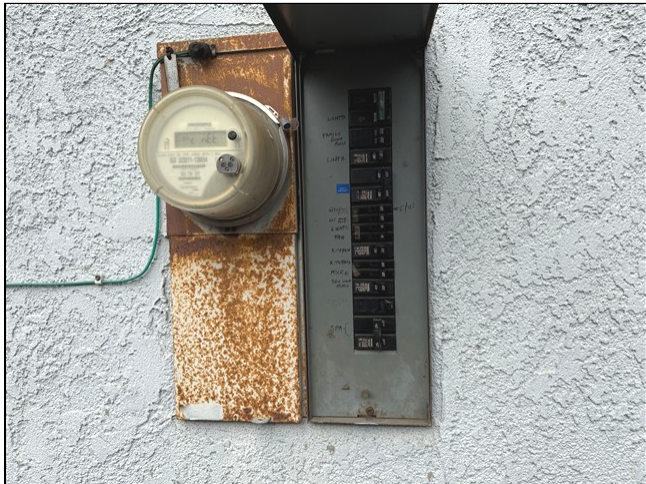
6.0 Item 1 (Picture) Electrical System

**Safety Issue:** The electrical panel is manufactured by Challenger. Challenger panels are known to have design and manufacturing defects, including breakers that may fail to trip under overload or short-circuit conditions. This creates a potential fire and electrical safety hazard. Further evaluation by a licensed electrician is recommended. Due to the known safety concerns associated with Challenger panels, replacement of the panel should be strongly considered to ensure a safe and reliable electrical system.

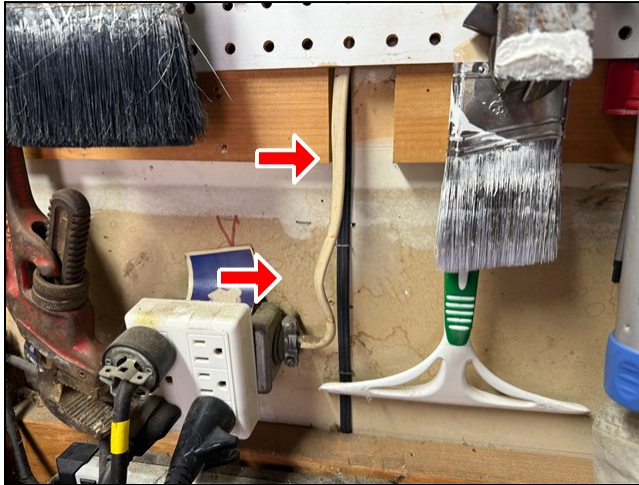
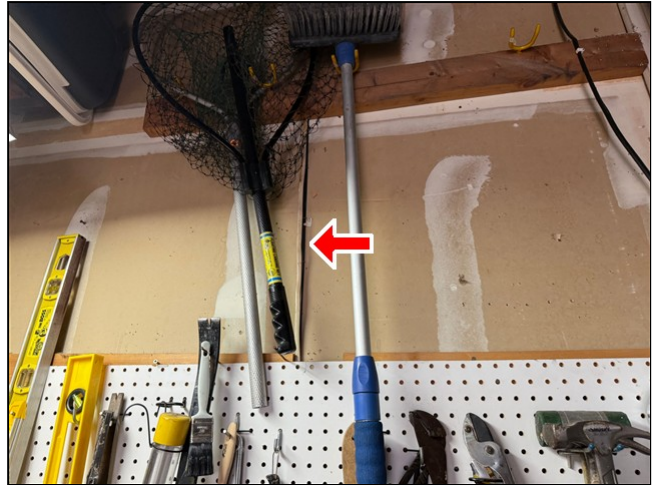
6.1 Item 1 (Picture) Electrical System

(1) **Safety Issue:** Exposed Romex wiring was observed at the garage in various locations. Romex wiring or any type of exposed wiring should not be accessible. It is suggested that the wiring be covered by a qualified professional.

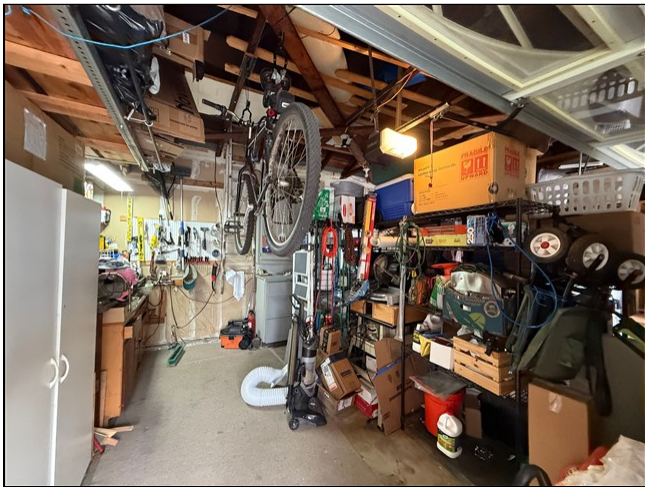
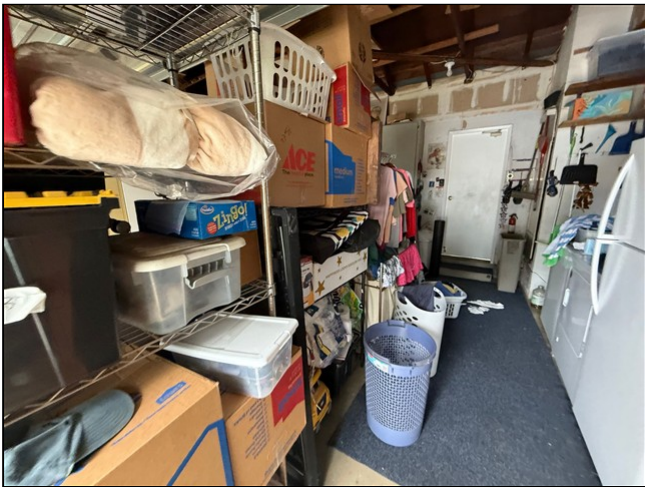
10.4 Item 1 (Picture) Garage

**Monitor:** The occupants belongings at the garage prevents full view.
