# EQUITY BUILDING INSPECTION

## RESIDENTIAL BUILDING INSPECTION

26 Oceanaire Dr  
Rancho Palos Verdes, CA 90275

11/14/2024

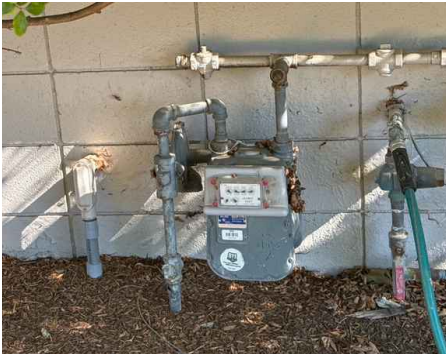
Front

I recommend that everyone living in the home familiarizes themselves with the location of the gas meter and the disconnect used to shut off the gas to the whole house.

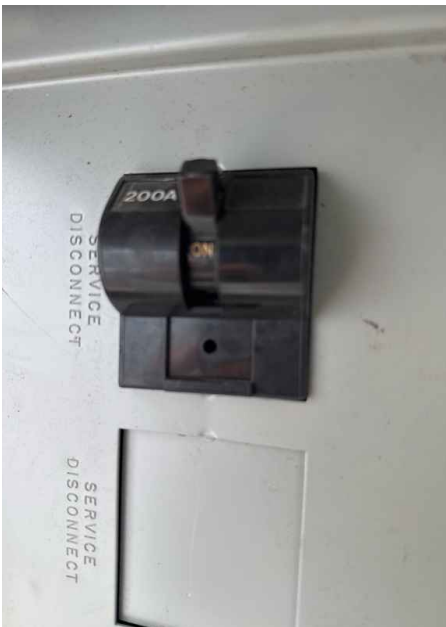
#### Electrical - Main Disconnect: Location

Rear of building

I recommend that everyone living in the home familiarizes themselves with the location of the electrical service panel and the disconnect used to shut off power to the whole house. Knowing the location of the panel may be beneficial to all members of the family, whether it's to reset a tripped breaker or to disconnect power in the event of an emergency.

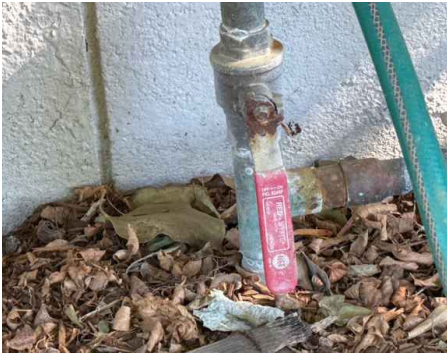
### Water - Main Shut Off Valve: Location

Front side

I recommend that everyone living in the home familiarizes themselves with the location of the main water supply.

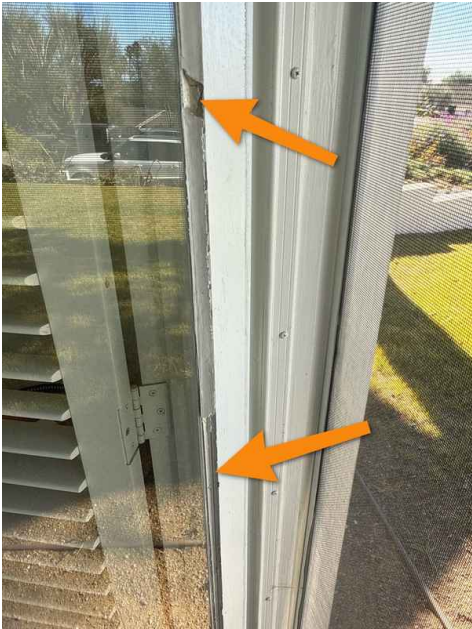
Sealant around widows was old, discolored, cracked, and needed maintenance to avoid potential moisture intrusion. The Inspector recommends maintenance be performed by a qualified contractor.

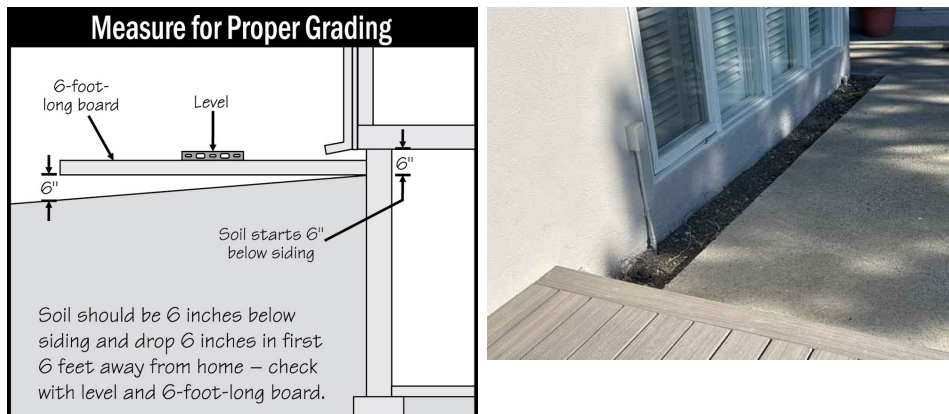
#### **IMPROPER GRADING**

Areas of the grading are not properly sloped away from the home. In order to promote good drainage of rainwater away from the foundation, I recommend having the grading improved by a qualified landscaping contractor prior to closing.

This image shows proper grading and how to measure it.

Contact a qualified landscaping contractor

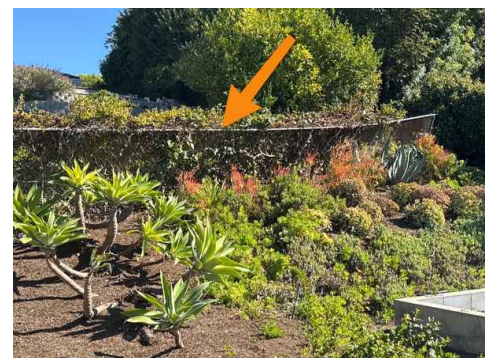
### 4.3.1 Fence - Gates

#### **FENCE - IN NEED OF REPAIRS**

Areas of the fence are in need of repair. I recommend having this evaluated and repaired/replaced as necessary by a qualified fence contractor prior to closing.

Contact a qualified fencing contractor

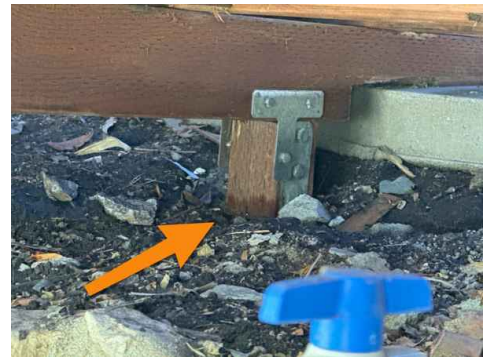
### 4.6.1 Deck

#### **DECK SUPPORTS IN DIRT**

One or more sections of the decking support numbers are in direct contact with the earth. We recommend repair to prevent deterioration and termite damage.

Contact a qualified professional.

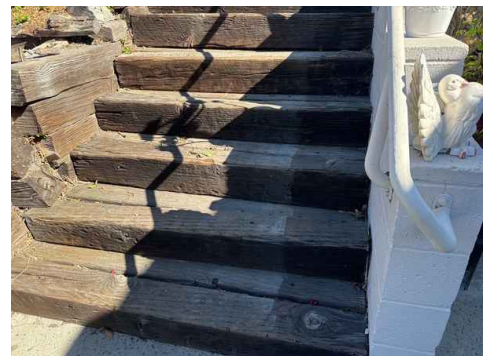
Stairs/steps are uneven in height and/or do not meet current building safety standards for rise and run. This is a possible safety concern. Recommend review by a qualified professional for repair or replacement as necessary.

Contact a qualified professional.

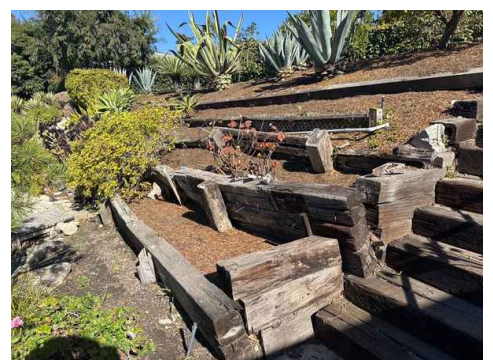
4.12.1 Retaining walls

**RETAINING WALL - NOT PROPER**

Contact a qualified professional.

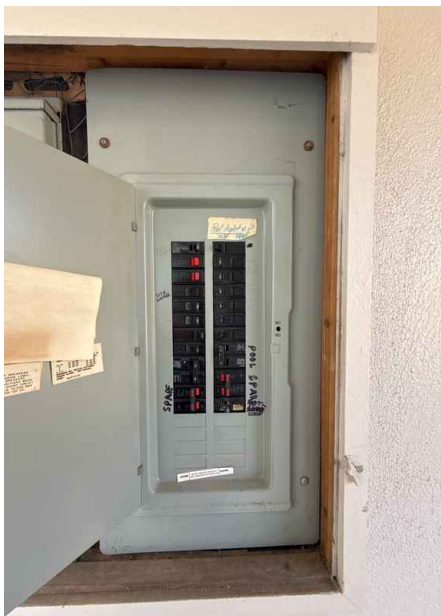
#### Service Panel(s) / Wiring: Picture of Service Panel

## Service Panel(s) / Wiring: Panel(s) ok

The main electrical panel, any installed sub panels, and their associated components, or found to be in serviceable condition with exceptions noted within.

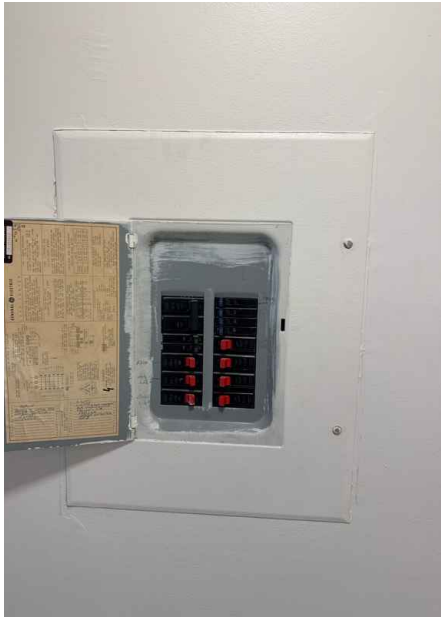
**Grounding: Grounding OK**

The grounding element was found to have been installed properly.

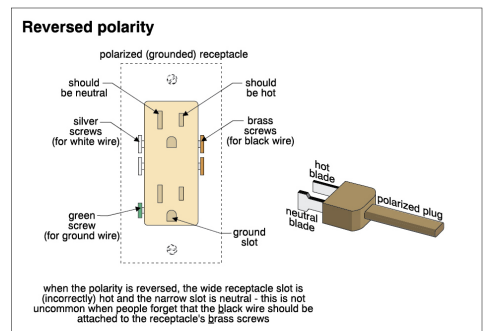
#### RECEPTACLES - 3 PRONG UNGROUND 2 WIRE

#### NUMEROUS LOCATIONS

3-slot receptacles (outlets) were installed in one or more areas without a ground wire hookup. These do not have an equipment ground. These outlets should either be upgrade to grounded receptacles, which typically requires installing new wiring from the main panel. The NEC (National Electric Code) also allows these outlets to be replaced with GFCI protection as a repair to use grounded appliances with them. Appliances that require a ground should not be used with ungrounded receptacles. Examples of such appliances include computers and related hardware, refrigerators, freezers, portable air conditioners, clothes washers, aquarium pumps, and electrically operated gardening tools. The client should be aware of this limitation when planning use for various rooms, such as an office. Consult with a qualified electrician about upgrading to 3-wire, grounded circuits or installing GFCI protection.

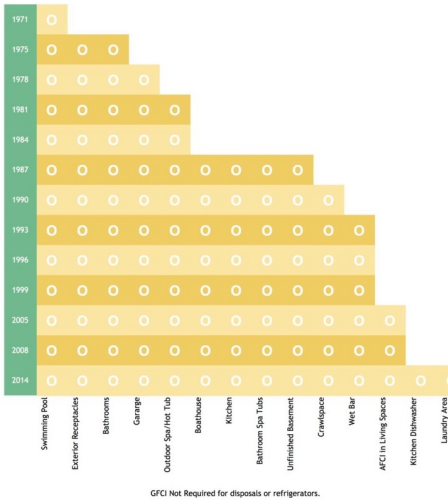
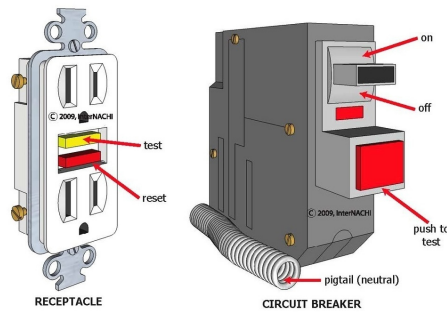
### 5.12.1 GFCI & AFCI

#### **GFCI PROTECTION NOT INSTALLED**

Ground Fault Circuit Interrupters

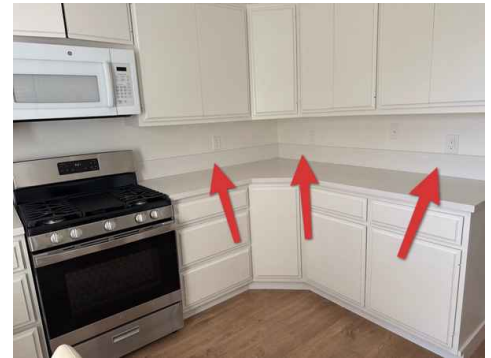
5.12.2 GFCI & AFCI

**NOT ALL COUNTER GFCI**

Contact a qualified professional.

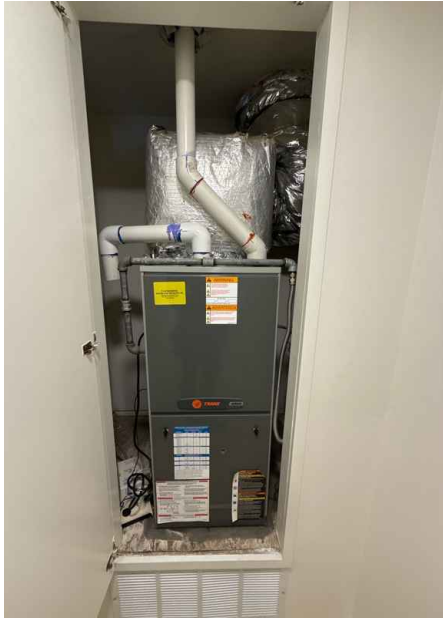
**Forced Air Furnace rear unit:  
Equipment Photo**

**Forced Air Furnace rear unit:  
Heater Age(s)**  
Unknown

**Forced Air Furnace rear unit:  
Thermostat Location**  
Hallway

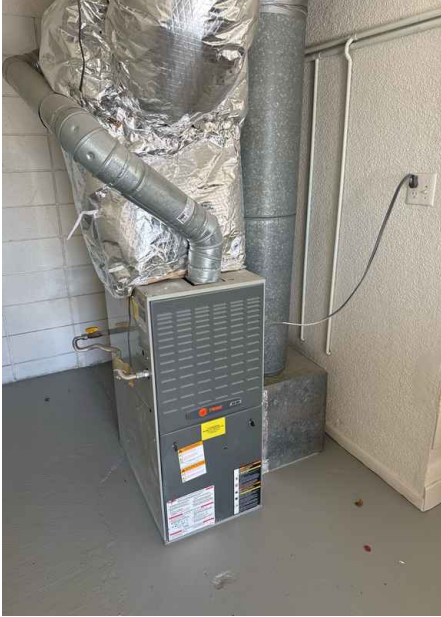
**Forced Air Furnace: Equipment Photo**

**Forced Air Furnace: Heater Age(s)**  
Unknown**Forced Air Furnace: Energy Source**

Natural Gas

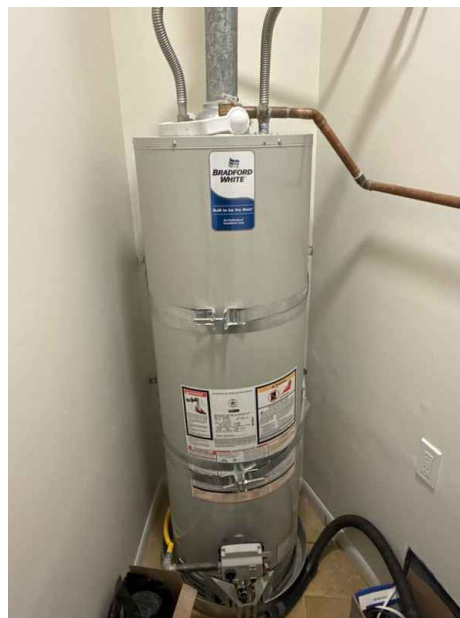
#### Water Heater: Earthquake straps Water Heater: Equipment Photo

Yes

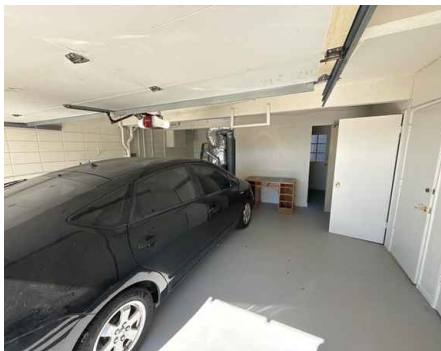
### General: General Photos

The finished surfaces, garage door opener if installed, hardware, windows, and doors were found to be generally in good condition at the time of our inspection with possible exceptions noted herein.

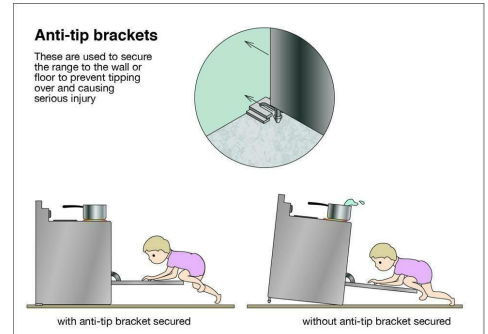
## 12.6.1 Range/Oven Combination

**ANTI-TIP BRACKET - NOT INSTALLED**

This image shows how an anti-tip bracket can prevent injury.

Contact a handyman or DIY project

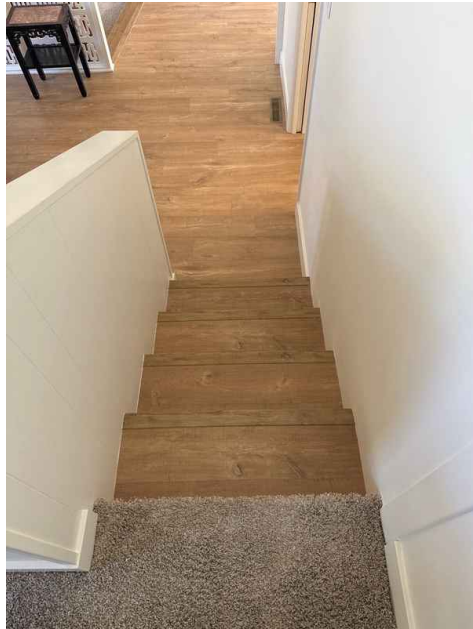
## 13.8.1 Steps, Stairways &amp; Railings

**HANDRAILS - MISSING**

Contact a qualified professional.

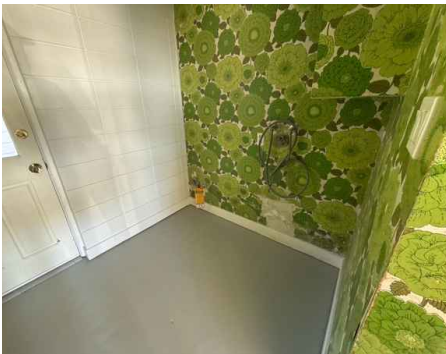
### General: All ok

Both the washer and dryers visible hookups were found to be in acceptable condition where visible. We recommend cleaning the dryer vent on a regular basis to prevent buildup. The operation of these units is outside the scope of this type of inspection.

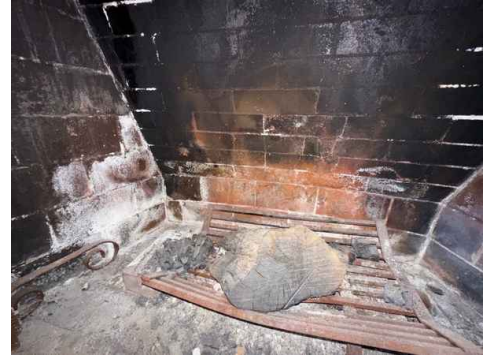
### 17.2.3 Masonry Wood Burning Fireplace

#### **EFFLORESCENCE**

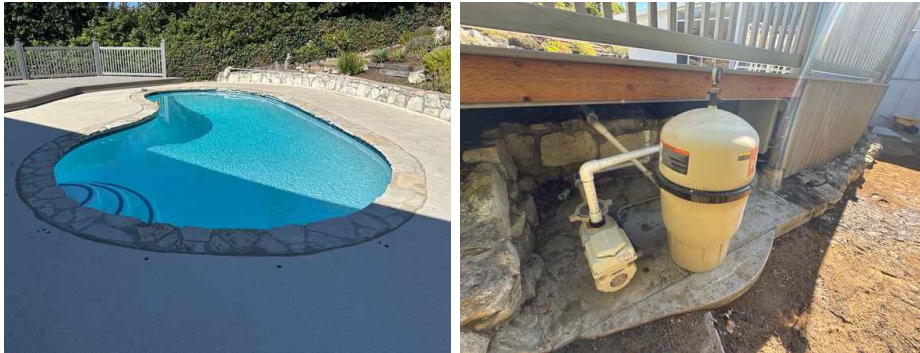
### General: Pool/Spa View

### General: Pool operated

The pool and or Spa operated properly with exceptions noted herein
