# WOOD DESTROYING PESTS AND ORGANISMS INSPECTION REPORT

| Building No.<br><b>649</b> | Street<br><b>Asilo</b> | City<br><b>Arroyo Grande</b> | Zip<br><b>93420-1413</b> | Date of Inspection<br><b>10/24/2025</b> | Number of Pages<br><b>1 of 7</b> |

**Report #: 111996**

| General Description:<br><b>Single story; Single family residence; Stucco exterior; Composition shingle roof; Vacant.</b> | Inspection Tag Posted:<br><b>GARAGE</b> |

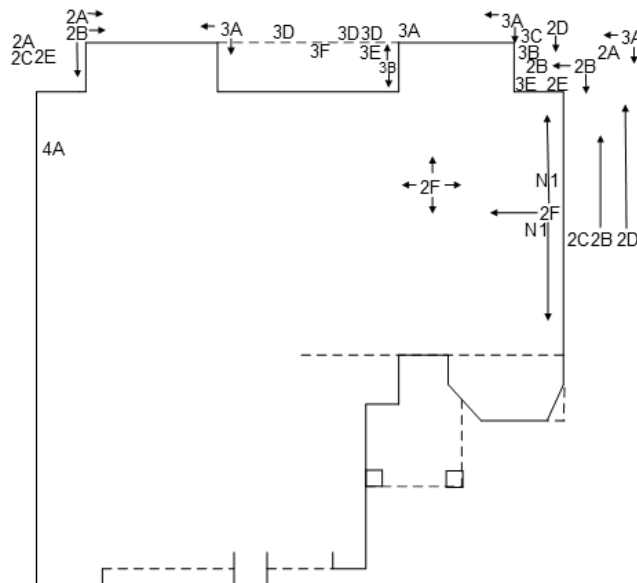
\*\*\*Complete Inspection Report\*\*\*  
 Diagram not to scale  
 Finding locations approximate

| Finding: | 2A | Evidence of Drywood Termite infestation was found at the exterior and appears to extend into inaccessible areas of the structure. |
| Finding: | 2B | Drywood Termite damage was found at the fascia. |
| Finding: | 2C | Minor Drywood Termite damage was found at the outrigger. |
| Finding: | 2D | Drywood Termite damage was found at the sheathing. |
| Finding: | 2E | Drywood Termite damage was found at the rafter end. |
| Finding: | 2F | Evidence of Drywood Termite infestation was found at the attic. |

Finding: 3A Fungus damage was found at the fascia of the eave area.

Finding: 3B Fungus damage was found at the roof sheathing of the eave area.

Finding: 3C Fungus damage was found at the outrigger.

Finding: 3D Fungus damage was found at the patio cover pickets.

Finding: 3E Fungus damage was found at the exterior door frame.

Finding: 3F Fungus damage was found at the base of the patio cover post.

Finding: 4A The toilet was found to be loosely bolted to the floor. This creates a potential source of leakage.

| Recommendation: | | Seal the structure and fumigate with a gas lethal to Drywood Termites (Sulfuryl Fluoride). All occupants and pets must vacate the structure until the fumigation is complete. This company will exercise reasonable caution, but cannot be held responsible for damage to plants, TV antennas or roofing due to the fumigation. Further terms and instructions will be supplied upon request or upon scheduling of the fumigation. Information may also be obtained from the fumigation page on our website at <a href="http://www.keytermite.com">www.keytermite.com</a><br><b>***Fumigations are guaranteed for 5 years from the date completed***</b> |
| Recommendation: | | Remove and replace the damaged portion of the fascia as needed. |
| Recommendation: | | Repair the minor damage of the wood member with a wood filler. |
| Recommendation: | | Remove and replace the damaged portion of the sheathing as needed. |
| Recommendation: | | Remove and replace the damaged portion of the rafter end as needed. |

Recommendation: Replace the fungus damaged portions of fascia as needed.

Recommendation: Replace the fungus damaged portions of roof sheathing as needed.

Recommendation: Remove and replace the damaged portions of the outrigger as needed to eliminate the fungus infection and damage.

Recommendation: Remove and replace the damaged portions of the patio cover pickets as needed to eliminate the fungus infection and damage.

Recommendation: Replace the damaged portions of the door frame as necessary.

Recommendation: Cut the post at the base to remove the rotted portions of wood. Insert pressure treated wood pad(s).

Recommendation: Reset the toilet using a new wax seal and bolts. Additional costs may apply if the toilet flange is found to be damaged or if existing supply line/valve cannot be reused.
