Building No.	Street		City		Zip	Date of Inspection	Number of Pages
1211	Mariah Lane		Paso Robles		93446	01/30/2023	1 of 6
	PO Box 969,	and PEST C , Atascadero, CA 805-466-8026 fax	93423-0969			ATOR IS AN ER FIELD. TIVE TO THE LD BE REFER.	CONTROL EXPERT IN QUESTIONS IIS REPORT ERRED TO
Ordered by: Jeremy Ho 1211 Maria Paso Robl		Jeremy H 5490 Jaro	r and/or Party of Interest: loward dine Road bles, CA 93446		Report sent to: Remax Parkside Kyler Hamann 711 12th Street Paso Robles, Ca		
COMPLETE	E REPORT⊠ I	LIMITED REPORT	SUPPLEMENTAL	. REPORT [REINS	PECTION REP	ORT 🗌
General Description: Single story; Single family residence; Tile roof; Stucco exterior; Vacant.					nspection Tag Posted:		
				(Other Tags Posted:		
	has been made of the structure y other structures not on the dia		n in accordance with the Structur	ral Pest Cont	rol Act. Detached por	ches, detached s	teps, detached
	ean Termites Dryv	wood Termites tes that there were visible p	Fungus/Dryrot 🗵 (roblems in accessible areas. Read	Other Find	ings 🗵 Furth details on checked item	ner Inspection

Complete Inspection Report

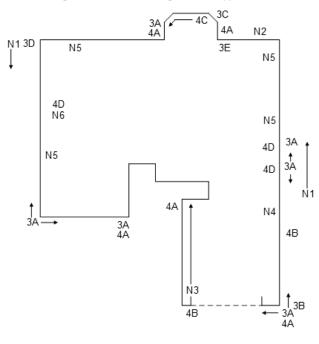
Diagram not to scale-Finding locations approximate

Finding: 3A Fungus damage was found at the fascia of the eave area.

Finding: 3B Fungus damage was found at the rafter end of the eave area.

Finding: 3C Minor fungus damage was found at the fascia. Replacement of the wood member appears

to be impractical.

Finding: 3D Fungus damage was found at the wood members of the eave area.

Finding: 3E Minor fungus damage was found at the door jamb. Replacement of the wood member

appears to be impractical.

Finding: 4D Moisture damage has occurred to the baseboard.

Finding: 4A An excessive moisture condition exists due to leakage at the gutters.

Finding: 4B An excessive moisture condition exists due to cracks or holes in the exterior stucco that

may allow leakage into the interior of the wall spaces.

Finding: 4C Moisture damage was noted at the interior window sill and appears to have been caused

by leakage at the window frame.

Recommendation: Replace the fungus damaged portions of fascia as needed.

Recommendation: Replace the fungus damaged portions of the rafter end as needed.

Recommendation: Remove the minor damage with a wood chisel. Fill the void with an exterior wood filler.

Recommendation: Replace the fungus damaged portions of the wood members as needed.

Recommendation: Remove and replace the baseboard.

Recommendation: Make the necessary corrections to eliminate the excessive moisture condition.

Recommendation: Patch the holes or cracks in the exterior stucco to eliminate the excessive moisture

condition.

Recommendation: Repair the damaged window sill and seal the window frame as needed to control the

leakage.
