WOOD DESTROYING PESTS AND ORGANISMS INSPECTION REPORT

Building No. 3579	Street Seaglen Drive	City Rancho Palos Verdes	ZIP 90275	Date of Inspection 04/20/2022	Number of Pages 4
----------------------	-------------------------	-----------------------------	--------------	----------------------------------	----------------------

Report # : 12801
 Registration # : PR7795
 Escrow # :
 CORRECTED REPORT

GENERAL DESCRIPTION: 2 story stucco tile roof attached garage occupied	Inspection Tag Posted: Attic
	Other Tags Posted:

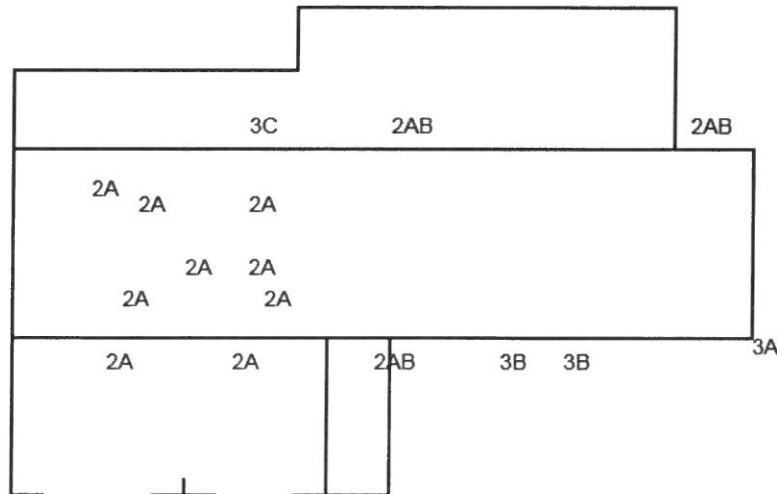
Diagram Not To Scale

2A Drywood termites at attic plumbing access and fascia

2B Termite damage at fascia boards.

3A Fungus damage at fascia

3B Fungus damage at shiplap

3C Fungus damage at deck door.
