Inspector: **Frank Bua**

Property address: **1685 S Belle Ave  
Corona CA 92882-4804**

Inspection date: **Wednesday, October 21, 2026**

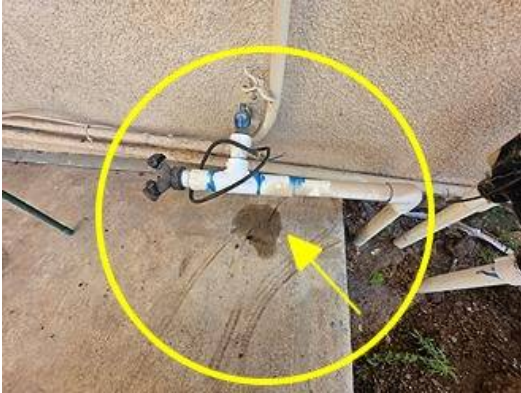
**Photo 3-1**

Concern: A minor drip/leak was noted at a PVC pipe connection supplying the added exterior Hose Faucet. Repair the leaking connection as required.

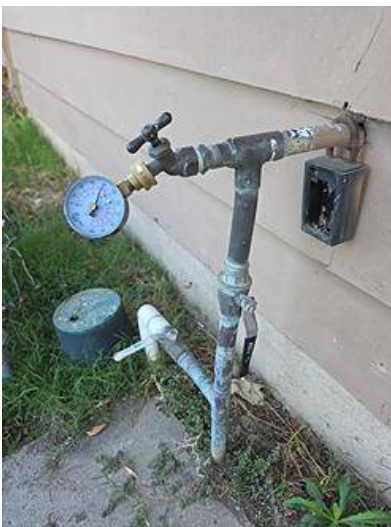
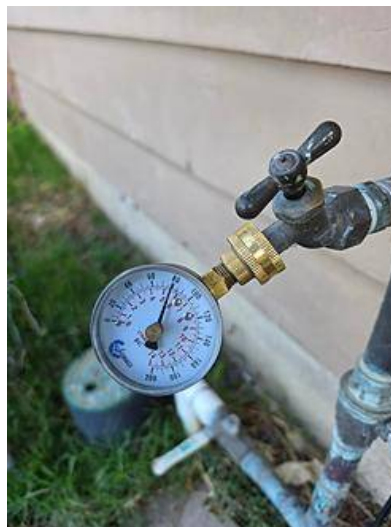
**4) Serviceable** - Water House Service & Pressure=80

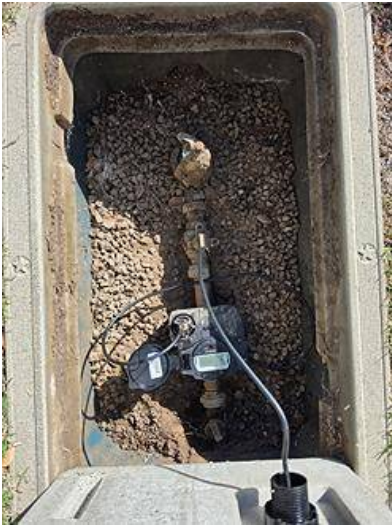
**Photo 5-1**

Comment: No movement was observed at the water meter when plumbing fixtures were at rest.

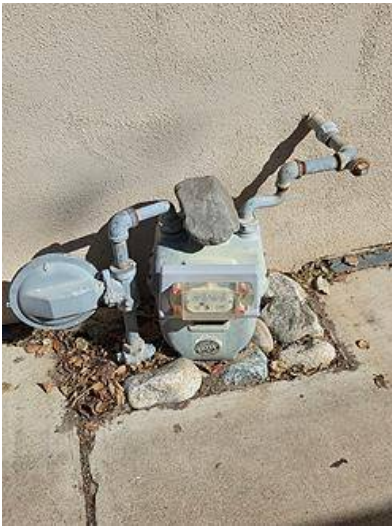
**Photo 6-1**

Comment: No dial or meter movement was observed while Gas Appliances were at rest

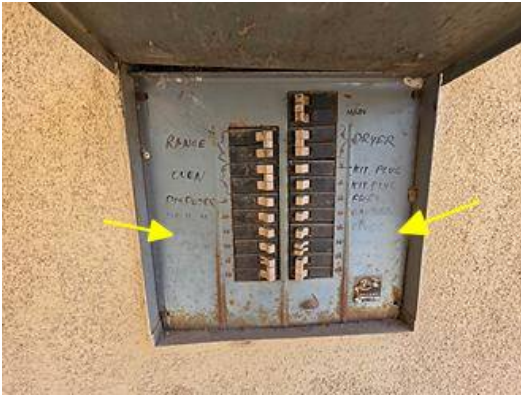
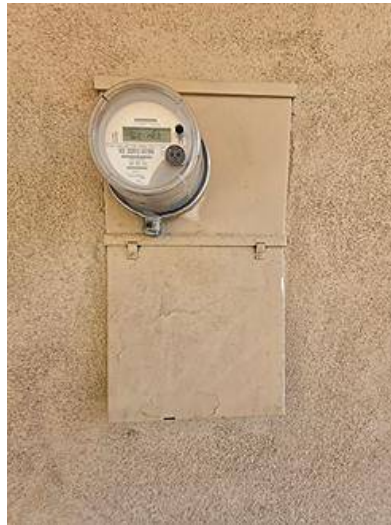
Photo 7-1

- (1) Breaker identification labeling was missing/incomplete. Identify and properly label all breakers as required.
- (2) The Electrical Panel outer cover did not latch securely due to a missing latch tab. Repair or replace the latch mechanism as required.

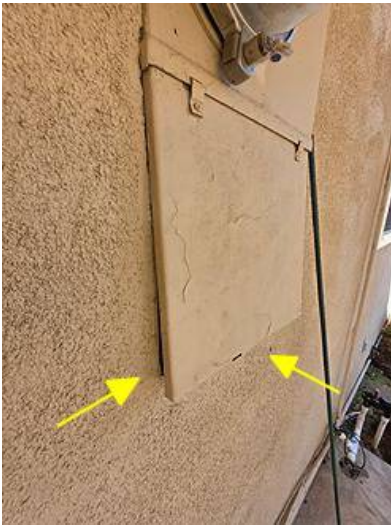
Photo 7-3

(1) Breaker identification labeling was missing/incomplete. Identify and properly label all breakers as required.

(2) The Electrical Panel outer cover did not latch securely due to a missing latch tab. Repair or replace the latch mechanism as required.

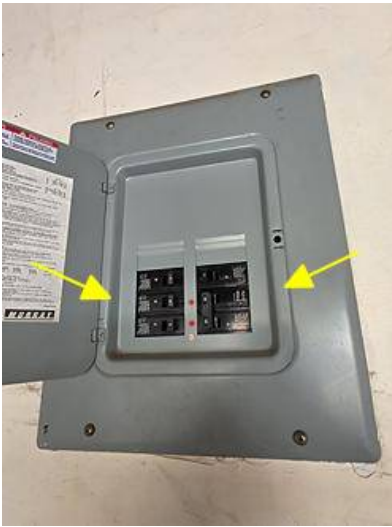
Photo 8-1

**8) Needs Attention, Install/Missing** - Electrical SubPanel-Missing Breaker Labeling  
Concern: Breaker identification labeling was missing. Identify and properly label all breakers.  
Note: The Panel was otherwise in good condition.  
Related Professional-Electrician, Any Qualified

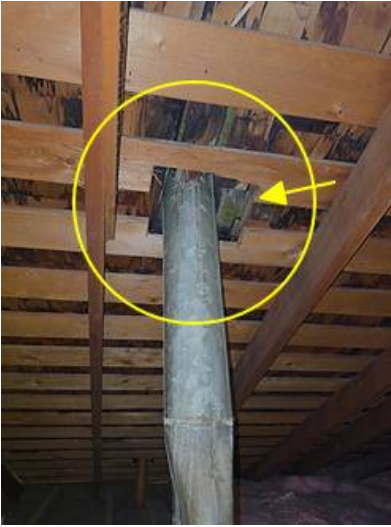
**Photo 9-1**

Concern: The Furnace metal vent pipe was in contact with or too close to combustible roofing materials, including the wood shake shingles and roof boards. Proper clearance from combustible materials is required to reduce the risk of fire. Have the vent installation evaluated and corrected as required.

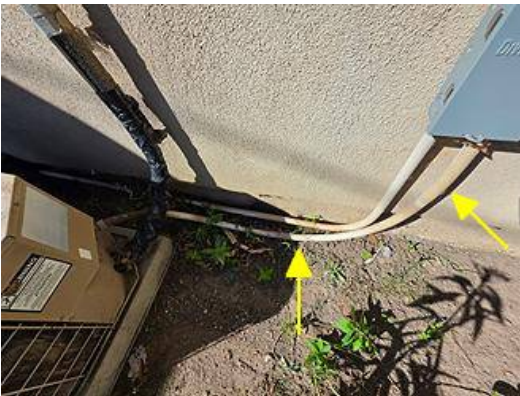
**Photo 10-1**

Concern: The Air Conditioner electrical conduit was not properly secured to the exterior wall near the disconnect box. Secure the conduit within 12 inches of the disconnect box as required.

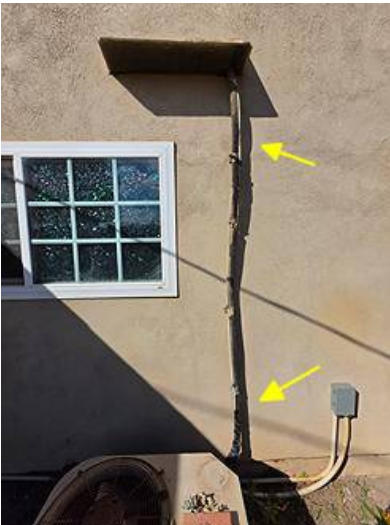
**Photo 12-1**

Concern: The exterior Refrigerant Line Set was exposed and lacked adequate physical protection along the wall. Install a protective metal chase or channel to enclose and protect the lines from damage.

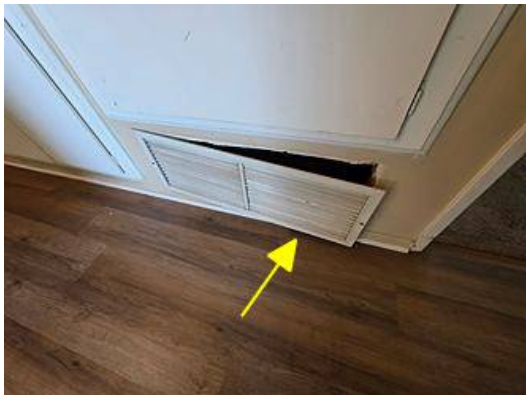
**Photo 13-1**

**13) Needs Attention, Repair** - Return Air Vent-Loose  
Concern: The Return Air vent grille was loose and partially detached. Secure the grille as required.  
Related Professional-HVAC, Any Qualified

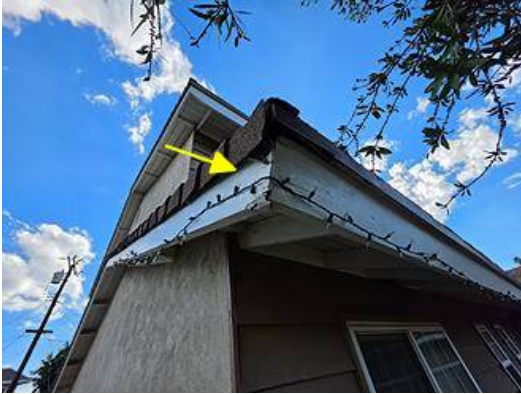
**Photo 18-1**

Concern: Some visible and possible underlying wood damage in one or more location of the eaves was noted. Evaluate and Repair as needed.

Note: A Structural Pest Control inspection is recommended to evaluate for the presence of wood-destroying pests and/or wood damage and to recommend any necessary repairs or treatments. Refer to existing Structural Pest Control report, if available.

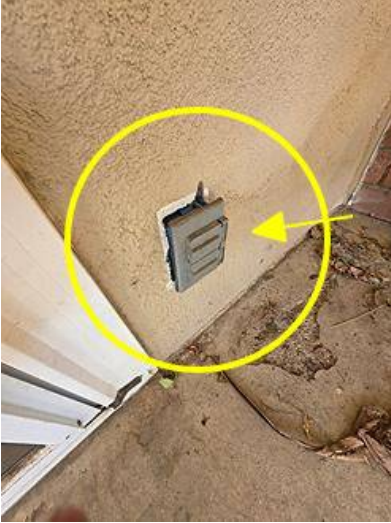
**Photo 21-1**

Concern: The exterior Electrical Box adjacent to the rear Patio Door was loose and partially detached from the wall. Secure the box as required.

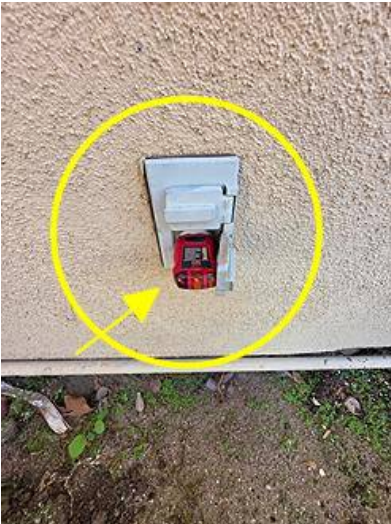
**Photo 22-1**

**22) Safety, Needs Attention, Repair** - Exterior Electrical Outlet-Ungrounded

Concern: The exterior Electrical Outlet tested as ungrounded. Evaluate and correct the grounding as required.

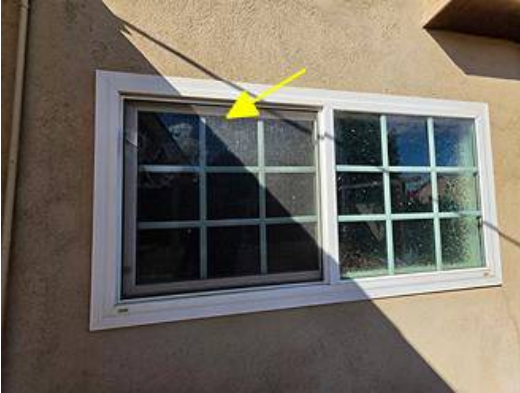
**Photo 23-1**

Concern: Two Window Screens at the rear of the home were damaged. Repair or replace as required.

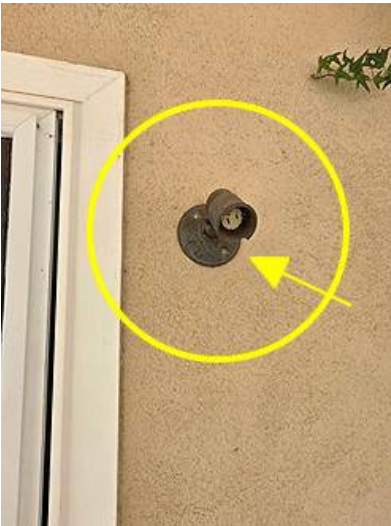
**Photo 24-1**

Concern: The exterior Light Fixture was deteriorated and missing a bulb. Electrical power was verified at the fixture. Replacement of the Light Fixture is recommended.

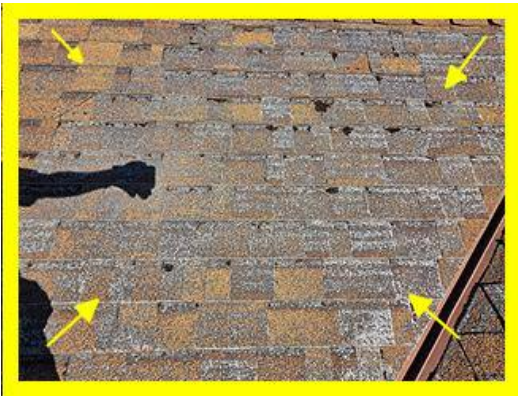
Photo 25-1

Concern: Moderate to significant granule loss and deterioration were observed throughout much of the Shingle Roof. The roofing material is estimated to be 20-25+ or- years old and has reached or exceeded its useful service life. Roof replacement is recommended. Evaluation for replacement by a Roofing professional is needed.

Note: The existing Shingle Roof was installed over original wood shake roofing. When replaced, the existing roofing materials will need to be removed, and roof sheathing installed as required before installing new roofing materials.

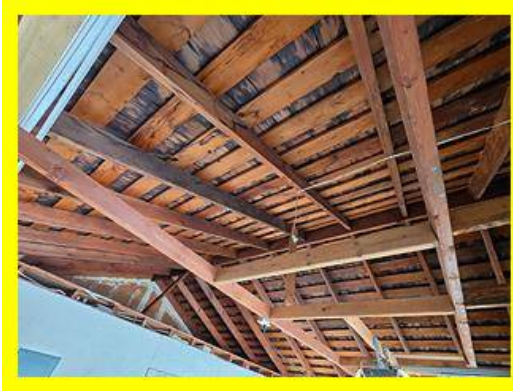
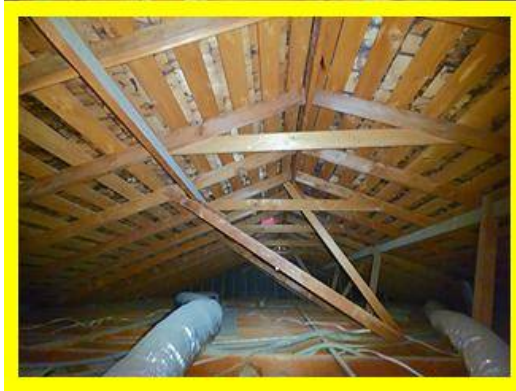
**26) Comment - Original Wood Shake Roofing-Present**

Comment: Original wood shake roofing and spaced roof boards were visible from the attic. The existing composition Shingle Roof was installed over this original roofing material.

Note: See related Shingle Roof replacement concern regarding removal of existing roofing materials and installation of roof sheathing when the Roof is replaced.

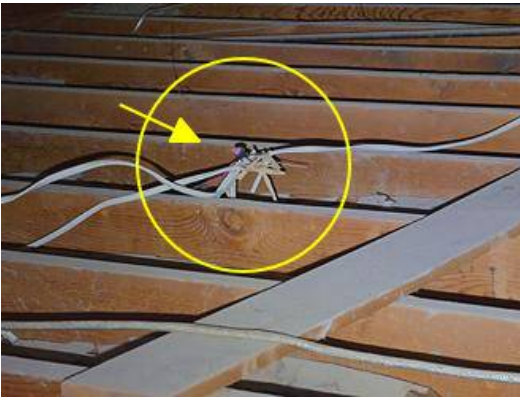
**Photo 27-1**

Concern: Electrical wire splices were observed outside a covered junction box in the Attic. Install the splices in an approved, covered junction box as required.

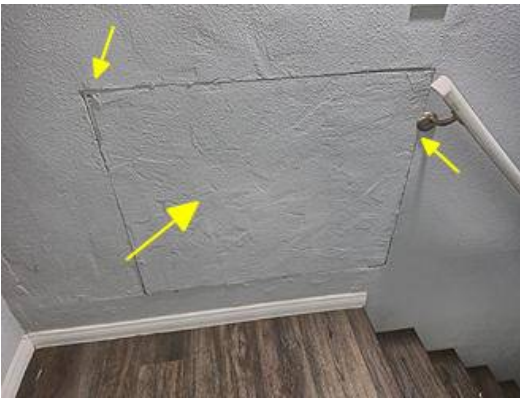
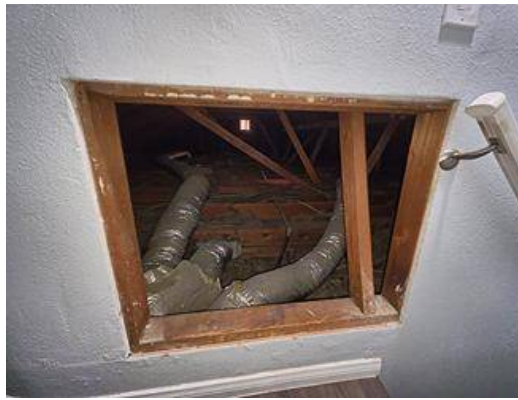
**Photo 28-1**

Concern: The Attic access panel consisted of a drywall cutout secured by a screw and metal bracket. Replace with a conventional, properly supported and secured Attic access panel or door as required.

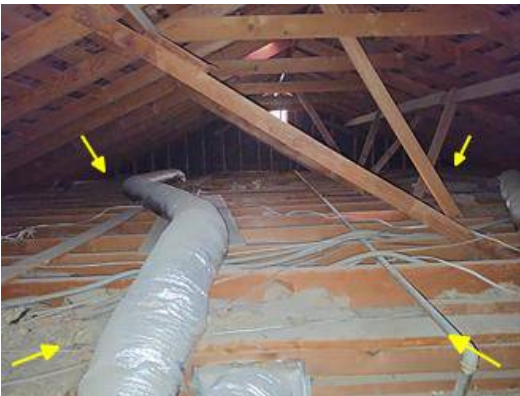
**Photo 29-1**

Concern: The paper backing on the existing Attic insulation was deteriorated in several areas. Evaluate the insulation for removal or replacement as required.

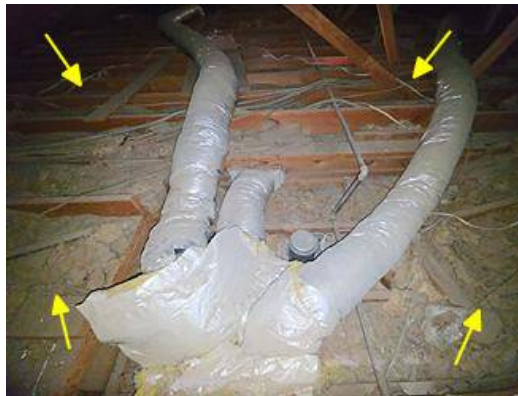
**Photo 29-2**

**29) Needs Attention, Replace, Evaluate - Attic Insulation-Deteriorated Paper Backing**

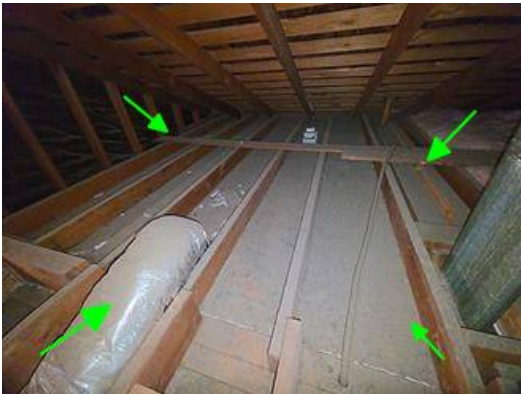
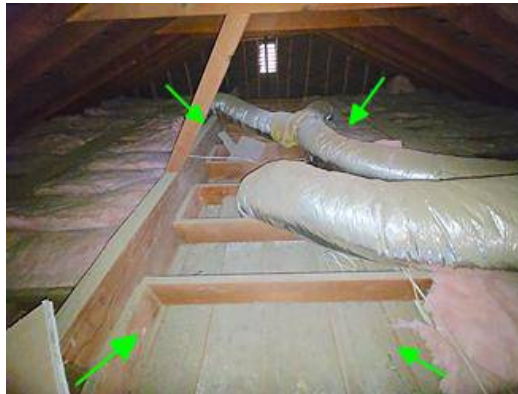
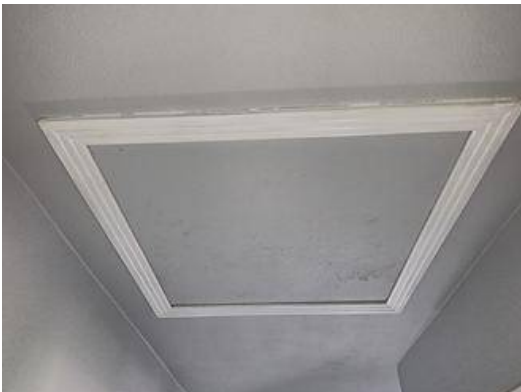
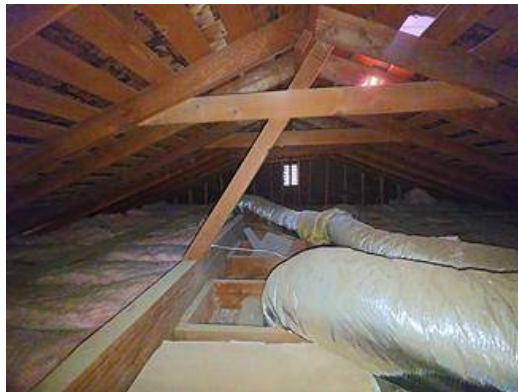
### 30) *Needs Attention, Install/Missing* - Attic Insulation-Incomplete Installation-Second Floor

Note: The Home may not have been originally insulated.

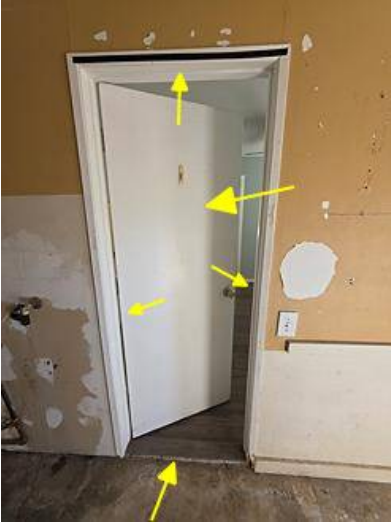
**Photo 31-1**

**31) Safety, Needs Attention, Repair, Install/Missing** - Garage Entry Door-Missing Self-Closing Device/Seals  
Concern: The solid-core door between the Garage and living space lacked a self-closing device, weather-stripping, and bottom seal. Install the missing components as required.

Note: Proper door closure and sealing help reduce the entry of smoke, fumes, and carbon monoxide from the Garage into the home.

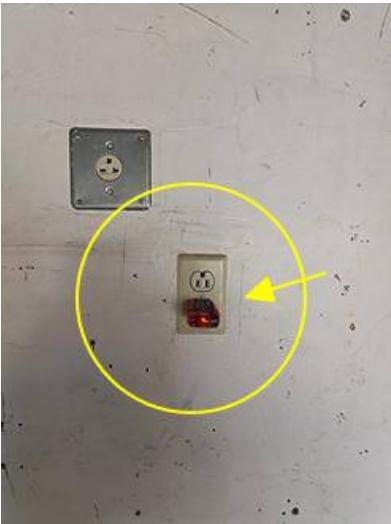
**Photo 32-1**

Concern: The Electrical Outlet on the side wall tested was ungrounded. Evaluate and correct the grounding as required.

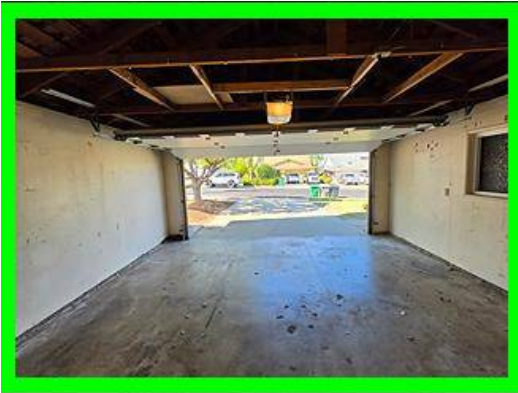
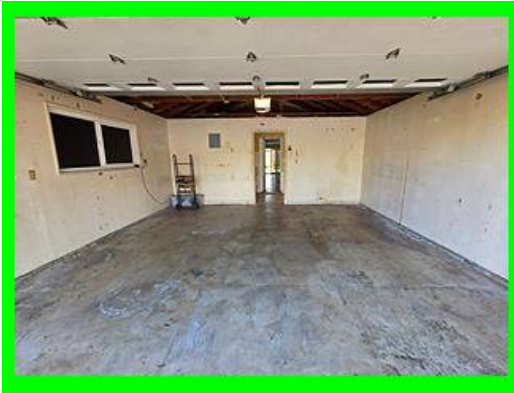
**33) Needs Attention, Maintain, Cosmetic** - Garage-General Cosmetic Conditions

Comment: General cosmetic wear, wall and ceiling damage, floor staining, and unfinished surfaces were noted throughout the Garage. Patch, repair, and refinish for improved appearance as needed.

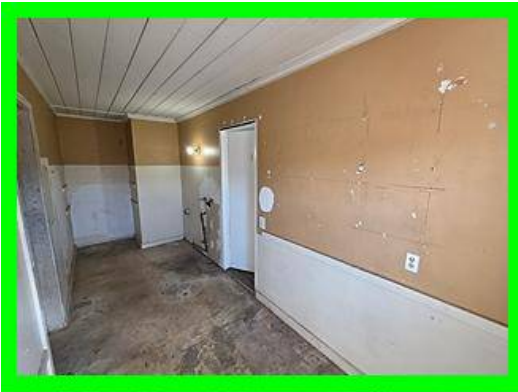
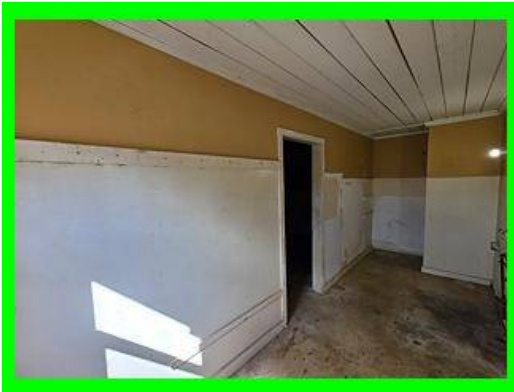
**34) Needs Attention, Maintain, Cosmetic** - Laundry Area-General Cosmetic Conditions

Comment: General cosmetic wear, wall damage, and unfinished surfaces were noted throughout the Laundry Area. Patch, repair, and refinish for improved appearance as needed.

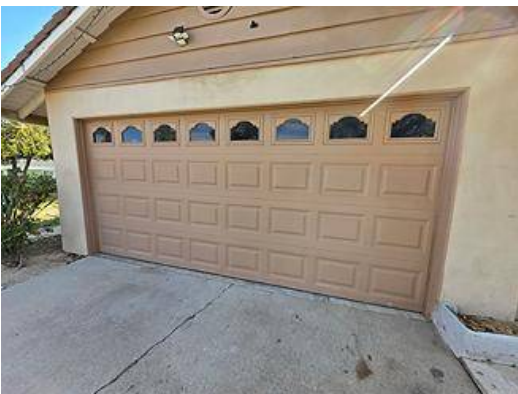
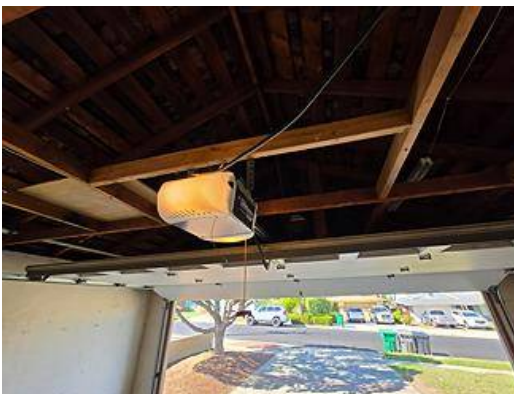
**35) Serviceable, Comment** - Garage Door & Opener:

Comment: The garage door and opener for the double door were tested and found to be operable at the time of inspection and appeared to be in serviceable condition.

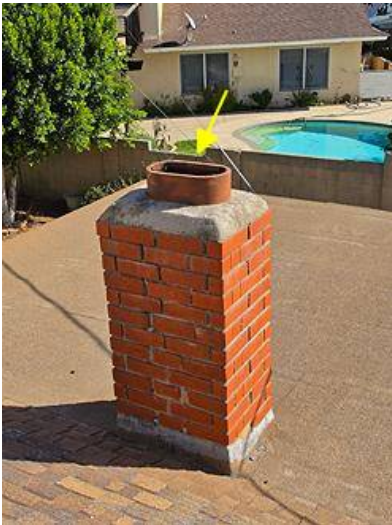
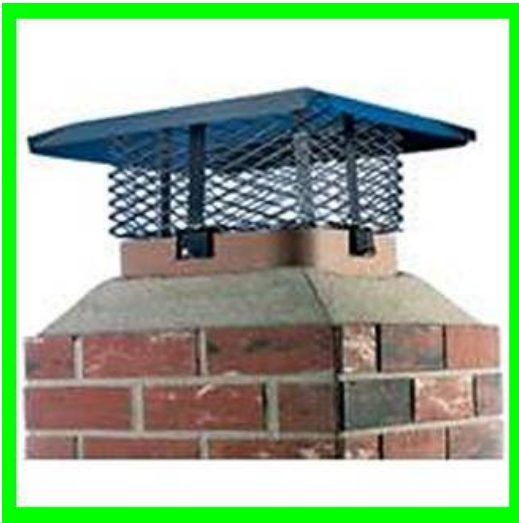
Photo 36-1

**36) Safety, Needs Attention, Repair, Comment** - Fireplace Chimney-Damaged Spark Arrestor Screen  
Concern: The spark arrestor screen within the chimney flue was damaged/collapsed. Repair or replace the screen, or install an approved chimney cap with a spark arrestor as an alternative.  
Related Professional-Fireplace, Chimney

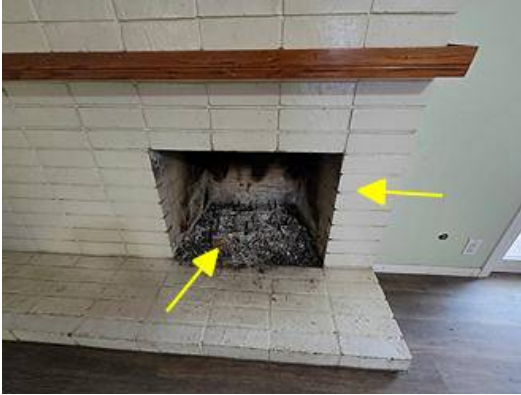
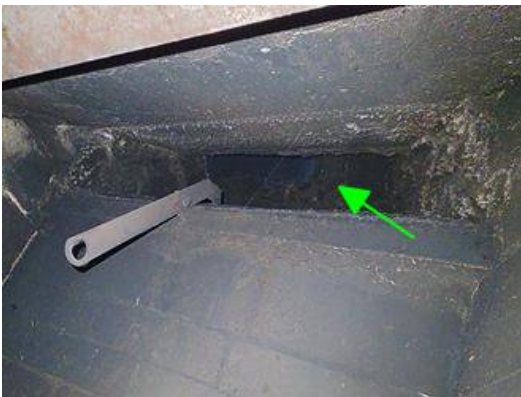
Photo 37-1

(1) A protective Fireplace screen was missing/not installed. Provide a suitable Fireplace screen as required.

(2) Ash and debris accumulation was noted within the Firebox. Have the Firebox and chimney cleaned and serviced, including inspection of the flue, prior to use.

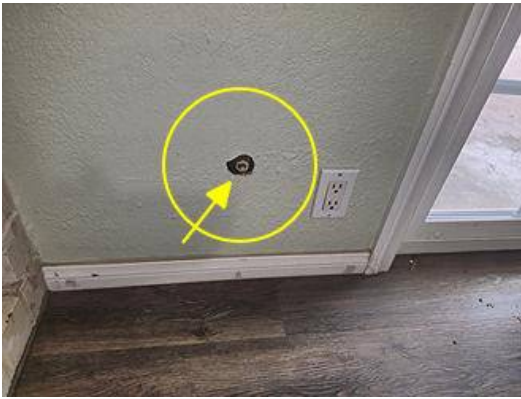
Photo 38-1

Concern: The decorative trim plate at the Fireplace gas shutoff valve was missing/not installed. Install a suitable trim plate as required.

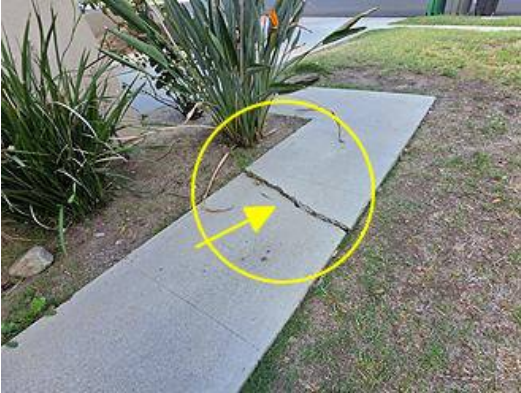
**39) Safety, Needs Attention, Repair** - Concrete Walkways-Front Yard

Concern: A trip hazard was found in the concrete at the main walkway leading to the porch. Grind, ramp, or otherwise correct the uneven surface to reduce trip hazards.

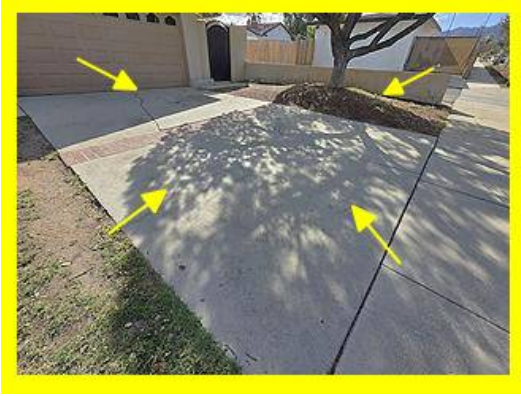
**Photo 40-1**

Concern: Cracking and lifting of the concrete Driveway and adjacent Walkway at the side gate were noted, likely due to nearby tree-root growth. The uneven surfaces present potential trip hazards. Evaluate the tree for possible removal or root remediation and repair or replace affected concrete sections as required.

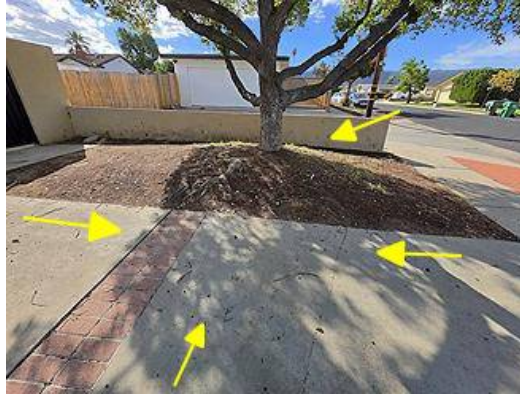
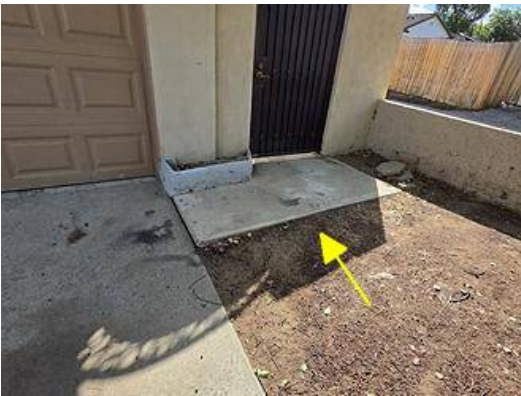
Concern: Cracking and lifting of the concrete Driveway and adjacent Walkway at the side gate were noted, likely due to nearby tree-root growth. The uneven surfaces present potential trip hazards. Evaluate the tree for possible removal or root remediation and repair or replace affected concrete sections as required.

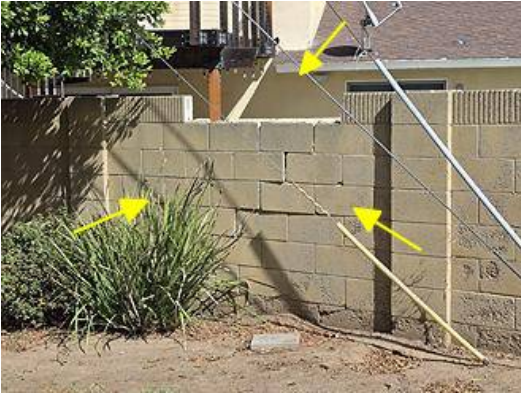
**Photo 41-1**

Concern: Damaged/missing blocks and mortar joint separation were noted at sections of the Block Wall. Repair and repoint affected areas as required.

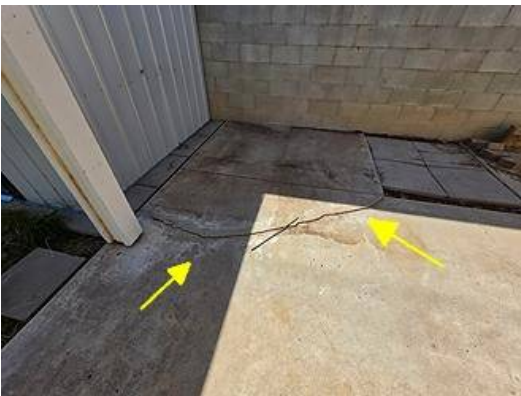
**Photo 42-1**

Concern: Cracking and minor lifting of the concrete were noted at the south end of the Patio. Repair or replace affected sections as required.

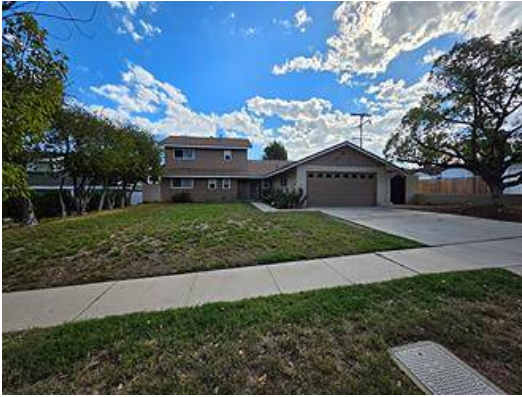
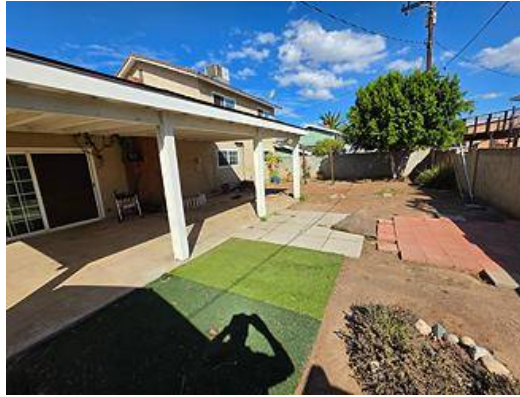
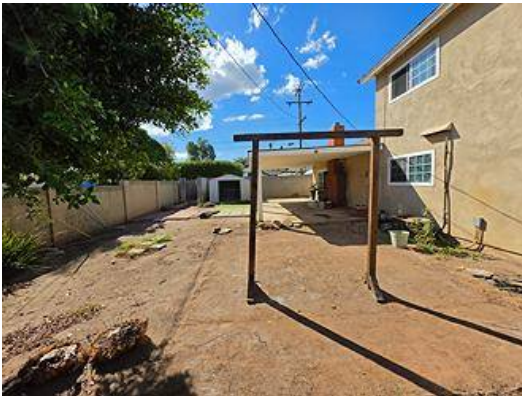
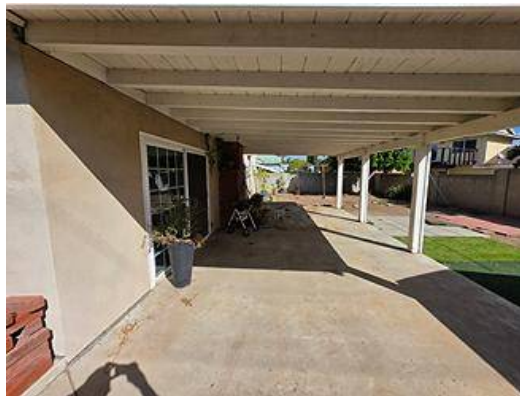
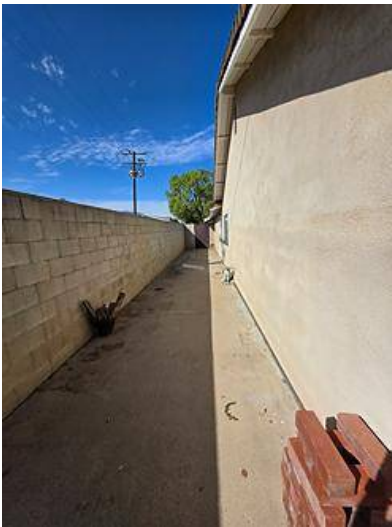
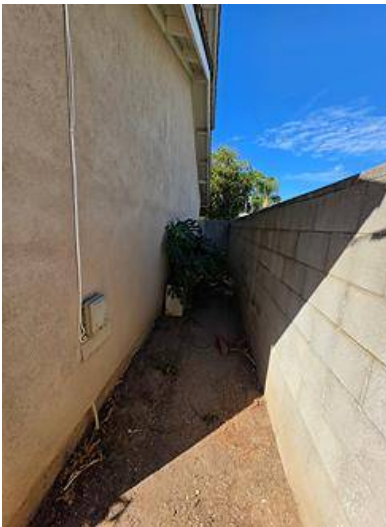
Comment: The front, rear, and side yard areas exhibited deferred maintenance, sparse landscaping, bare soil, and areas needing cleanup and improvements. General yard cleanup, landscaping, grading, and maintenance are recommended as needed.

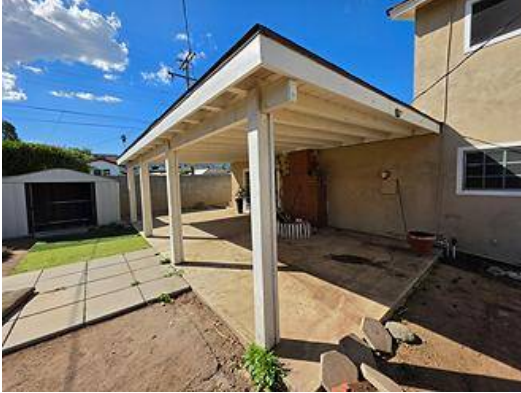
Photo 44-1

Note: A Structural Pest Control inspection is recommended to evaluate for the presence of any possible wood-destroying pests and/or wood damage and to recommend any necessary repairs or treatments. Refer to existing Structural Pest Control report, if available.

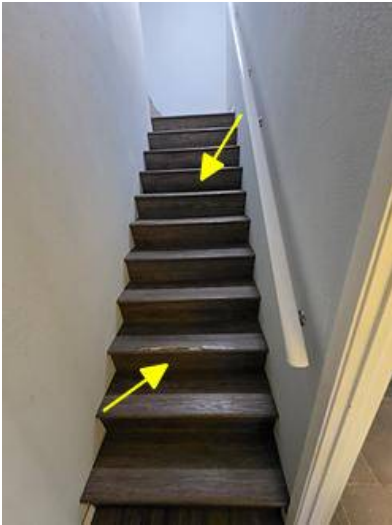
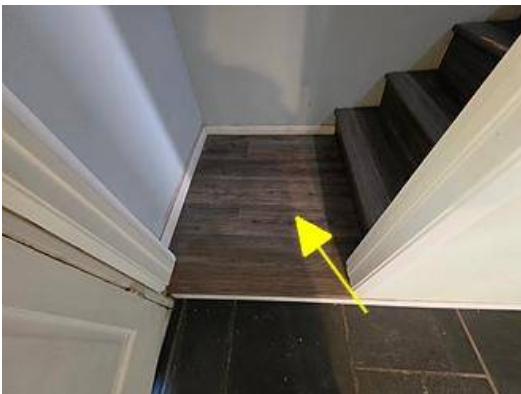
Photo 45-1

(1) Damage and separation of the laminate flooring were noted at several Stairway treads and the upper landing transition. Repair or replace affected flooring and secure loose edges as required.

(2) The lower Stairway landing was loose, creaked, and exhibited movement when walked on. Evaluate the underlying support and secure or repair as required.

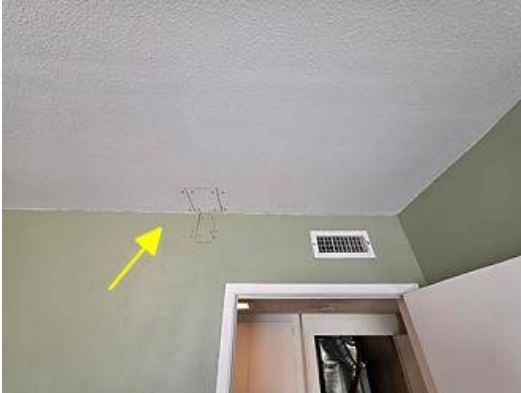
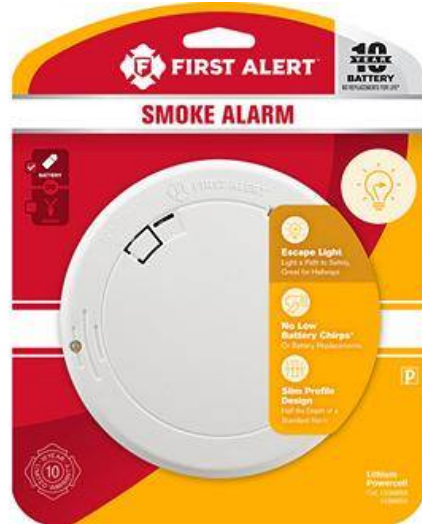
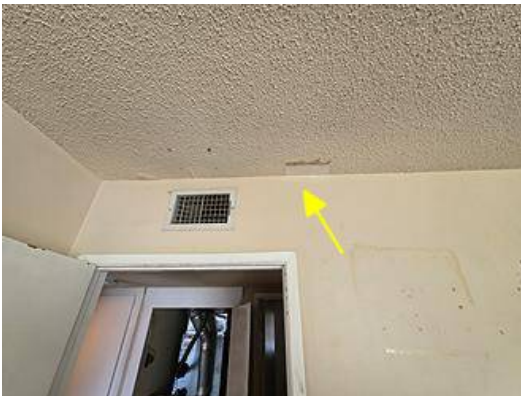
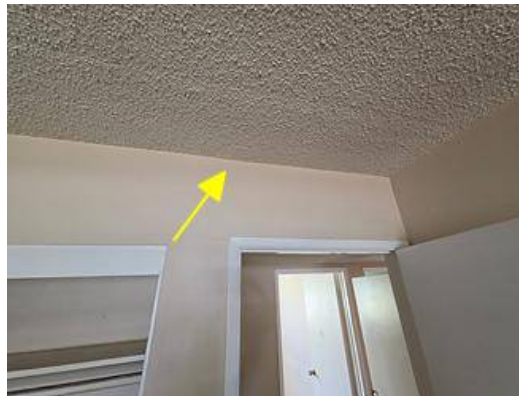
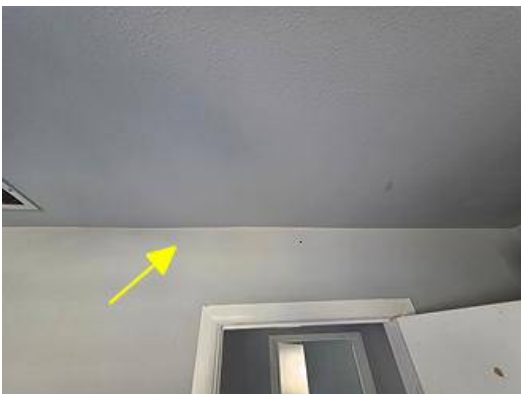
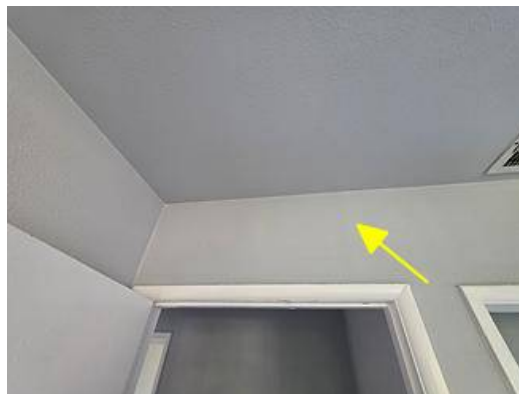
Comment: Smoke Detectors were otherwise installed in the bedroom hallways on both levels.

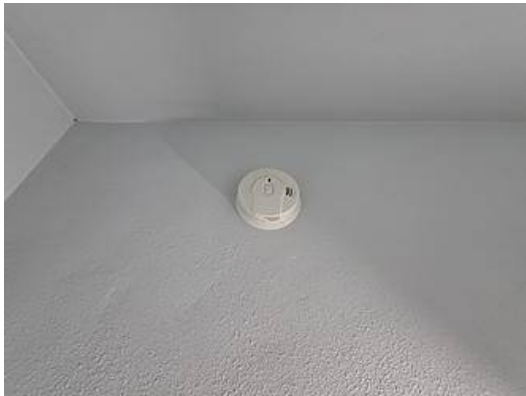
Photo 46-9

**46) Safety, Needs Attention, Install/Missing** - Smoke Detectors-Missing/Not Installed-Bedrooms  
Concern: Smoke Detectors were missing/not installed in all Bedrooms, including the Office/Den (optional Bedroom 6).

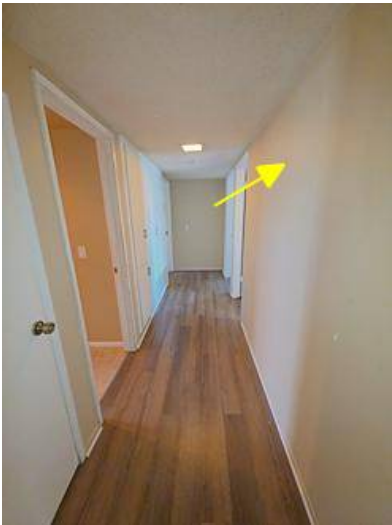
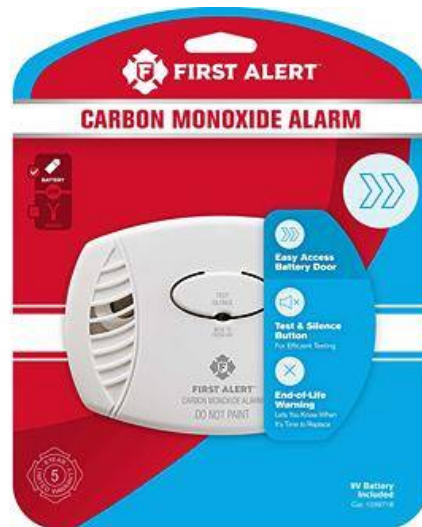
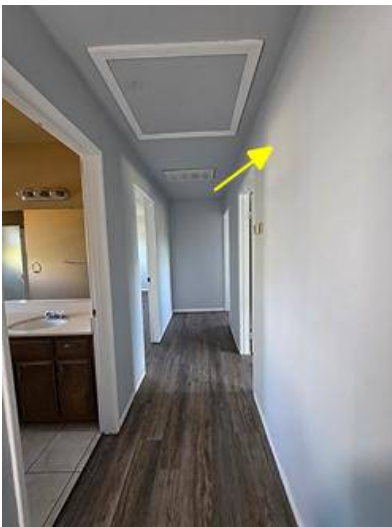
Concern: Carbon Monoxide Detectors were missing/not installed in the Bedroom Hallways on both levels. Install Carbon Monoxide Detectors on each level and outside the sleeping areas as required.

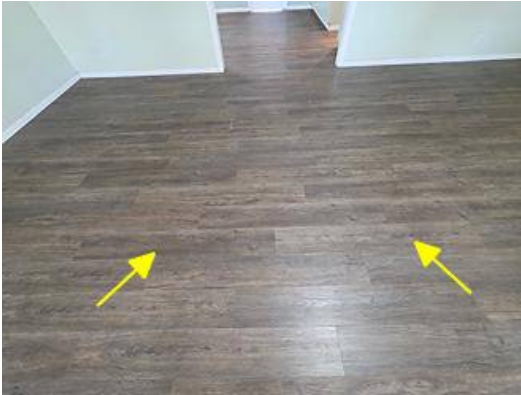
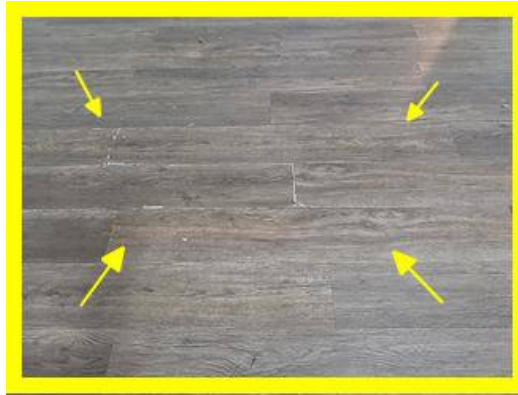
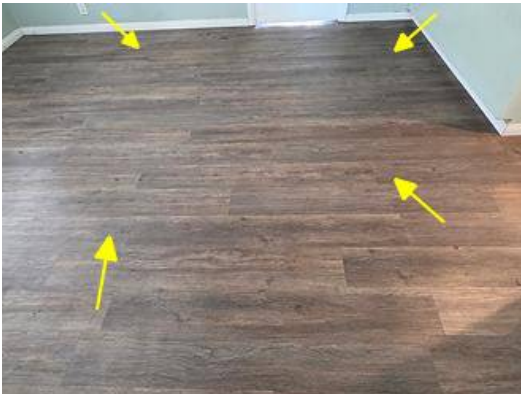
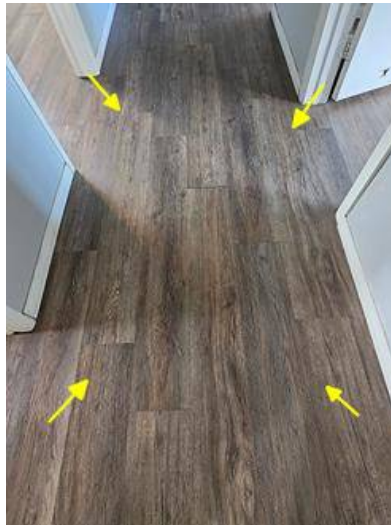
**48) Needs Attention, Repair, Replace, Evaluate** - Laminate Flooring-Damage/General Wear

- (1) Localized damage to the Laminate Flooring was noted in the Great Room. Repair or replace affected sections as required.
- (2) Edge lifting and separation/gapping were noted in various areas, more noticeably in the Dining Room. Repair or replace as required.
- (3) General wear was noted in the Laminate Flooring throughout portions of the home. Evaluate the overall condition and repair or replace as needed.

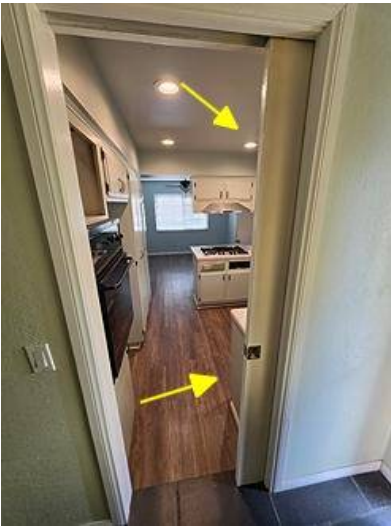
**Photo 49-1**

**49) Needs Attention, Repair** - Pocket Door-Difficult Operation

Concern: The Pocket Door was difficult to open and close when operated. Adjust or repair the door mechanism as required.

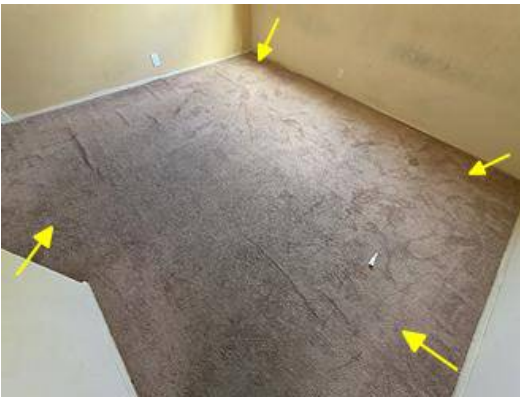
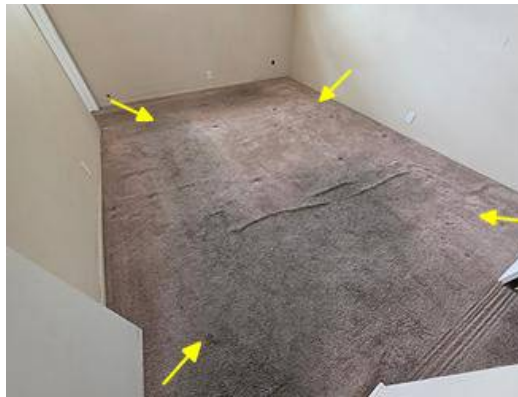
**50) Needs Attention, Replace, Evaluate** - Carpeting-Deteriorated/Stained-Bdrs 1 & 2

Concern: Significant wear, deterioration, and staining were noted in the Bedroom carpeting. Replacement of the affected carpeting is recommended.

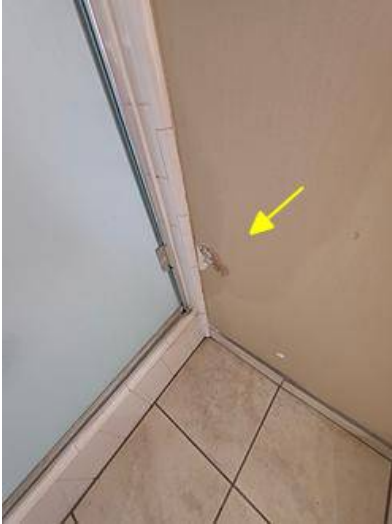
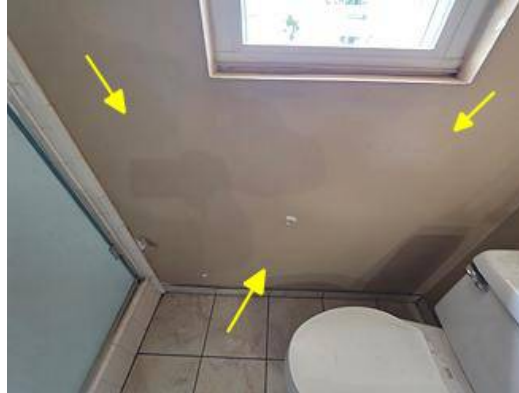
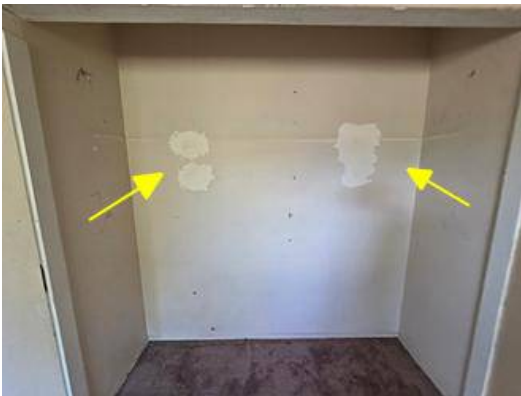
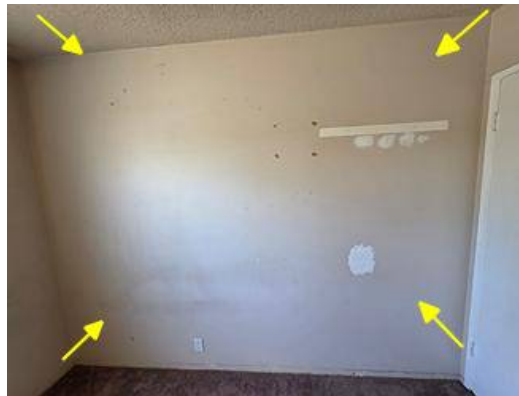
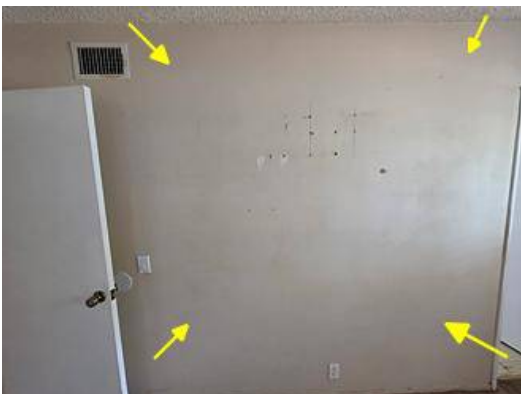
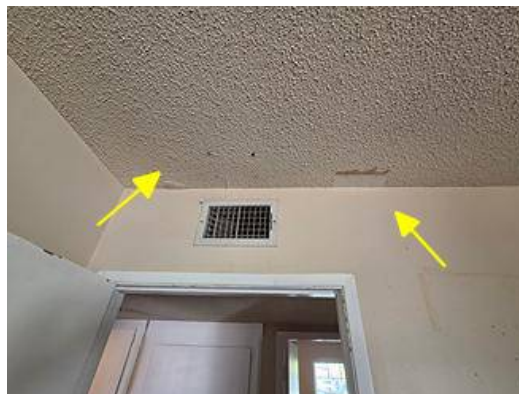
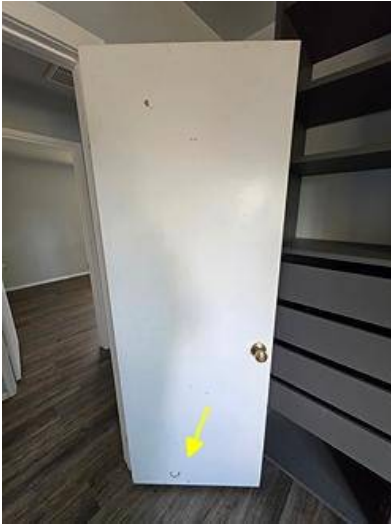
**51) Needs Attention, Maintain, Cosmetic, Comment** - Interior-General Cosmetic Conditions

Comment: General cosmetic wear, surface damage, unfinished patching, paint imperfections, and other minor cosmetic conditions were prevalent throughout the home. While some conditions are specifically identified elsewhere in this report, this comment addresses the overall cosmetic condition of the interior. Patch, repair, and refinish as needed.

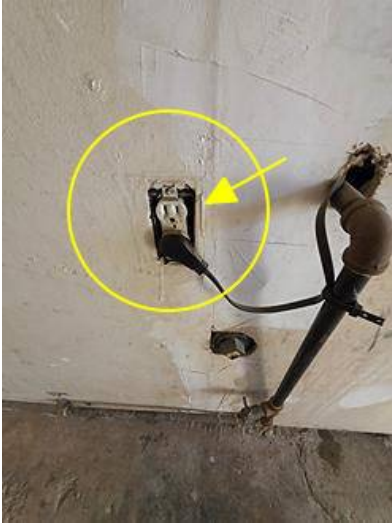
**Photo 52-1**

**52) Safety, Needs Attention, Install/Missing** - Electrical Cover Plate-Missing

Concern: The electrical cover plate was missing/not installed. Install a cover plate as required.

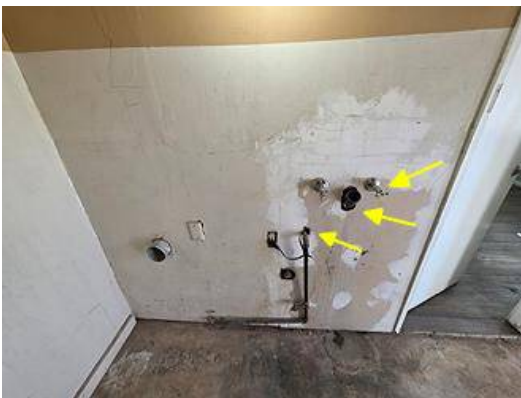
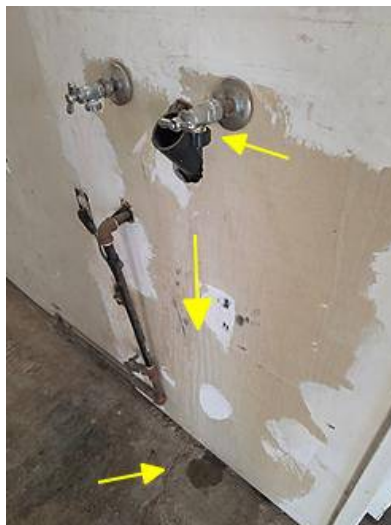
**53) Serviceable, Comment** - Laundry Plumbing-Leaking Faucet/Drywall Openings

(1) The cold-water Laundry Faucet was dripping/leaking. A temporary cap was installed during the Inspection to stop the leakage. Repair or replace the Faucet as required.

(2) Unfinished drywall openings and patching were noted around the Laundry plumbing connections and drain pipe. Patch and finish as required.

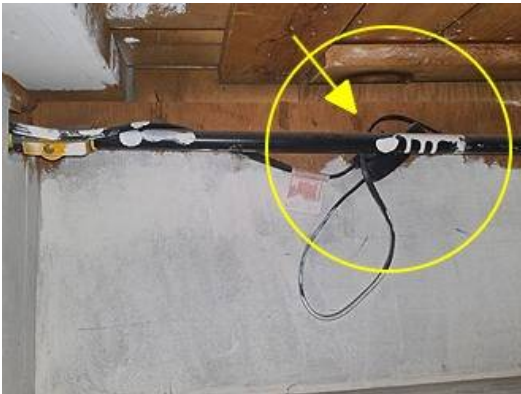
**Photo 54-1**

Concern: The Cooktop was powered by an extension cord connected to a remote Electrical Outlet. Install a properly located, permanent Electrical Outlet for the Cooktop and eliminate the extension cord connection. Related Professional-Electrician

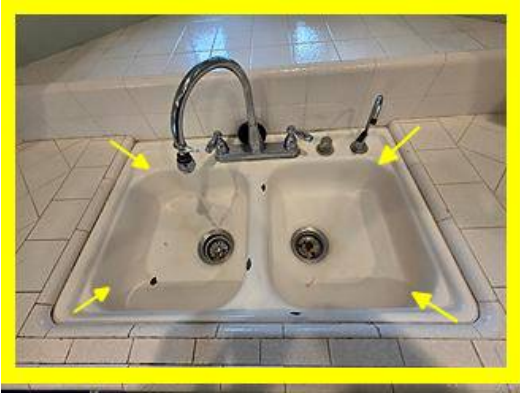
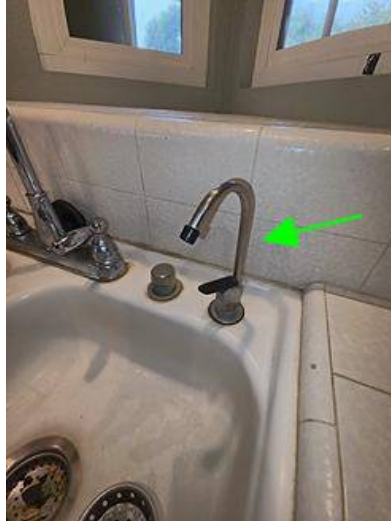
**55) Needs Attention, Repair, Replace, Evaluate** - Kitchen Sink-Surface Damage/Water Purification Faucet  
Concern: Surface damage and deterioration were noted at the Kitchen Sink. Evaluate for refinishing or replacement as required.

Comment: A separate drinking water faucet was installed, but no associated water purification system was present. Consult the seller regarding its purpose and operation.

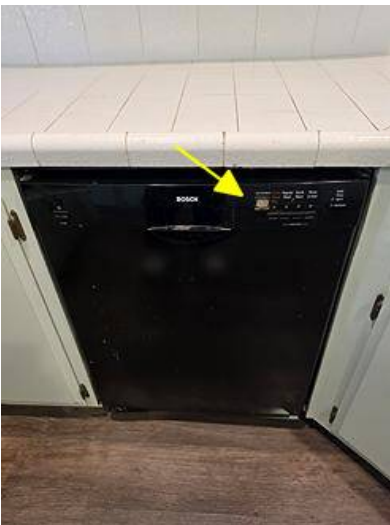
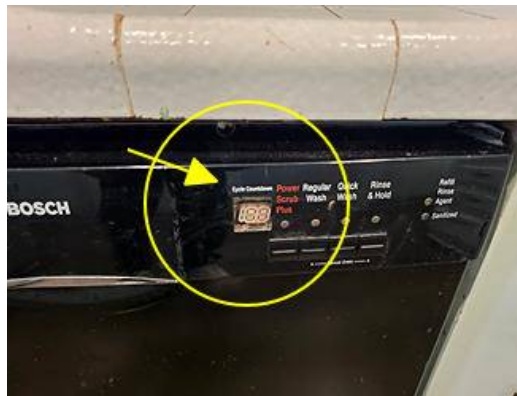
**56) Needs Attention, Repair, Replace, Evaluate** - Dishwasher-Control Panel Display Cover Missing  
Concern: The Dishwasher control panel display window/cover was missing. Repair or replace the affected control panel components as required. Consider replacement of the Dishwasher if repairs are not practical.

Note: The Dishwasher was otherwise operable when tested.
