Inspector: **Frank Bua**

Property address: **1685 S Belle Ave  
Corona CA 92882-4804**

Inspection date: **Wednesday, October 21, 2026**

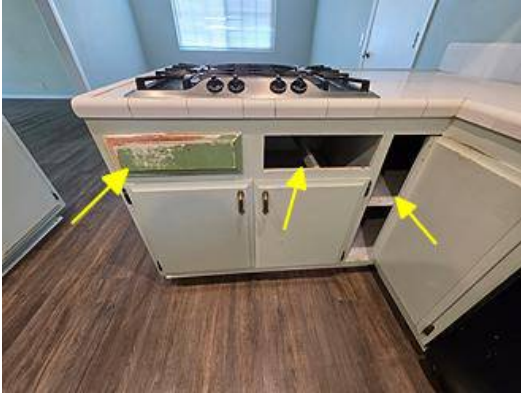
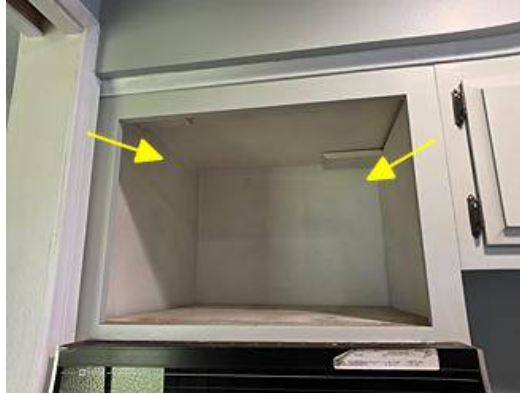
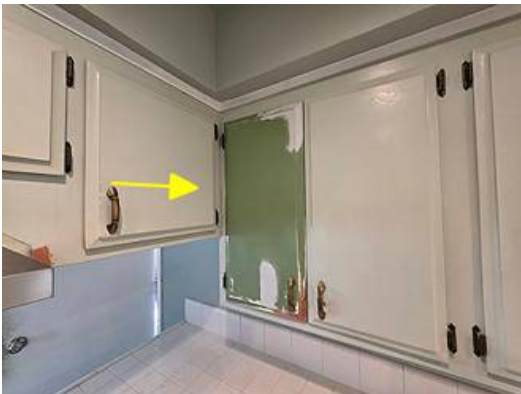
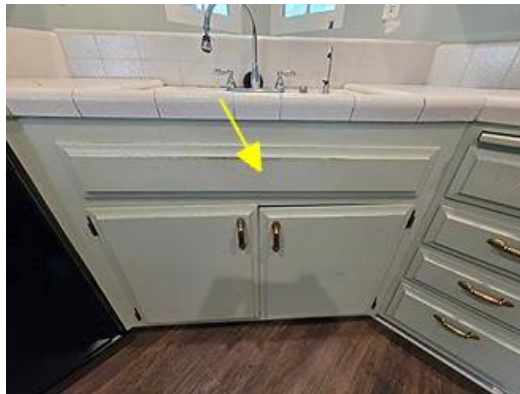
**57) Needs Attention, Repair, Install/Missing, Cosmetic** - Kitchen Cabinets-Missing Doors/Unfinished Surfaces

- (1) Several Kitchen Cabinet doors were missing/not installed. Install replacement doors as required.
- (2) Unfinished or partially refinished surfaces were noted on a cabinet drawer front and door. Complete refinishing as required.
- (3) One or more doors need adjustment.

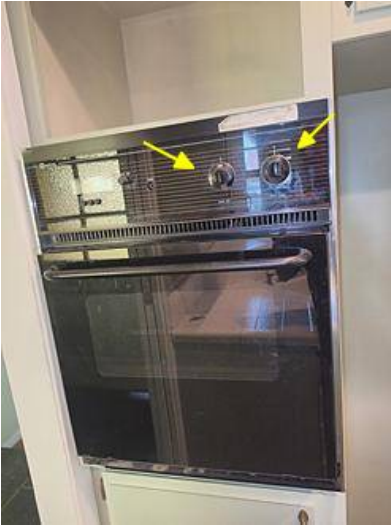
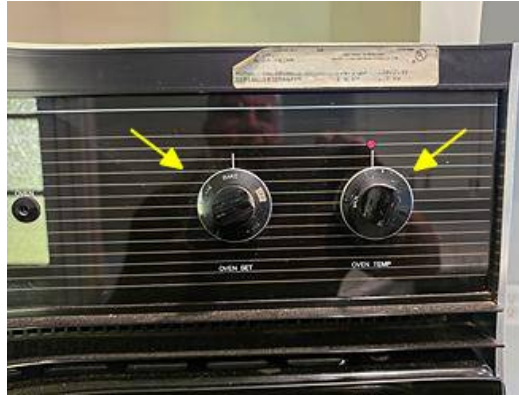
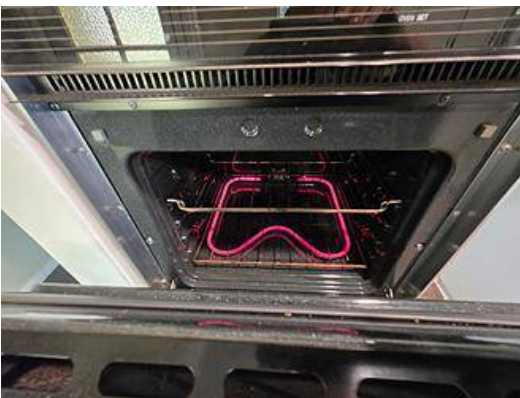
**58) Needs Attention, Repair** - Oven-Control Knob Labeling Worn

Concern: The Oven control knob labeling was worn and illegible. Replacement of the affected knobs is recommended.

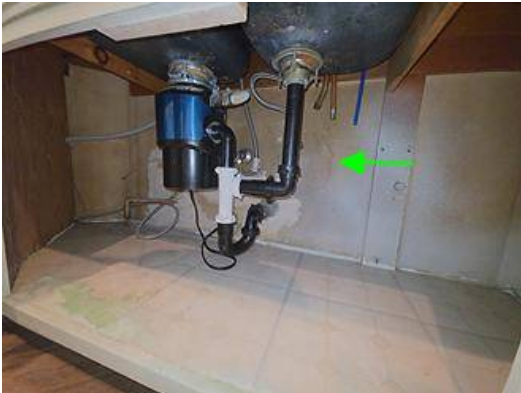
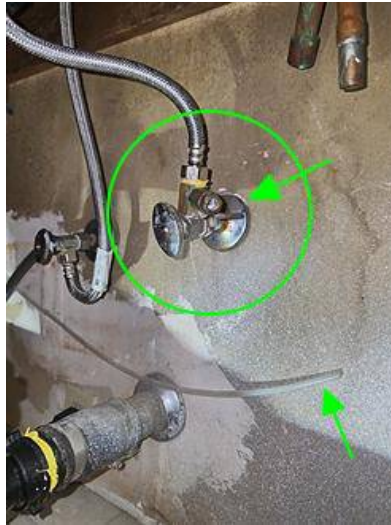
**59) Serviceable, Comment** - Kitchen Sink-Undersink Plumbing

Comment: An unused 1/4-inch water supply valve and plastic tubing were noted beneath the Kitchen Sink. No leakage was observed. Noted for client awareness.

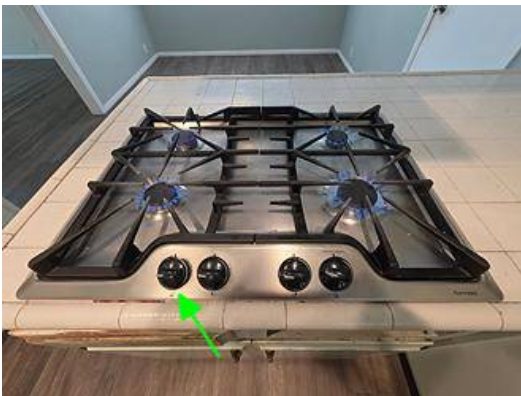
**Photo 60-1**

Concern: Minor damage was noted at the left Cooktop control knob. Replace the knob as desired.

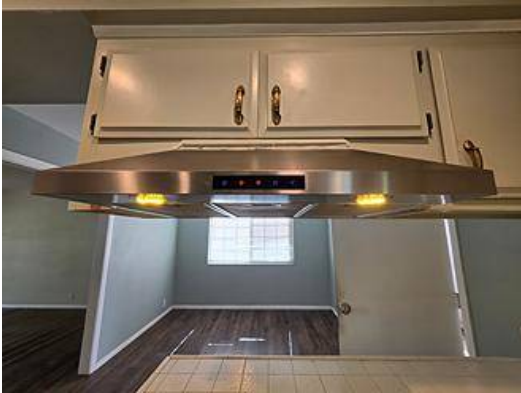
**61) Serviceable** - Vent Hood-Operation

Comment: Vent hoods are tested using basic fan and light functions. The unit powered on and the fan operated during a limited test. This does not represent full ventilation performance or airflow effectiveness.

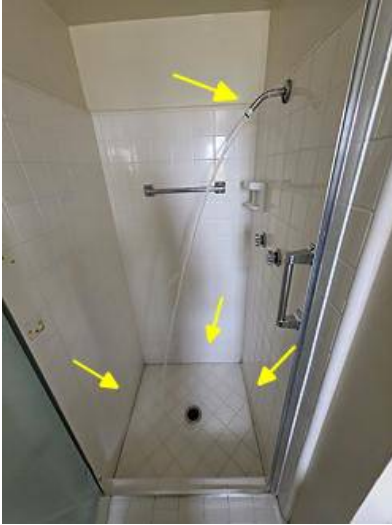
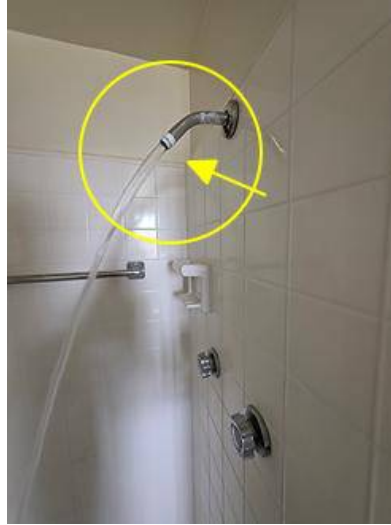
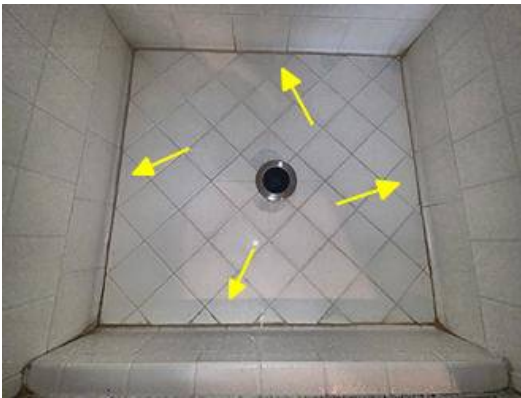
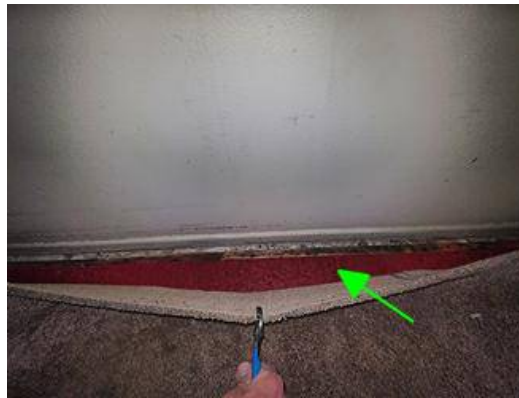
**63) Needs Attention, Repair, Install/Missing, Evaluate** - Shower-Pan Leakage Suspected/Missing Shower Head/Door Closure

(1) Cracking and separation were noted around the perimeter of the Shower Pan. Water entering the recessed perimeter area appeared to drain away through an undetermined path. Evaluate for possible leakage and repair or replace the Shower Pan as required.

(2) The Shower Head was missing/not installed. Install a suitable Shower Head as required.

(3) The Shower Door did not remain closed when tested. Adjust or repair the closure mechanism as required.  
Note: Moisture testing at the adjacent Bedroom wall and floor area did not indicate elevated moisture levels at the time of inspection.

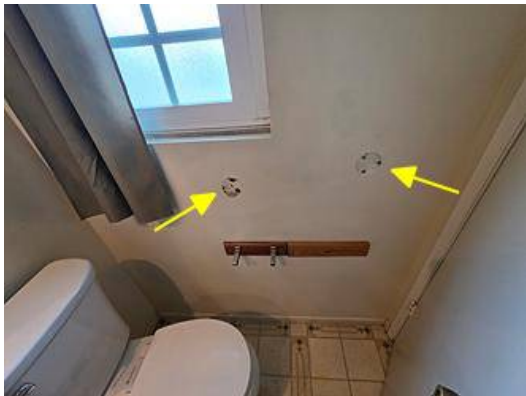
Photo 64-1

**64) Needs Attention, Repair, Cosmetic** - Bathroom Wall-Former Hardware Mounting Locations  
Comment: Two former hardware mounting locations, possibly from a removed grab bar, were noted on the wall adjacent to the Toilet. Patch and refinish as needed.  
Related Professional-Any Qualified

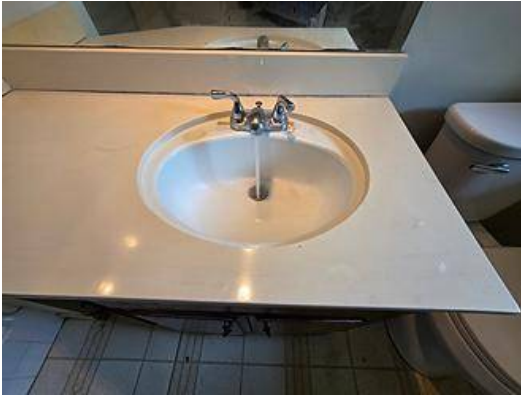
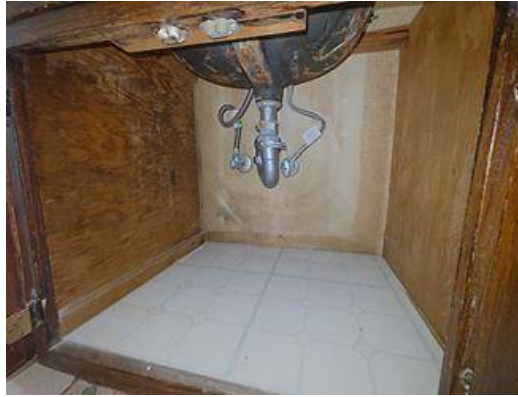
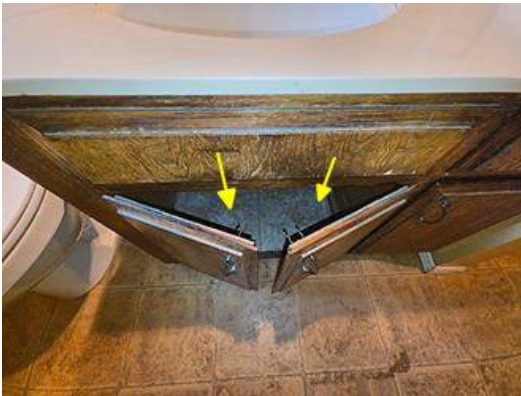
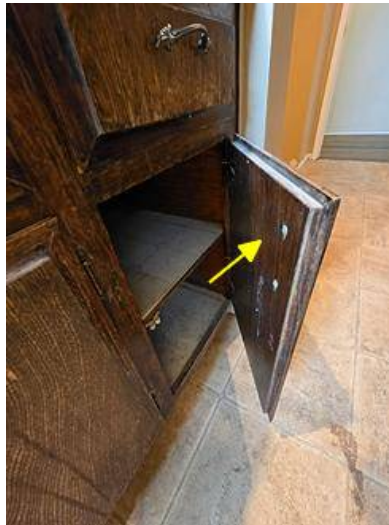
**65) Needs Attention, Repair, Comment** - Vanity-Cabinet Door Catches Missing/Damaged

Concern: The cabinet door catch clips were missing or damaged at both sets of doors. Install replacement catches as required.

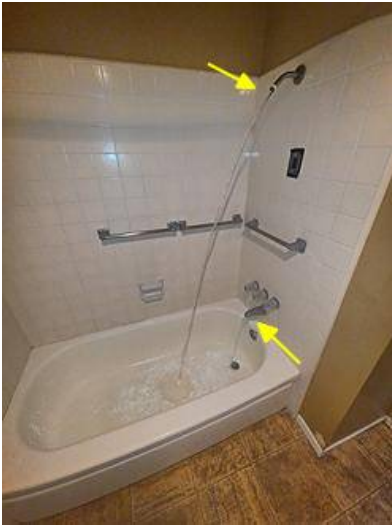
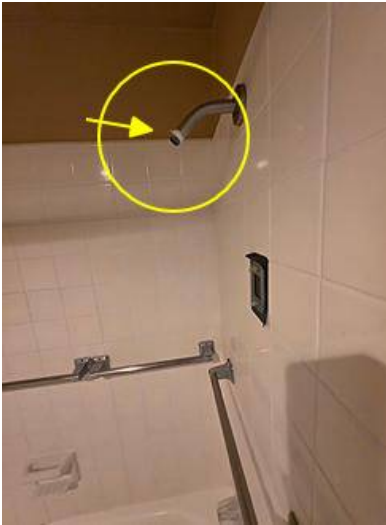
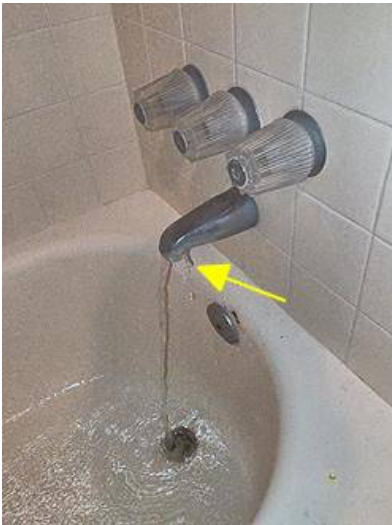
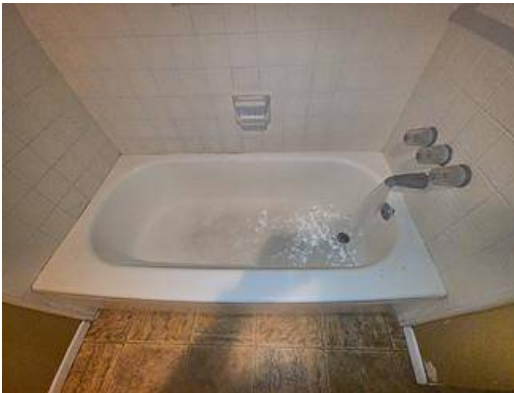
**68) Needs Attention, Repair, Install/Missing, Evaluate - Tub/Shower-Missing Shower Head/Diverter**

- (1) The Shower Head was missing/not installed. Install a suitable Shower Head as required.
- (2) Excessive water continued to flow from the Tub Spout when the diverter was activated for shower operation.

Repair the diverter system as required.

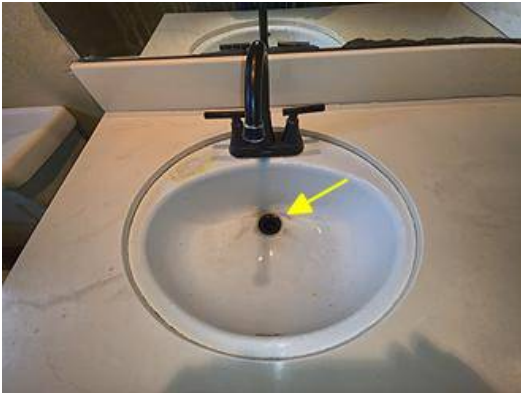
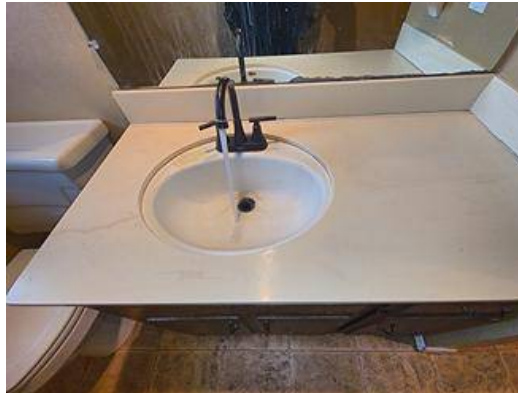
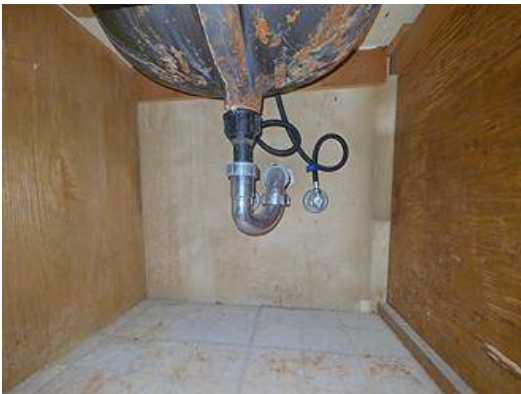
**69) Needs Attention, Install/Missing** - Vanity-No Sink Stopper

Concern: No Sink Stopper or basket strainer was installed. Provide Sink Stopper or basket strainer as needed.

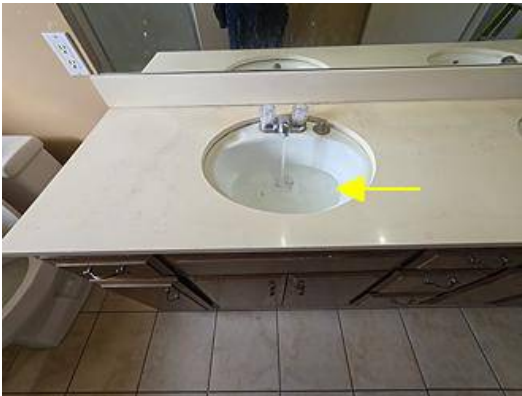
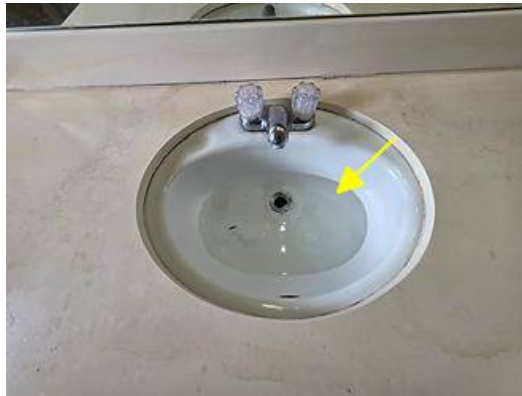
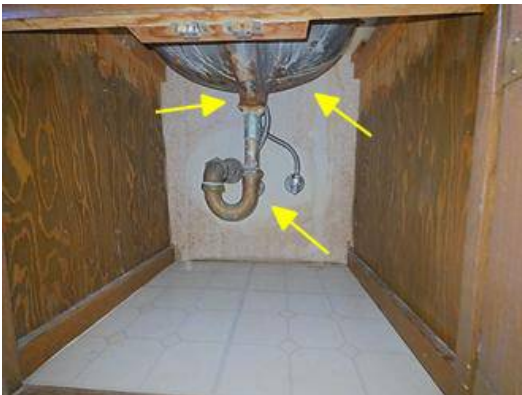
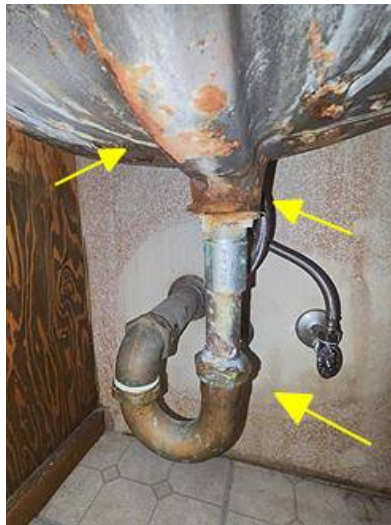
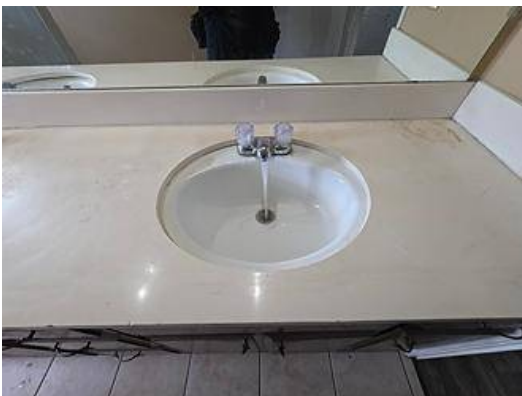
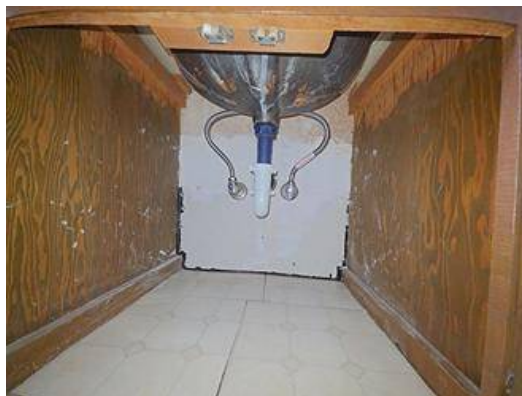
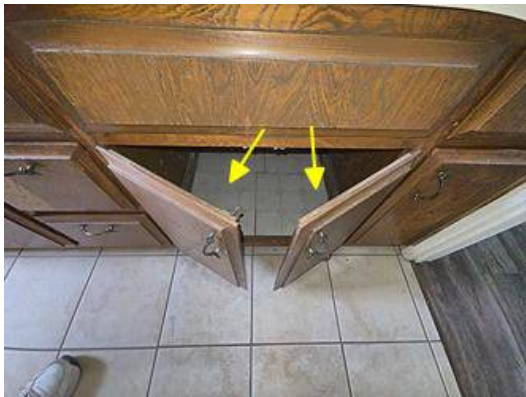
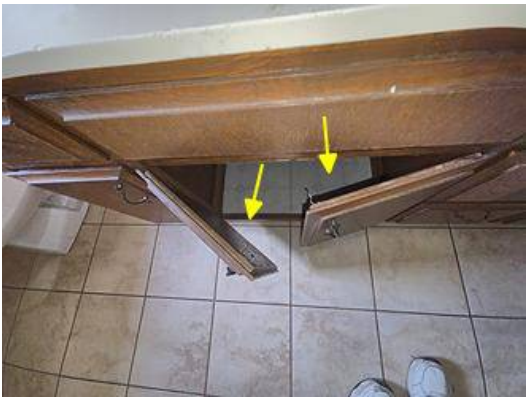
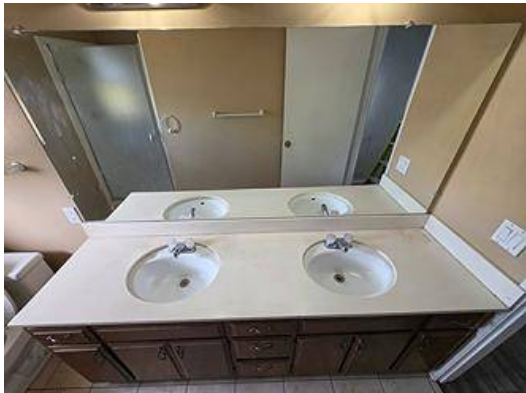
**72) Needs Attention, Repair, Evaluate** - Vanity Sinks-Drainage/Corrosion/Sealing/Cabinet Hardware

- (1) The left Vanity Sink did not drain properly when filled and tested. Clear the drain obstruction as required.
- (2) Rust and corrosion were noted on the underside of the left Vanity Sink and P-trap. Evaluate and repair or replace affected components as required.
- (3) Both Vanity Sinks need to be resealed around their rims to prevent water intrusion beneath the countertop.
- (4) The cabinet door catch clips were missing or damaged at both sets of doors. Install replacement catches as required.

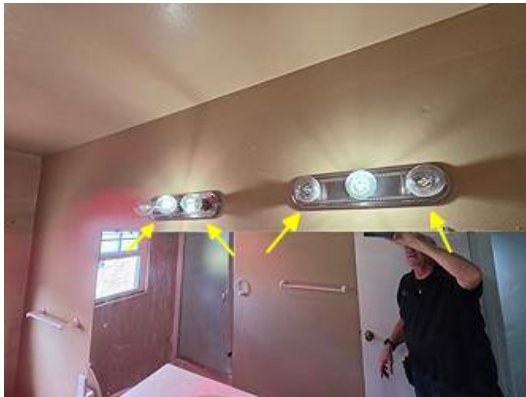
Photo 73-1

**73) Needs Attention, Repair, Evaluate** - Light Fixtures-Inoperable  
Observation: One or more light bar bulbs were inoperable. Replace bulbs and evaluate further as required.  
Related Professional-Any Qualified

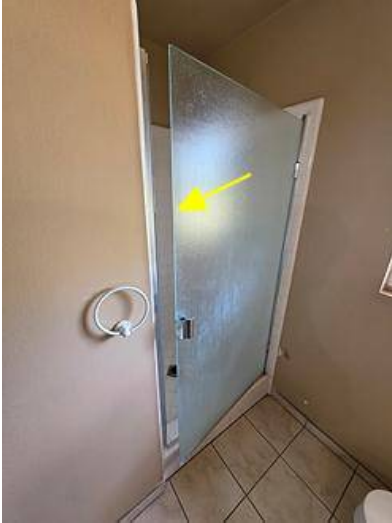
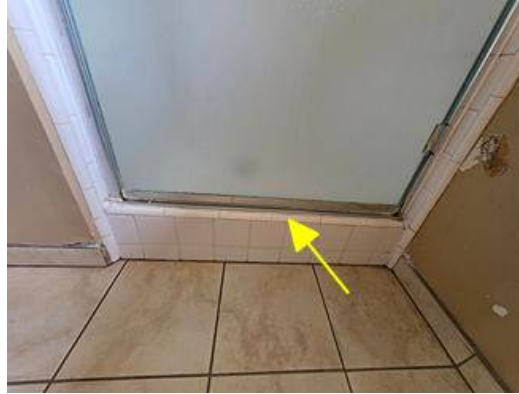
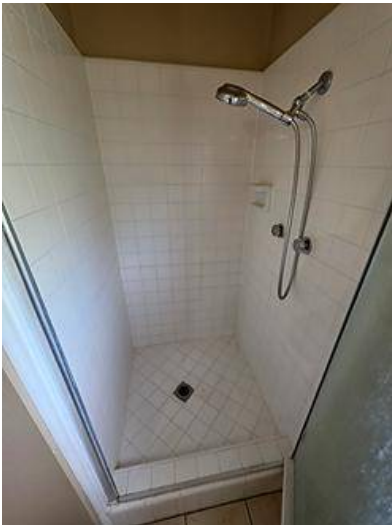
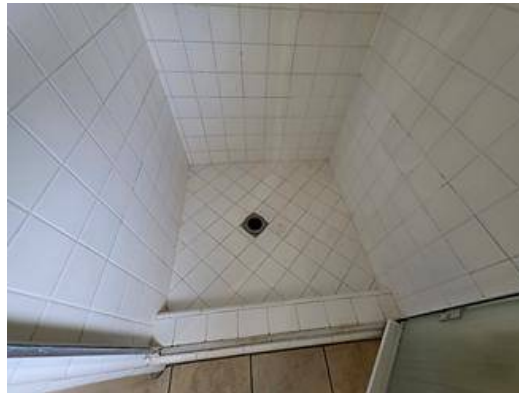
**74) Needs Attention, Repair - Shower Door-Closure/Bottom Seal Missing**

- (1) The Shower Door did not remain closed when operated. Adjust or repair the closure mechanism as required.
- (2) The Shower Door bottom seal was missing/not installed. Install a suitable bottom seal to prevent water leakage.

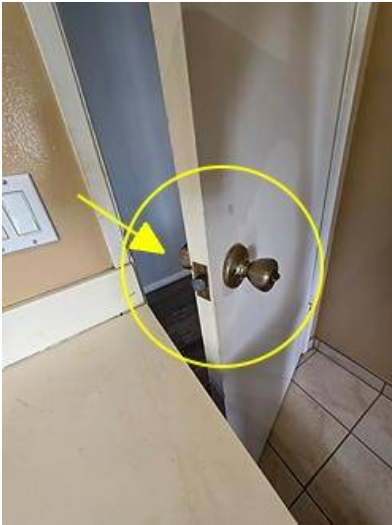
**Photo 75-1**

**75) Needs Attention, Repair** - Bathroom Door-Reversed Latch

Concern: The Bathroom Door latch was installed backward. Reverse or reinstall the latch as required.

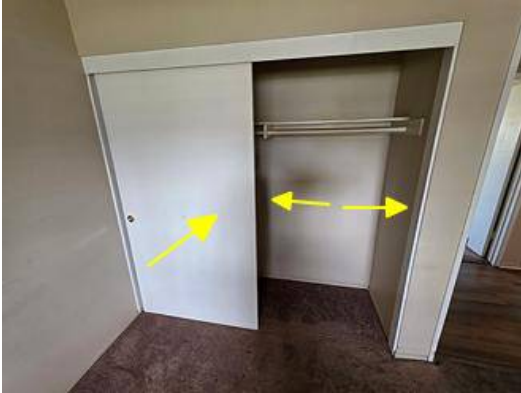
**Photo 78-1**

**78) Needs Attention, Repair** - Closet Doors-Difficult Operation

Concern: The closet doors were difficult to operate. Adjust and/or repair as needed.

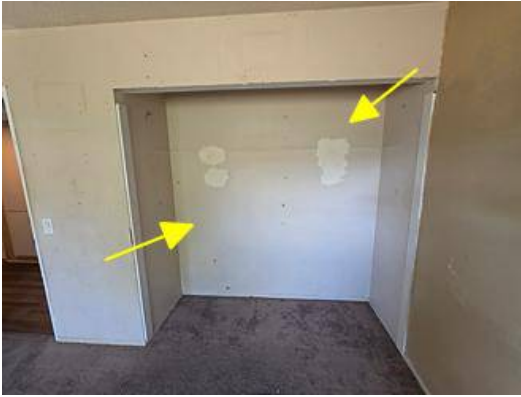
**Photo 80-1**

**80) Needs Attention, Repair, Install/Missing** - Closet-Missing Doors/Shelf and Rod

- (1) Closet doors were missing/not installed. Install doors as required.
- (2) The Closet shelf and hanging rod were missing/not installed. Install as required.

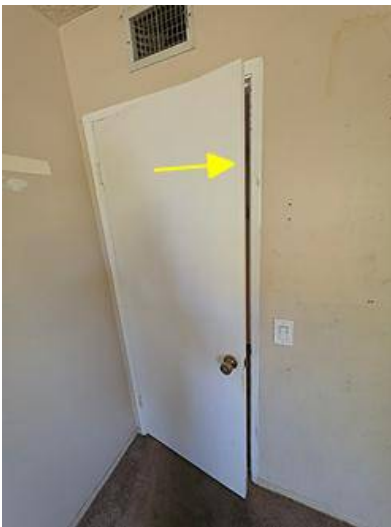
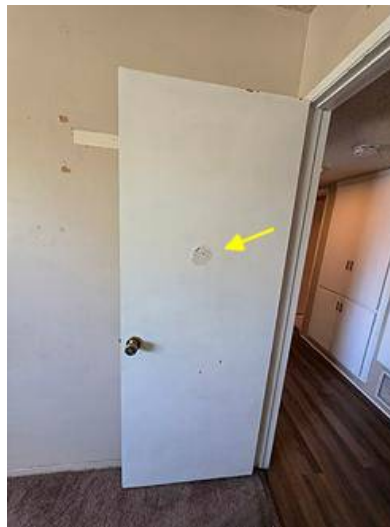
**81) Needs Attention, Repair, Cosmetic** - Interior Door-Binding Operation/Surface Patch

- (1) The room Door binds in the jamb when operated. Adjust or repair as needed.
- (2) An unfinished surface patch was noted on the hallway side of the Door. Patch and refinish as required.

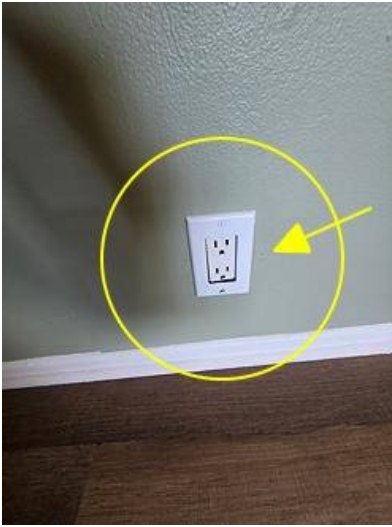
**Photo 83-1****84) Needs Attention, Repair, Install/Missing** - Closet-Missing Doors/Sagging Shelf and Rod

Concern: The Electrical Outlet and cover plate were loose at the bottom. Secure both components as required.  
Related Professional-Electrician, Any Qualified

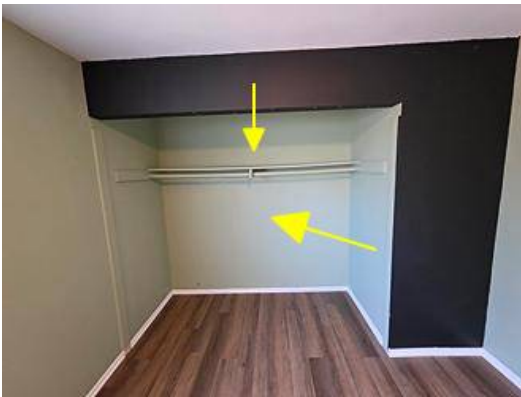
**Photo 84-1**

- (1) Closet doors were missing/not installed. Install doors as required.
  - (2) The Closet shelf and hanging rod were sagging. Repair or reinforce the supports as required.
- Related Professional-Door & trim, Any Qualified

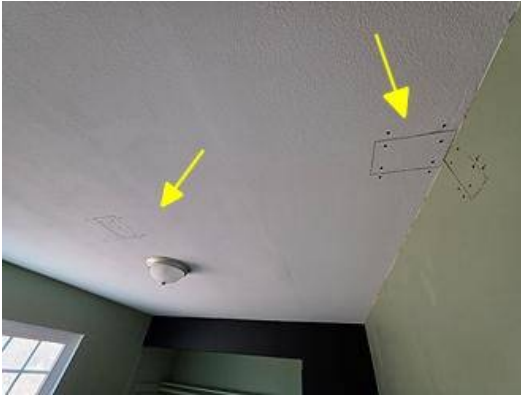
**Photo 85-1**

**85) Needs Attention, Repair, Evaluate** - Ceiling-Patching/Previous Repairs

Concern: Several areas of previous patching and unfinished repairs were noted at the Ceiling. The reason for these repairs was undetermined. Evaluate further for possible underlying conditions and complete patching and refinishing as required.

Related Professional-General Contractor, Any Qualified

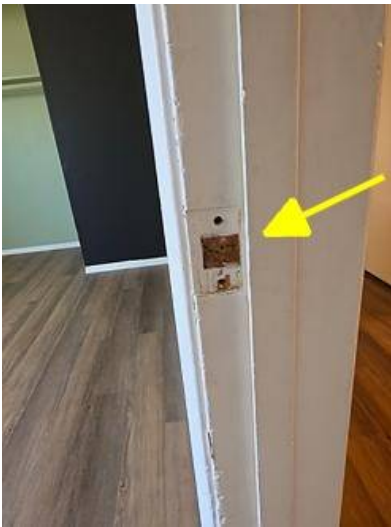
**Photo 86-1**

**86) Needs Attention, Install/Missing** - Interior Door-Strike Plate Missing

Concern: The Door strike plate was missing/not installed. Install a suitable strike plate as required.

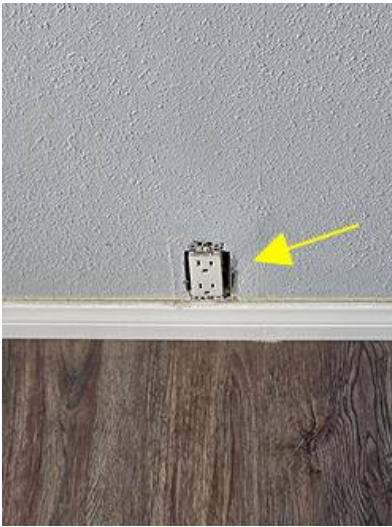
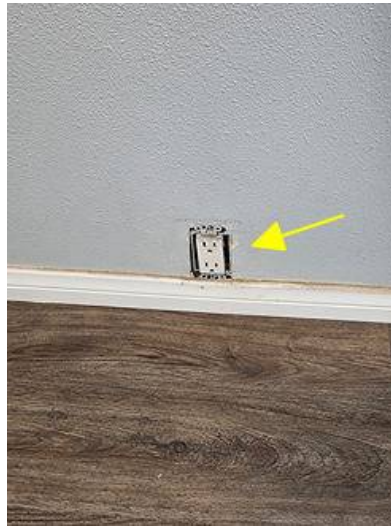
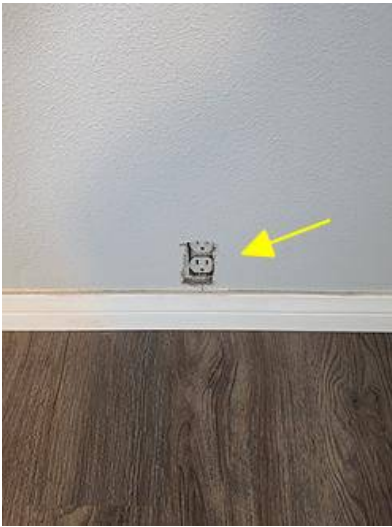
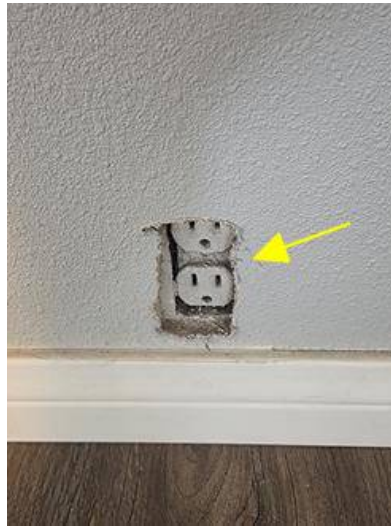
Photo 88-1

**88) Safety, Needs Attention, Install/Missing** - Electrical Cover Plates - Missing

Concern: One or more electrical cover plates were missing/not installed. Provide and Install a cover plates as required.

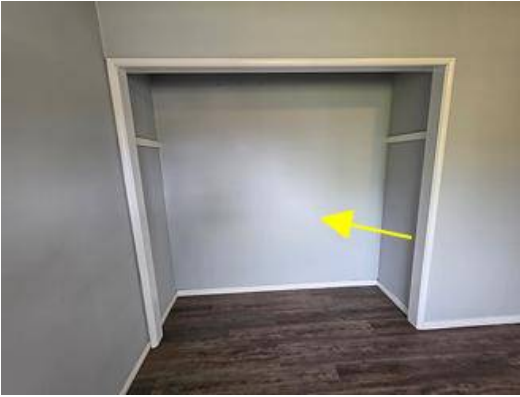
**Photo 89-1**

**89) Needs Attention, Repair, Install/Missing** - Closet-Missing Doors/Shelf and Rod

- (1) Closet doors were missing/not installed. Install doors as required.
- (2) The Closet shelf and hanging rod were missing/not installed. Install as required.

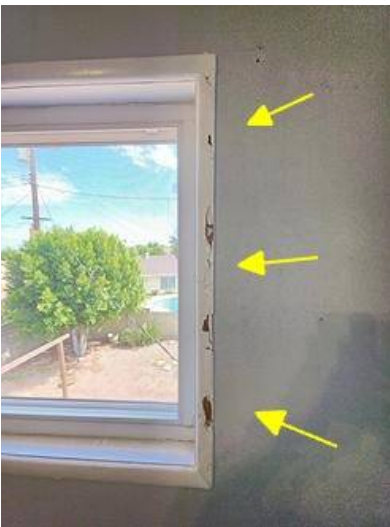
**Photo 90-1**

**90) Needs Attention, Repair, Evaluate** - Window Trim-Wood Deterioration

Concern: Wood damage was noted along the interior Window trim, possibly associated with wood-destroying organisms. Have a Pest/Termite Professional evaluate the affected area and repair or replace damaged materials as required.

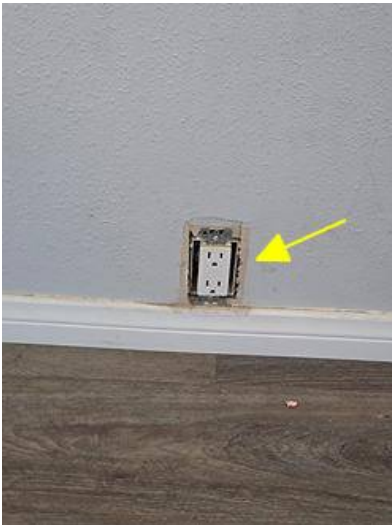
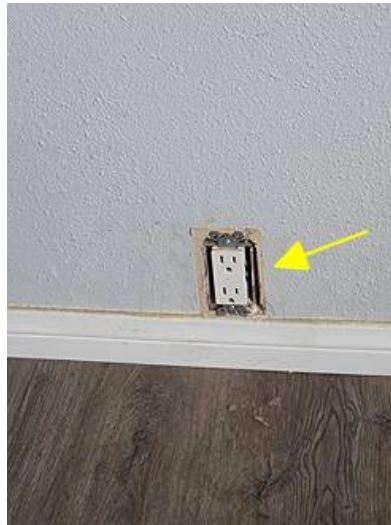
**Photo 92-1**

**92) Safety, Needs Attention, Install/Missing** - Electrical Cover Plates - Missing

Concern: One or more electrical cover plates were missing/not installed. Provide and Install a cover plates as required.

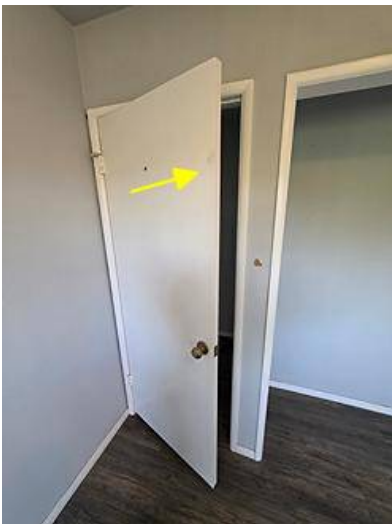
**Photo 93-1**

**93) Needs Attention, Repair** - Interior Door-Binding Operation

Concern: The room door binds in the jamb when operated. Adjust or repair as needed.

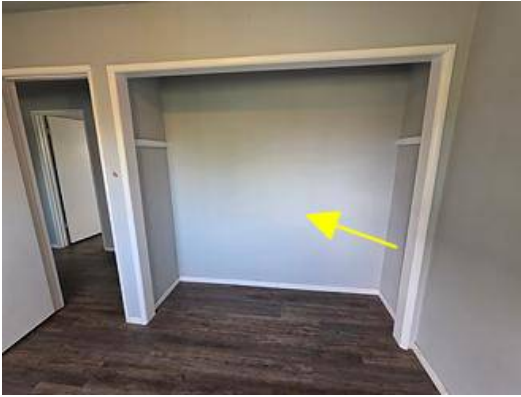
**Photo 94-1**

**94) Needs Attention, Install/Missing** - Closet-Missing Doors/Shelf and Rod

- (1) Closet doors were missing/not installed. Install doors as required.
- (2) The Closet shelf and hanging rod were missing/not installed. Install as required.

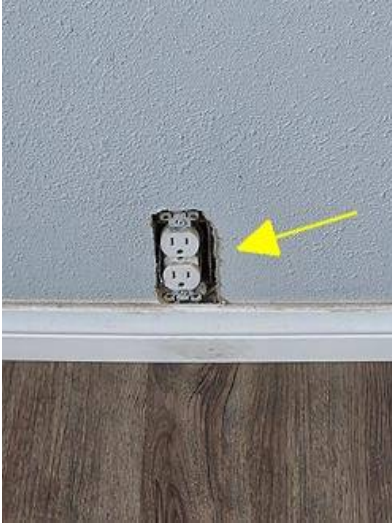
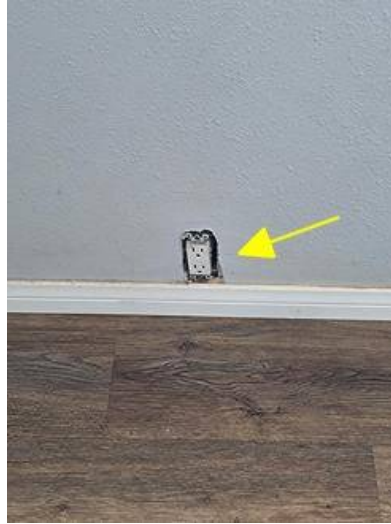
Photo 96-1

Concern: One or more electrical cover plates were missing/not installed. Provide and Install a cover plates as required.

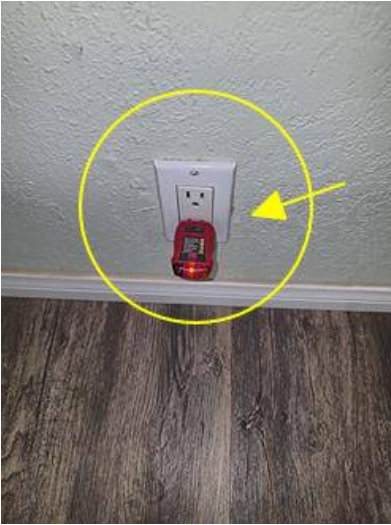
**Photo 98-1**

**98) Safety, Needs Attention, Repair, Evaluate** - Electrical Outlet-Ungrounded

Concern: The Electrical Outlet was ungrounded. Evaluate and correct the grounding as required.

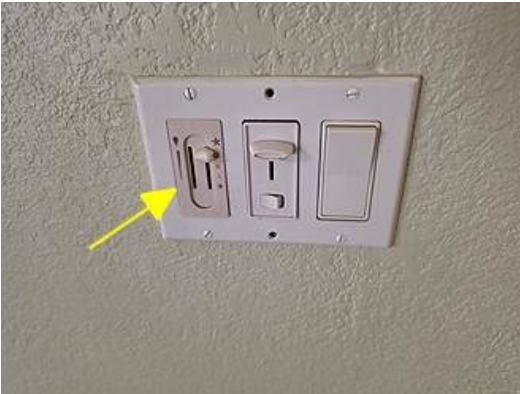
**Photo 99-1**

**99) Needs Attention, Repair, Replace** - Wall Switch-Missing Slider Control

Concern: The slider control was missing from a wall switch originally designed for a Ceiling Fan. Only a Light Fixture was installed at this location. Repair or replace the switch as required.
