Confidential Inspection Report 101 Scholz Plaza #221 Newport Beach, CA

February 5, 2021

SUMMARY OF AREAS REQUIRING FURTHER EVALUATION

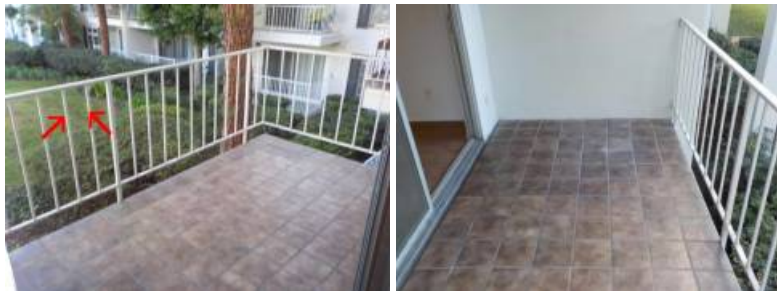
<i>Condition:</i>	OK MM RR <input type="checkbox"/> <input type="checkbox"/> <input checked="" type="checkbox"/>	Appears serviceable Handrail system appears serviceable with the following observed: Corrosion is present on the handrail system in multiple areas Recommend remediation
-------------------	---	--

A maximum of 4" in width between balusters is now the requirement

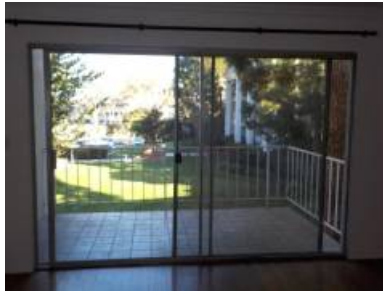
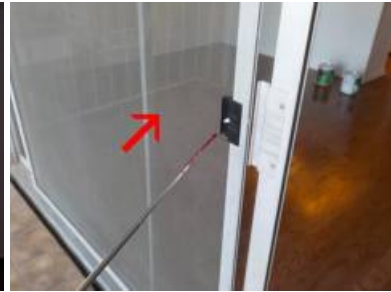
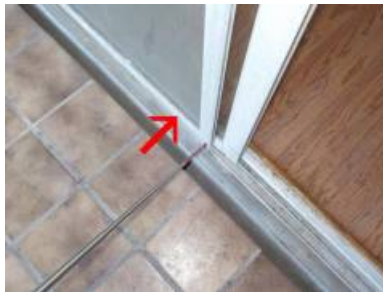
Door is very difficult to operate - improper

Lock/latch not functioning properly

Recommend repairs by a qualified service provider

Recommend repairs.

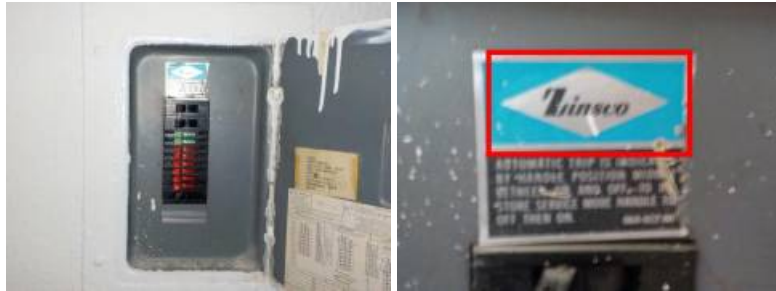
**These types of panels have a poor safety history
Recommend further inspection and deemed necessary repairs by
a licensed electrician.**

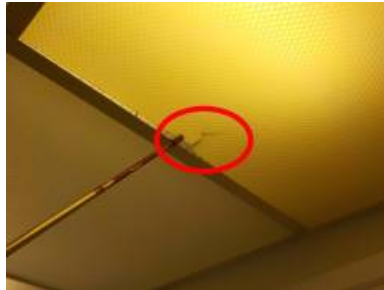
Appear serviceable with the following observed:
Damage viewed on the diffuser shield (light cover) in multiple areas
Recommend repairs.

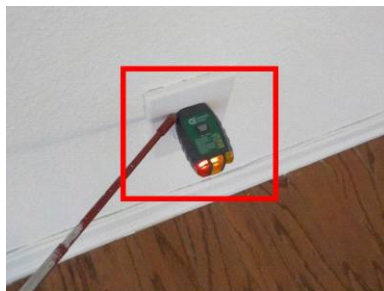
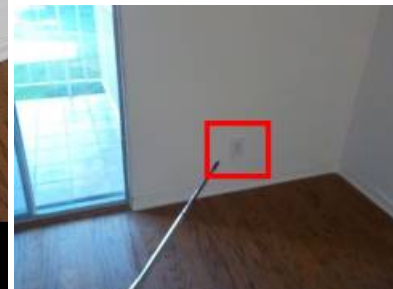
A representative sampling of outlets was tested.
As a whole, outlets throughout the house are in serviceable condition
with the following observed:
**North Living Room Wall: receptacles have reverse polarity (hot &
neutral wires are reversed) - improper**
Recommend further inspection and deemed necessary repairs by
a licensed electrician.

**Reverse polarity -
improper**

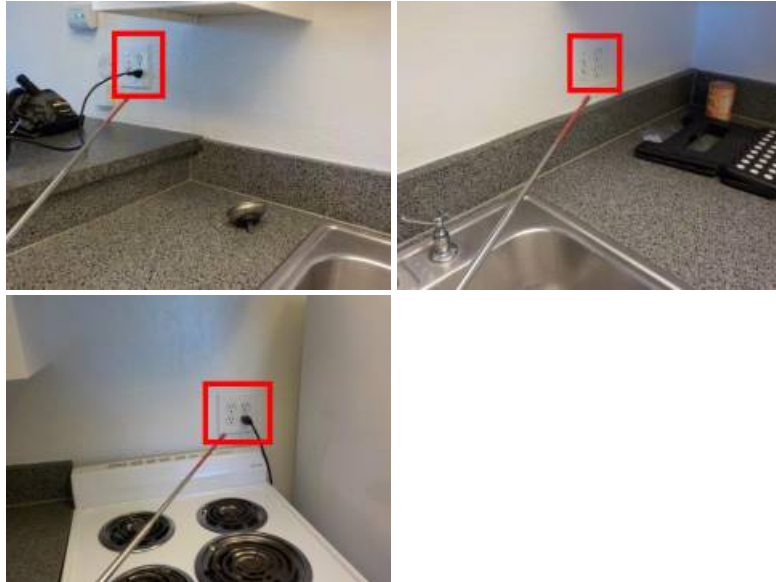
8 receptacles within 6' of the water source (sink) are not GFCI (Ground Fault Circuit Interrupter) protected - improper
This is a safety, liability and compliance issue.

Installation of GFCI receptacles at all outlets within 6' of the water source (sink) are required to restore to safe and compliant conditions.

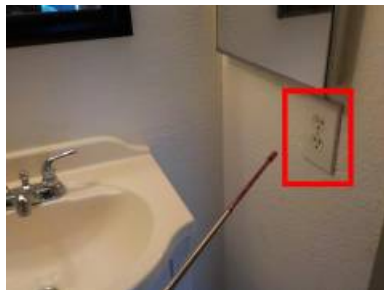
2 receptacles within 6' of the water source (sink) are not GFCI (Ground Fault Circuit Interrupter) protected - improper
This is a safety and compliance issue.

Installation of GFCI receptacles at all outlets within 6' of the water source (sink) are required to restore to safe and compliant conditions.

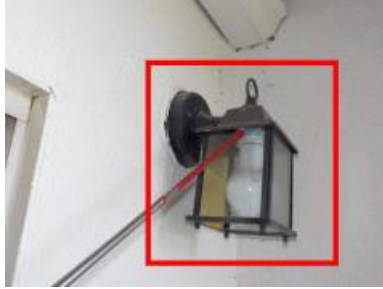
Light fixture is loose
Recommend repairs.

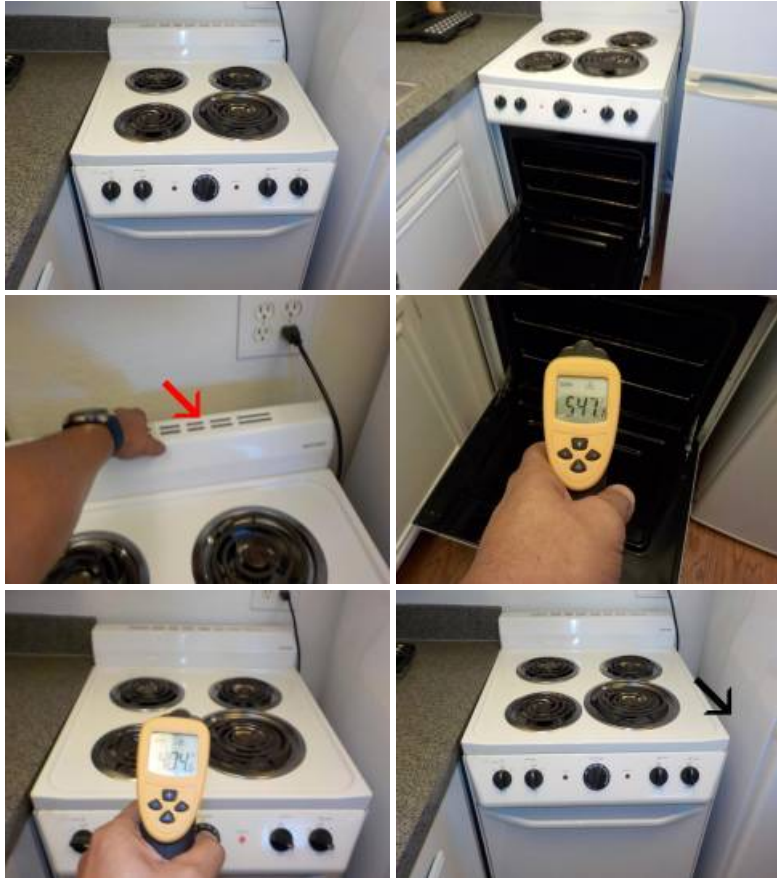
Missing anti-tip bracket - improper

Please Note: there is zero clearance between the oven and the refrigerator (improper and unusual).

Generally accepted building principles require a minimum 9' clearance between an oven and refrigerator.

Recommend installation of an anti-tip bracket to restore to safe conditions.

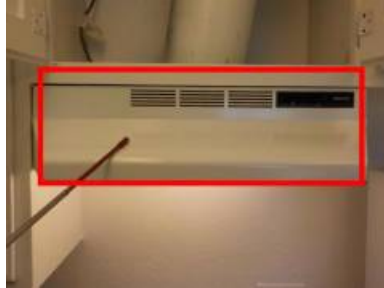
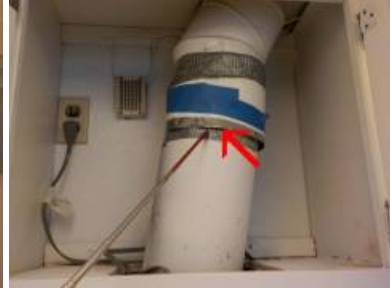
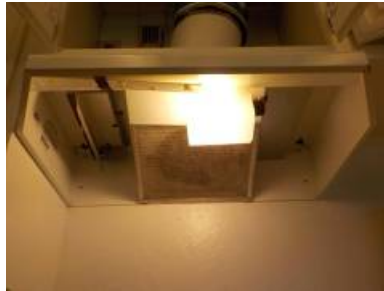
Appears serviceable with the following observed:
Duct connections are not secured properly
Vent is making unusual (loud) noise - improper
Recommend repairs by a qualified service provider.

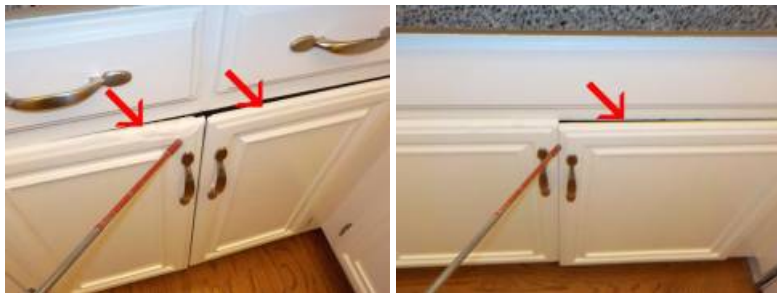
Appear serviceable with usual and normal wear observed.
Many doors do not shut fully/properly
Recommend repairs.

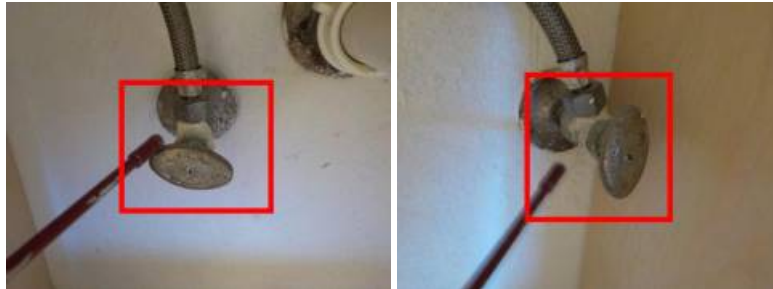
Appears serviceable with the following noted:
Angle Stops are heavily corroded (possible pin hole leaking) - improper
Recommend repairs by a qualified service provider.

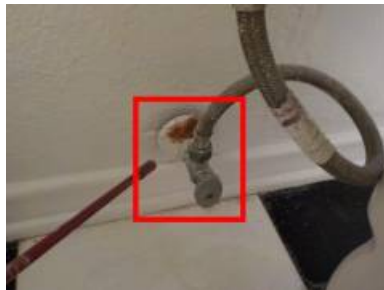
Appears serviceable with the following noted:
Angle Stop is heavily corroded (possible pin hole leaking) - improper
Recommend repairs by a qualified service provider

Please Note: the gallons per flush (GPF) does not comply with the CA standard of 1.28.

Recommend recaulking between base and floor to help prevent possible moisture intrusion.

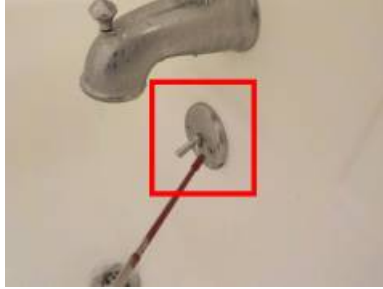
Appears serviceable with the following observed:
Drain stop not functioning
Recommend repairs.

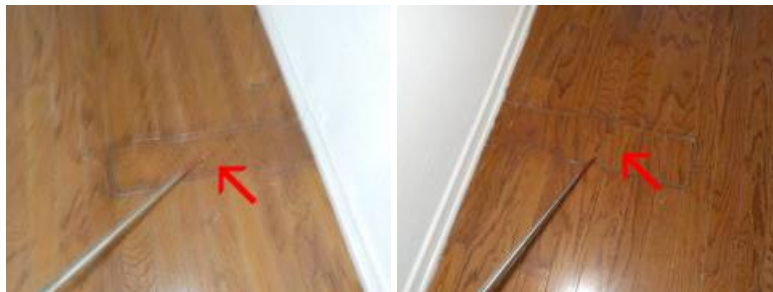
Please Note:
Anomalies (patching) is observed in entry hall

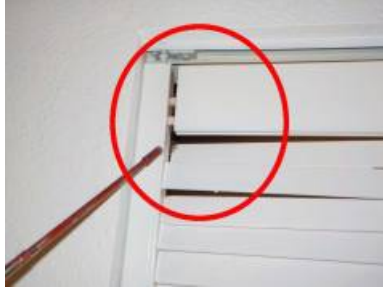
General: Appears serviceable with the following observed:
Damage is viewed
 Recommend repairs.
