15148 Carfax Ave

Property address: 15148 Carfax Ave
Bellflower CA 90706-4110

Inspection date: Friday, July 12, 2024

Report number: 070/24

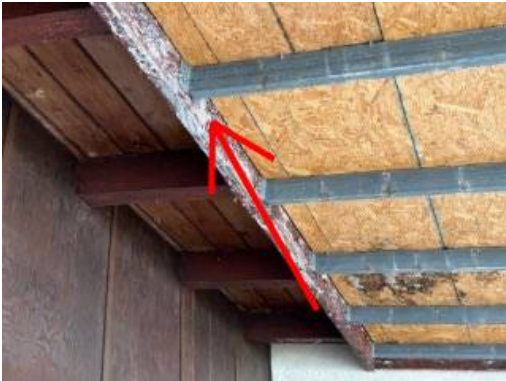
Photo 1-1

One or more deck, patio and/or porch covers were unstable due to substandard bracing, lack of diagonal bracing, or lack of attachment to the main building. This is a safety hazard since severe movement may cause the cover to collapse. A qualified contractor should repair as necessary.

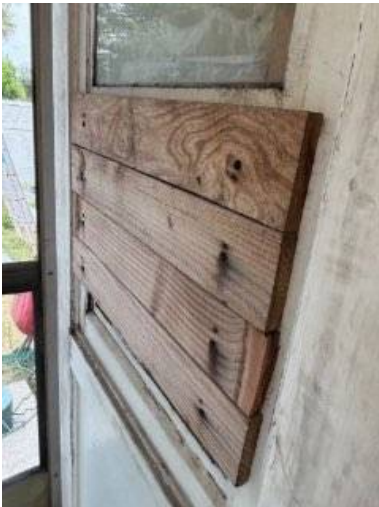
Photo 2-1

One or more exterior doors were significantly damaged or deteriorated. Recommend that a qualified person replace door(s) as necessary.

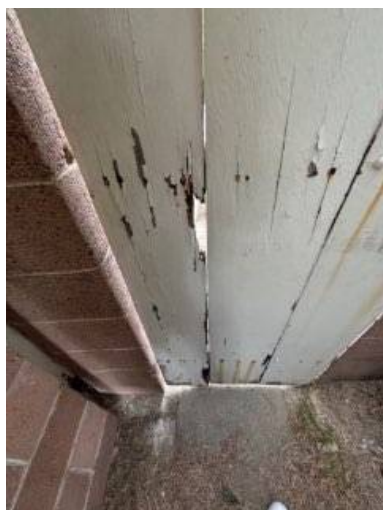
Photo 3-1

One or more gates were damaged or deteriorated and need repair.

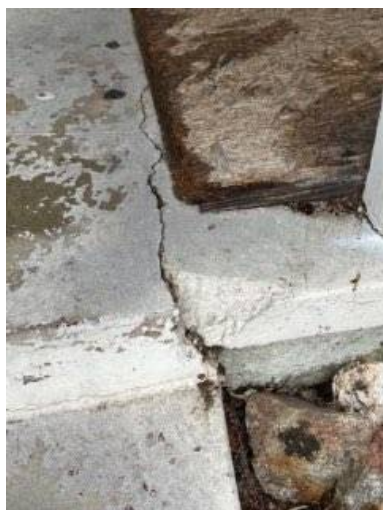
Photo 4-1

4) 🛠️ Cracks, holes, settlement, heaving and/or deterioration were found in porch and/or patios. Recommend that qualified contractor repair as necessary.

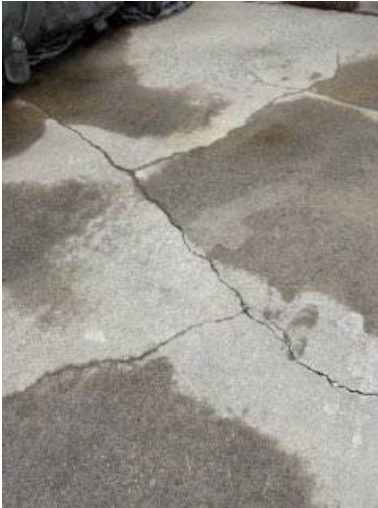
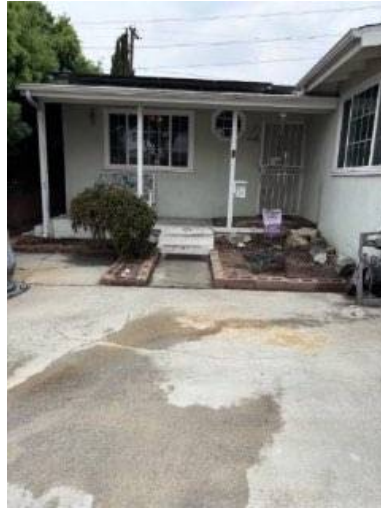
Photo 5-1

5) ⓘ Minor deterioration (e.g. cracks, holes, settlement, heaving) was found in the driveway, but no trip hazards were found. The client may wish to have repairs made for cosmetic reasons.

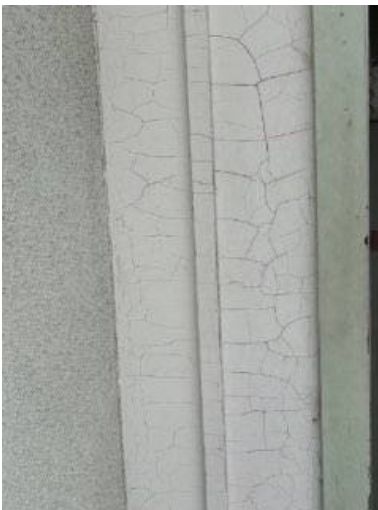
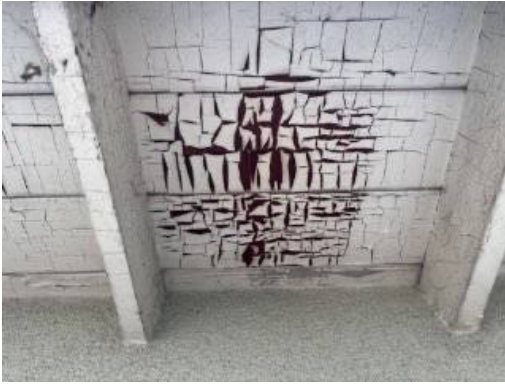
Photo 6-1

Evidence of active/past infestation of termites was found at location(s) # one or more wood areas in the form of galleries or holes in wood with visible wood damage. Recommend the following:
Correct any conducive conditions for wood-destroying organisms mentioned in this report.
Consult with the property owner about any history of infestation.
Have a state-licensed pest control operator evaluate further and treat as necessary.

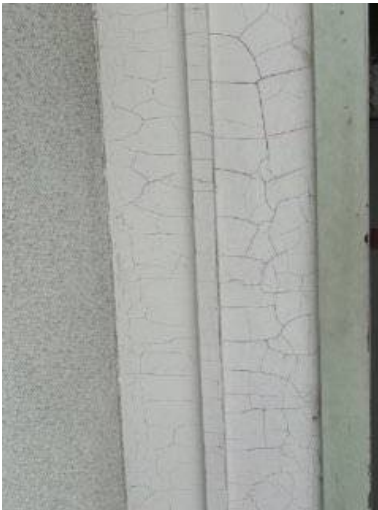
Photo 7-1

1) Significant amounts of debris, stored items and/or junk were found in the yard or around buildings.
- 2) Fungal rot was found at one or more window frames, soffits, fascia and/or one or more exterior wood areas . Conducive conditions for rot should be corrected (e.g. wood-soil contact, reverse perimeter slope). Recommend that a qualified person repair as necessary. All rotten wood should be replaced.
- 3) The paint or stain finish in some areas was failing (e.g. peeling, faded, worn, thinning). Siding and trim with a failing finish can be damaged by moisture. Recommend that a qualified contractor prep (e.g. clean, scrape, sand, prime, caulk) and repaint or restain the building exterior where necessary and per standard building practices. Any repairs needed to the siding or trim should be made prior to this.

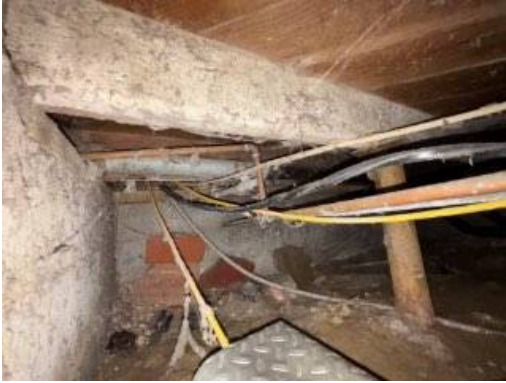
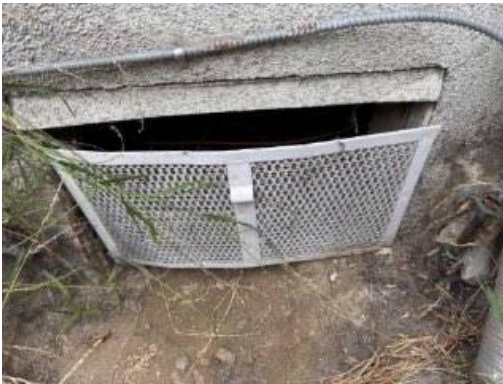
Photo 8-1

1) Foundation was in serviceable condition.
2) The screens for one or more crawl space vents were damaged. Vermin or pets can enter the crawl space and nest, die and/or leave feces and urine. Vermin often damage under-floor insulation too. Recommend that a qualified person install or replace screens where

necessary using 1/8-inch to 1/4-inch wire mesh.

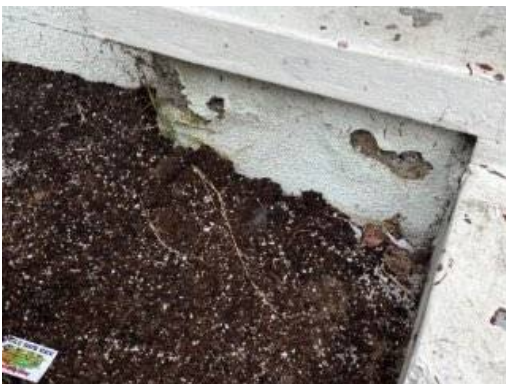
Photo 9-1

9) 🛠️💧 Cracks, deterioration and/or damage were found in one or more areas of the exterior stucco finish. In damp climates, moisture can enter cracks or damaged areas and further deteriorate the stucco. Also the wall behind the stucco can become damaged from moisture. Note that areas behind the stucco are inaccessible and excluded from this inspection. Recommend that a qualified contractor repair or replace stucco as necessary.

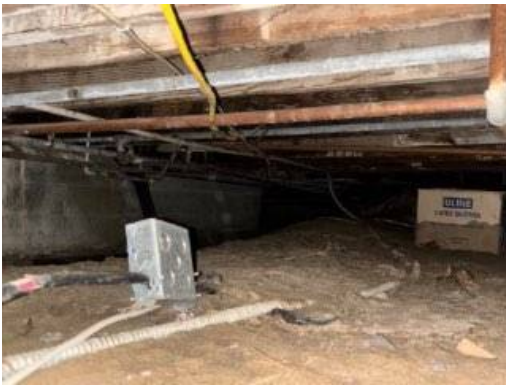
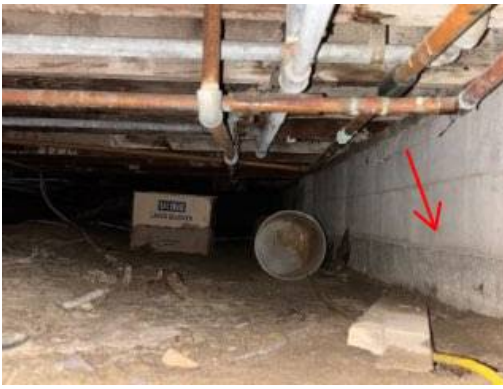
Photo 10-1

Evidence of prior water intrusion or accumulation was found in one or more sections of the crawl space. For example, sediment stains on the vapor barrier or foundation, and/or efflorescence on the foundation. Accumulated water is a conducive condition for wood-destroying organisms and should not be present in the crawl space. Recommend that the client review any disclosure statements available and ask the property owner about past accumulation of water in the crawl space. The crawl space should be monitored in the future for accumulated water, especially after heavy and/or prolonged periods of rain. If water is found to accumulate, then recommend that a qualified contractor who specializes in drainage issues evaluate and repair as necessary. Typical repairs for preventing water from accumulating in crawl spaces include:

- Repairing, installing or improving rain run-off systems (gutters, downspouts and extensions or drain lines)
- Improving perimeter grading
- Repairing, installing or improving underground footing and/or curtain drains

Ideally, water should not enter crawl spaces, but if water must be controlled after it enters the crawl space, then typical repairs include installing trenches, gravity drains and/or sump pump(s) in the crawl space.

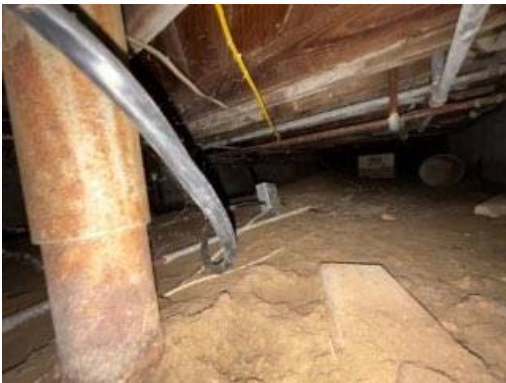
Photo 11-1

11) ✓ Crawl space was in serviceable condition.

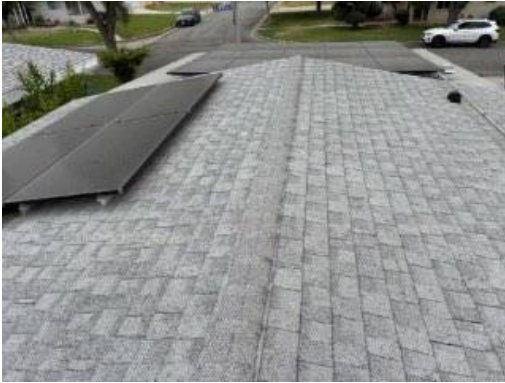
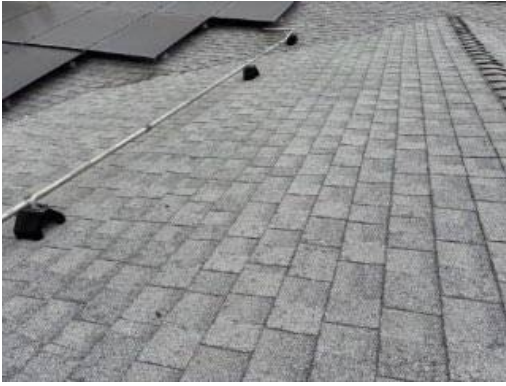
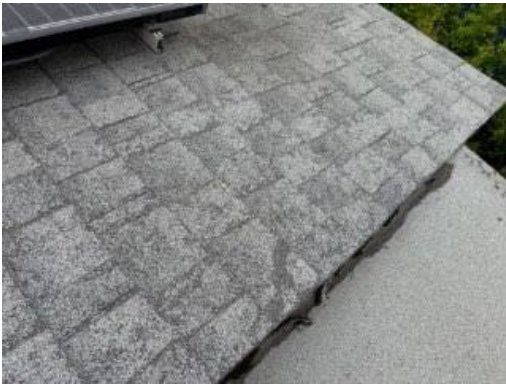
Photo 12-1

The roof surface appeared to be near the end of its service life and will likely need replacing in the near future even if repairs are made now. Recommend discussing replacement options with a qualified contractor, and budgeting for a replacement roof surface in the near future. The client may also wish to consider having a qualified contractor attempt to issue a "5 year roof certificate."

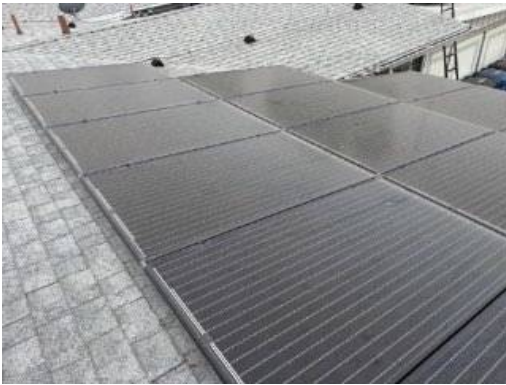
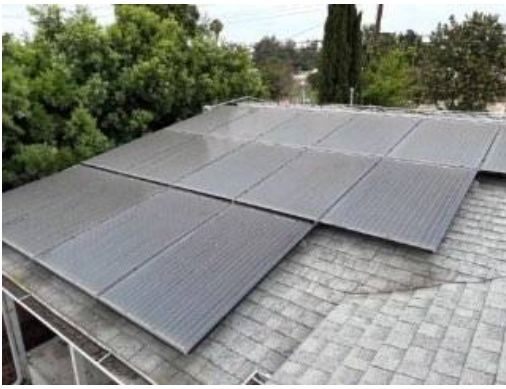
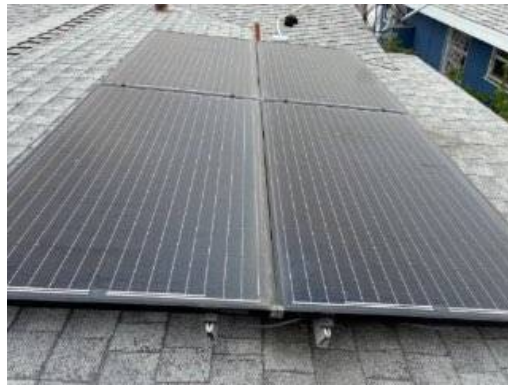
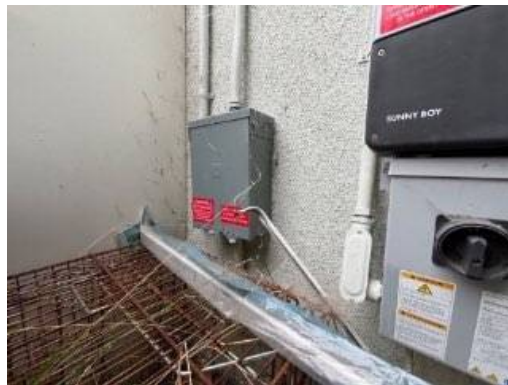
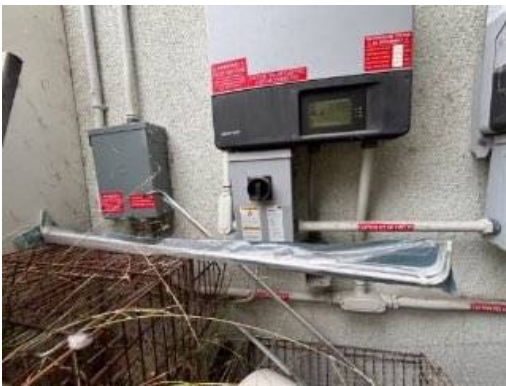
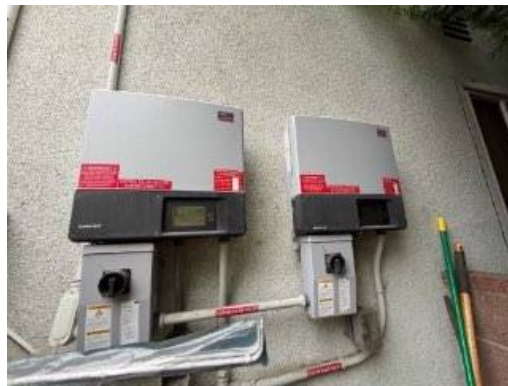
Photo 13-1

At the time of the inspection, the property had solar panels installed at the roof surface. This system and panels were not inspected. There are excluded from this inspection.

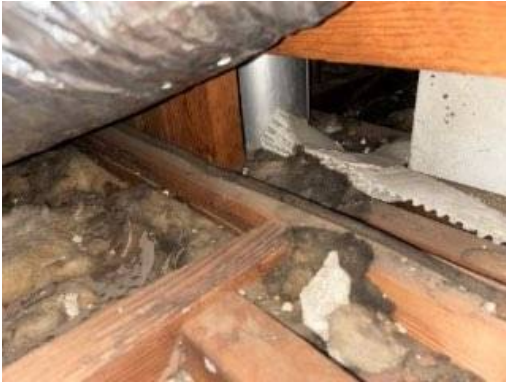
Photo 14-1

1) Attic was in serviceable condition.

2) The ceiling insulation installed in the attic was substandard and appeared to have an R rating that's significantly less than current

standards (R-38). Heating and cooling costs will likely be higher due to poor energy efficiency. Recommend that a qualified contractor install insulation for better energy efficiency and per standard building practices.

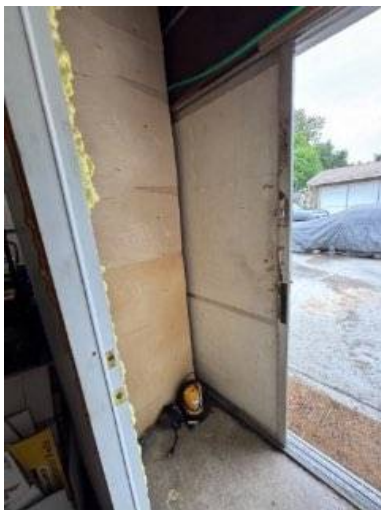
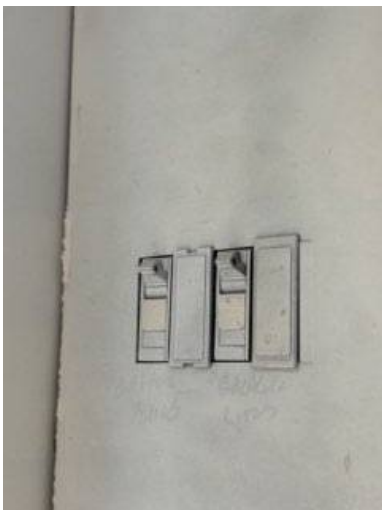
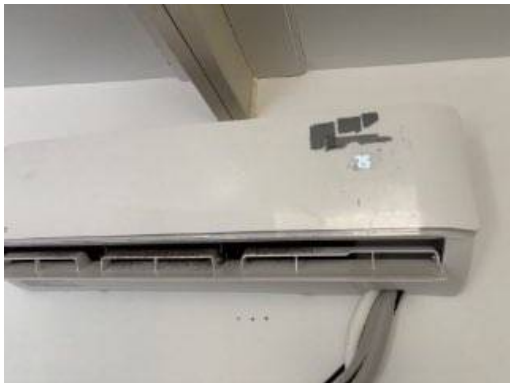
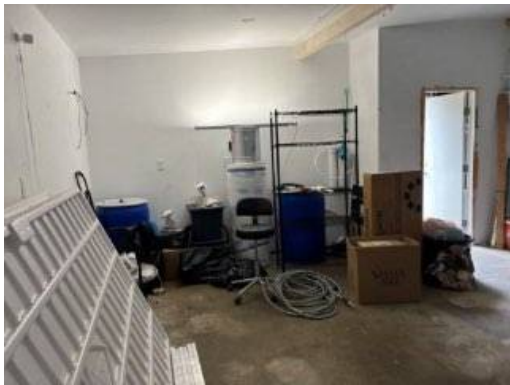
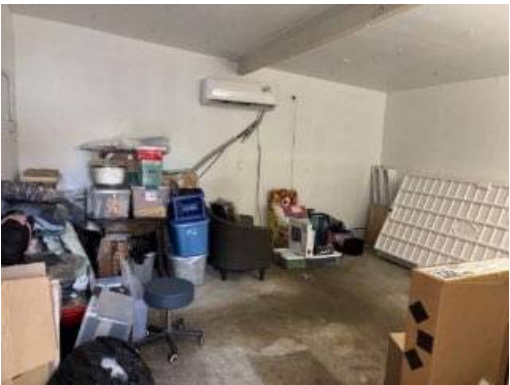
Photo 15-1

1) Garage should be converted as original .
 - 2) Garage had subpanel and wall air conditioning in serviceable and good condition.

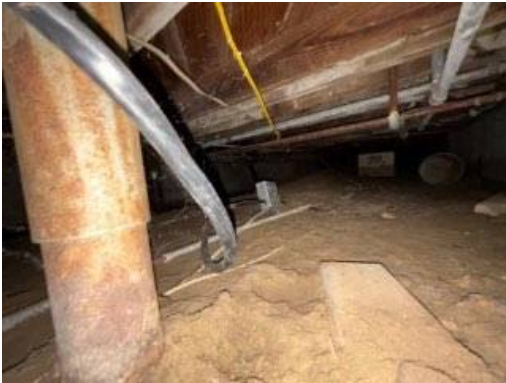
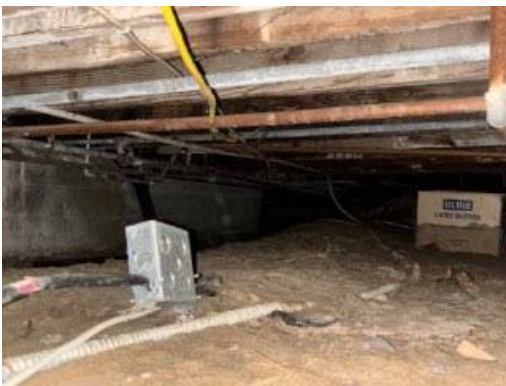
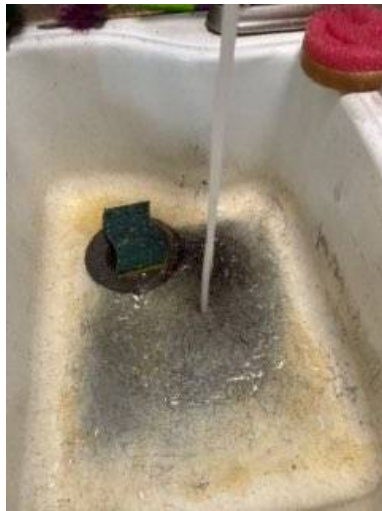
Photo 17-1

17) ✓ Plumbing system was in serviceable condition. There was hot water and no active leaks were found.

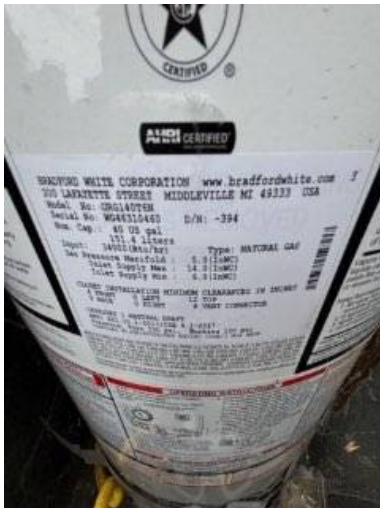
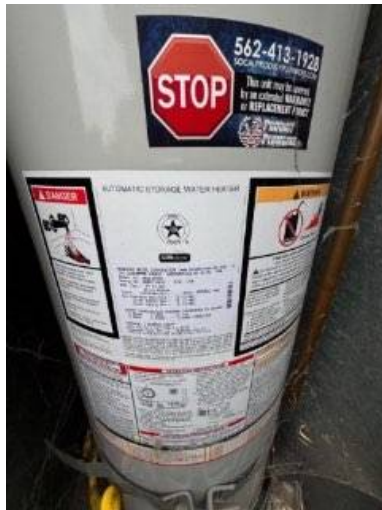
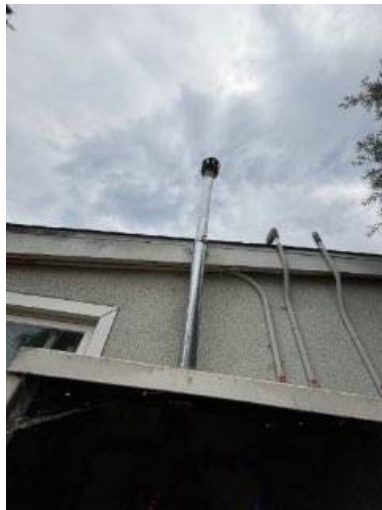
Photo 18-1

-
- 18) 🚧👍 1) The water heater's earthquake straps or struts were substandard. For example, they may allow significant movement or use substandard fasteners. This is a potential safety hazard in the event of an earthquake due to the risk of the water heater tipping over, gas lines breaking if it's gas-fired, or electric wiring being damaged if powered by electricity. Leaks can also occur in water-supply pipes. Recommend that a qualified person repair or replace existing earthquake reinforcement per standard building practices.
- 2) The exterior door was damaged and should be repair as necessary.
- 3) The water heater was in serviceable and good working condition.

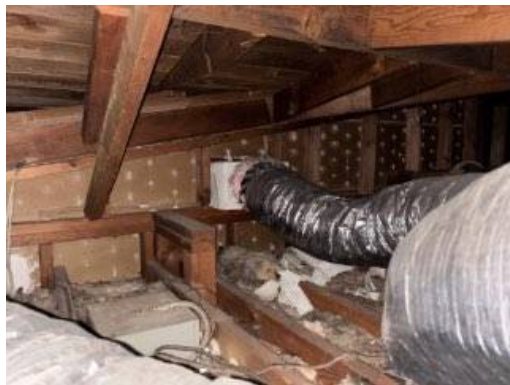
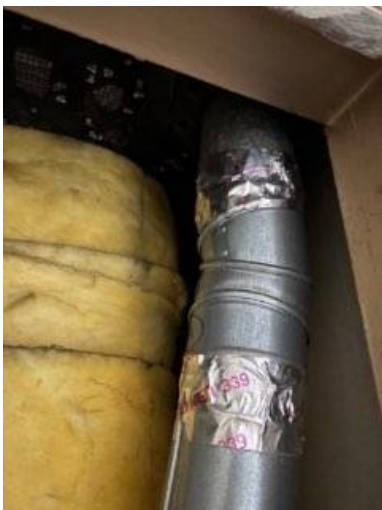
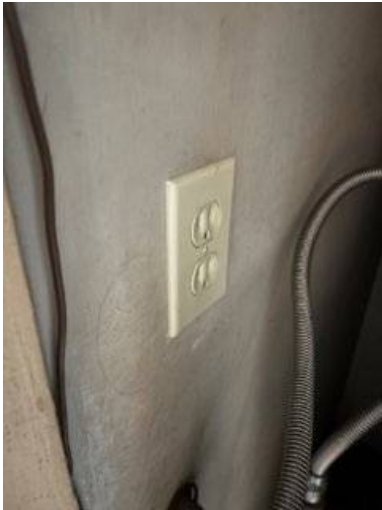
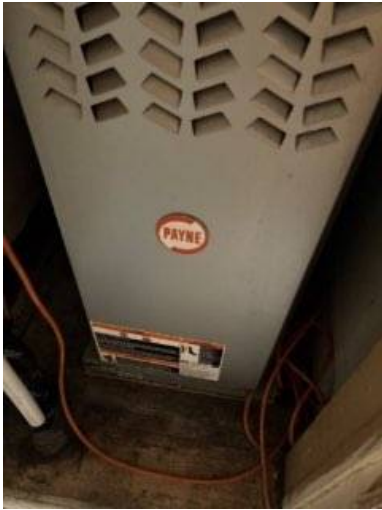
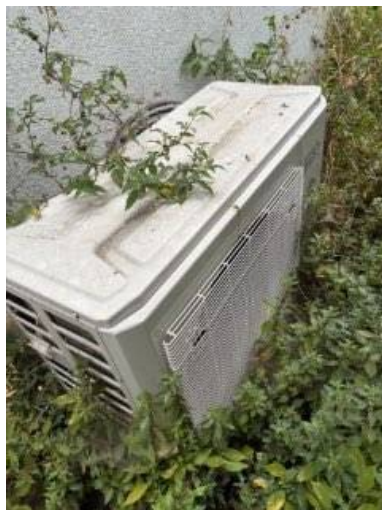
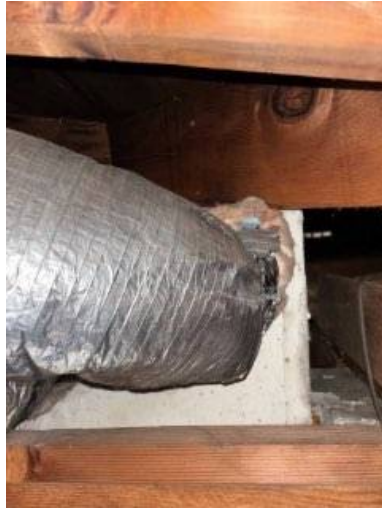
Photo 21-1

1) The last service date of the forced air heating/cooling system appeared to be more than 1 year ago, or the inspector was unable to determine the last service date. Ask the property owner when it was last serviced. If unable to determine the last service date, or if this system was serviced more than 1 year ago, recommend that a qualified HVAC contractor service this system and make repairs if necessary. Because this system has a compressor and refrigerant system, this servicing should be performed annually in the future. Any needed repairs noted in this report should be brought to the attention of the contractor when it's serviced.

2) One or more heating or cooling ducts were damaged. This can result in reduced energy efficiency. Recommend that qualified HVAC contractor repair or replace ducts or components as necessary.

3) One or more electric receptacles (outlets) appeared to have no power. Recommend asking the property owner about this. Switches may need to be operated to make some receptacles energized. If necessary, recommend that a qualified electrician evaluate and repair.

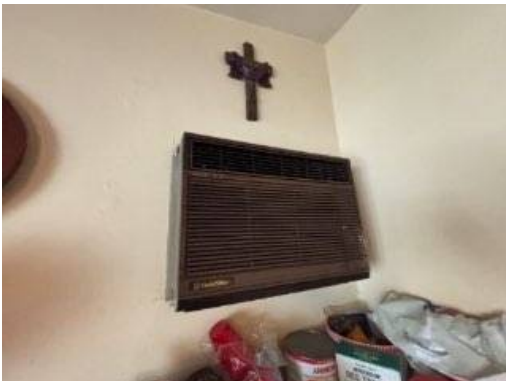
Photo 22-1

22) 🛠️ Wall/window air conditioning was inoperable.

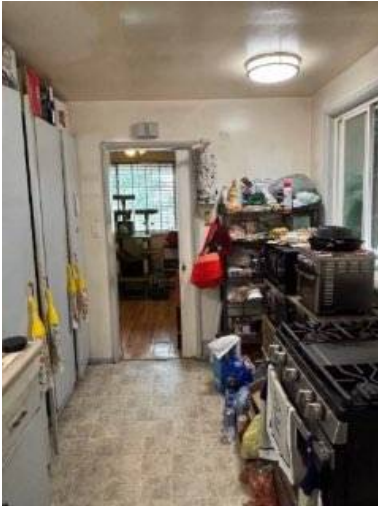
Photo 24-1

1) Kitchen needs repairs and replace some items.

2) The estimated useful life for most kitchen appliances is 10-15 years. One or more appliances appeared to be near, at or beyond their service life. Even if operable, recommend budgeting for replacements in the near future.

3) One or more cabinets, drawers and/or cabinet doors were damaged or deteriorated. Recommend that a qualified person repair or replace as necessary.

4) Countertops and/or backsplashes were damaged or deteriorated. Recommend repairing or replacing as necessary.

5) The sink was damaged or significantly deteriorated. Recommend that a qualified contractor replace the sink.

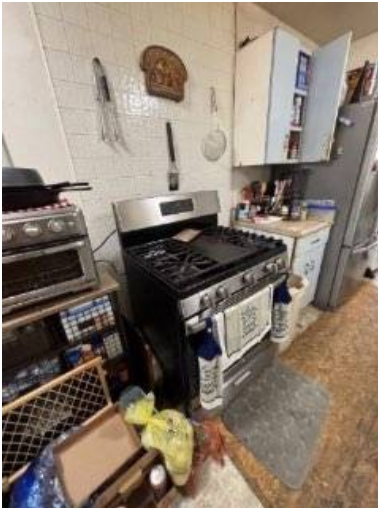
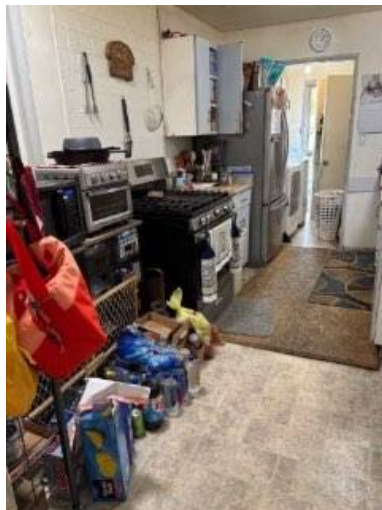
Photo 25-1

Vinyl, linoleum or marmoleum flooring in one or more areas was damaged , deteriorated and/or missing . If in a wet area, water can damage the the sub-floor as a result. Recommend that a qualified contractor replace or repair flooring as necessary.

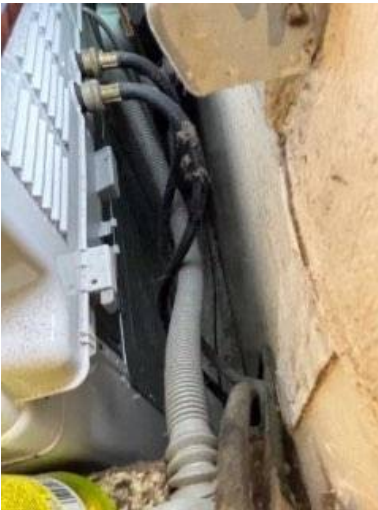
Photo 27-1

27) 🔑🔍 Connections for washer and dryer machines were not evaluated.

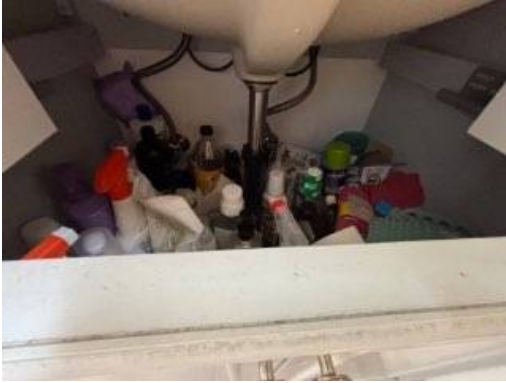
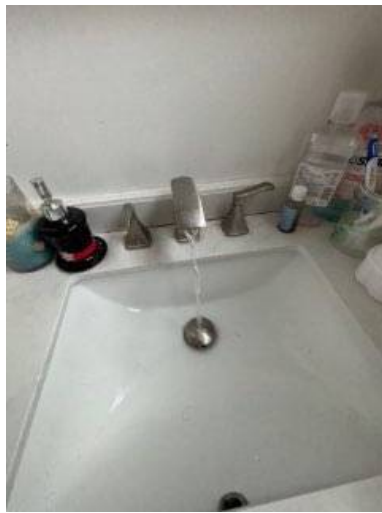
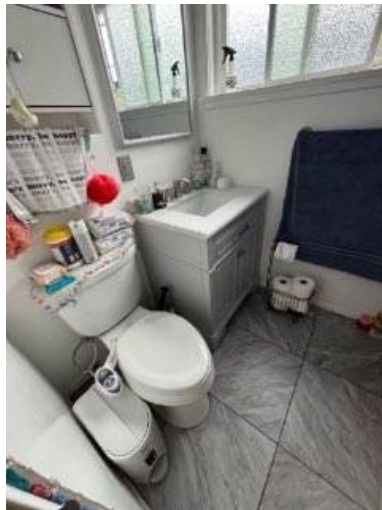
Photo 28-1

28) ✓ Bathroom was in serviceable and good condition. Toilet, sink, shower were in serviceable working condition. There was hot

water and no active leaks were found, at the time of the inspection.

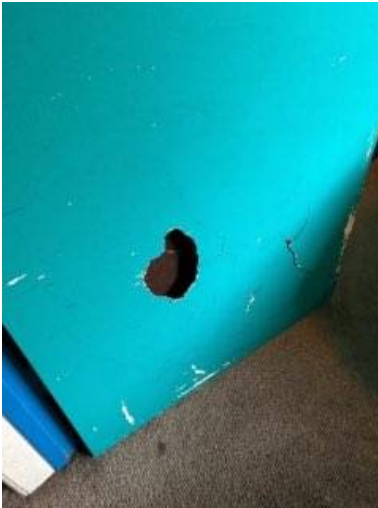
Photo 29-1

One or more interior doors were damaged. Recommend that a qualified person replace or repair doors as necessary.

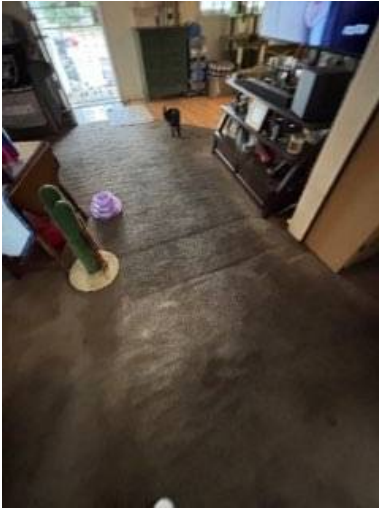
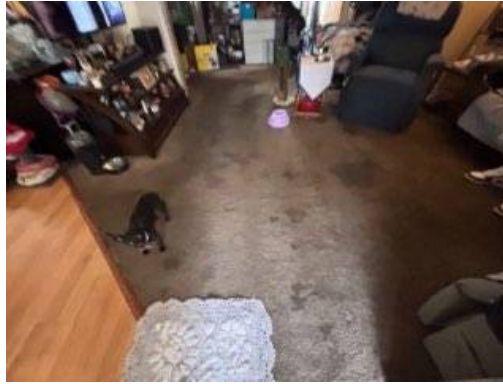
Photo 30-1

Carpeting in one or more areas was damaged or deteriorated. Recommend that a qualified contractor replace as necessary.

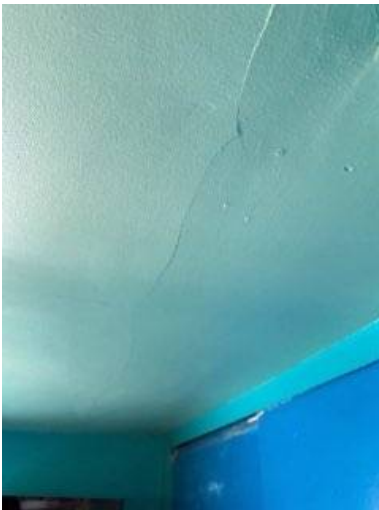
Photo 31-1

31) 🛠️ One or more walls and/or ceilings were damaged and/or had substandard repairs . Recommend that a qualified person repair as necessary.

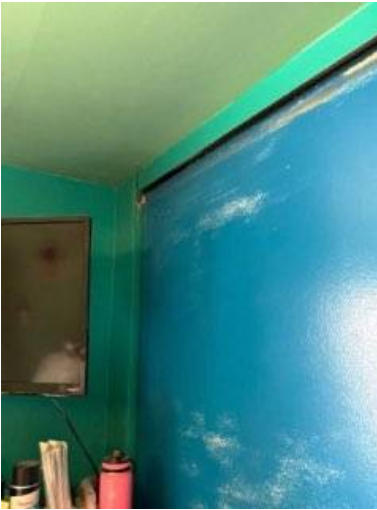
Photo 34-1

34) 🛠️ Closet doors did not open and close properly.
