WOOD DESTROYING PESTS AND ORGANISMS INSPECTION REPORT

Building No. 2112	Street Via Pacheco	City Palos Verdes Estates	Zip 90274	Date of Inspection 03/20/2024	Number of Pages 7
  <p>964 E. Badillo Street, Suite 237 Covina, California 91724 Off: 310.482.0720 / Tel: 818.482.7306 www.dabtermite.net <i>email: paul.guzman4@verizon.net</i></p>				Report # 106716	
				Lic. Registration # PR 6216	
				Escrow #	
Ordered by: Cindy Carter Keller Williams 407-496-7445 CindyCarter@kw.com	Property Owner and/or Party of Interest: Owner 2112 Via Pacheco Palos Verdes Estates, CA 90274	Report sent to: Cindy Carter Keller Williams 407-496-7445 CindyCarter@kw.com			
COMPLETE REPORT <input checked="" type="checkbox"/> LIMITED REPORT <input type="checkbox"/> SUPPLEMENTAL REPORT <input type="checkbox"/> REINSPECTION REPORT <input type="checkbox"/>		General Description: 1 story single family residence, attached garage, wood shake roof, raised foundation, vacant			
		Inspection Tag Posted: Garage

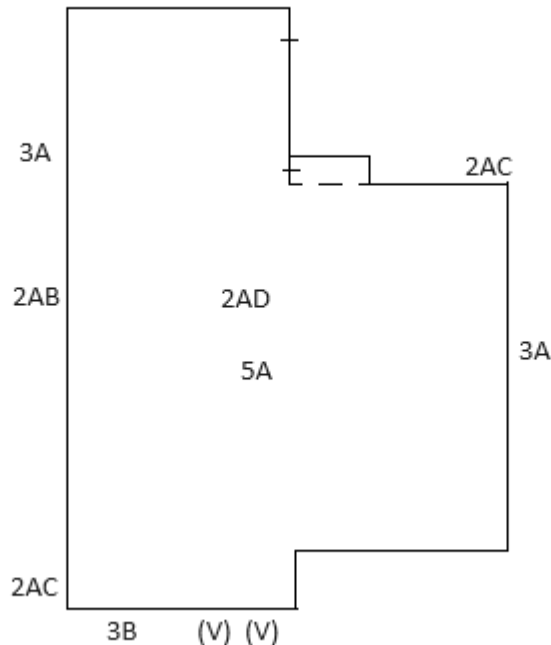
This Diagram is not to Scale

- 2A (Section I)
FINDING – Evidence of drywood termites noted at fascia and attic.
RECOMMENDATION – Locally treat area(s) for the control of drywood termites. Cover or remove accessible termite pellets. Treated areas have a one year warranty.
PRICE: \$750.00

- 2B (Section I)
FINDING – Termite damage wood noted at fascia.
RECOMMENDATION – Remove and replace termite damaged wood with new material. Priming / Painting is not included in this estimate.
PRICE: \$650.00

- 2C (Section I)
FINDING – Termite damage wood noted at fascia.
RECOMMENDATION – Repair termite damage. DAB Termite & Pest Solution will prime area repaired with one coat of primer.
PRICE: See item 2B

- 2D (Section I)
FINDING – Evidence of drywood termites noted at attic.
RECOMMENDATION – Apply Timbor to accessible unpainted timbers at area(s) marked on diagram. Treated areas have a one year warranty. **NOTE:** *To insects, the borate compound in Timbor acts as a slow-acting stomach poison. When the treated wood is ingested by termites, for example, the compound prevents the insects from metabolizing their food, which, in turn causes death. Also, during grooming, the topical presence of Timbor is ingested, producing the same results.*
http://www.ehow.com/about_5117836_timbor.html
PRICE: See item 2A

- 3A (Section I)
FINDING – Minor fungus damage noted at fascia, which appears to have been caused by moisture.
RECOMMENDATION – Dig or cut out fungus from infected wood, treat area with a registered fungicide, fill area with water resistant wood filler and prime area with one coat of primer.
PRICE: See item 2B

- 3B (Section I)
FINDING – Fungus damaged wood noted at bay window frame, which appears to have been caused by moisture.
RECOMMENDATION – Cut out fungus damage and repair area(s) noted on the diagram.
PRICE: See item 2B

- 5A **FINDING** – The sub area of the main structure is inaccessible for physical inspection due to lack of clearance, possible unsafe condition(s) and/or obstruction(s) to access the sub area.
RECOMMENDATION – If further inspection of this area is required, make inaccessible area(s) accessible. A supplemental report will be issued if there are any new findings.
