EQUITY BUILDING INSPECTION

RESIDENTIAL BUILDING INSPECTION

6224 Ocean Terrace Dr
Rancho Palos Verdes, CA 90275

11/13/2024

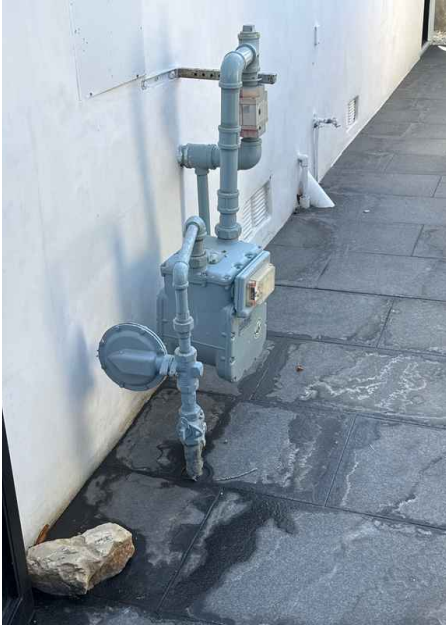
Right side

I recommend that everyone living in the home familiarizes themselves with the location of the gas meter and the disconnect used to shut off the gas to the whole house.

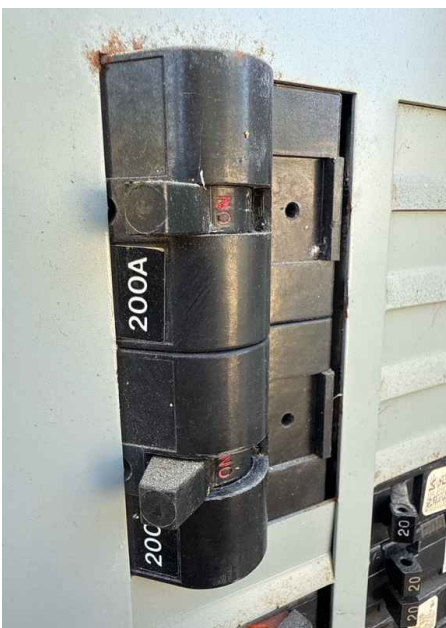
Electrical - Main Disconnect: Location

Right side

I recommend that everyone living in the home familiarizes themselves with the location of the electrical service panel and the disconnect used to shut off power to the whole house. Knowing the location of the panel may be beneficial to all members of the family, whether it's to reset a tripped breaker or to disconnect power in the event of an emergency.

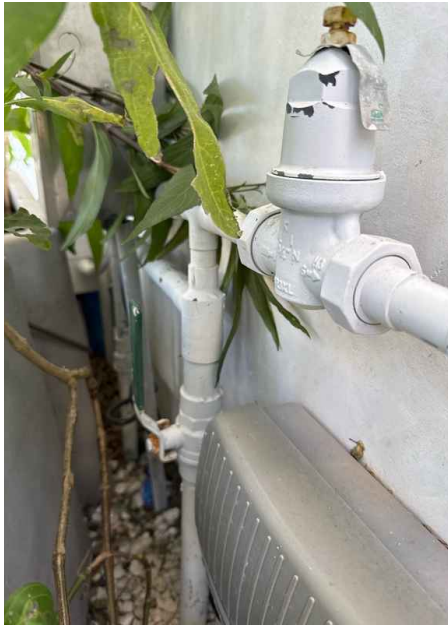
Water - Main Shut Off Valve: Location

Front side, Left side

I recommend that everyone living in the home familiarizes themselves with the location of the main water supply.

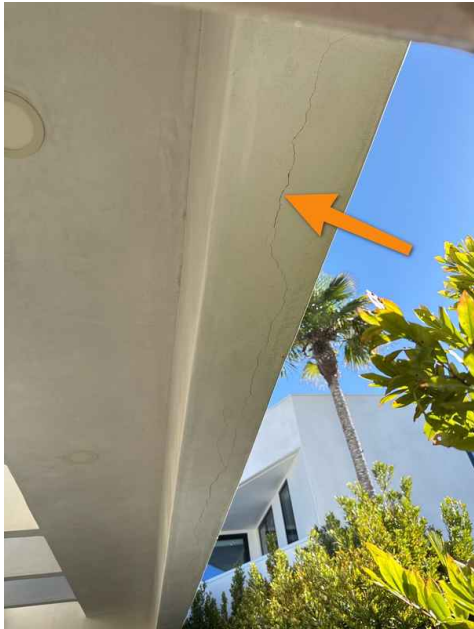
STUCCO - DAMAGE

There are sections of minor stucco damage. We recommend repair by a qualified stucco contractor.

Contact a stucco repair contractor

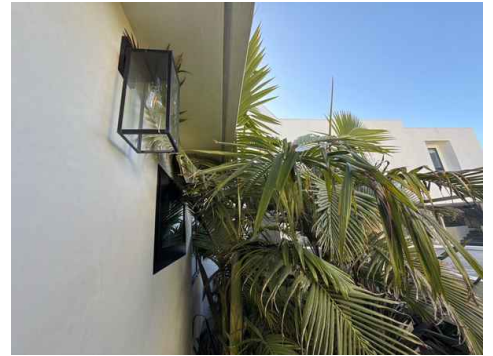
Areas of vegetation are in close contact with the building. In order to prevent branches from chafing the siding or roof, leaves from clogging gutters, and roots from damaging the foundation, critters from having a way to get onto the roof, etc., I recommend having the vegetation around the home evaluated and addressed as necessary.

Contact a qualified landscaping contractor

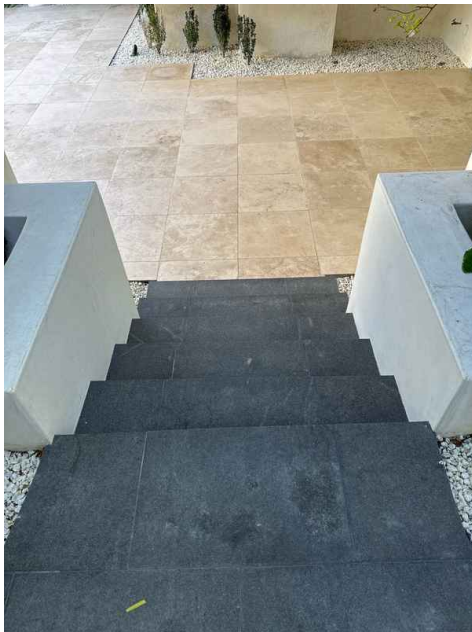
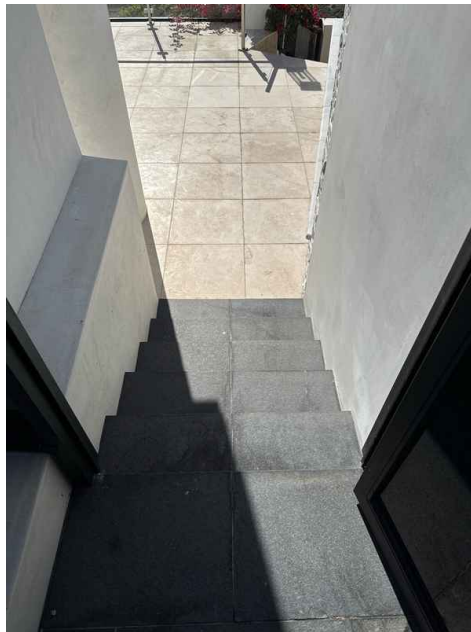
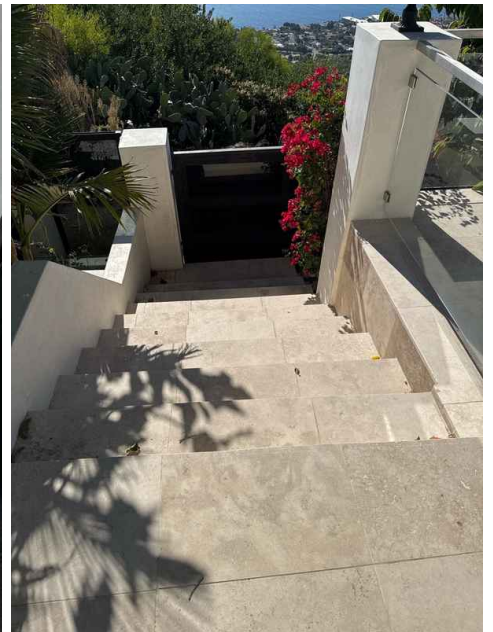
HANDRAILS - MISSING MORE THAN 4 STEPS

There were no handrails, where required. We recommend repair to prevent a fall injury.

Contact a qualified general contractor.

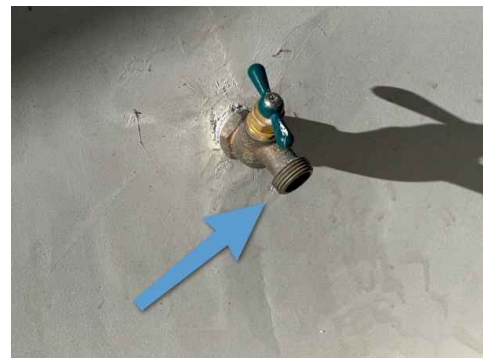
HOSE BIB MISSING BACKFLOW PREVENTER

One or more hose bib backflow preventers were missing at the time of our inspection. These are required to prevent the possibility of gray water entering back into the drinkable water supply. We recommend repair.

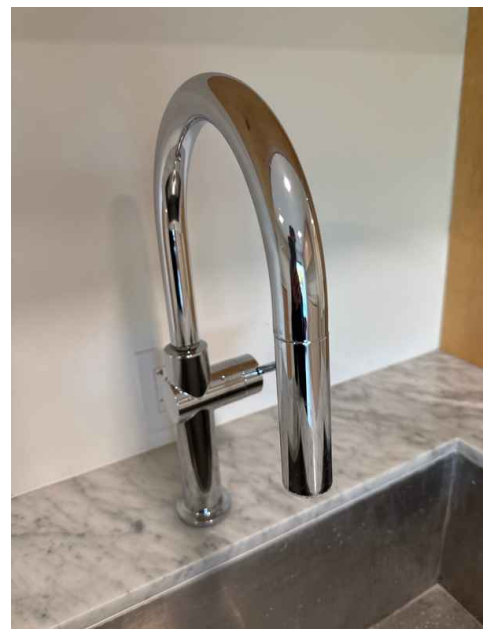
FAUCET - IN NEED OF REPAIR

The faucet(s) is in need of repair. I recommend having the faucet evaluated and repaired/replaced as necessary by a qualified plumbing contractor.(faucet touch feature not operating)

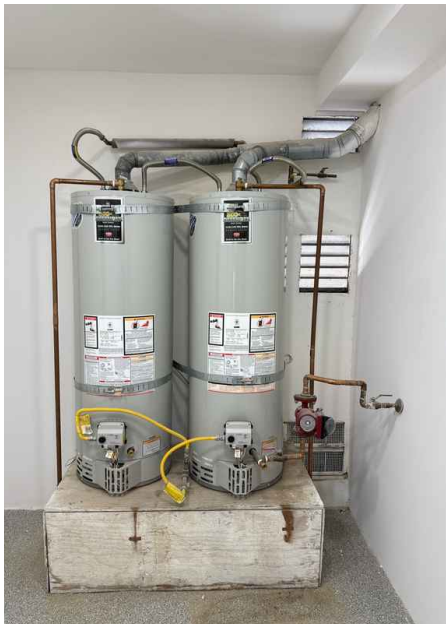
Water Heater: Ok

The water heater(s) was installed properly and operated as designed with exceptions noted below.

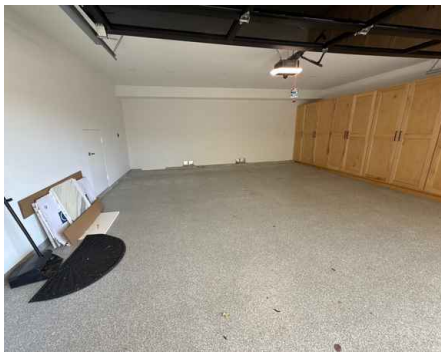
General: General Photos

The finished surfaces, garage door opener if installed, hardware, windows, and doors were found to be generally in good condition at the time of our inspection with possible exceptions noted herein.

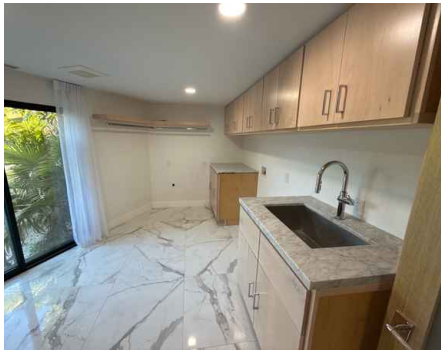
General: All ok

Both the washer and dryers visible hookups were found to be in acceptable condition where visible. We recommend cleaning the dryer vent on a regular basis to prevent buildup. the operation of these units is outside the scope of this type of inspection.

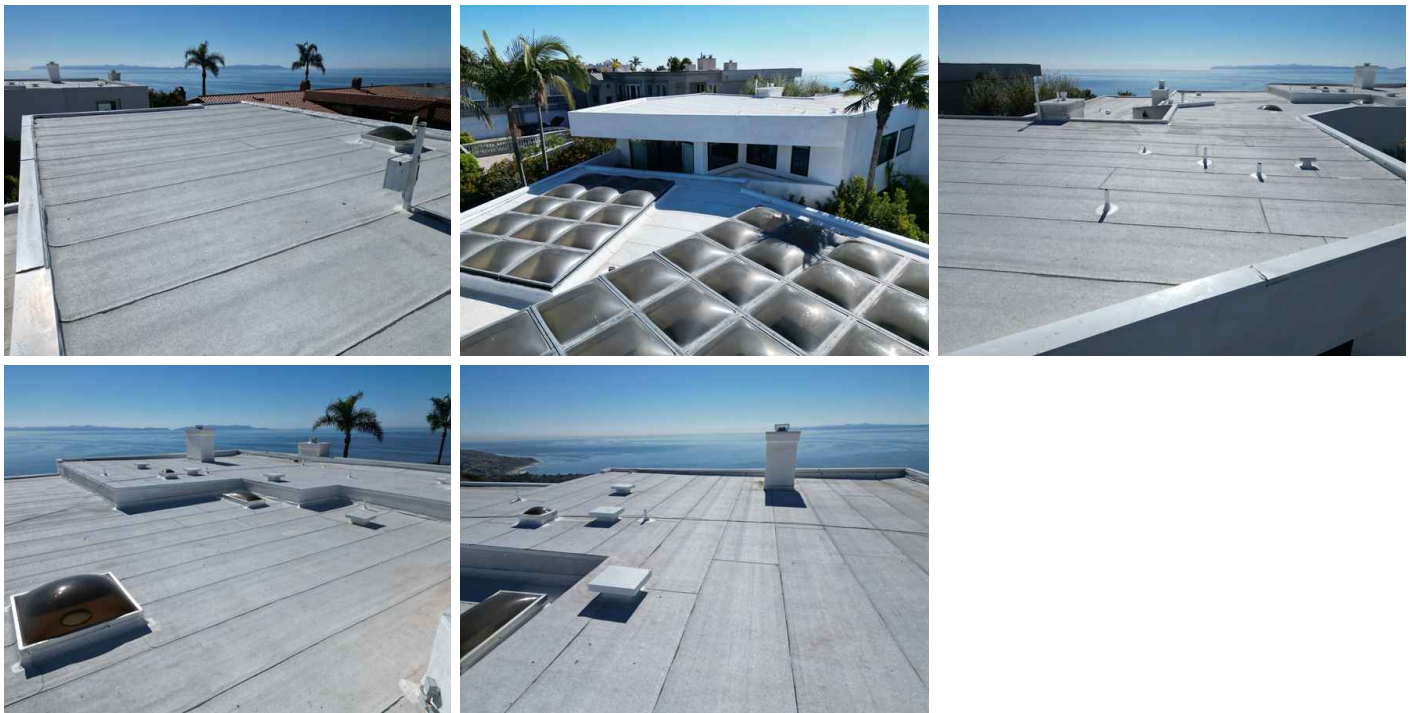
Built-up Roofing: Built-up roof OK

At the time of the inspection, the roof covering was in serviceable condition with possible exceptions noted herein.

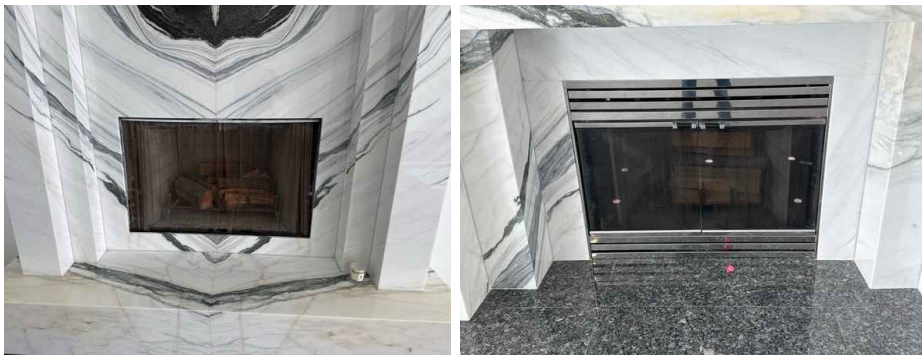
General: Serviceable Condition

The fireplace, and it's related components, are in in serviceable condition, with exceptions noted herein, at the time of the inspection.

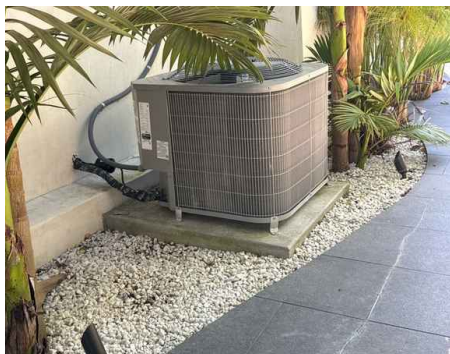
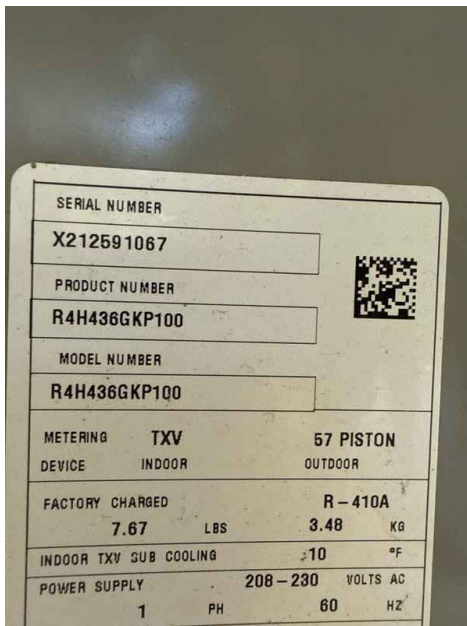
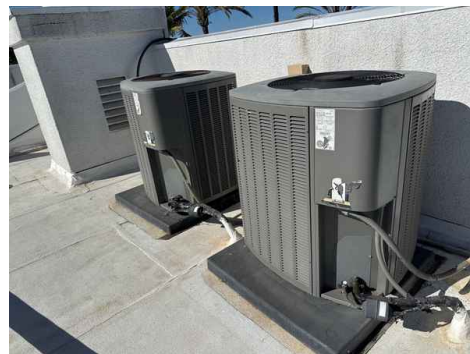
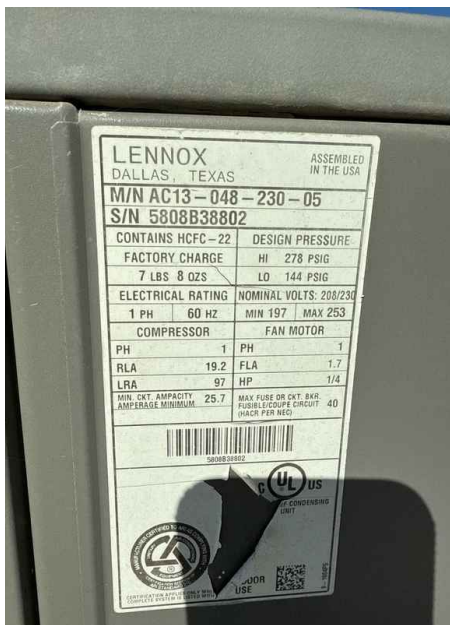
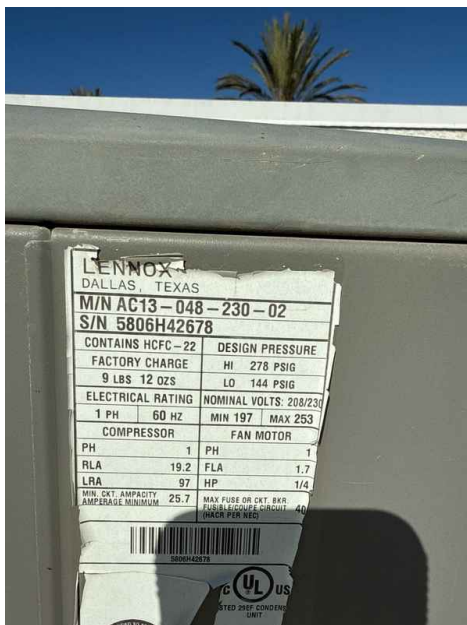
Air Conditioning: Equipment Photos

2021, 2008, 2006

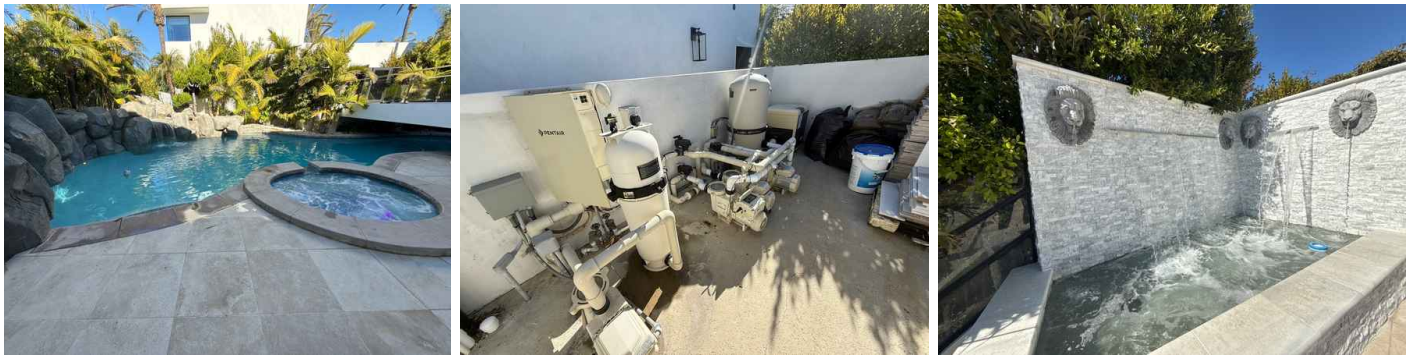
General: Pool/Spa View

The spa, and its related controls, operated properly when tested.
