# GIBSON HOME INSPECTION

## GIBSON HOME INSPECTION REPORT

3087 Coronado Rd  
Chico, CA 95973

04/06/2025

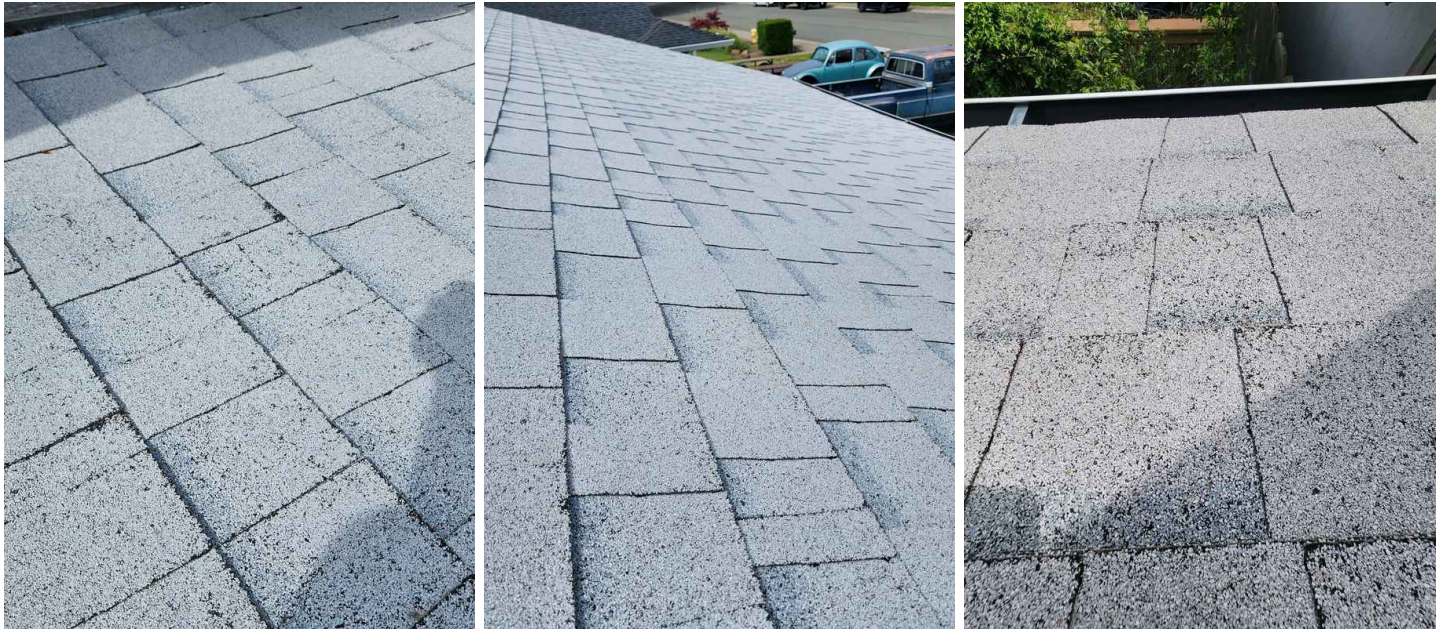
### 2.1.1 Roof Covering

Minor Defect

Roof shows signs of granular lose, this is a indicator of an older roof and maybe time to replace. Have evaluated and or replaced.

Contact a qualified roofing professional.

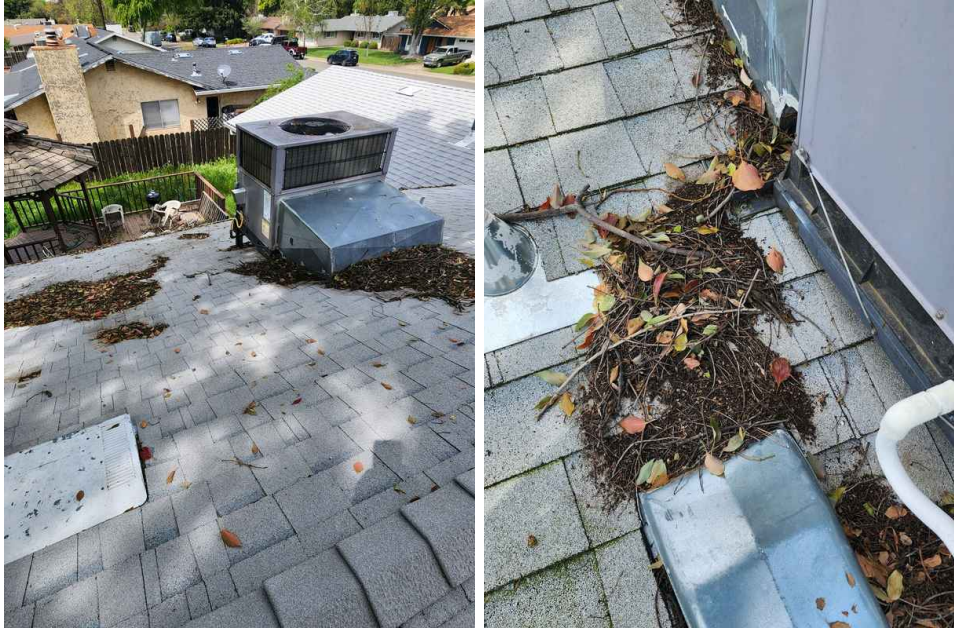
2.1.2 Roof Covering

**DEBRIS**

Debris on roof top covering recommended cleaning.

Minor Defect

Recommendation  
Recommended DIY Project

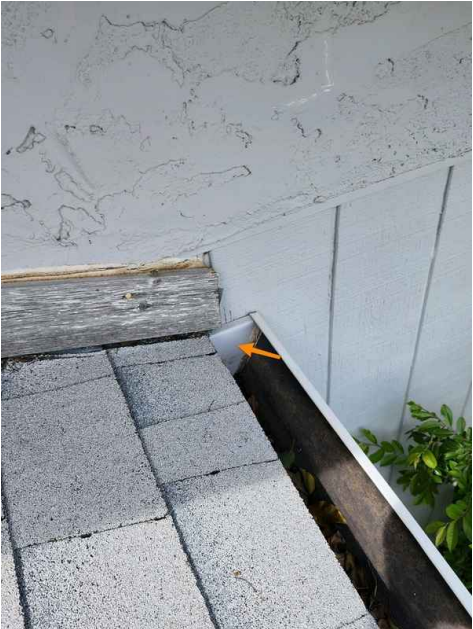
2.2.1 Flashing

**MISSING KICKOUT FLASHING**

Minor Defect

I observed a defect at the flashing area called a "kickout." It's missing. Not installed. A kickout flashing "kicks" the roof water away from the house structure and diverts it into a gutter. This missing flashing could lead to hidden moisture intrusion and water damage issues that I would not be able to observe during a visual-only home inspection. A roofing professional is needed to further evaluate and make necessary corrections.

Contact a qualified roofing professional.

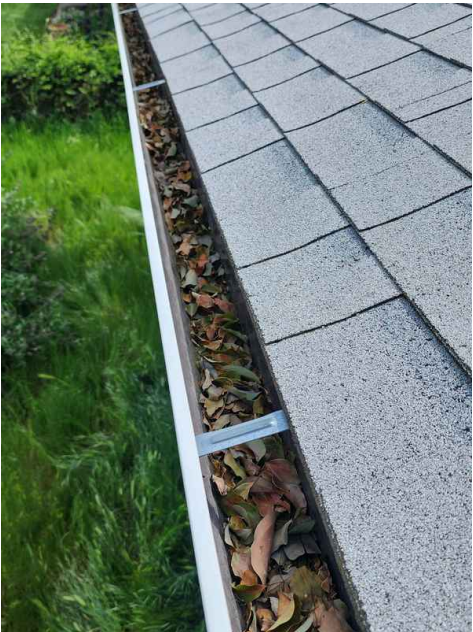
2.4.1 Gutters & Downspouts

**DEBRIS IN GUTTERS**

I observed debris in the gutter. Cleaning and maintenance is recommended.

Minor Defect

Recommended DIY Project

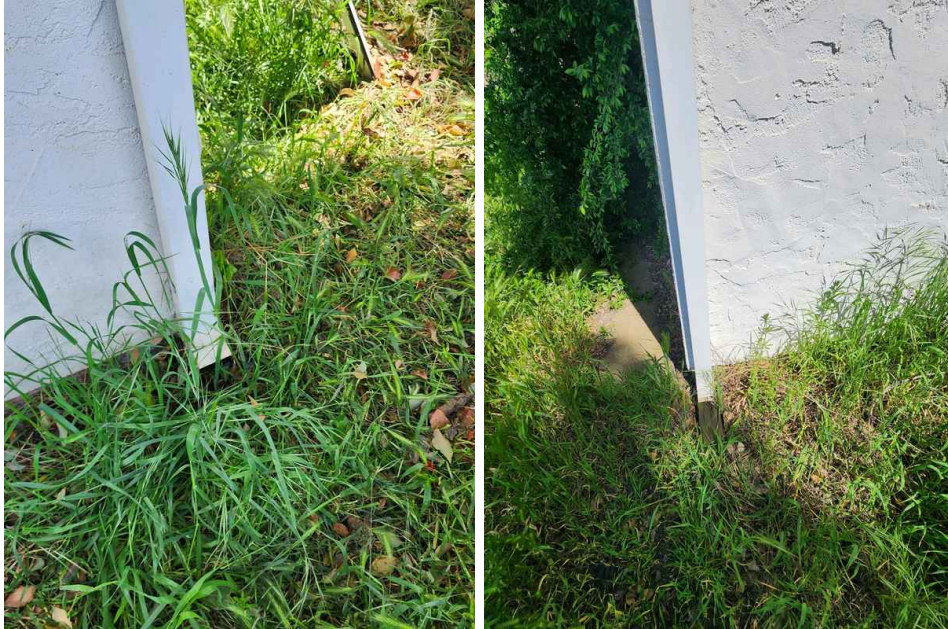
## 2.4.2 Gutters &amp; Downspouts

One or more downspouts drain too close to the home's foundation. This can result in excessive moisture in the soil at the foundation, which can lead to foundation/structural movement. Recommend a qualified contractor adjust downspout extensions to drain at least 6 feet from the foundation. A handy homeowner should be able to do this project.

Recommended DIY Project

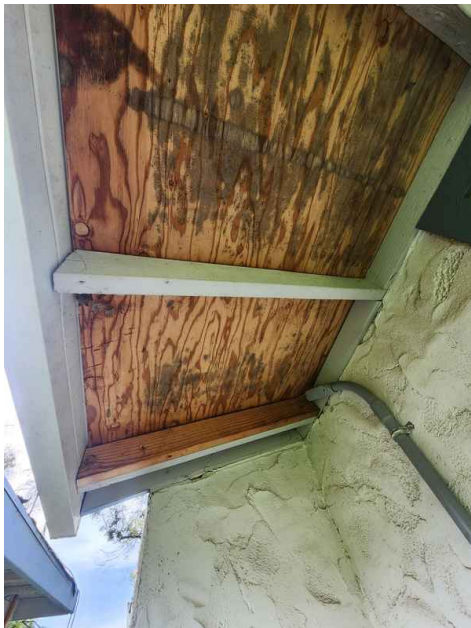
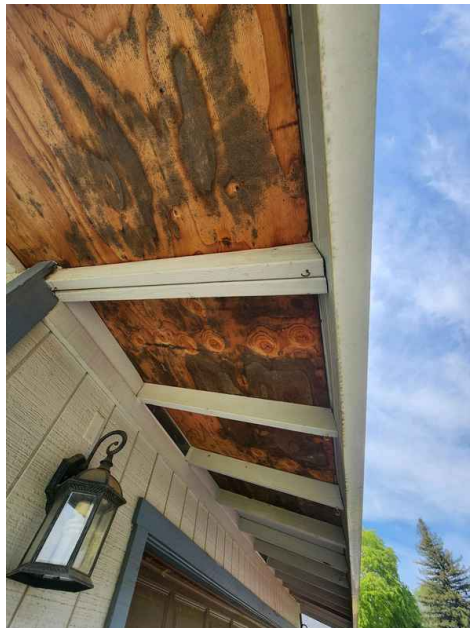
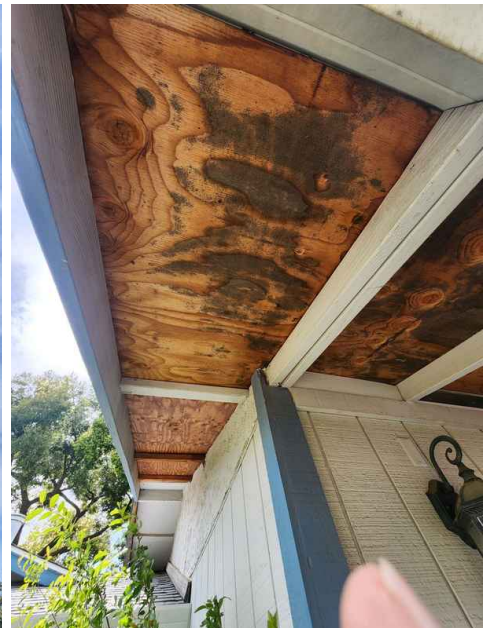
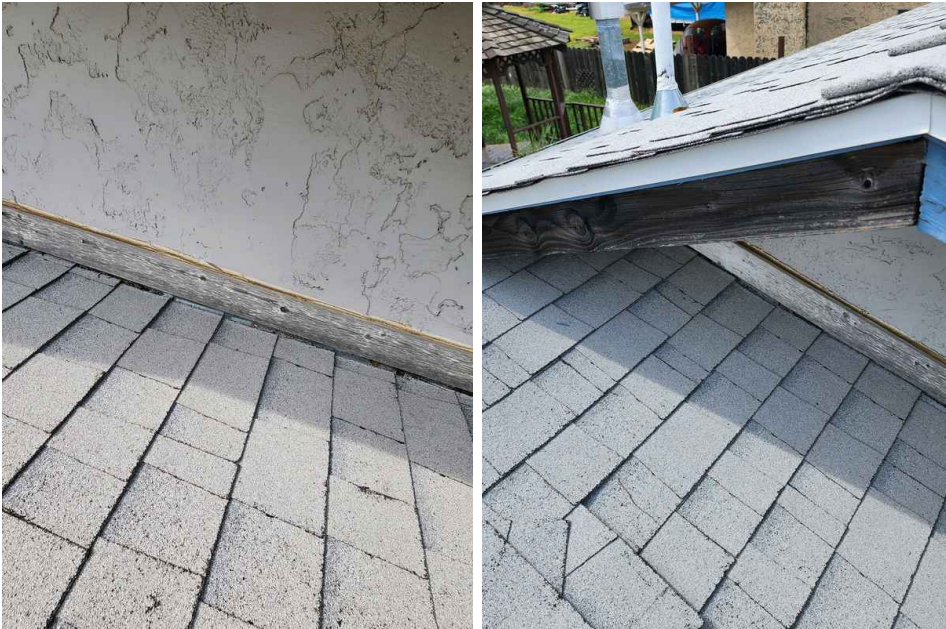
### 3.2.2 Eaves, Soffits & Fascia

Major Defect

#### **PAINT SURFACE IN POOR CONDITION**

I observed indications of paint or staining in poor condition. Flaking, cracking, and worn areas.

Correction and further evaluation is recommended.

Contact a qualified painting contractor.

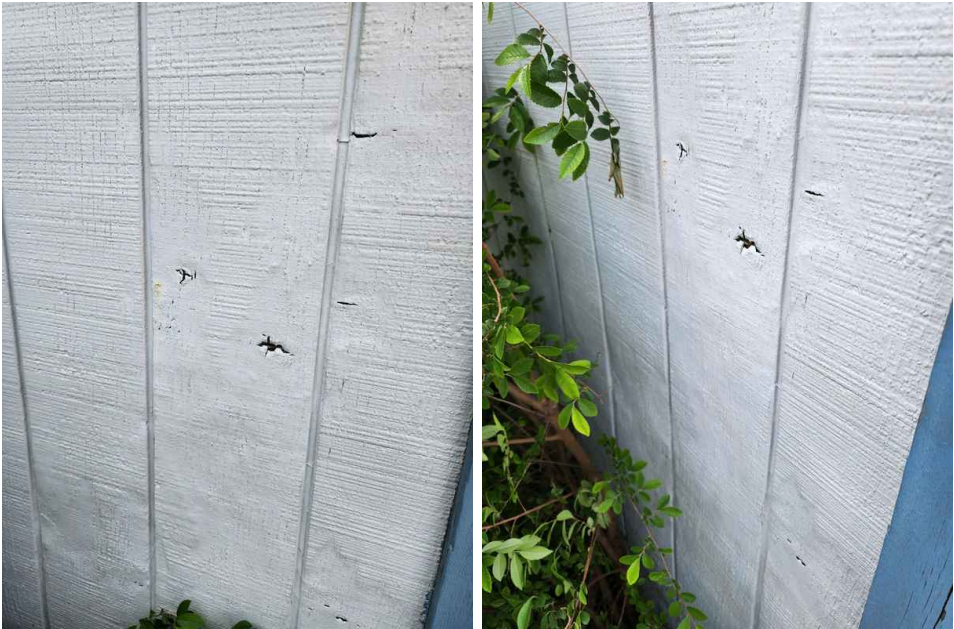
### 3.3.2 Wall-Covering, Flashing & Trim

#### WOOD ROT

Couple areas on the siding had what appeared to be wood rot. Have evaluated and corrected.

Major Defect

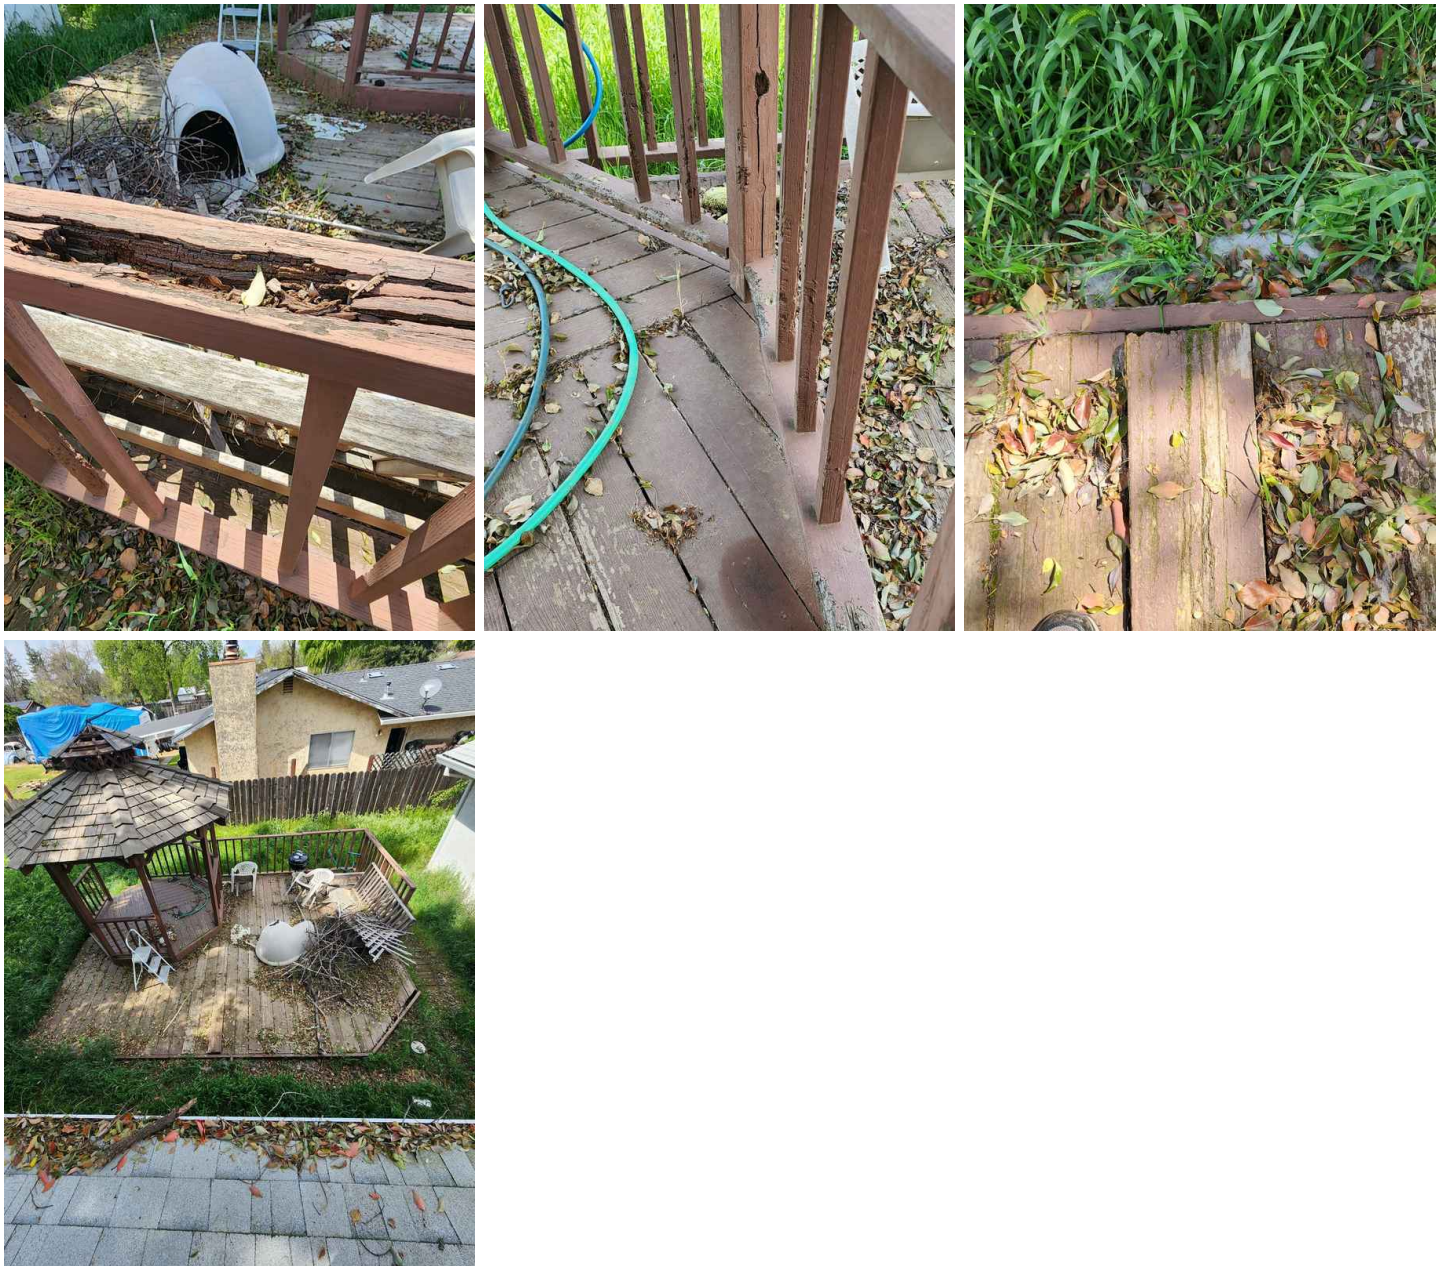
3.8.1 Porches, Patios, Decks, Balconies & Carports

Major Defect

**DECK - INADEQUATE STRUCTURAL COMPONENT**

I observed a structural defect at the deck. The deck's structural condition is inadequate. This is a major defect.

Correction and further evaluation of the deck is recommended.

Contact a qualified deck contractor.

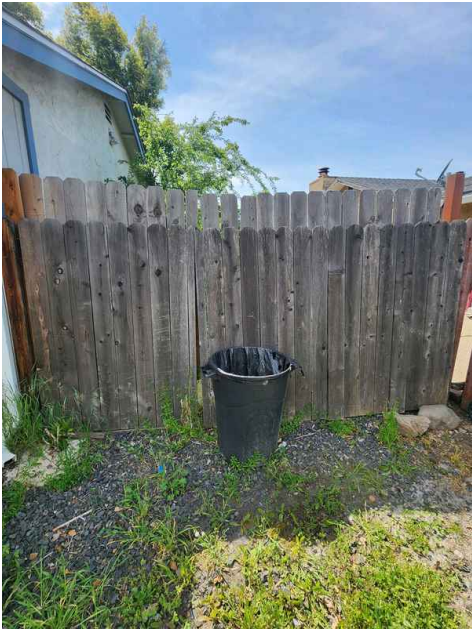
3.13.1 Gate

**GATE IS NOT OPERABLE**

Minor Defect

Gate and access to backyard did not operate recommend replacing.

Contact a qualified fencing contractor

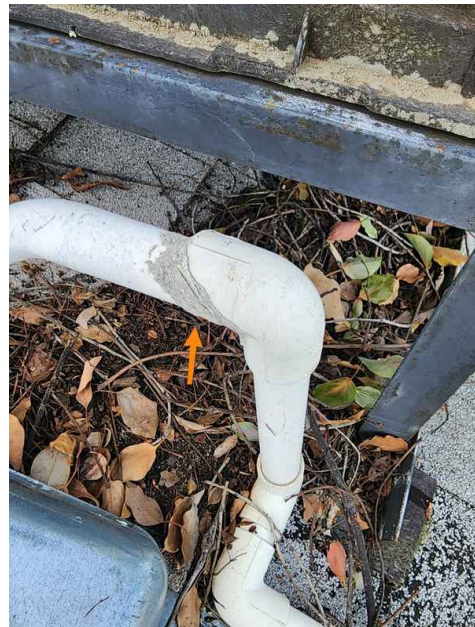
#### DEFECT AT CONDENSATE

Major Defect

I observed a defect at the air conditioner's condensate drainage. Looks to be a small crack in line or sealant, have evaluated and corrected.

Contact a qualified HVAC professional.

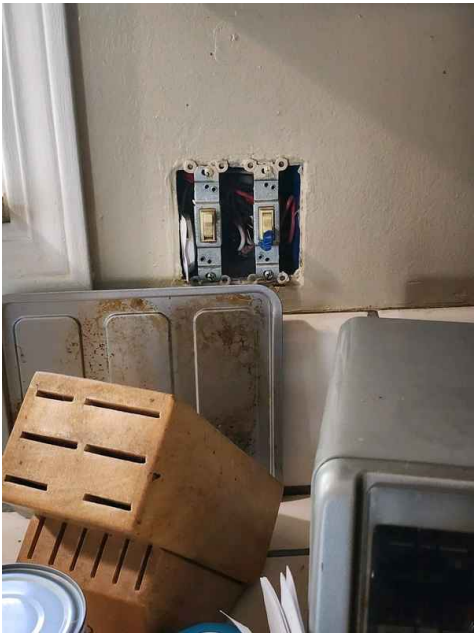
COVER PLATES MISSING

One or more receptacles/light switches are missing a cover plate. This is a potential short and shock risk. Recommend installation of plates.

Major Defect

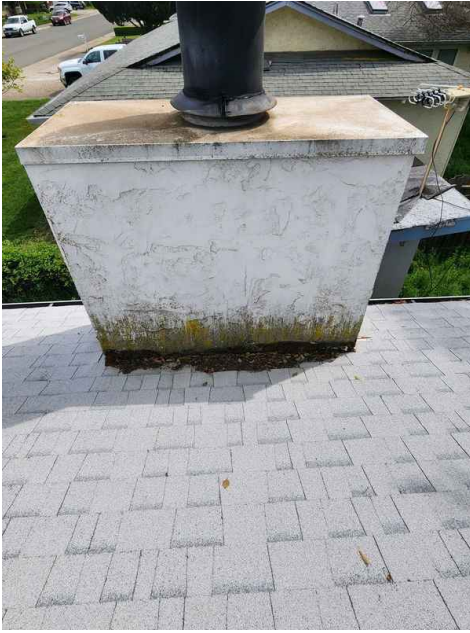
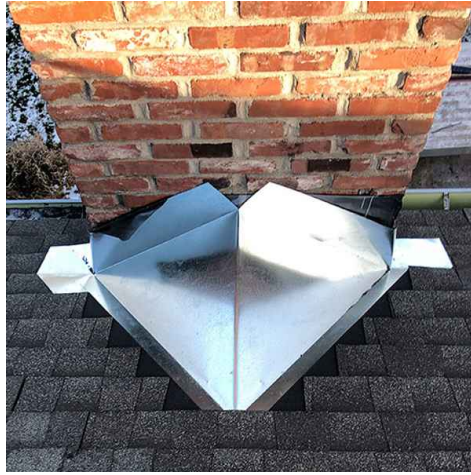
When roof gets replaced I recommend adding a cricket to divert water and debris from building up behind chimney stack.

Contact a qualified professional.
