Mold Assessment Performed on 1/28/2022
Report Finalized on 2/1/2022

Project #JL-25975

**1608 Cataluna Place
Palos Verdes Estates, CA 90274**

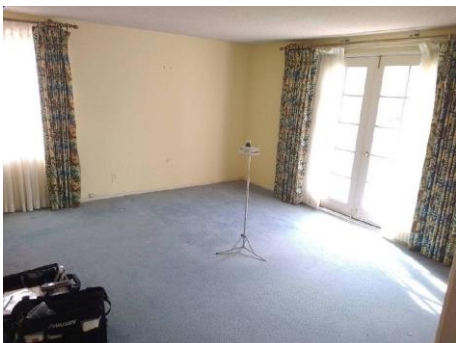
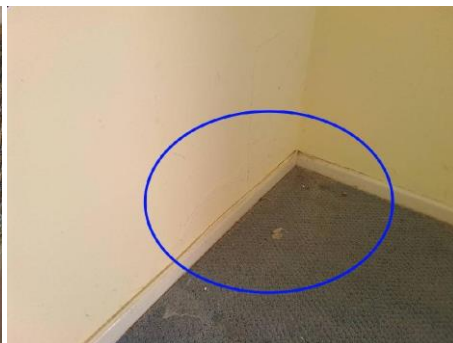
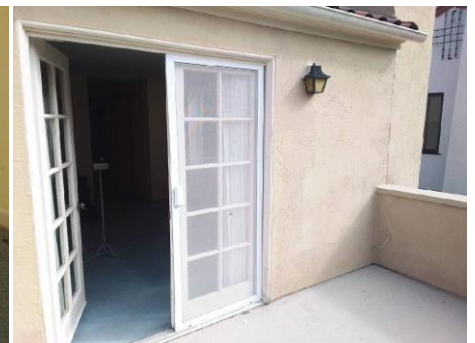
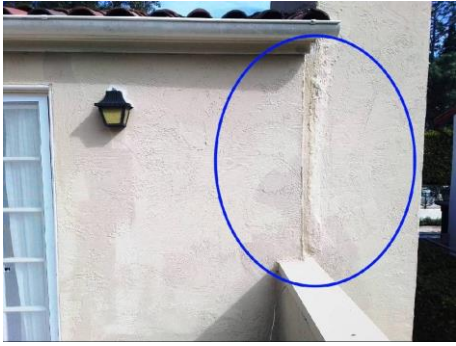
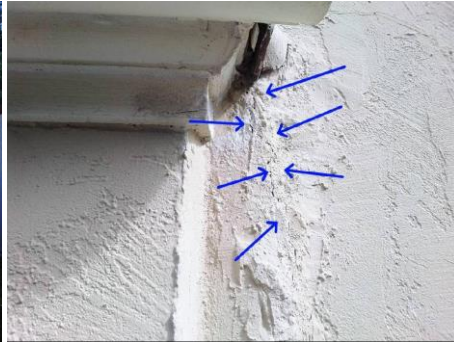
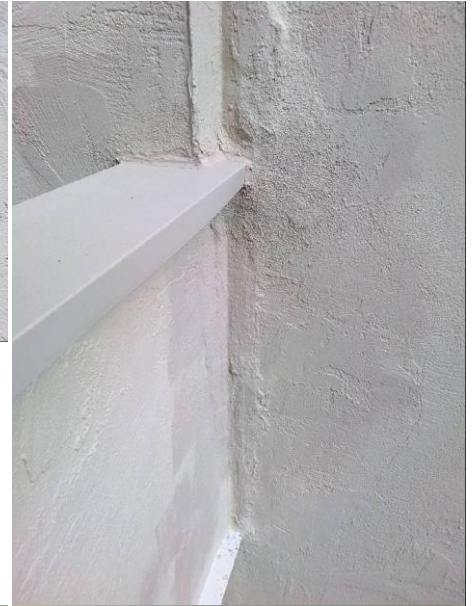
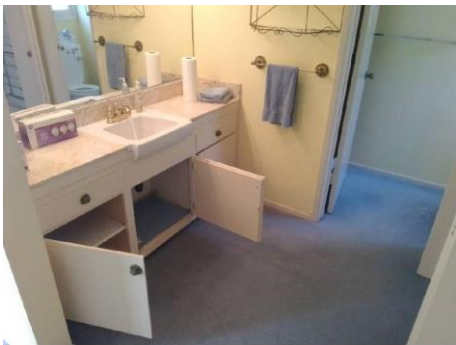
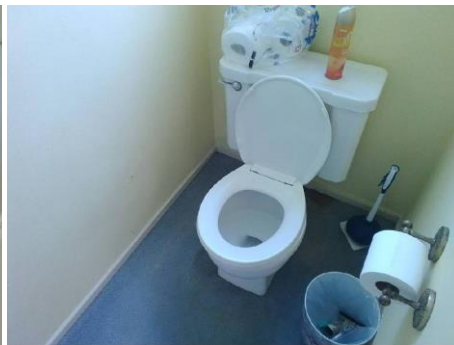
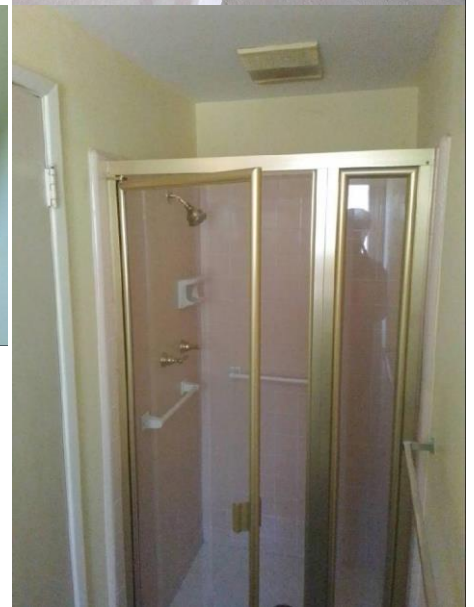
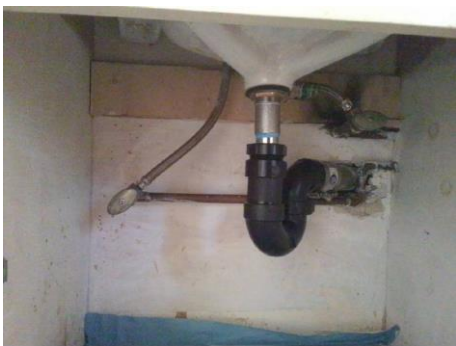
Photos

At the time of JLM Environmental's inspection, visible water damage was observed in the corner of the bedroom on the fireplace wall believed to be the result of a prior water intrusion. No elevated moisture levels were detected in this area at the time of the survey. On the exterior of this area, visible patching of the stucco where the chimney is connected to the structure was observed; at the time of inspection, a thin crack was observed running through the patchwork. In the master bathroom, no active leaks or elevated moisture levels were detected at the time of the

inspection. An ambient air sample was collected in the master bedroom to assess the current air quality conditions.

- It is the responsibility of the client to verify that the moisture intrusion or water leak in the affected area listed above has been repaired.
- Set up a containment accompanied with negative air pressure to completely isolate the master bedroom from the rest of the property where remediation will take place

- Remove and dispose of insulation and any debris found within exposed cavities. Removal of affected materials should extend 2 feet beyond all visibly impacted areas.

- Exposed wooden structural members exhibiting staining should be sanded, wire, brushed, HEPA vacuumed, and damp wiped with a fungicide.
- HEPA vacuum all horizontal and vertical surfaces that may be impacted by aerosolized mold spores inside of the containment area.

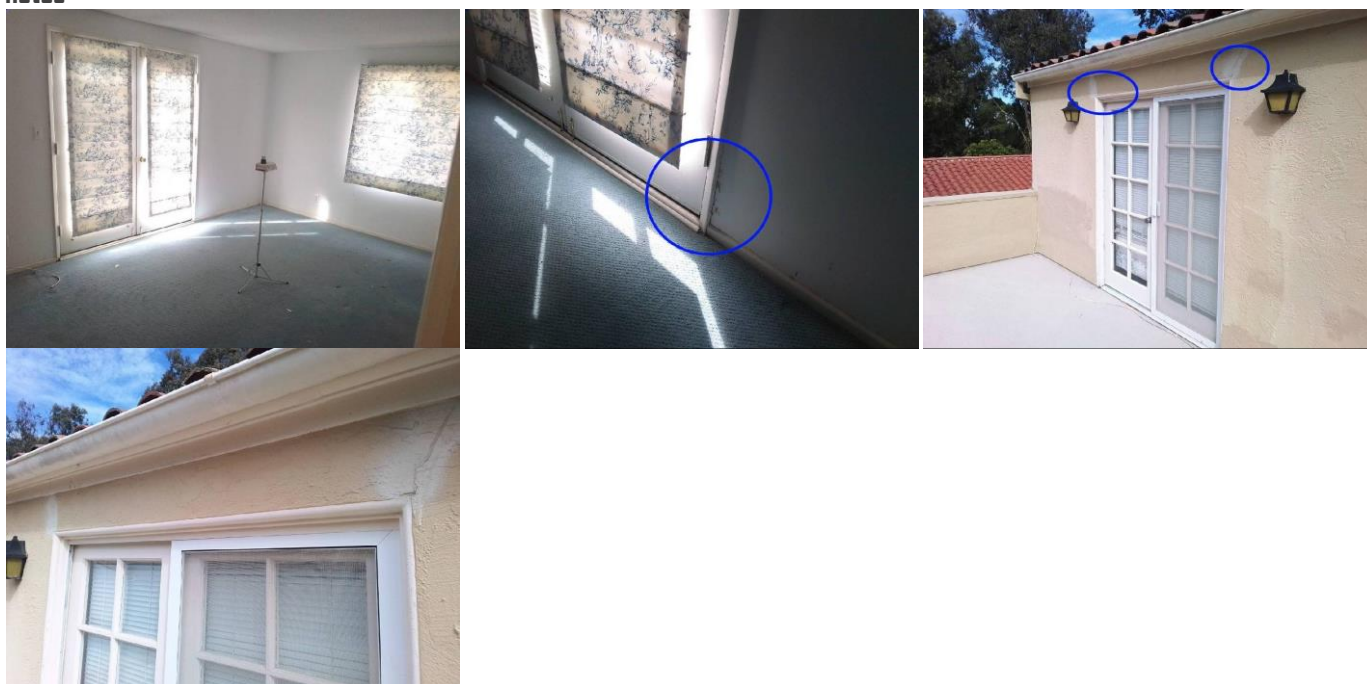
Photos

At the time of JLM Environmental's inspection, cracking was observed at the bottom interior of the French door where the frame has partially separated from the wall. On the exterior, settling cracks were observed at the corners of both doors. No elevated moisture levels were detected at the time of the inspection. An ambient air sample was collected from the front guest bedroom to assess the current air quality conditions.

- Remove plaster from right side of French door (extending 3' up and 2' to the right)
- Remove carpet and carpet pad
- Remove and dispose of insulation and any debris found within exposed cavities. Removal of affected materials should extend 2 feet beyond all visibly impacted areas.

- Exposed wooden structural members exhibiting staining should be sanded, wire, brushed, HEPA vacuumed, and damp wiped with a fungicide.
- HEPA vacuum all horizontal and vertical surfaces that may be impacted by aerosolized mold spores inside of the containment area.

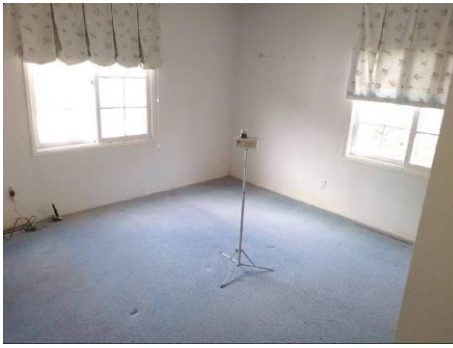
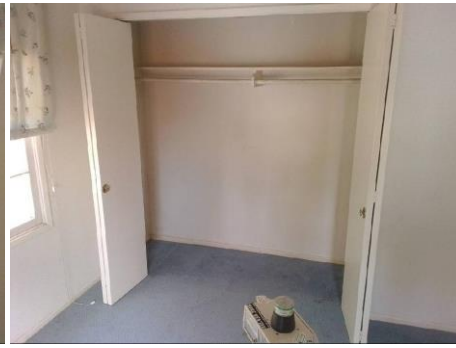
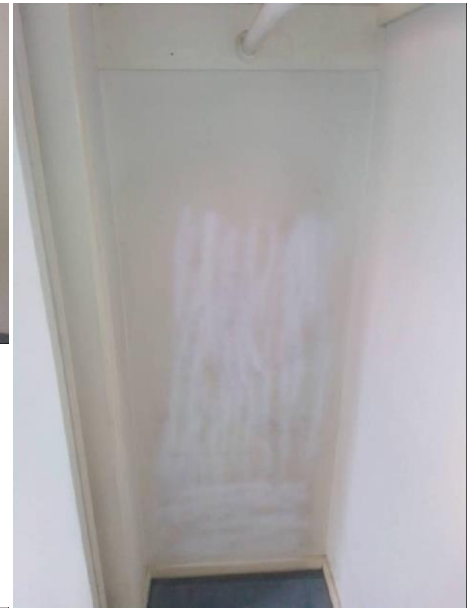
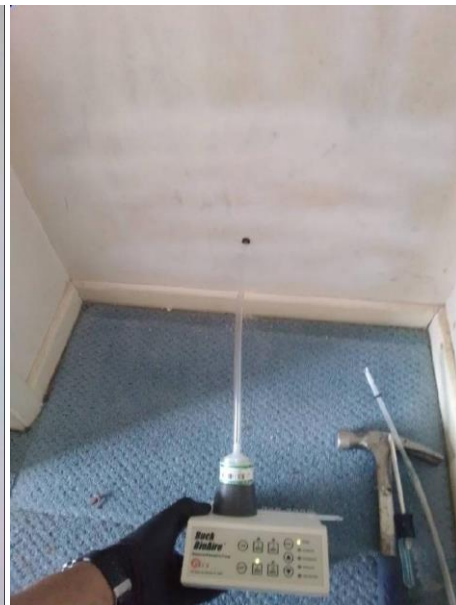
Photos

Due to the high presence of drywall dust and debris, a quantitative analysis of the cavity sample could not be completed; a qualitative analysis of spore types present was performed instead. The cavity sample results indicated the presence of spore counts of allergenic mold types identified: **Aspergillus/Penicillium**. **Therefore, in the judgment of the inspector, response actions in this area are recommended as indicated below.**

At the time of inspection, white paint (possibly spray paint) was observed on the rear guest bedroom's closet wall; the paint appears to be covering dark colored spotting on the wall. At the time of survey, no elevated moisture levels were detected. A cavity sample was collected from within the wall to assess the current conditions within the concealed cavity. An ambient air sample was also collected in the middle of the bedroom to assess the current air quality conditions.

- Remove carpet and carpet pad
 - Remove plaster from wall with spray paint/spotting (approx. 10 sq. ft.)
 - Remove and dispose of insulation and any debris found within exposed cavities. Removal of affected materials should extend 2 feet beyond all visibly impacted areas.

- Exposed wooden structural members exhibiting staining should be sanded, wire, brushed, HEPA vacuumed, and damp wiped with a fungicide.
 - HEPA vacuum all horizontal and vertical surfaces that may be impacted by aerosolized mold spores inside of the containment area.

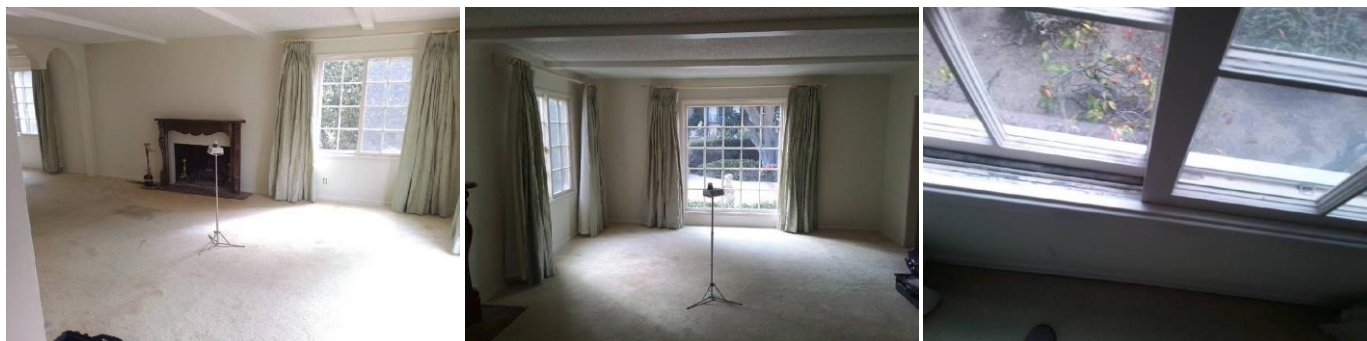
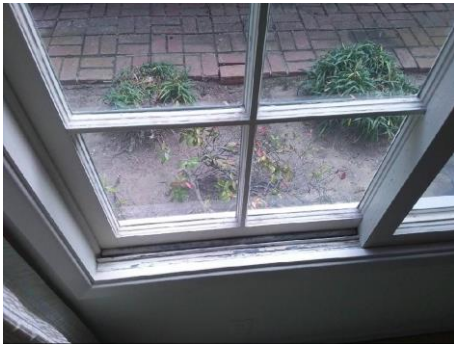
Photos

At the time of inspection, visible water damage and staining were observed on the living room window; the conditions observed are believed to be from condensation forming on the glass and coming into contact with the track and frame over the years. An ambient air sample was collected in the living room to assess the current air quality conditions.

As a precaution, recommend to place an additional HEPA air scrubber in this area while remediation is being performed in other areas of the home.

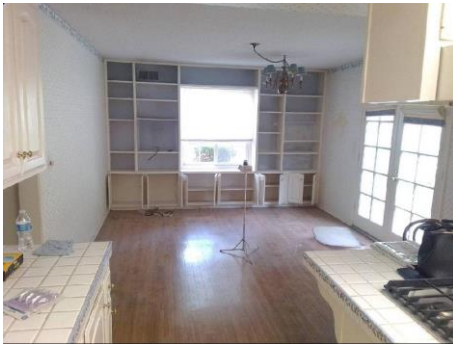
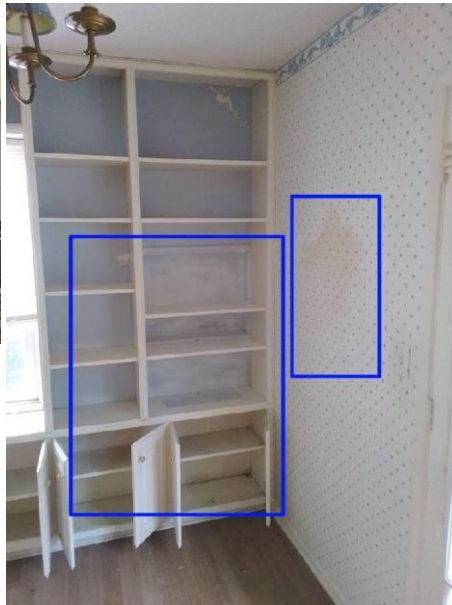
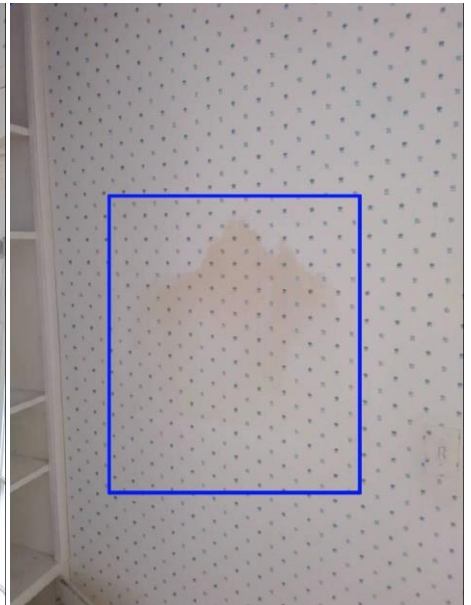
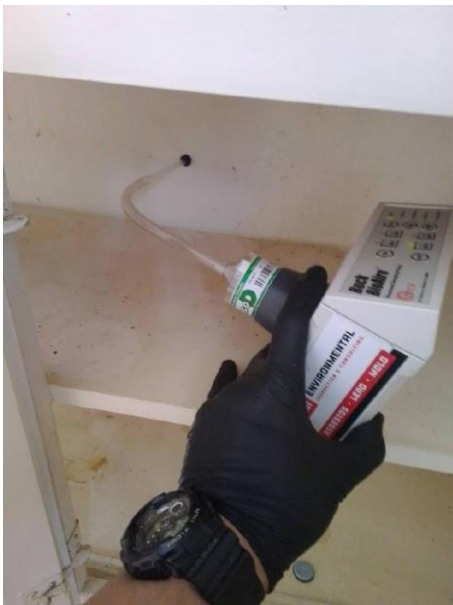
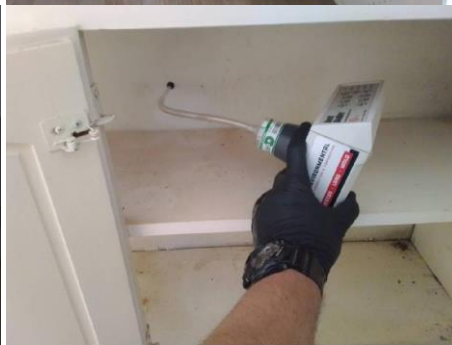
Location	Dining Room
Humidity	50%
Elevated moisture levels detected.	No
Elevated moisture levels conducive to fungal growth were detected.	No
Musty odors detected upon entry to the area?	No
Visible growth observed.	Yes
Visible water damage observed.	No
Visible stain observed.	Yes
Dusty/dirty conditions recommend thorough house cleaning.	Yes
To qualitatively and quantitatively determine the identification of molds present, sampling is recommended.	The client has accepted the recommendations. The results of the sample collected can be found in the Lab Results section of this report.
Air Sample Collection	Air Sample 05 – Dining Room
	Sample results indicated the presence of above average spore counts of allergenic mold types identified: Stachybotrys
Cavity Sample Collection	Cavity Sample 07 – Dining Room (Built-In Bookshelf Wall)
	The cavity sample results indicated the presence of elevated spore counts of allergenic mold types identified: Aspergillus/Penicillium . In addition, above average spore concentrations of Stachybotrys were also detected.

At the time of JLM Environmental's inspection, a large stain was observed on the rear dining room wall; based on the inspector's observations, it appears that the staining is limited to just the wallpaper. Inside the built-in bookshelf, spray paint was observed on the rear wall, covering what appears to be dark colored spotting; on the bottom cabinet, no spray paint is present but visible brown spotting/growth was observed. All building materials in the dining room tested dry at the time of the inspection. An ambient air sample was collected from the middle of the dining room to assess the current air quality conditions; a cavity sample was collected from the rear wall of the built-in bookshelf to assess the current conditions within the concealed cavity.

Prep and repaint/re-wallpaper stained wall

- Remove and dispose of insulation and any debris found within exposed cavities. Removal of affected materials should extend 2 feet beyond all visibly impacted areas.

- Exposed wooden structural members exhibiting staining should be sanded, wire, brushed, HEPA vacuumed, and damp wiped with a fungicide.
 - HEPA vacuum all horizontal and vertical surfaces that may be impacted by aerosolized mold spores inside of the containment area.

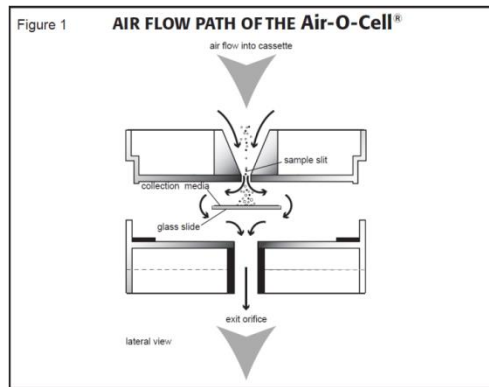
The Air-O-Cell operates on the well-established principle of inertial impaction. Particles in the air stream are accelerated as they approach the tapered inlet opening and drawn through a small slit aimed directly at a glass slide. This glass slide contains a sticky and optically clear sampling media which can permanently collect and hold particles. As the particles come through the slit, the air velocity forces the particles to impact into the sampling media, while the air stream makes a sharp 90 degree turn and proceeds around the slide and out of the cassette. The air flow path through the Air-O-Cell cassette is illustrated below in Figure 1.
