Inspection Report

Property Address:
2925 E Spaulding St #302
Long Beach CA 90804

Property Address 2925 E Spaulding St #302 Long Beach CA 90804	Date of Inspection 1/9/2023	Report ID 20230109-2925-E-Spaulding-St-302
Customer(s) Patrick Fodell	Time of Inspection 09:00 AM	Real Estate Agent Melinda Elmer Century 21 Masters

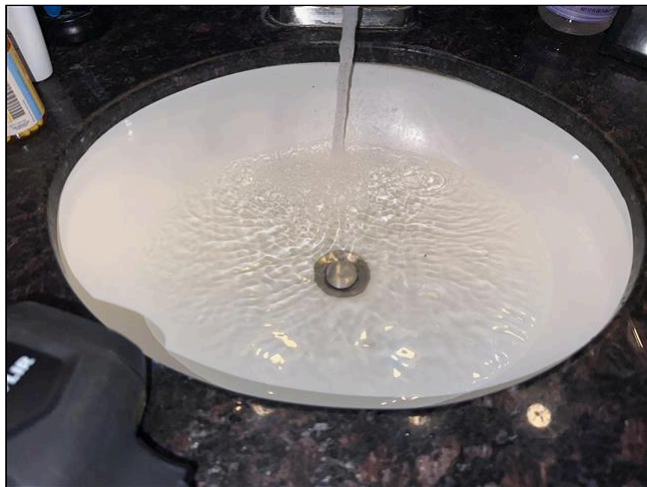
Item 1 - Item 1(Picture) Plumbing System

1. **Repair or Replace:** The hallway bathroom sink was observed to drain slowly. Suggest repair.

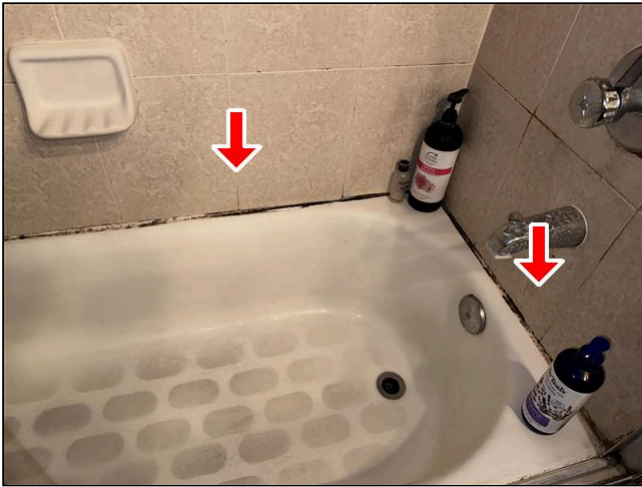
Item 2 - Item 1(Picture) Interiors

2. **Repair or Replace:** The caulking at the hallway bathroom shower/tub is in need of replacement.

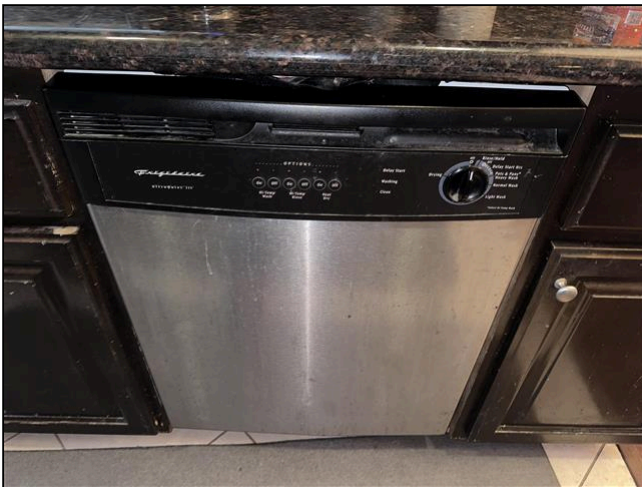
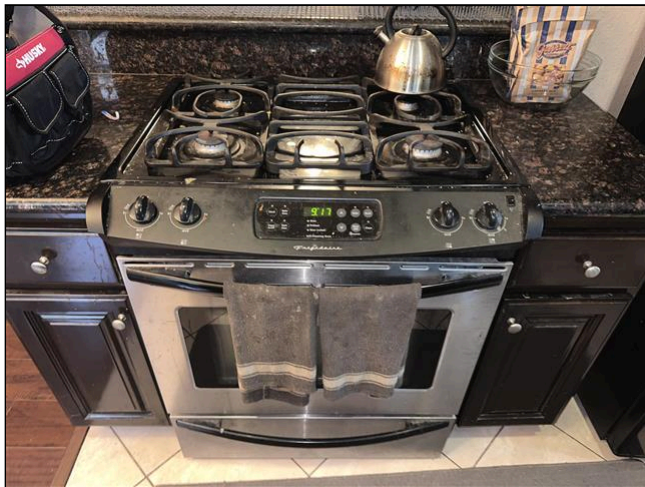
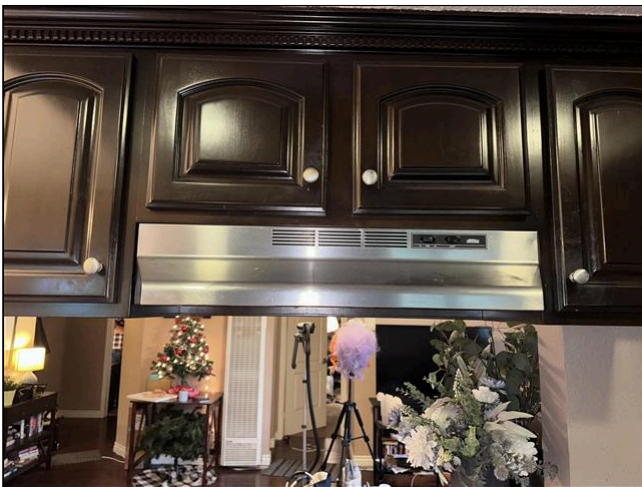
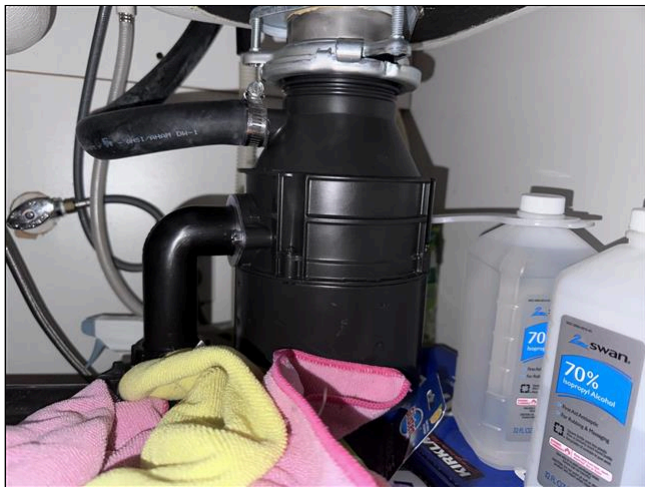
Item 3 - Item 1(Picture) Appliances

3. **Repair/Replace/Monitor:** The kitchen appliances are at and/or nearing the end of their service life. The appliances can fail at any time. Eventual replacement of the appliances should be anticipated.

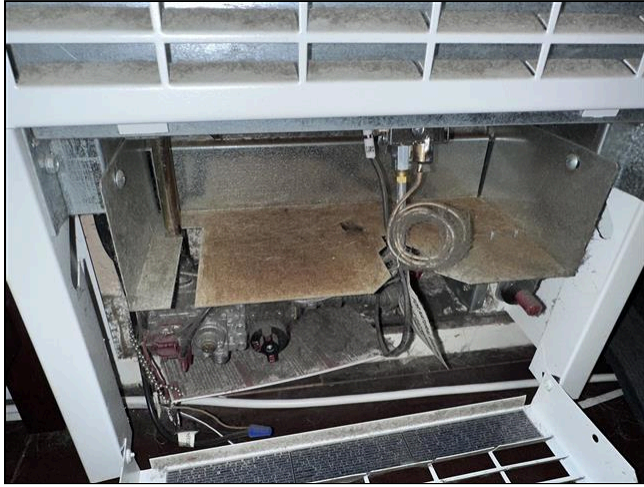
4.0 Item 2(Picture) Heating/Central Air

(2) **Improve:** The wall heater is in need of cleaning prior to operation.

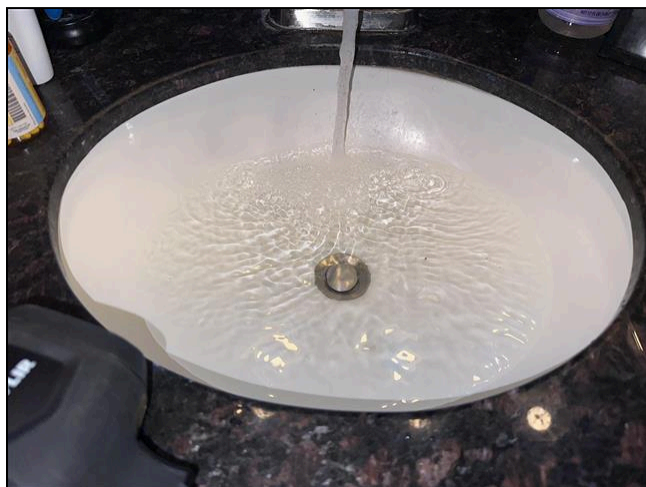
5.0 Item 1(Picture) Plumbing System

Repair or Replace: The hallway bathroom sink was observed to drain slowly. Suggest repair.

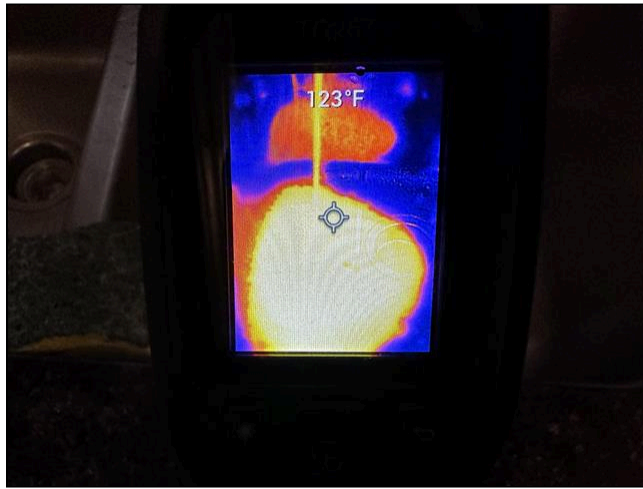
5.2 Item 1(Picture) Plumbing System

Note/Monitor: The water heater was operational and produced hot water at time of inspection.

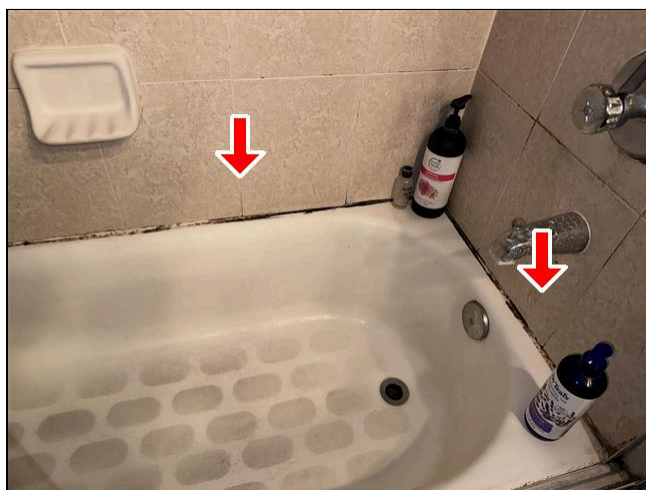
8.9 Item 1(Picture) Interiors

Repair or Replace: The caulking at the hallway bathroom shower/tub is in need of replacement.

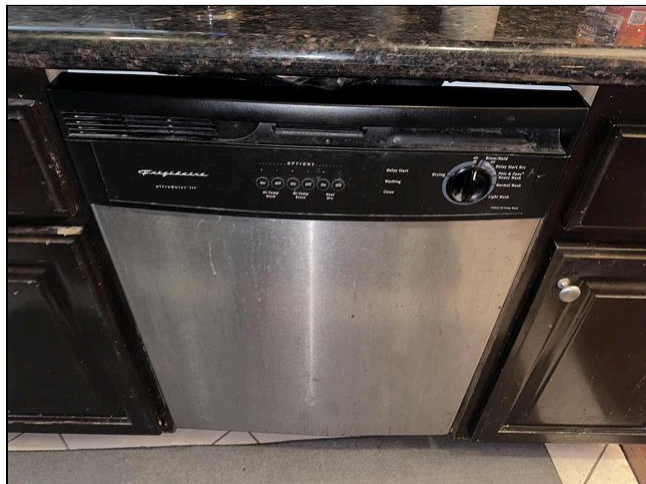
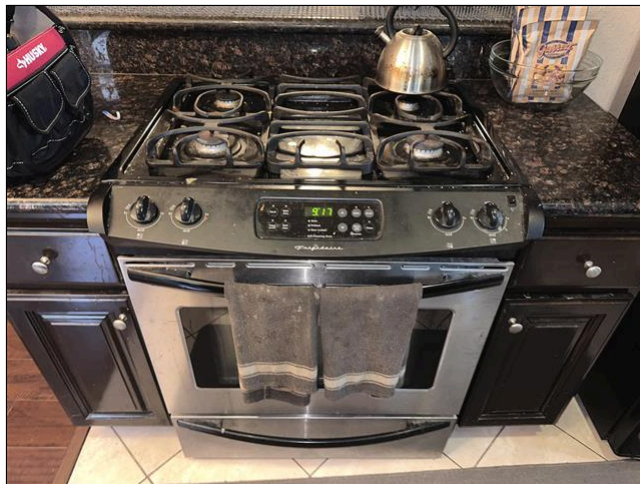
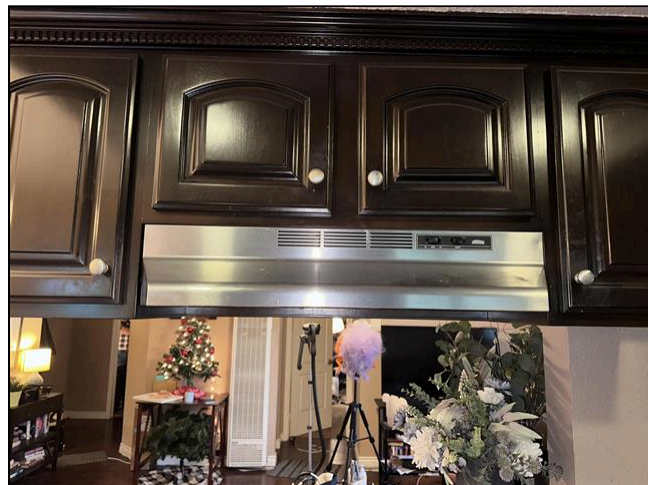
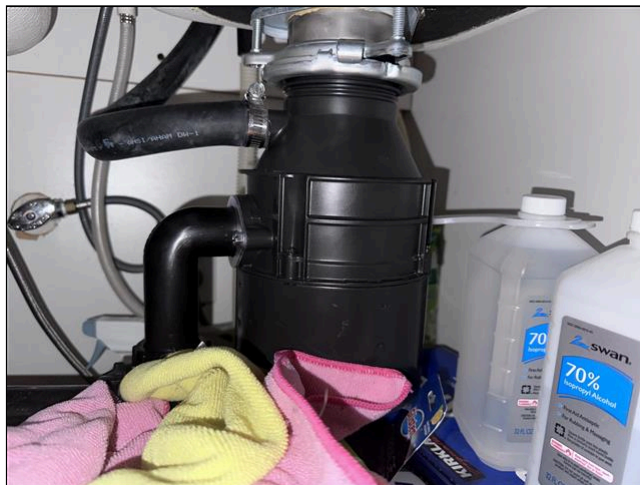
10.9 Item 1(Picture) Appliances

Repair/Replace/Monitor: The kitchen appliances are at and/or nearing the end of their service life. The appliances can fail at any time. Eventual replacement of the appliances should be anticipated.
