## GREENCO PROPERTY INSPECTIONS - RESIDENTIAL INSPECTION

26915 Grayslake Rd  
Rancho Palos Verdes, CA 90275

03/22/2024

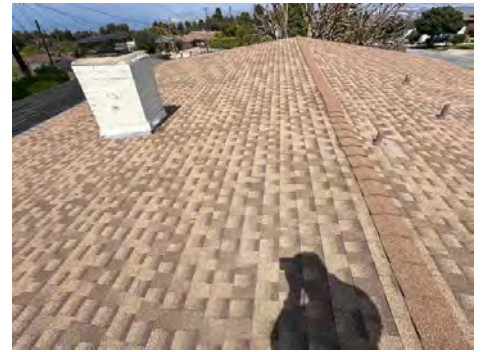
**Roof Coverings: Roofing Materials**  
3 Tab Shingle, Satisfactory

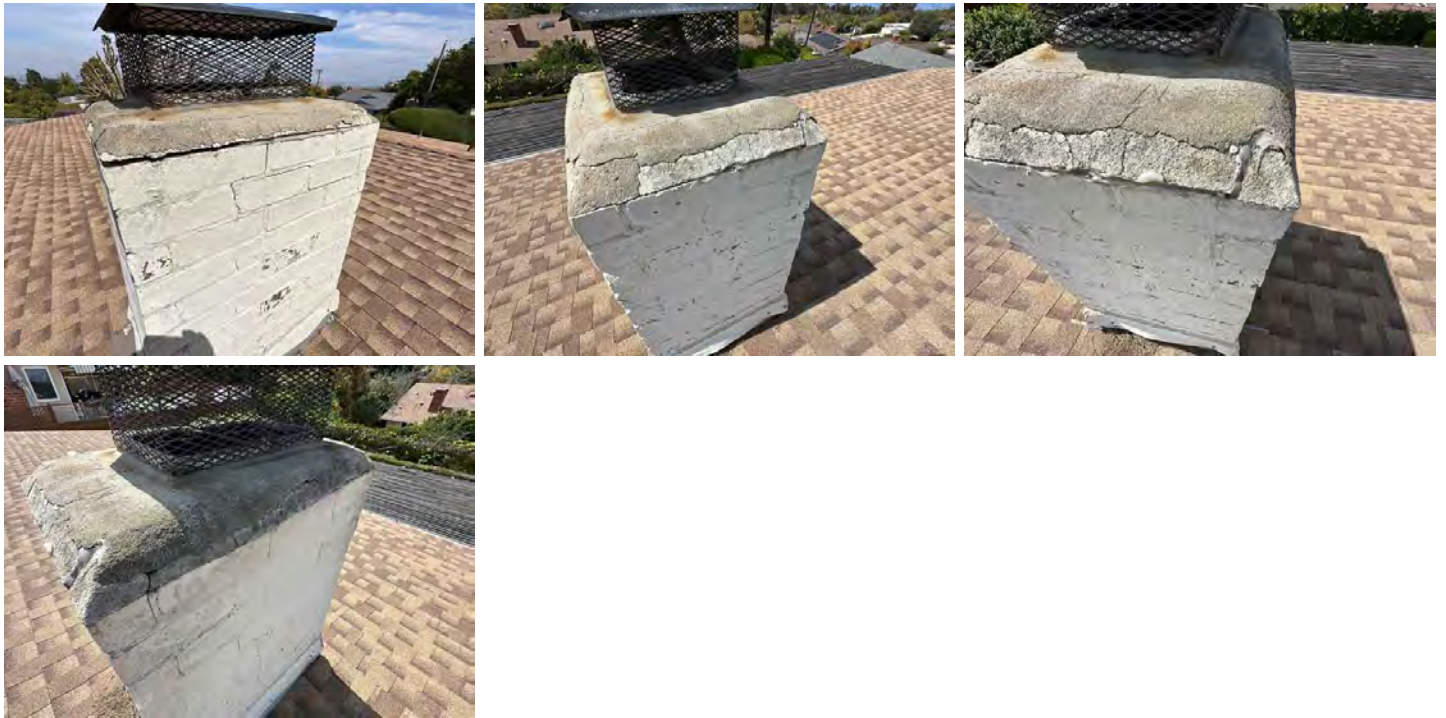
2.5.1 Chimney

**CHIMNEY COPING REQUIRES MAINTENANCE**

The chimney coping requires maintenance. Recommend evaluation by a qualified masonry professional.

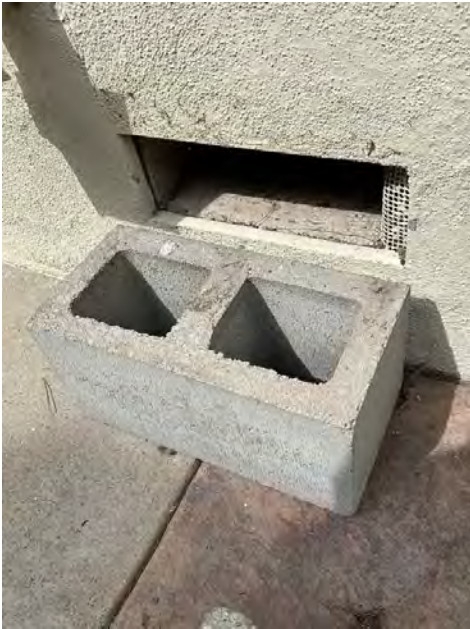
### **ALL CRAWL SPACE VENTS AND PENETRATIONS**

All crawl space vents and penetrations should be secured with wire mesh to guard against rodent and animal entry. Recommend evaluation by a qualified handyman.

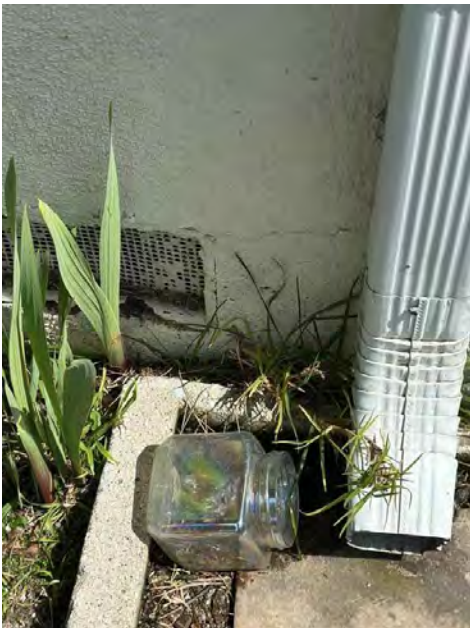
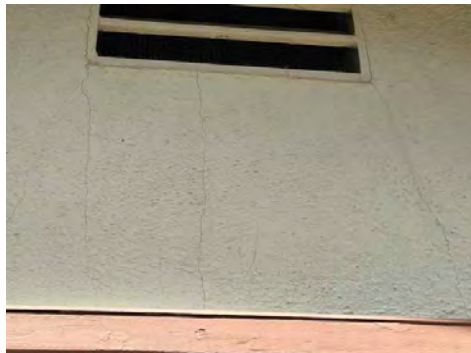
### 3.1.2 Exterior Coverings

#### **STUCCO CRACKING AND CHIPPING**

Cracking, blistering, staining or chipping of stucco is observed. Recommend evaluation by a painter for basic patch and paint maintenance.

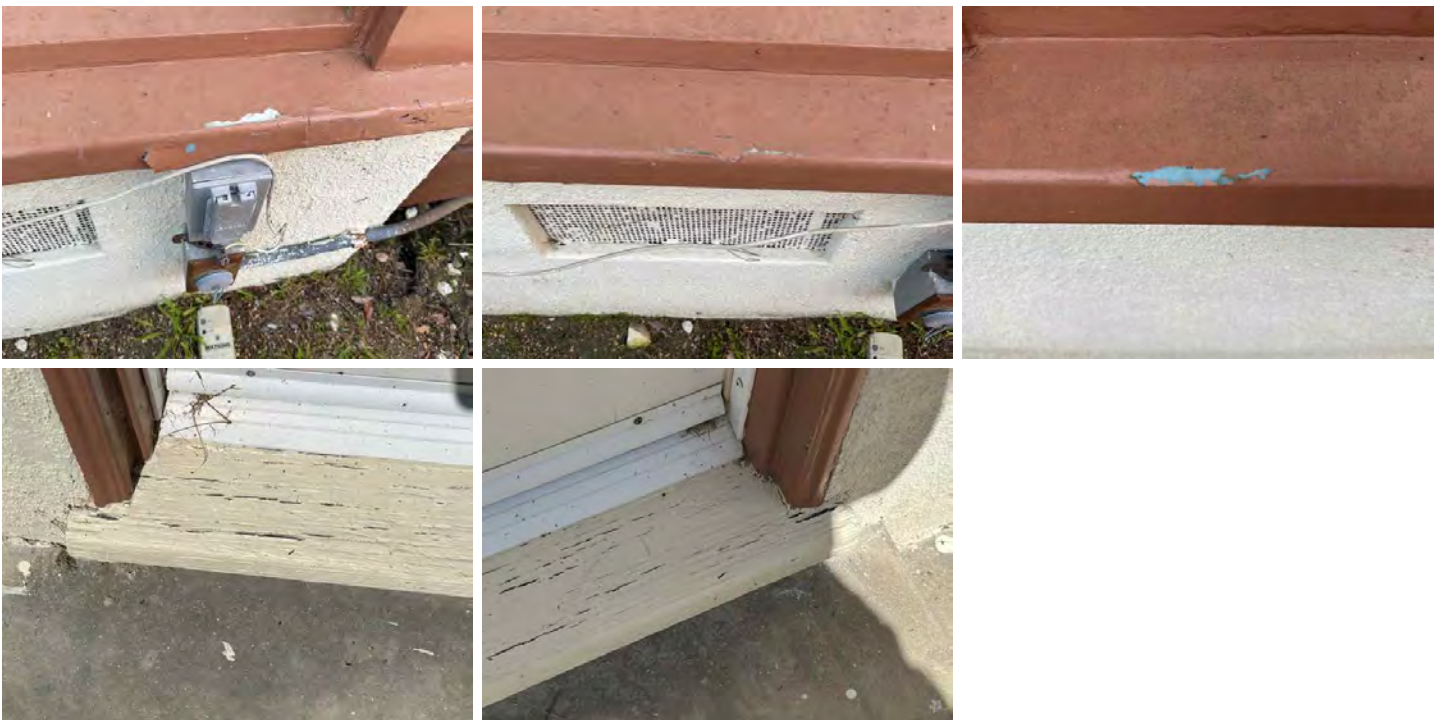
3.2.1 Exterior Trim Materials

**AREAS OF THE EXTERIOR TRIMS APPEAR DETERIORATED**

Areas of the exterior trims appear deteriorated, from water or wood eating organisms, or both. Recommend evaluation by a qualified termite inspection professional.

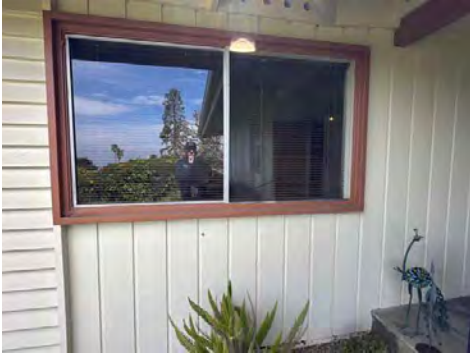
**SEVERAL WINDOWS SCREEN REPAIR**

Several windows require screen repair or replacement. Recommend evaluation by a qualified window professional.

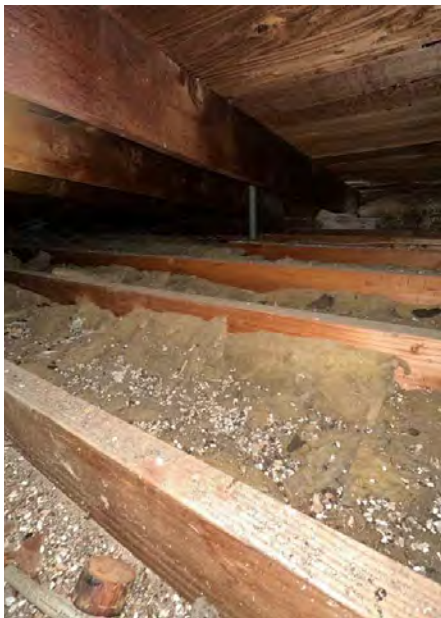
**Crawl Space: Underfloor  
Insulation**  
Not Present

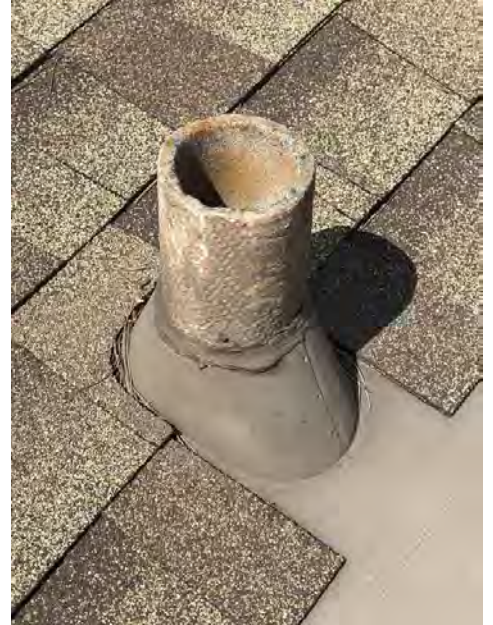
### **TRANSITE EXHAUST DUCT**

Transite Exhaust duct contains asbestos. Recommend replacement by a qualified HVAC repair professional or roofer.

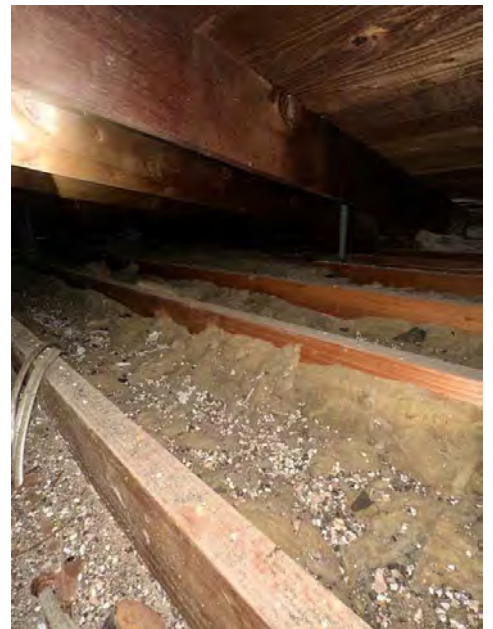
4.2.2 Attic

### **ADDITIONAL INSULATION**

Recommend additional insulation. Recommend evaluation by a qualified insulation professional.

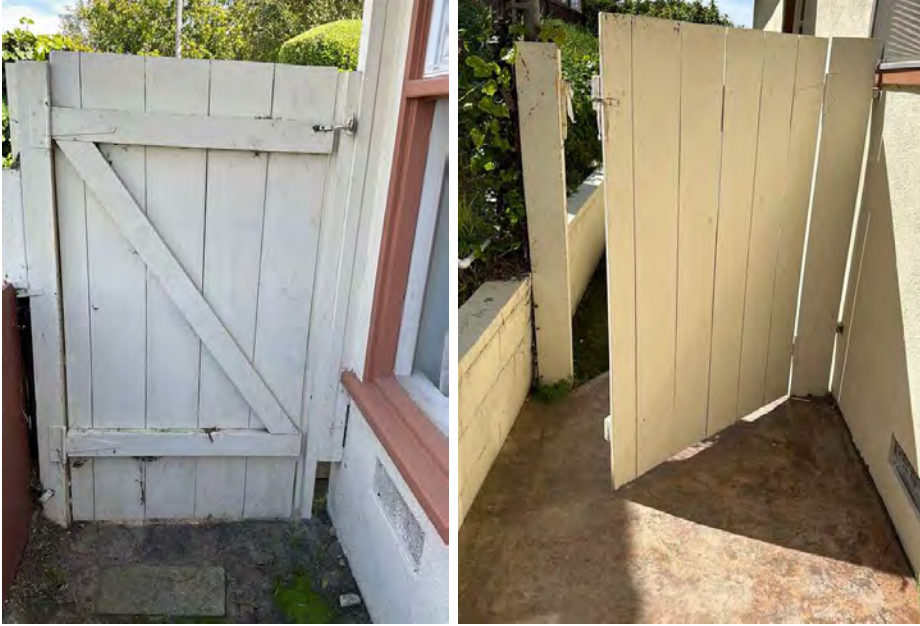
**Walls: Gate Materials**

Wood, Repair or Replace

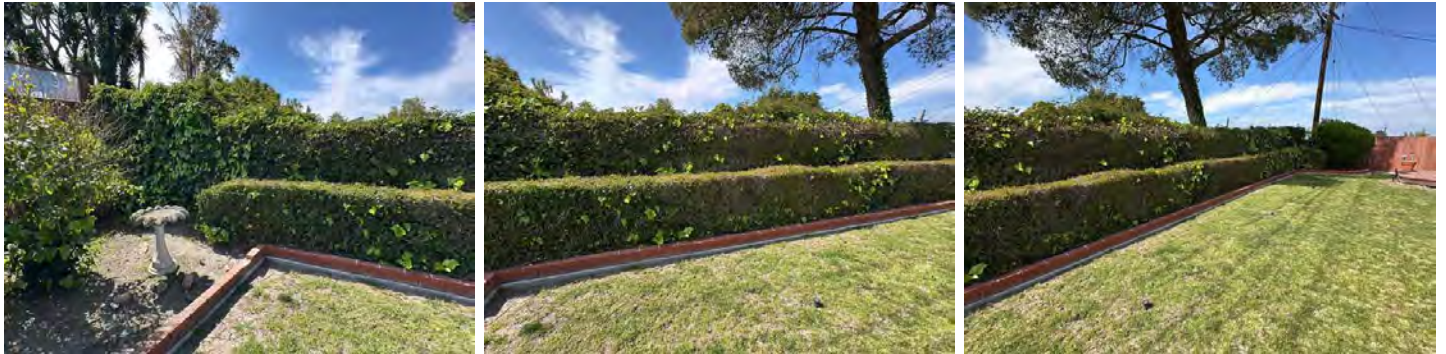
### SOME OF THE WALLS

Some of the walls were obscured by vegetation and were not inspected.

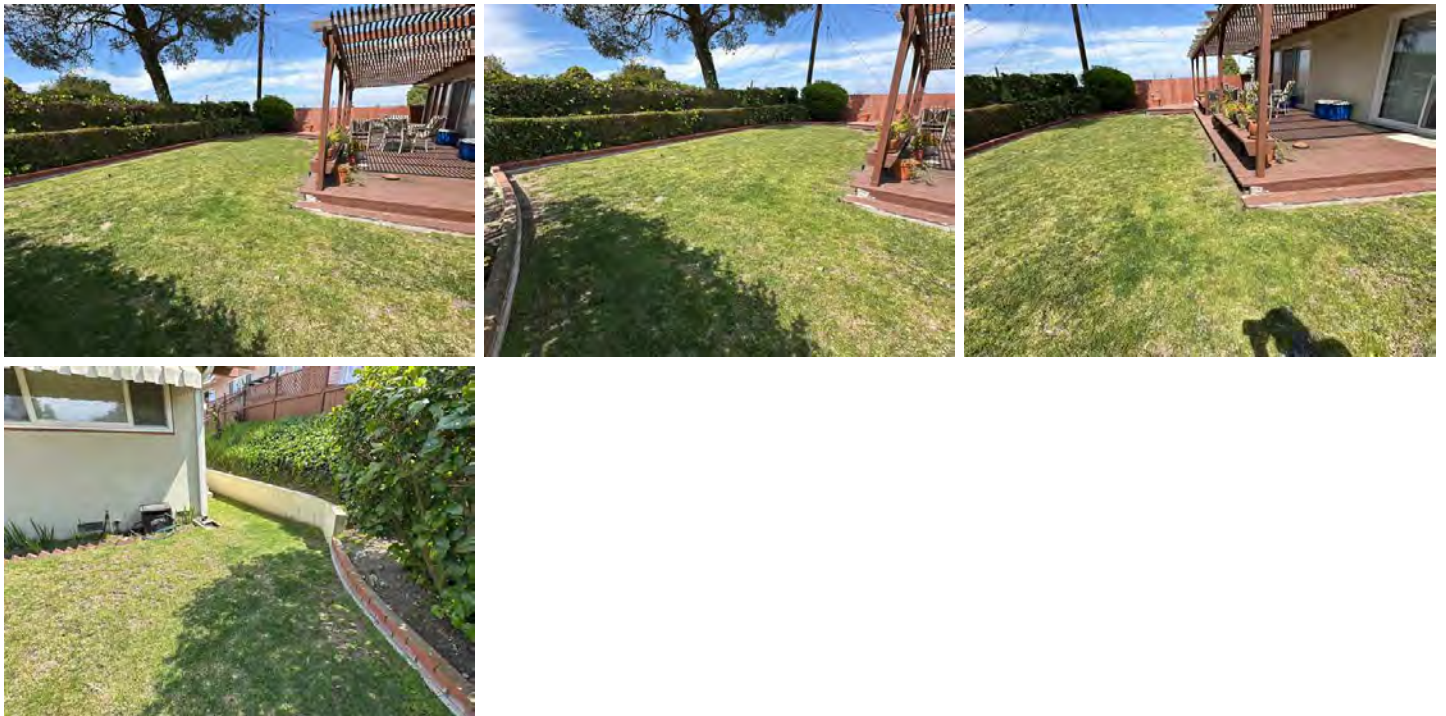
5.1.1 Site Grading

Backyard slopes to house with no apparent means for drainage. Recommend evaluation by a qualified landscaper.

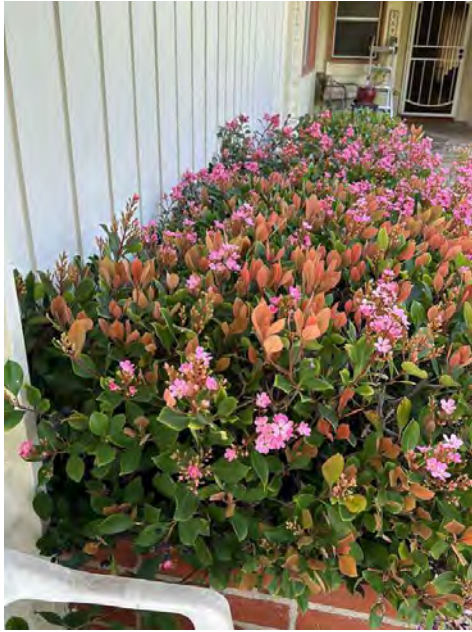
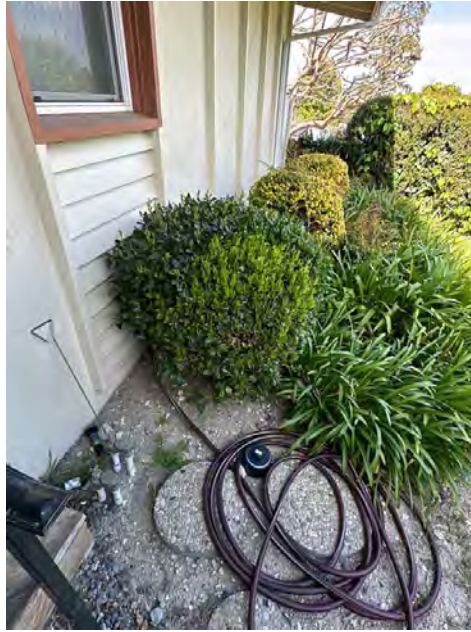
5.2.1 Vegetation

### VEGETATION IS TOUCHING

Plants and trees should be trimmed back at least 1 foot from house, foundation and / or roof to reduce wear and rot on roof, siding and eaves. Eaves exhibit signs of rot and repairs, and weakening of sheathing at eaves. Recommend evaluation by a qualified landscaper or arborist.

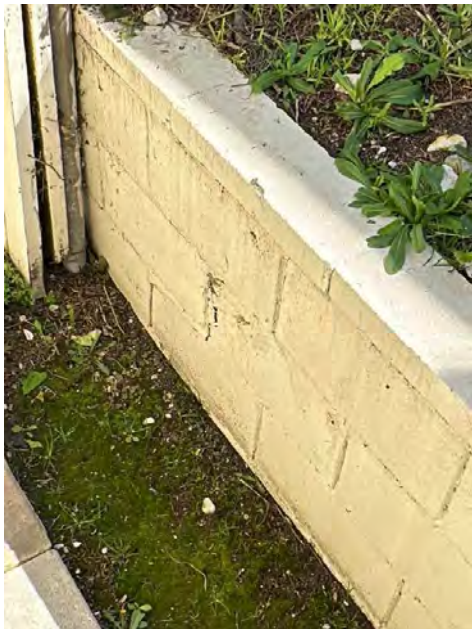
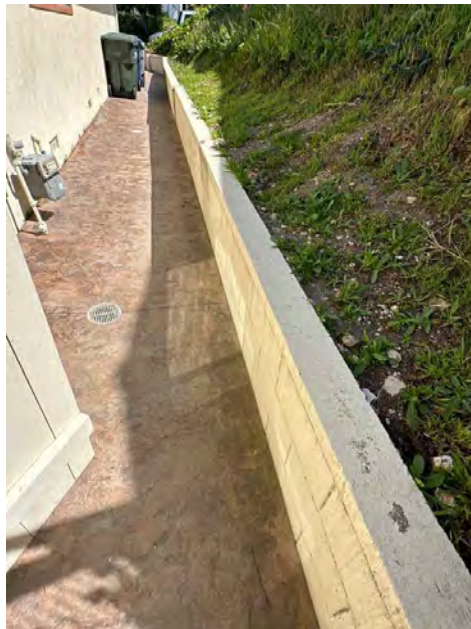
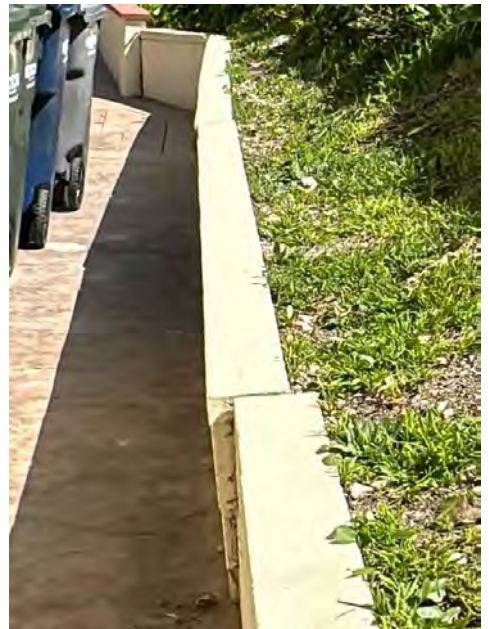
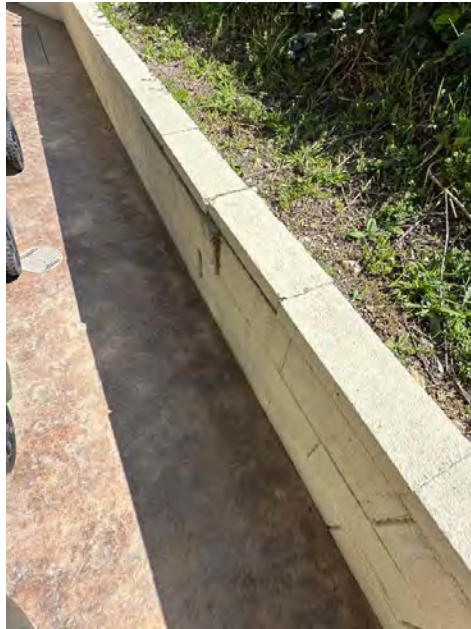
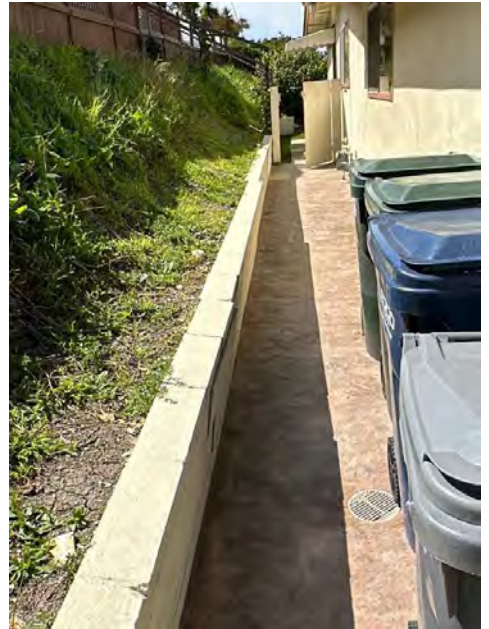
### 5.3.1 Retaining Walls

#### **RETAINING WALL IS CRACKED AND LEANING**

Retaining walls is cracked, deteriorated and leaning. Recommend evaluation by a qualified mason.

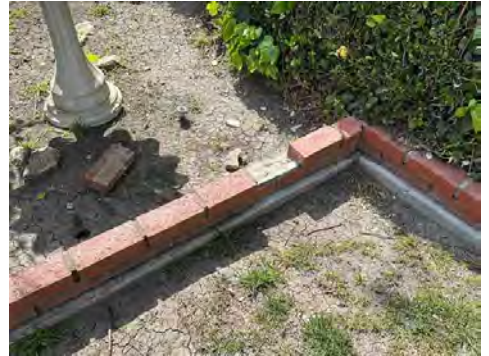
5.4.1 Planters

**PLANTER BRICKS ARE CRACKED, LOOSE OR MISSING.**

Planter bricks are cracked, loose or missing. Recommend evaluation by a qualified mason.

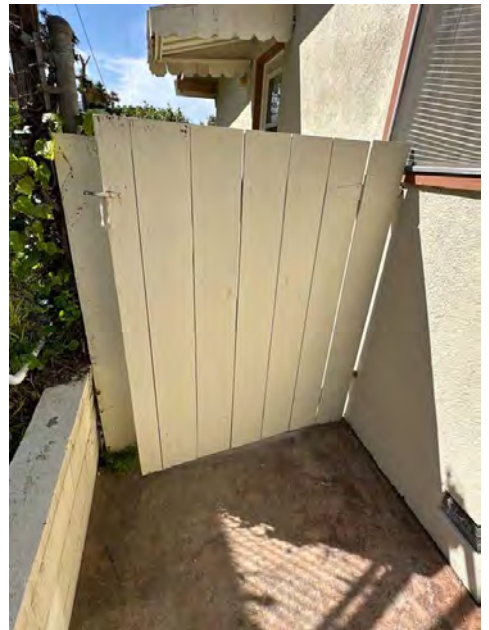
**WOOD GATE IS DETERIORATED**

Wood Gate is deteriorated and dragging. Recommend evaluation by a qualified gate repair professional or carpenter.

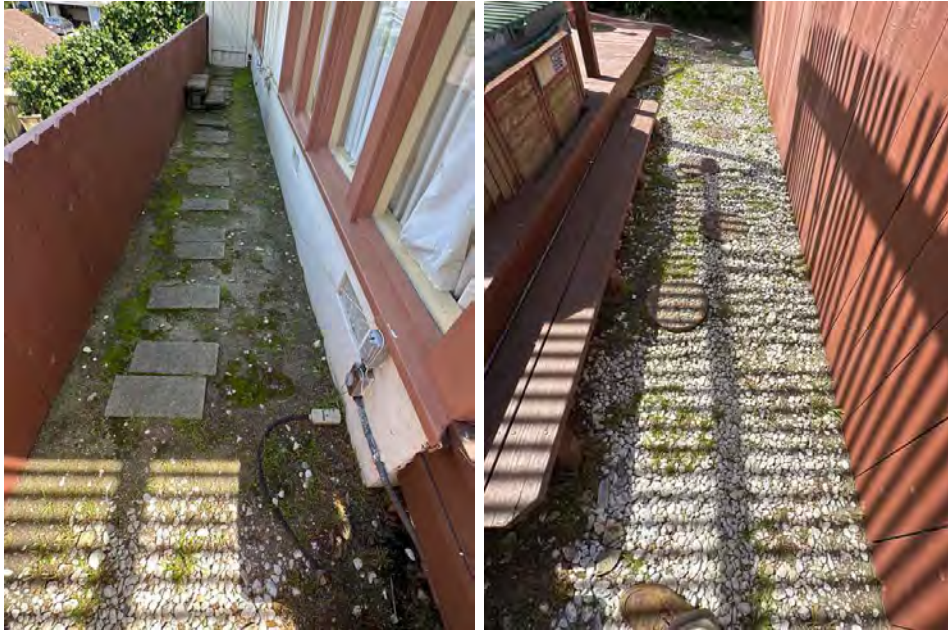
5.7.1 Walkways

**WALKWAYS HAVE UNEVEN TRANSITIONS**

Walkways have uneven transitions and cracks, which may pose trip hazards. Recommend evaluation by a qualified landscape repair professional.

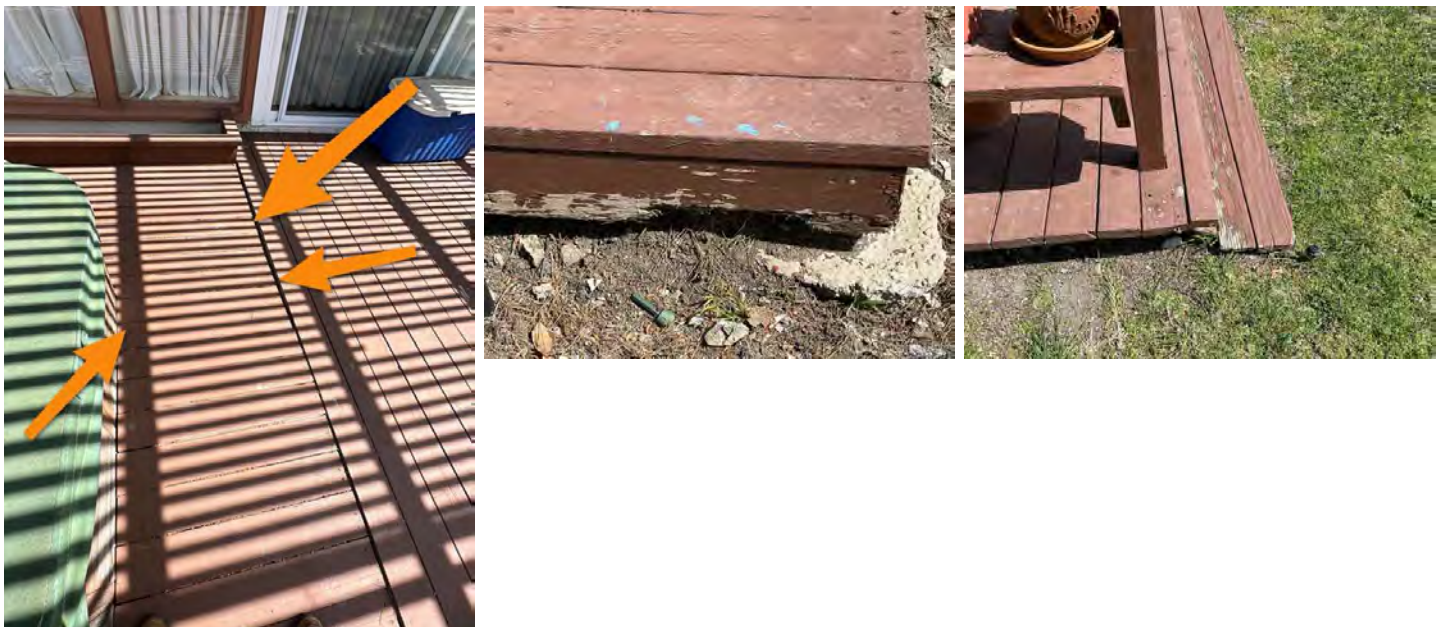
5.9.1 Patios & Decks

**PATIO DECK DETERIORATED**

Patio / Deck exhibits signs of deterioration due to water or wood eating organisms. Recommend evaluation by a qualified termite inspection professional and carpenter.

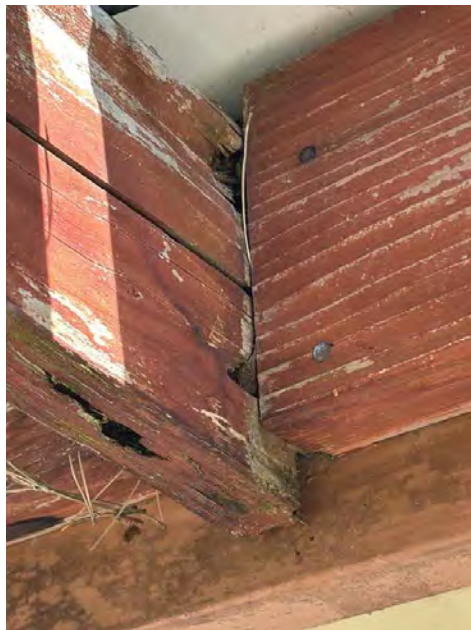
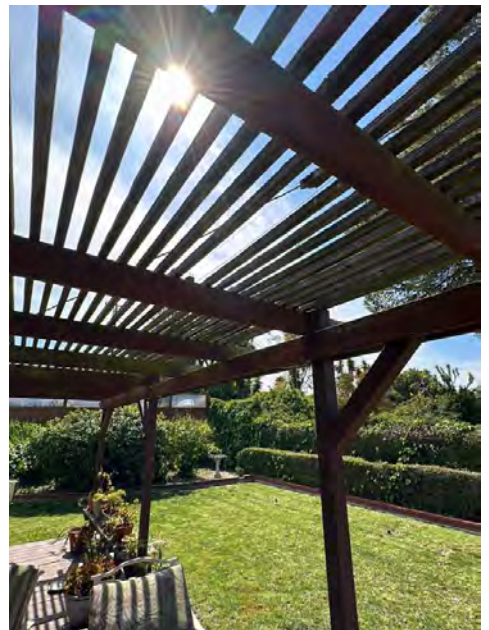
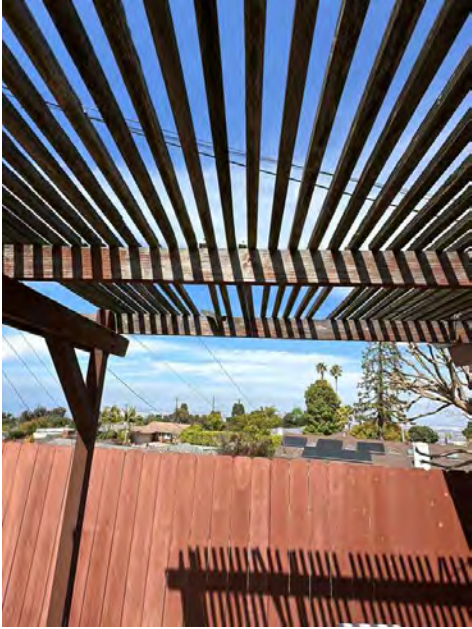
5.10.1 Awnings

**AWNING IS DETERIORATED**

Awning is deteriorated in areas. Recommend evaluation by a qualified termite inspection professional.

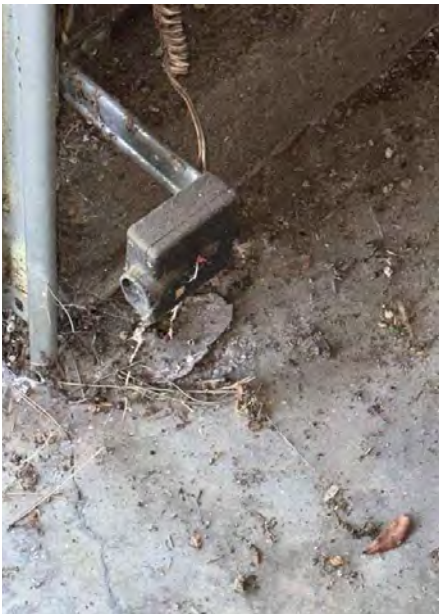
**Garage Electrical Outlets, Lights & Wiring: Garage wall outlets**  
Not GFI Protected, Repair or Replace

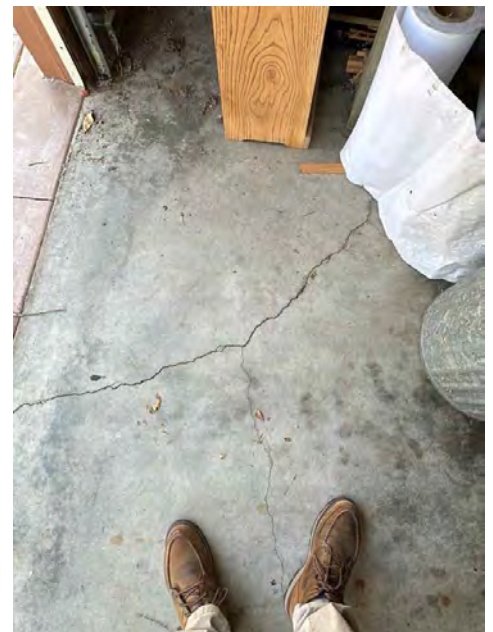
#### **GARAGE FLOOR IS NOMINALLY CRACKED**

Garage floor is nominally cracked, but probably does not present a trip hazard. Recommend evaluation by a qualified concrete repair professional.

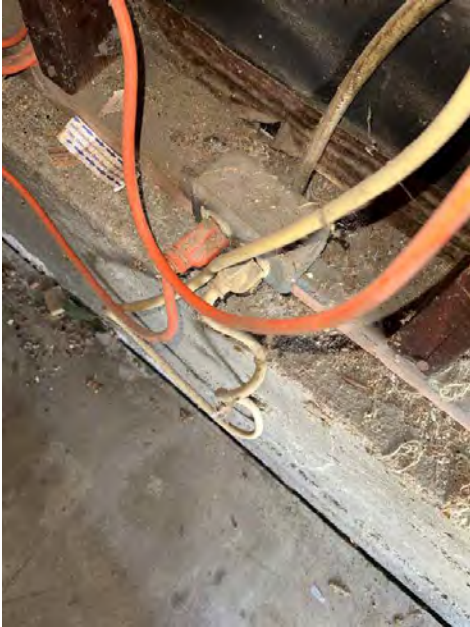
#### **GARAGE NOT GFI**

Electrical outlets in garage are not GFI protected. Recommend evaluation by a qualified electrician for safety.

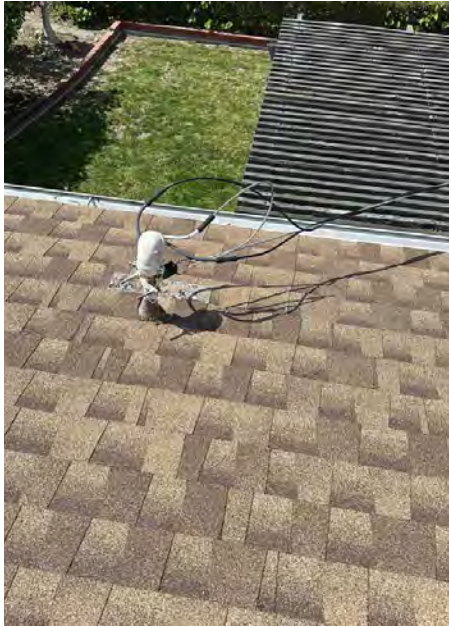
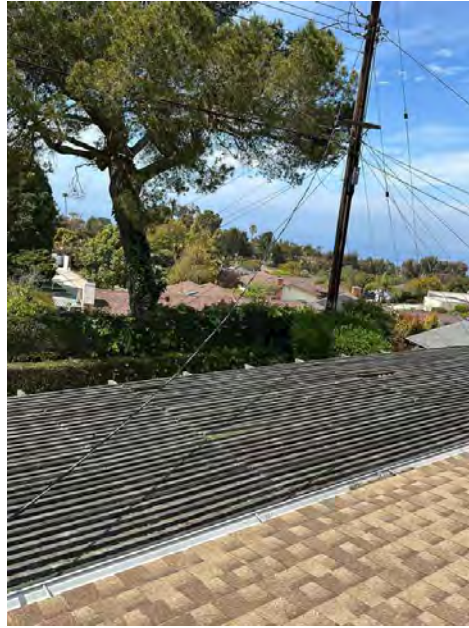
**General Service Panel Items: Type of Service**

Overhead, Repair or Replace

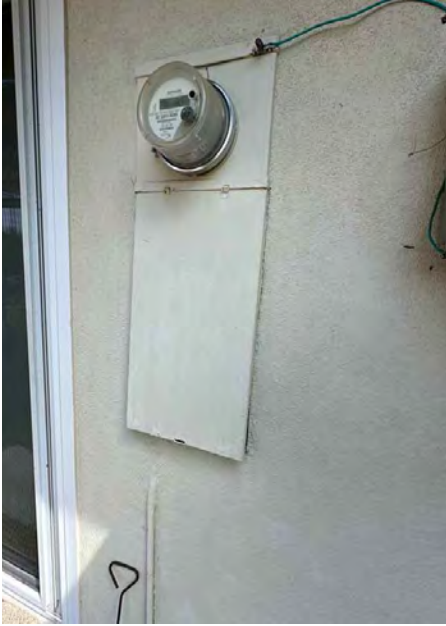
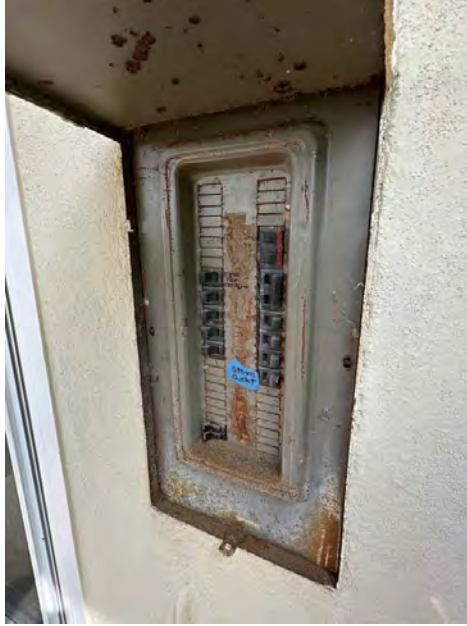
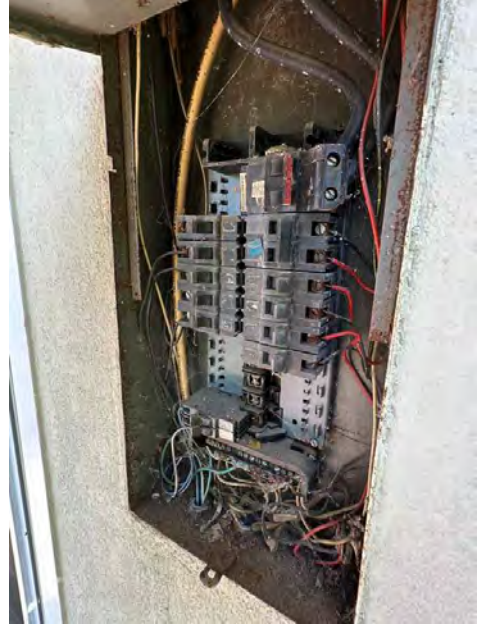
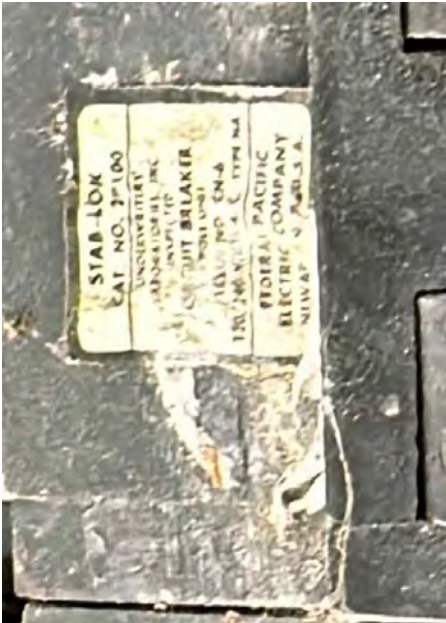
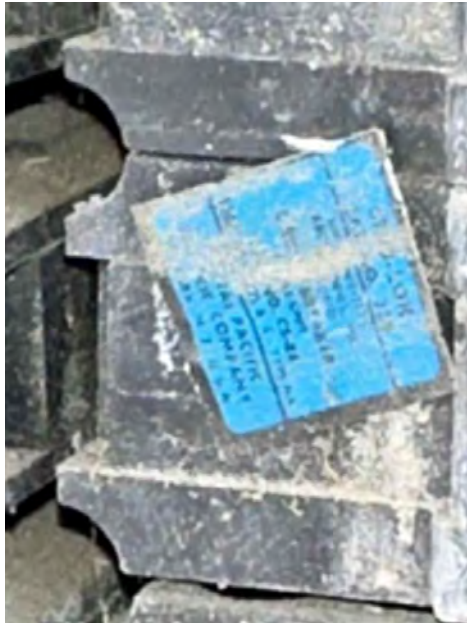
**Service Panel: Service Panel Manufacturer**  
Federal Pacific, Further Evaluation Required

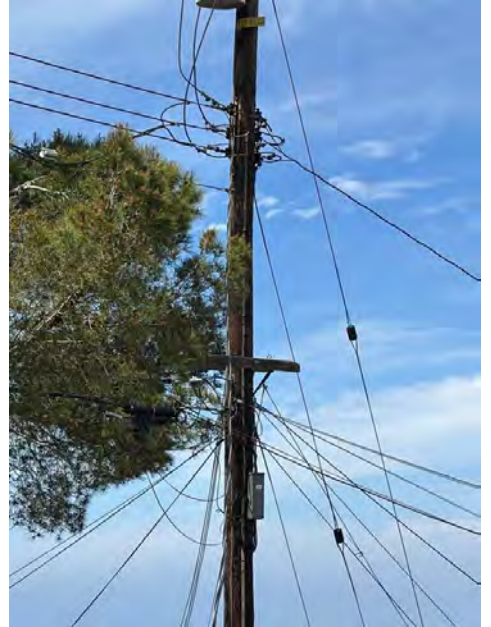
## 8.1.1 General Service Panel Items

Repair or Replace**SERVICE DROP TREES**

Trees should be trimmed at least 3 feet from service drop and weather head of electrical service. Recommend evaluation by a qualified tree trimmer.

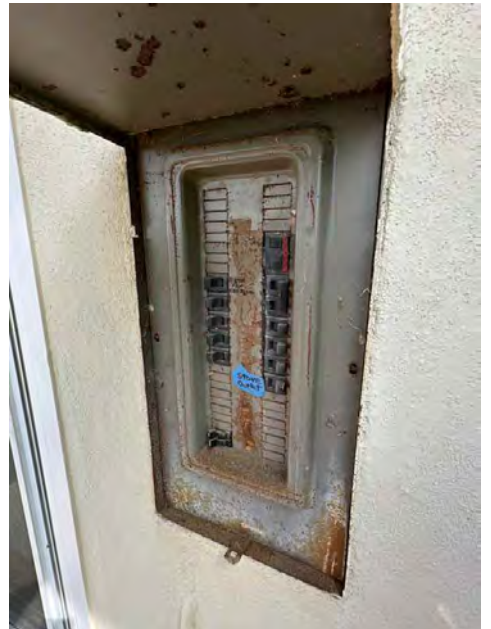
## 8.2.1 Service Panel

Repair or Replace**SERVICE PANEL CIRCUITS**

Service panel circuits are not labeled completely or legibly. Recommend evaluation by a qualified electrician.

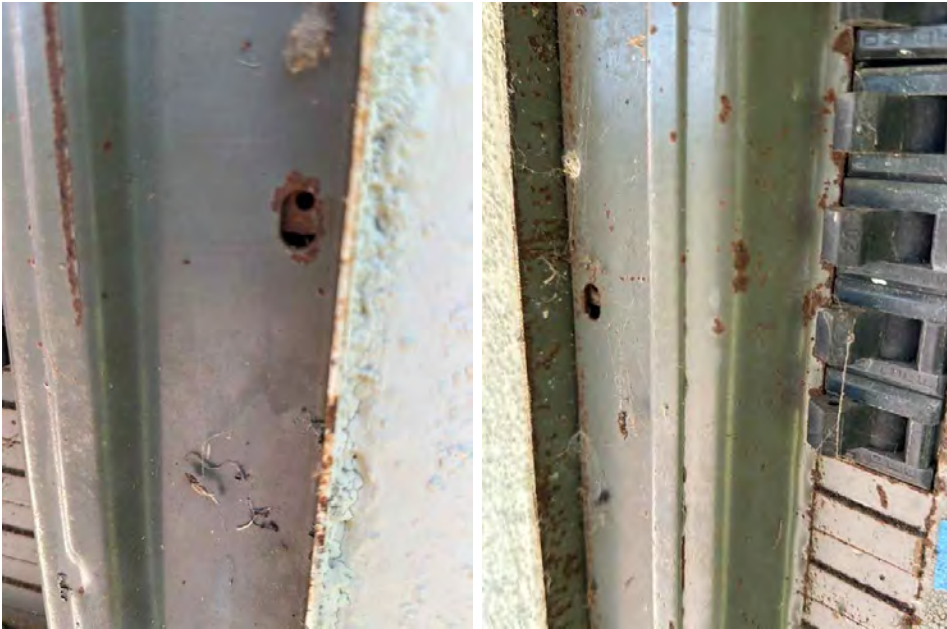
## 8.2.2 Service Panel

Repair or Replace**PROPER SCREWS ARE MISSING**

Proper screws are missing to secure panel cover. Screw should be blunt end. Recommend evaluation by a qualified electrician for safety.

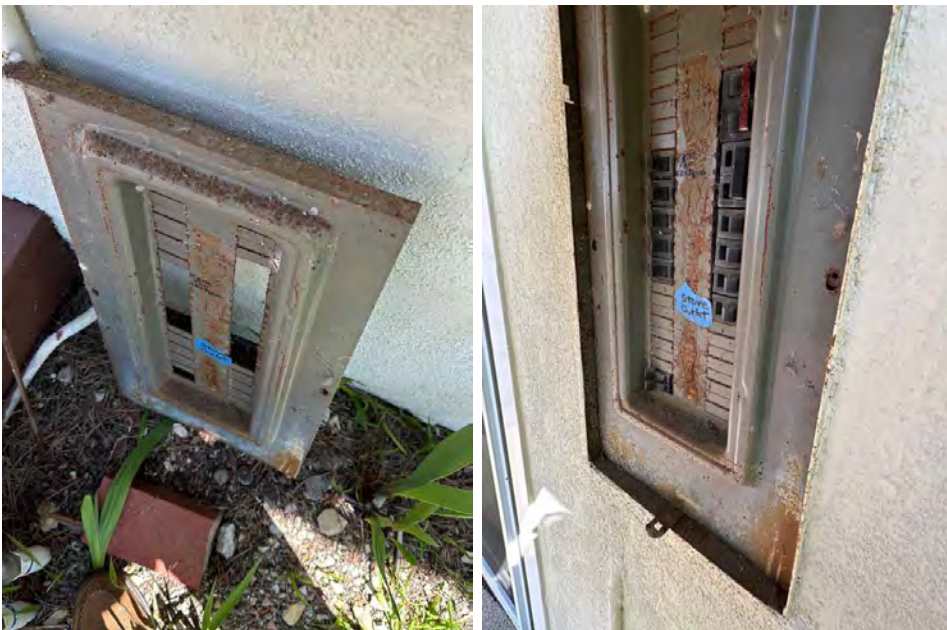
8.2.3 Service Panel

**SERVICE PANEL RUSTING**

Service panel dead front cover is rusting. Recommend evaluation by a qualified electrician for safety.

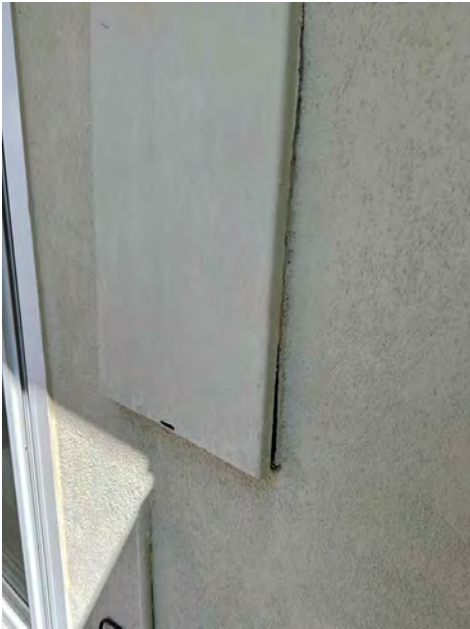
Service panel door is obstructed by stucco so it's hard to open or close. Recommend evaluation by a qualified electrician.

Repair or Replace

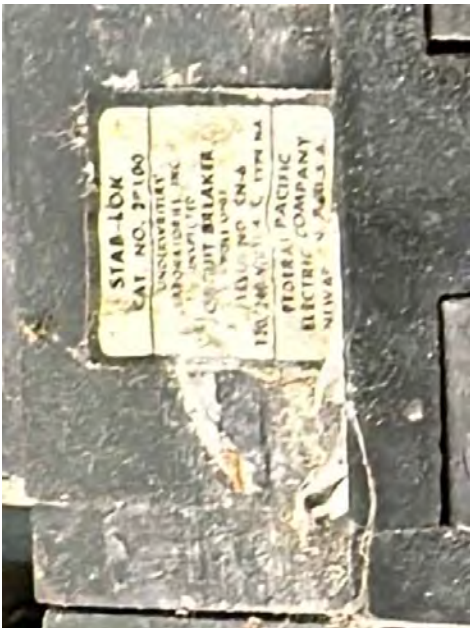
8.2.5 Service Panel

**FPE STABLOK PUSHMATIC**

FPE "Stab-Lok" or "Pushmatic" breaker & panel installations may be hazardous. Recommend evaluation by a licensed electrician for safety evaluation.

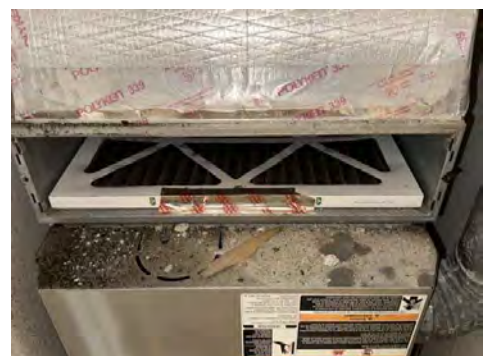
Air filter(s) is / are dirty. Recommend evaluation by a qualified HVAC maintenance professional.

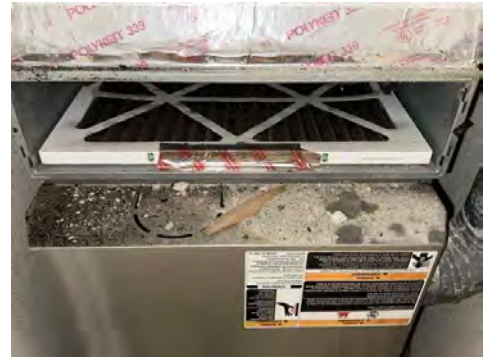
9.3.2 Heating 1

**FILTER IS NON-STANDARD**

Filter is non-standard. Recommend evaluation by a qualified HVAC professional.

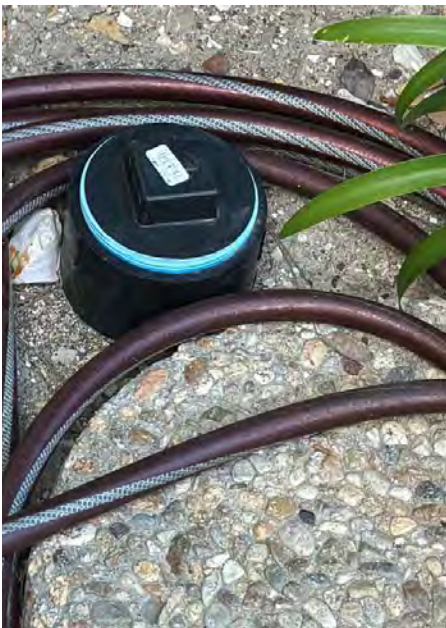
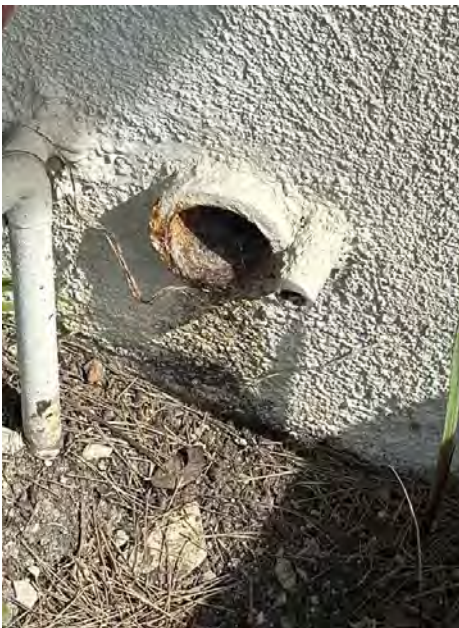
**Sewer System: Waste Pipe Material**

ABS Plastic, Cast Iron, Further Evaluation Required

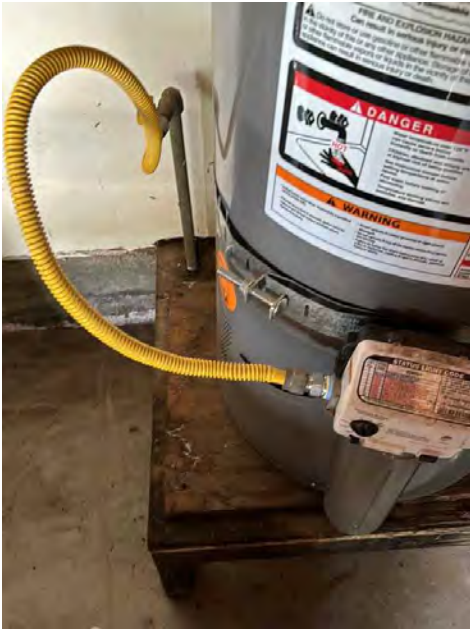
**WATER HEATER GAS SUPPLY IS MISSING SEDIMENT TRAP**

The water heater gas supply line is missing a sediment trap. Recommend evaluation by a qualified plumber.

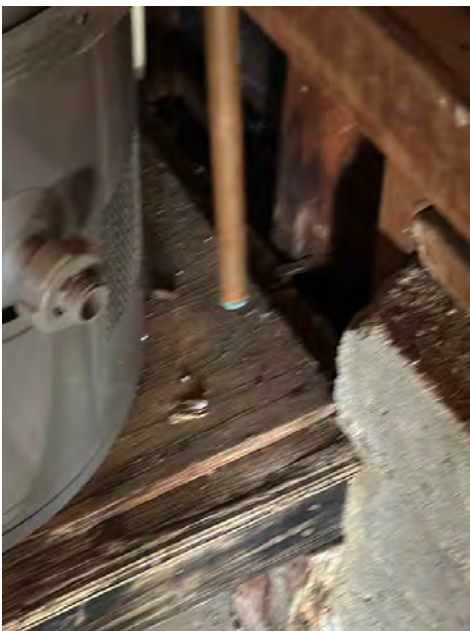
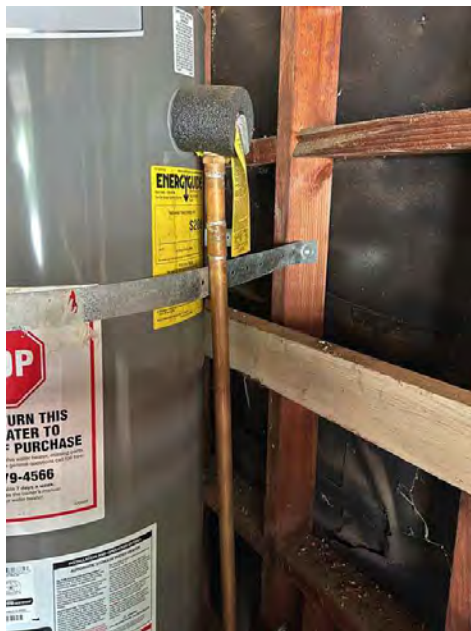
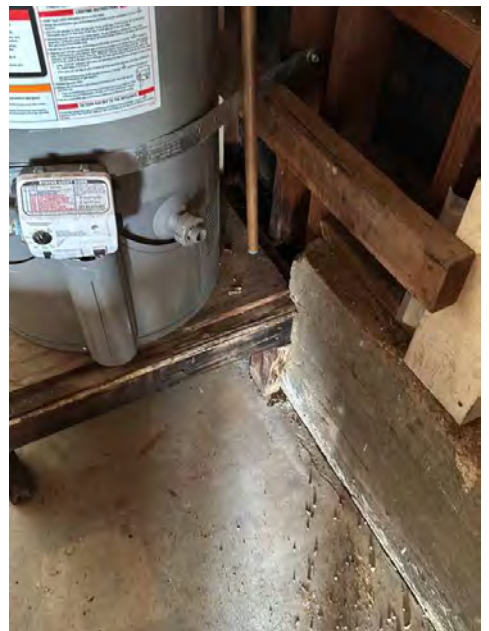
**TPR BLOWOFF LEG SHOULD BE ROUTED**

The TPR valve blowoff let should be routed to within 4" of a catch pan, a concrete floor, or through a raised wood floor towards the dirt under the home. Recommend evaluation by a qualified plumber.

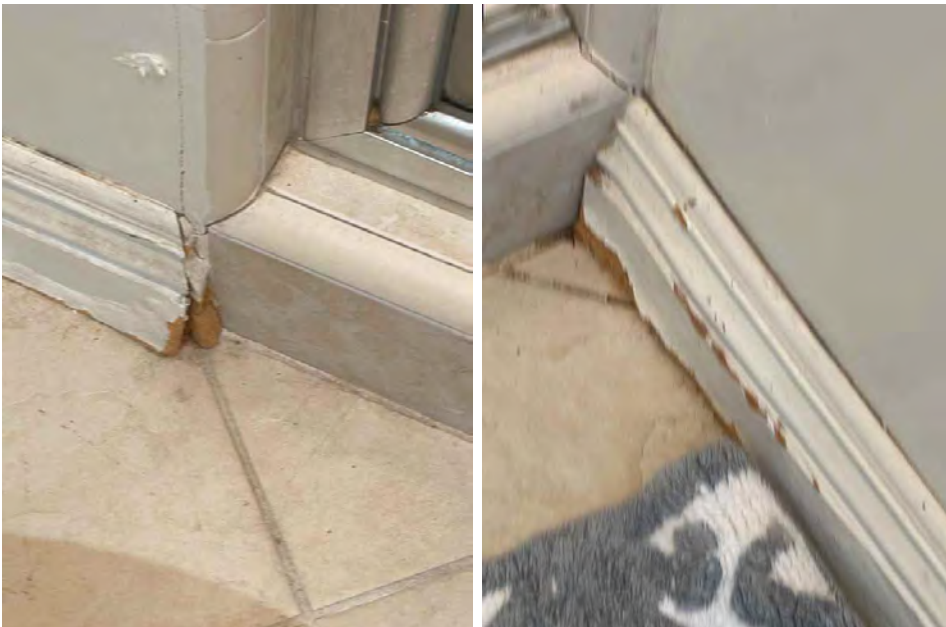
11.2.1 Ceiling and Walls

**BATHROOM WALL IS WATER DAMAGED.**

Bathroom wall / baseboard is water damaged. Recommend evaluation by a qualified drywall repair and painting professional.

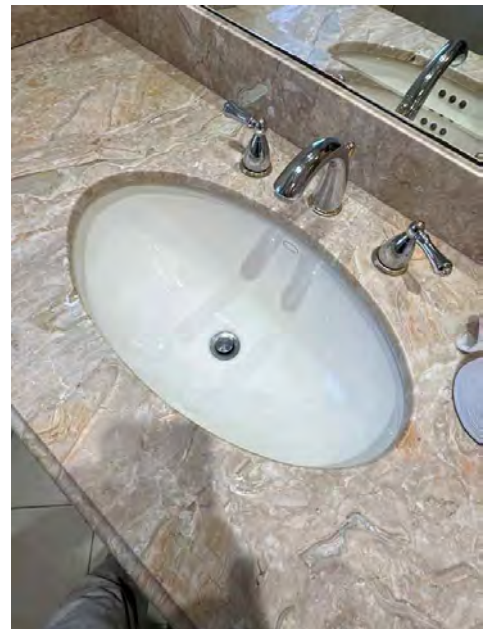
#### 11.7.2 Sinks

### A SLOW DRAIN

A slow drain is apparent in the sink. Recommend evaluation by a qualified plumber.

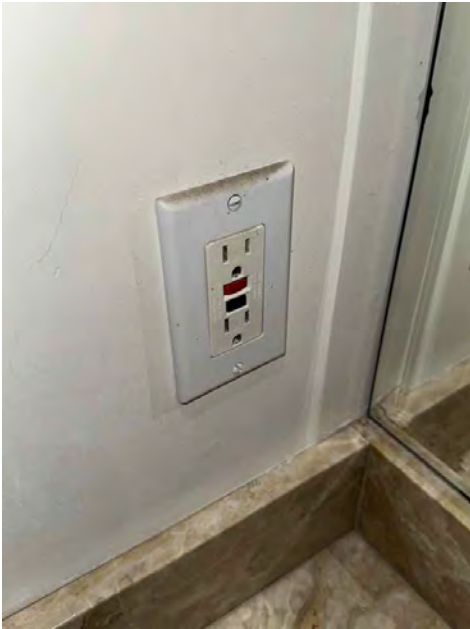
GFI outlet in bath is not operational. Recommend evaluation by a qualified electrician for safety.

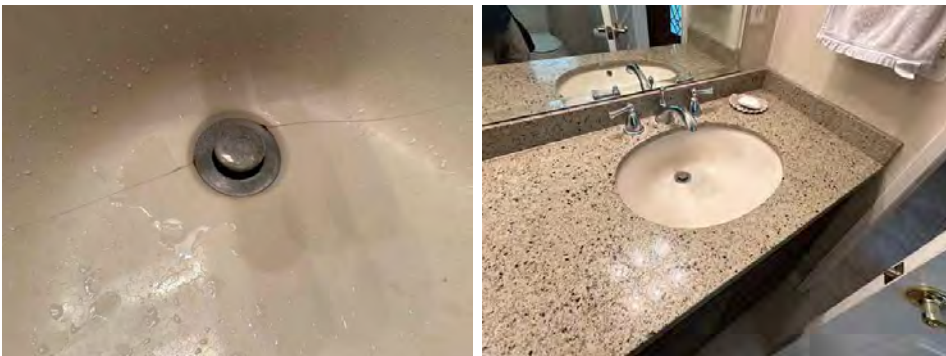
12.7.1 Sinks

**CRACKS OR CHIPS IN SINK**

Cracks or chips and / or deterioration is observed in sink. Recommend evaluation by a qualified sink reglazer.

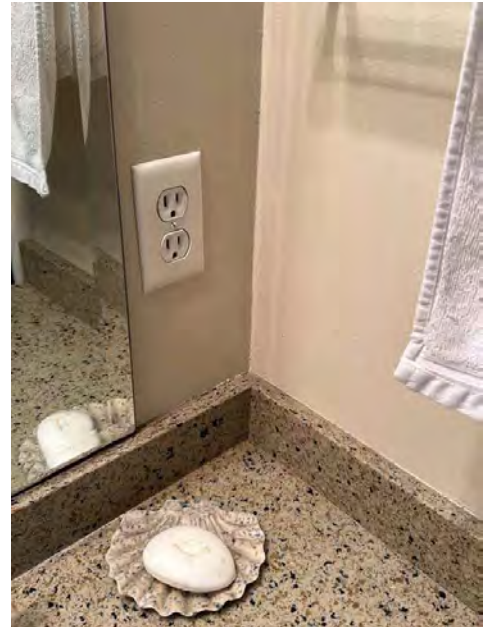
12.12.1 GFI Protection

**GFI NOT PRESENT**

GFI protection in bath is not present. Recommend evaluation by a qualified electrician.

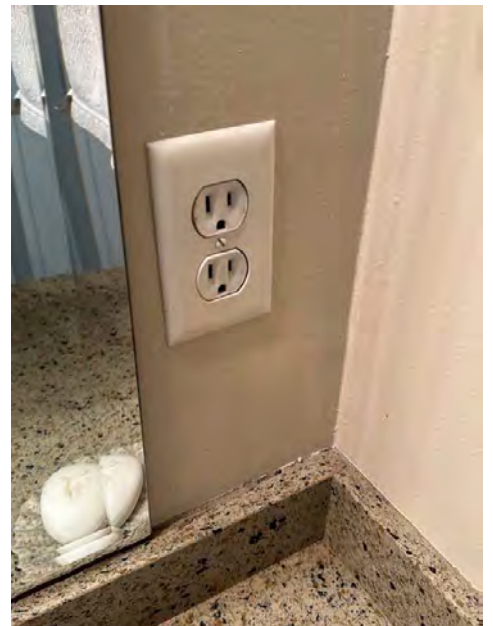
12.12.2 GFI Protection

**OUTLET IN BATH OPEN GROUND**

Outlet in bath tests open ground. Recommend evaluation by a licensed electrician.

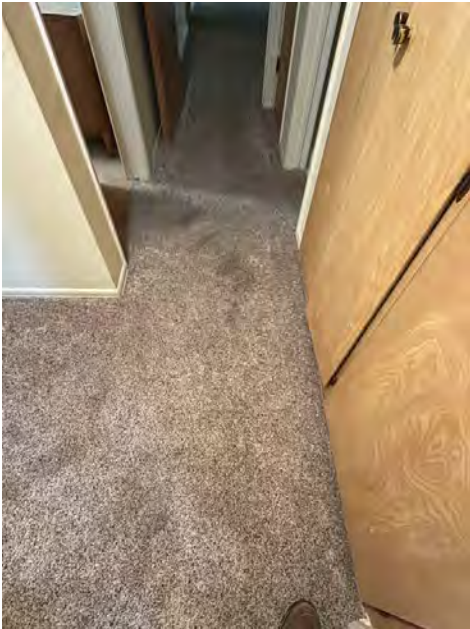
13.2.1 Flooring

**CARPET HAS VARIOUS STAINS**

Carpet has various stains and wear damage. Recommend evaluation by a qualified flooring repair professional.

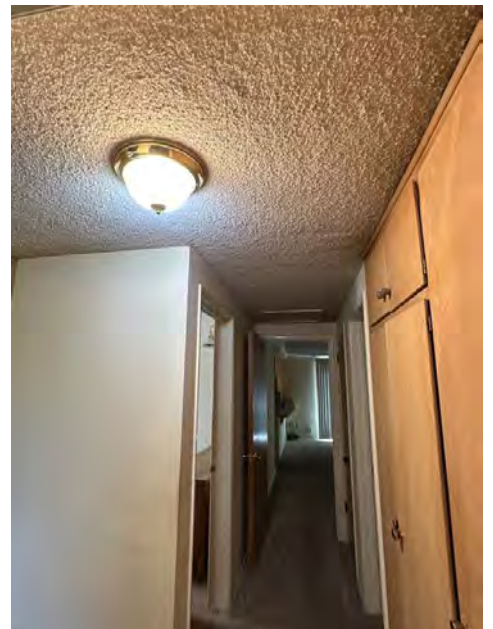
**A SMOKE DETECTOR IS MISSING**

A smoke detector is missing. Recommend correction by a qualified handyman.
