## GREENCO PROPERTY INSPECTIONS - RESIDENTIAL INSPECTION

26915 Grayslake Rd  
Rancho Palos Verdes, CA 90275

03/22/2024

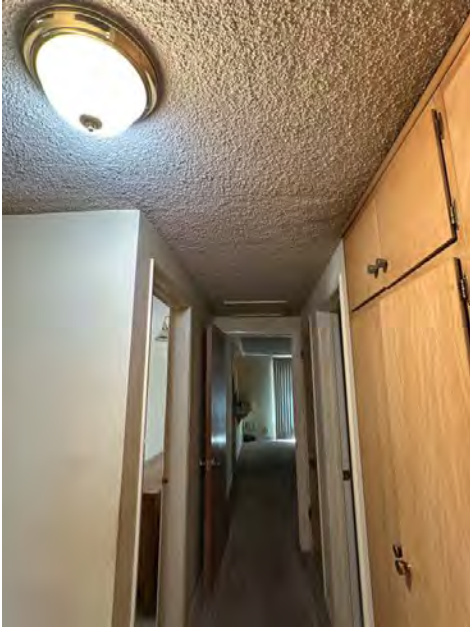
**A CO DETECTOR IS MISSING**

A CO detector is missing in the hallway. Recommend evaluation by a qualified handyman.

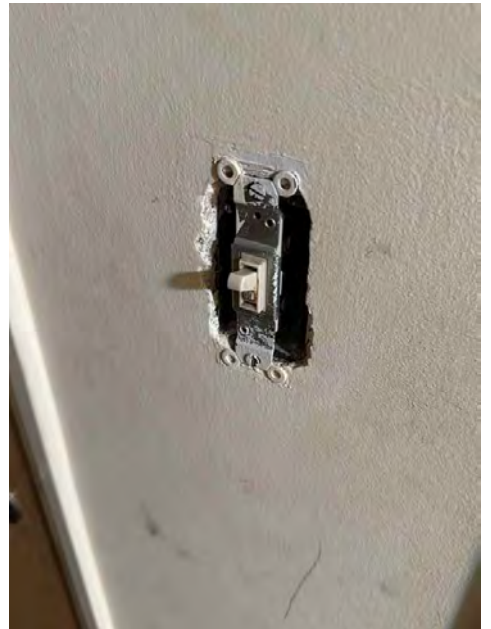
**OUTLET OR SWITCH COVER MISSING**

An outlet or switch cover is missing. Recommend evaluation by a qualified electrician.

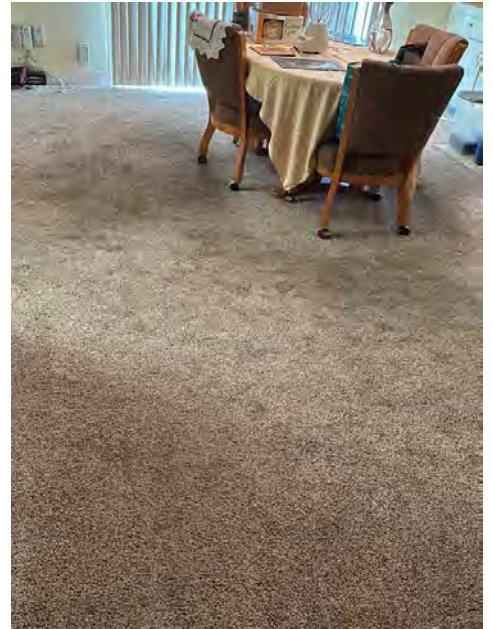
15.2.1 Flooring

**CARPET IS STAINED.**

Carpet is stained. Recommend evaluation by a qualified carpet cleaner.

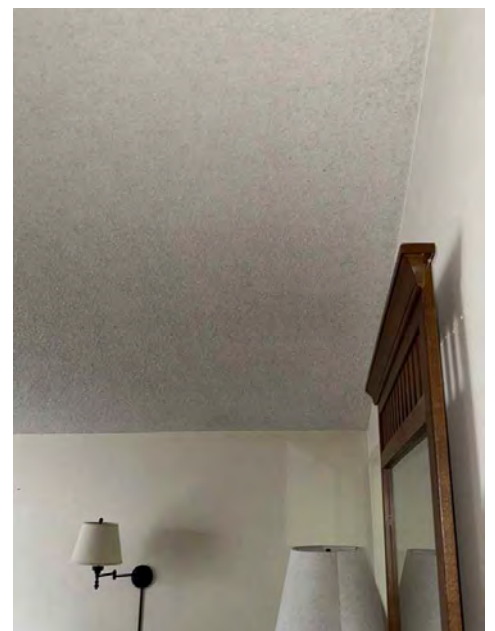
Acoustically sprayed ceilings may contain asbestos. Recommend evaluation by a qualified acoustical ceiling repair professional.

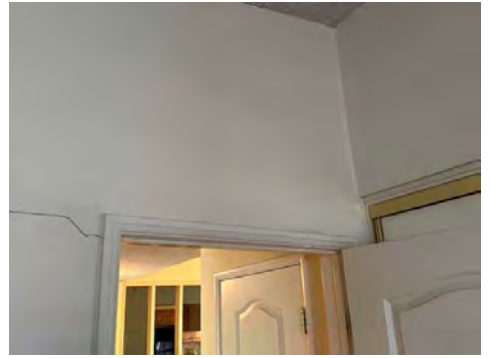
Repair or Replace**SMOKE DETECTOR MISSING**

Smoke detector is missing. Recommend evaluation by a qualified handyman.

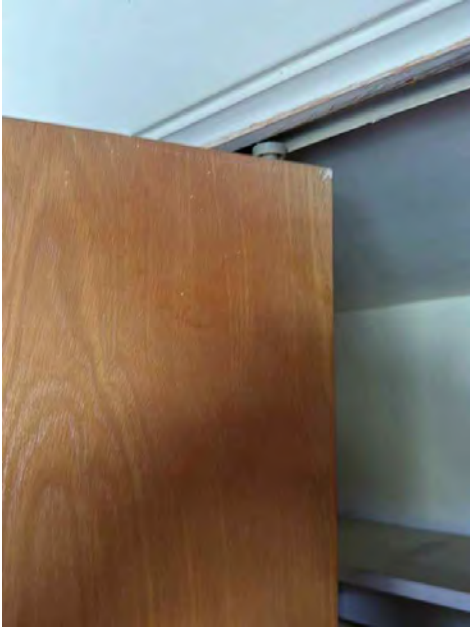
Bi-fold doors are off top track. Recommend evaluation by a qualified door professional.

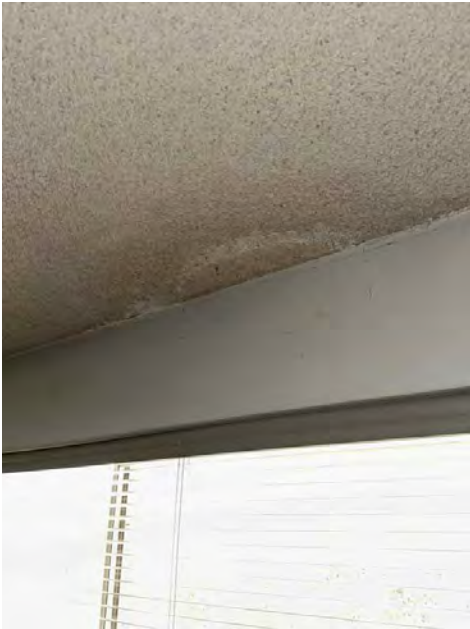
### THE CEILING IS DAMAGED

The ceiling appears to exhibit old water damaged with deteriorating repairs. Recommend evaluation by a qualified drywall repair professional.

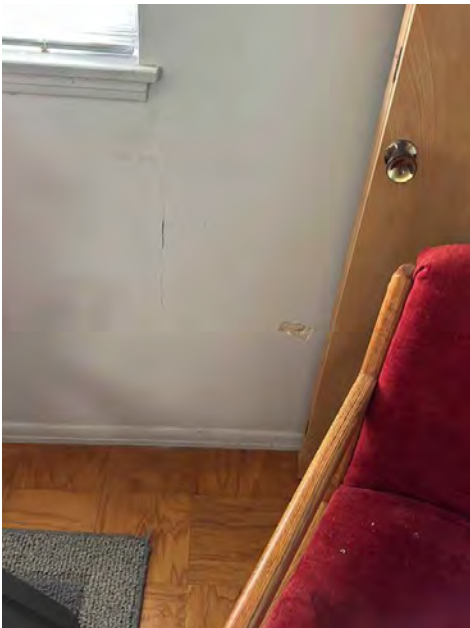
### 18.1.2 Ceiling and Walls

#### **WALL IS DAMAGED**

Wall is damaged. Recommend evaluation by a qualified plaster or drywall repair professional.

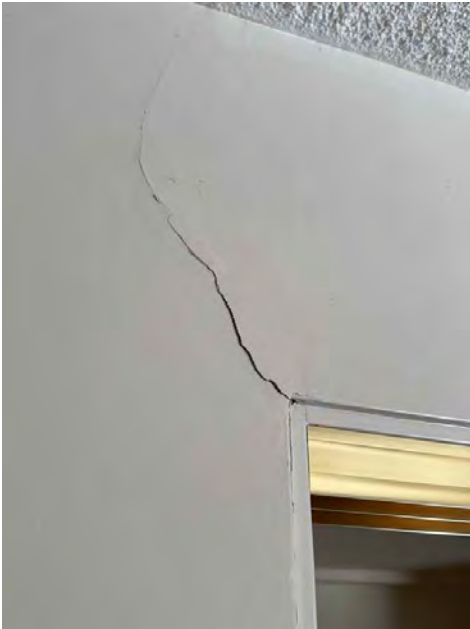
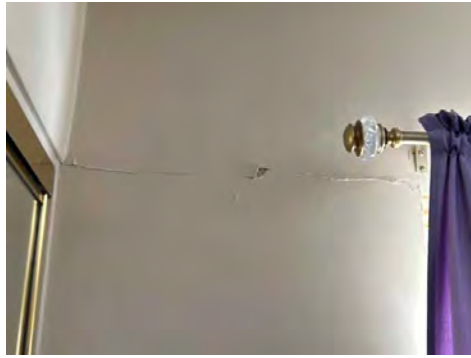
#### **WALLS ARE DAMAGED**

Walls are damaged. Recommend evaluation by a qualified residential structural engineer, plaster or drywall repair professional and painter.

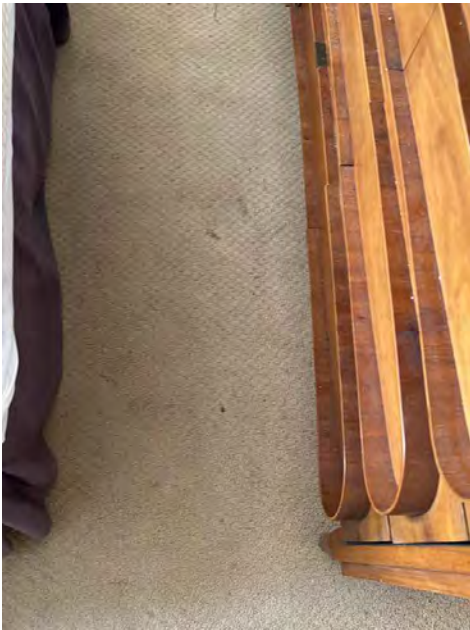
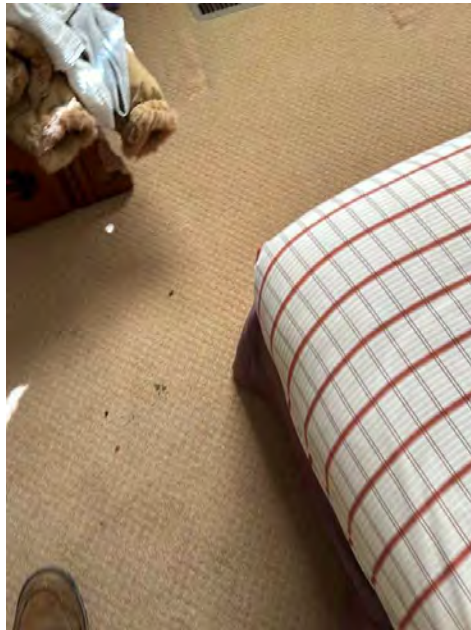
**CARPET IS STAINED**

Carpet has various stains, wear damage and / or faded areas. Recommend evaluation by a qualified carpet or flooring professional.

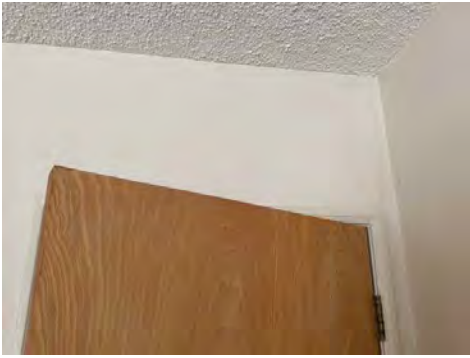
Smoke detector is missing. Recommend evaluation by a qualified handyman.

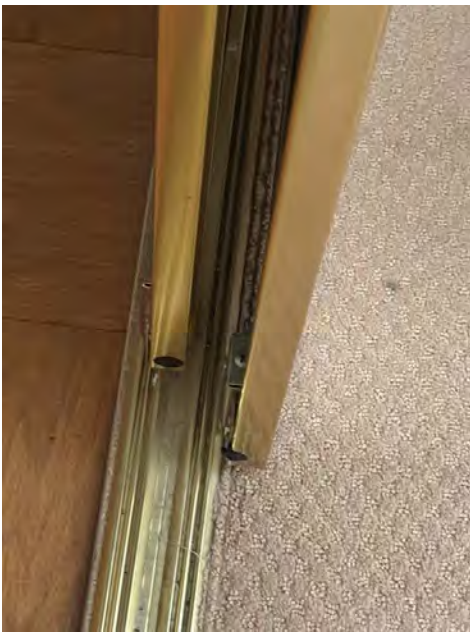
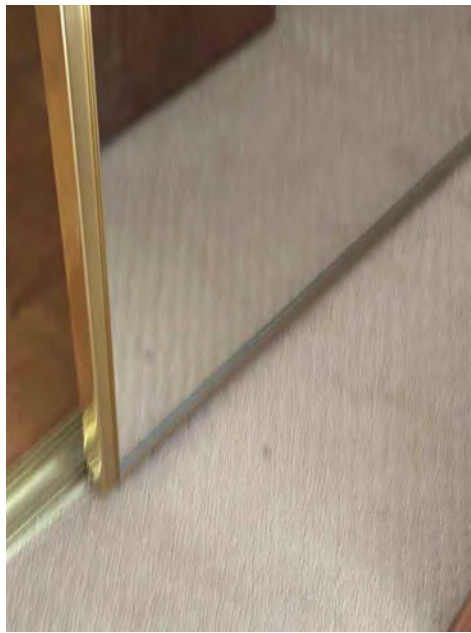
Closet door is off track. Recommend evaluation by a qualified closet door repair professional.

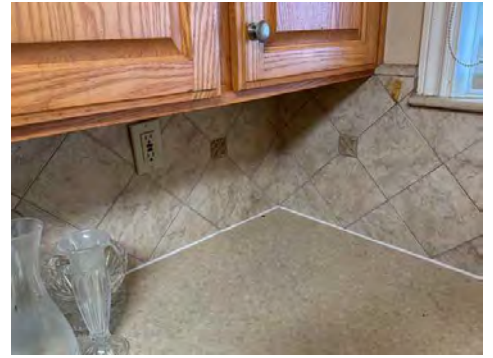
Countertop outlets are mis-wired. Recommend evaluation by a qualified electrician for safety.

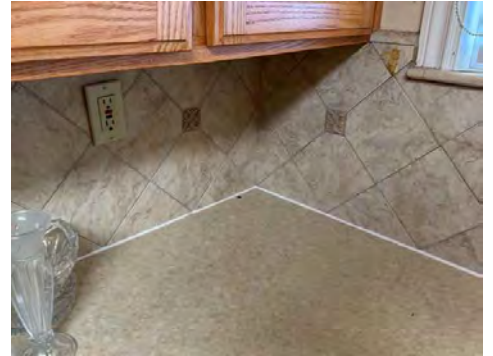
**OUTLET BOX IS LOOSE**

Outlet in box is not properly anchored. Recommend evaluation by a qualified electrician for safety.

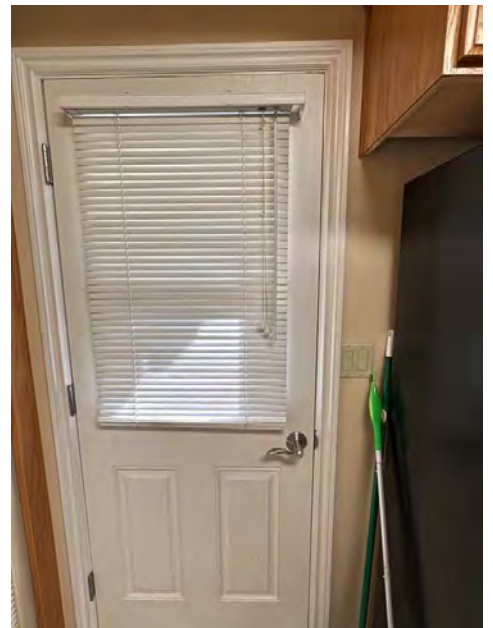
**DOOR IS RUBBING IN THE JAMB**

Door is missing. Recommend evaluation by a qualified door repair professional.

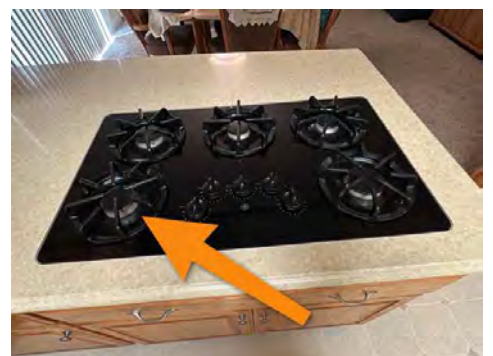
**BURNER DOES NOT IGNITE**

Burner(s) does not ignite. Recommend evaluation by a qualified appliance repair professional.

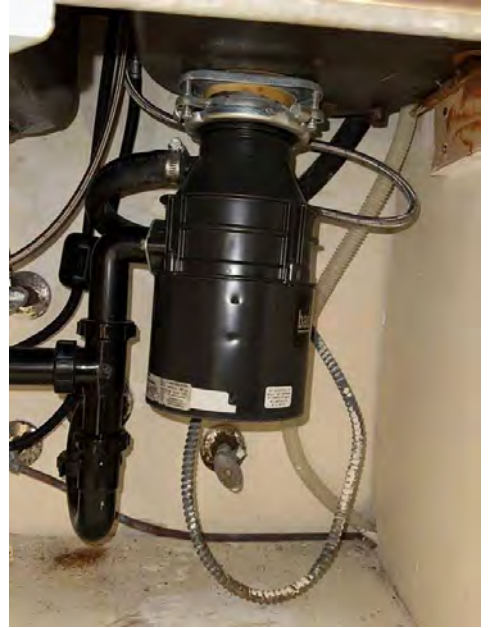
Repair or Replace**DISPOSAL IS NON OP**

Disposal does not function. Recommend evaluation by a qualified plumber.

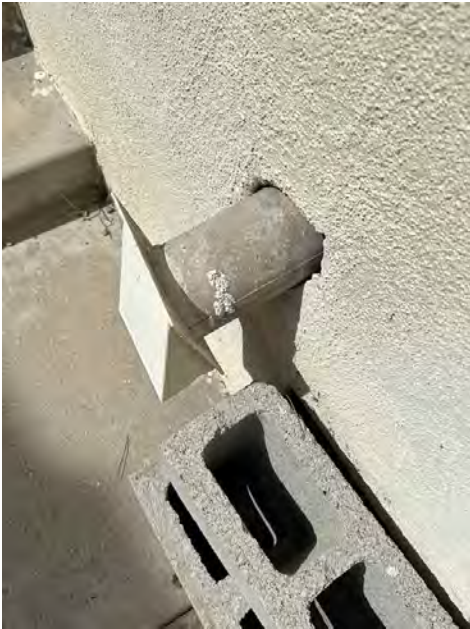
21.6.1 Dryer Venting

**DRYER VENT ASSEMBLY IS BROKEN OR DETACHED**

Dryer vent assembly is broken or detached. Recommend evaluation by a qualified handyman.

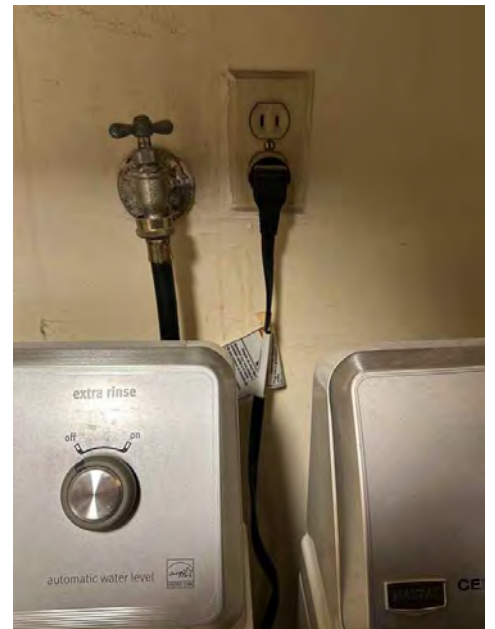
GFI protection is not present at these electrical outlets for laundry. (Usually 20 amp GFI receptacle) Recommend evaluation by a qualified electrician for safety.

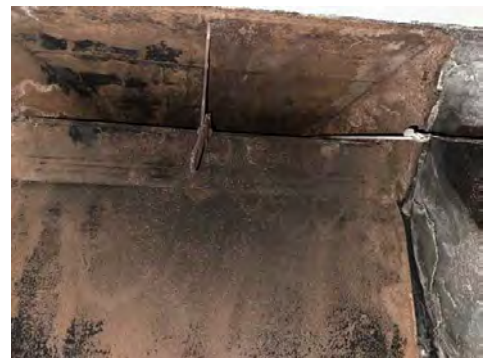
22.2.1 Fireplace(s)

### FLU STOP MISSING

Flu stop is missing in fireplace. Recommend evaluation by a qualified fireplace professional.
