Seller's comments to the Morisson Property Inspection Report dated May 3, 2022 (revised 5/5/22)

PROPERTY INSPECTION REPORT

11337 Nebraska Ave., Unit 301, Los Angeles, CA 90025

Inspection Date: 5/3/2022
Report Number: 2022050302IG
Real Estate Agent:
Home Inspector: Isaias Godoy

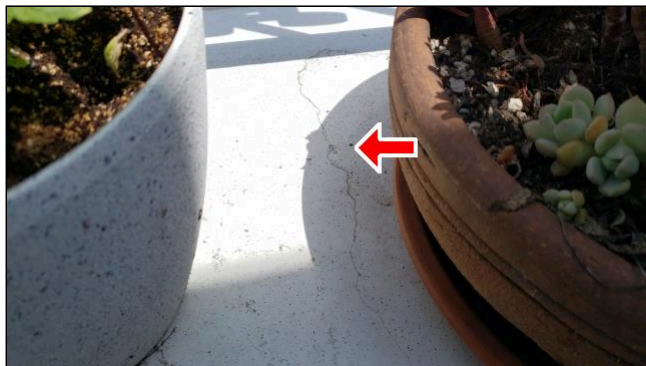
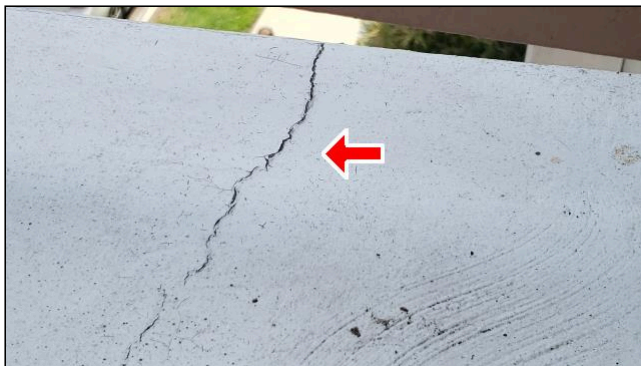
2.1 Item 2(Picture)

📍 (2) Deterioration observed at the rear balcony decking. Recommend further review by a qualified contractor.

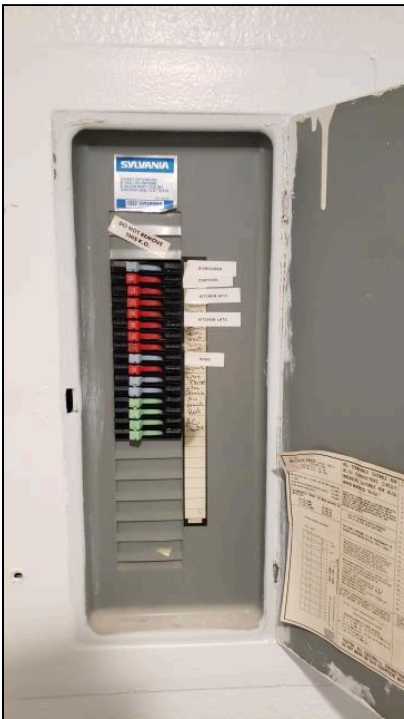
Electrical Service Entrance: Below Ground	Main Service Voltage: 120/240 Volts	Main Disconnect Amperage: Unable to determine
Main Disconnect Location: Exterior closet/cabinet	Main Panel Manufacturer: Unable to determine	Sub Panel Location: Hallway
Sub Panel Manufacturer: Sylvania/Zinsco	Sub Panel Disconnect Amperage: Unable to determine	Overload Protection Type: Circuit breakers
Branch Circuit Wiring Type: Not Visible	Branch Circuit Wiring Material (15 and 20 amp): Copper	Grounding Location(s): 2 - Locations found
Smoke & Carbon Monoxide Detectors: Installed	Security System: Not Installed

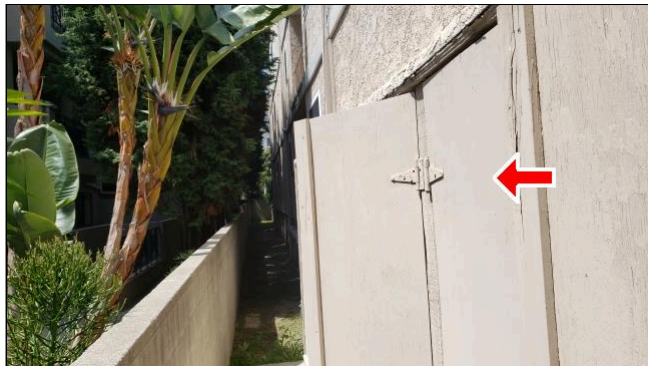
3.1 Item 2(Picture)

(2) Exterior access cover is painted/sealed shut - limited review. Suggest verifying condition.

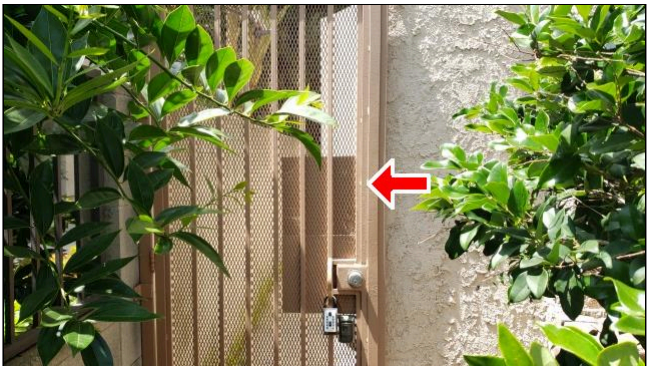
3.1 Item 3(Picture)

(3) Unable to inspect, panel locked access at the time of the inspection in common area. Recommend verifying the condition.

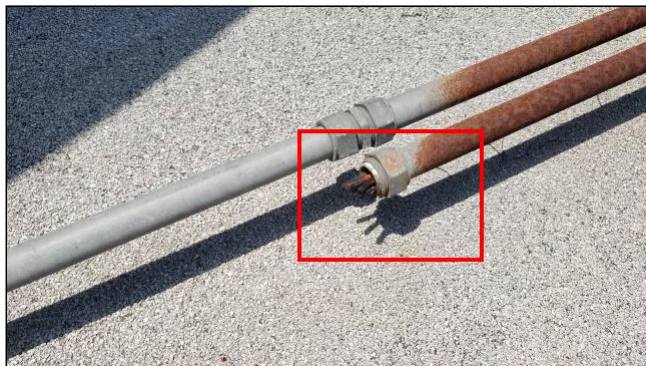
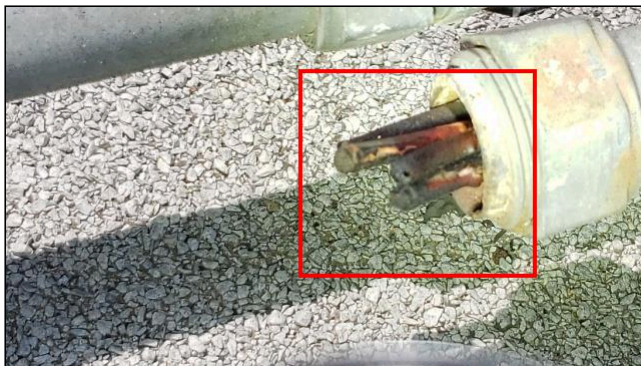
3.3 Item 1(Picture)

🏠 Open splices and scorching observed near AC condensers - safety concern. Recommend correcting and verifying condition by a qualified electrician.

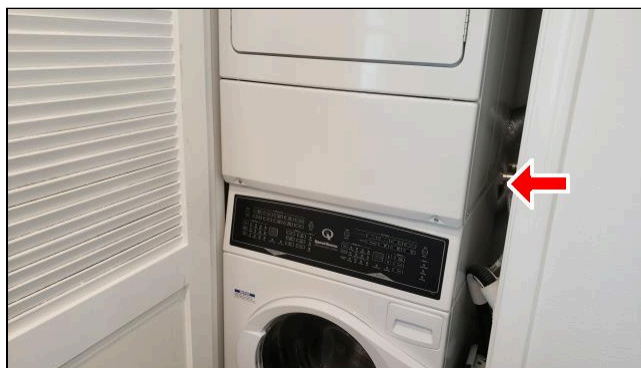
4.4 Item 1(Picture)

🏠 (3) Drip pan with drain line is not installed underneath the upper level washer. Recommend installing.

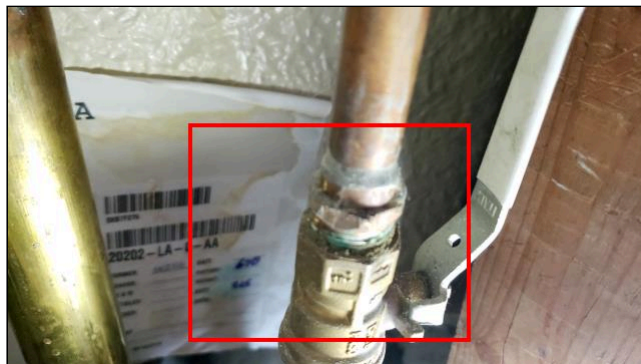
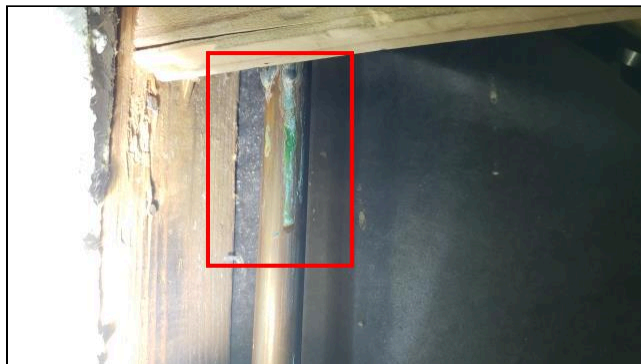
4.5 Item 1(Picture)

🏠 Rust and corrosion observed under the sink at kitchen and hallway tub access compartment valves. Recommend correcting.

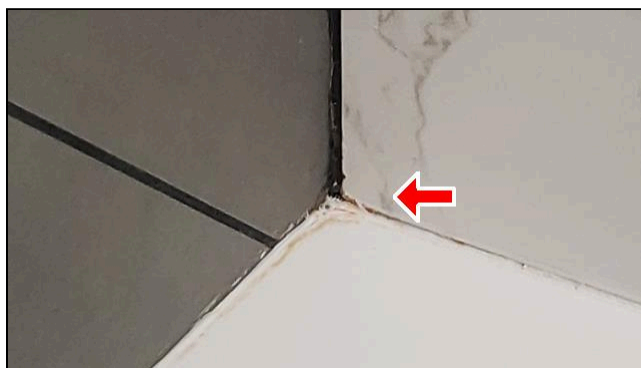
4.6 Item 1(Picture)

Caulking/grout at hall bathroom tub is deteriorated. Recommend repair.

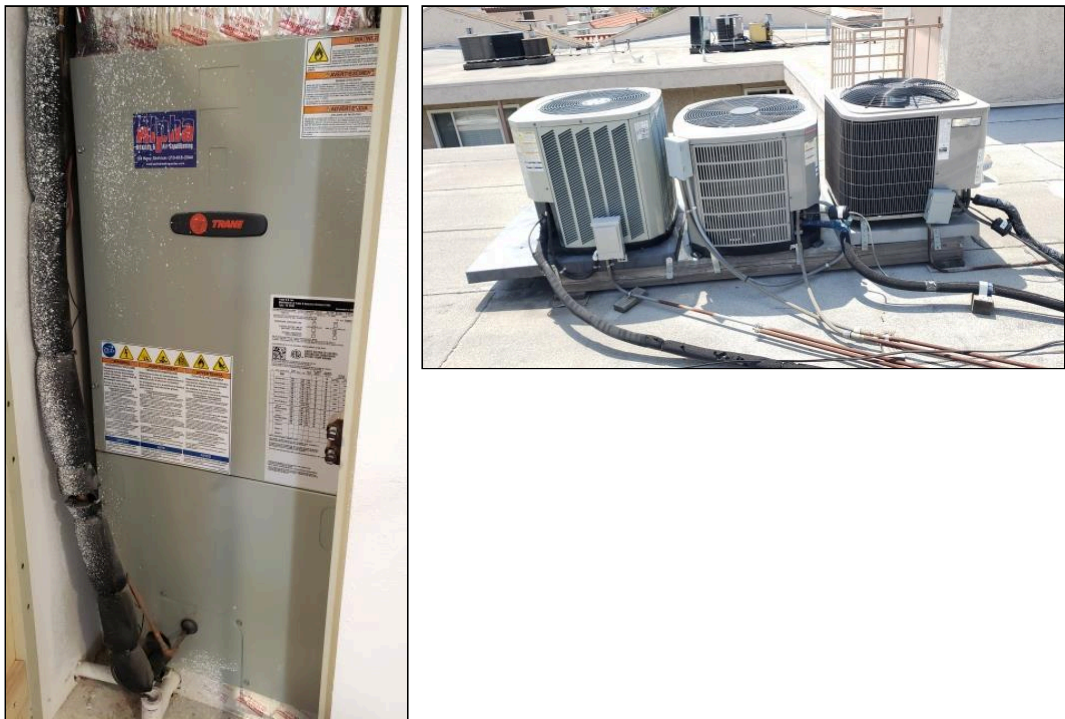
Air Conditioning Equipment Type: Split System/Forced Air - Electric Condenser	Air Conditioning Manufacturer: Unable to determine	Air Conditioning Location: Roof
Heating Equipment Type: Heat pump electric	Heating Manufacturer: Trane	Heating Equipment Location: Interior closet
Thermostat Locations: Living room	Primary Condensate Termination: Unable to determine termination point	Alternate Condensate Termination: Kill switch installed
Ductwork: Not Visible	Cooling Differential: Greater than 15 degrees Fahrenheit	Heating Operation: Unit provided heat

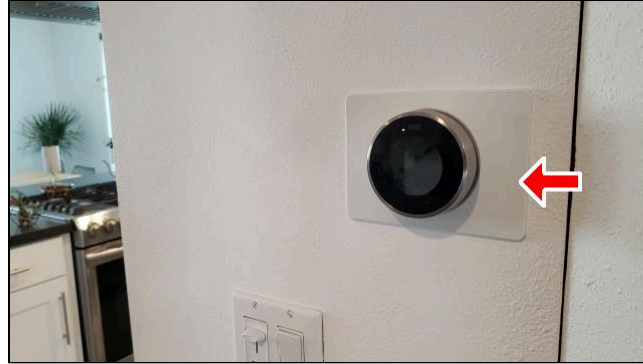
6.0 Item 1(Picture)

(2) A Nest system is present. Due to the nature of these systems, we were unable to remove the access cover to the furnace to inspect mechanical items - limited review. The client is advised to have the furnace/heat pump interiors checked by a qualified HVAC technician.

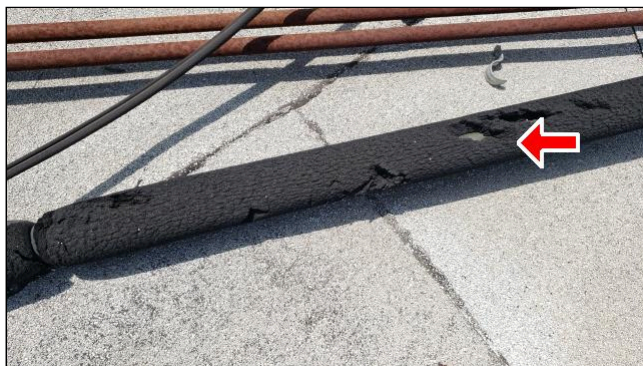
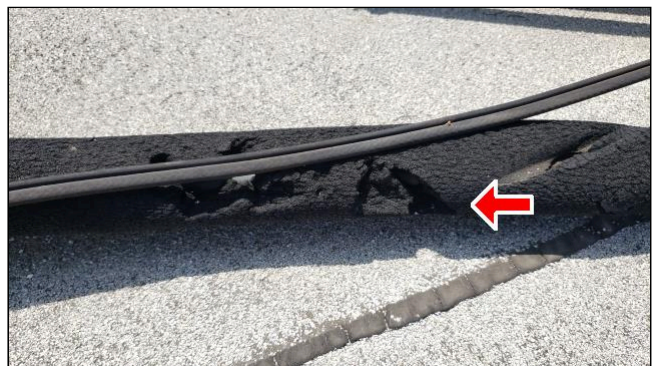
6.1 Item 1(Picture)

(2) Deterioration or missing insulation observed at the refrigeration lines. Recommend replacement.

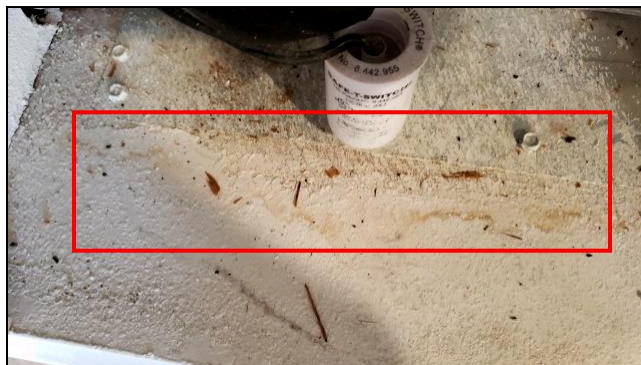
6.3 Item 1(Picture)

📍 Water staining observed at heating unit closet. Recommend further review by a qualified professional.

6.3 – Owner is not aware of any existing leaks with the property.

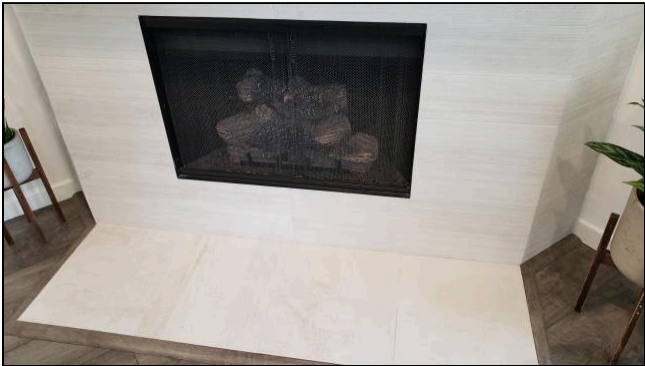
Chimneys (exterior): Direct Vent Flue	Viewed Chimney From: Roof	Chimney Locations: Through Roof
Type of Fireplace: Gas Appliance Manufactured	Fireplace Locations: Living Room

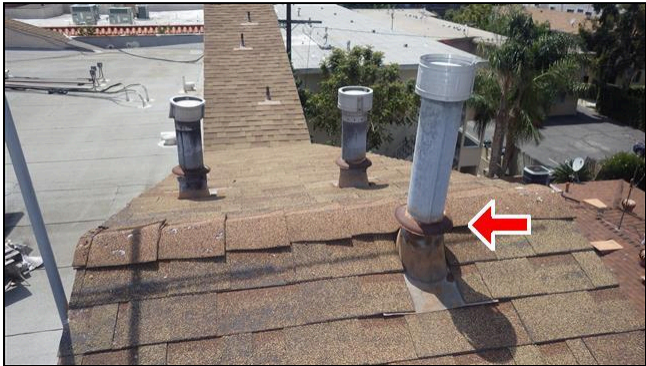
7.0 Item 1(Picture)

Rust/corrosion observed. Suggest further review by a qualified fireplace specialist.

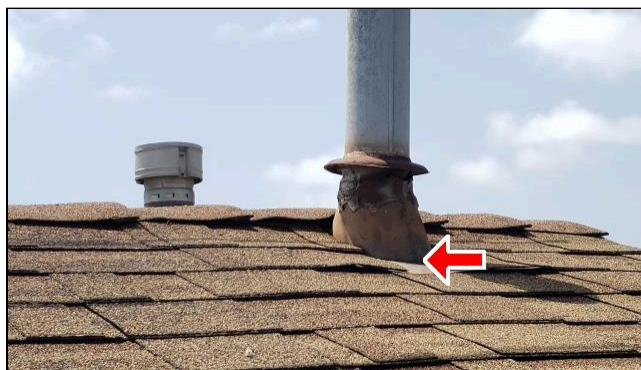
7.1 Item 1(Picture)

Lifting of flashing observed. Recommend correcting.

7 – Generally, roof maintenance is the responsibility of the HOA.

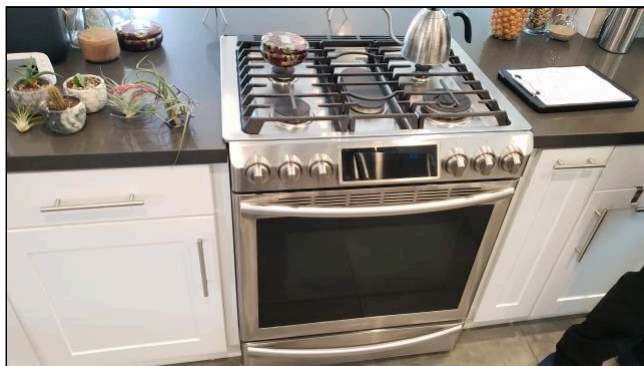
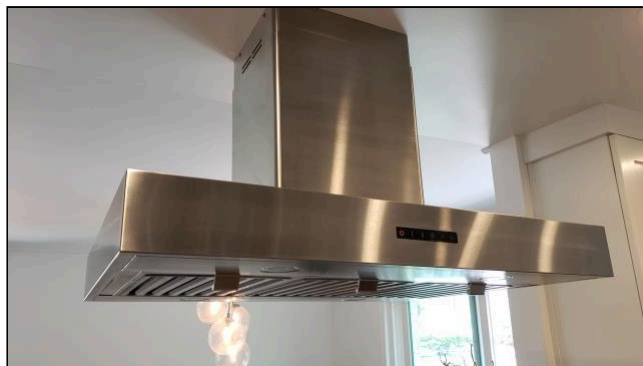
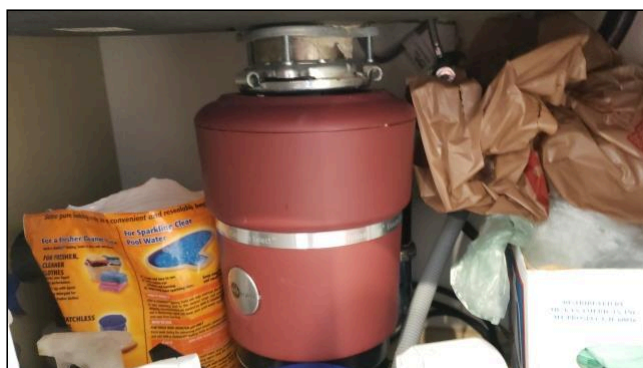
Exhaust Hood Brand:	Dishwasher Brand:	Disposal Brand:
Unable to determine	Samsung	In-Sink Erator
Stove/Oven Brand(s):		
Samsung

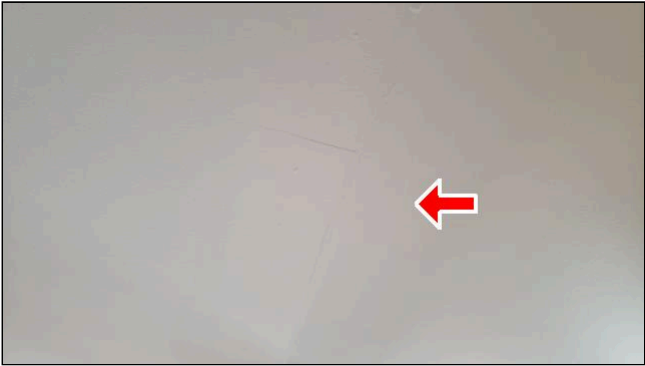
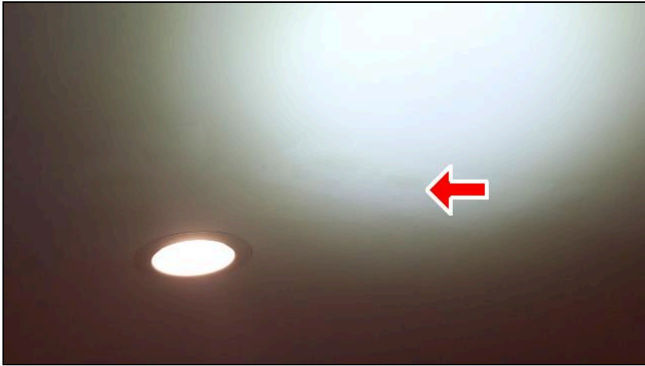
9.1 Item 1(Picture)9.1 Item 2(Picture)

Evidence of repairs observed at living room ceiling. We are unable to determine the cause or effectiveness of these repairs.
