Inspection Report
14264 Memory Lane, Clearlake, California 95422

Report ID
AP-381-001311

Inspection Date
March 31, 2022 at 08:00 AM

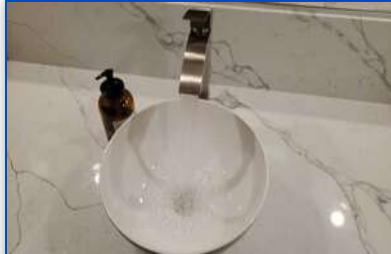
Location: HALLWAY BATHROOM

The bathroom faucet hot and cold handles are reversed. Recommended repair by a professional contractor.

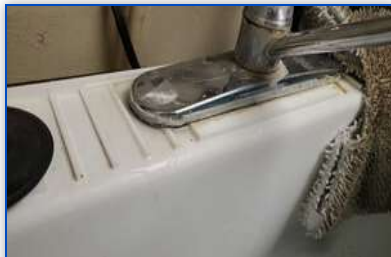
Location: LAUNDRY ROOM

6.5.1 Faucet Leaks When Operated

One or more faucets leak were found at the handle(s) or at their base when the fixture is turned on. Replacement of the fixture is needed.

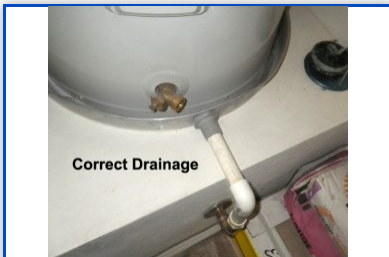
8.1.2 No drip pan or drain

A water heater is installed that has no catch pan or drain installed. Recommend having a qualified contractor install a catch pan and drain to prevent water damage if/when the water heater develops a leak or is drained.

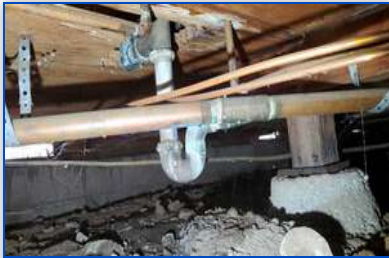
Location: HALLWAY BATHROOM
CRAWLSPACE

11.7.2 Active Drain Leak

The inspector found one or more active drain leaks. We recommend that the affected drains be repaired as needed by a professional contractor.

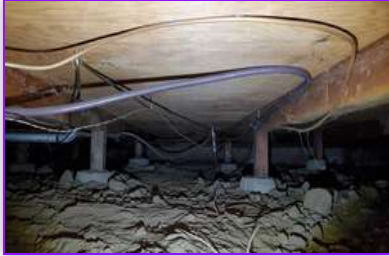
There was no insulation was installed in the crawl space between floor joist which is typical in older homes. The Inspector recommends considering installing insulation for greater heating and cooling efficiency of the home.

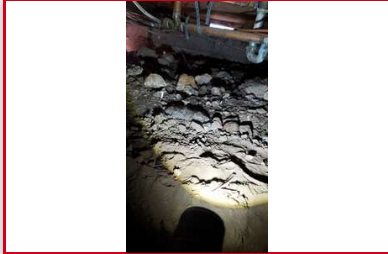
Location: CRAWLSPACE

Evidence of rodents such as bait stations, traps, and/or other signs were found in one or more locations. Maintenance is recommended to prevent rodent problems.

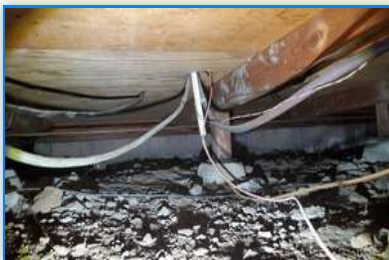
The condensation from an HVAC unit drains into the crawlspace. This will increase crawlspace humidity and may lead to mold or mildew growth. It is recommended to have the drain terminate to the exterior.

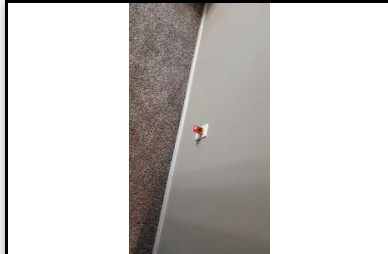
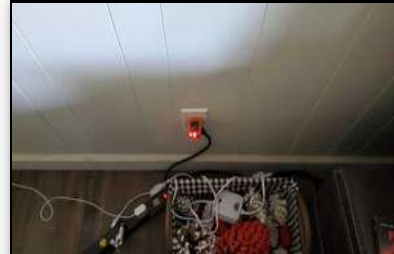
1.1 Hot Neutral Reverse

One or more electric outlets had wiring that was hot and neutral wires were reversed. This is a shock concern. We recommend that this repaired as needed by a professional electrical contractor.

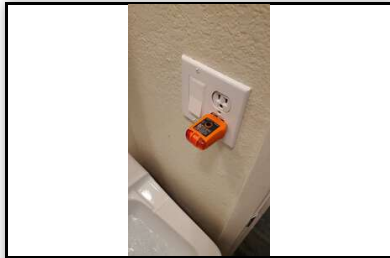
Location: HALF BATHROOM

One or more electric outlets had wiring that was hot and neutral wires were reversed. This is a shock concern. We recommend that this repaired as needed by a professional electrical contractor.

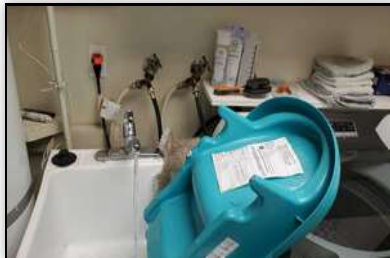
The receptacle in the laundry room is not GFCI protected. It is recommended to have this receptacle switched/updated to a GFCI outlet for protection, to help prevent possibility of electrical shock. GFCI protections was required in laundry rooms since 2005. All work should be performed by a professional electrical contractor.

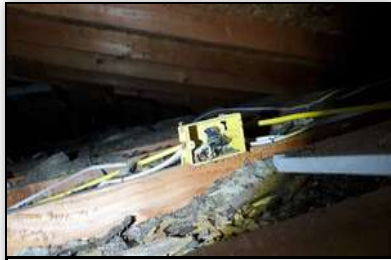
Location: CONVERTED GARAGE ACCESS

10.5.1 Missing junction box cover plates

There were one or more junction boxes in the attic that did not have cover plates installed to protect the exposed wires. the inspector recommends proper cover plates be installed as needed by a professional electrical contractor.

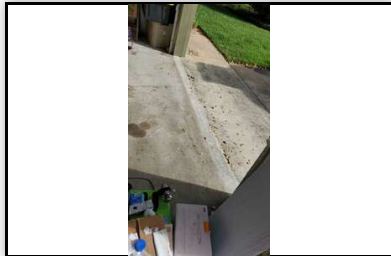
No photo sensors were installed servicing the garage door. These are a safety feature to prevent a door from closing on a child or other person/animal. We recommend that they be installed.

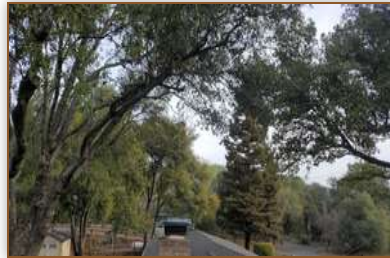
1.7.1 Vegetation Findings(Multiple Defects)

1. OVERHANGING LIMBS (POTENTIAL FOR DAMAGE)

Trees near the house have limbs that overhang the home. These have a potential to damage homes during storms or high wind situations. We recommend that the tree limbs in question be trimmed by a professional removal company.

2. TREE LIMBS IN CONTACT WITH ROOF

There are tree limbs that are in contact with roof, or hanging near roof and should be trimmed back. The inspector recommends that the trees be trimmed, by a professional tree trimming contractor. It is recommended to trim tree branches several feet away from the house.

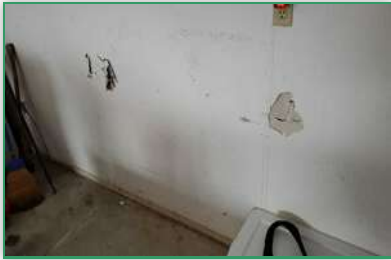
12.2.1 Garage Walls (Damaged drywall)

The garage walls had moderate damage and/or poorly repaired areas at the time of the inspection. The inspector recommends that you have the affected areas repaired as needed by a professional drywall repair contractor.

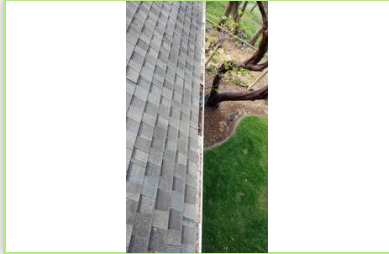
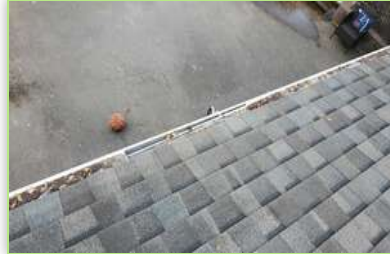
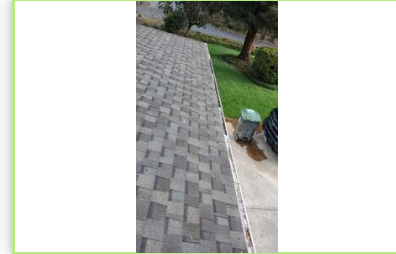
At the time of inspection, one or more areas of the screening for the gutter gaurd system was missing or damaged. Monitoring for damage at least once a year is necessary as screens may need to be replaced or repaired.

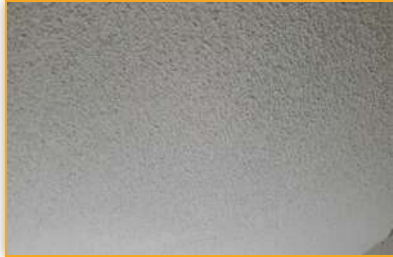
Any popcorn ceilings that predate 1978 likely contain asbestos, which can cause mesothelioma, asbestosis, and lung cancer. The best thing to do with an asbestos product that is in good condition is to leave it alone. Disturbing asbestos can create a health hazard where none was present before. The material can be lab tested to determine whether it contains asbestos or not.

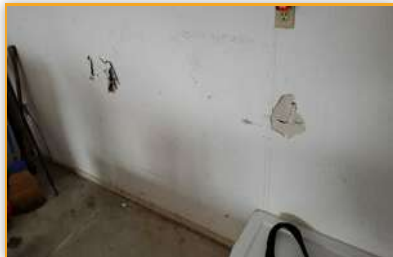
12.2.1 Garage Walls (Damaged drywall)

The garage walls had moderate damage and/or poorly repaired areas at the time of the inspection. The inspector recommends that you have the affected areas repaired as needed by a professional drywall repair contractor.

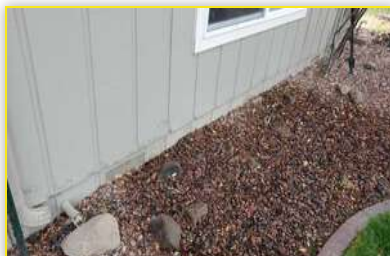
2.10.1 Improper Clearance

Improper ground clearance was observed at one or more locations around the house. It is recommended for siding to have 6-8 inches of clearance to prevent moisture or soil related deterioration. If damage was found, it will be noted in the picture. It is recommended for repairs to be made as needed by a professional contractor to industry standards.
