ELITE GROUP

2214 Curtis Ave, Redondo Beach, CA 90278
Inspection prepared for: Mario & Florence Furtado
Real Estate Agent: -

Date of Inspection: 3/31/2022 Time: 2:00 PM
Age of Home: 1986 Size: 2064
Order ID: 279803

Inspector: Brian Poppinga

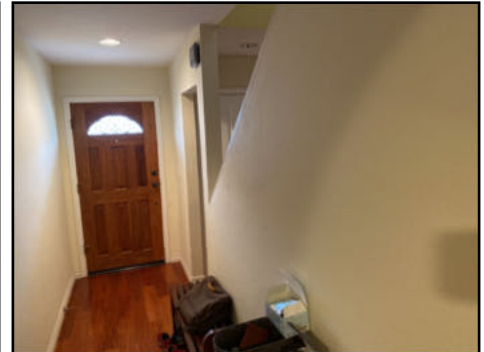
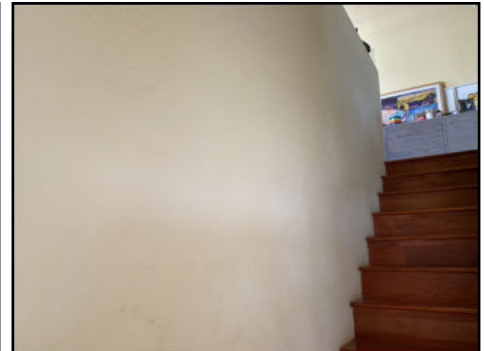
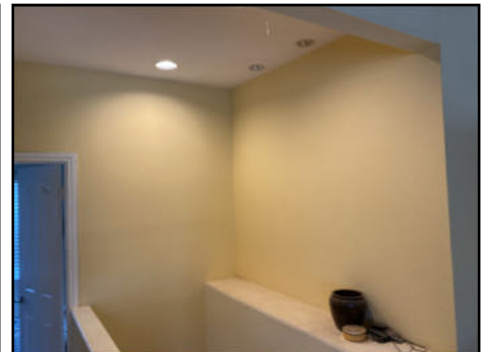
1. Wall Conditions

Small cracks/holes/chipped/dirty areas/cosmetic blemishes observed - typical for age of structure • Small cracking may be found throughout the structure, this is normal for California construction and generally caused by settling, earthquake, and wind conditions.

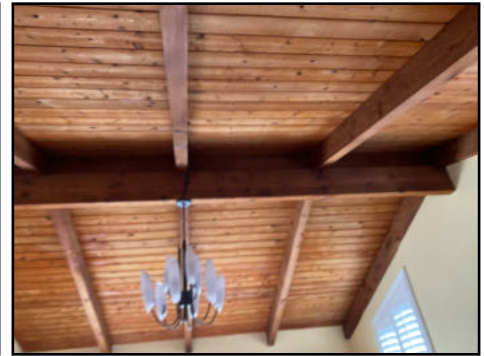
2. Ceiling Conditions

No major visible defects observed at the time of inspection • Small cracking may be found throughout the structure, this is normal for California construction and generally caused by settling, earthquake, and wind conditions.

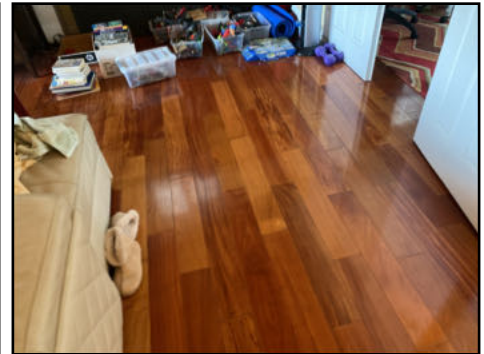
3. Floor Conditions

Scatched/worn areas - typical for age and use • Consult termite report for wood floors • Area rugs present - some areas of floors not visible • Personal items/furnishings prevent complete inspection in areas

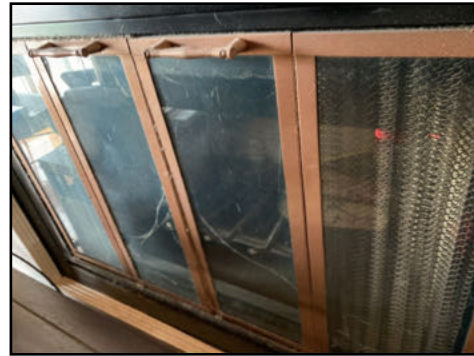
The fireplace is visually inspected only, the fireplace is not lit to test flame color or condition. The internal cavity of the fireplace is not inspected. It is recommended that you have an internal inspection of the chimney and a Gas Company evaluation of the fireplace prior to operating the fireplace.

Recommend fireplace professional evaluate and repair any issues found before attempting to use fireplace

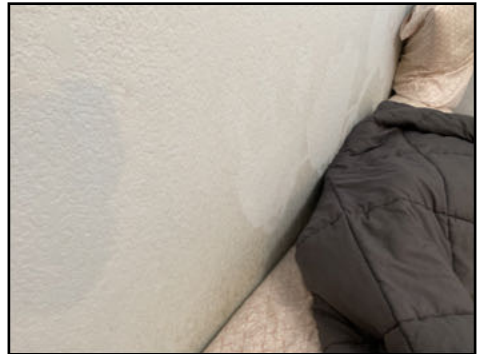
2. Wall Conditions

Small cracks/holes/chipped/dirty areas/cosmetic blemishes observed - typical for age of structure • Recommend patching/painting • Small cracking may be found throughout the structure, this is normal for California construction and generally caused by settling, earthquake, and wind conditions.

Recommend patching/painting

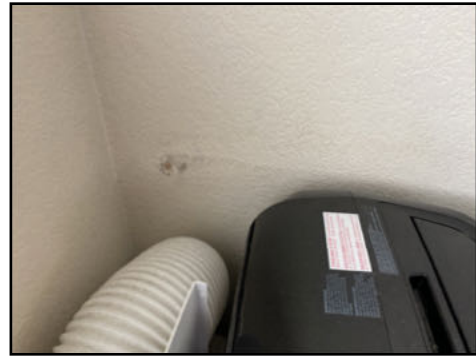
Small cracks/holes/chipped/dirty areas/cosmetic blemishes observed - typical for age of structure

Recommend patching/painting

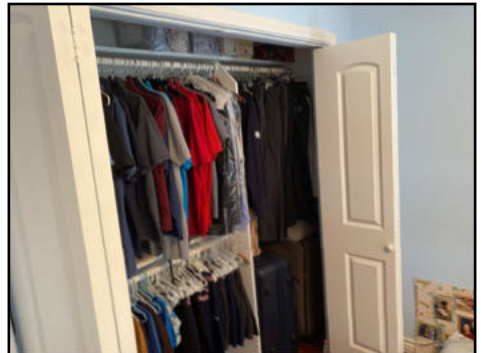
8. Closets

Worn closets with loose/worn hardware - typical for age • Bi-fold doors do not operate properly - needs to be serviced • Some closet areas not visible for inspection due to personal storage

Bi-fold doors do not operate properly - needs to be serviced

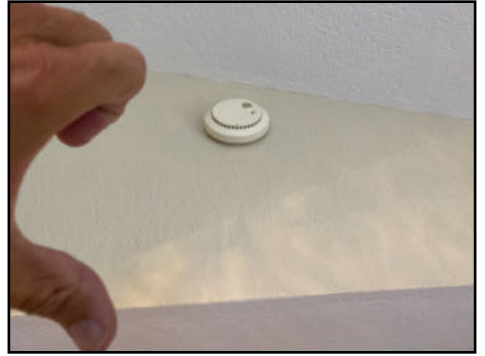
9. Smoke Detectors

Did not operate - needs to be serviced or replaced

Did not operate - needs to be serviced or replaced

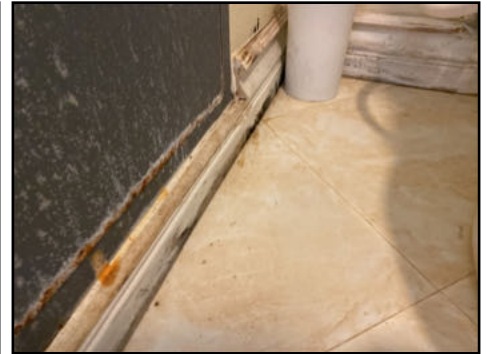
2. Wall Conditions

Small cracks/holes/chipped/dirty areas/cosmetic blemishes observed - typical for age of structure • Stains at base - moisture present when tested with moisture meter - needs to be serviced/further evaluated • Small cracking may be found throughout the structure, this is normal for California construction and generally caused by settling, earthquake, and wind conditions.

Stains at base - moisture present when tested with moisture meter - needs to be serviced/further evaluated

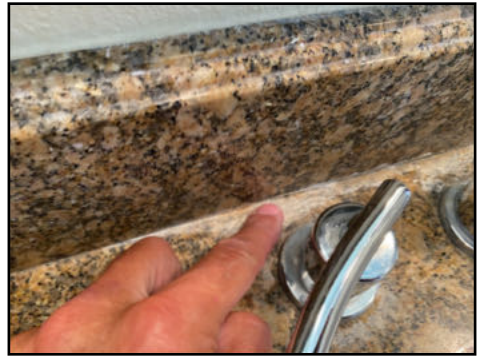
Counter is worn and has typical wear for age • Recommend grout/sealer/stone maintenance • Some counter areas not visible for inspection due to personal storage • **Gap at backsplash to countertop joint - needs to be serviced**

Gap at backsplash to countertop joint - needs to be serviced

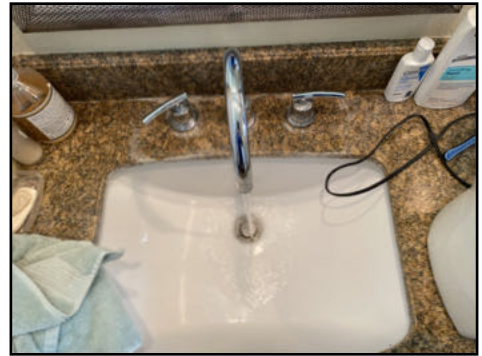
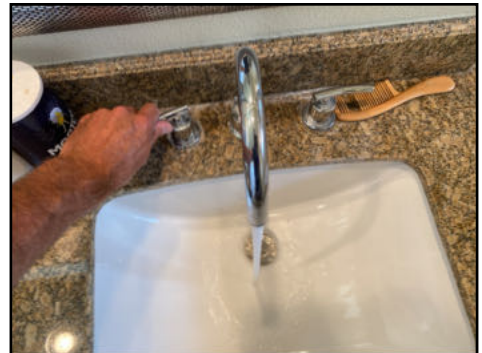
Worn fixture/sink - typical for the age

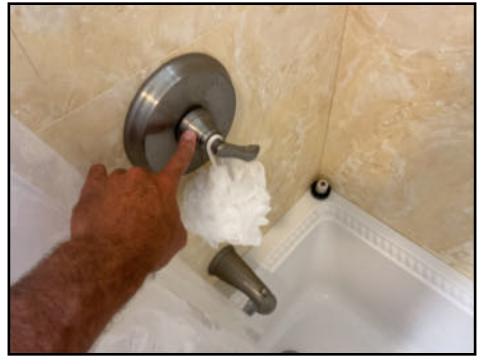
Fixture was tested and operating at the time of the inspection • Fixture was in a worn/older condition at the time of the inspection - typical for age • Loose fixture(s) - needs to be serviced • Tub fixture difficult to operate - needs to be serviced • Tub to shower diverter not operating properly - needs to be serviced • Hot water above 120 degrees, recommend adjusting the temperature at the water heater or upgrading fixture to anti-scald device • Tub has normal wear for age at the time of the inspection - no major visible defects • Drain stopper missing - needs to be serviced • Spa/whirlpool tub function not tested due to length of time needed to fill tub - motor was dry tested once to determine if powered only • Bathtubs are not filled to overflow opening to test • Spa tub hoses and connections are not inspected • Some areas not visible due to personal items • **Tub fixture leaks when operated - needs to be serviced**

Tub fixture difficult to operate - needs to be serviced

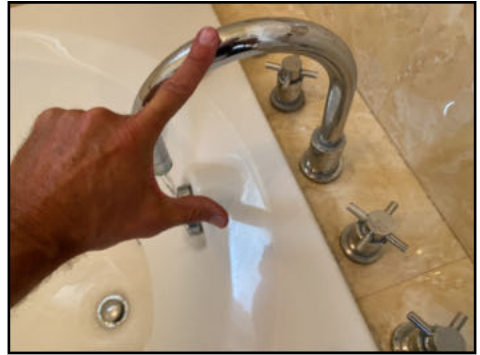
Tub fixture leaks when operated - needs to be serviced

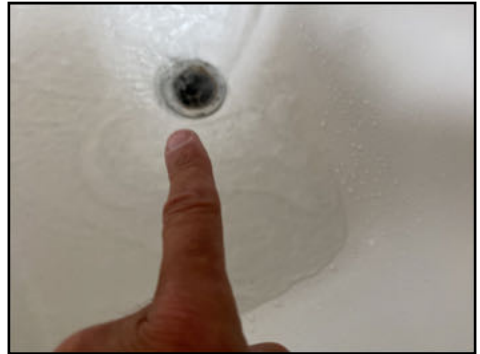
Loose fixture(s) - needs to be serviced

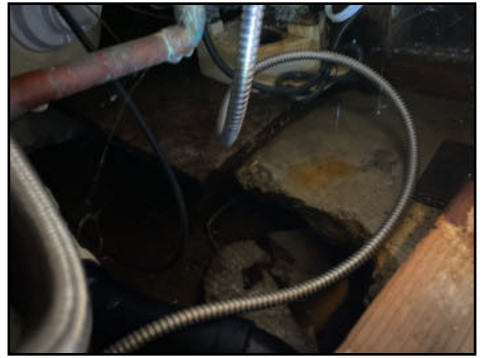
Corrosion is present at plumbing areas - this is a sign of slow leaking and should be further evaluated by a plumber

Recommend licensed plumber to further evaluate

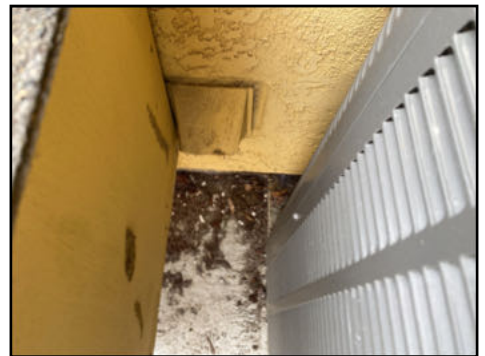
Dryer vent should be cleaned periodically to prevent lint fire hazards • Worn exterior cover - typical for age
• Backdraft damper missing/damaged at exterior termination - needs to be serviced • Lint clog observed at clothes dryer termination at sidewall - needs to be serviced

**Backdraft damper
missing/damaged at exterior
termination - needs to be serviced**

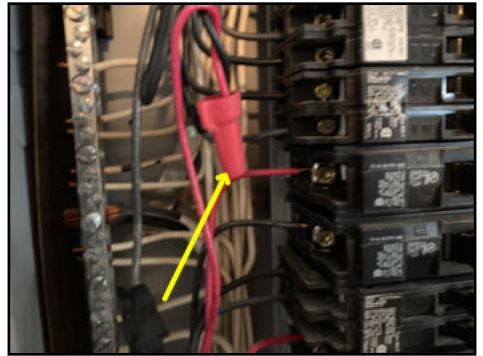
Wiring type: copper • Wiring method: non-metallic sheathed cable (romex) • Unable to determine if this panel is properly grounded - recommend further evaluation by a licensed electrician • Visible wiring has normal wear for age with no major visible defects at the time of the inspection • Spliced/taped/wire nut connections present are evidence of alterations to panel – consider further evaluation by an electrician to ensure that splices are not bypassing or overloading breakers • Some wire types cannot be determined due to wire casings cover wires entering the breakers. • Inspector does not perform a load calculation to determine service capacity adequacy • Wiring not completely visible due to amount of wires inside panel

Spliced/taped/wire nut connections present are evidence of alterations to panel – consider further evaluation by an electrician to ensure that splices are not bypassing or overloading breakers

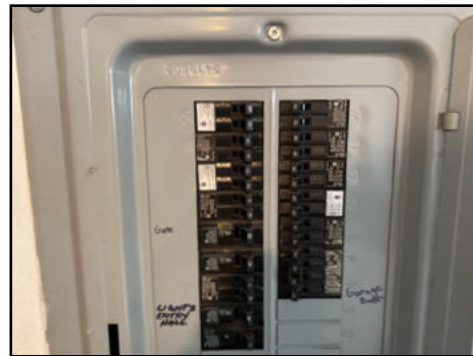
Number of breakers in off position: • Number of unused breakers: • Unused breaker(s) present • No visible labeling for breakers on panel cover - needs to be serviced • Loose/worn breakers - typical for age • Breakers are visually inspected only - the inspector does not perform any electrical stress tests on the system to determine if a breaker trips properly (consult an electrician for further evaluation, if this is a concern)

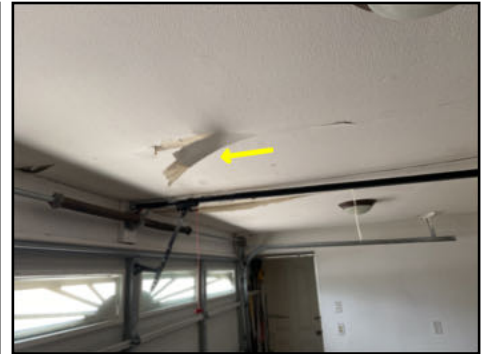
Cracking small - typical for age, recommend patching • Loose tape - needs to be serviced • Blistered paint - cause of blistering is unknown • Recommend contractor to further evaluate • **Heavy blistering - needs to be evaluated/serviced**

Blistered paint - cause of blistering is unknown

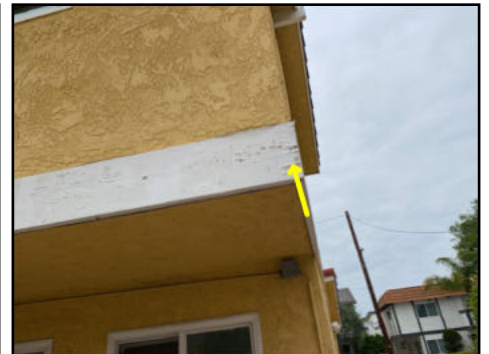
Deteriorated wood - needs to be serviced - consult termite report

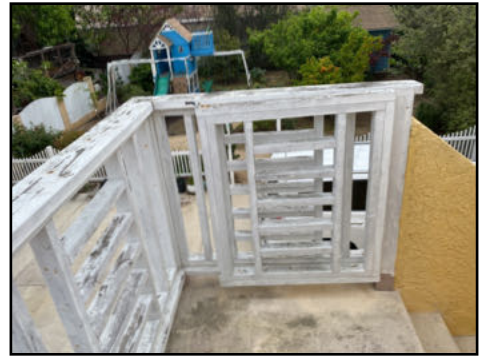
Deteriorated wood - needs to be serviced - consult termite report

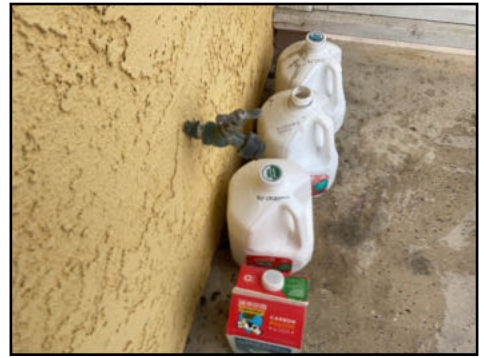
Exterior hose faucet(s) leaks/drips when turned off - needs to be serviced

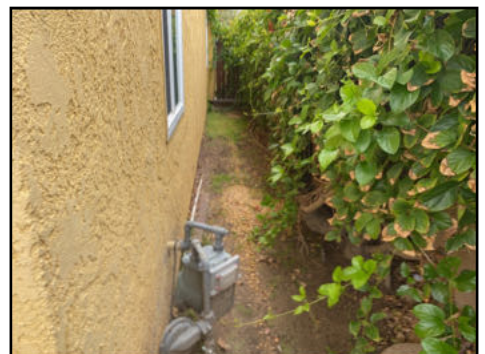
Excessive moisture present in areas; possibly irrigation over-watering - needs to be serviced
