Standard Swimming Pool Inspection

Inspection Location: 401 Yarmouth Road, PalosVerdes Estates, CA 90274

Inspection Date: 6/2/2026

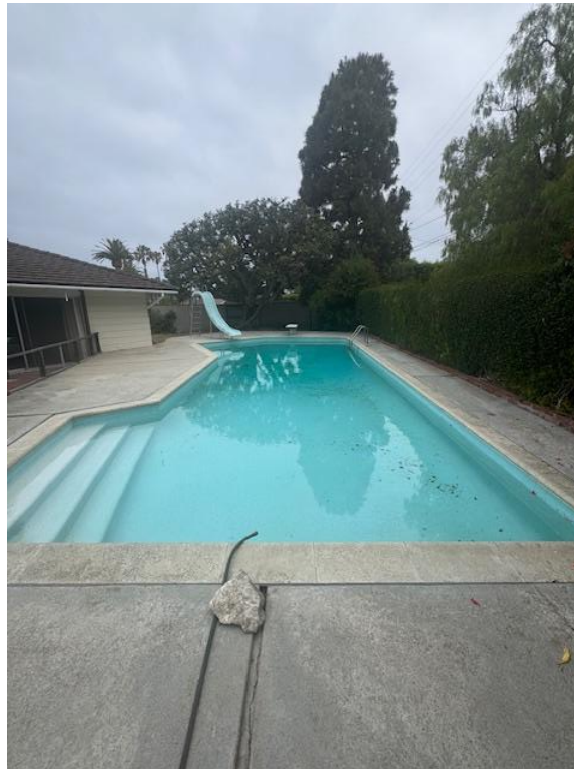
Swimming Pool

Shape – Rectangular/ semi free form, pool only no spa.

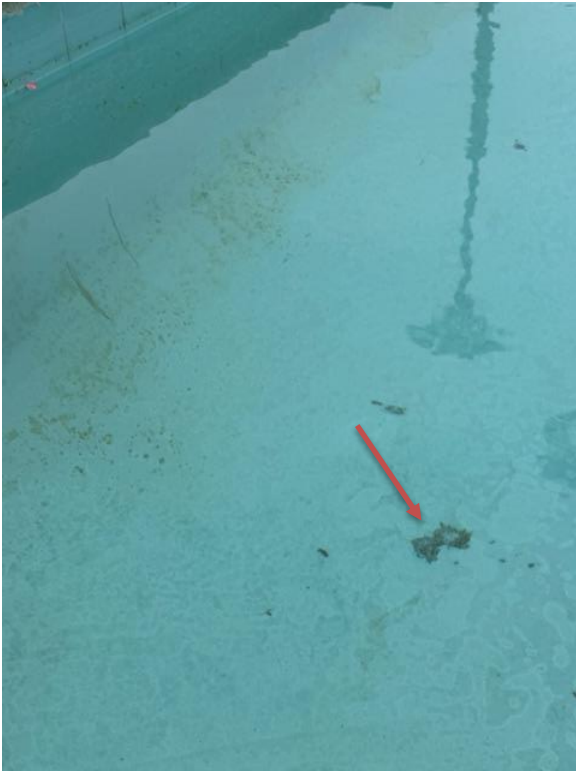
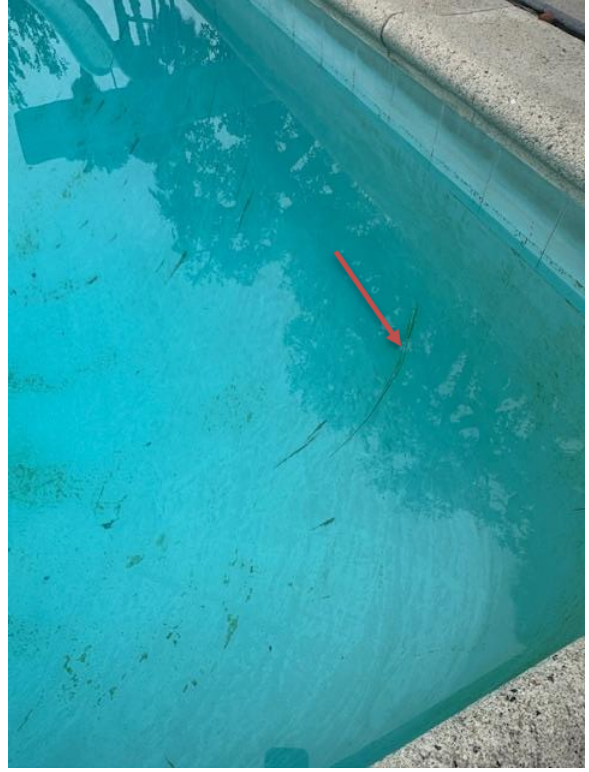
Pool Finish

Observation: White smooth plaster finish. The swimming pool has several areas that have calcium nodules. Some are larger than others but several areas are affected by the nodule formation. The pool finish is stained and has raised/rough forms of efflorescence referred to as Calcium Nodule spots that sporadically form on a plaster surface. Nodules may be circular volcano-type formations or stalactite like drips down the plaster wall. They are most often associated with plaster delaminating that combined with the surface discoloration indicates the plaster is a candidate for re-finishing soon.

Recommendation: Replaster the pool and spa. Apply a waterproofing membrane prior to plastering the pool.

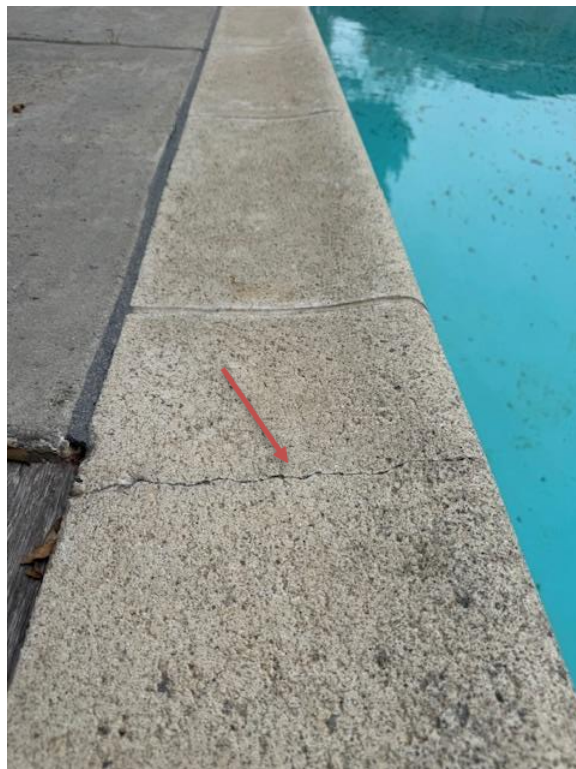
Coping Stone

Observation: Pre-Cast safety grip coping, is in good condition. There are a few hair line cracks in a few coping pieces but this is considered normal. Any cracks larger than the width of a dime coin would be a cause for concern, but all copings are in good condition.

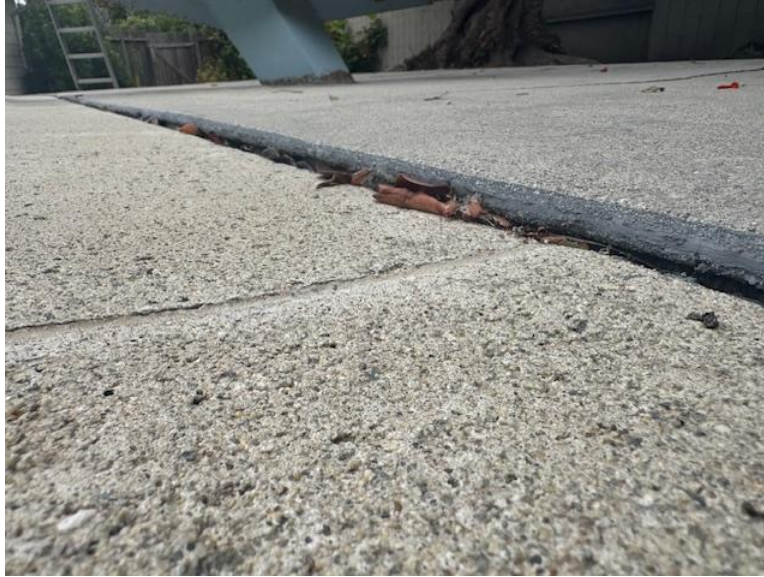
Expansion Joint

Observation: The expansion joint needs to be replaced. The deep end of the pool has a slightly higher deck which has created significant separation on the expansion joint.

Recommendation: Redo the expansion joint.

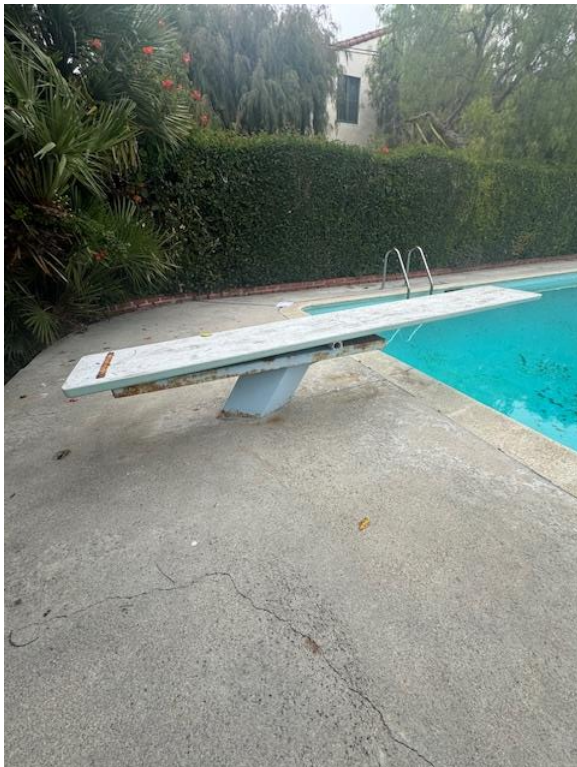
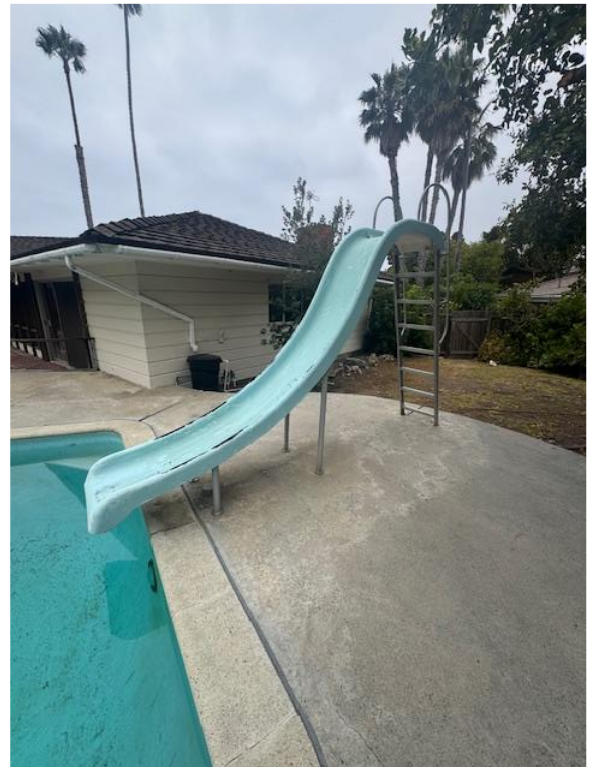
Diving Board/ Handrails, Slides

Observation: Diving board is in good condition. No stress cracks or damage to existing board or structure. The slide needs to be resurfaced.

Recommendation: None for diving board. The slide should be resurfaced as the fiberglass slide is showing wear. Contact Tim Cross with Cross Fiberglass Restoration – (310) 374-0393

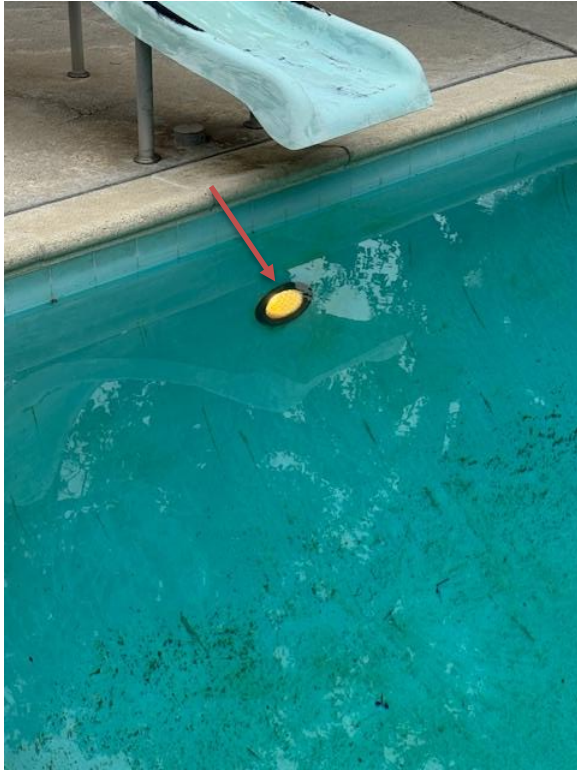
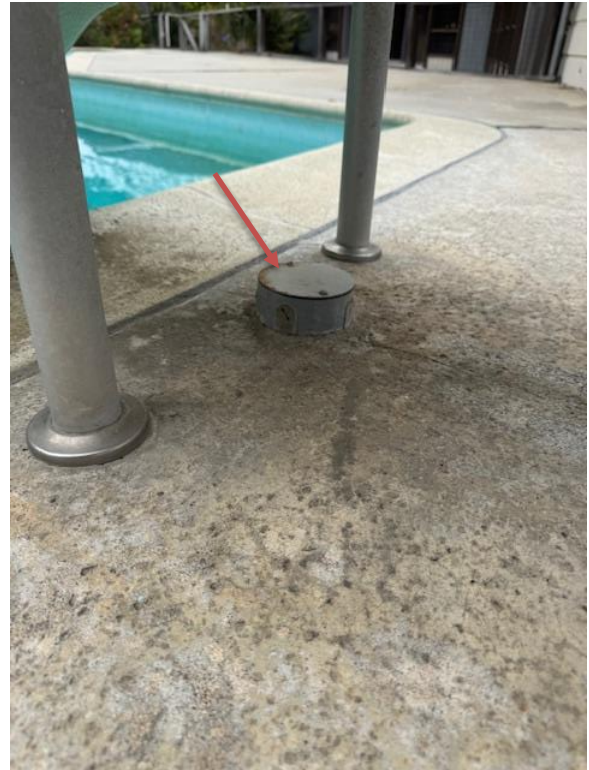
Swimming Pool Light

Observation: One American Products full sized light installed in pool. Light works but is not GFCI protected. The light has an older style “deck junction box”. Those junction boxes are no longer approved and unsafe.

Recommendation: Replace pool light with a new style LED light, eliminate deck junction box and run new conduit with proper junction box and GFCI to protect bathers.

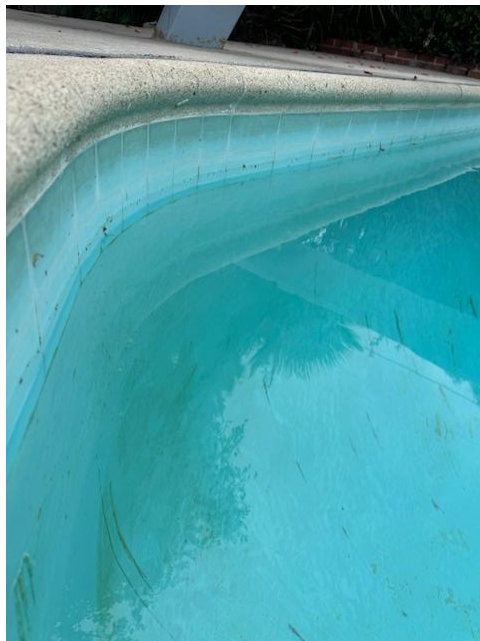
Observation: Porcelain tile throughout pool. Tile is in good condition.

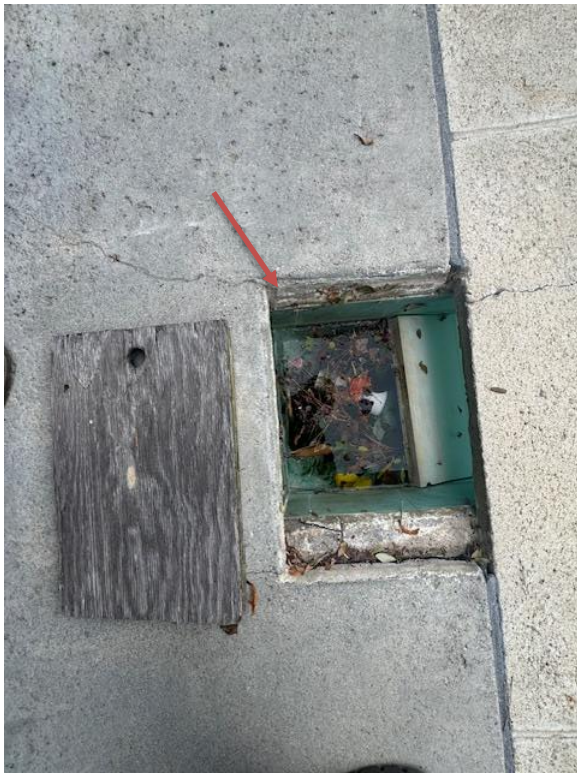
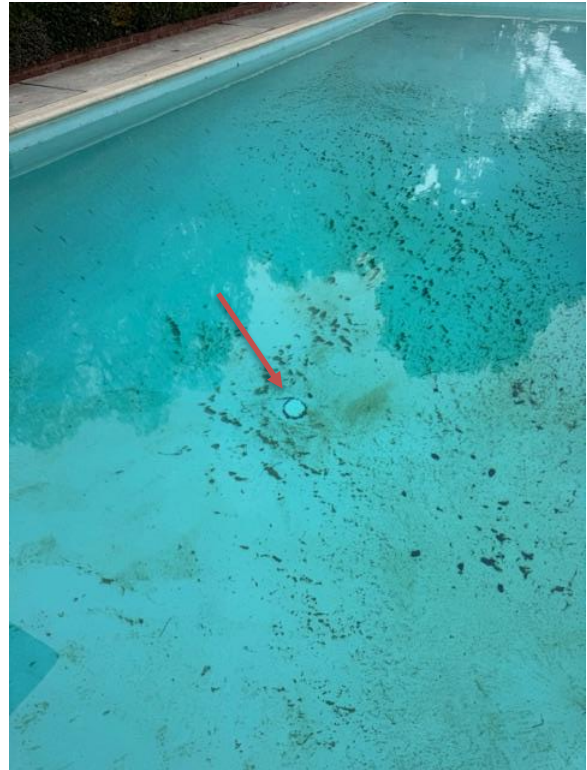
Skimmer & Main Drain

Observation: Swimming pool currently only has one main drain. This is no longer approved and should be corrected. Skimmer is an older cement style skimmer which are prone to leaking.

The Virginia Graeme Baker Pool and Spa Safety Act (VGBA) is a United States law named after Virginia Graeme Baker, who died after sustaining a pool suction-drain injury in June 2002, when the suction from a spa drain entrapped her under the water. It is incorporated as Title 14 of the U.S. Energy Independence and Security Act of 2007 (EISA Title 14, Pub.L. 110-140). This act became enforceable law on December 19, 2008.

Recommendation: Drain pool and add a dual drain to meet VGB Act. Replace skimmer.

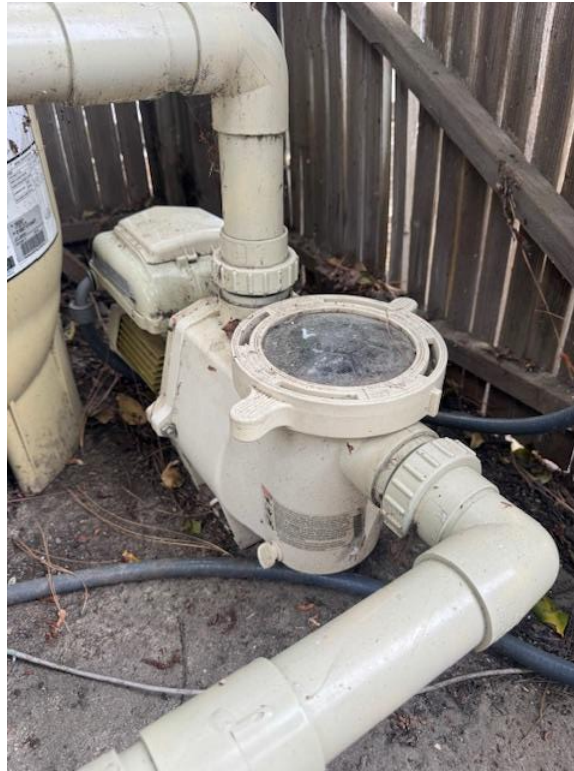
Pump/ Motor

Observation: 2024 Pentair Whisperflow VST in great working condition. Pump is not currently bonded.

Recommendations: Bond pool pump.

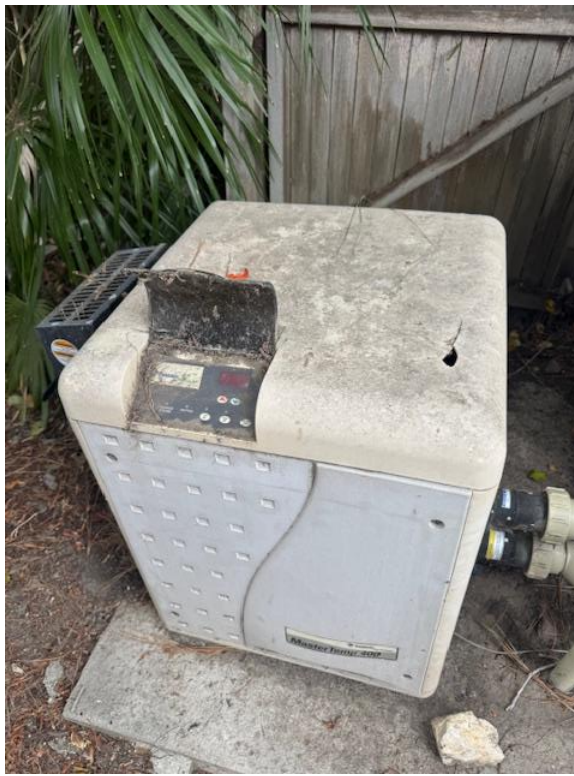
Heater

Observation: 2011 Pentair MasterTemp not working. Does not turn on and based on the age, not worth repairing.

Recommendation: Replace heater with new unit.

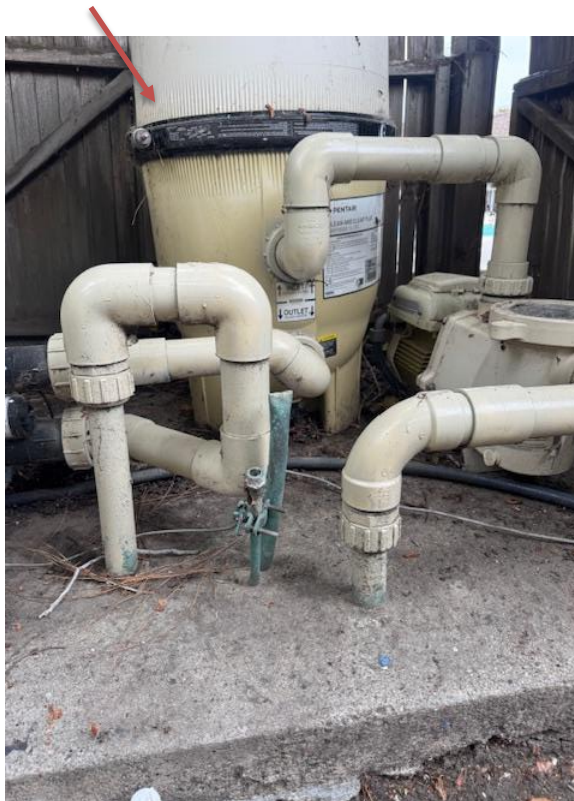
Filter

Observation: 2021 Pentair Clean and Clear filter is working in good condition.

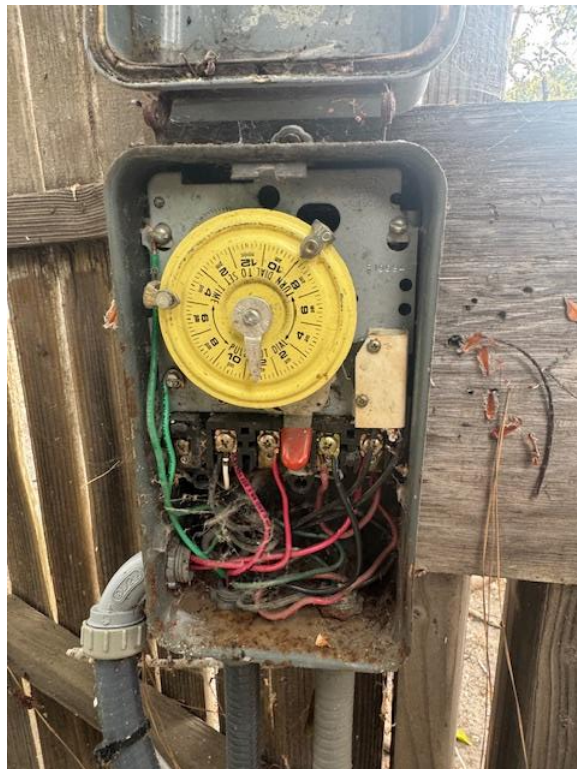
Time Clock / Control Panel

Observation: Paragon older style timer. In good working condition.

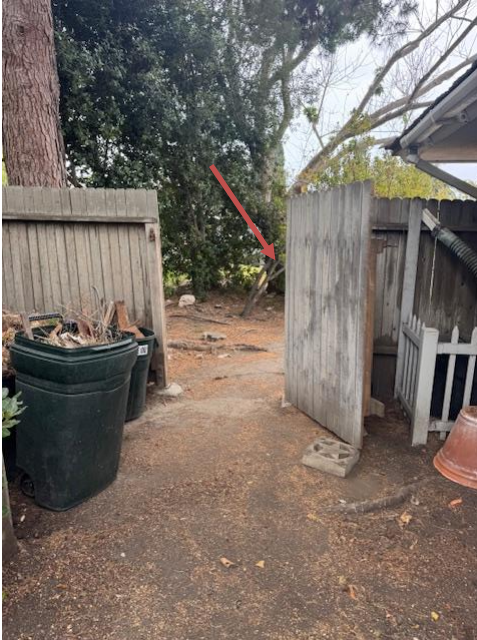
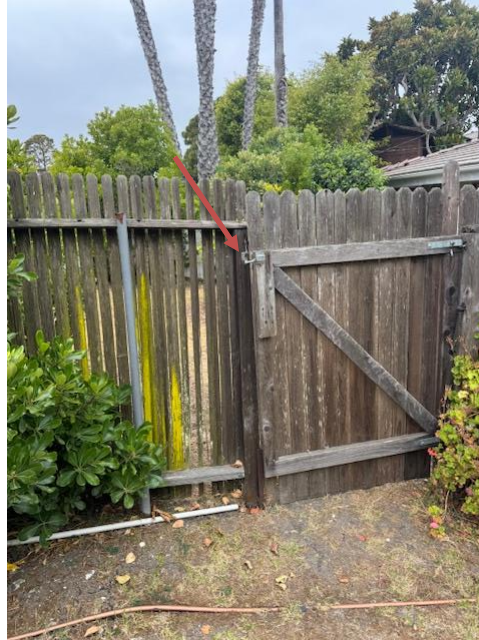
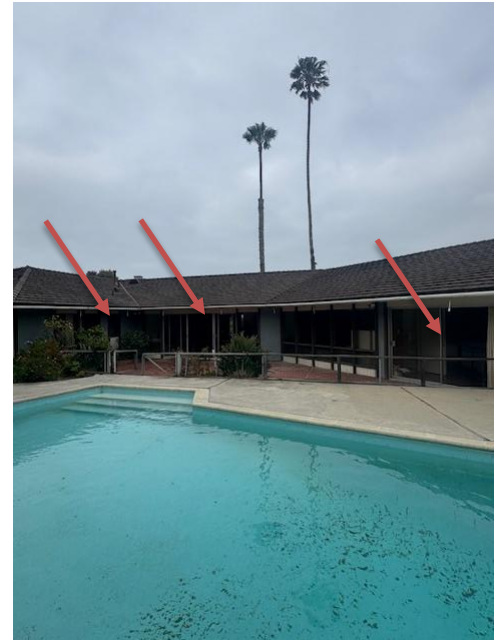
Safety Fence/ Net/ Gates

Observation: All gates leading to the pool are not safe. The left side wood gate opens inward, does not self close or self latch. The right side wood gate opens inward, does not self close or self latch. The two rear home glass sliders do not have alarms and the wood door leading from the home to the pool does not have an alarm.

Recommendation: Contact a fence company to correct wood gates and add alarms to all doors leading to the pool. Contact one of the two companies below to add a fence around the pool.
