Inspection reference: 401 Yarmouth Rd, PVE, CA 90274

Confidential Inspection Report
401 Yarmouth Rd.
Palos Verdes Estates CA 90274

May 12, 2026

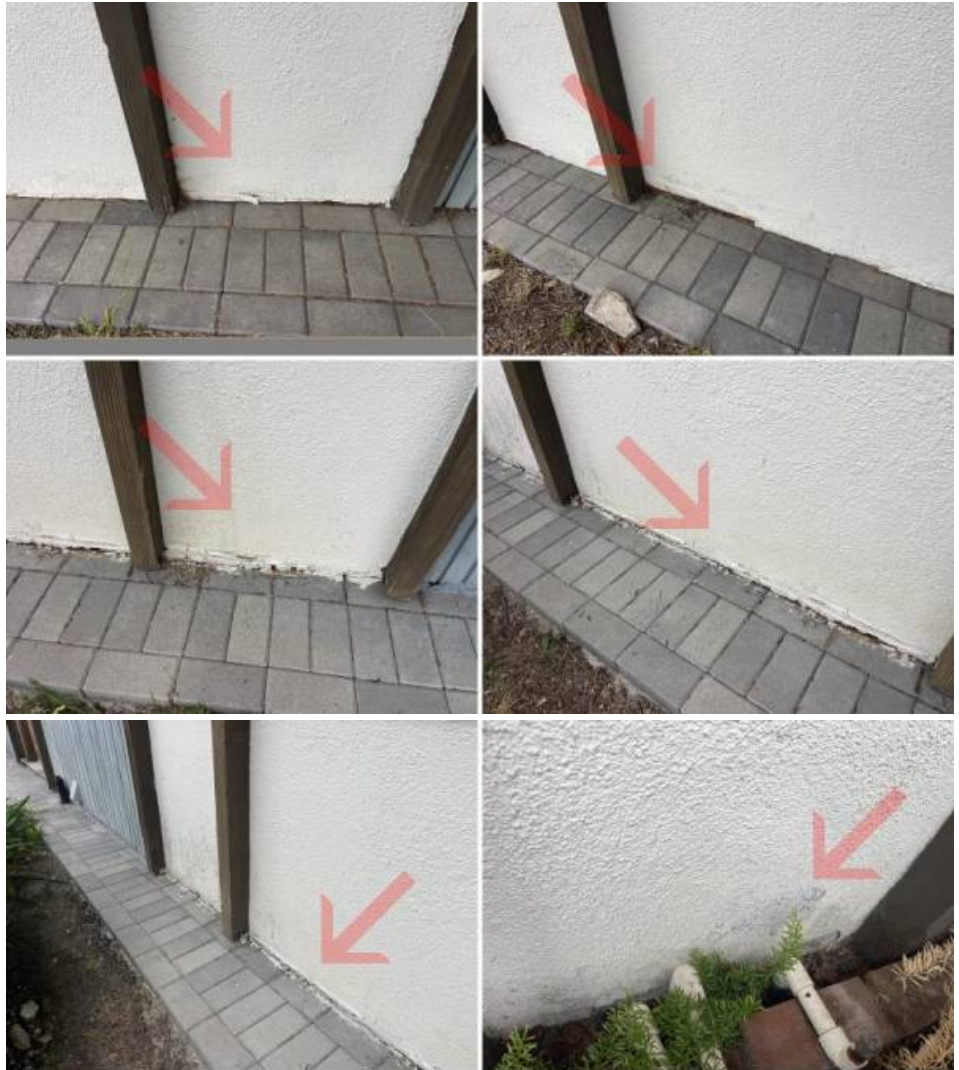
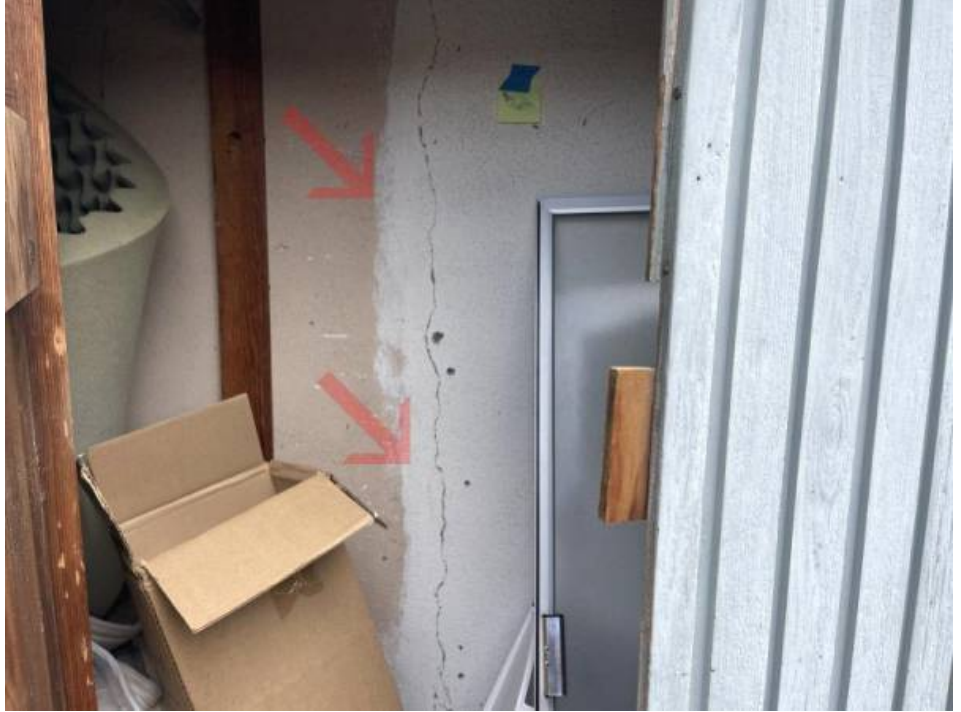
Stucco

MAINTENANCE: Some cracked or damaged stucco viewed. We recommend further evaluation and repairs as needed at this time to protect against moisture intrusion and to enhance the structure's appearance.

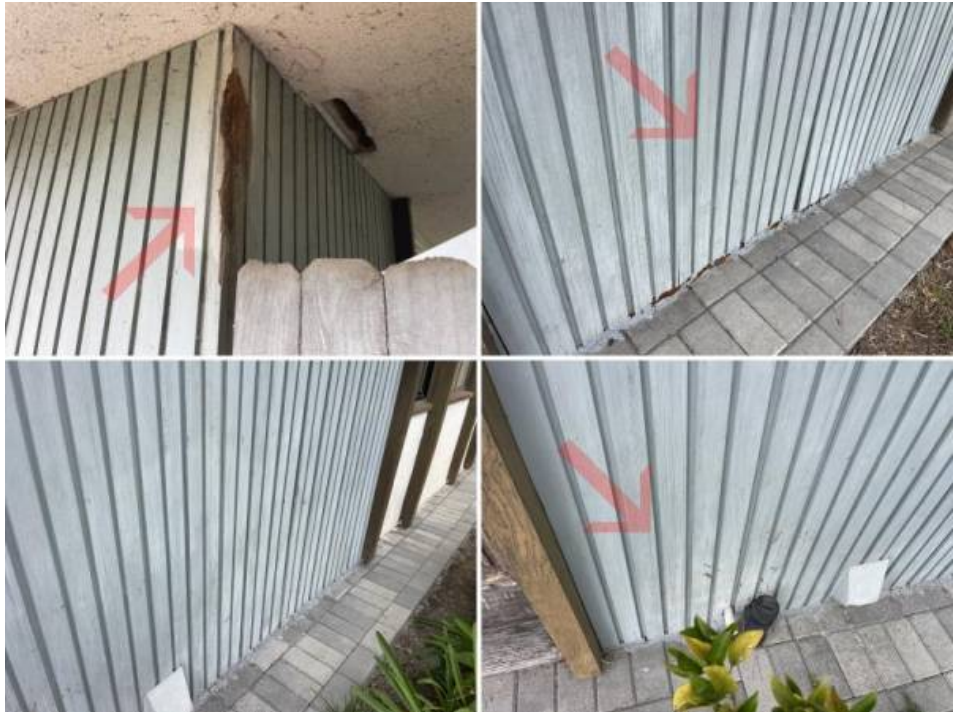
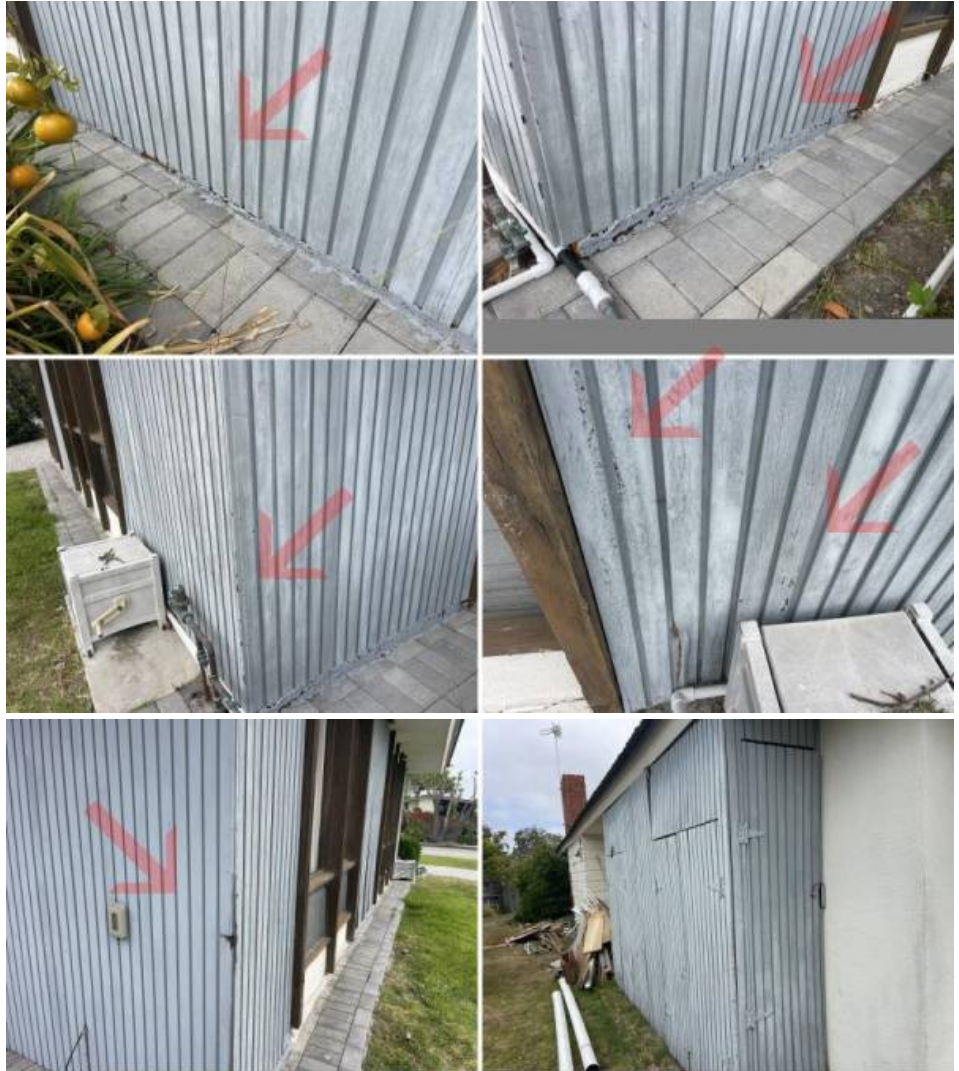
Siding

MAINTENANCE: Some loose or broken boards.

MAINTENANCE: Some loose or peeling paint viewed. We recommend painting at this time to protect the wood from further deterioration and to enhance its appearance.

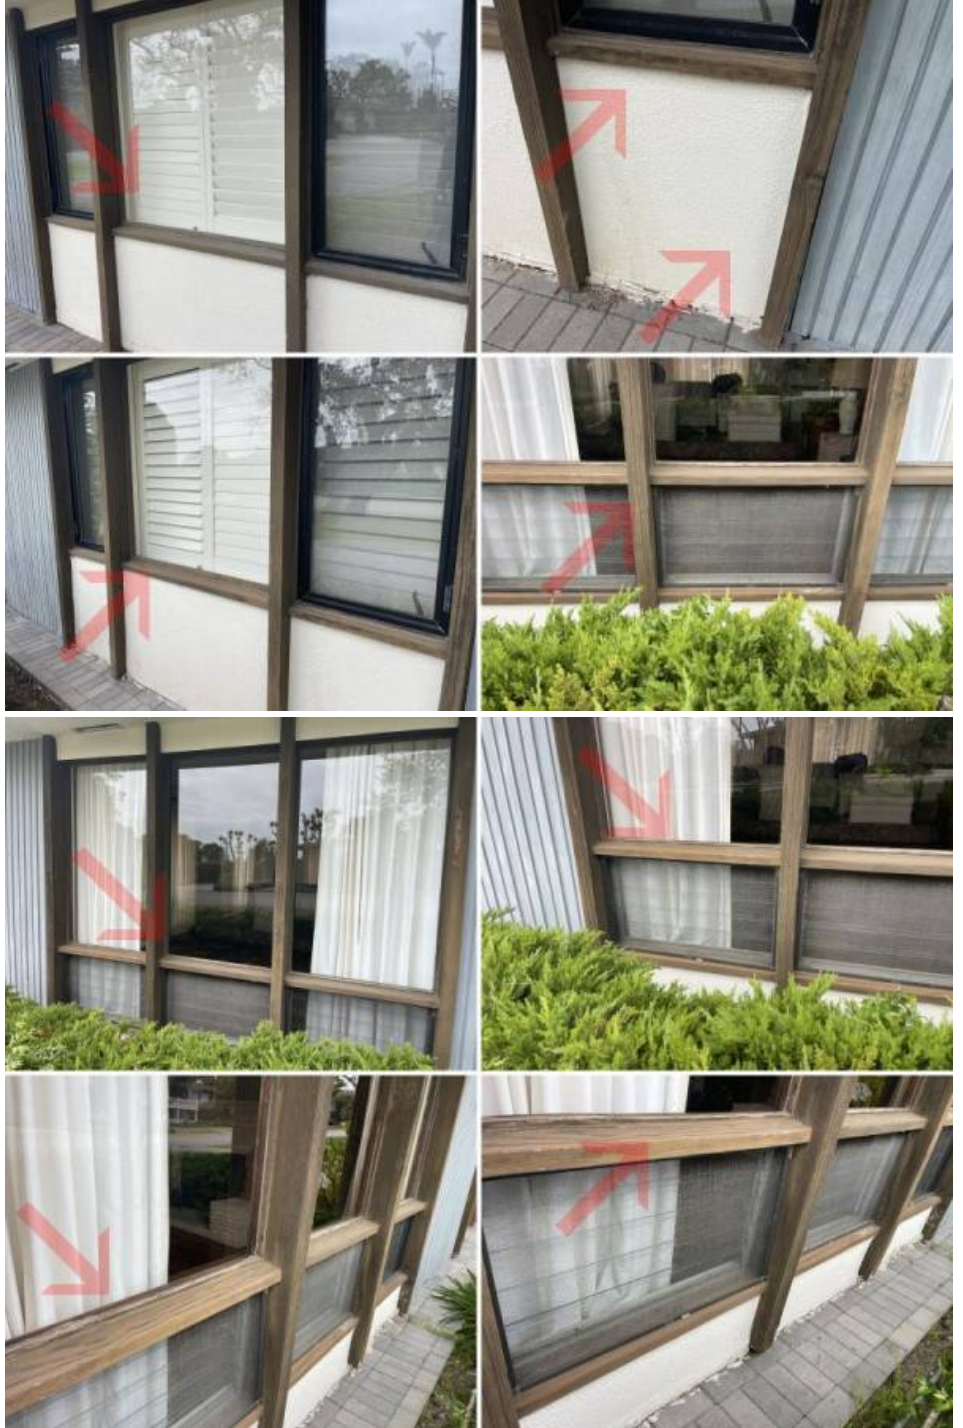
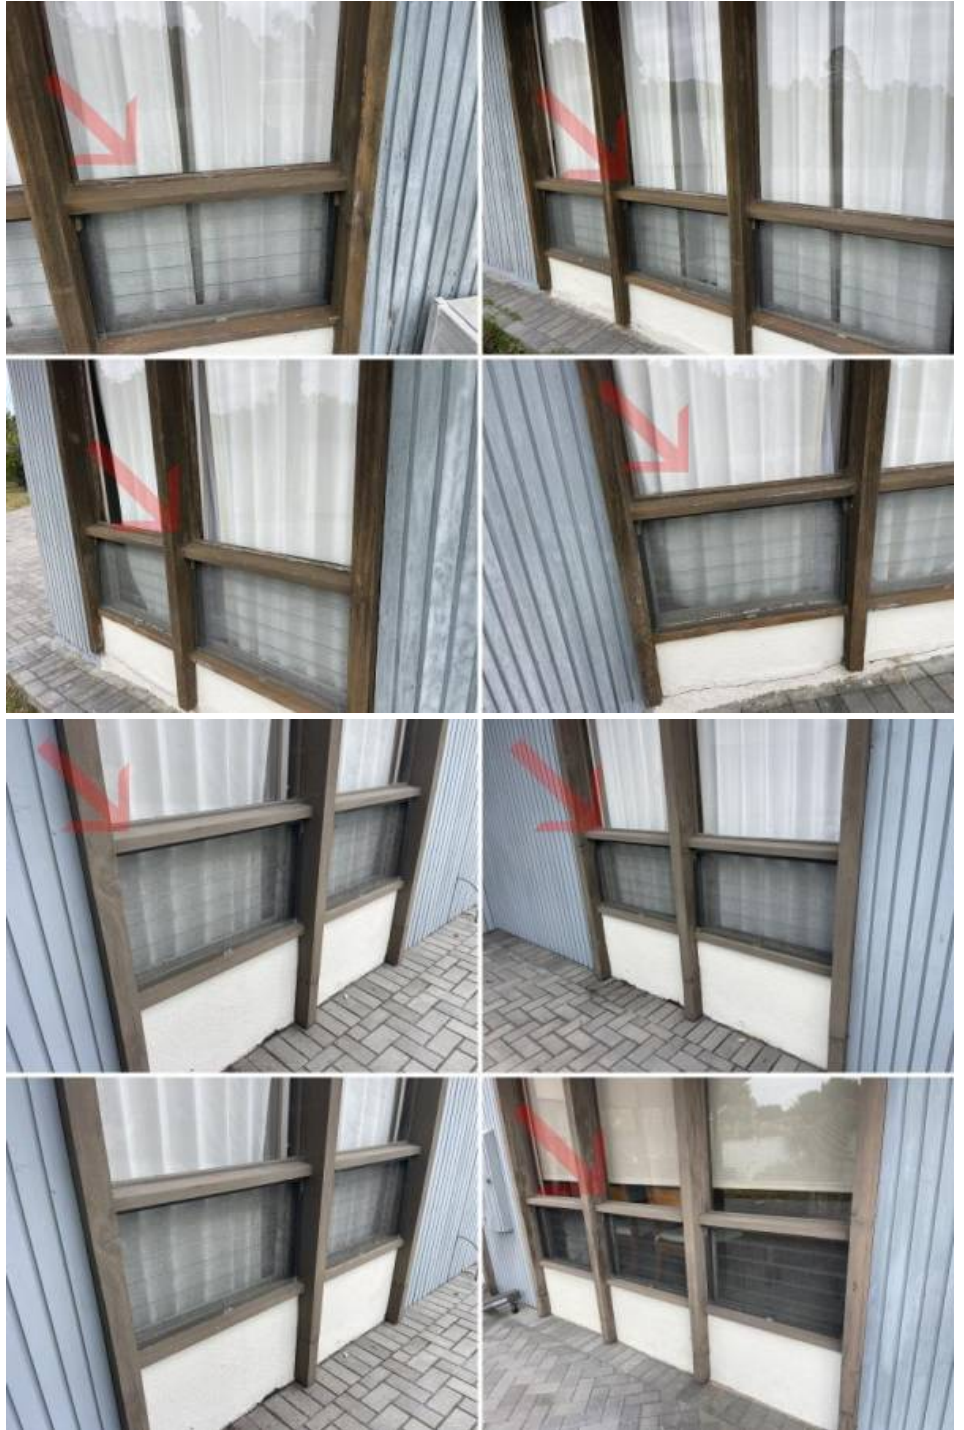
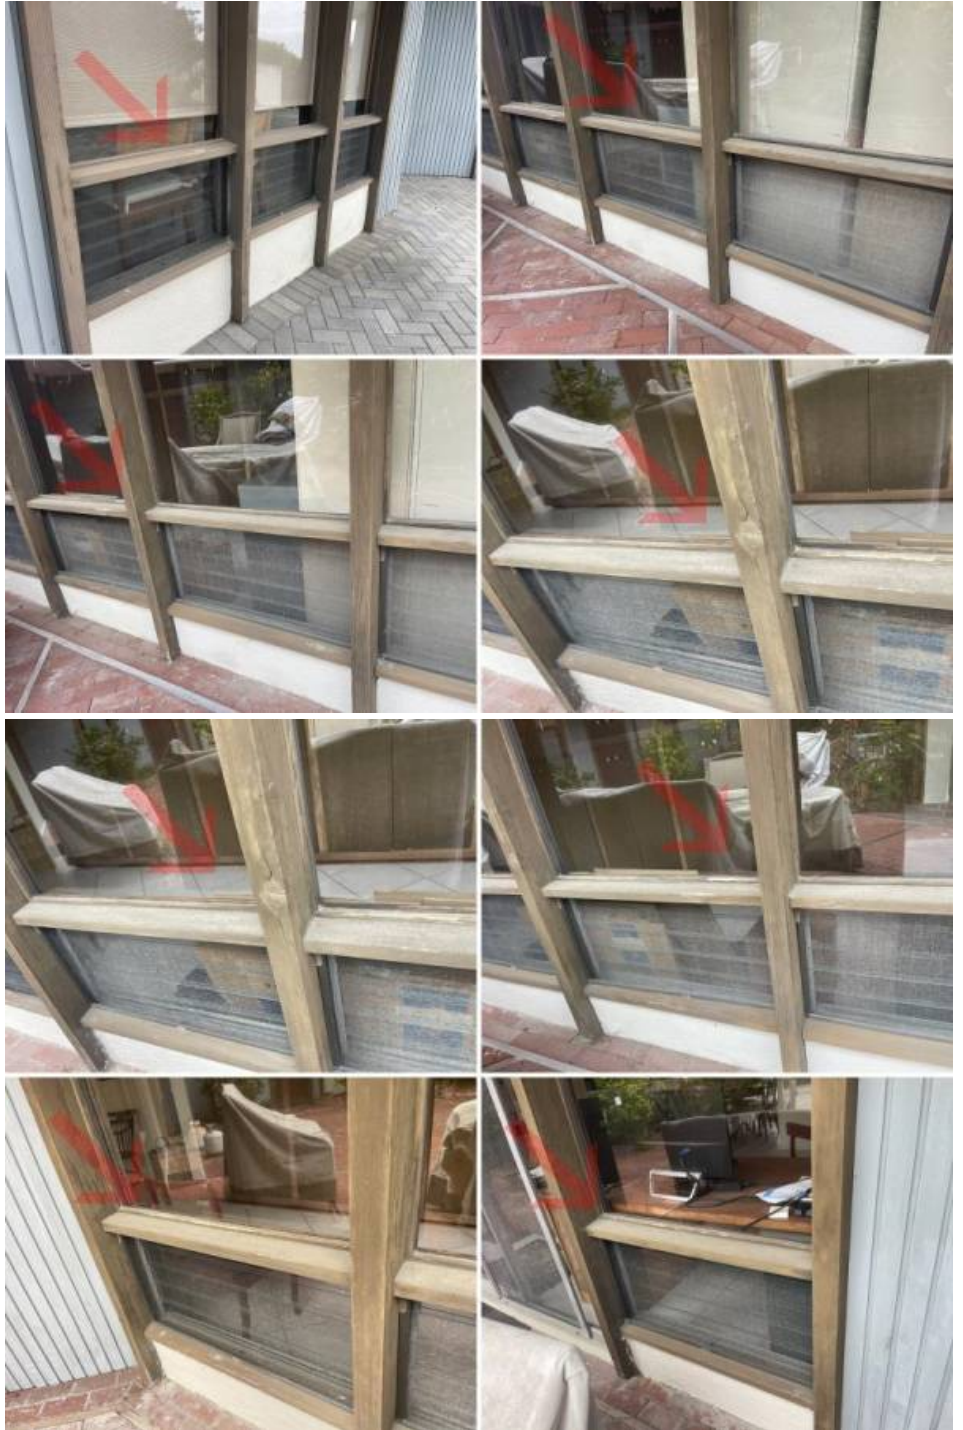
DEFERRED: Rot/insect damage viewed one or more locations.

MAINTENANCE: Paint is deteriorated, loose or peeling. We recommend painting at this time to protect the wood from further deterioration and to enhance its appearance.

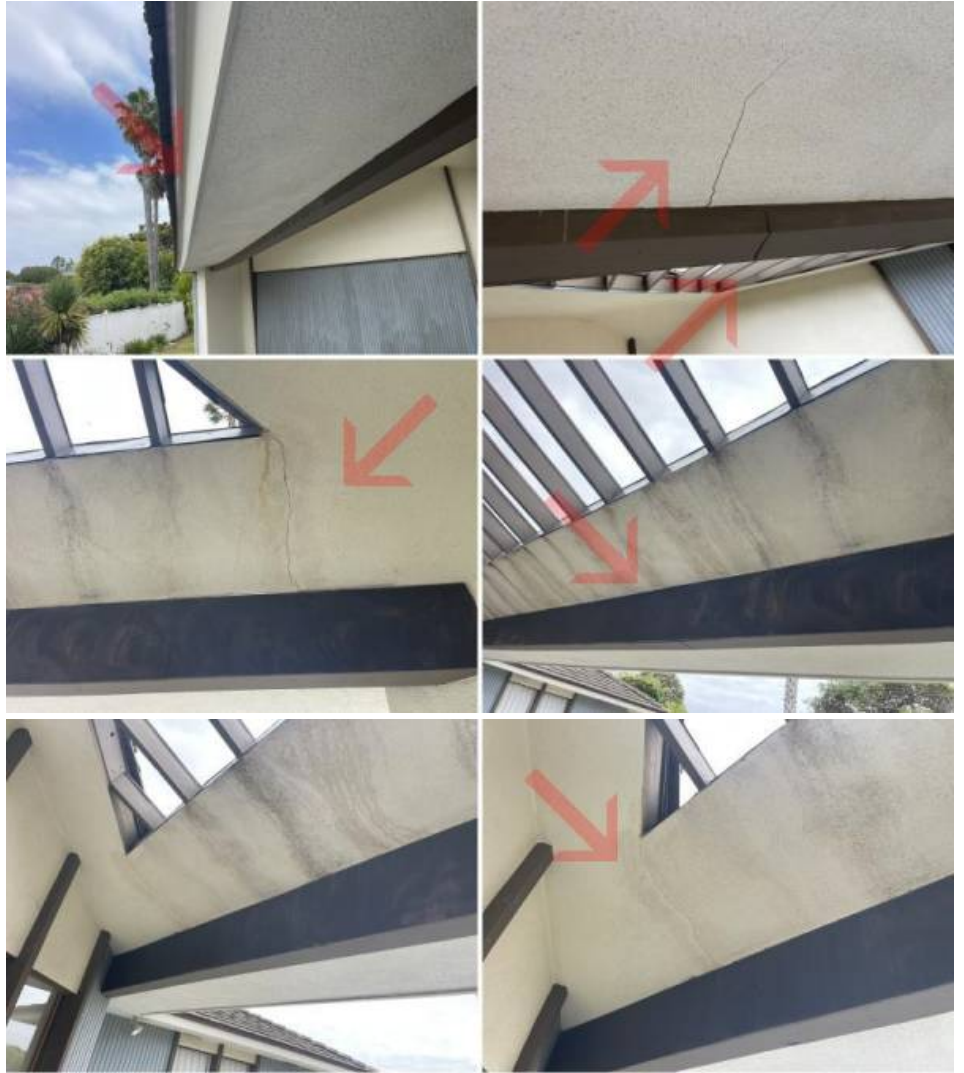
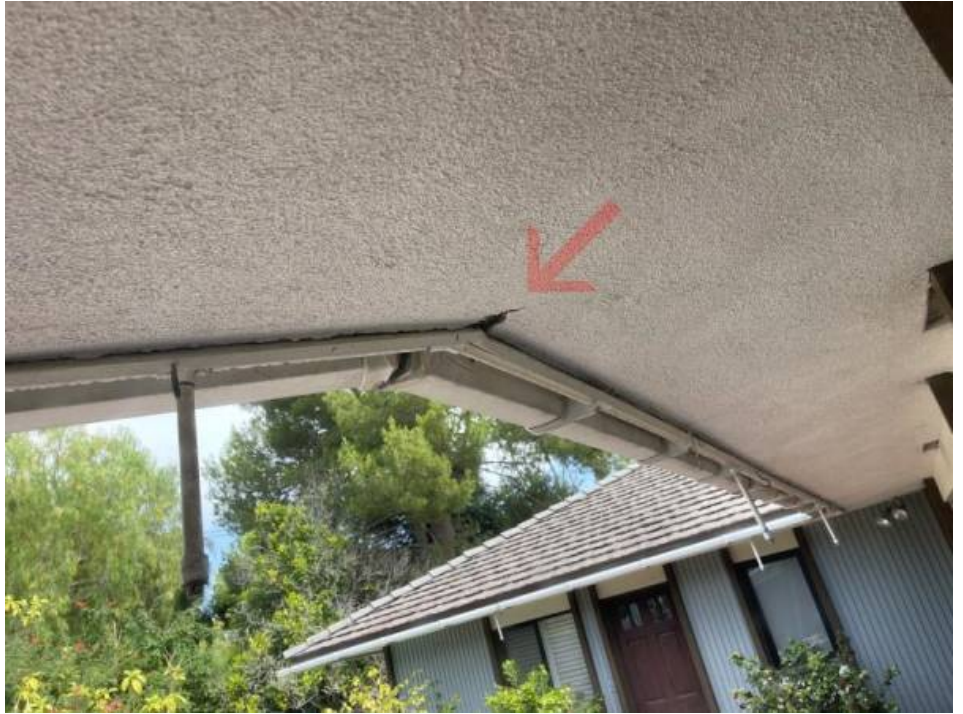
Eaves

Garage overhang is sagging.
DEFERRED: The support beam is split and sagging. Some repairs were made.
Overhang is still sagging. Recommend further inspection and repairs as needed.
Small crack at rear patio.

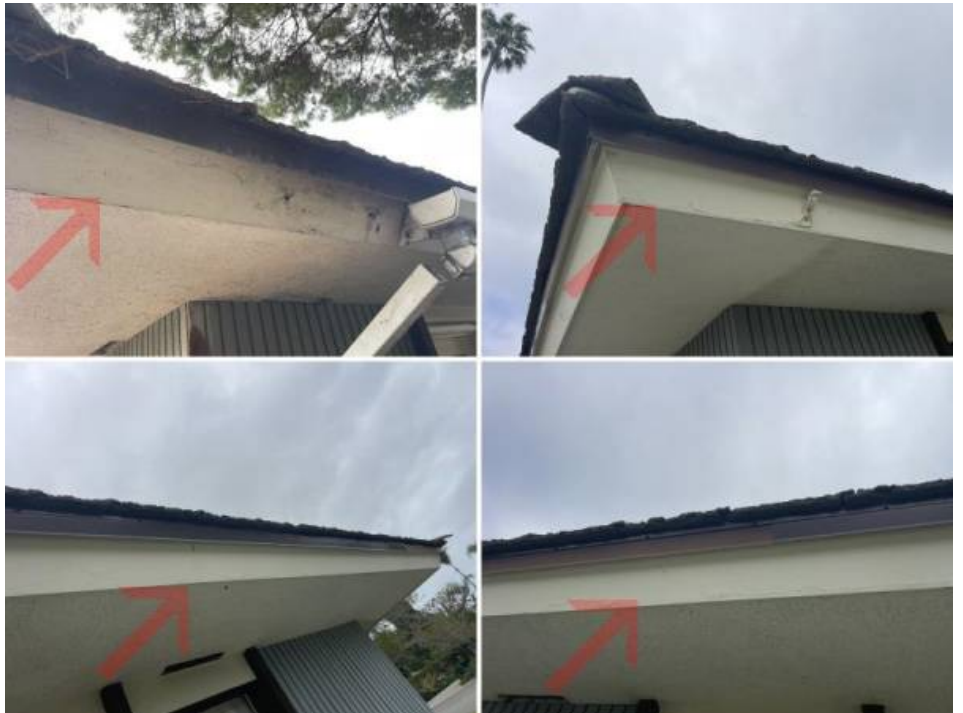
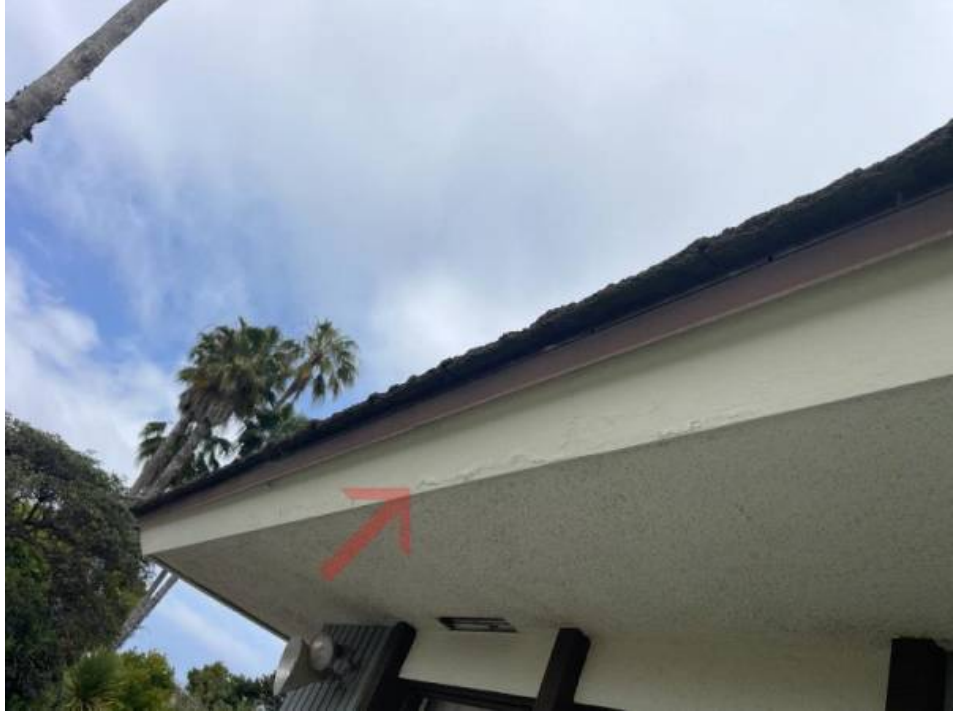
Fascias

MAINTENANCE: Paint is deteriorated, loose or peeling. We recommend painting at this time to protect the wood from further deterioration and to enhance its appearance.

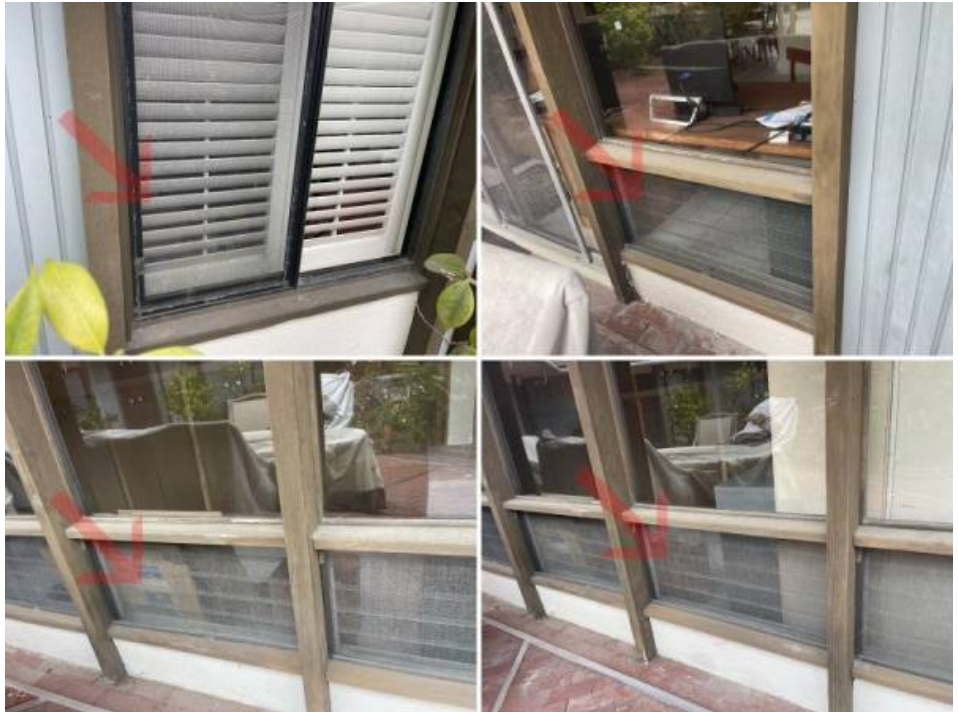
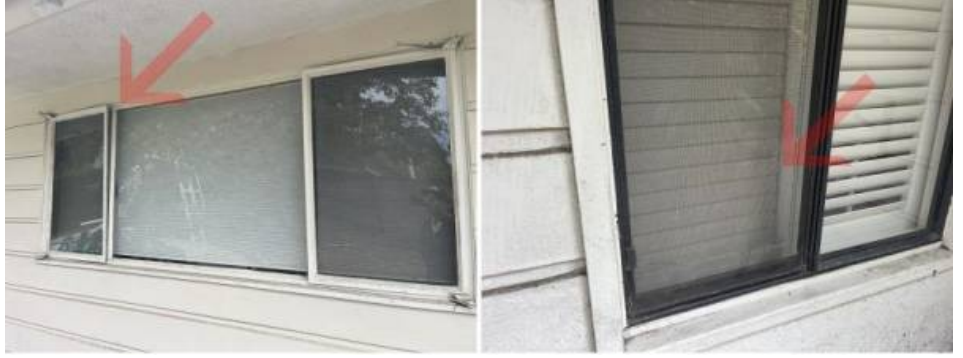
Many lower louver window screens.
MAINTENANCE: Screen was damaged at one or more windows sampled.

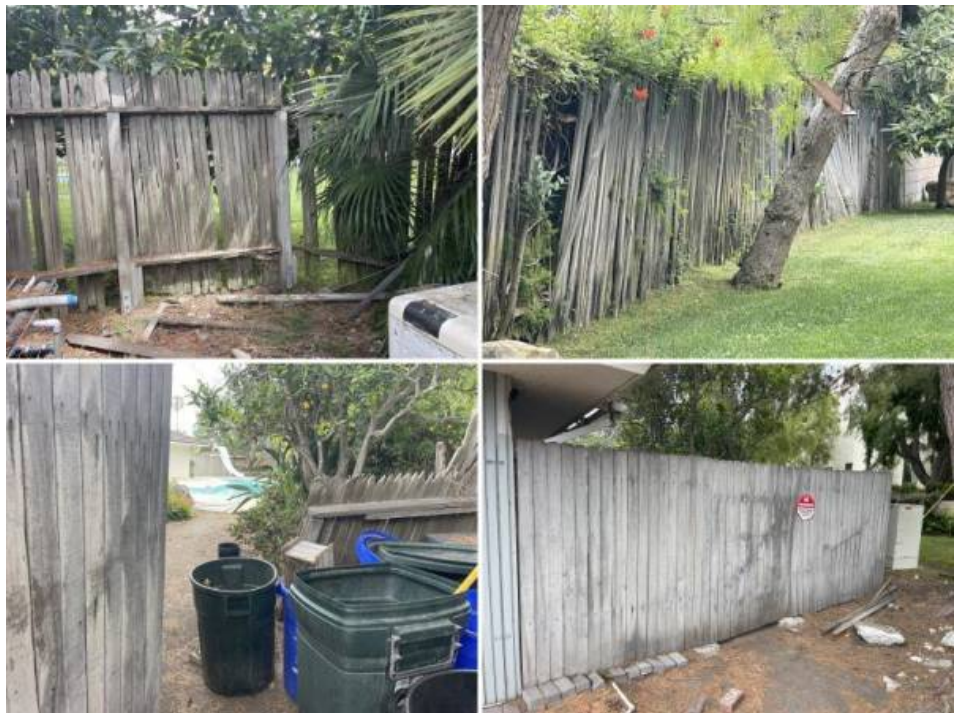
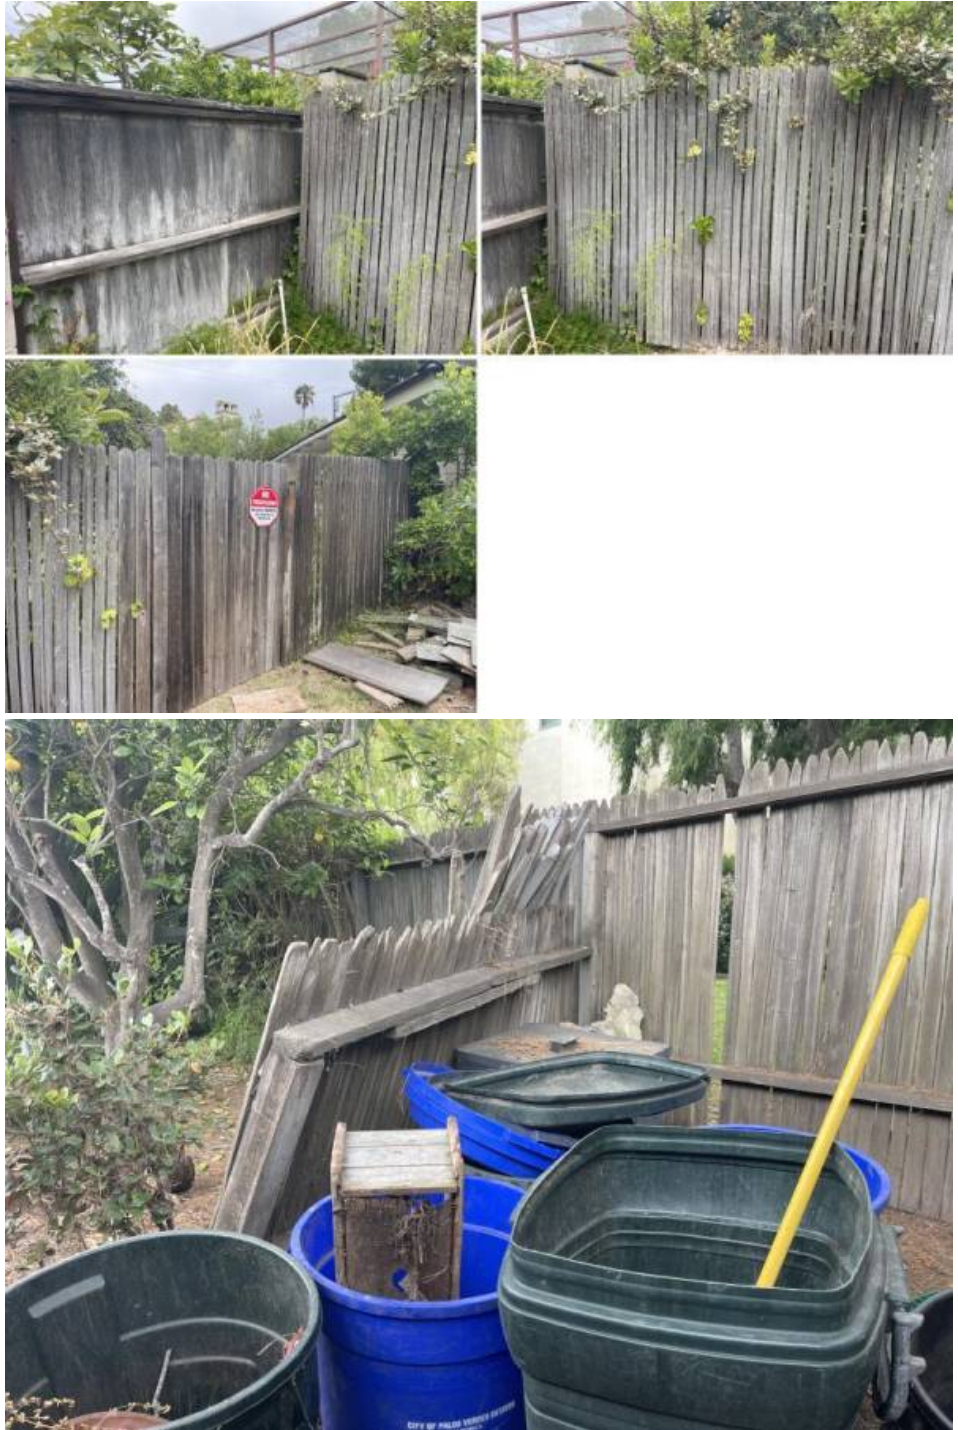
DEFECTIVE: Inadequate swimming pool safety barriers. Gates should swing away from the pool/spa area, be self closing and latching with the latches located out of reach of small children. We strongly recommend checking with the local building department for specific requirements in this area and corrections as needed.

DEFECTIVE: Gates are in deteriorated condition and needs repair or replacement.

DEFERRED: Fence is in overall poor condition and will require extensive repairs or replacement.

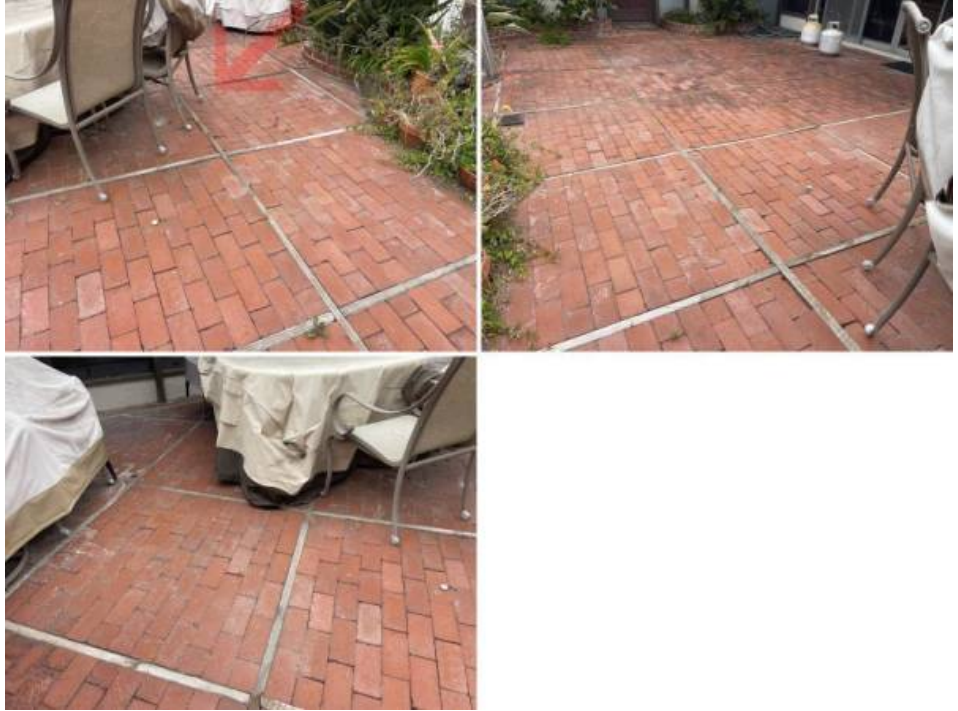
SAFETY: Missing/damaged spacer resulting in trip hazard. We recommend repairing trip hazards whenever they occur.

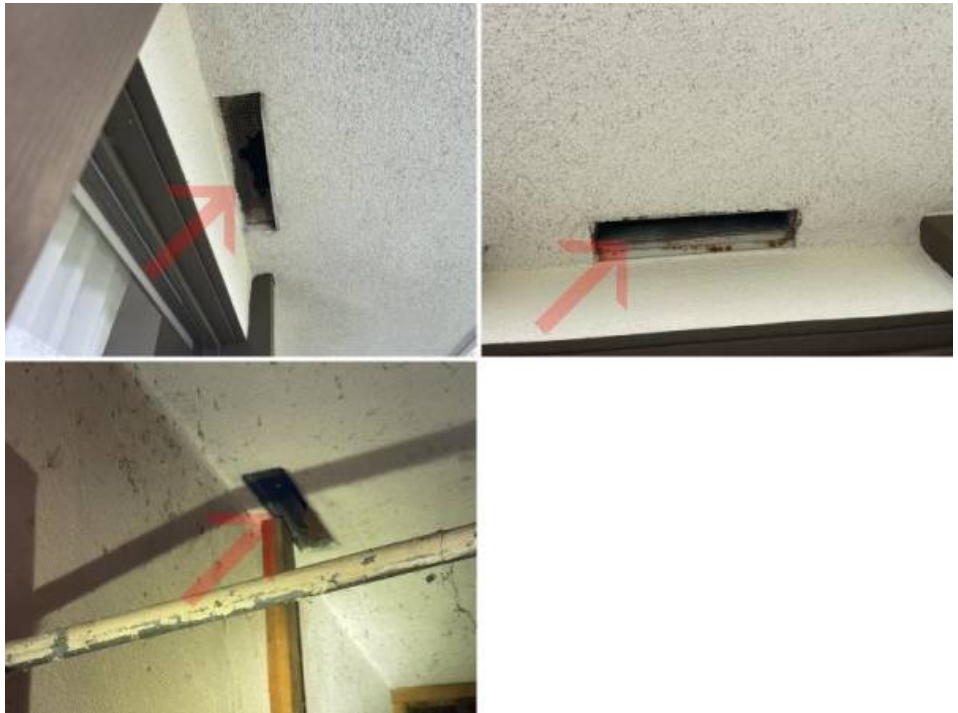
MAINTENANCE: Ventilation screens are damaged or missing at one or more locations. Attic space should be well ventilated to remove excessive moisture and heat, which can have an adverse affect on framing members, reduce the life expectancy of roofing materials, compress insulation reducing its efficiency and create an environment favorable for mold and mildew. We recommend repairing or replacing ventilation screens to prevent rodents, insects or birds from entering and to allow for proper air circulation.

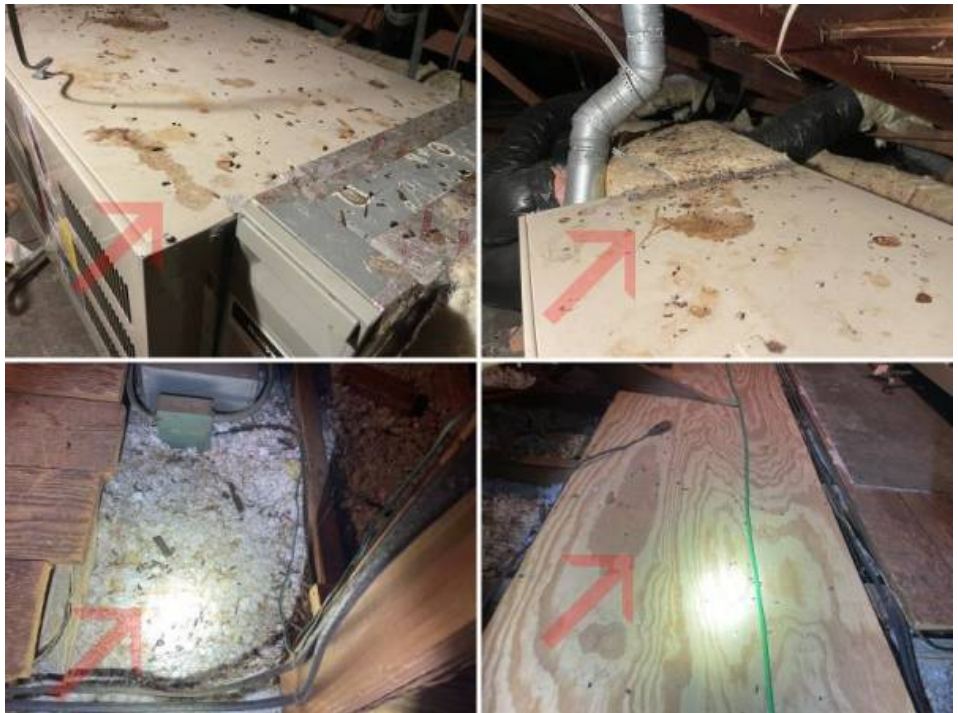
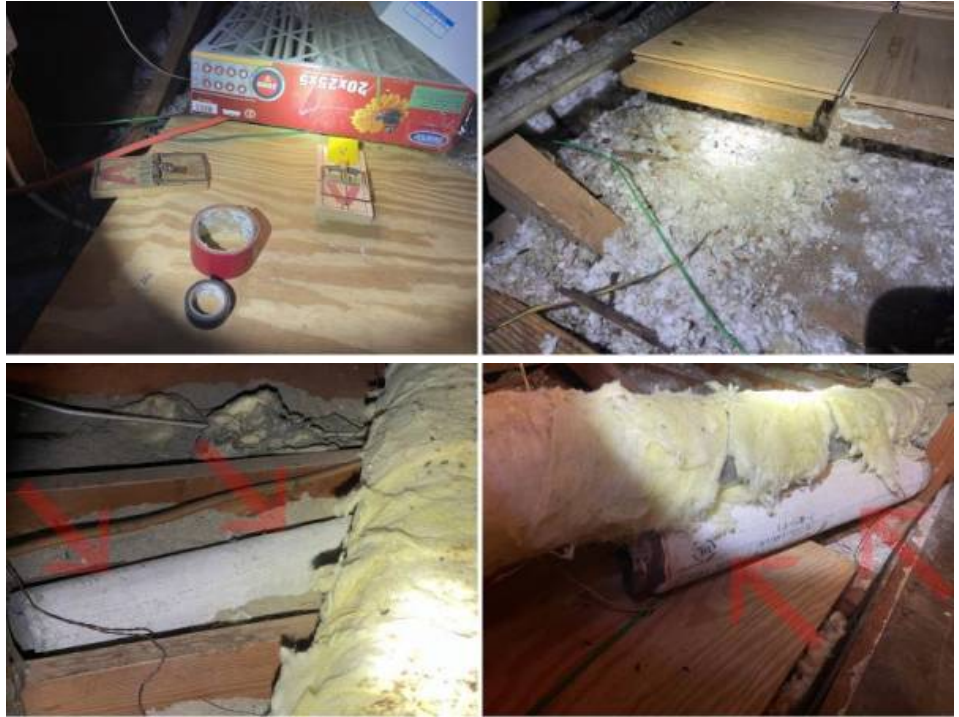
SAFETY: Droppings or other evidence of rodents viewed. Recommend further inspection and insulation may need to be replaced.

SAFETY: Possible asbestos vent pipe(s) observed. This type of material is known to contain asbestos and will need special handling if removed or repaired.

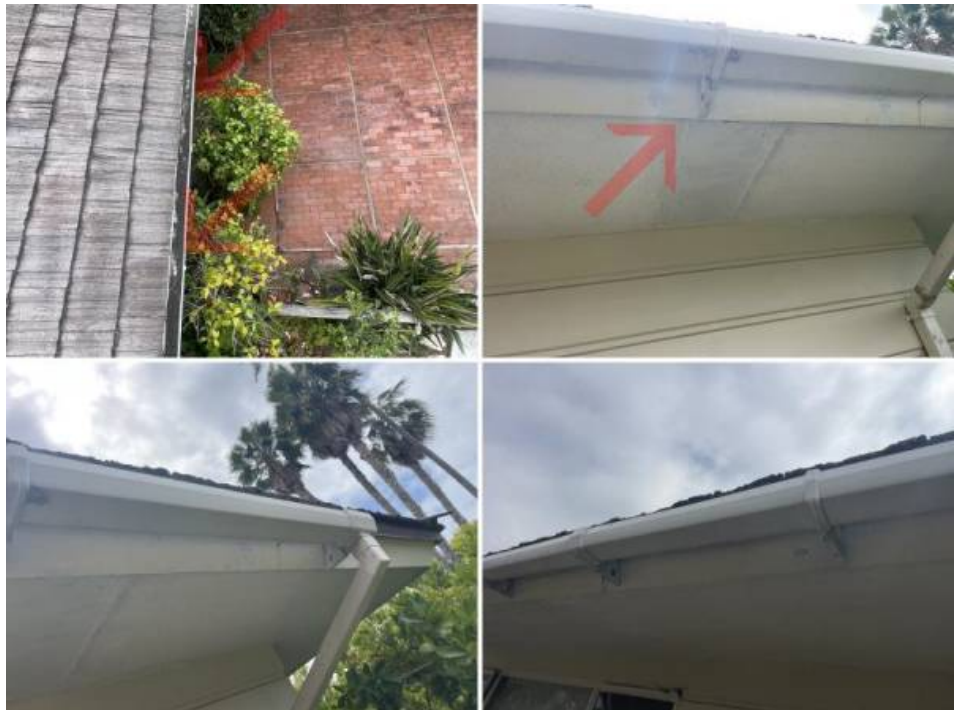
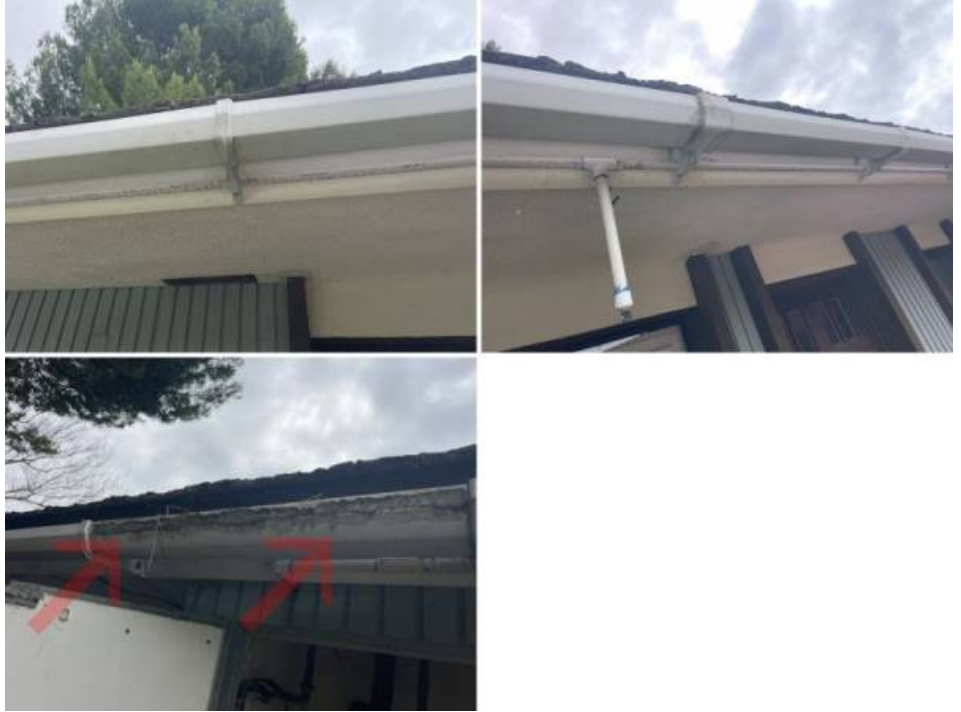
MAINTENANCE: We recommend installing rain gutters to control/divert roof runoff water away from the foundation.

DEFERRED: Gutters are repaired on north side.

MAINTENANCE: Debris noted in the gutters. We recommend cleaning the gutters now and prior to each rainy season and periodically as needed.

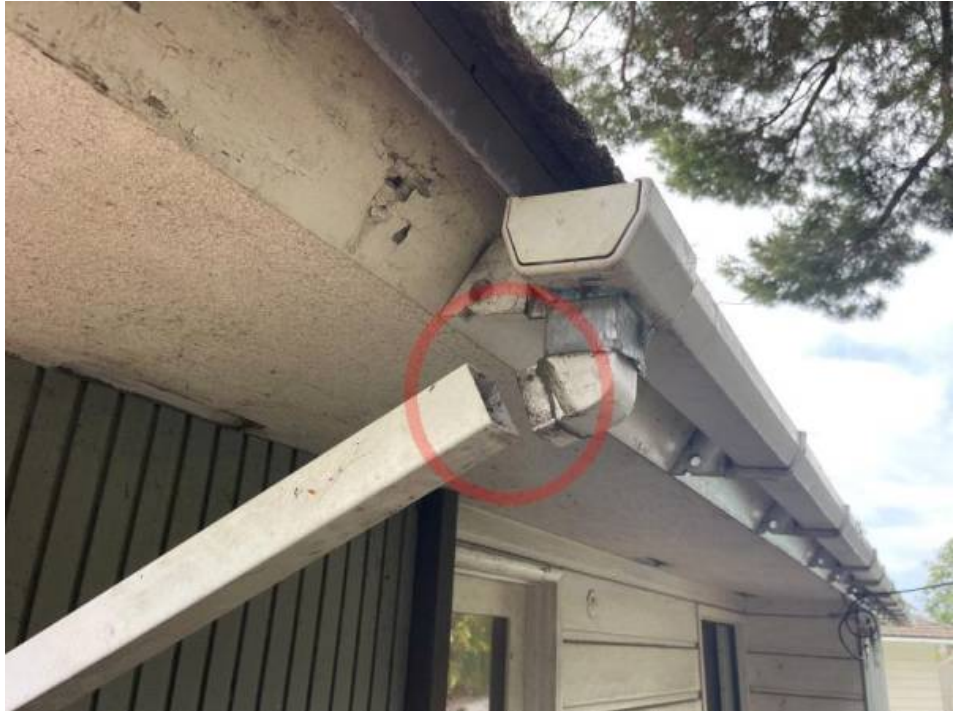
Downspouts

Disconnected at N east corner.
DEFECTIVE: Downspout damaged at one or more locations.

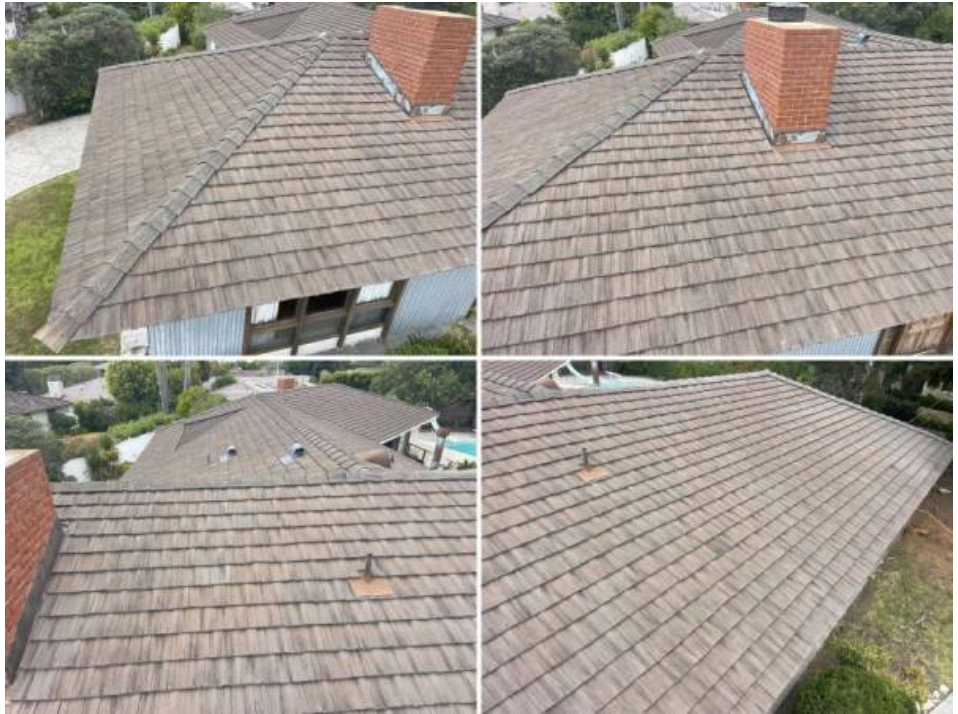
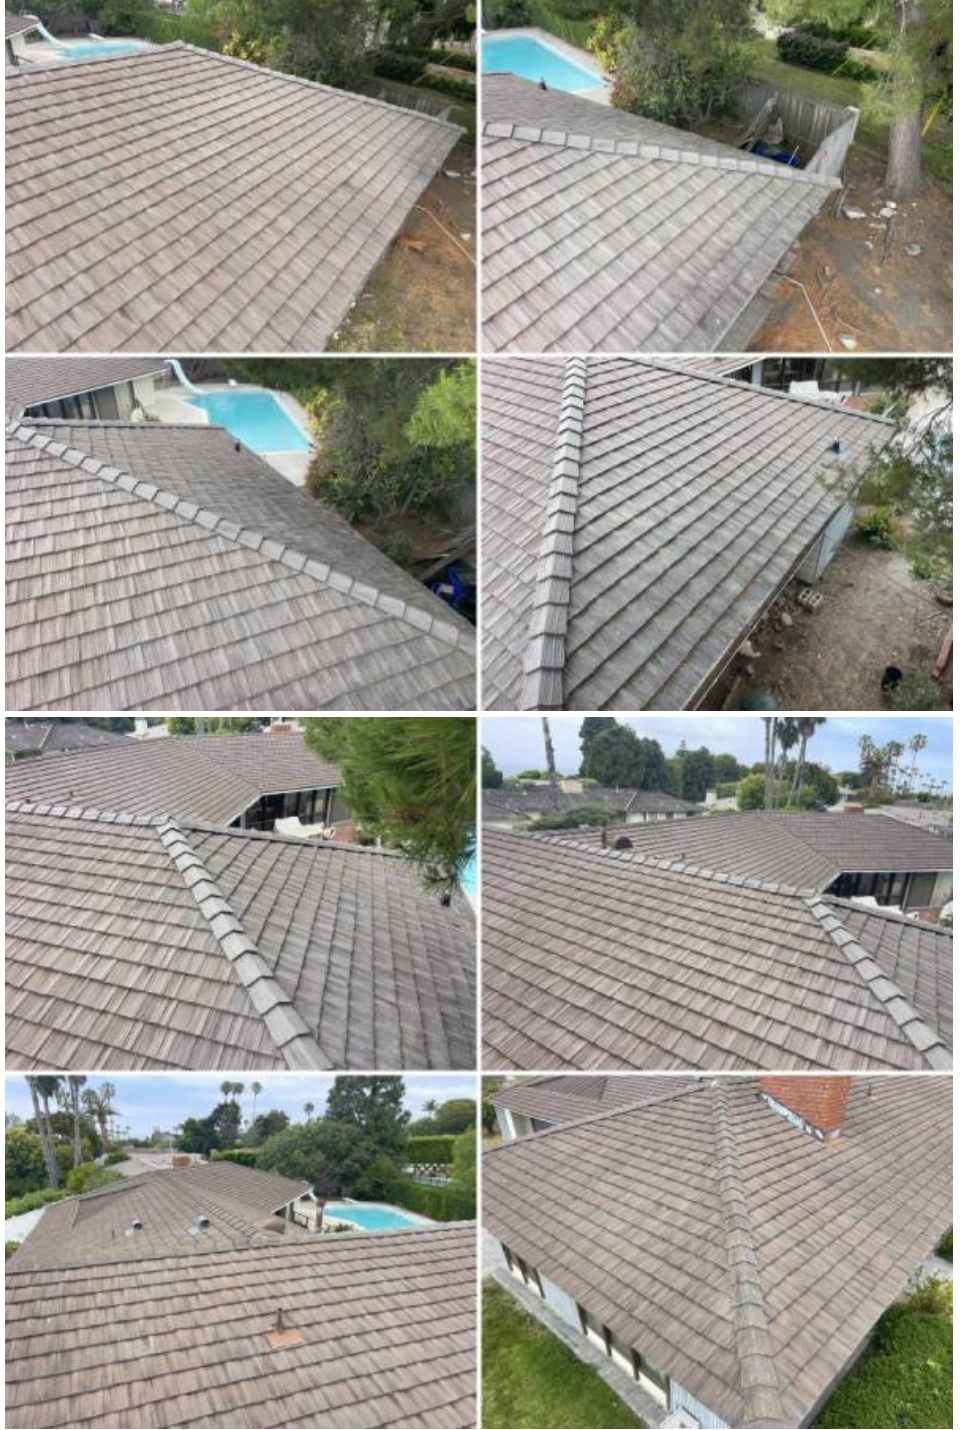
Cracked and chipped tiles viewed. North side.

DEFECTIVE: Some broken/cracked or loose tiles observed. Tiles protect the waterproof membrane from exposure to damaging UV rays and broken or loose tiles may fall causing injury to persons or property. We recommend further evaluation and repairs as needed by a licensed roofer at this time.

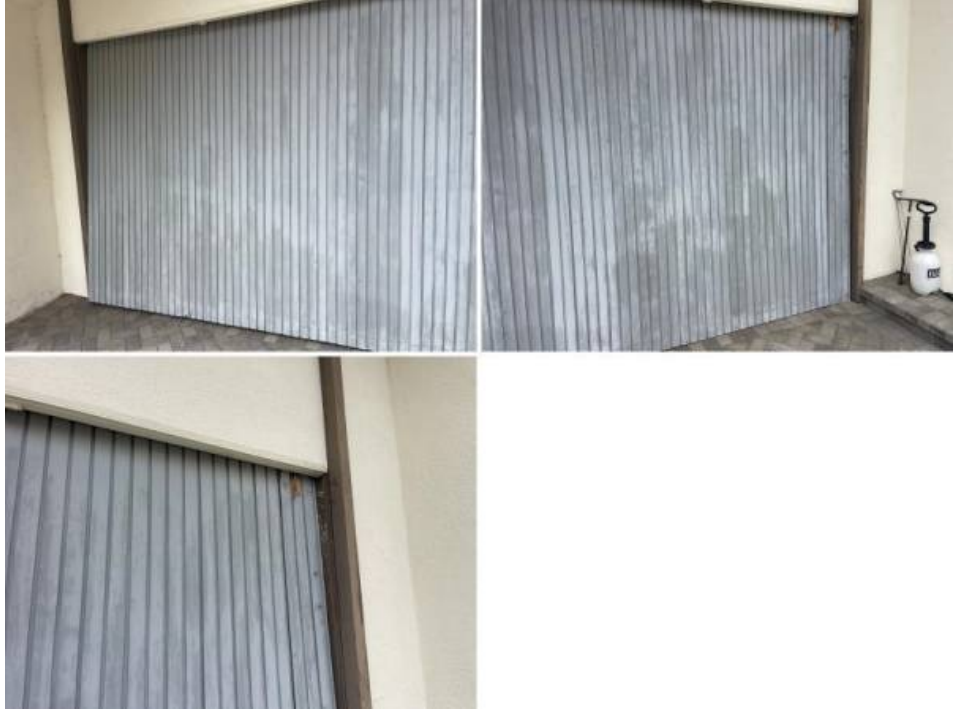
MAINTENANCE: Door is damaged, does not appear to affect operation.

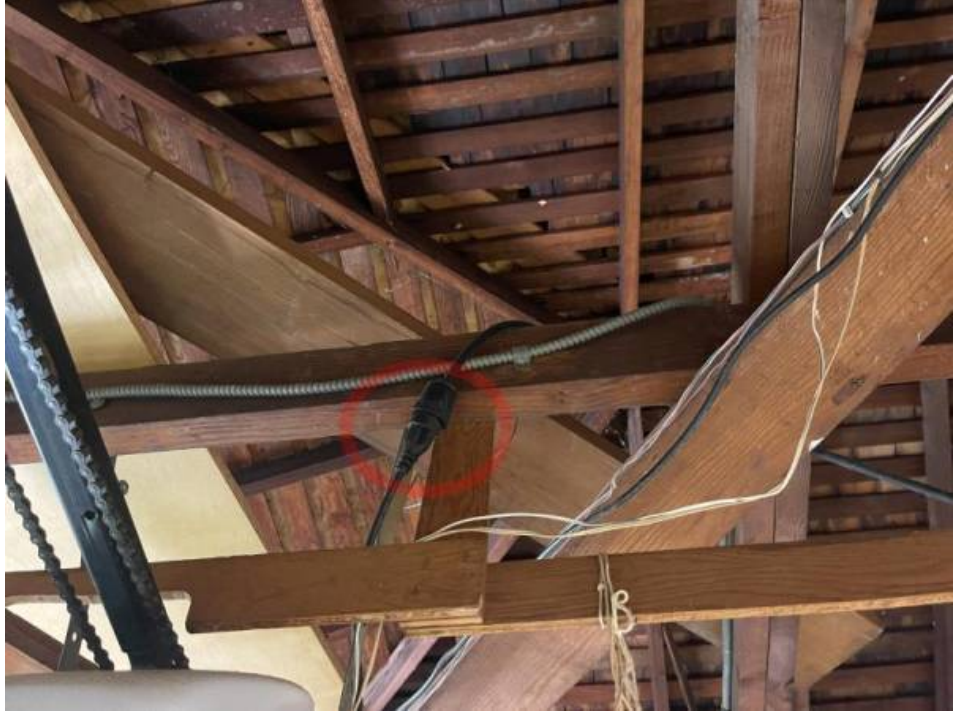
DEFECTIVE: Opener is plugged into an extension cord. Permanently plugged in devices should have an outlet within reach of the appliance's cord.
