Inspection reference: 401 Yarmouth Rd, PVE, CA 90274

Confidential Inspection Report
401 Yarmouth Rd.
Palos Verdes Estates CA 90274

May 12, 2026

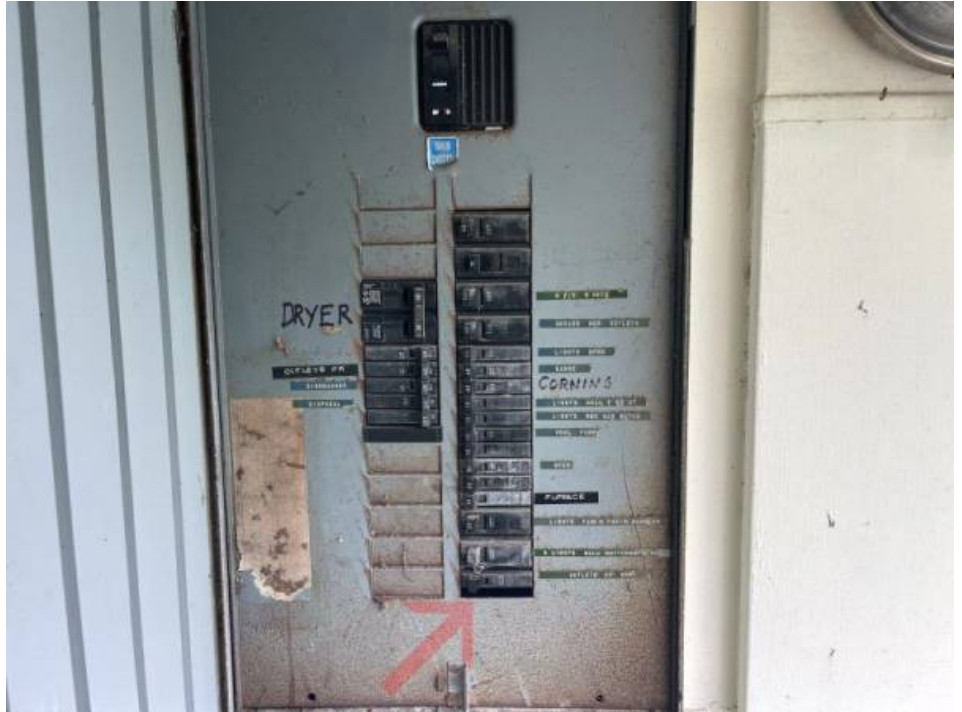
| <i>Panel observations, exterior</i> | SERVICEABLE. Small gap. DEFECTIVE: Unused openings in the panel are missing covers and exposing energized parts to accidental contact. |

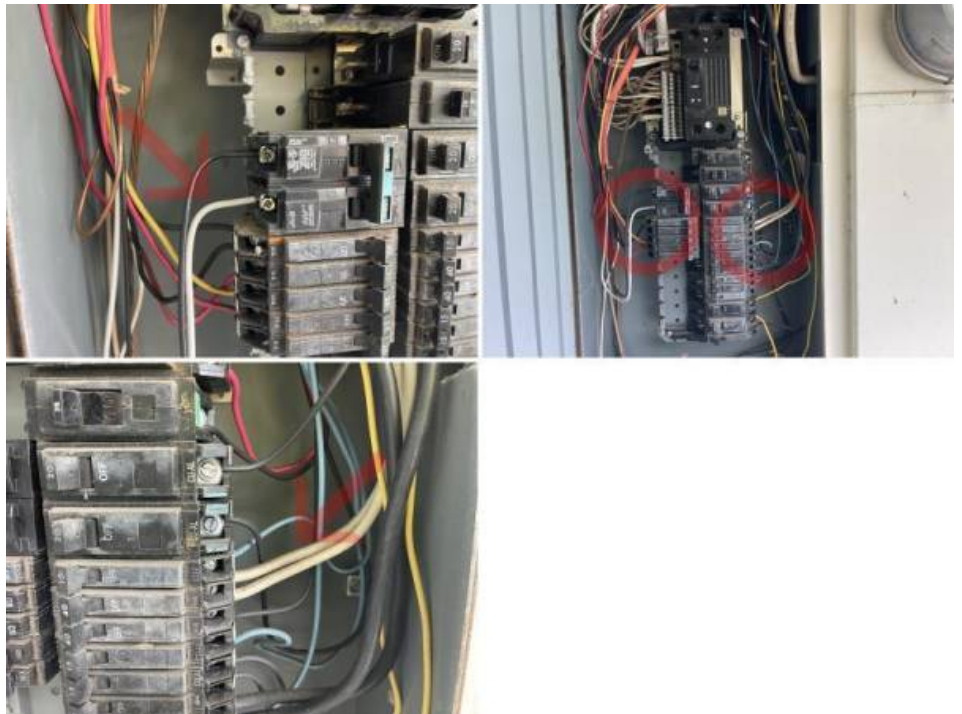
Panel observations, interior

DEFECTIVE: Improper wiring. White or green wire used as current carrying conductor. This condition can compromise electricians' safety and wires should be properly identified.

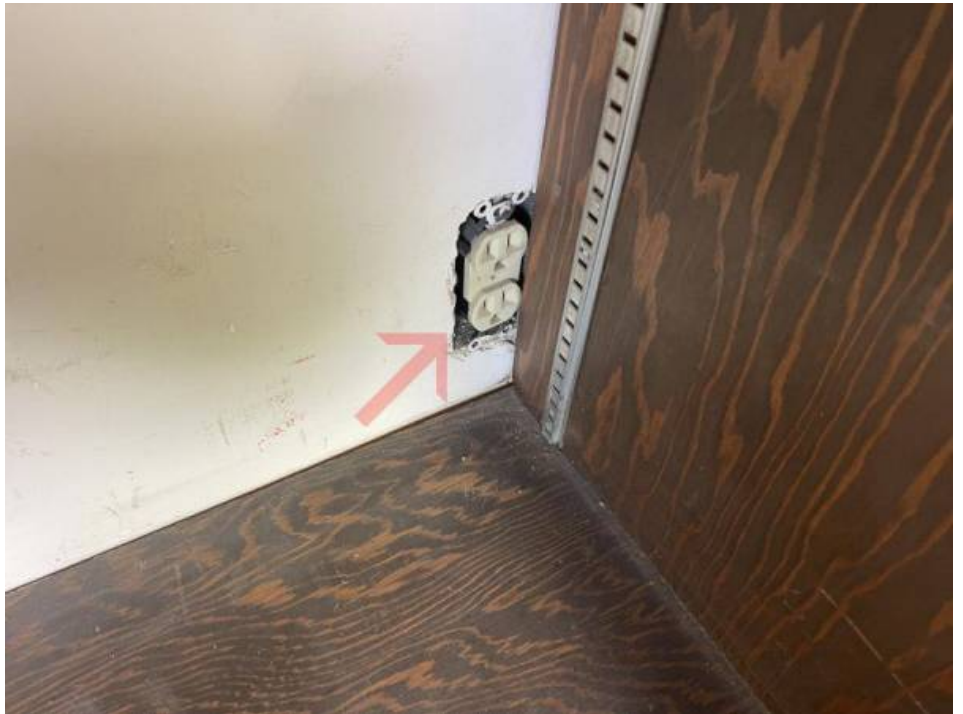
DEFECTIVE: Cover plate is missing or damaged at one or more locations. Risk of accidental contact with energized parts. We recommend installing or replacing damaged cover plates as needed at this time.

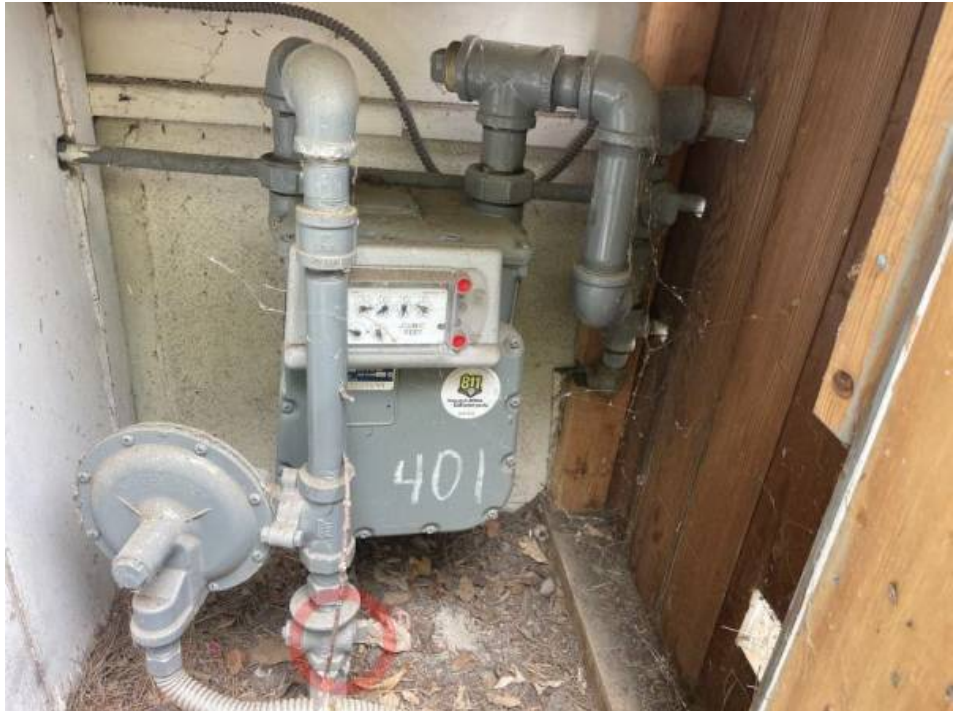
SAFETY: No seismic shutoff valve. We recommend installing a seismic shutoff valve on the gas meter for protection against fire loss in the event of a damaging earthquake. (A seismic shutoff valve is required to be installed on the gas system of residences in the City of Los Angeles prior to the transfer of title.)

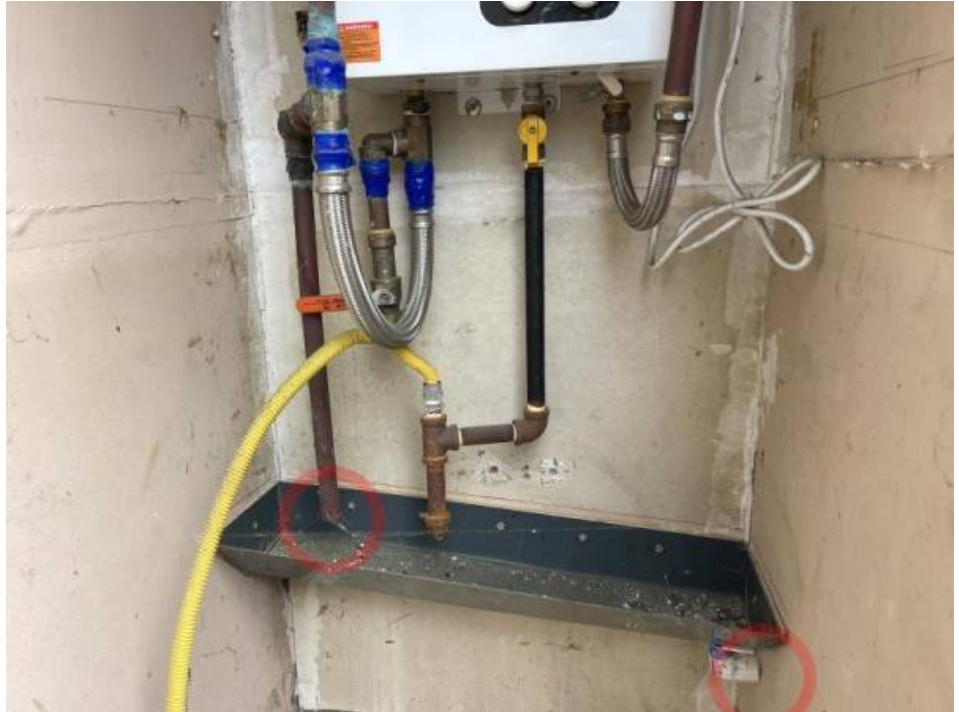
DEFECTIVE: Improper or no discharge line. The discharge piping should be of hard drawn copper or steel or other type approved for hot water distribution. It should be no smaller than the outlet of the valve and must pitch downward to allow complete drainage of the safety relief valve and discharge line. The end of the discharge line should not be threaded and should terminate below the controls at the exterior of the building and within 6" of the ground or other approved location. Valves, reducer couplings, or flexible connectors should not be installed on the discharge line.

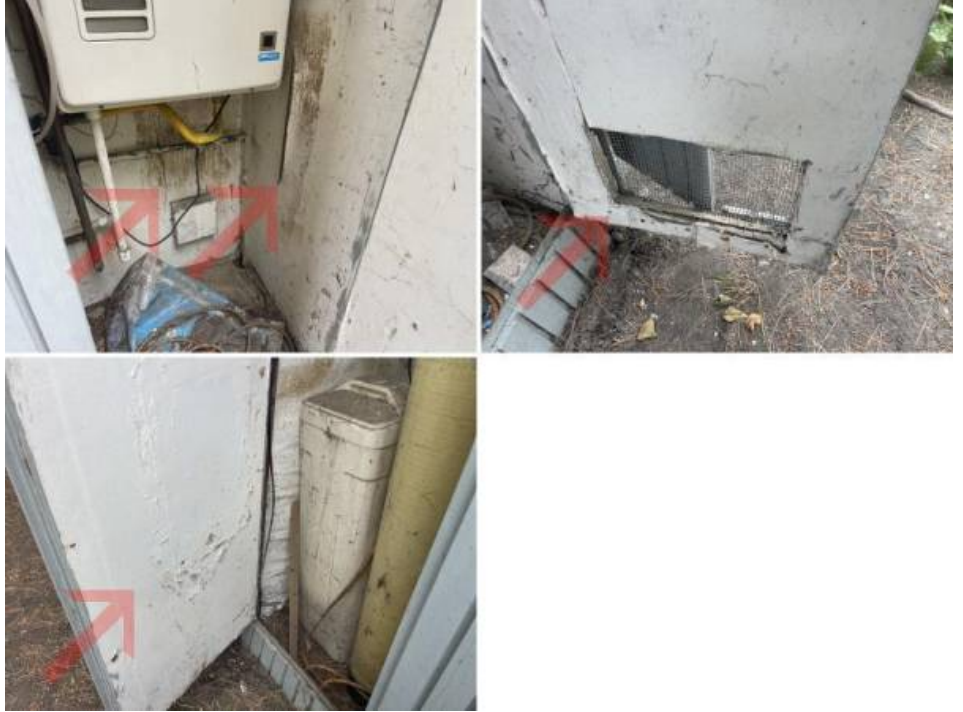
Enclosure DEFERRED: Moisture stains on the wall/platform. We suspect there are caused by an old/repared plumbing leak.
DEFERRED: Door is moisture/insect damaged. We recommend further evaluation by a licensed pest control operator.

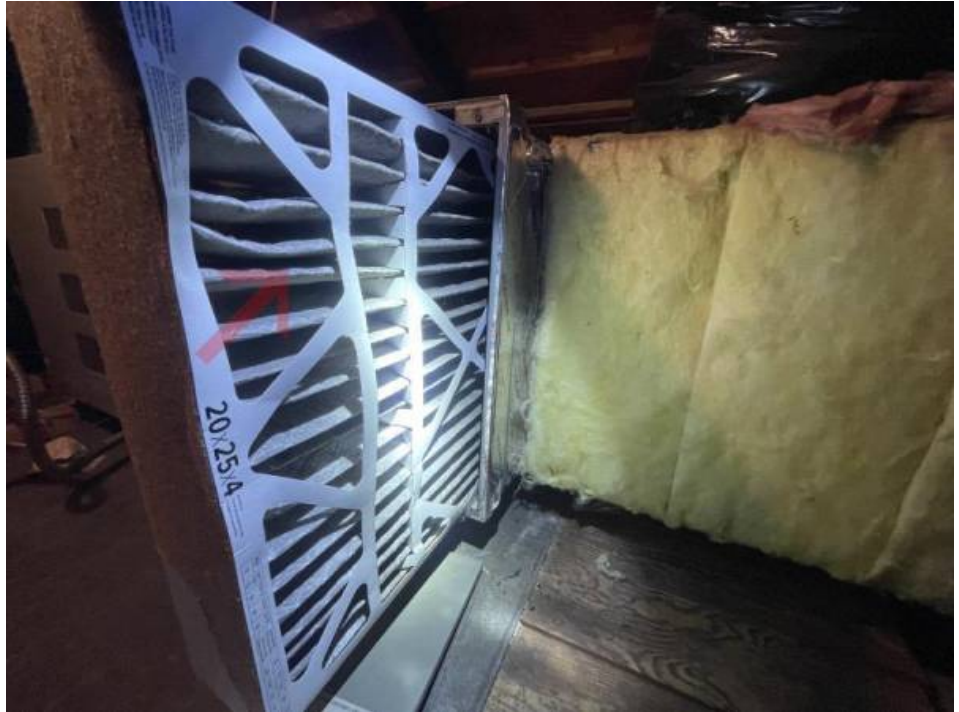
MAINTENANCE: Filter is dirty. Filters should be checked every two to three months and cleaned or changed as needed. We recommend cleaning or replacing filters when any dust can be observed for increased efficiency and energy conservation.
Extras in attic.

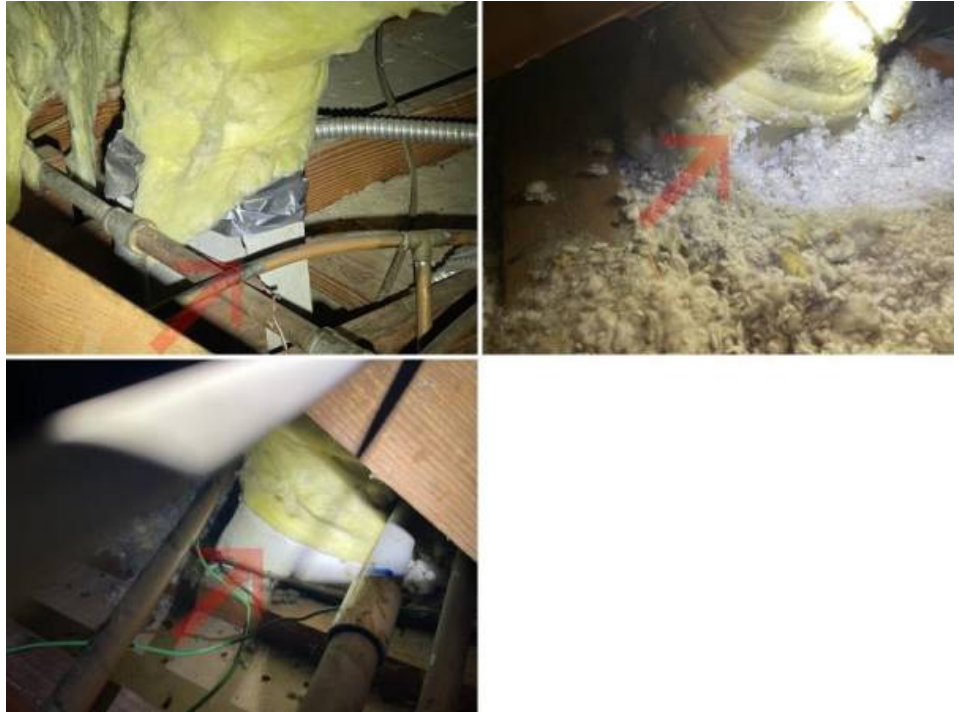
MAINTENANCE: Insulation on the ducts is loose, damaged or missing. We recommend repairs as needed at this time for energy conservation reasons.

DEFERRED: The connectors were not replaced. The possible asbestos tape appears to have been sealed to harden the tape.

Recommend an upgraded more efficient duct system.

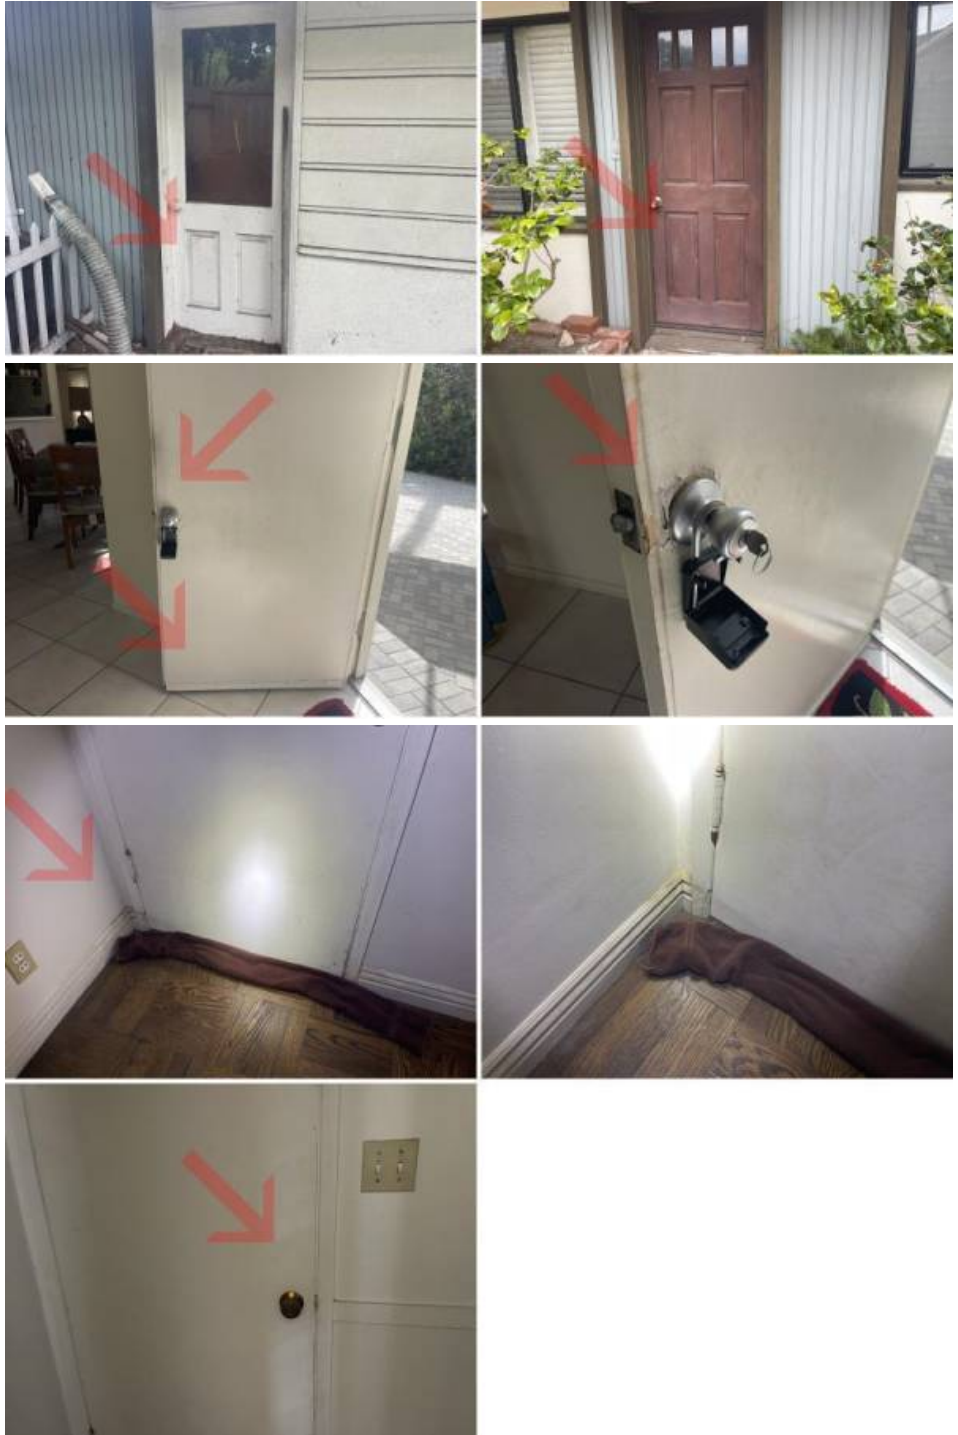
DEFECTIVE: Evidence of moisture intrusion at one or more doors sampled.

MAINTENANCE: Door finish is weathered or not painted on all sides at one or more doors sampled. We recommend refinishing at this time as needed to preserve the wood. Most door manufacturers require that all six sides must be painted as a warranty requirement.

Both bedroom doors missing deadbolts.

SAFETY: No deadbolt installed. We recommend installing a modern deadbolt that meets current security standards.

MAINTENANCE: Door needs minor repairs.

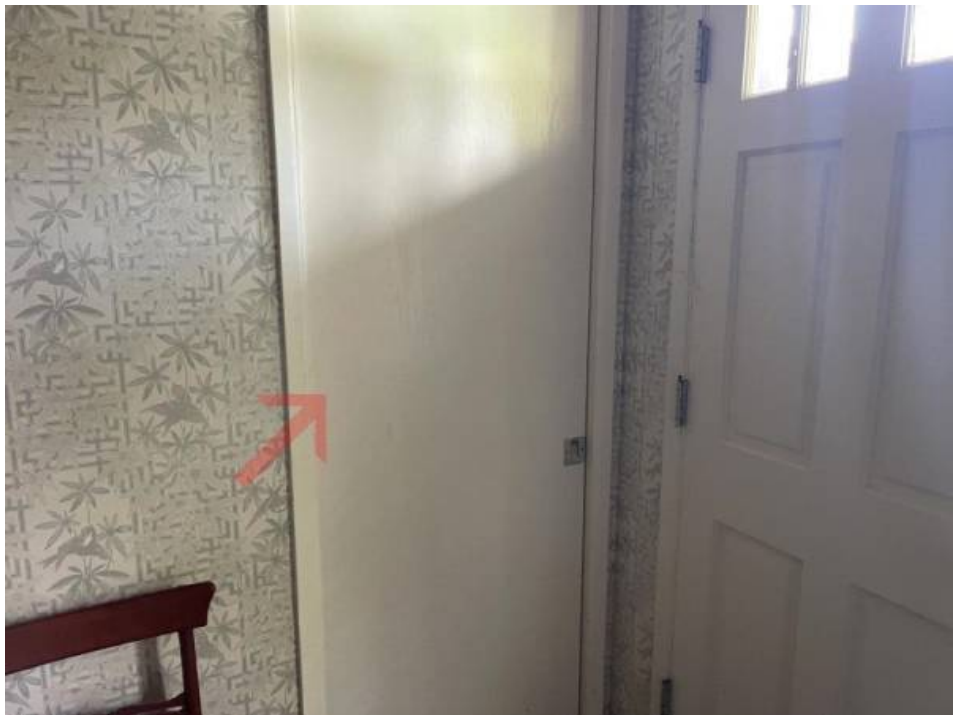
MAINTENANCE: Pocket door/s stick; hardware may need adjustment or repair or door may need to be trimmed or replaced.

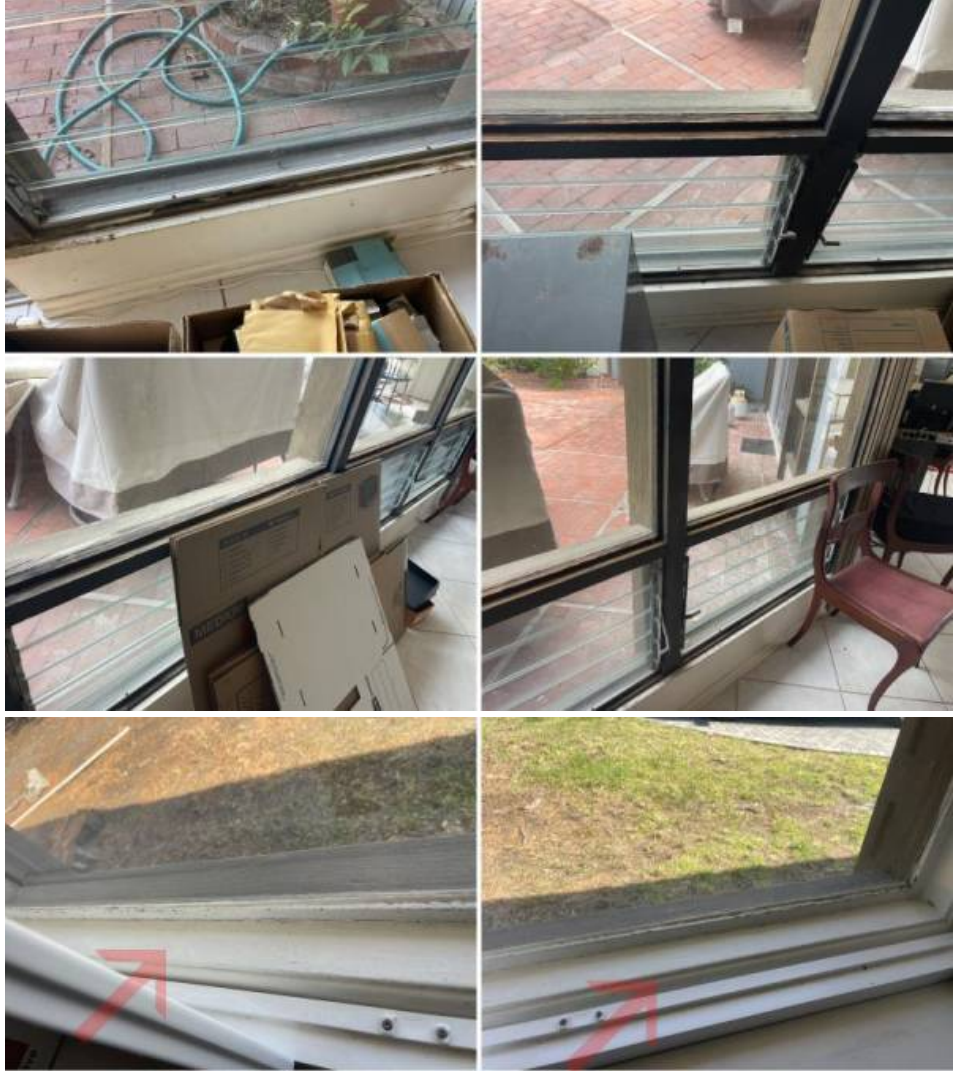
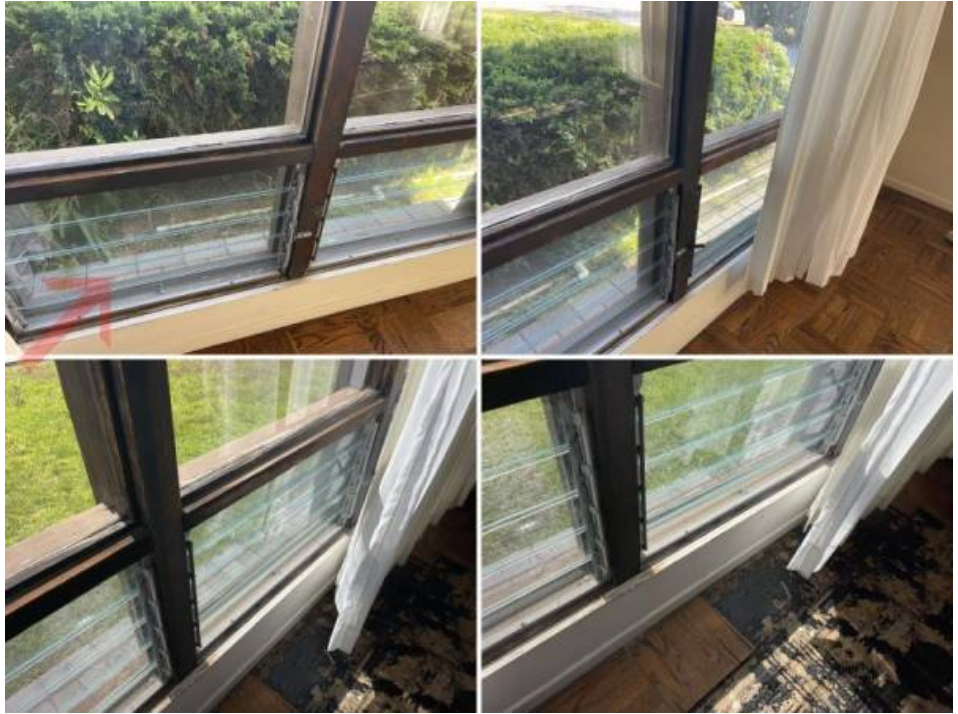
MAINTENANCE: Louver windows. These type of windows are difficult to secure and allow excessive amounts of air to infiltrate (drafty). We recommend upgrading to more secure and energy efficient windows for security and energy conservation.

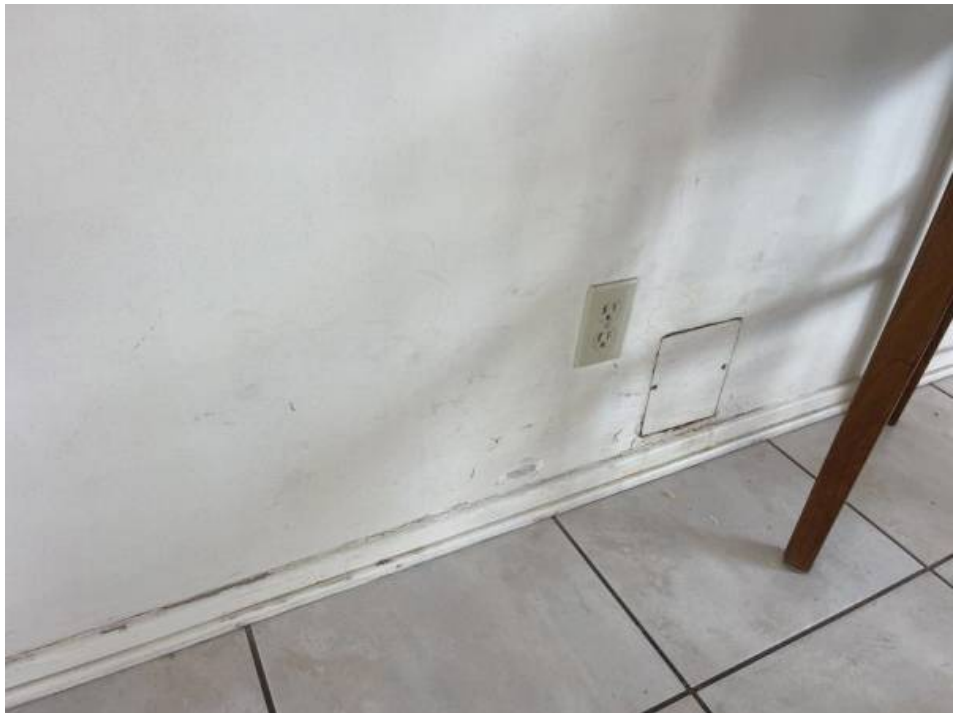
Plaster

MAINTENANCE: Some damaged viewed needs repairing.

DEFERRED: Entry, Front living room, Bedroom left, 1st bathroom walls and bedroom ceiling covered in wallpaper. walls were not viewed for cracks and damage.

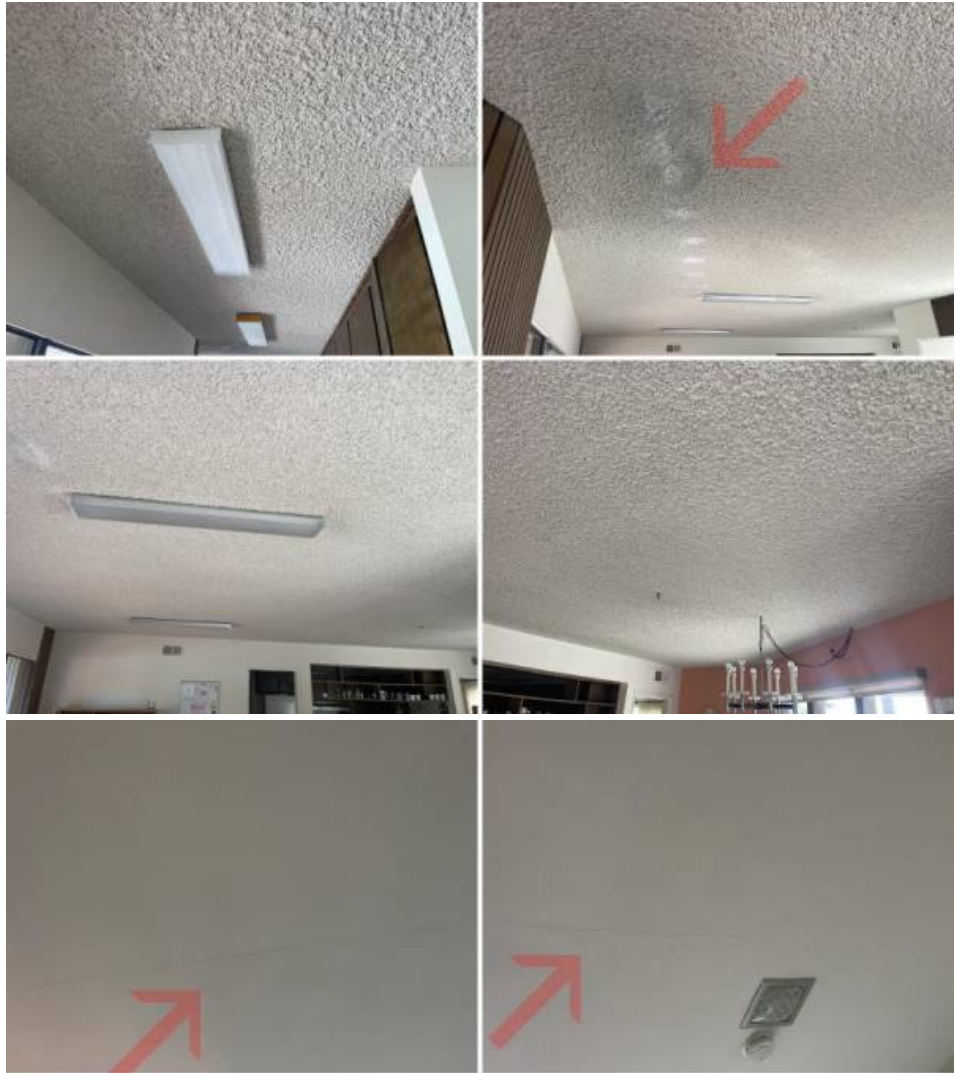
Bedroom left, Tape crack.

MONITOR: Some cracks in the walls and ceilings viewed at various locations likely

indicate moderate settlement/movement or seismic racking. We suggest monitoring and if any changes are observed we recommend further evaluation by a structural engineer. SAFETY: Acoustic ceilings viewed may contain asbestos. Positive identification of asbestos can only be made by a certified laboratory. The acoustic ceilings appear to be in good condition. Removal or encapsulation is not generally recommended unless the material is damaged and/or in friable condition. Asbestos was widely used in building materials prior to 1983. This material if present can pose health risks and will require special handling if disturbed. Your real estate agent may be able to provide you with the pamphlet "Asbestos In The Home" (CPSC Document #453) or you may obtain one yourself from the Consumer Products Safety Commission by calling them at (800) 638-CPSC, or it can be found at their web site: www.cpsc.gov. We also have that document available as a .pdf file, which we will e-mailed to you upon request.

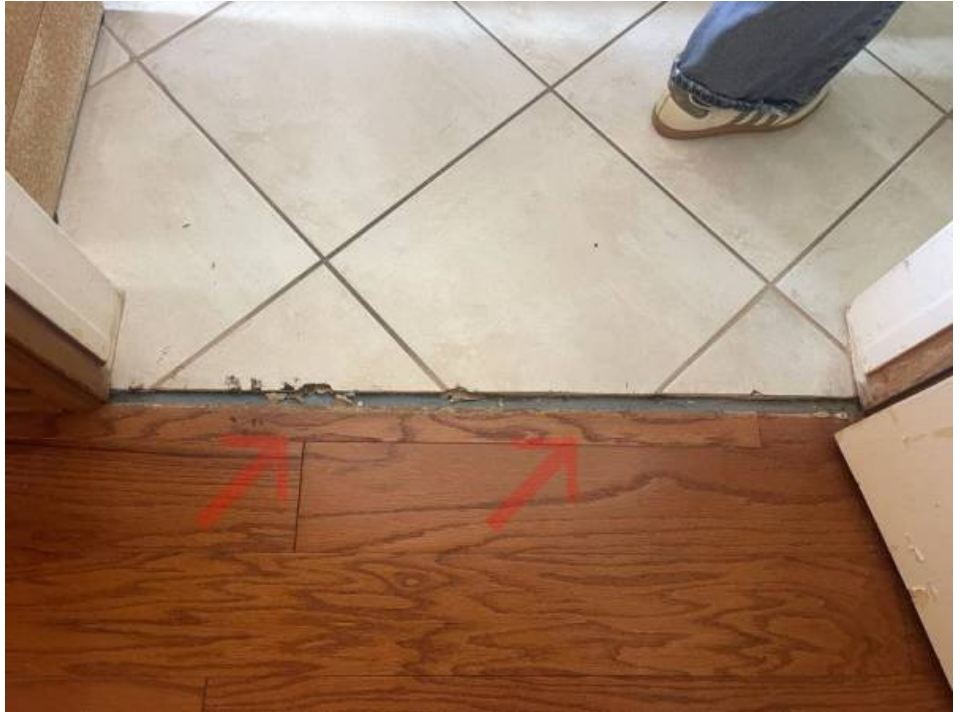
Hallway to garage,
DEFERRED: No trim and tiles are chipped at edge.
MAINTENANCE: Rear 3/4 bath, grout missing or worn.

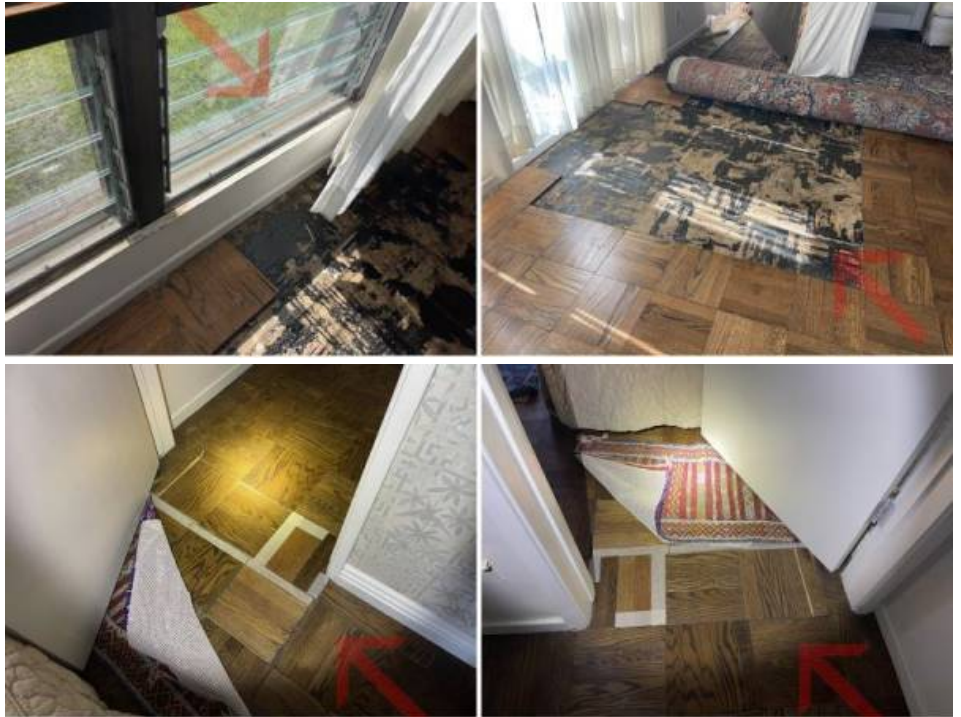
Front living room, damage from sprinklers leaking through louver windows into living room.

DEFERRED: Buckled wood or open joints indicate excessive moisture.

DEFERRED: Damaged wood, unable to see cause.

Hallway to bedrooms at bathroom. 3 different types of wood. The plumbing line was repaired and floor wood was not matched when repaired.

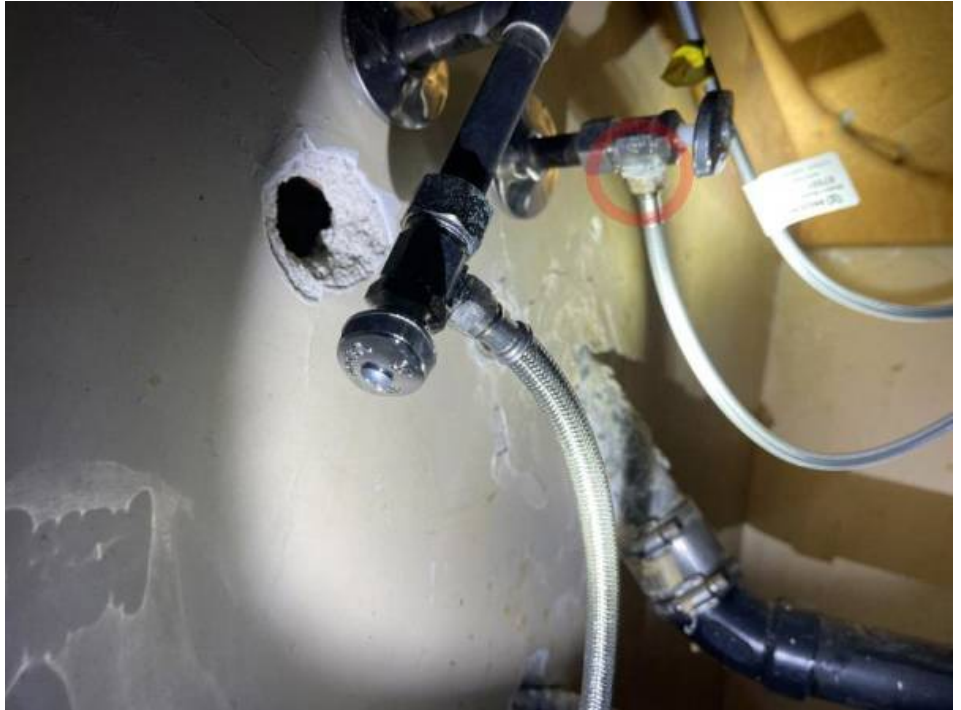
MAINTENANCE: Shutoff valve or connector is corroded. Corroded components will eventually fail; we recommend replacing corroded components when observed.

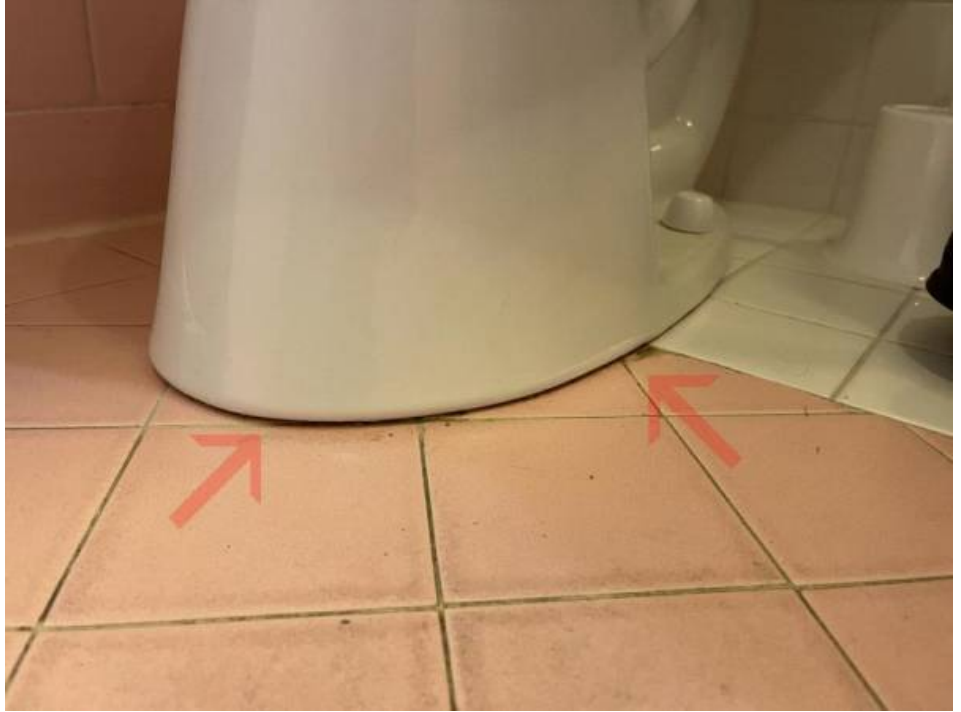
Loose seat.

DEFECTIVE: Seat is damaged or loose.

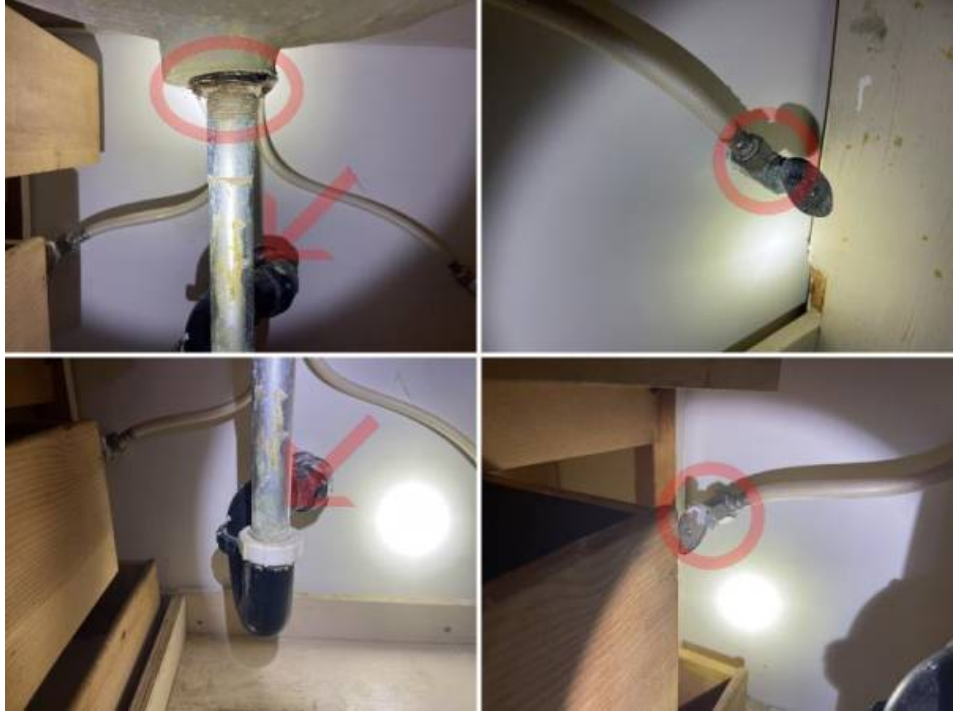
Rear bath.
 MAINTENANCE: Moderate corrosion on the drain line. We recommend replacing corroded components before they begin to leak.
 MAINTENANCE: Shutoff valve or connector is corroded. Corroded components will eventually fail; we recommend replacing corroded components when observed.

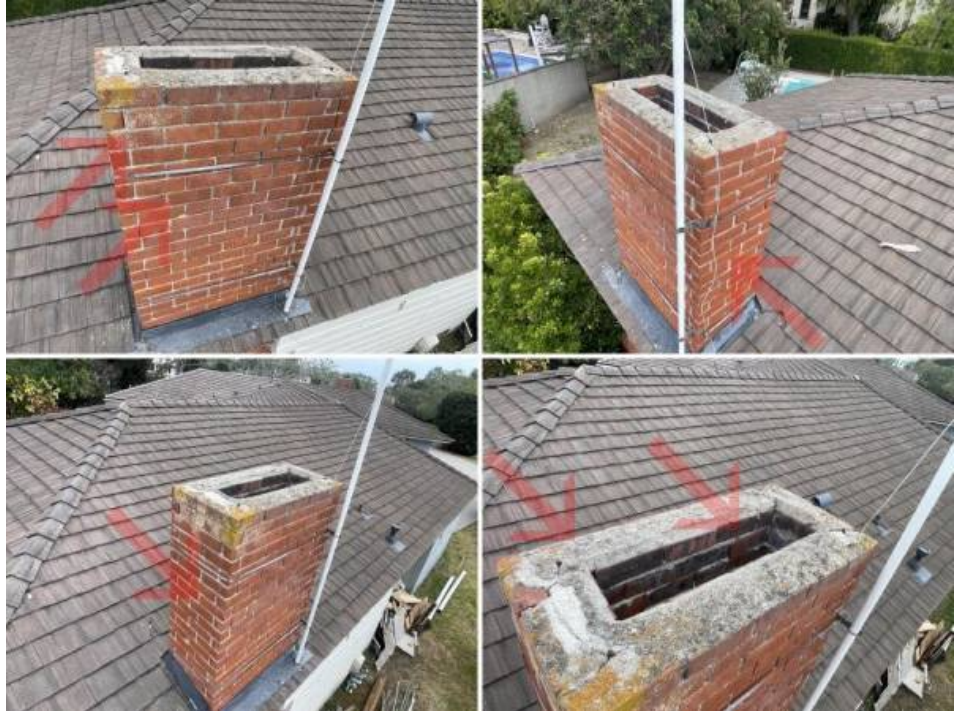
MAINTENANCE: No rain cap. Rain caps are not required on masonry chimneys; however, they protect the chimney and firebox from deterioration and we recommend installing them on all chimneys.

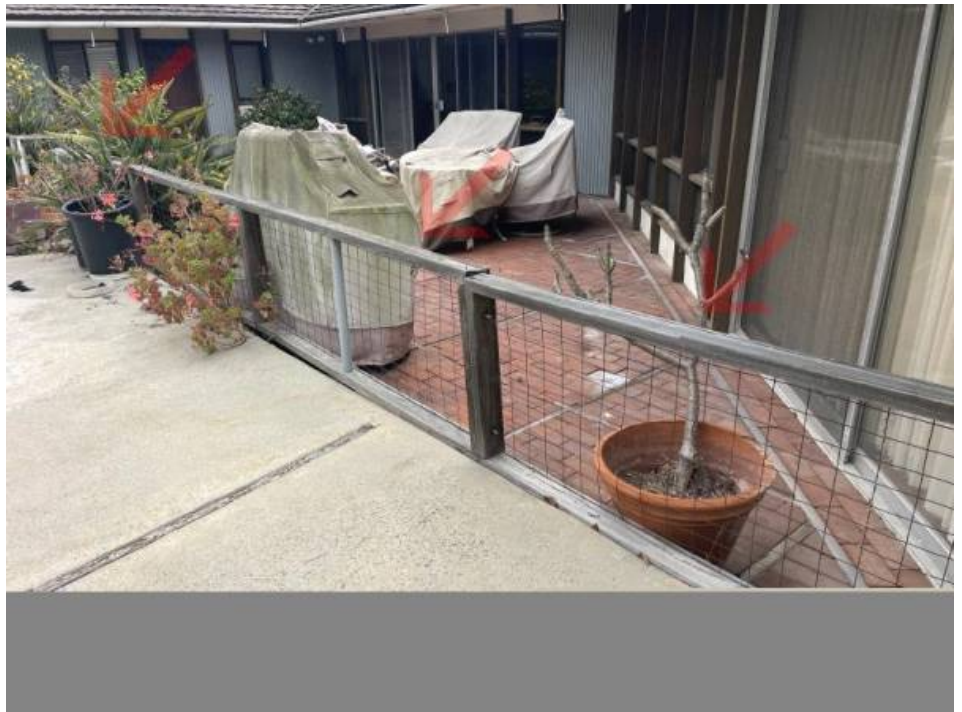
MAINTENANCE: Barrier and gate in need of repairs. Worn from the elements.

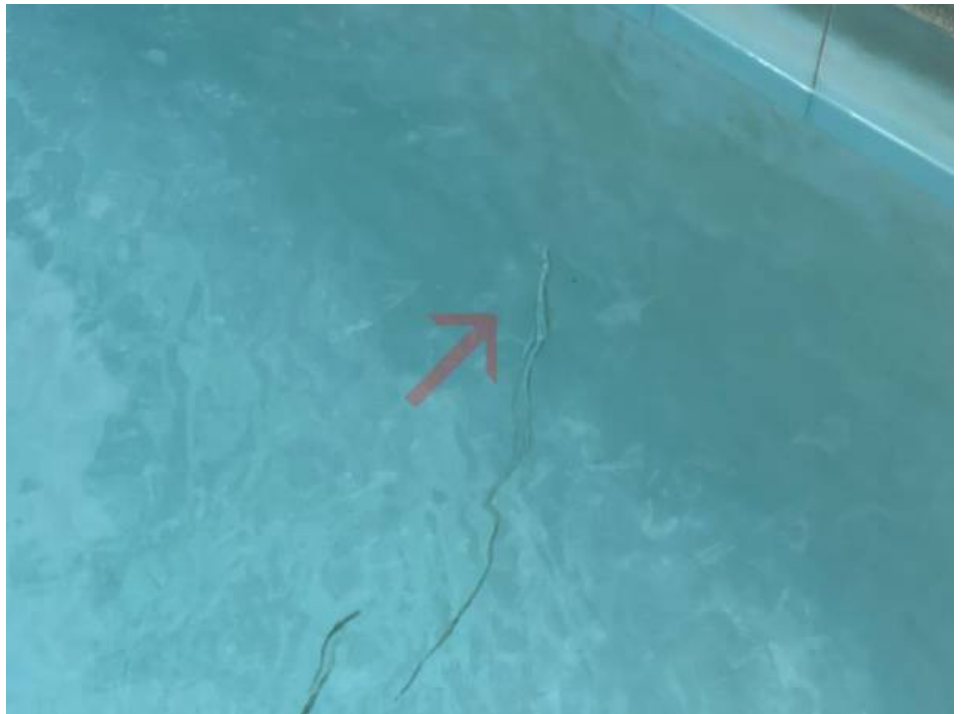
Plaster/Gunite,
DEFERRED: Cracks or blemishes viewed. We recommend further evaluation by a licensed swimming pool contractor at this time.

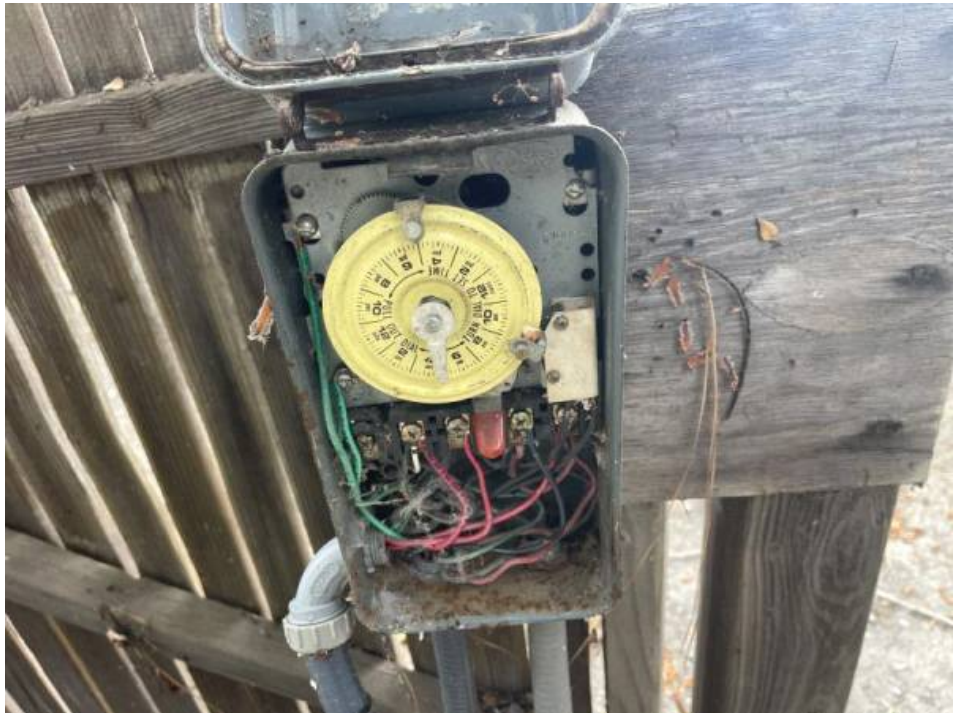
Timer

DEFECTIVE: Unit did not shut off at the timer switch, recommend further inspection and repairs as needed.
