## YOUR INSPECTION REPORT

1026 Sentinel Ave  
Los Angeles, CA 90063

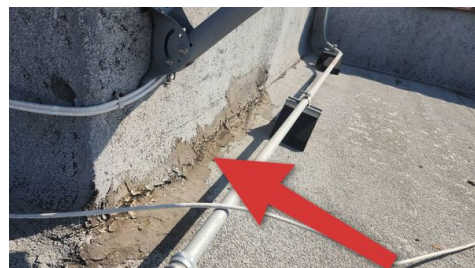
**PRIOR REPAIRS EVIDENT**

Prior repairs to the roofing are evident. This would suggest that problems have been experienced in the past. This area should be monitored.

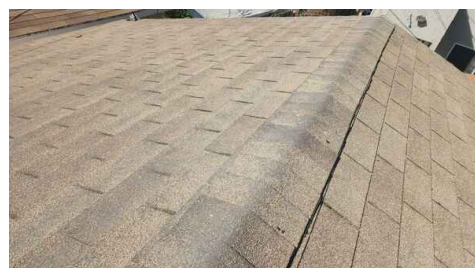
**GRANULE LOSS**

A portion of the roof has experienced granule loss. Granules are tiny pebbles made of sand, minerals, and crushed stone that protect your roof from the sun and regulate temperature. When shingles lose their granules, the asphalt underneath is exposed to UV damage, which can lead to cracking, brittleness, and water leaks.

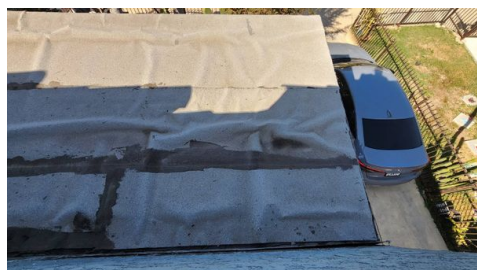
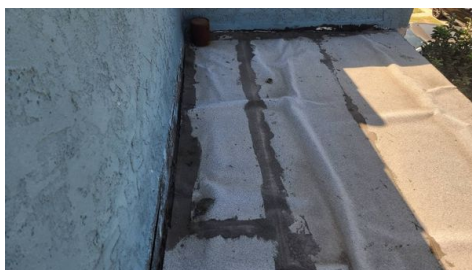
**ROLL ROOF BUBBLING/BLISTERS**

The roof has bubbles and/or blisters, which should be cut and repaired by a qualified roofer.

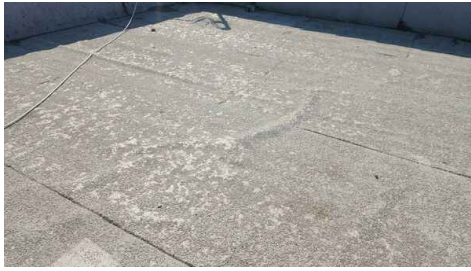
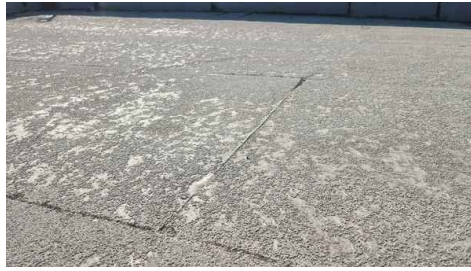
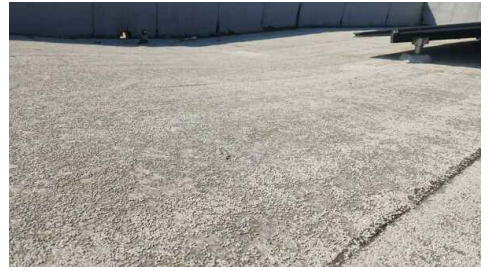
**ROLL ROOFING AT END OF LIFE**

The roofing material is deteriorated and should be repaired or replaced as necessary.

Contact a qualified professional.

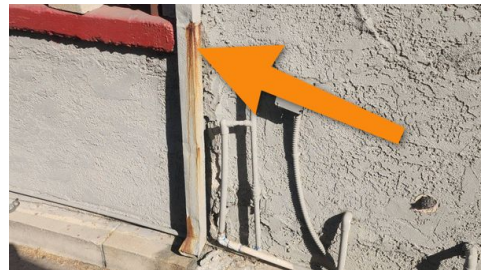
**GUTTER DAMAGED**

Gutters were damaged. This can result in excessive moisture in the soil at the foundation, which can lead to foundation/structural movement.

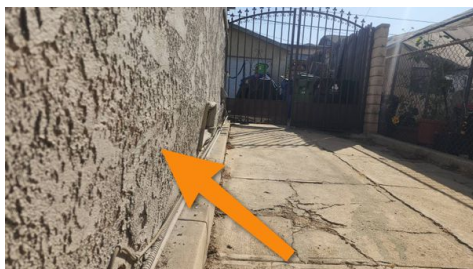
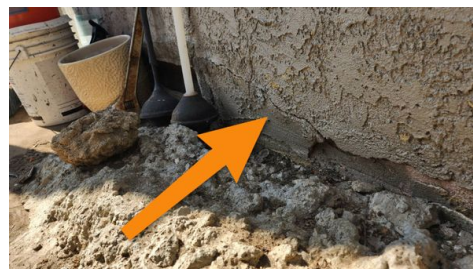
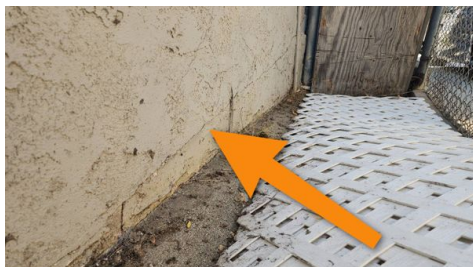
**HORIZONTAL CRACKING AND BULGING**

Contact a qualified professional.

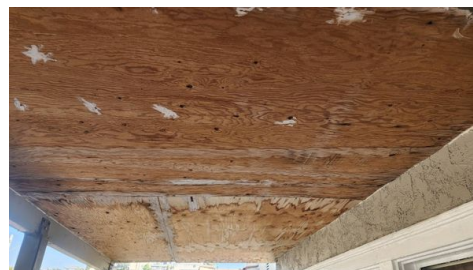
**PAINT OR STAIN NEEDED**

Paint or stain needed to prevent material deterioration of exposed wood.

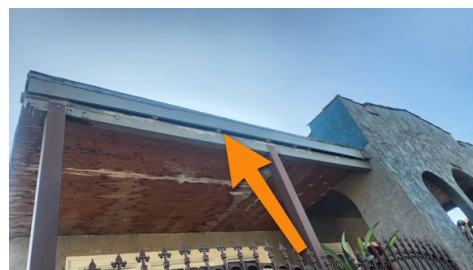
**SOFFIT GAP**

There is an opening, gap, or hole in the fascia/soffit which should be repaired. This can allow water intrusion and rodent entry as well as deterioration of the surrounding material.

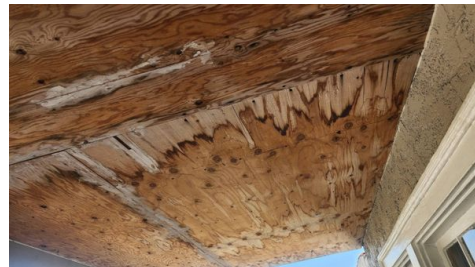
**WATER STAINS ON THE EAVE**

Water staining was observed on the eave. This suggest that the roof may be leaking in this area. Repair may ne needed.

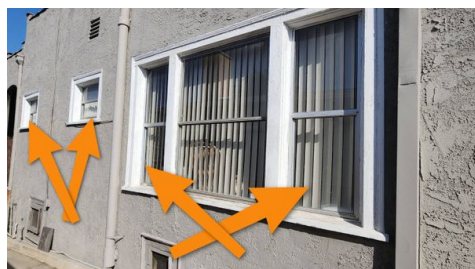
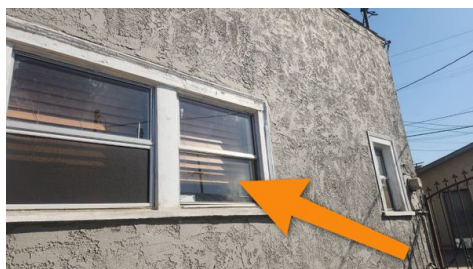
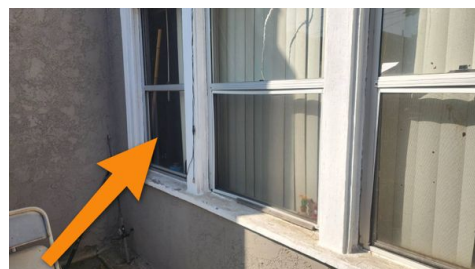
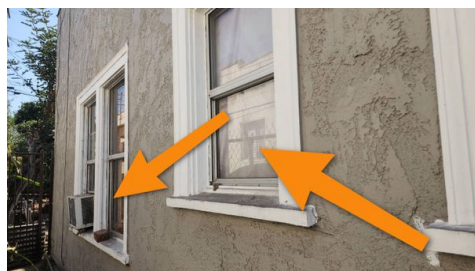
#### MISSING SCREENS

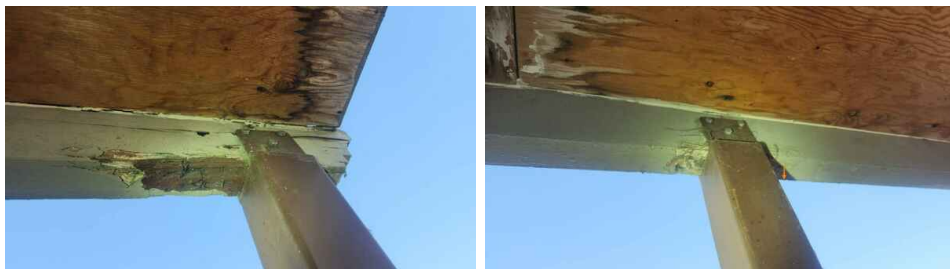
#### ROTTED WOOD

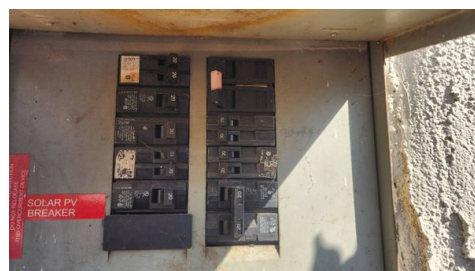
### MISSING LABELS ON PANEL

Panel labeling was missing at the time of the inspection. Each circuit should be clearly and specifically identified as to its purpose.

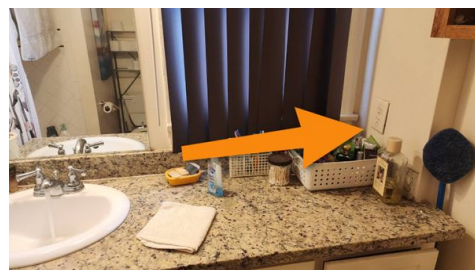
### NO GFCI PROTECTION INSTALLED

No ground fault circuit interrupter (GFCI) protection of home electrical receptacles was provided in the home at the time of inspection. Although GFCI protection may not have been required at the time the home was built, for safety reasons, the Inspector recommends that electrical receptacles located in basements, crawlspaces, garages, the home exterior, and interior receptacles located within 6 feet of a plumbing fixture be provided with ground fault circuit interrupter (GFCI) protection in good working order to avoid potential electric shock or electrocution hazards. **Upgrading to GFCI is recommended for added safety.**

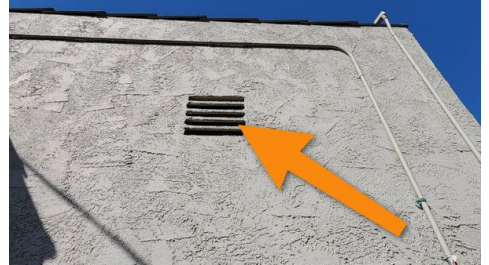
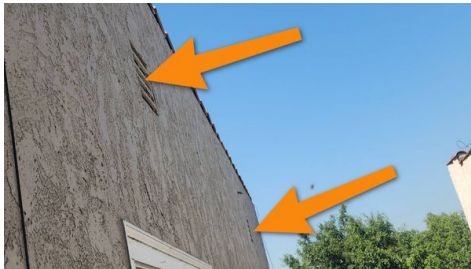
**VENT SCREEN MISSING**

The vent lacked a screen to effectively prevent rodent/bird entry into the roof structure. The Inspector recommends correction by a qualified handyman.

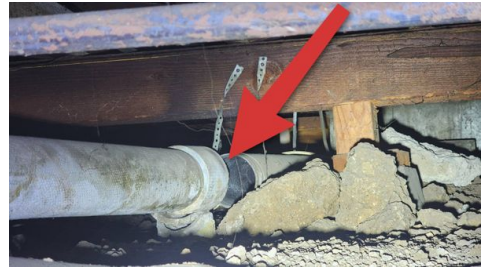
**FURNACE VENT PIPE  
DISCONNECTED**

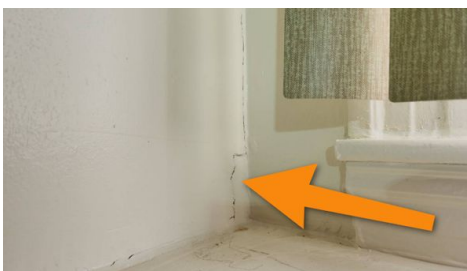
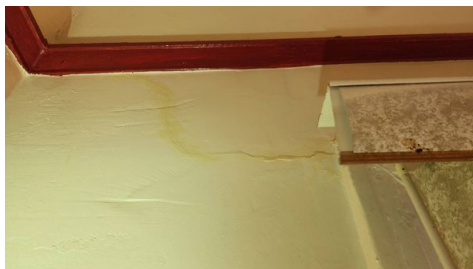
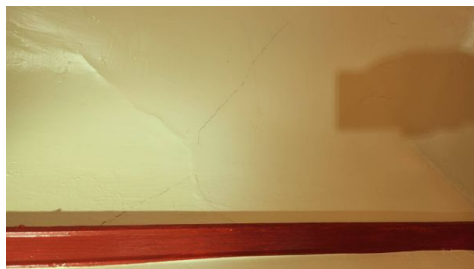
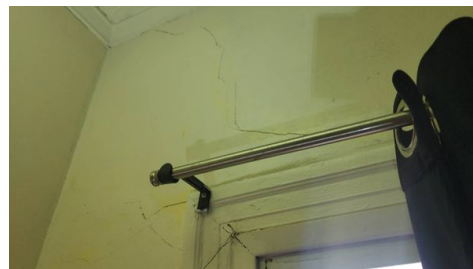
The walls have stress fractures (cracks), which have resulted from movement. As a house ages, it's normal for it to settle and shift slightly. This can be due to the weight of the building, changes in temperature and humidity, or soil moisture. Be aware that such cracks can continue to reappear, and particularly if they are not repaired correctly.

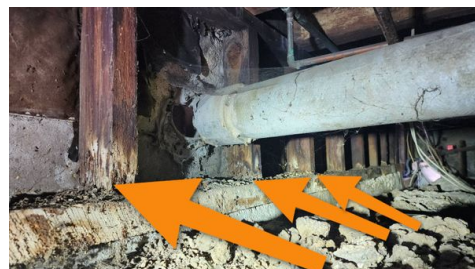
#### CRIPPLE WALL ROTTED

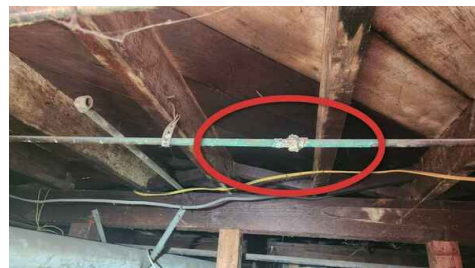
### DISTRIBUTION LINE CORRODED, PAST LEAKAGE

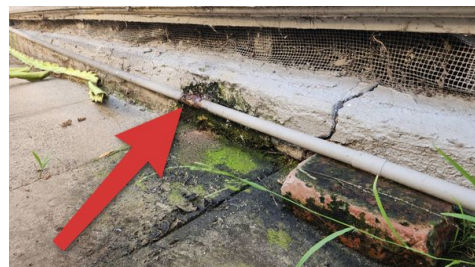
### DISTRIBUTION PIPE LEAKING

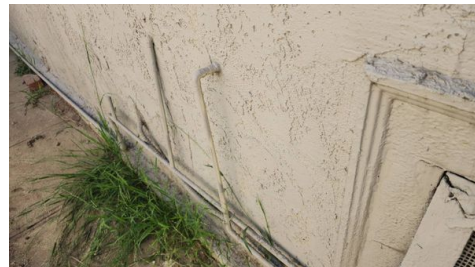
### COPPER PIPES EXPOSED - NO PROTECTIVE SLEEVE

Main water supply pipe was missing protective sleeve/insulation, which prevents corrosion, retains energy efficiency, and extends lifespan.

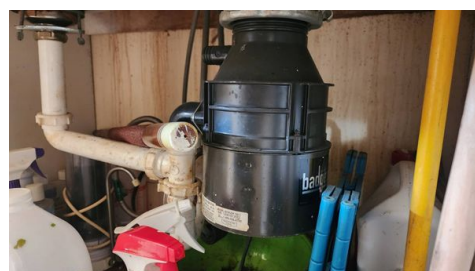
**INOPERABLE**

Garbage disposal was inoperable at the time of inspection.
