# Inspection Report

**Property Address:**  
72543 Beavertail St  
Palm Desert CA 92260

<b>Date:</b> 10/2/2023	<b>Time:</b> 09:00 AM	<b>Report ID:</b> 20231002-72543-Beavertail-St
<b>Property:</b> 72543 Beavertail St Palm Desert CA 92260	<b>Customer:</b> Sara Rostand, Trustee	<b>Real Estate Professional:</b> Richard Von Ernst Compass

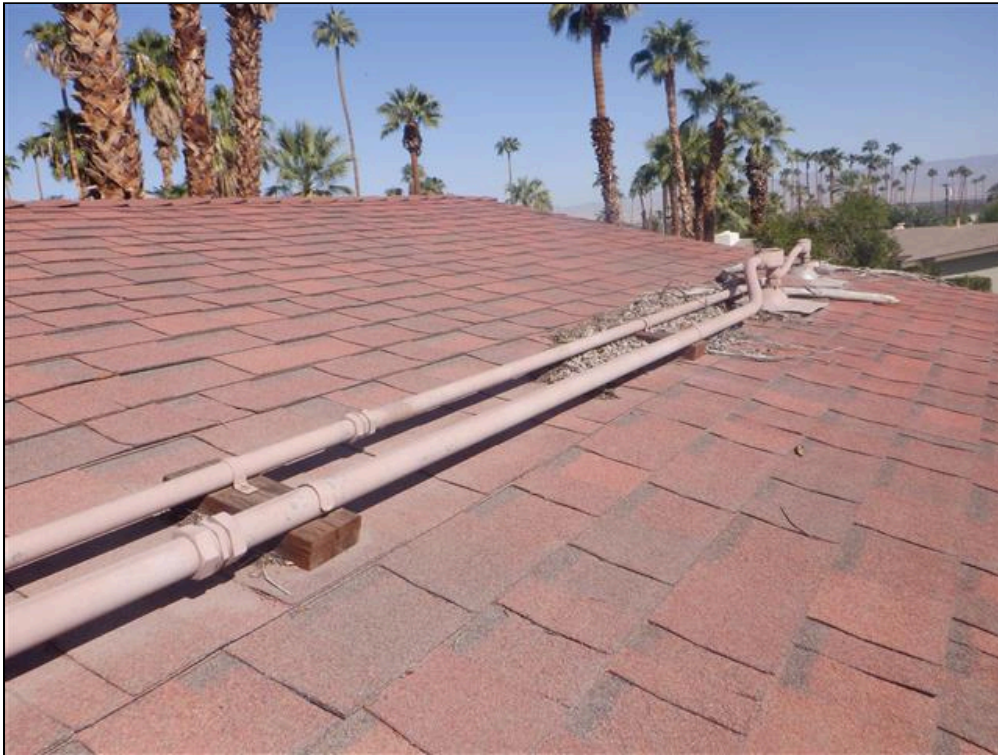
1.0 Item 1(Picture) Roof Covering

**1.0** This roof consist of Asphalt/Composite roofing shingles. No damaged, deteriorating or missing shingles were noted. This roof appeared to be in serviceable condition (useable/functional).

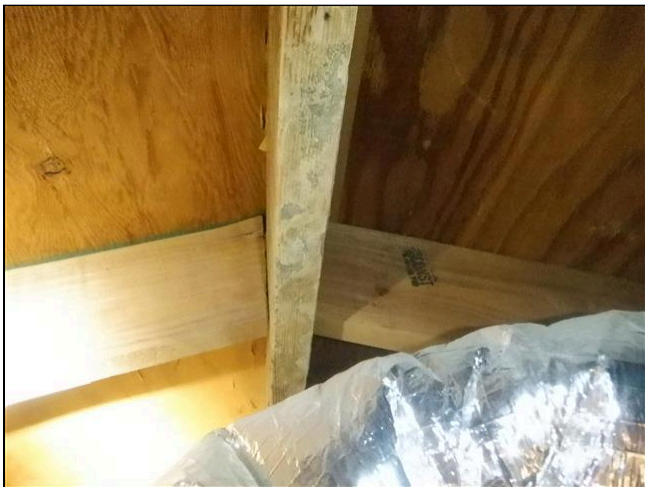
1.4 Item 1(Picture) Roof Framing/Roof Decking

**1.4** Although we had a limited view in this attic visible portions of the roof decking/sheathing had no evidence of leaks or staining at the time of inspection, as well as all of the portions of the ceilings in the house.

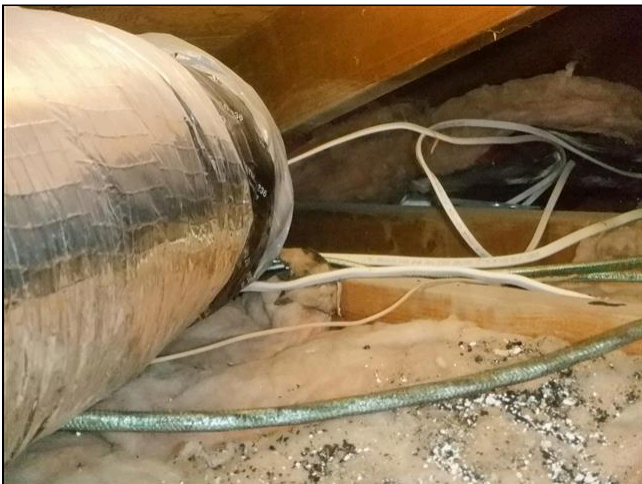
1.5 Item 1(Picture) Attic Insulation

**1.5** This attic is insulated with fiberglass batt that 4-6 thick if that. Requirements for attic insulation have changed over the years and in this climate a correctly insulated attic consist of at least R-30 about 8-10 inches of insulation. Recommend evaluation by a specialist to determine if more insulation needs to be added and to add if needed. FYI this attic appears under insulated.

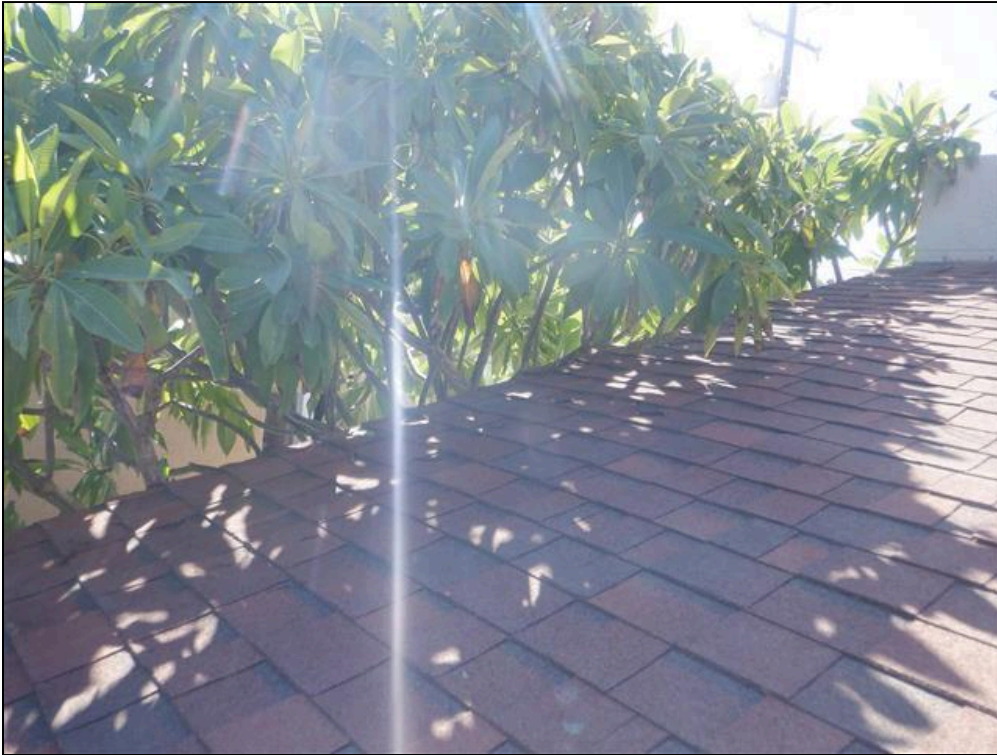
1.6 Item 1(Picture) Roof Tree Contact

**1.6** (1) The tree limbs that are in contact with roof or hanging near roof should be trimmed. Trees/ bushes that grow close to or onto the roof can damage roofing materials as well as allowing rodents and pests access to the attic areas.

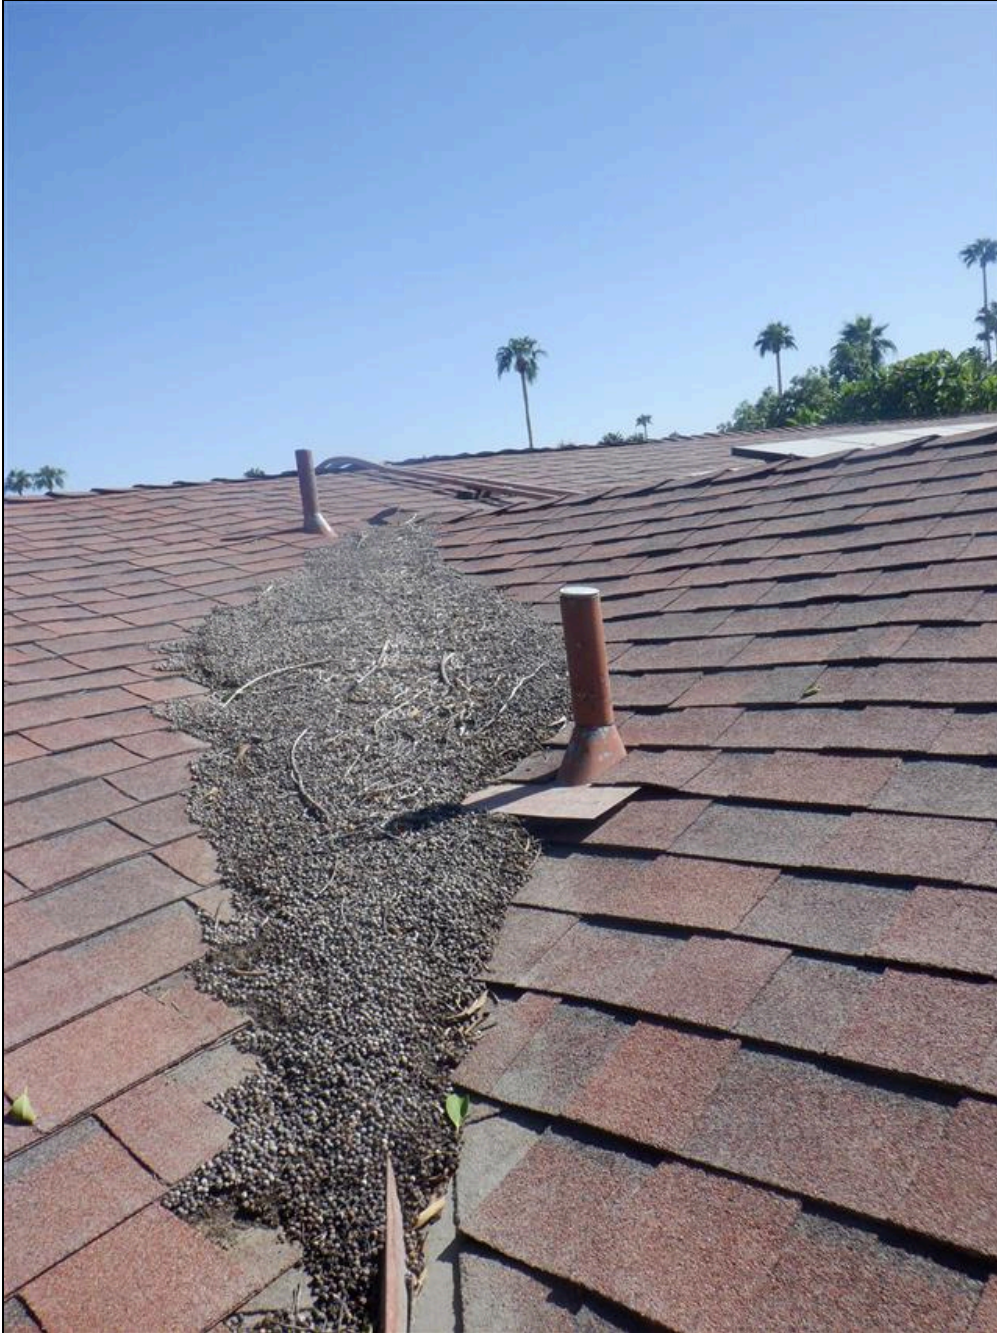
1.6 Item 2(Picture) Roof Debris

**1.6** (2) We noted debris on this roof in several locations. It is possible for this debris to impede drainage in a rain event. Recommend removal of debris to insure proper drainage.

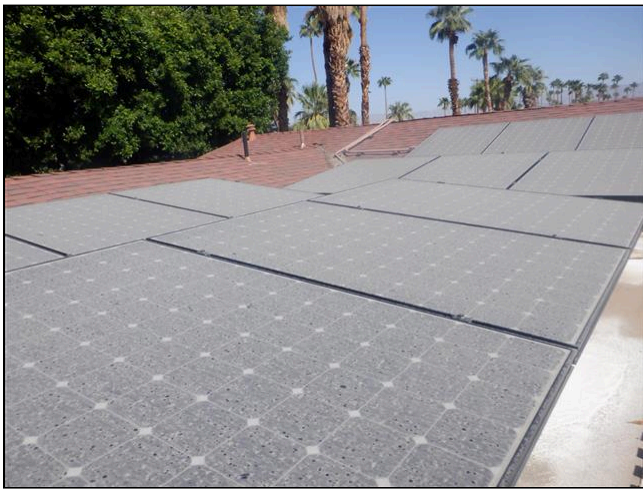
1.8 Item 1(Picture) Solar Panels

**1.8** We noted that this house is equipped with solar panels/solar equipment. Our company dose not inspect solar panels/equipment and we have no way of telling if they are functioning properly or if they were installed correctly. Improperly installed solar panels can lead to roof leaks. This solar equipment should be evaluated by a licensed specialist. FYI recommend reaching out to the manufacture or installer for information on existing warranties and maintenance schedules.

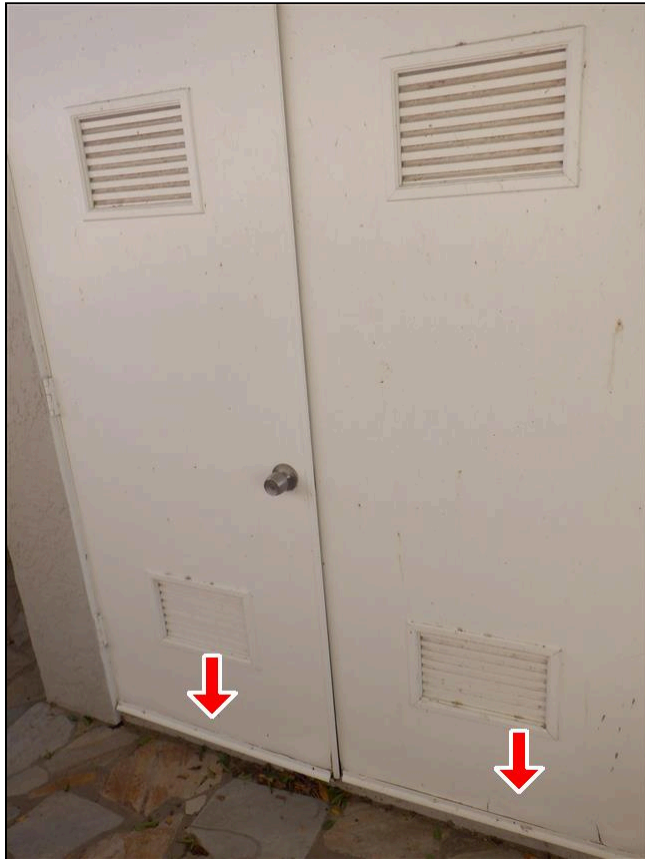
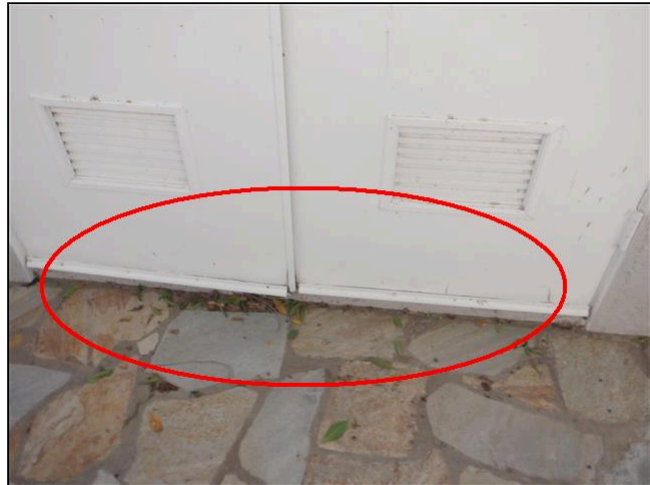
2.1 Item 1(Picture) Utility Room Doors Weathered

**2.1** We noted that the heating and water heater compartment doors appeared weathered and damaged. Recommend evaluation by a licensed contractor repair replace as needed.

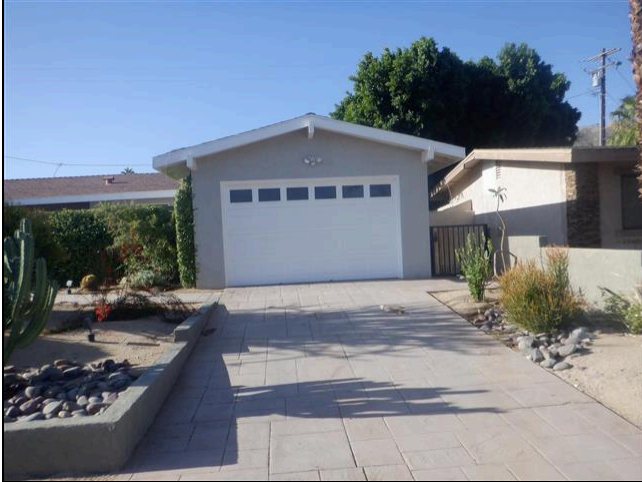
2.3 Item 1(Picture) Driveway Cracks

**2.3 (1)** Cracks were noted in the concrete driveway and patio slab. These slab cracks are normal shrinkage cracks for this climate, none of which exceeded 1/8 inch in size. Recommend repair as desired.

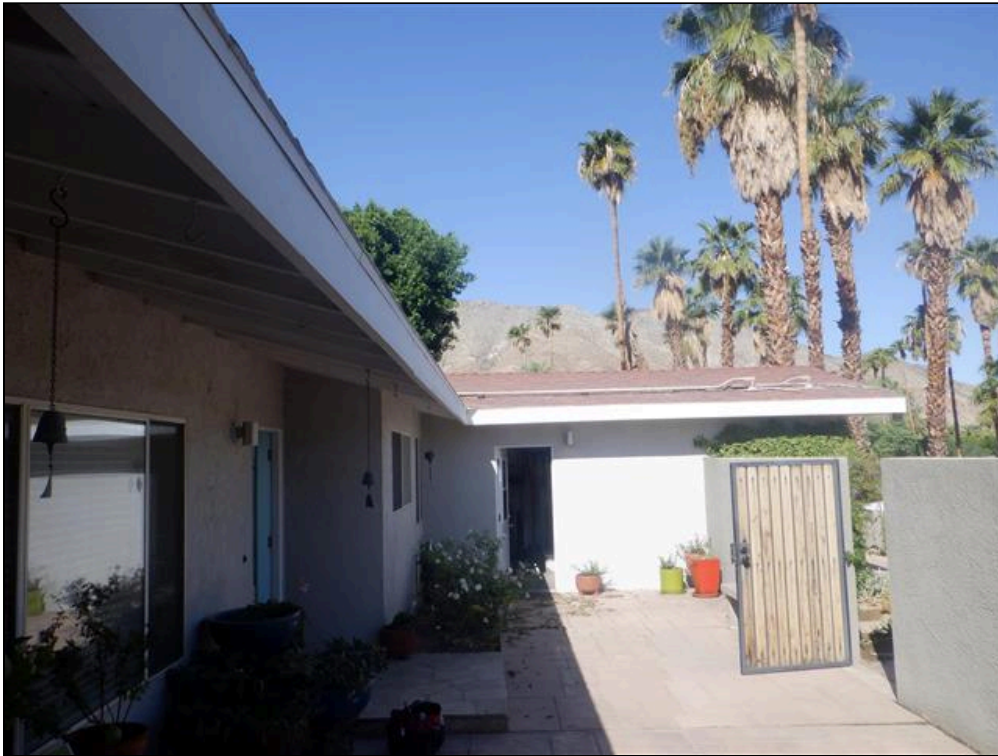
2.3 Item 11(Picture) Rain Gutters Needed

**2.3 (2)** We noted that a portion of the slab in the courtyard has an even grade and there appears to be only one way the water during rain events can drain out of this area (through the gate). Recommend adding a rain gutter system to the eaves and drilling weep holes in the courtyard walls by a licensed contractor.

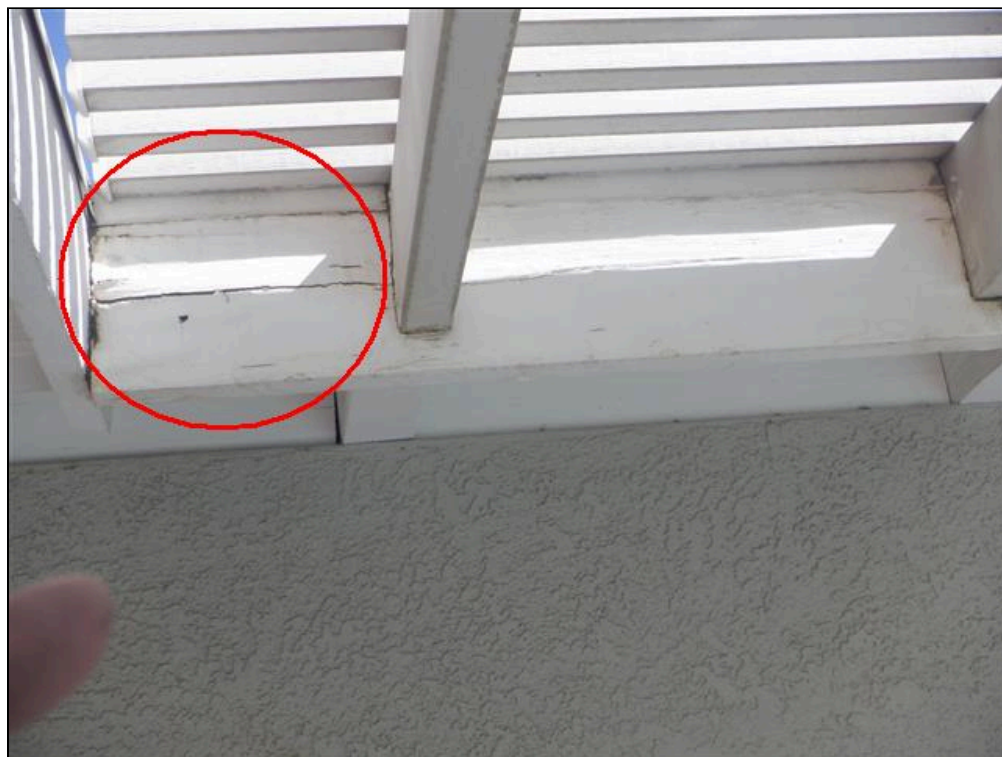
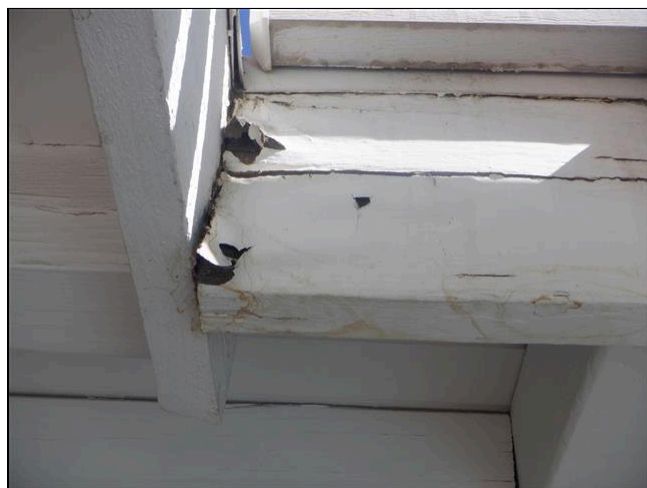
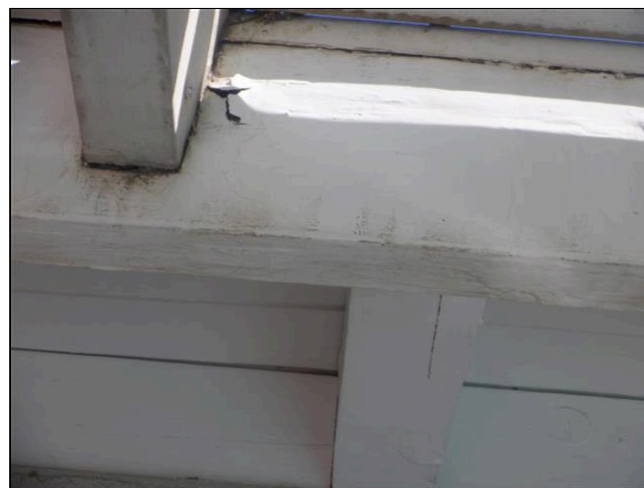
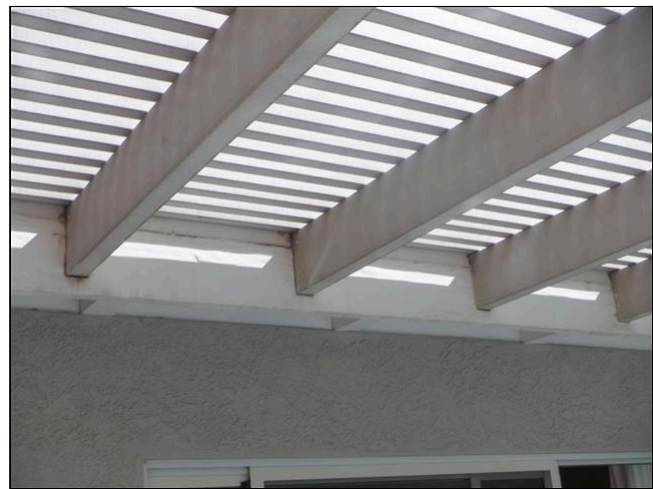
2.4 Item 1(Picture) Damaged Wood

**2.4** The paint on the eaves and the fascia boards appears to be peeling and failing in at least one area (rear patio). We also noted damaged wood in at least one area. Recommend evaluation and repair of any damaged wood prep and painting of the fascia boards and eaves to insure future integrity of wood by a licensed contractor.

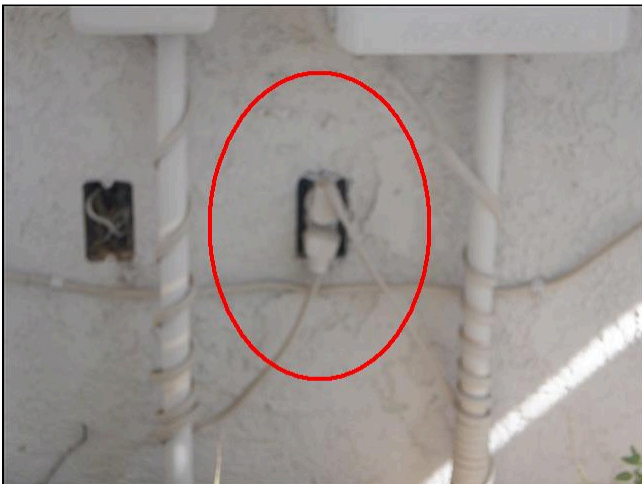
2.6 Item 1(Picture) Outlet No GFCI Protection

**2.6** Although most exterior outlets were GFCI protected we noted at least one that was not. All exterior outlets should be GFCI protected, we highly recommend the installation of GFCI outlets by a licensed electrical contractor for proper shock protection and to avoid any safety issues. Location of none GFCI protected outlets as follows

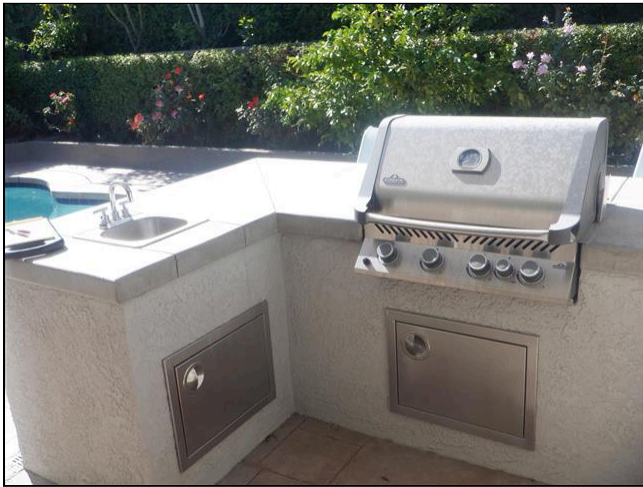
2.11 Item 1(Picture) BBQ

**2.11 (1)** BBQ appeared to be functioning properly at the time of inspection.

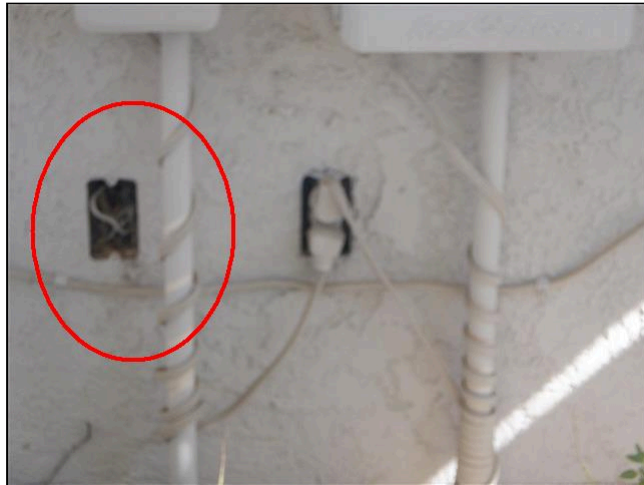
**2.12** We noted that the cable box cover on the south side of home was missing. This missing cover will allow moisture and pest into wall cavity and cause damage. Recommend installation of cover.

2.12 Item 1(Picture) Missing Cable Box Cover

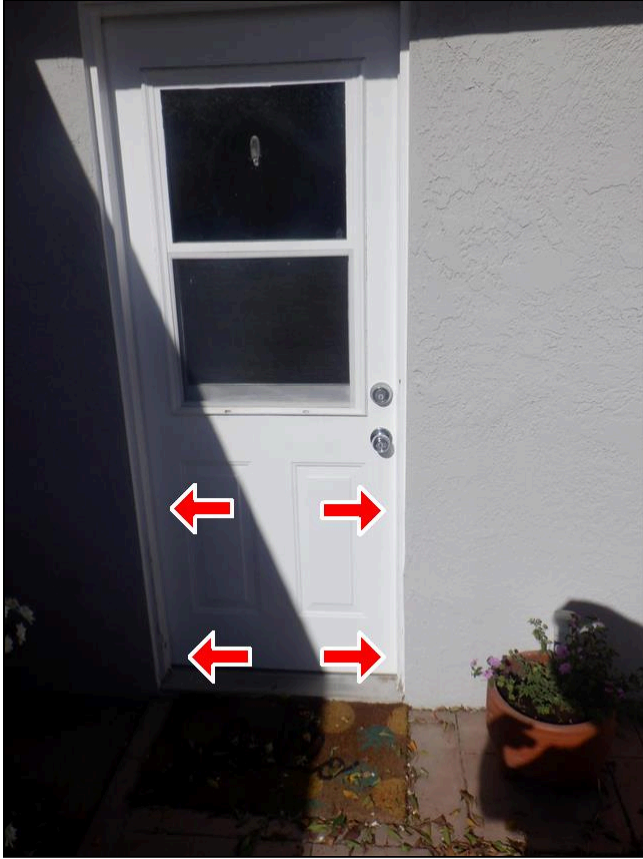
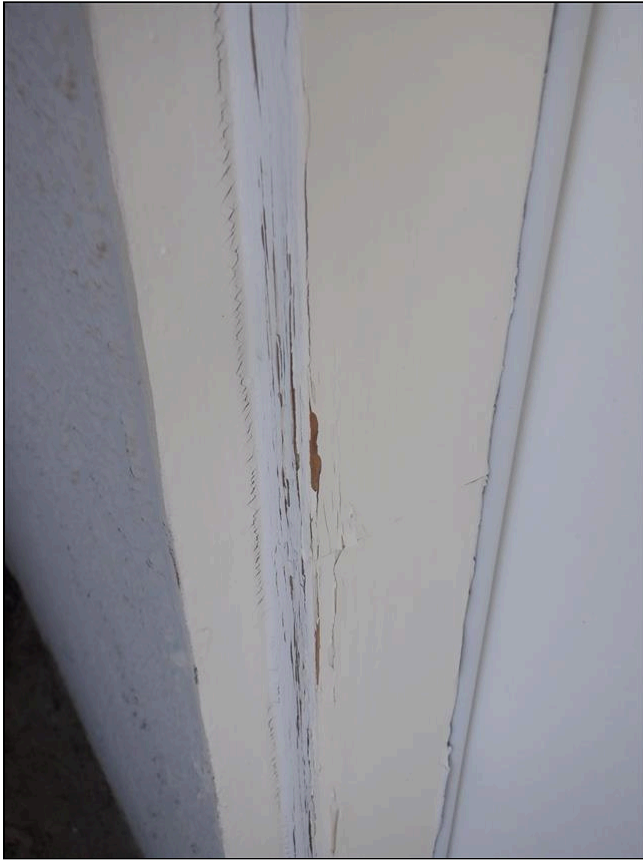
3.6 Item 1(Picture) Failing Trim Paint

**3.6 (1)** We noted that the paint on the exterior door jam around the main garage pedestrian door appears to be bubbling and failing. Recommend prep and paint door jam as needed to ensure future integrity of the wood.

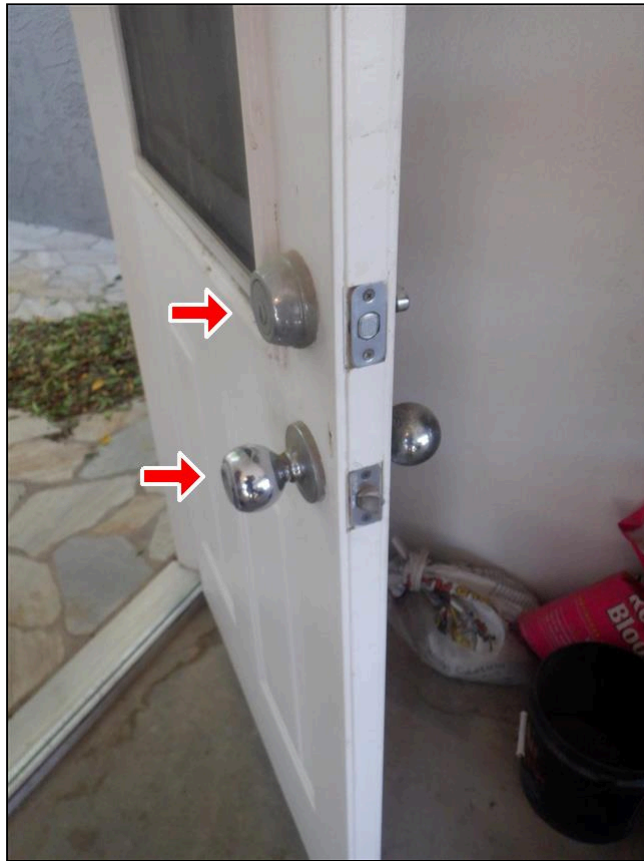
3.6 Item 5(Picture) Locks Not Functioning

**3.6** (2) We noted that the locks on the auxiliary garage pedestrian door were not functioning at time of inspection. Recommend evaluation by a licensed contractor repair replace as needed.

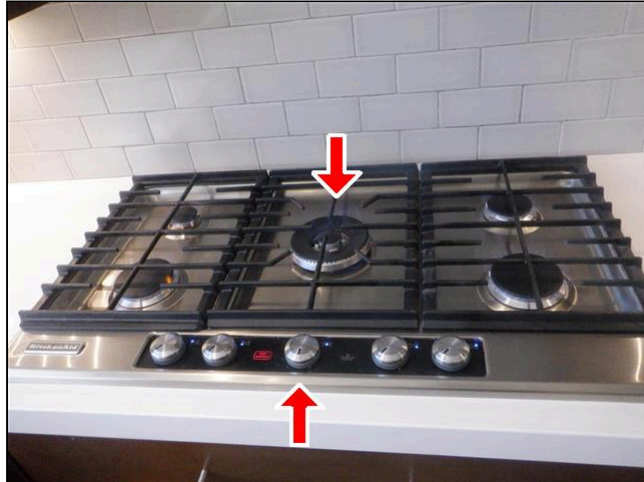
**4.9** Although the oven and all burners were function we noted that the center cooktop burner and igniter were not functioning properly. The igniter would not light the burner and the burner did not appear to the functioning as intended. Recommend evaluation by a licensed appliance contractor repair replace as needed.

4.9 Item 1(Picture) Center Burner/Igniter

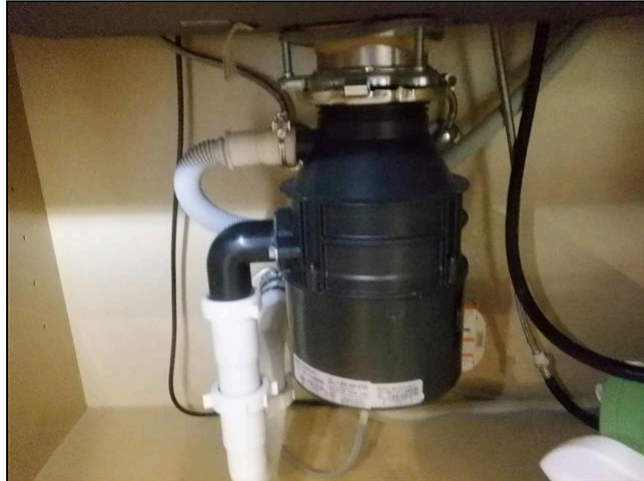
**4.11** We noted that the food waist disposal was inoperative (frozen) at time of inspection. Recommend evaluation repair replace as needed by an appliance contractor.

4.11 Item 1(Picture) Food Waist Disposer

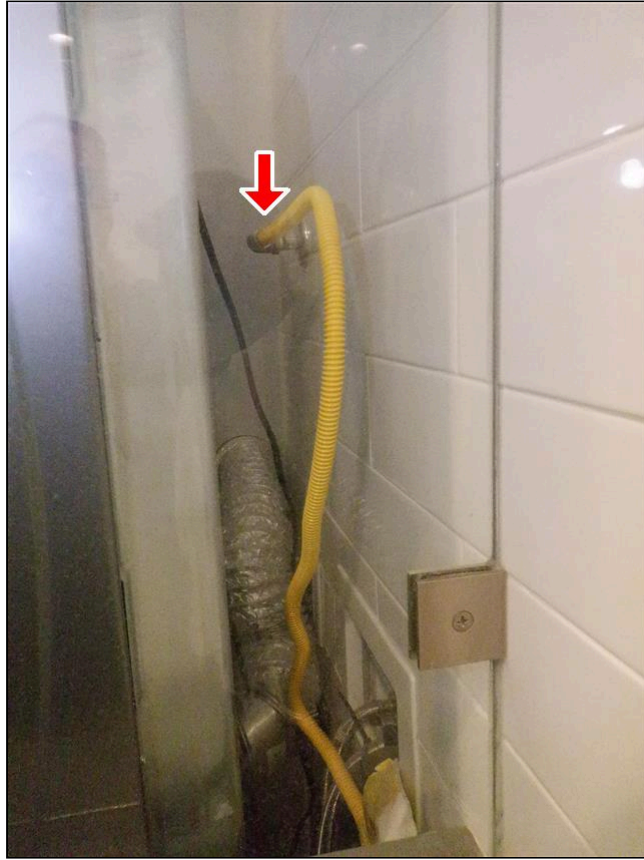
4.14 Item 1(Picture) Dryer Gas Supply No Shut Off

**4.14** Although this gas dryer was functioning we noted that this dryers gas line dose not have a fuel line shut off valve in plain sight at the unit. This is a safety issue that should be corrected. All appliances must be equipped with a fuel line shut off within line of sight of unit. Recommend evaluation and repair by a licensed plumbing contractor to avoid any future safety issues. FYI we believe that the shut off for this unit is in the utility room for the furnace and dryer.

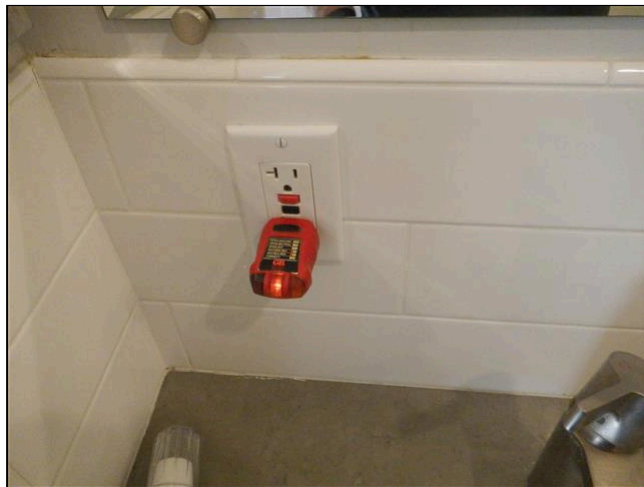
**6.5.A Bathroom GFCI was not functioning properly. This GFCI failed to trip when tested. Any GFCI outlet that dose not function as intended will be consider a safety issue. This is a possible shock hazard that should be corrected. Recommend evaluation by an electrical contractor and installation of new GFCI as needed.**

6.5.A Item 1(Picture) GFCI Not Functioning Properly

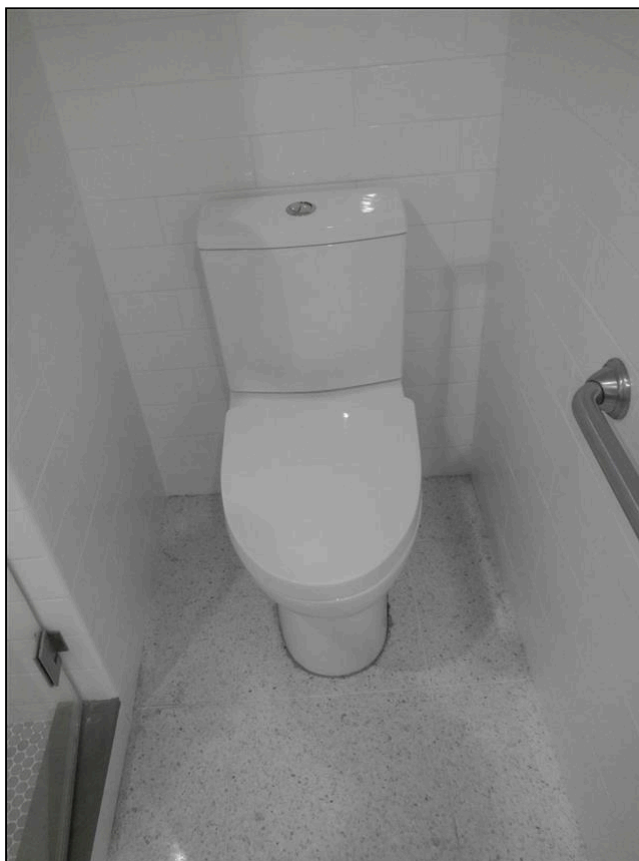
**6.7.A** This toilet is a low flow combo gpf toilet and it appeared to be functioning properly.

6.7.A Item 1(Picture) Low Flow Combo Toilet

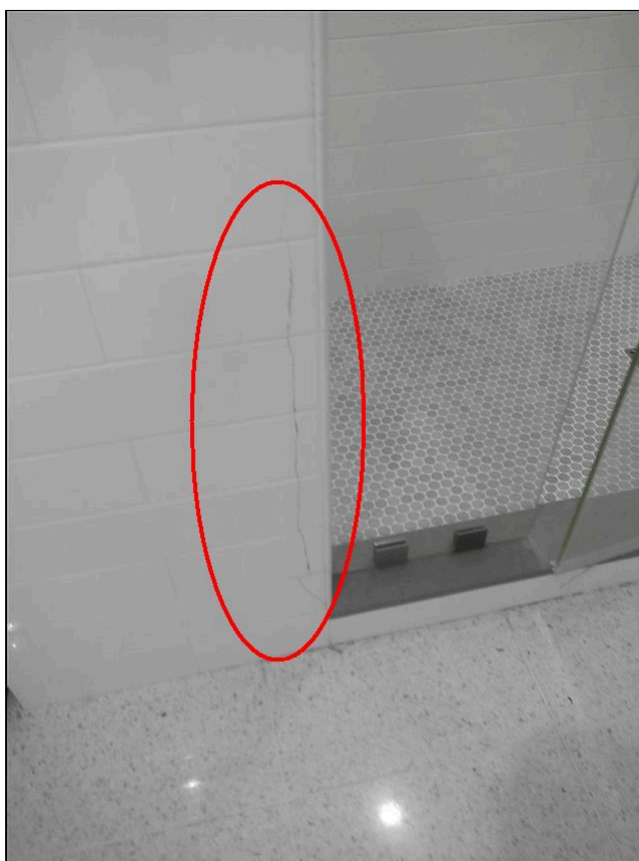
6.10.A Item 1(Picture) Damaged Tiles

**6.10.A** We noted several tiles on the outside of this shower that were damaged. Recommend evaluation and repair as needed by a licensed contractor.

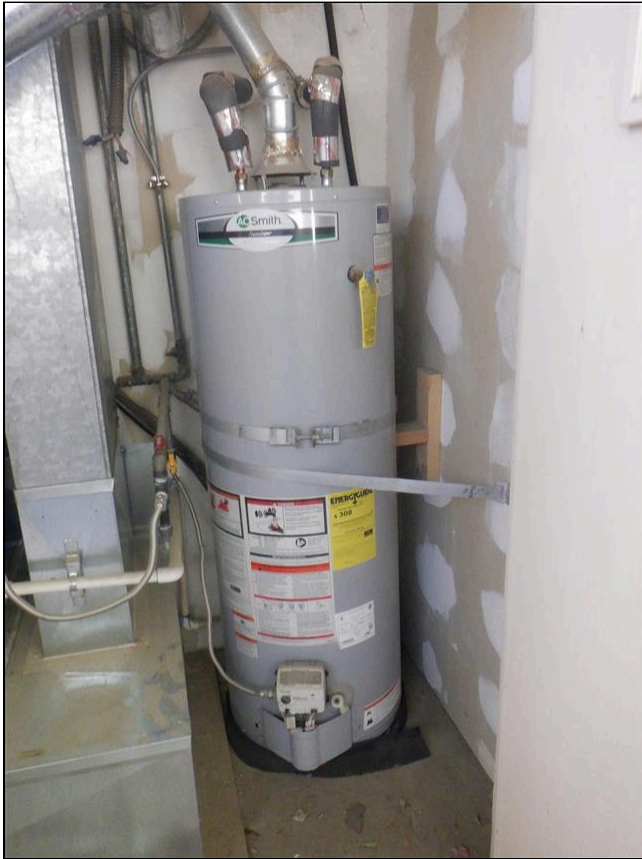
8.2 Item 1(Picture) Water Heater

**8.2 (1)** Although this water heater was functioning at time of inspection we noted that there was no sediment trap (Drip Leg) installed on the fuel line. The installation of fuel line sediment traps have been required for many years. We highly recommend installation of sediment traps (Drip Legs) on all gas fired tankless and tank type water heaters they are installed per manufactures installation requirements to help prevent sediment in the gas piping from getting into the gas valve or burner area of an appliance and causing safety issues with combustion. The installation of sediment traps may extend the life of an appliance. Recommend evaluation and installation of sediment trap by a licensed plumbing contractor. This unit has a 50 gallon tank it is 6 years old. FYI the lack of a sediment trap may

void the manufactures warranty if applicable.

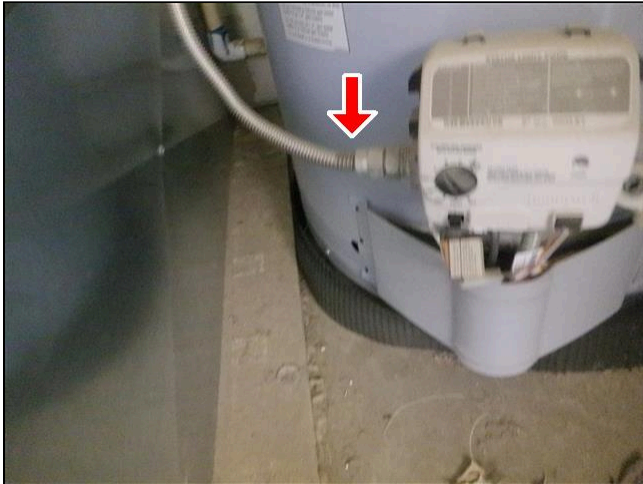
8.2 Item 3(Picture) Water Heater Fuel Line Missing Sediment Trap

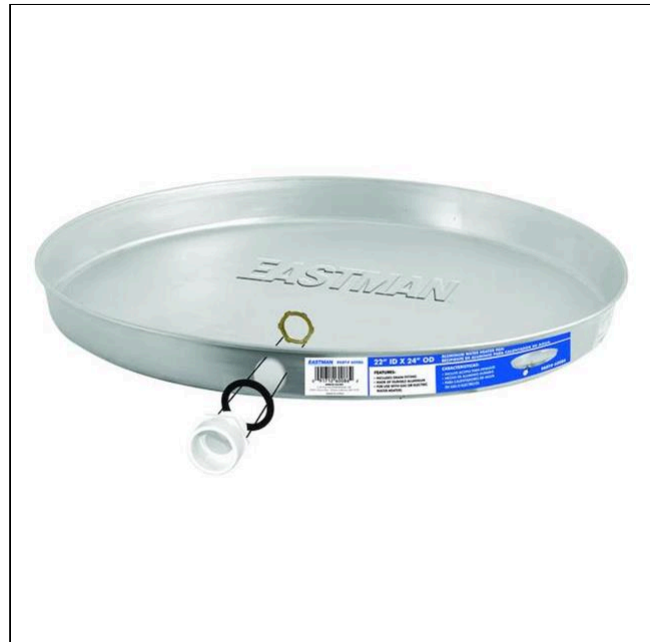
8.2 Item 6(Picture) Catch Pan Sample

**8.2 (2)** We also noted that this water heater has no catch pan under it. Catch pans have been required now for many years, they are required where damage to wall and framing members could occur from leakage (this includes all tank type and tankless water heaters). Considering the age of this water heater a catch pan should have been installed. Recommend installation of catch pan.

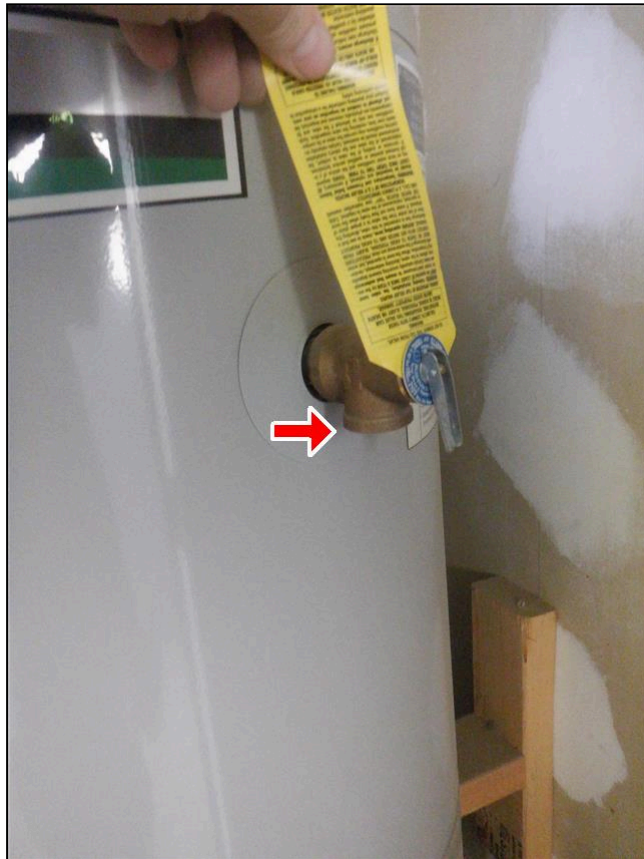
8.3 Item 1(Picture) Water Heater Missing TPR Valve Piping

**8.3** Although this water heater appeared to be functioning at the time of inspection, we noted that it was missing its TPR valve piping. TPR valve piping is required on all tank type and tankless gas water heaters. This is a safety issue that should be corrected. Recommend installation of TPR valve piping to avoid any future safety issues by a licensed plumbing contractor.

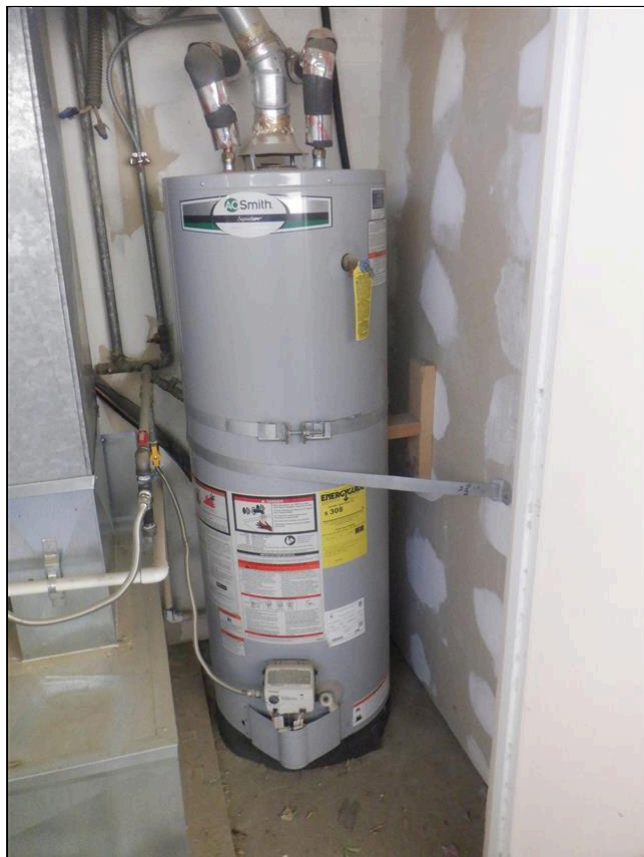
8.4 Item 1(Picture) Water Heater One Seismic Strap Only

**8.4** We noted that this water heater only had 1 seismic strap at time of inspection. All tank type water heaters are required to have a minimum of at least 2 seismic straps at all times, these seismic straps must be installed in the upper one third and lower one third of the unit, this is a hazard that should be corrected. Recommend evaluation and installation of second strap as needed by a licensed plumbing contractor.

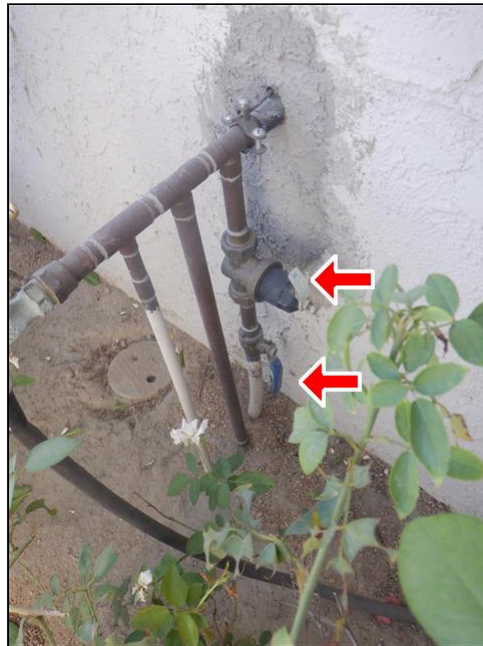
**8.5** (1) Main water shut and off and regulator are located at the front of house.

8.5 Item 1(Picture) Main Water Shut Off/Regulator

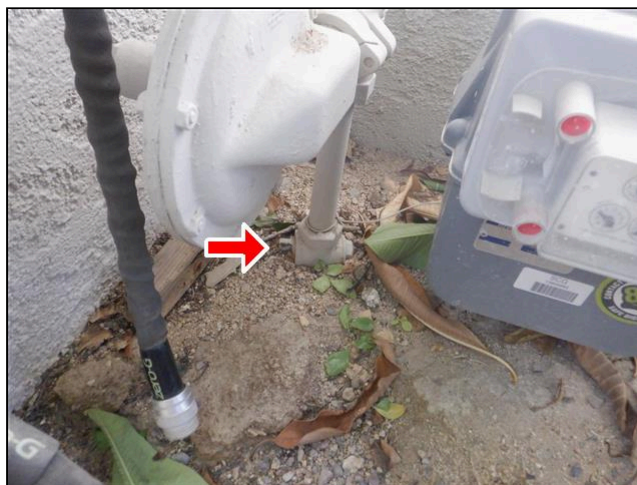
**8.6** Gas meter/shut off is located on the east side of the home. FYI main gas shut off wrenches are usually available at your local hardware store

8.6 Item 1(Picture) Main Gas Shut Off

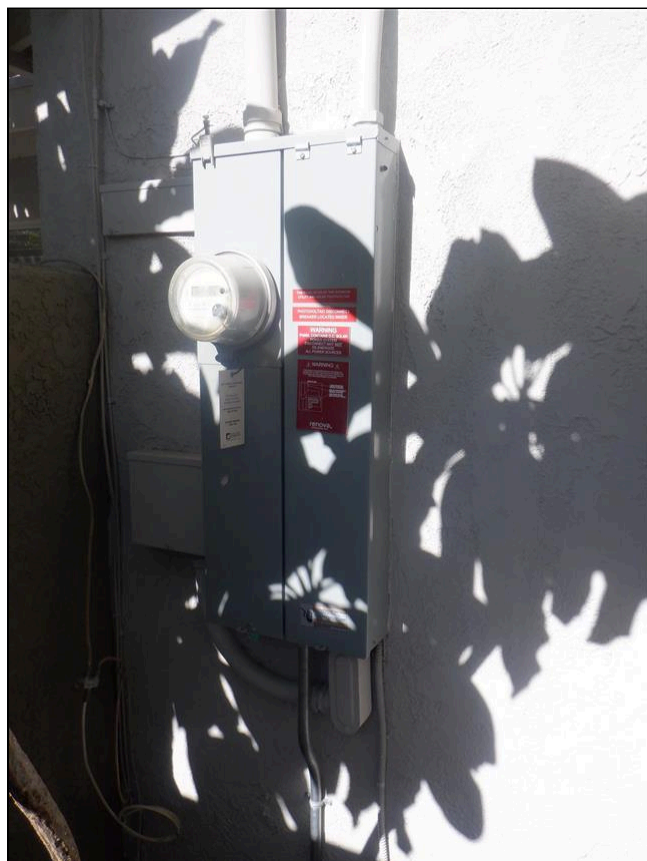
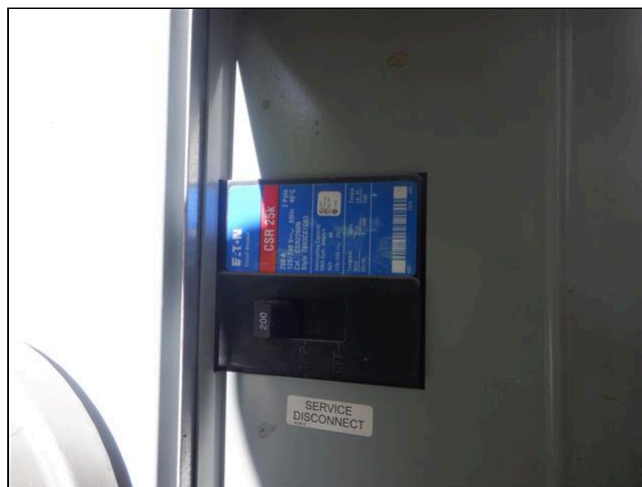
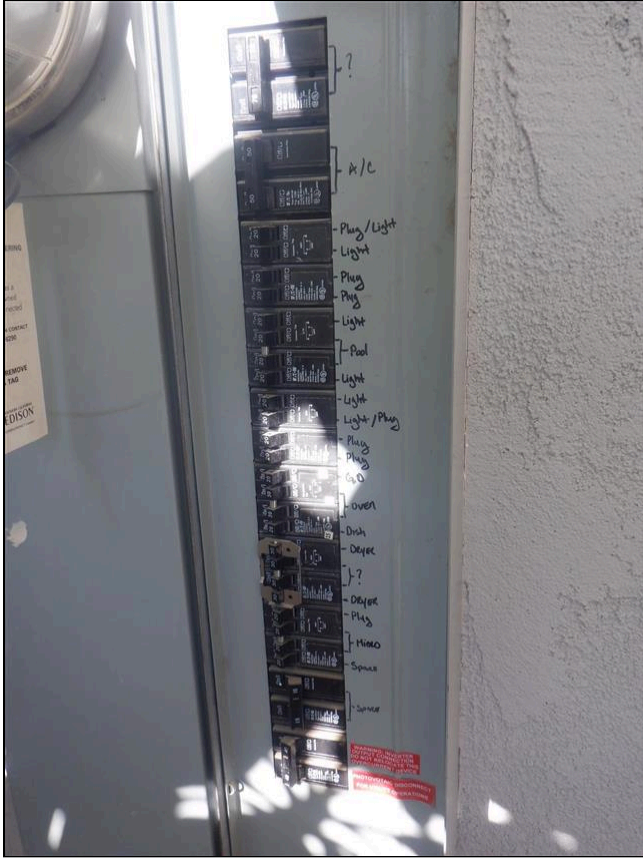
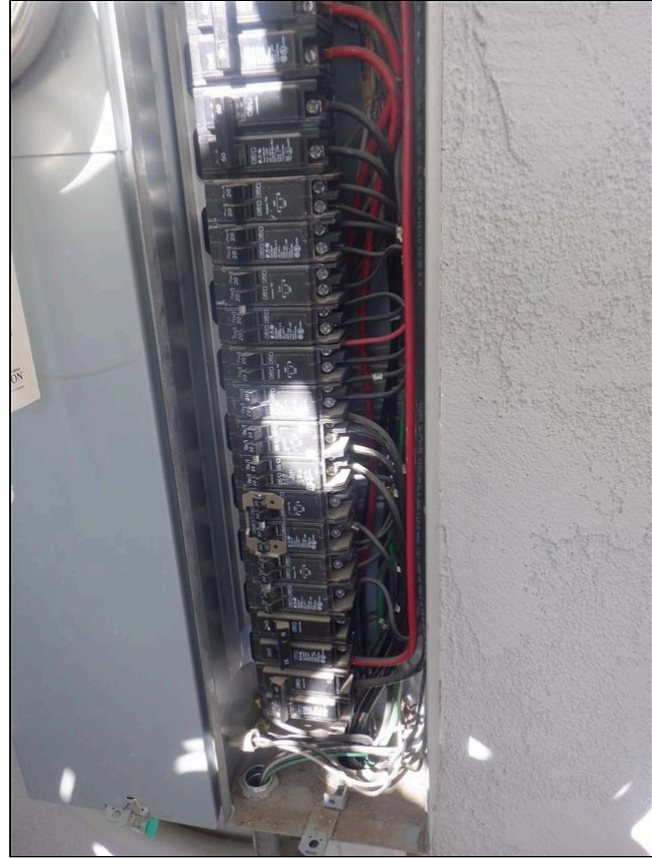
**9.1** The main electrical panel is located east side of the home it has a 200 amp main breaker. We did not find any irregularities in this panel at the time of inspection.

9.1 Item 1(Picture) Electrical Panel

9.1 Item 2(Picture) Electrical Panel Disconnect 200 Amp

9.1 Item 3(Picture) Electrical Panel Distribution

9.1 Item 4(Picture) Electrical Panel Breakers/ Conductors

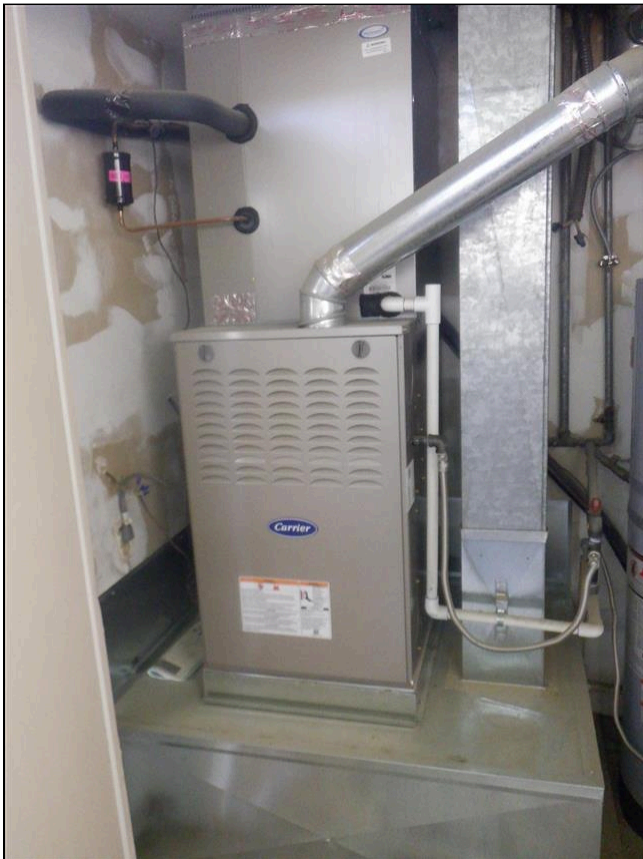
**10.0** (1) Although this heater is newer (3 years old) we noted that it failed to activate when thermostat was turned to heat mode. Recommend evaluation repair replace as needed by a licensed

10.0 Item 1(Picture) Heating Unit

HVAC contractor.

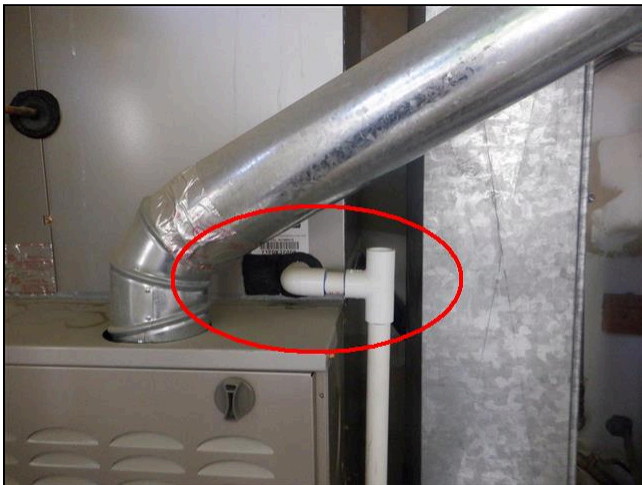
**10.0 (2)** This heater is 3 years old and although it failed to functioning at the time of inspection we noted that its missing its condensate safety micro switch, any unit installed on the interior of a home, utility room or garage should have a condensate safety switch, any blockage or overflow of condensate can cause damaged to interior drywall and framing members. Recommend evaluation and installation of a condensate safety switch by a licensed HVAC contractor.

10.0 Item 4(Picture) Heating Unit Missing Condensate Safety Switch

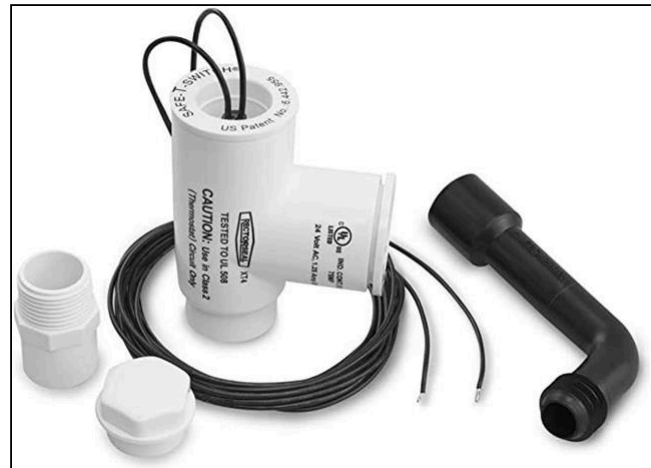
10.0 Item 5(Picture) Condensate Safety Switch Sample

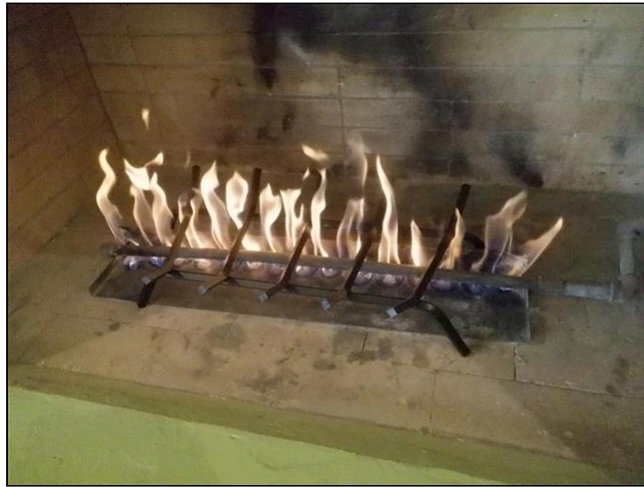
**10.5** Level 2 fireplace inspection should be conducted upon the sale or transfer of a property or after an operation malfunction or external event that is likely to have caused damage to the chimney. Building fires, chimney fires, seismic events as well as weather events are all indicators that this level of inspection is warranted. There are no specialty tools (i.e. demolition equipment) required to open doors, panels or coverings in performing a Level 2 inspection. A Level 2 inspection shall also include a visual inspection by video scanning or other means in order to examine the internal surfaces and joints of all clay or metal flue liners incorporated within the chimney. No removal or destruction of permanently attached portions of the chimney or building structure or finish shall be required by a Level 2 inspection. We highly recommend a level 2 fireplace inspection by a licensed fireplace specialist. Call All Seasons Fireplaces at 760.365.6668 Rick Newsom. FYI brick fireplaces have clay flue liners that are susceptible to damage during seismic events that's why we highly recommend this fireplace inspection.

10.5 Item 1(Picture) Fireplace
