# Inspection Report

**Property Address:**  
72543 Beavertail St  
Palm Desert CA 92260

<b>Date:</b> 10/2/2023	<b>Time:</b> 09:00 AM	<b>Report ID:</b> 20231002-72543-Beavertail-St
<b>Property:</b> 72543 Beavertail St Palm Desert CA 92260	<b>Customer:</b> Sara Rostand, Trustee	<b>Real Estate Professional:</b> Richard Von Ernst Compass

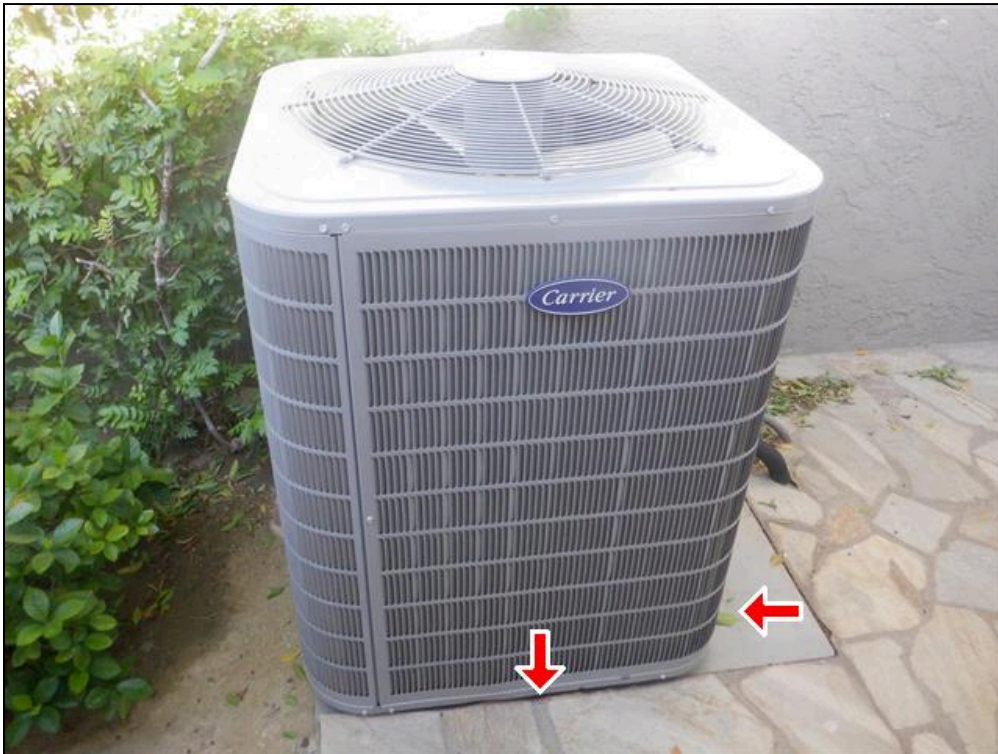
10.6 Item 1(Picture) Cooling Unit Not Secured

**10.6** This cooling unit is 3 years old and appeared to be functioning however we noted that it was not secured to the appliance pad at time of inspection. Recommend evaluation and repair by a licensed HVAC contractor.

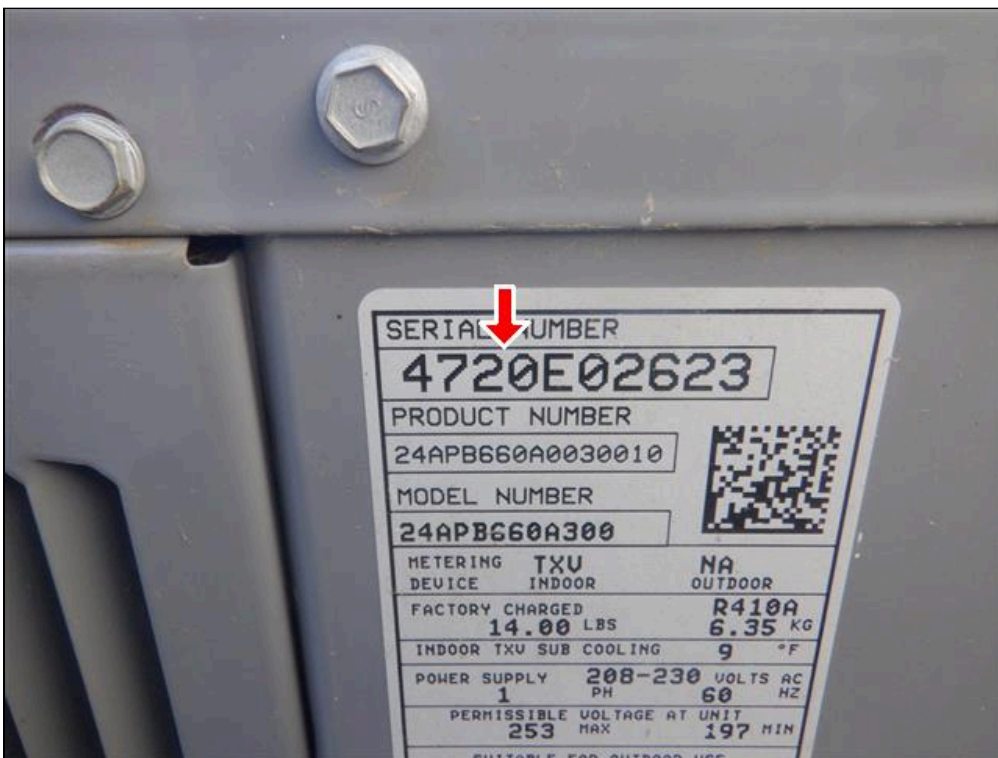
10.6 Item 2(Picture) Cooling Unit

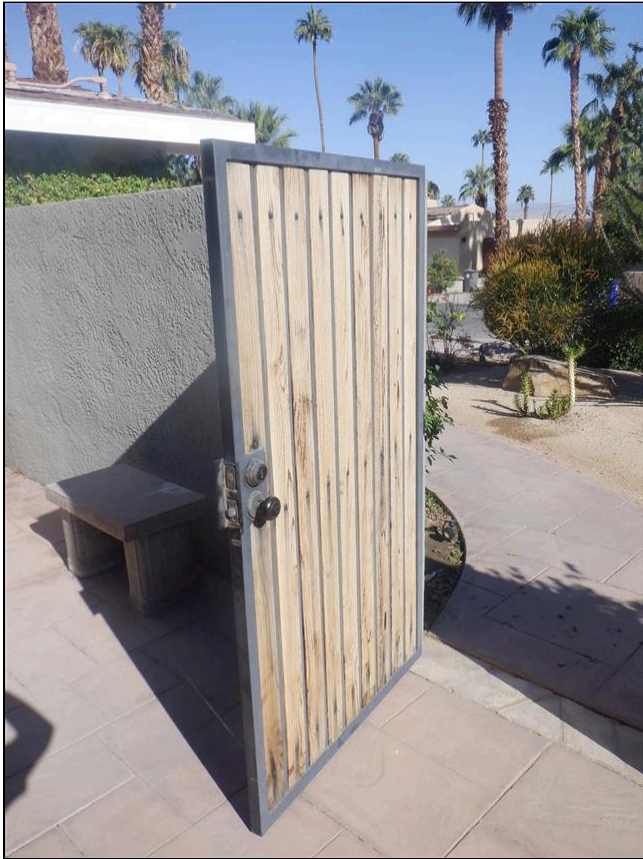
**11.8** We noted that this home has multiple gates that access the backyard from the street, all gates that can access the pool area from the street are required to have self closing self latching hardware, they are also required to open outwards towards the street and the self latching hardware cannot be any lower that 54 inches from grade any deviation in these requirements results in a safety issues. These safety requirements are designed to keep young children away from the pool area and safe. Recommend evaluation of all gates and repair of all the above mentioned issues by a licensed contractor who is familiar with these pool safety features. FYI these gates do not meet these safety protocols. Gate 1 (courtyard) opens inward and dose not have self closing or self latching hardware

11.8 Item 1(Picture) Gate 1

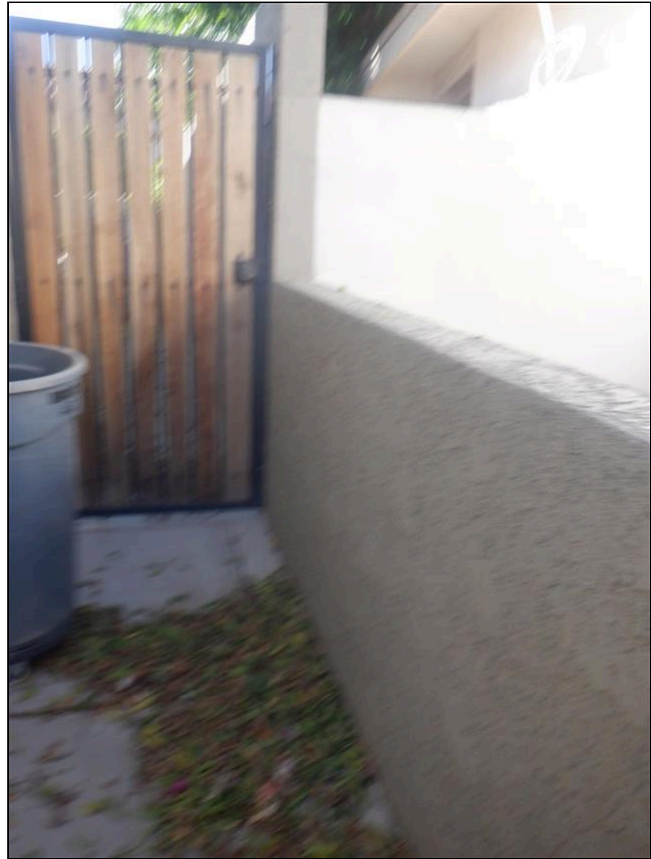
11.8 Item 2(Picture) Gate 2

gate 2 opens outward and dose not have self closing or self latching hardware.

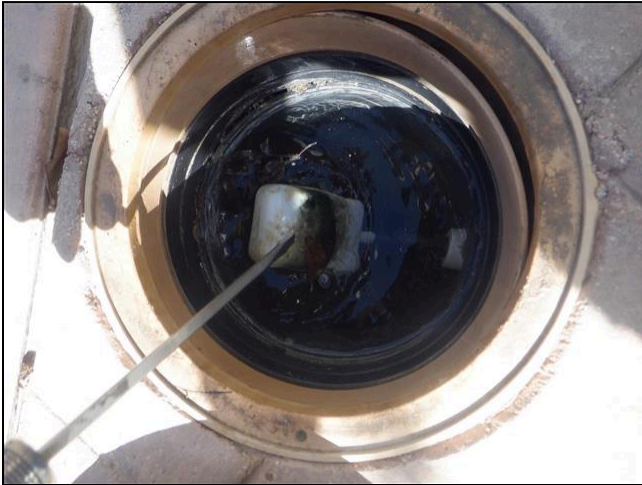
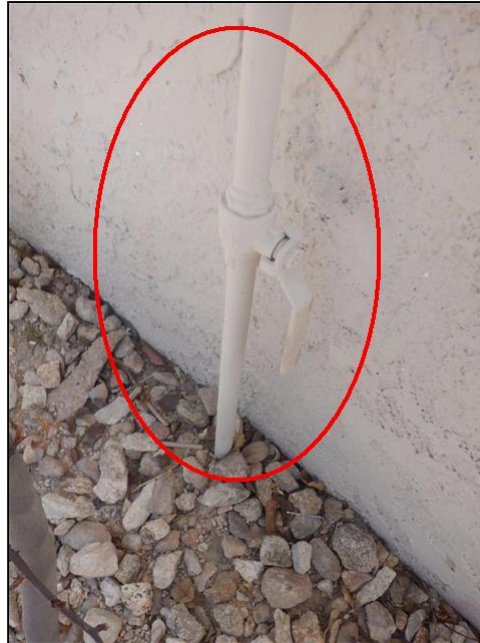
**11.13** Although the auto fill appeared to be functioning properly we were unable to locate the required backflow preventer. All pools with an auto fill are required to have a backflow preventer. Recommend evaluation by a licensed pool contractor to install the required backflow preventer.

11.13 Item 1(Picture) Pool Auto Fill

11.13 Item 2(Picture) Auto Fill Supply Missing Backflow Preventer

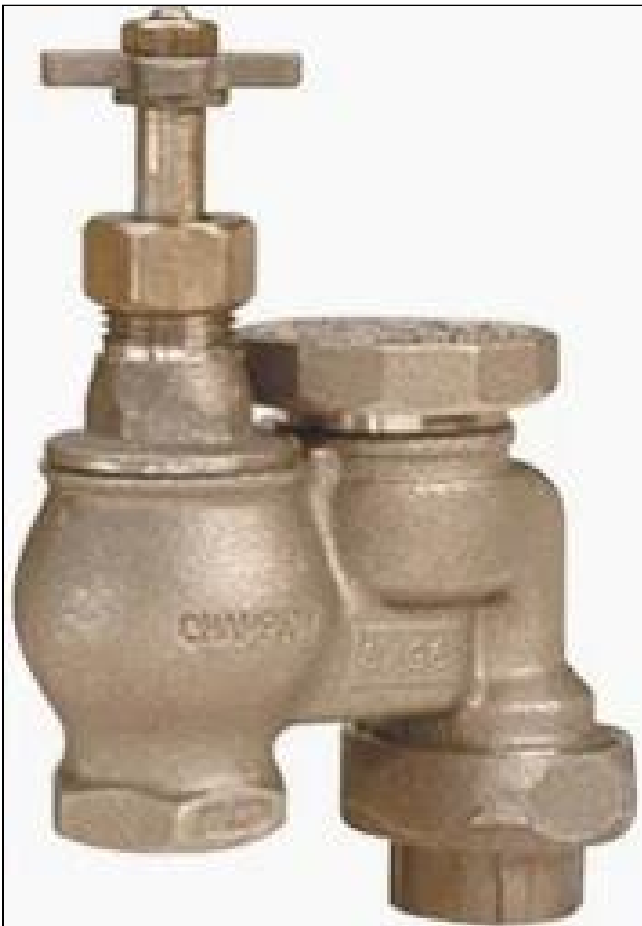
11.13 Item 3(Picture) Backflow Preventer Sample

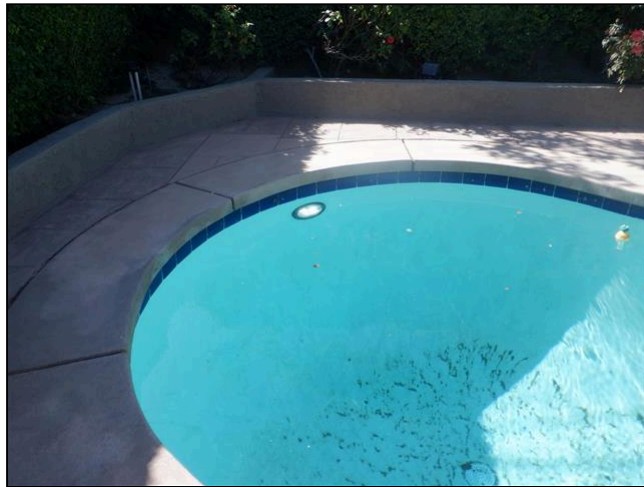
**11.16** Pool light functioning properly at the time of inspection.

11.16 Item 1(Picture) Pool Light

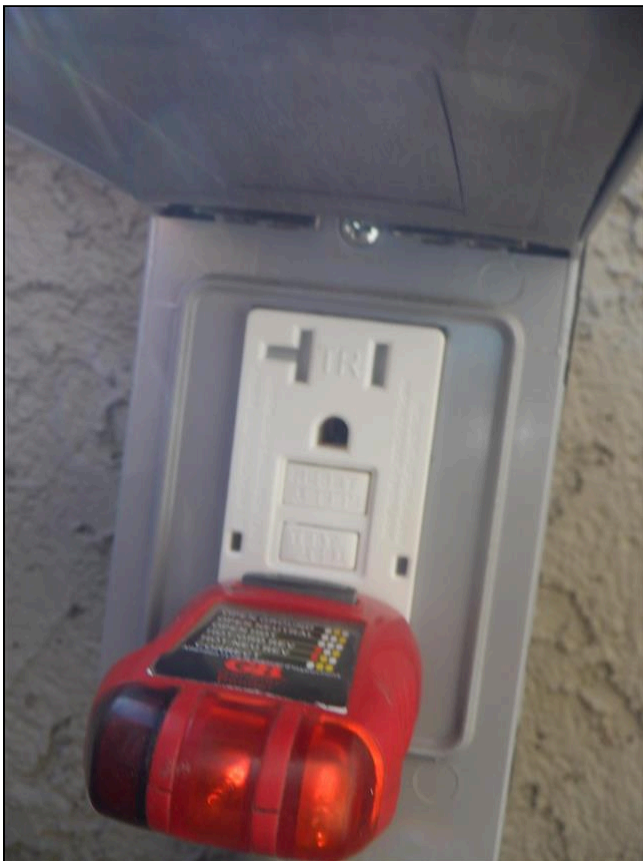
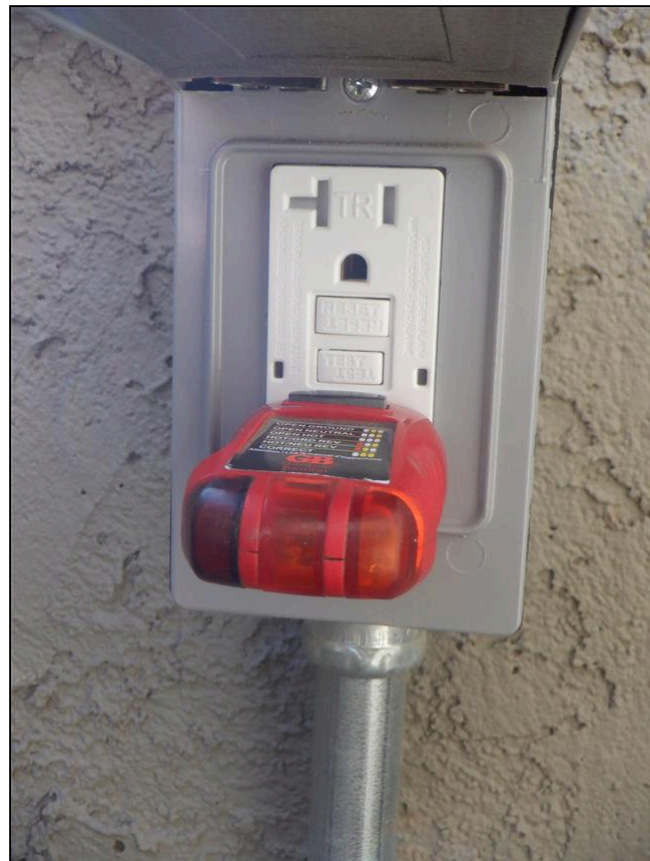
**11.17** Pool light GFCI functioning properly at the time of inspection.

11.17 Item 1(Picture) Pool Light GFCI

11.17 Item 2(Picture) Pool Light GFCI Functioning Properly

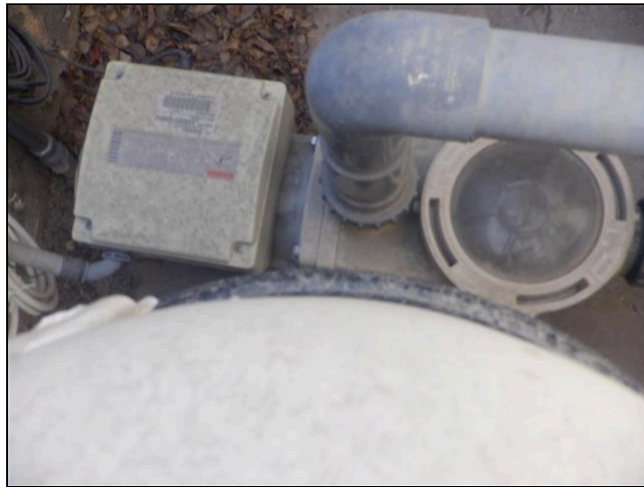
**11.18** We noted all pumps and motors were functioning properly at time of inspection.

11.18 Item 1(Picture) Pool Pump

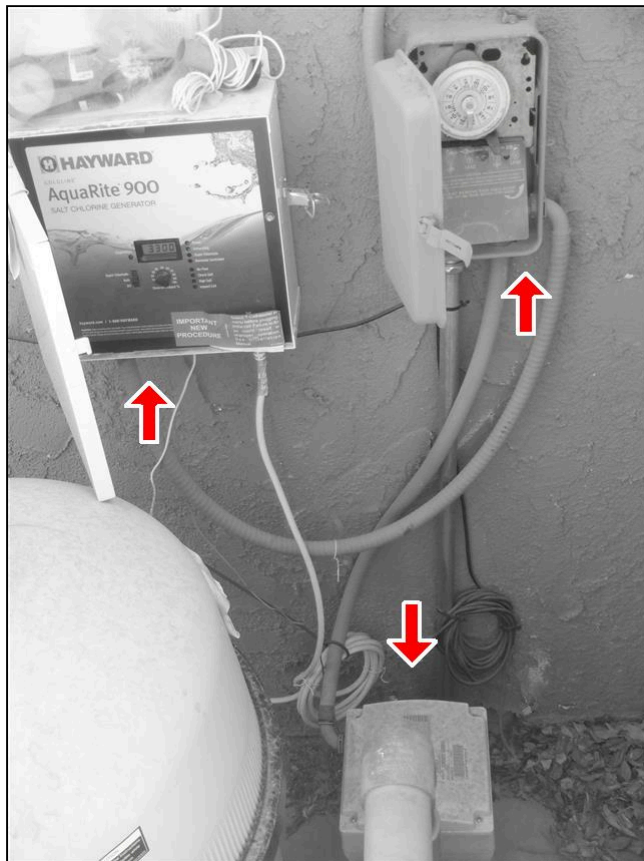
11.27 Item 1(Picture) Pool Equipment No Bond Wire Present

**11.27** We noted that there was no bond wire present at the pool equipment at the time of inspection. This is a possible shock hazard that should be corrected. All metal parts of pool/spa pumps, motors, heaters, control panels, switches and sub panels should be bonded together and bonded to the pools bonding grid at all times. FYI the installation of a ground rod may solve this issue. Recommend checking local codes for the installation of ground rod and evaluation repair replace as needed by a licensed pool contractor.

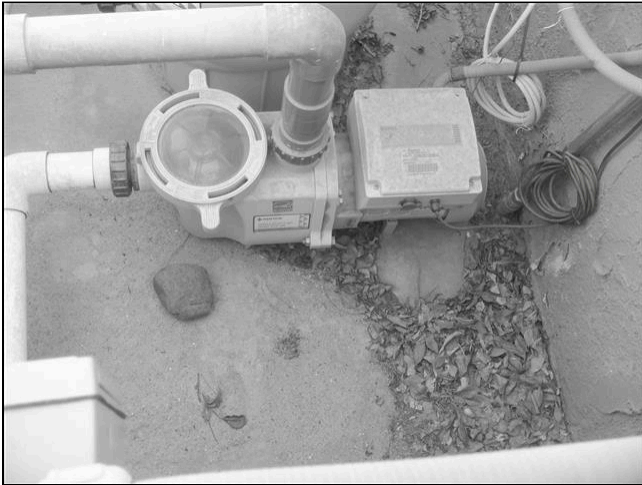
**11.28** We noted that all this pool equipment appeared to be older the requirements for the pool equipment electrical has changed over the years the new requirements are as follows all pool pumps are required to be individually GFCI protected by a electrical panel GFCI breaker and if this pool equipment is to be upgraded these requirements should be met. Recommend evaluation by a licensed pool contractor to determine if this pool equipment requires any additional GFCI protection and install as needed. FYI this additional GFCI protection may be required in certain jurisdictions for a vacation

11.28 Item 1(Picture) :Pool Pump No GFCI Protection

rental permits. FYI follow all local codes on this issue.

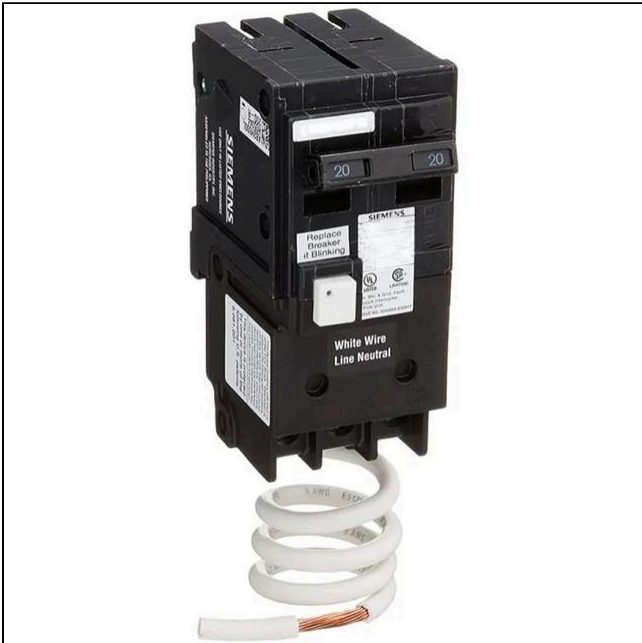
11.28 Item 3(Picture) GFCI Protection Sample

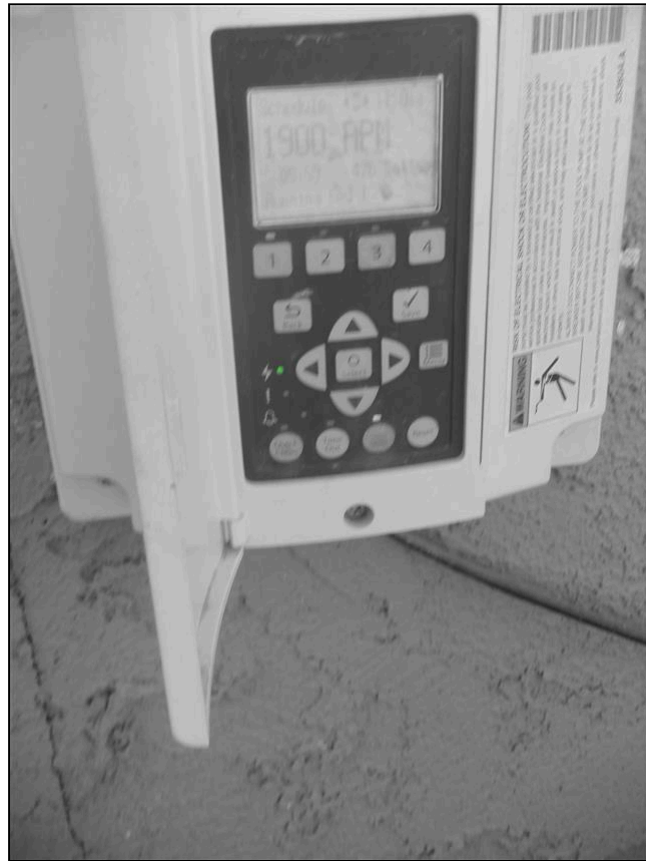
**11.29** The controller present is for activation/de activation of pool pump and speed control.

11.29 Item 1(Picture) Pump Controls

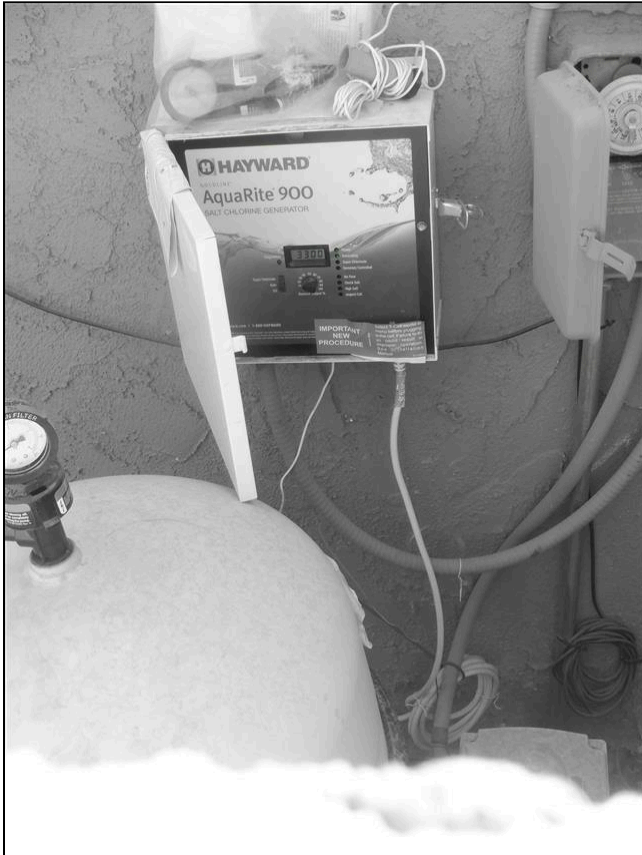
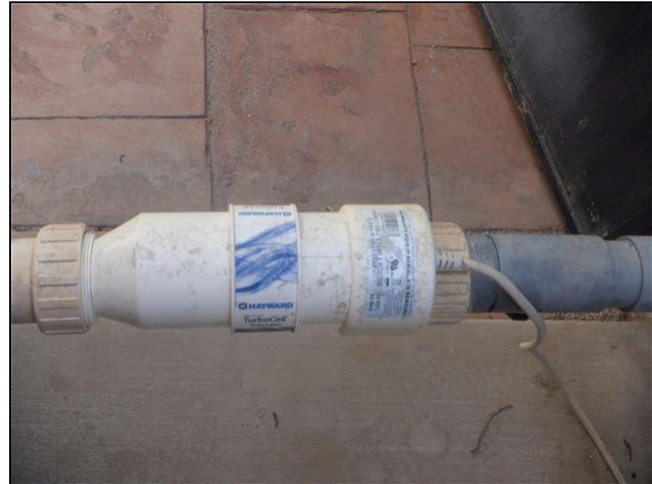
11.32 Item 1(Picture) Chlorine Generator

**11.32** We believe that this pool is equipped with a electronic salt/chlorine generating system. We have no way of testing these units for proper operation or even knowing if there functioning properly. This unit should be evaluated for proper operation by a licensed pool contractor.

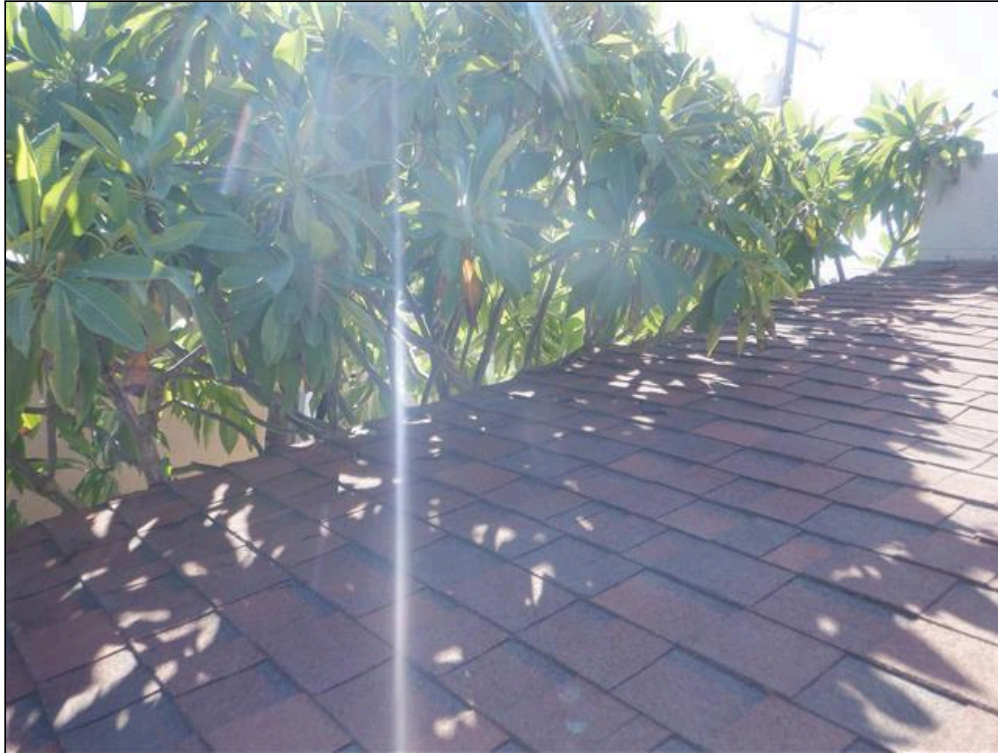
1.6 Item 1(Picture) Roof Tree Contact

(1) The tree limbs that are in contact with roof or hanging near roof should be trimmed. Trees/bushes that grow close to or onto the roof can damage roofing materials as well as allowing rodents and pests access to the attic areas.

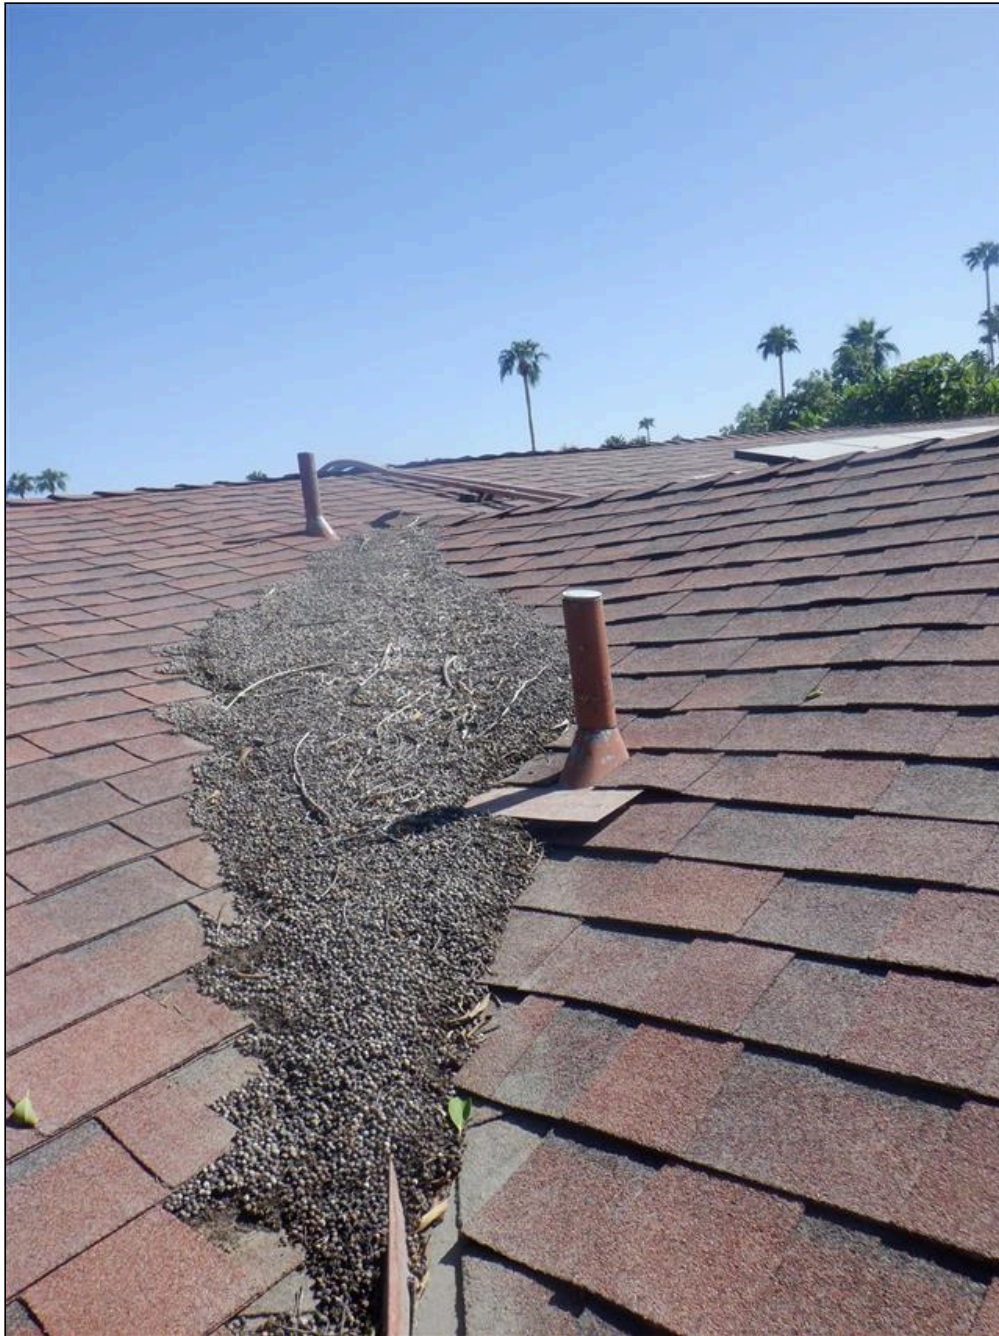
1.6 Item 2(Picture) Roof Debris

(2) We noted debris on this roof in several locations. It is possible for this debris to impede drainage in a rain event. Recommend removal of debris to insure proper drainage.

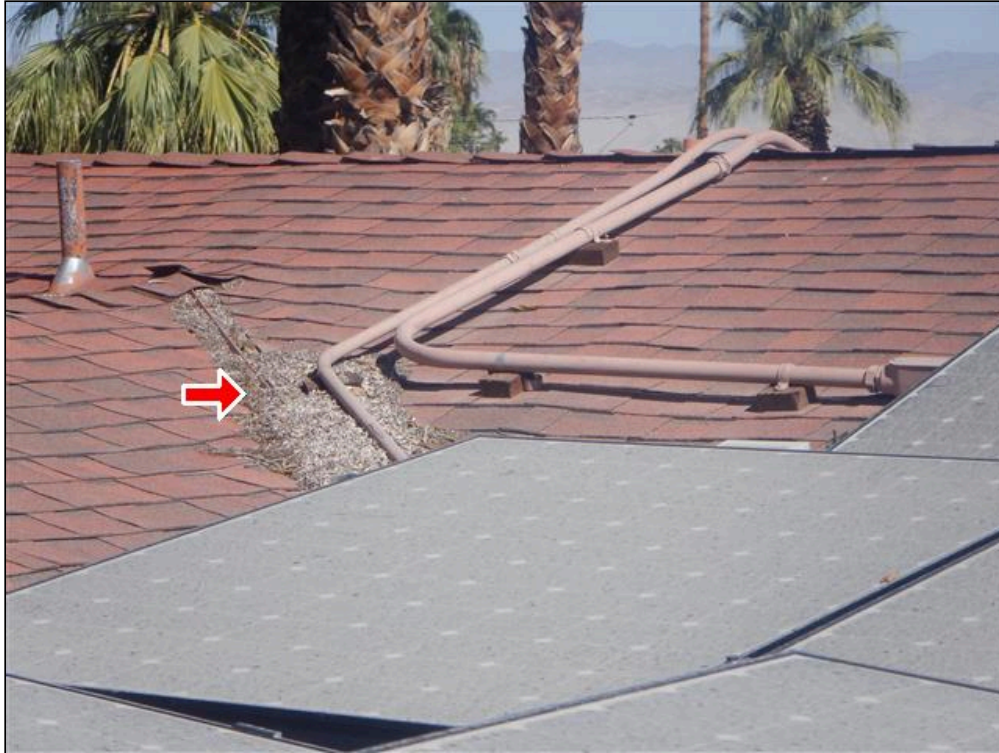
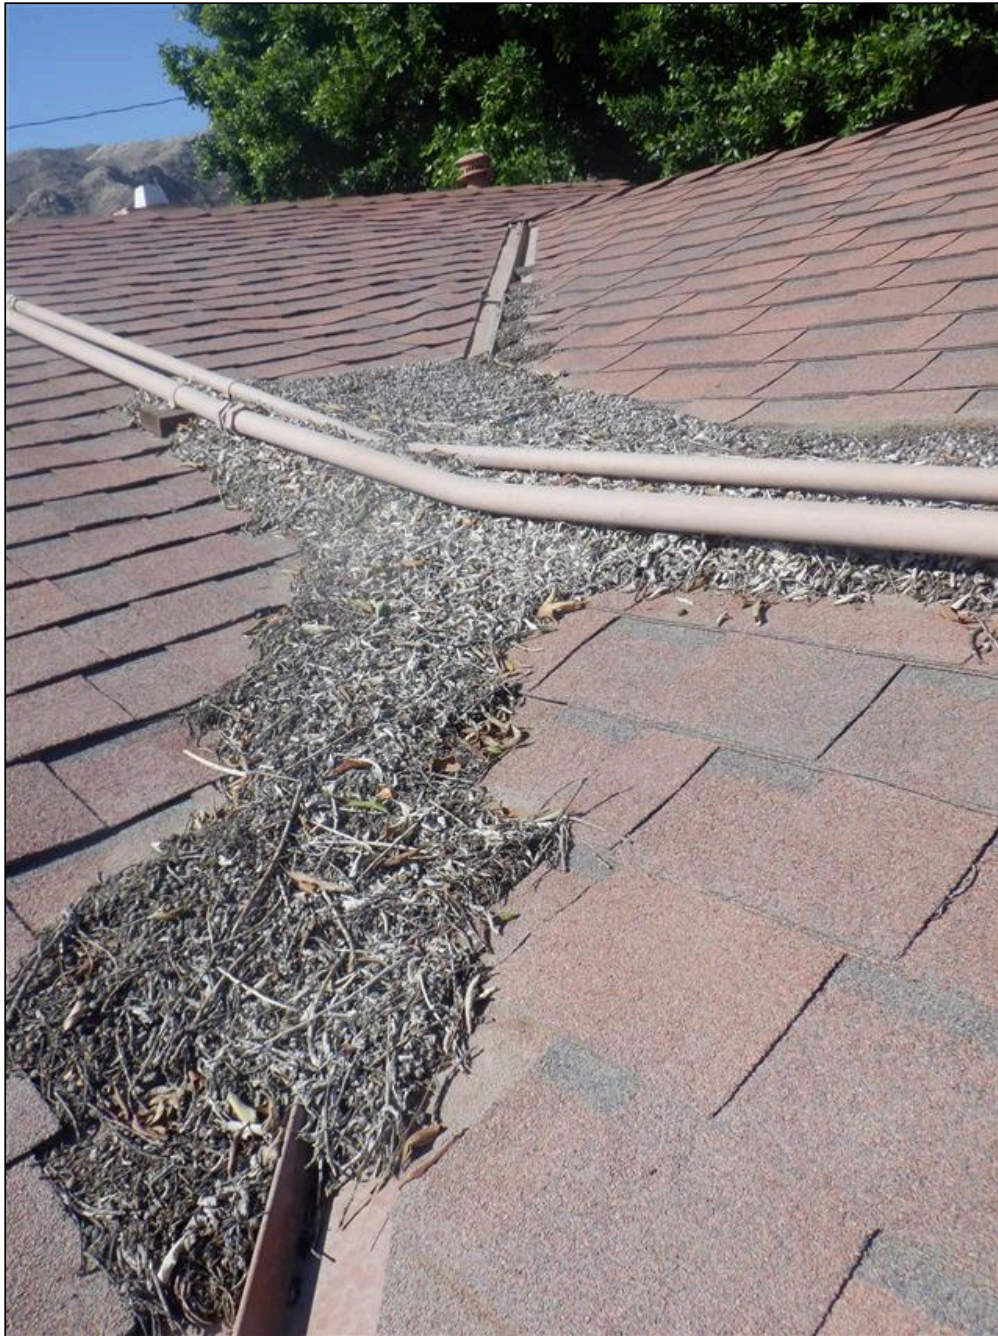
1.6 Item 3(Picture) Roof Debris

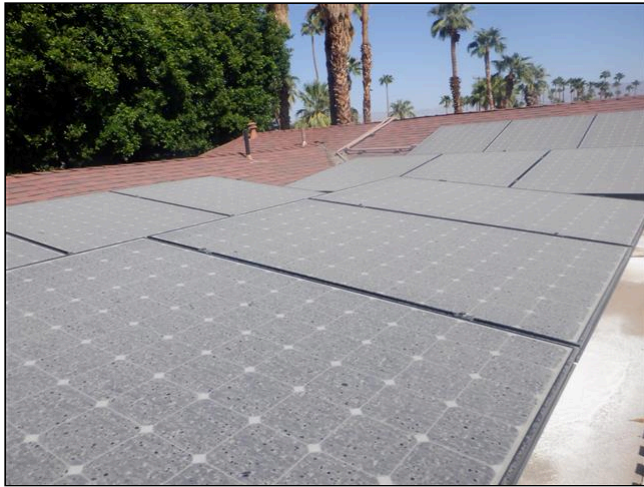
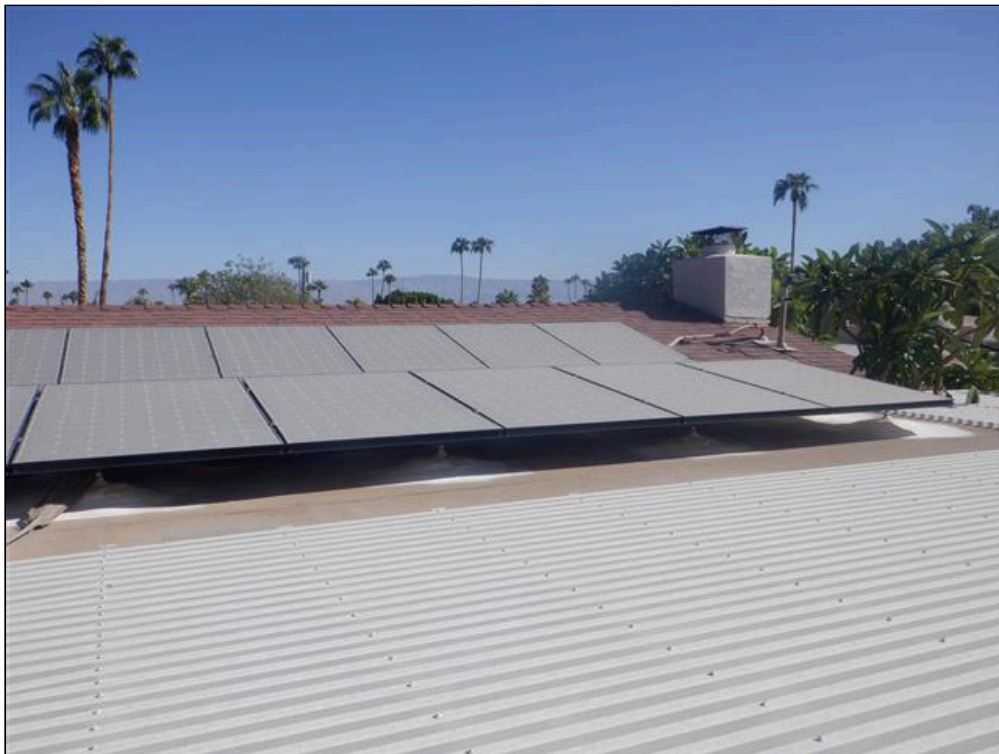
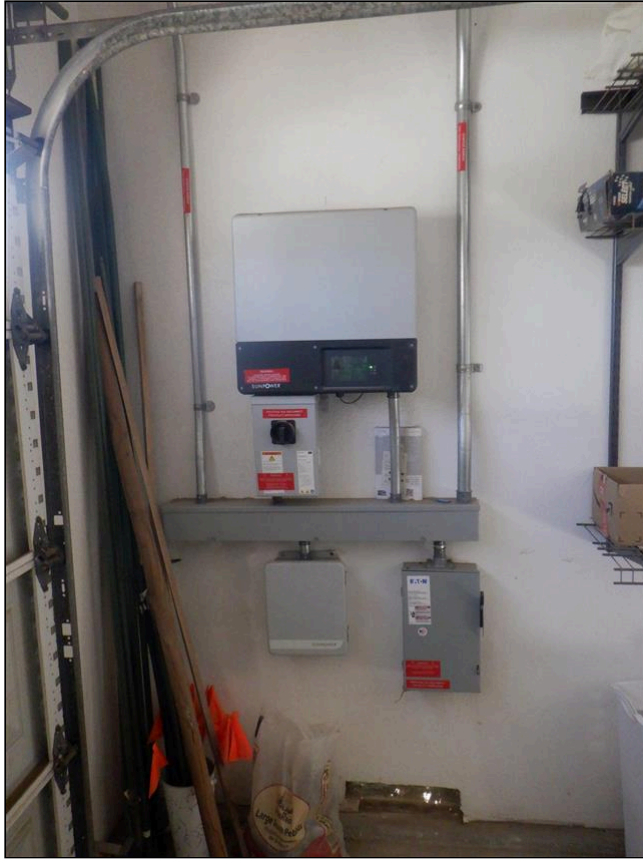
We noted that this house is equipped with solar panels/solar equipment. Our company dose not inspect solar panels/equipment and we have no way of telling if they are functioning properly or if they were installed correctly. Improperly installed solar panels can lead to roof leaks. This solar equipment should be evaluated by a licensed specialist. FYI recommend reaching out to the manufacture or installer for information on existing warranties and maintenance schedules.

1.8 Item 1(Picture) Solar Panels

1.8 Item 2(Picture) Solar Panels

1.8 Item 3(Picture) Solar Equipment

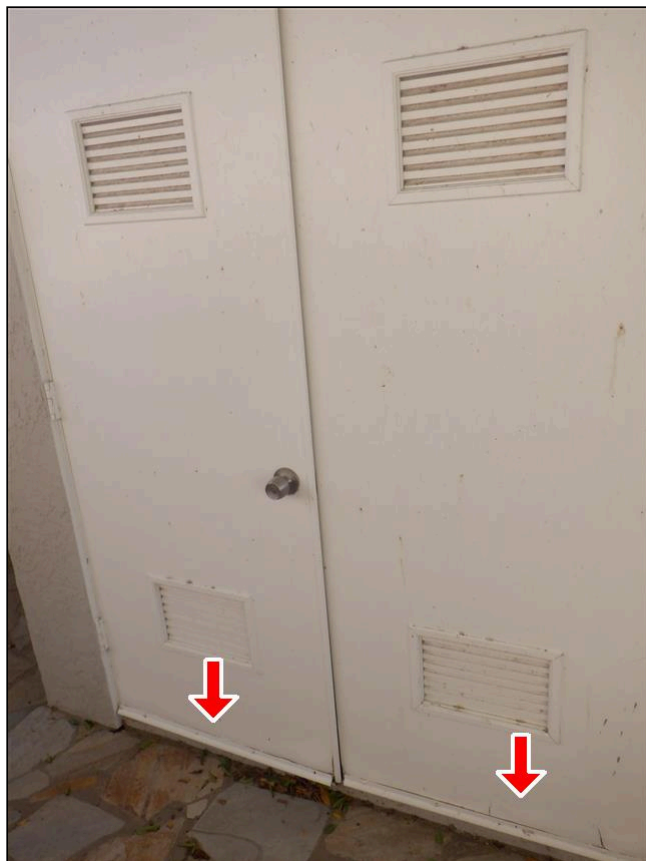
2.1 Item 1(Picture) Utility Room Doors Weathered

We noted that the heating and water heater compartment doors appeared weathered and damaged. Recommend evaluation by a licensed contractor repair replace as needed.

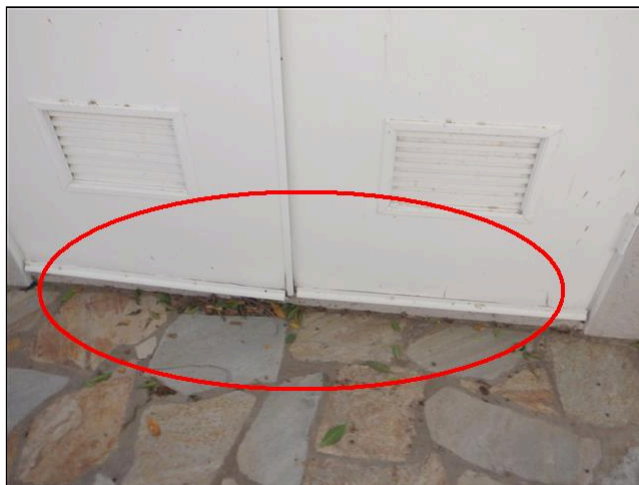
2.1 Item 2(Picture) Utility Room Doors Weathered

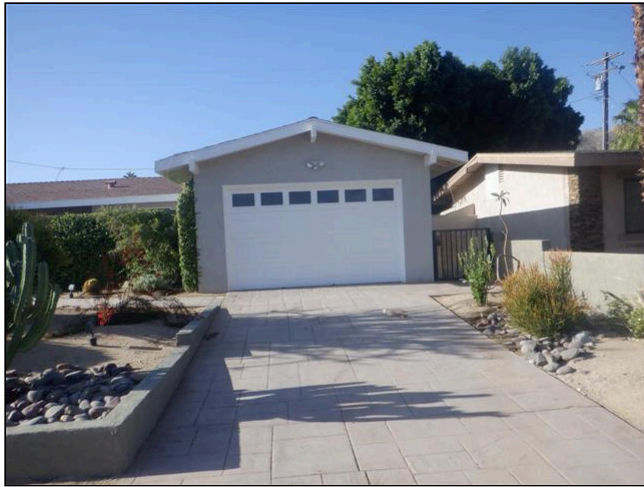
(1) Cracks were noted in the concrete driveway and patio slab. These slab cracks are normal shrinkage cracks for this climate, none of which exceeded 1/8 inch in size. Recommend repair as desired.

2.3 Item 1(Picture) Driveway Cracks

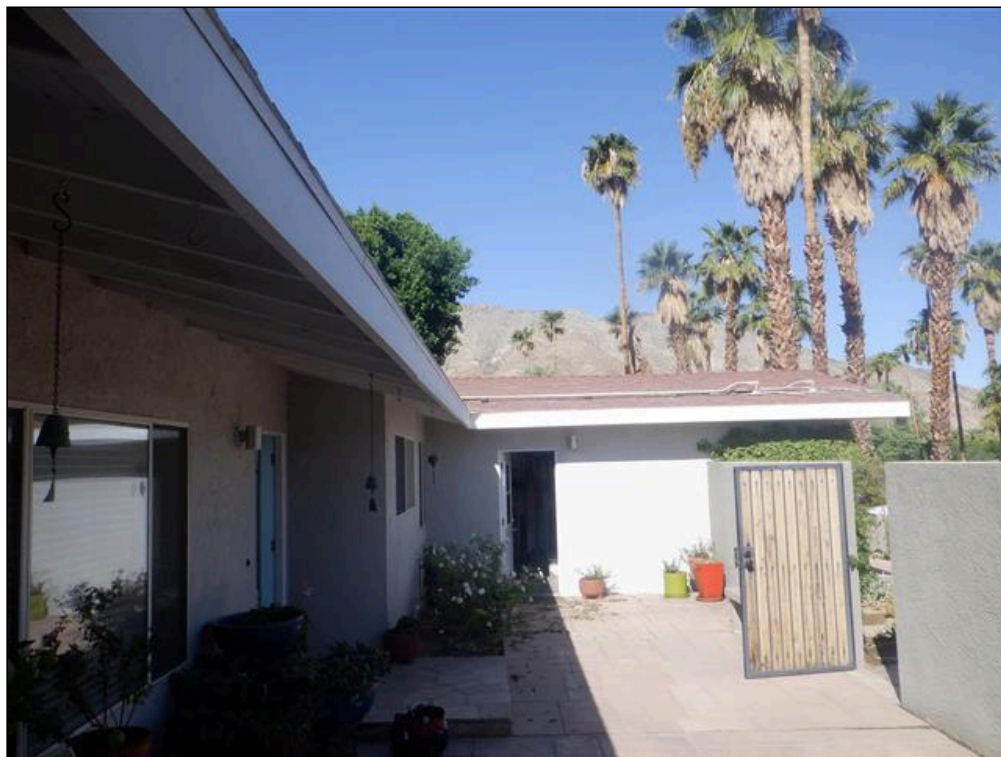
2.3 Item 11(Picture) Rain Gutters Needed

only one way the water during rain events can drain out of this area (through the gate). Recommend adding a rain gutter system to the eaves and drilling weep holes in the courtyard walls by a licensed contractor.

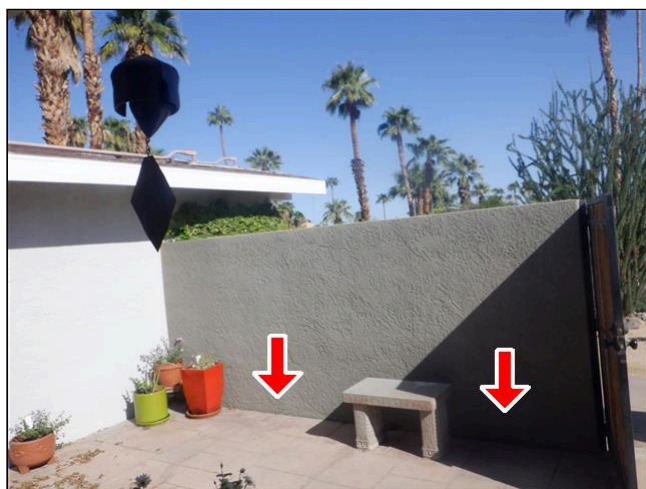
(2) We noted that a portion of the slab in the courtyard has an even grade and there appears to be

2.3 Item 12(Picture) Weep Holes Needed

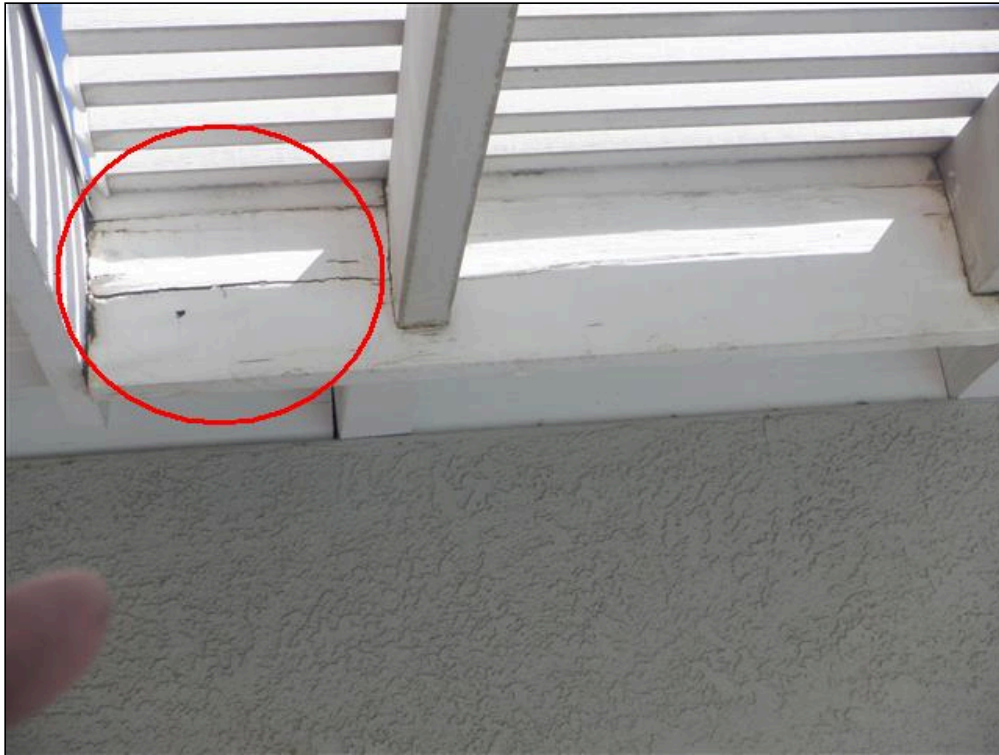
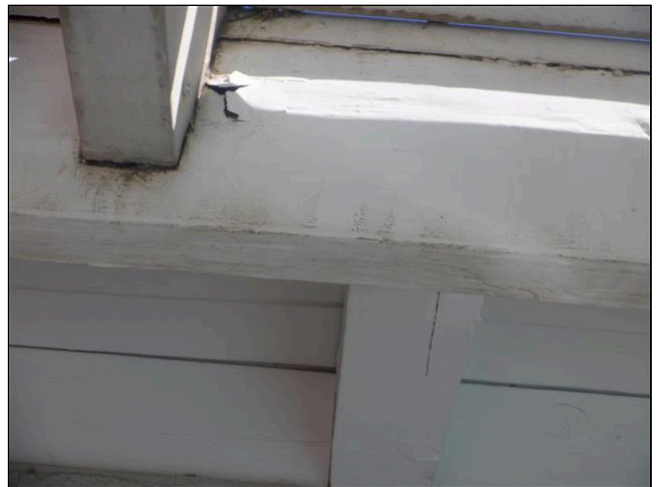
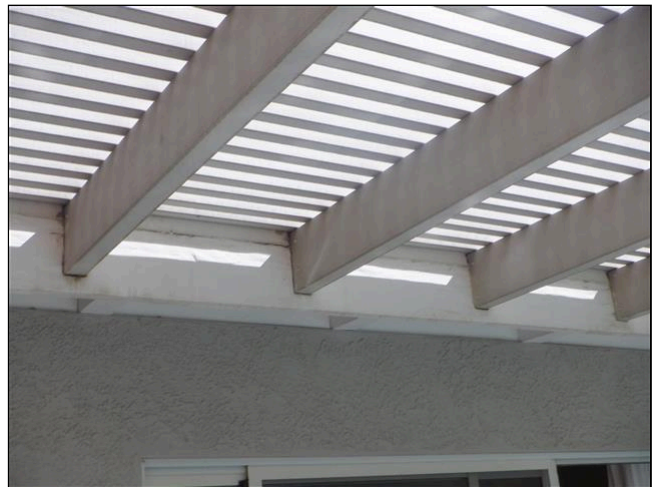
2.4 Item 1(Picture) Damaged Wood

The paint on the eaves and the fascia boards appears to be peeling and failing in at least one area (rear patio). We also noted damaged wood in at least one area. Recommend evaluation and repair of any damaged wood prep and painting of the fascia boards and eaves to insure future integrity of wood by a licensed contractor.

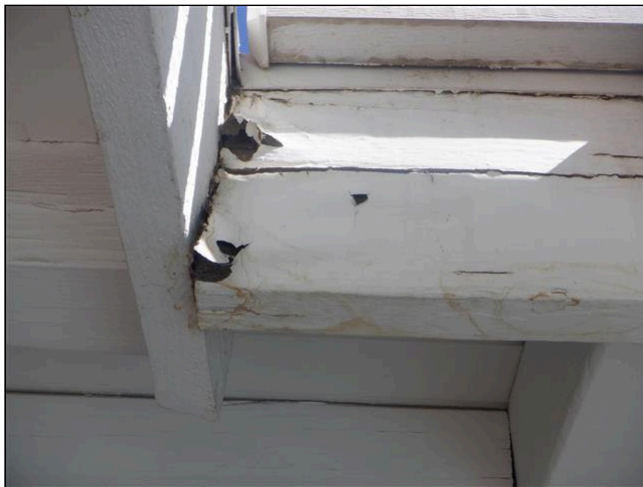
2.4 Item 2(Picture) Damaged Wood

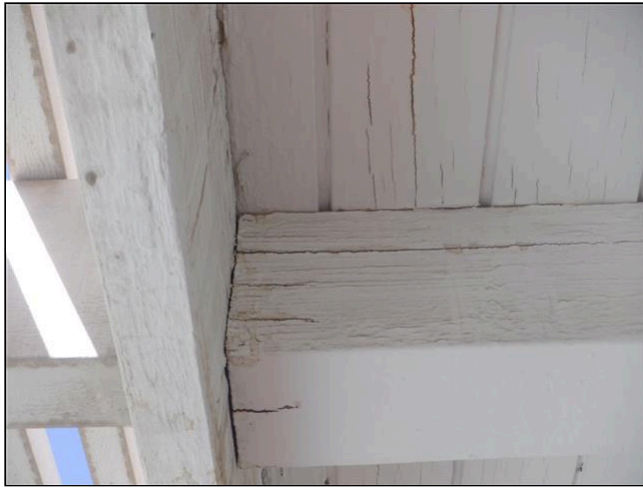
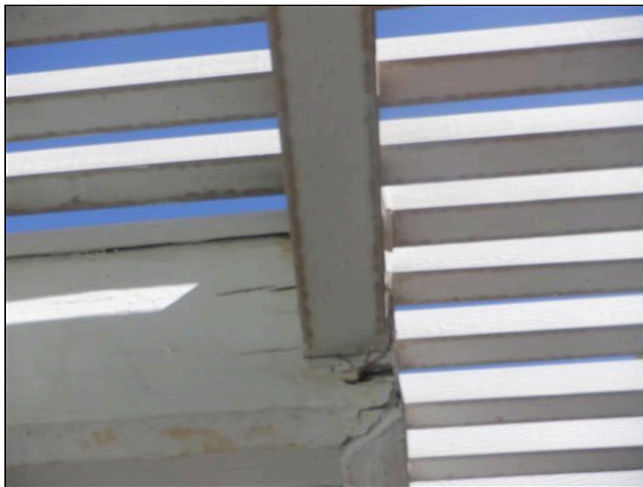
2.4 Item 5(Picture) Failing Paint

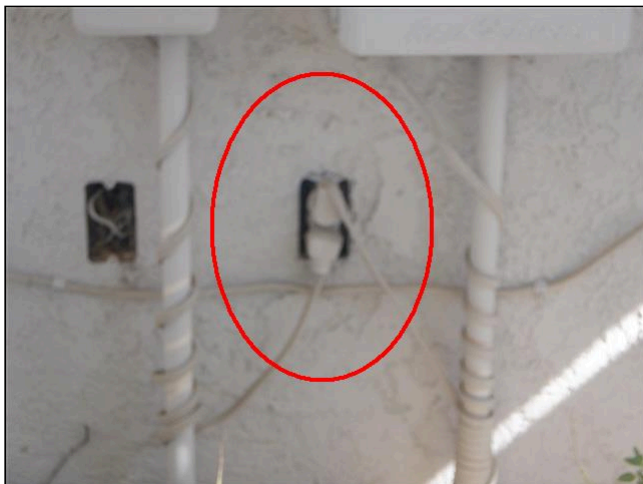
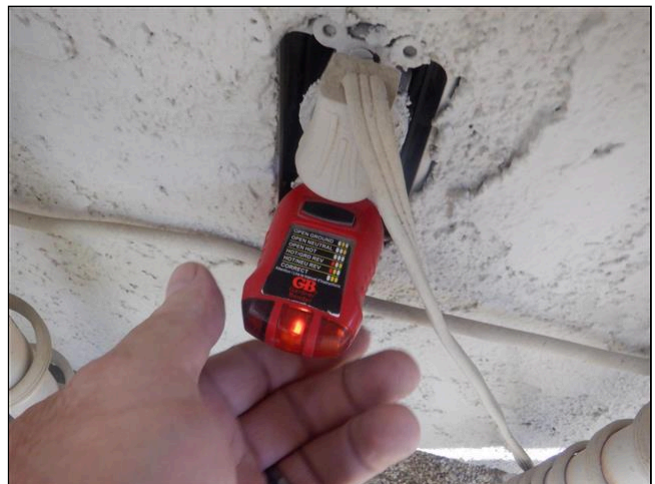
Although most exterior outlets were GFCI protected we noted at least one that was not. All exterior outlets should be GFCI protected, we highly recommend the installation of GFCI outlets by a licensed electrical contractor for proper shock protection and to avoid any safety issues. Location of none GFCI protected outlets as follows

2.6 Item 1(Picture) Outlet No GFCI Protection

2.6 Item 2(Picture) Outlet No GFCI Protection

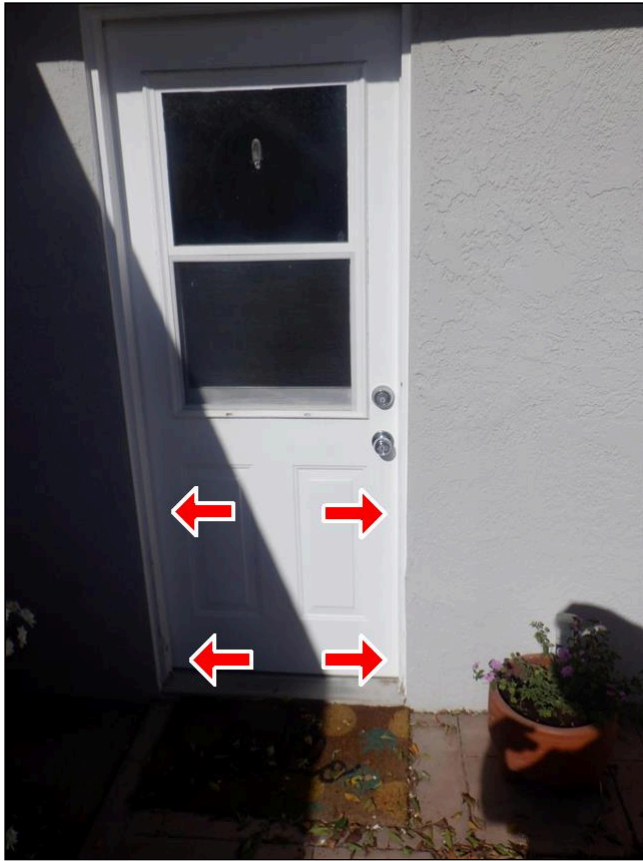
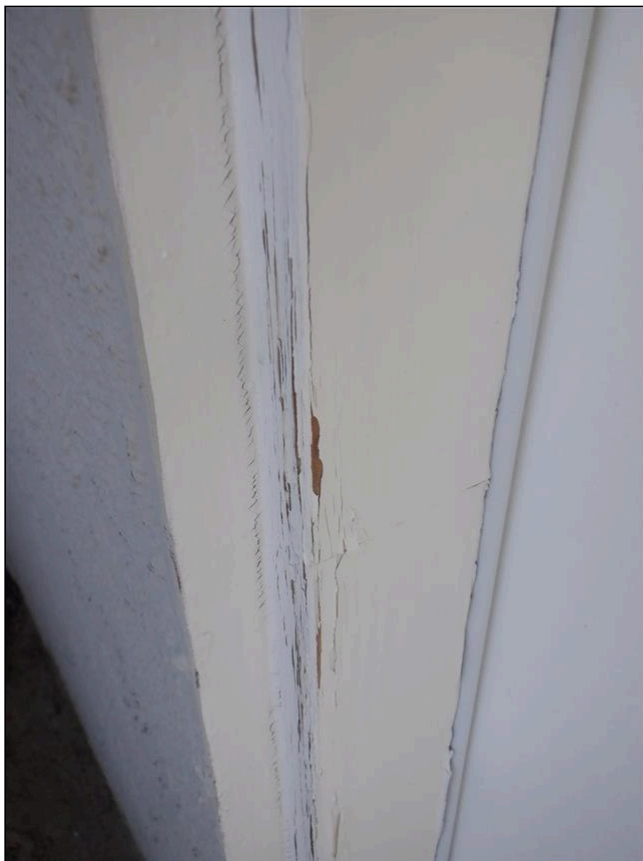
3.6 Item 1(Picture) Failing Trim Paint

(1) We noted that the paint on the exterior door jam around the main garage pedestrian door appears to be bubbling and failing. Recommend prep and paint door jam as needed to ensure future integrity of the wood.

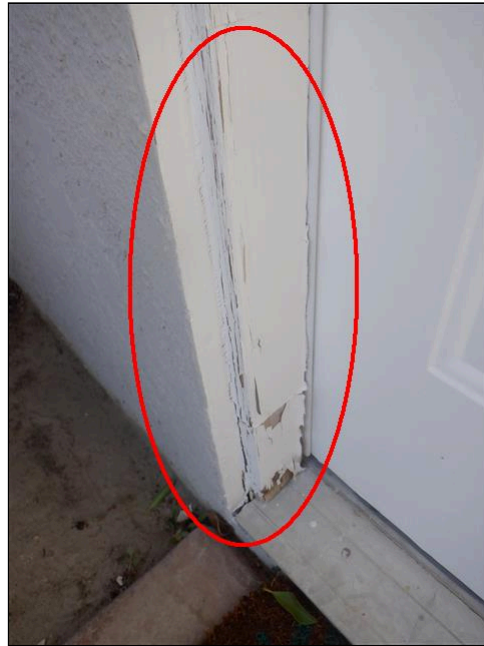
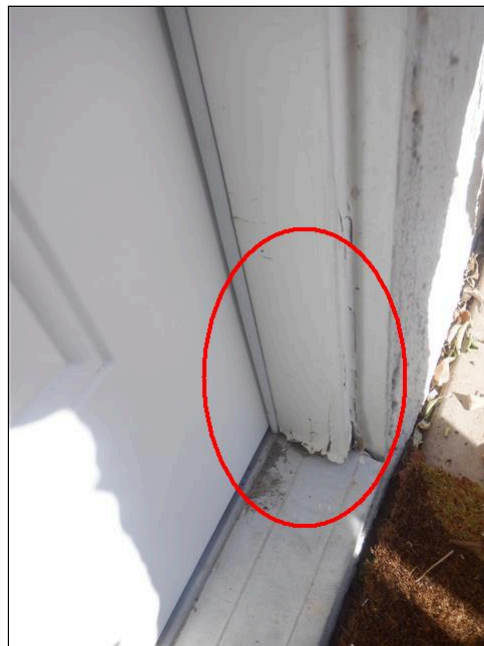
3.6 Item 2(Picture) Failing Trim Paint

3.6 Item 4(Picture) Failing Trim Paint
