# Inspection Report

**Property Address:**  
72543 Beavertail St  
Palm Desert CA 92260

<b>Date:</b> 10/2/2023	<b>Time:</b> 09:00 AM	<b>Report ID:</b> 20231002-72543-Beavertail-St
<b>Property:</b> 72543 Beavertail St Palm Desert CA 92260	<b>Customer:</b> Sara Rostand, Trustee	<b>Real Estate Professional:</b> Richard Von Ernst Compass

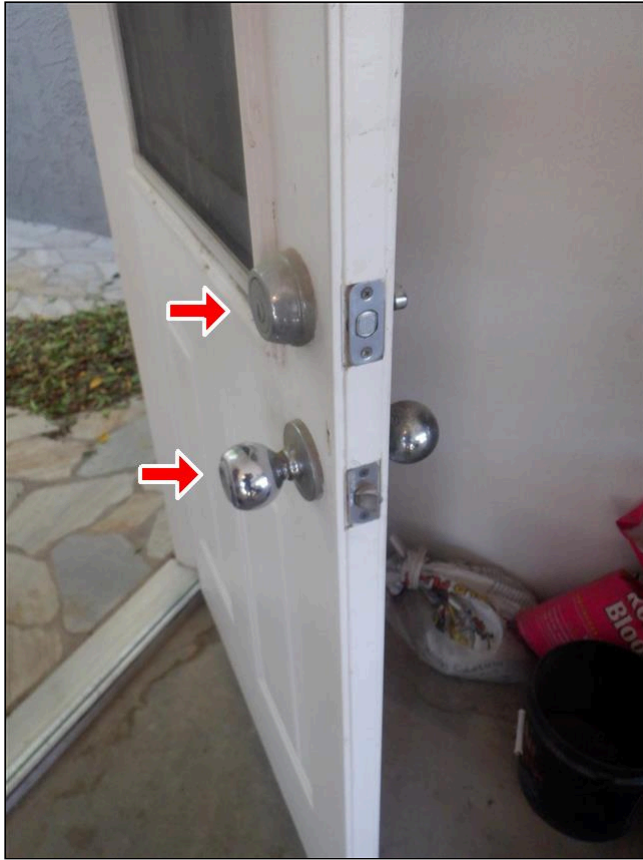
3.6 Item 5(Picture) Locks Not Functioning

inspection. Recommend evaluation by a licensed contractor repair replace as needed.

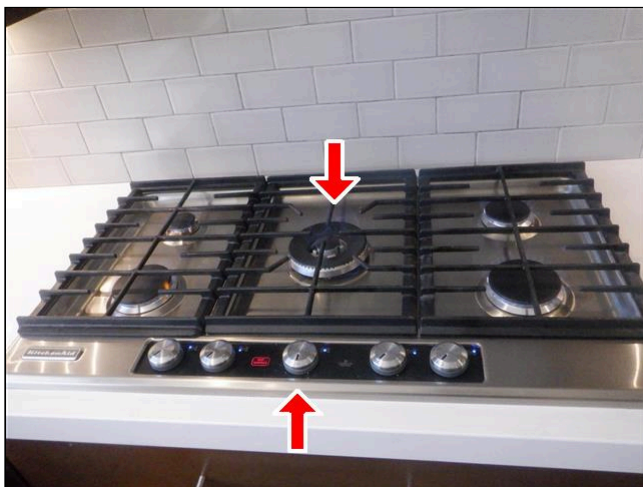
Although the oven and all burners were function we noted that the center cooktop burner and igniter were not functioning properly. The igniter would not light the burner and the burner did not appear to the functioning as intended. Recommend evaluation by a licensed appliance contractor repair replace as needed.

4.9 Item 1(Picture) Center Burner/Igniter

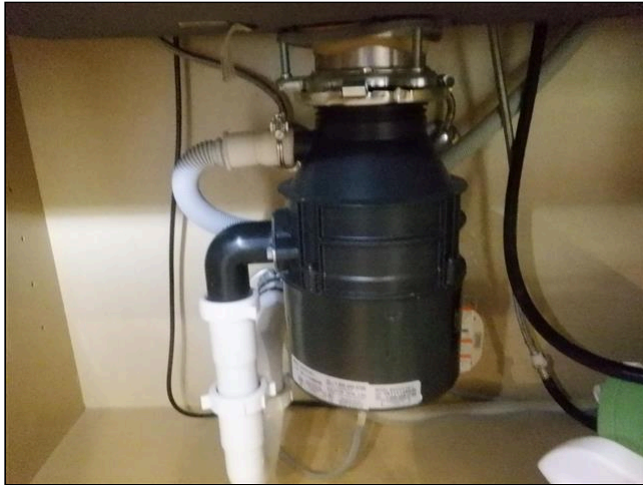
We noted that the food waist disposal was inoperative (frozen) at time of inspection. Recommend evaluation repair replace as needed by an appliance contractor.

4.11 Item 1(Picture) Food Waist Disposer

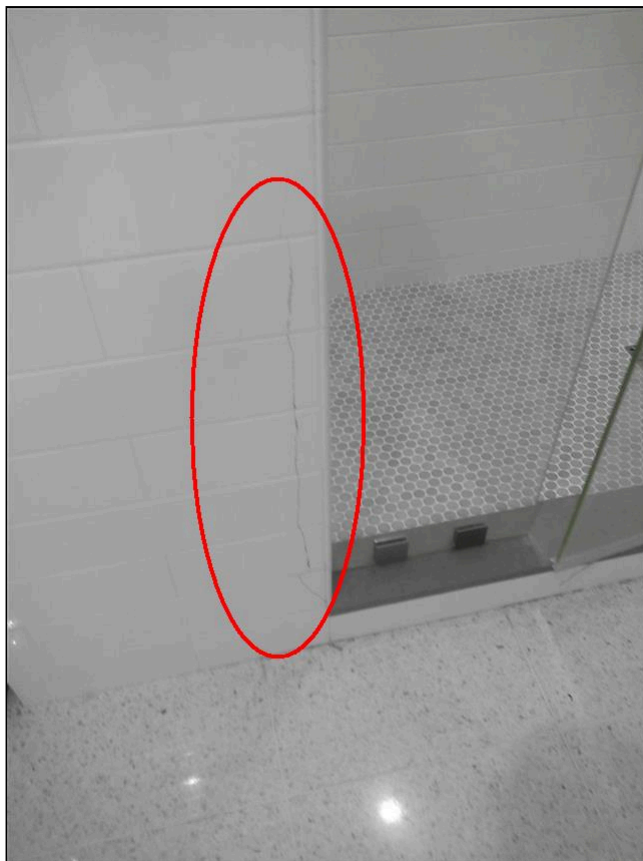
6.10.A Item 1(Picture) Damaged Tiles

We noted several tiles on the outside of this shower that were damaged. Recommend evaluation and repair as needed by a licensed contractor.

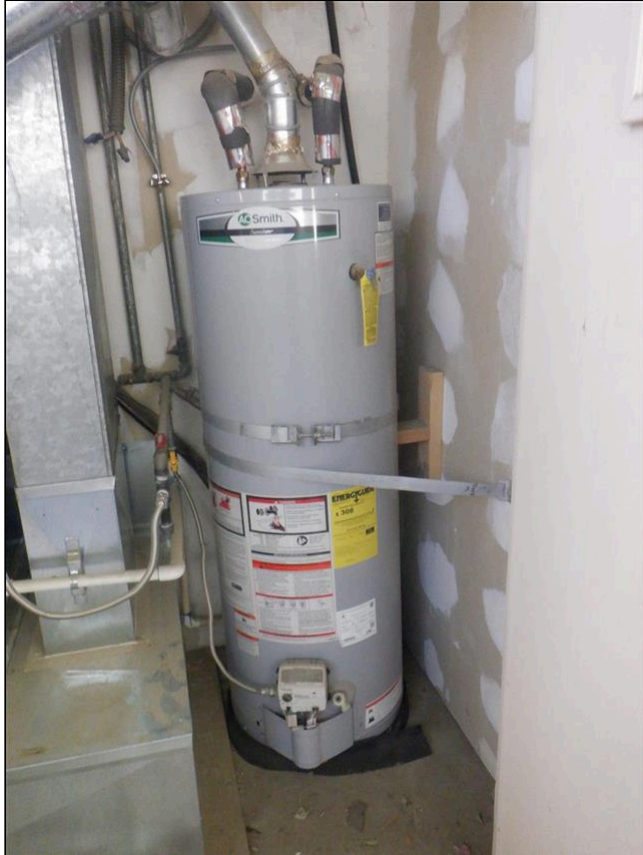
8.2 Item 1(Picture) Water Heater

(1) Although this water heater was functioning at time of inspection we noted that there was no sediment trap (Drip Leg) installed on the fuel line. The installation of fuel line sediment traps have been required for many years. We highly recommend installation of sediment traps (Drip Legs) on all gas fired tankless and tank type water heaters they are installed per manufactures installation requirements to help prevent sediment in the gas piping from getting into the gas valve or burner area of an appliance and causing safety issues with combustion. The installation of sediment traps may extend the life of an appliance. Recommend evaluation and installation of sediment trap by a licensed plumbing contractor. This unit has a 50 gallon tank it is 6 years old. FYI the lack of a sediment trap may void the manufactures warranty if applicable.

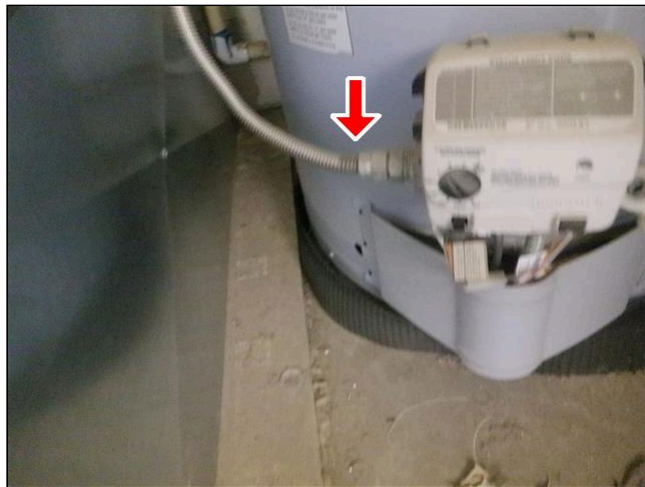
8.2 Item 3(Picture) Water Heater Fuel Line Missing Sediment Trap

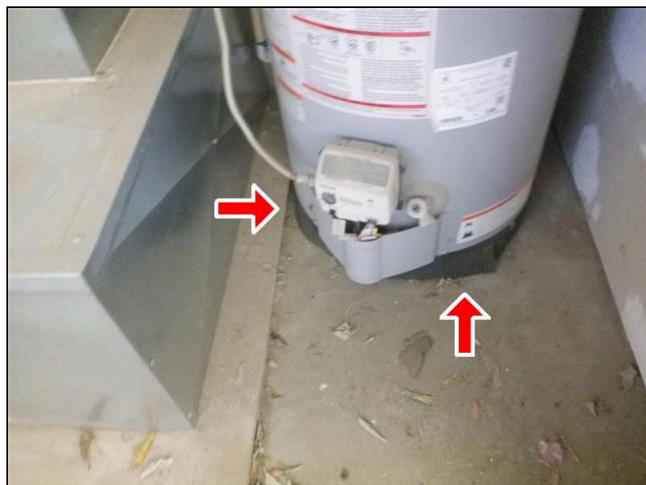
(2) We also noted that this water heater has no catch pan under it. Catch pans have been required now for many years, they are required where damage to wall and framing members could occur from leakage (this includes all tank type and tankless water heaters). Considering the age of this water heater a catch pan should have been installed. Recommend installation of catch pan.

8.2 Item 5(Picture) Water Heater Missing Catch Pan

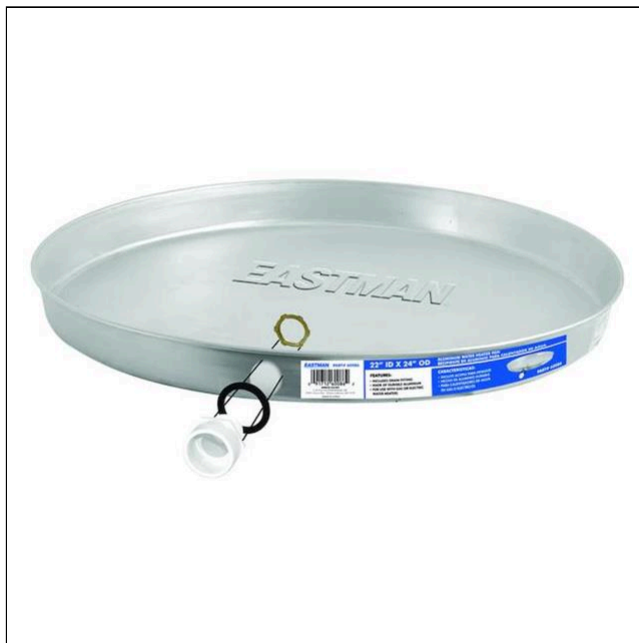
8.2 Item 6(Picture) Catch Pan Sample

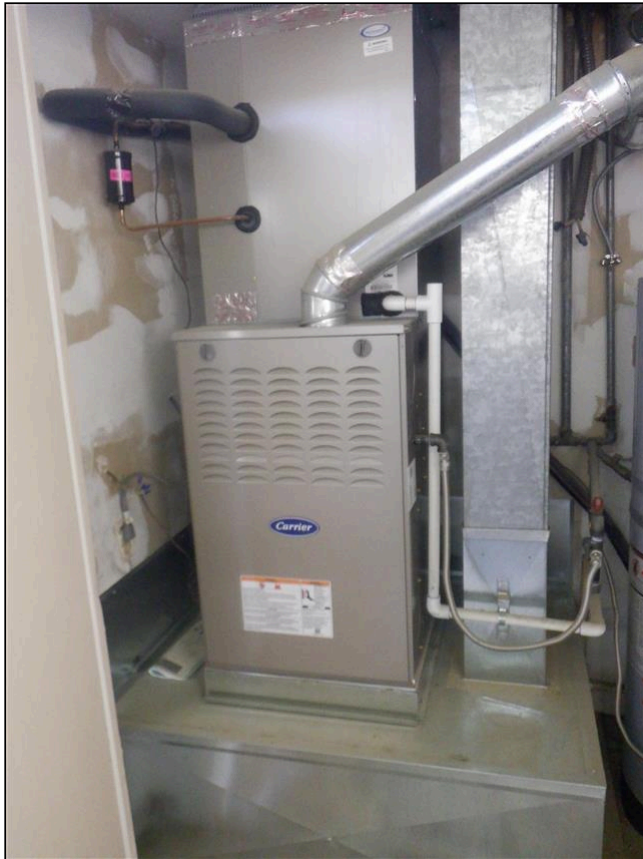
10.0 Item 1(Picture) Heating Unit

(1) Although this heater is newer (3 years old) we noted that it failed to activate when thermostat was turned to heat mode. Recommend evaluation repair replace as needed by a licensed HVAC contractor.

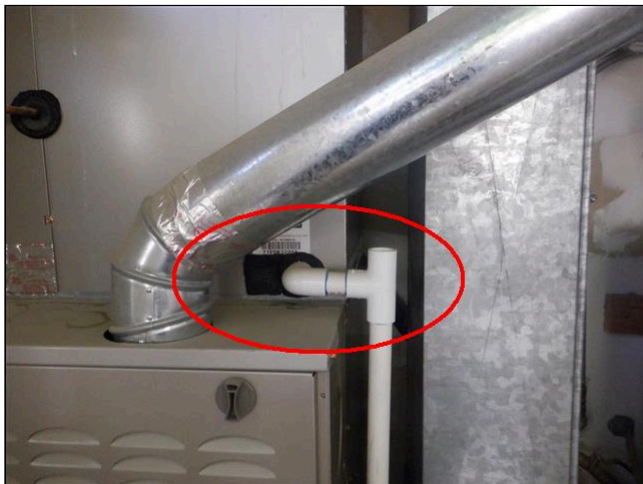
(2) This heater is 3 years old and although it failed to functioning at the time of inspection we noted that its missing its condensate safety micro switch, any unit installed on the interior of a home, utility room or garage should have a condensate safety switch, any blockage or overflow of condensate can cause damaged to interior drywall and framing members. Recommend evaluation and installation of a condensate safety switch by a licensed HVAC contractor.

10.0 Item 4(Picture) Heating Unit Missing Condensate Safety Switch

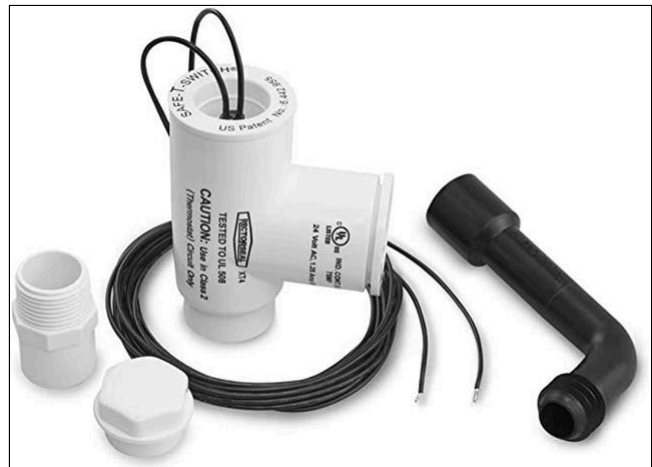
10.0 Item 5(Picture) Condensate Safety Switch Sample

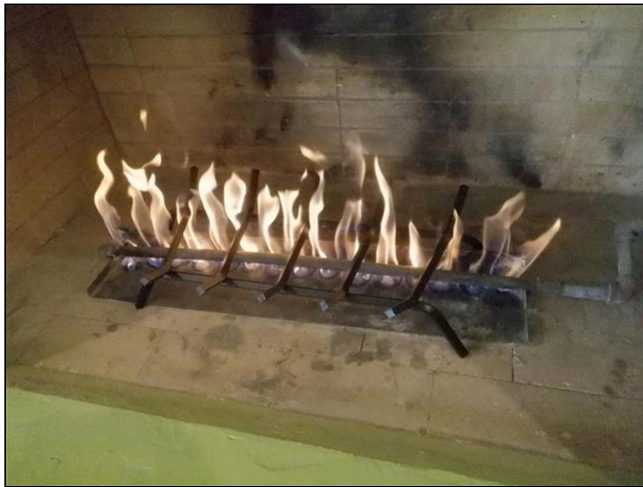
10.5 Item 1(Picture) Fireplace

Level 2 fireplace inspection should be conducted upon the sale or transfer of a property or after an operation malfunction or external event that is likely to have caused damage to the chimney. Building fires, chimney fires, seismic events as well as weather events are all indicators that this level of inspection is warranted. There are no specialty tools (i.e. demolition equipment) required to open doors, panels or coverings in performing a Level 2 inspection. A Level 2 inspection shall also include a visual inspection by video scanning or other means in order to examine the internal surfaces and joints of all clay or metal flue liners incorporated within the chimney. No removal or destruction of

permanently attached portions of the chimney or building structure or finish shall be required by a Level 2 inspection. We highly recommend a level 2 fireplace inspection by a licensed fireplace specialist. Call All Seasons Fireplaces at 760.365.6668 Rick Newsom. FYI brick fireplaces have clay flue liners that are susceptible to damage during seismic events that's why we highly recommend this fireplace inspection.

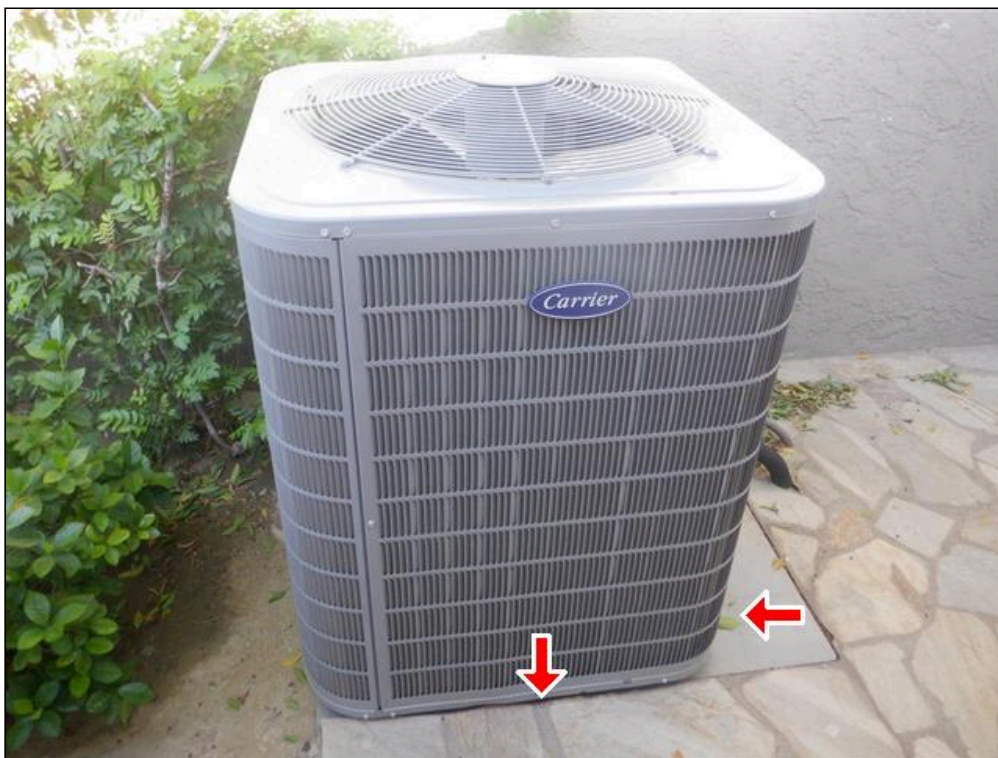
10.6 Item 1(Picture) Cooling Unit Not Secured

This cooling unit is 3 years old and appeared to be functioning however we noted that it was not secured to the appliance pad at time of inspection. Recommend evaluation and repair by a licensed HVAC contractor.

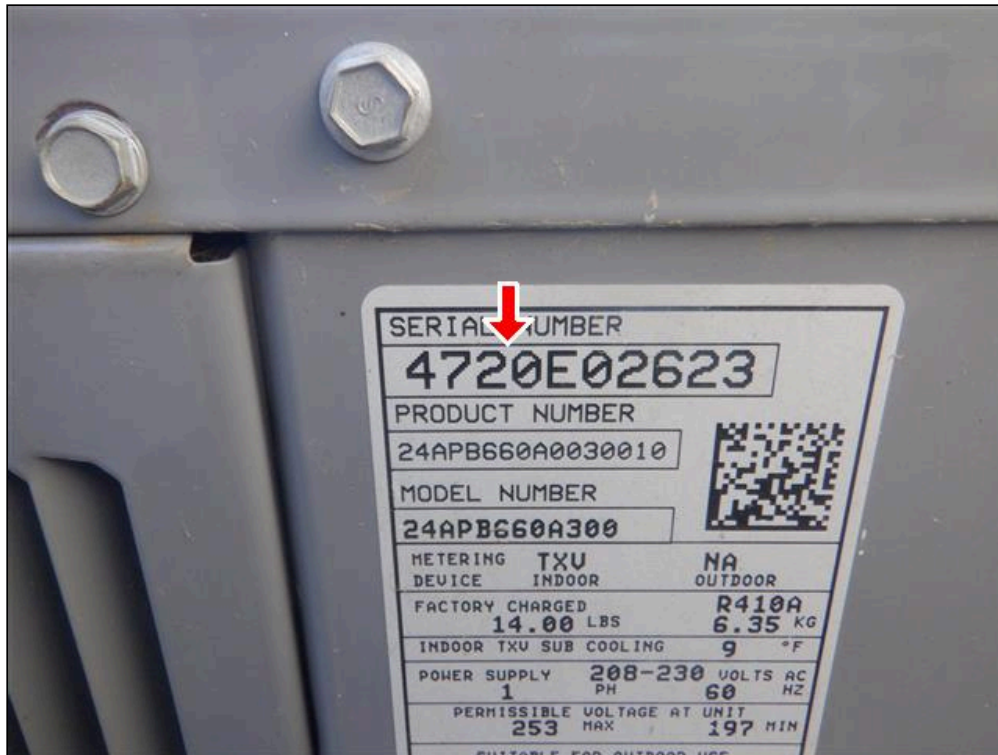
10.6 Item 2(Picture) Cooling Unit

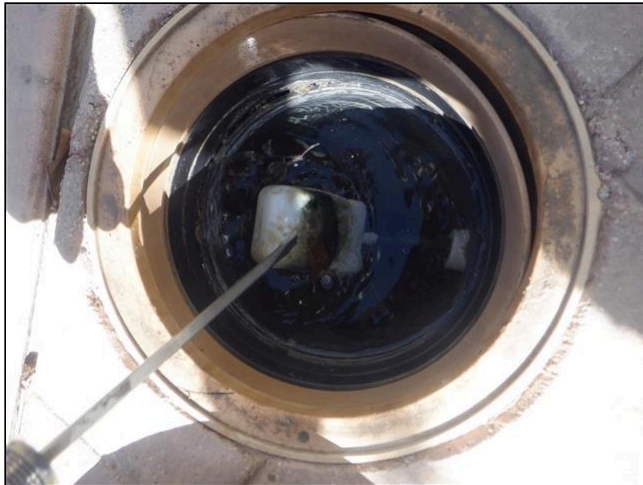
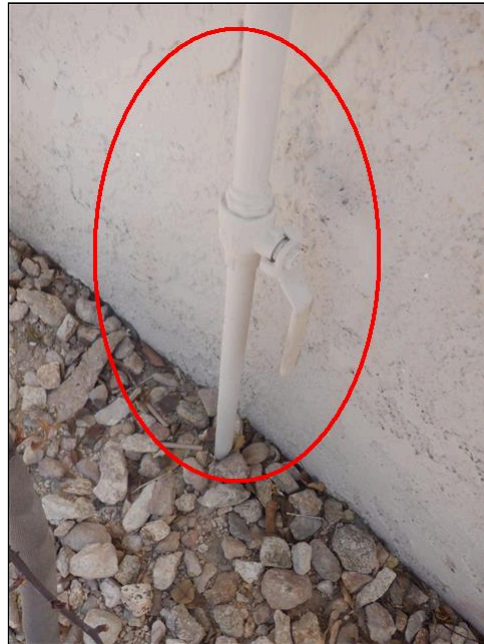
Although the auto fill appeared to be functioning properly we were unable to locate the required backflow preventer. All pools with an auto fill are required to have a backflow preventer. Recommend evaluation by a licensed pool contractor to install the required backflow preventer.

11.13 Item 1(Picture) Pool Auto Fill

11.13 Item 2(Picture) Auto Fill Supply Missing Backflow Preventer

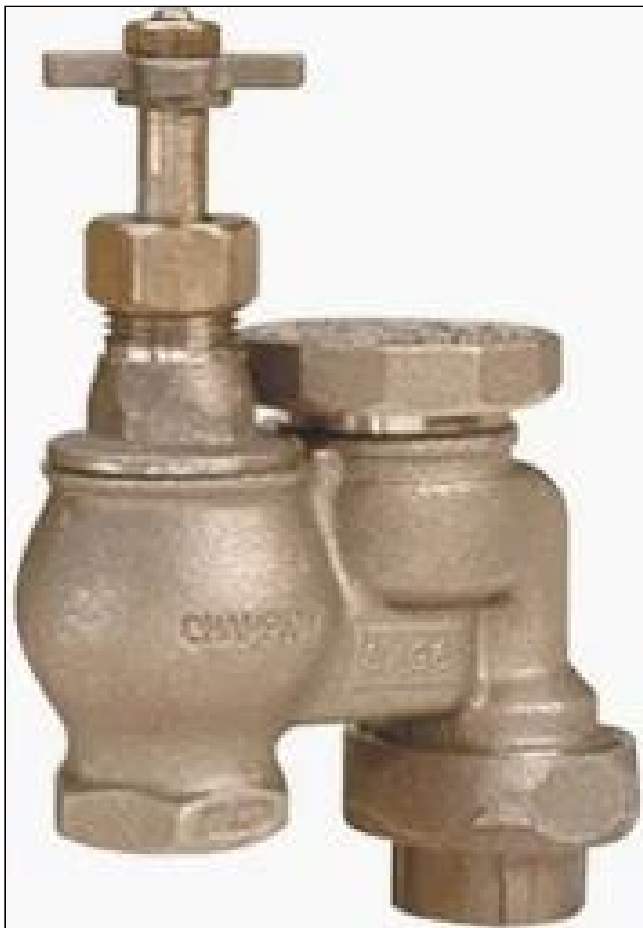
11.13 Item 3(Picture) Backflow Preventer Sample

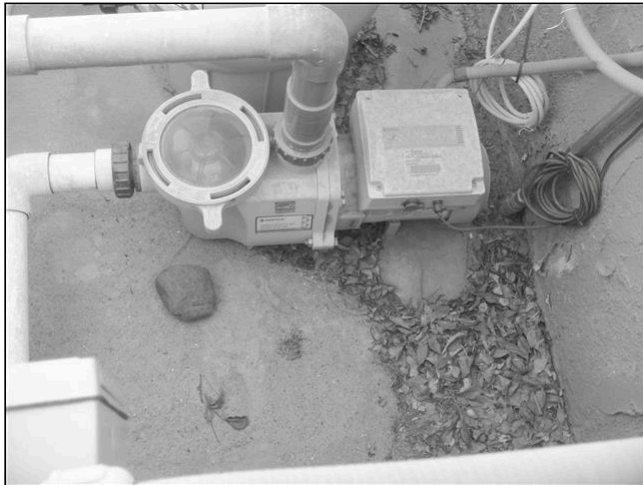
We noted that all this pool equipment appeared to be older the requirements for the pool equipment

electrical has changed over the years the new requirements are as follows all pool pumps are required to be individually GFCI protected by a electrical panel GFCI breaker and if this pool equipment is to be upgraded these requirements should be met. Recommend evaluation by a licensed pool contractor to determine if this pool equipment requires any additional GFCI protection and install as needed. FYI this additional GFCI protection may be required in certain jurisdictions for a vacation rental permits. FYI follow all local codes on this issue.

11.28 Item 1(Picture) :Pool Pump No GFCI Protection

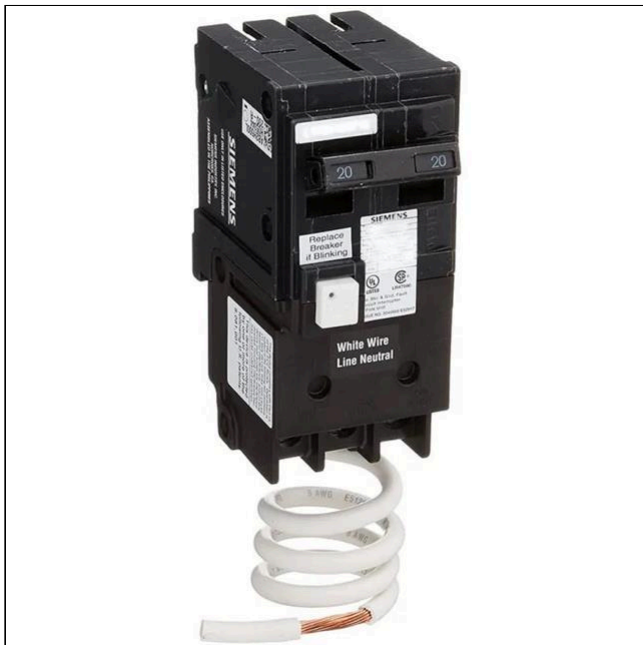
11.28 Item 3(Picture) GFCI Protection Sample

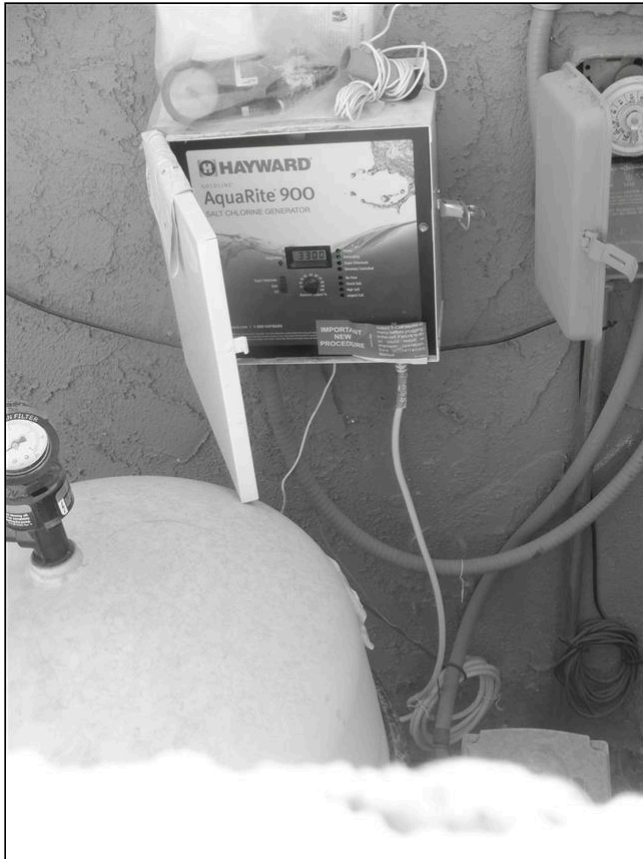
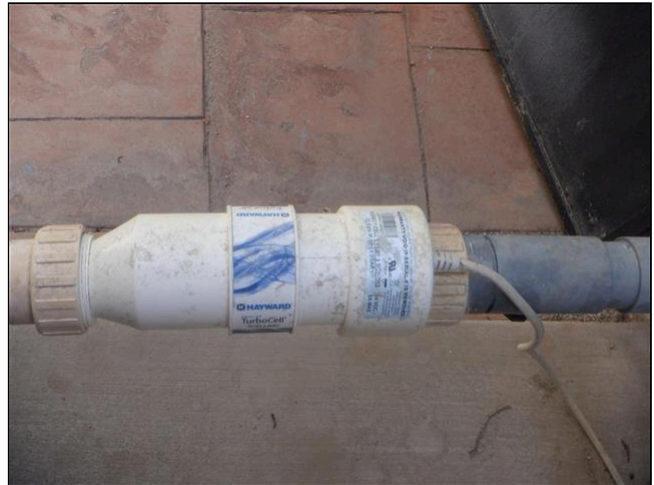
11.32 Item 1(Picture) Chlorine Generator

We believe that this pool is equipped with a electronic salt/chlorine generating system. We have no way of testing these units for proper operation or even knowing if there functioning properly. This unit should be evaluated for proper operation by a licensed pool contractor.

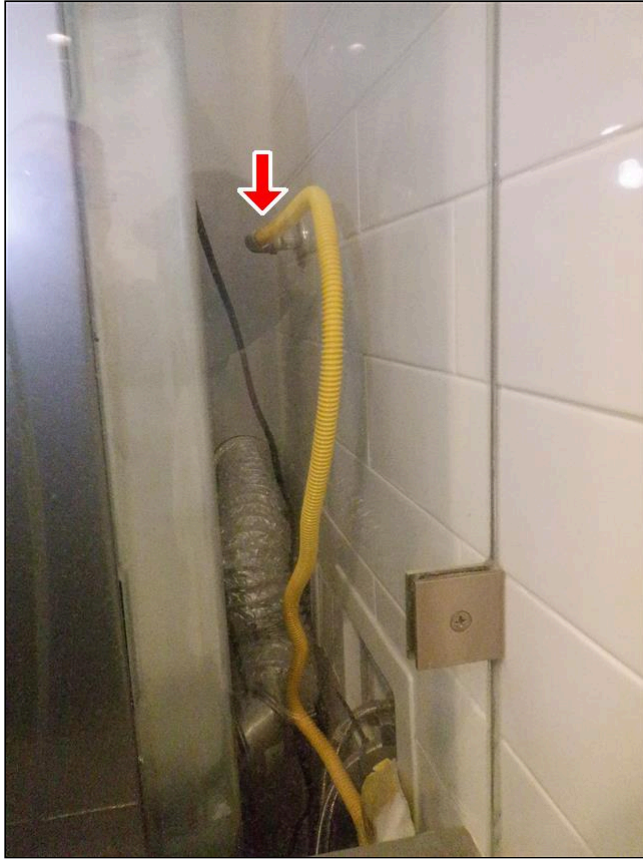
4.14 Item 1(Picture) Dryer Gas Supply No Shut Off

Although this gas dryer was functioning we noted that this dryers gas line dose not have a fuel line shut off valve in plain sight at the unit. This is a safety issue that should be corrected. All appliances must be equipped with a fuel line shut off within line of sight of unit. Recommend evaluation and repair by a licensed plumbing contractor to avoid any future safety issues. FYI we believe that the shut off for this unit is in the utility room for the furnace and dryer.

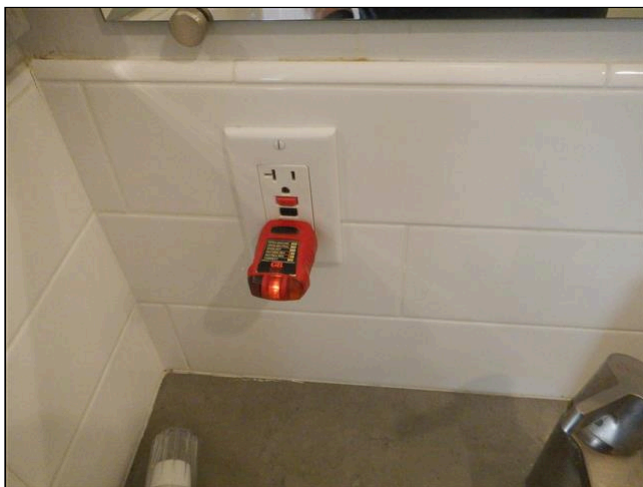
Bathroom GFCI was not functioning properly. This GFCI failed to trip when tested. Any GFCI outlet that dose not function as intended will be consider a safety issue. This is a possible shock hazard that should be corrected. Recommend evaluation by an electrical contractor and installation of new GFCI as needed.

6.5.A Item 1(Picture) GFCI Not Functioning Properly

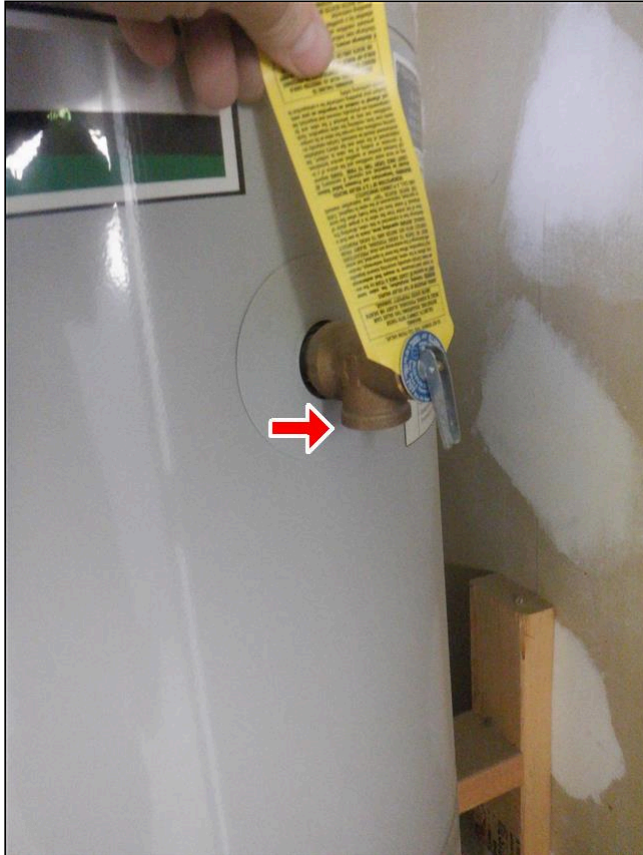
8.3 Item 1(Picture) Water Heater Missing TPR Valve Piping

Although this water heater appeared to be functioning at the time of inspection, we noted that it was missing its TPR valve piping. TPR valve piping is required on all tank type and tankless gas water heaters. This is a safety issue that should be corrected. Recommend installation of TPR valve piping to avoid any future safety issues by a licensed plumbing contractor.

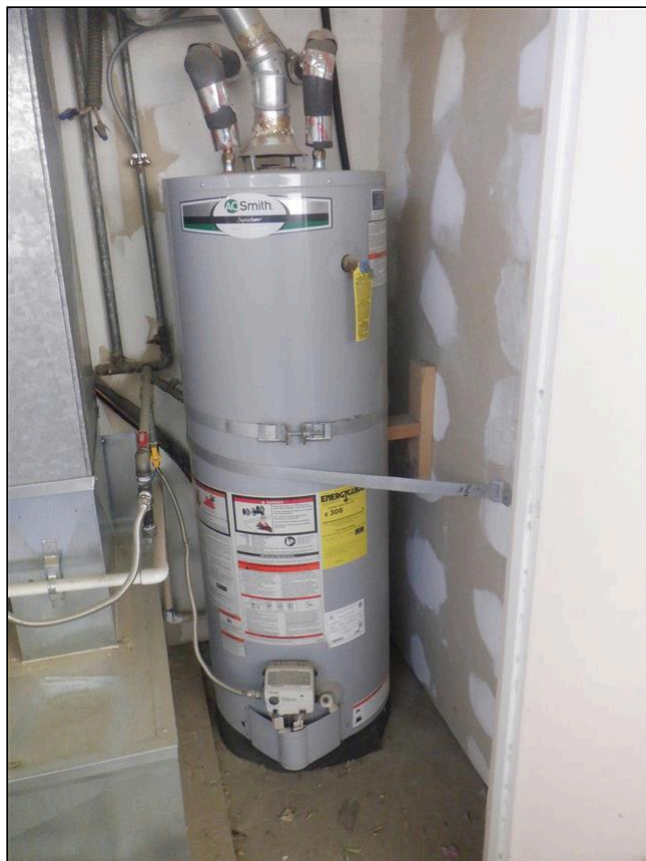
8.4 Item 1(Picture) Water Heater One Seismic Strap Only

**8.4** We noted that this water heater only had 1 seismic strap at time of inspection. All tank type water heaters are required to have a minimum of at least 2 seismic straps at all times, these seismic straps must be installed in the upper one third and lower one third of the unit, this is a hazard that should be corrected. Recommend evaluation and installation of second strap as needed by a licensed plumbing contractor.

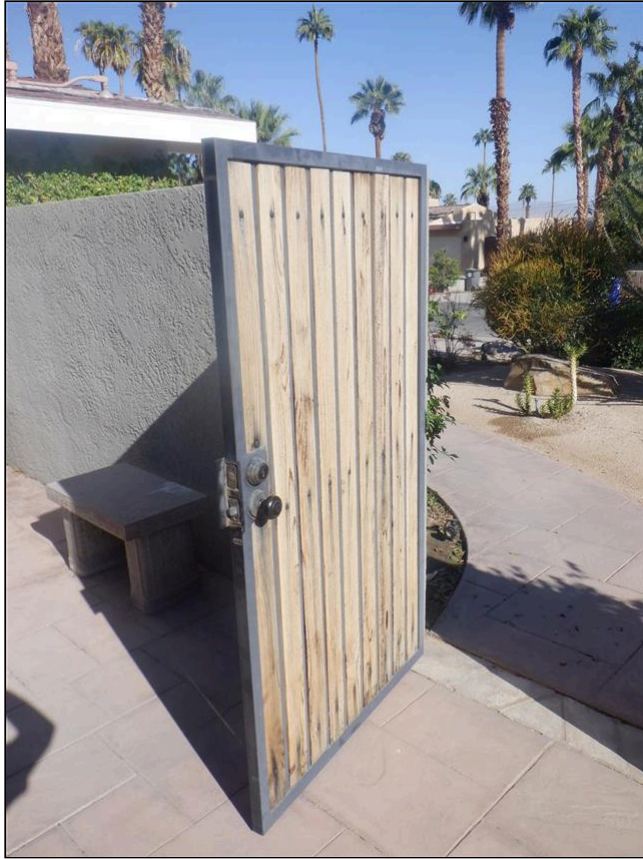
11.8 Item 1(Picture) Gate 1

We noted that this home has multiple gates that access the backyard from the street, all gates that can access the pool area from the street are required to have self closing self latching hardware, they are also required to open outwards towards the street and the self latching hardware cannot be any lower that 54 inches from grade any deviation in these requirements results in a safety issues. These safety requirements are designed to keep young children away from the pool area and safe. Recommend evaluation of all gates and repair of all the above mentioned issues by a licensed contractor who is familiar with these pool safety features. FYI these gates do not meet these safety protocols. Gate 1 (courtyard) opens inward and dose not have self closing or self latching hardware gate 2 opens outward and dose not have self closing or self latching hardware.

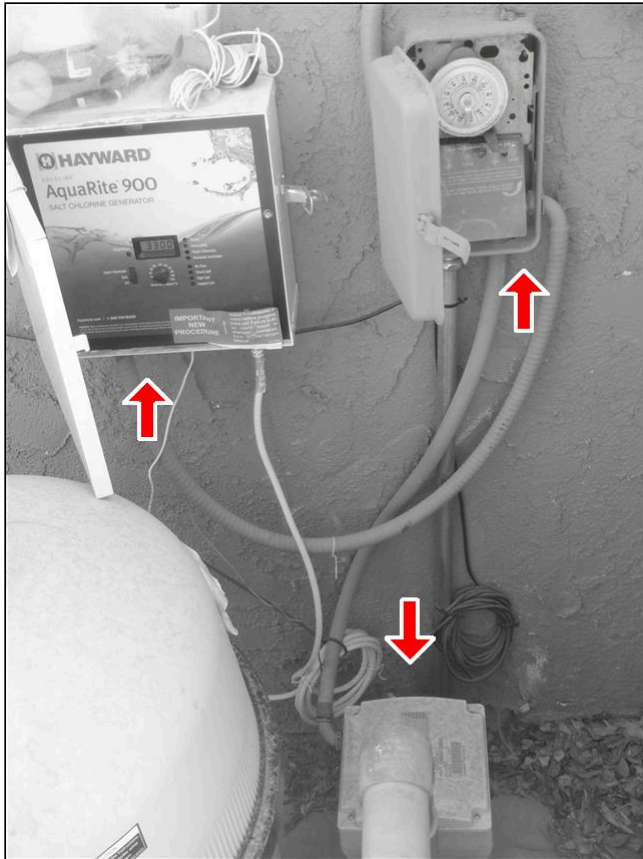
11.27 Item 1(Picture) Pool Equipment No Bond Wire Present

**11.27** We noted that there was no bond wire present at the pool equipment at the time of inspection. This is a possible shock hazard that should be corrected. All metal parts of pool/spa pumps, motors, heaters, control panels, switches and sub panels should be bonded together and bonded to the pools bonding grid at all times. FYI the installation of a ground rod may solve this issue. Recommend checking local codes for the installation of ground rod and evaluation repair replace as needed by a licensed pool contractor.
