Confidential Inspection Report

LOCATED AT:
134 Sandpiper Lane
Aliso Viejo, California 92656

INSPECTED ON:
Friday, March 25, 2022

Inspector, Brian Gapik NACHI21070645
Provision Property Inspections

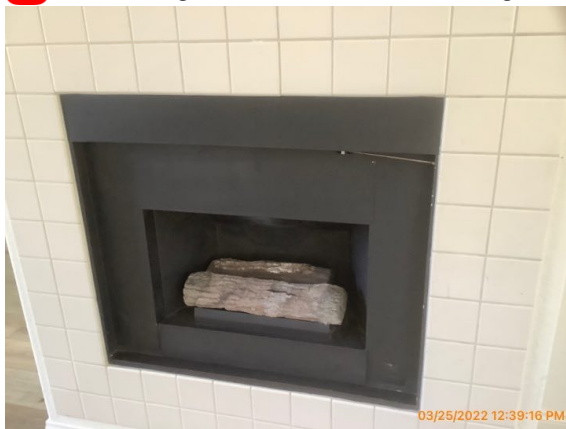
CR **FE** 56: with exceptions noted, I was not able to operate the fireplace

SC 57: The glass doors were missing.

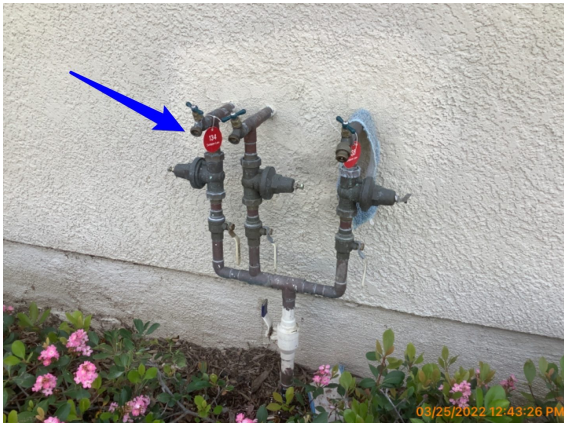
602 WATER SHUTOFF

64: The main water shutoff valve was located at the right side of the building.

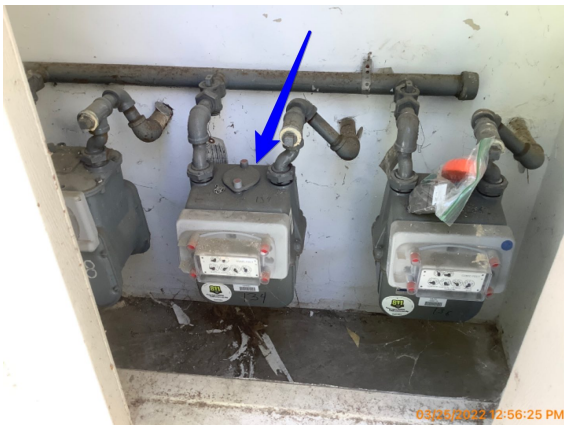
606 GAS SHUTOFF

65: The gas meter and shutoff valve are located at the left side of the building

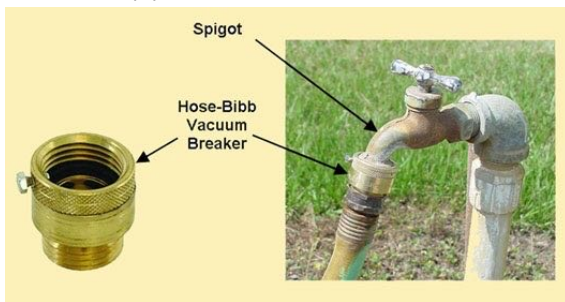
611 HOSE FAUCETS

RU 70: The vacuum breakers were missing from the hose faucet(s). We recommend correcting the condition(s) noted.

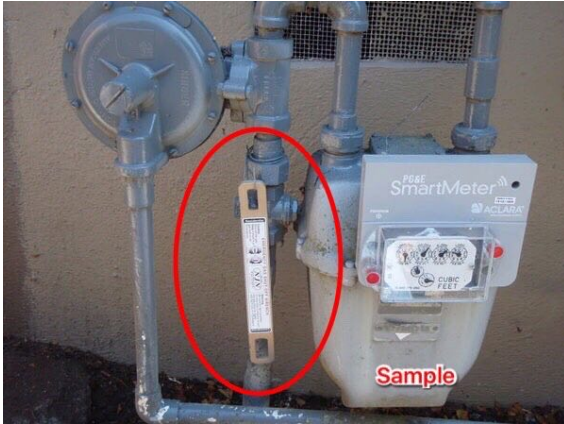
RU 76: The supply shutoff appeared serviceable, we do not operate these devices. There is no emergency shutoff wrench present. We recommend providing a wrench or installing a seismic automatic shut off valve for emergencies.

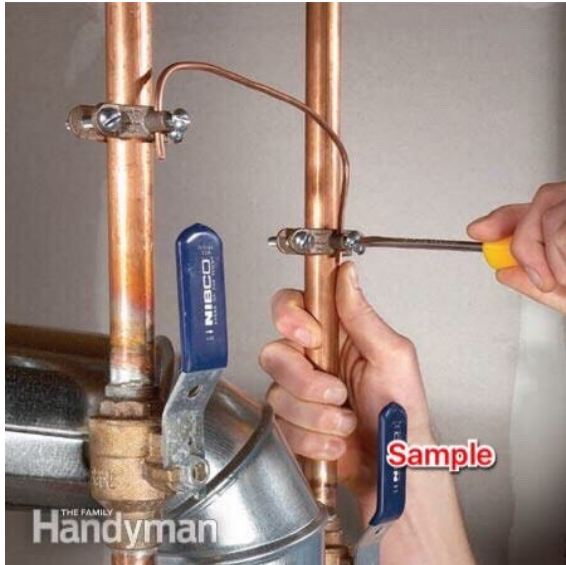
708 WATER PIPES

RU 84: The water pipes are not bonded. If the bonding is not in place, it is possible for the hot and cold plumbing to be at different voltage potentials. Which means if you grab a hot and cold handle, you could complete a circuit. We recommend correcting the condition(s) noted.

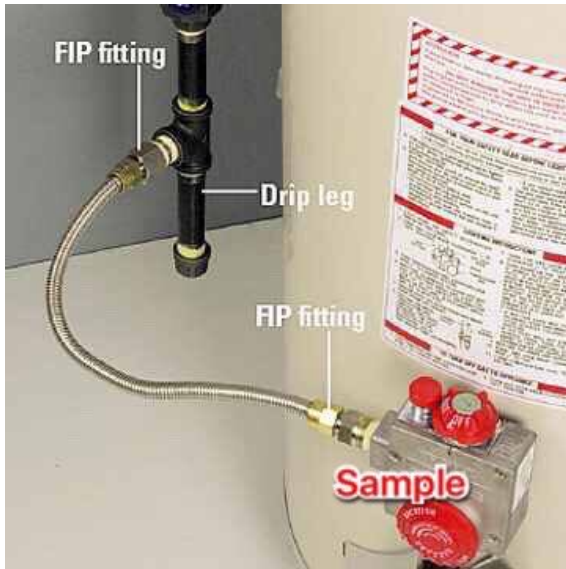
713 ENERGY SUPPLY

CR 90: There were no drip leg/sediment traps installed on the gas supply line. We recommend correcting the condition(s) noted.

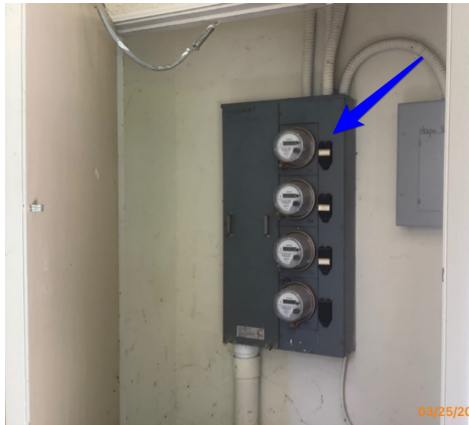
802 MAIN PANEL

94: Located at the left side of the building

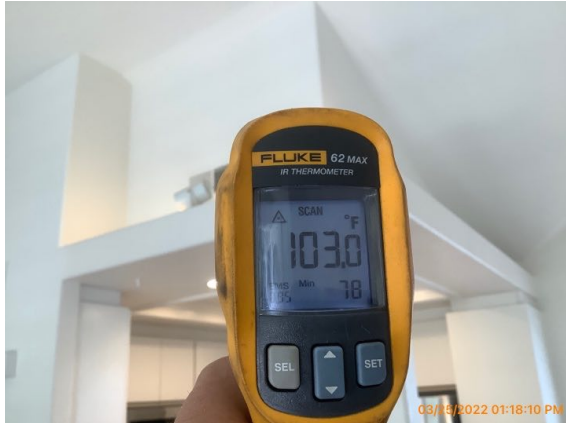
910 HEATING UNIT

120: The furnace was serviceable

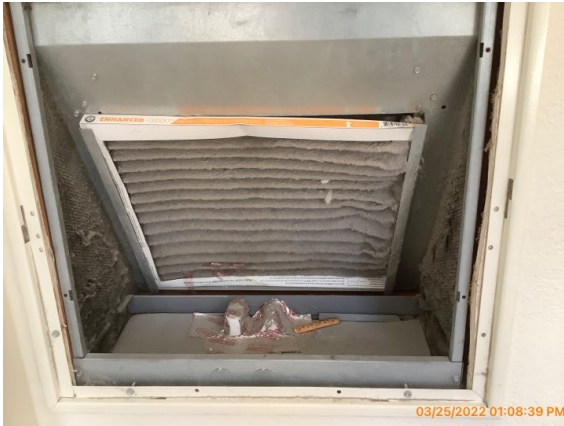
918 SUGGESTIONS

FE 126: The furnace and related components were dirty. We recommend having the furnace, related parts and cooling system components when present, cleaned and serviced by a specialist in the appropriate trade.

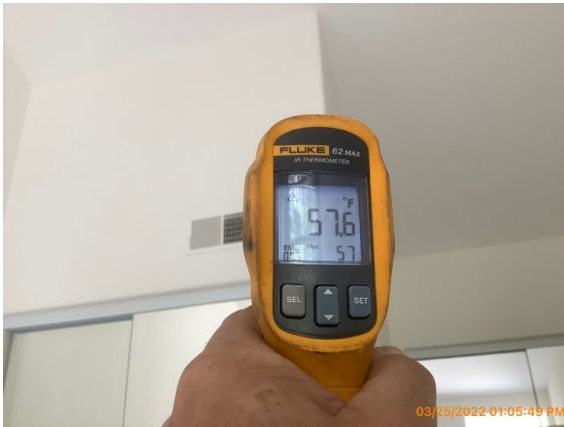
1005 APPROX. SIZE

132: 2 ton

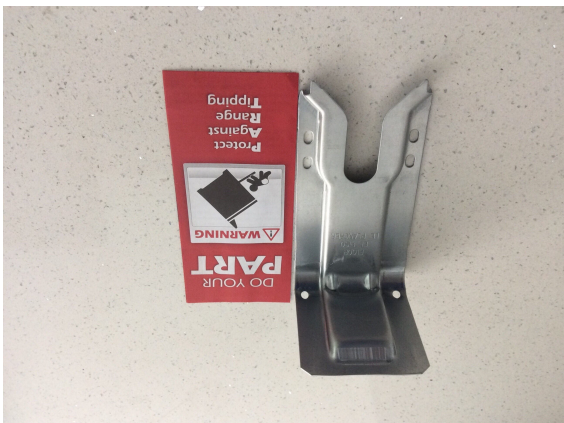
CR SC 152: The range/oven lacked an anti-tip device at the rear as required. This condition is a topple hazard. We recommend correcting the condition(s) noted.

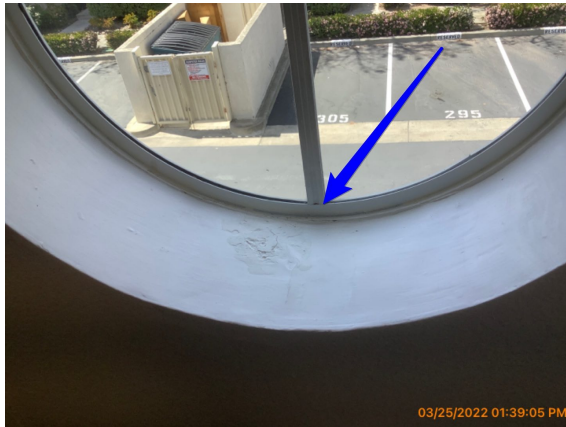
1309 WINDOWS

CR 214: There was moisture stains and damage in the window(s). We recommend locating and correcting the source and any damaged materials.
