Inspection Report

Property Address:
8721 Lyndora St
Downey CA 90242

Inspection Industries, LLC

Date: 10/31/2023	Time: 09:00 AM	Report ID: 8721Dora
Property: 8721 Lyndora St Downey CA 90242	Customer: Barbara Santa Cruz	Real Estate Professional:

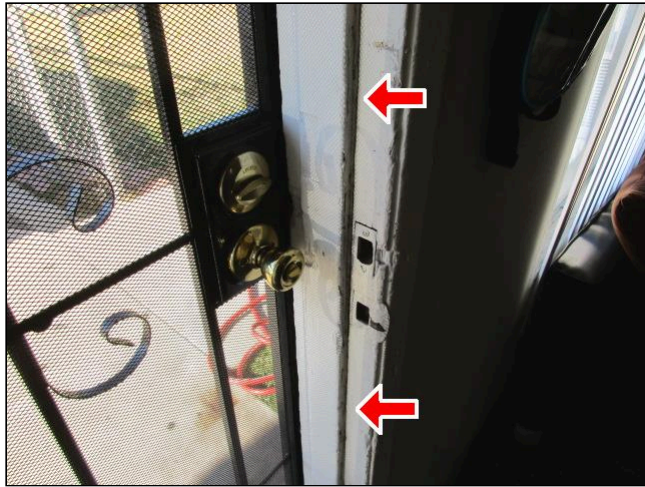
- 1** The front entry doors are in need of new weather-stripping and door sweeps in each unit. Without correction, this can allow some heat loss in winter and loss of cool air in summer. Install as needed.

Add Weather Stripping

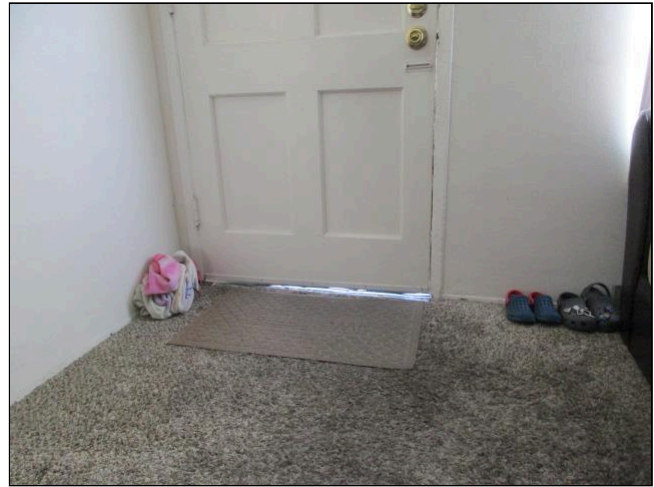
Add Door Sweeps

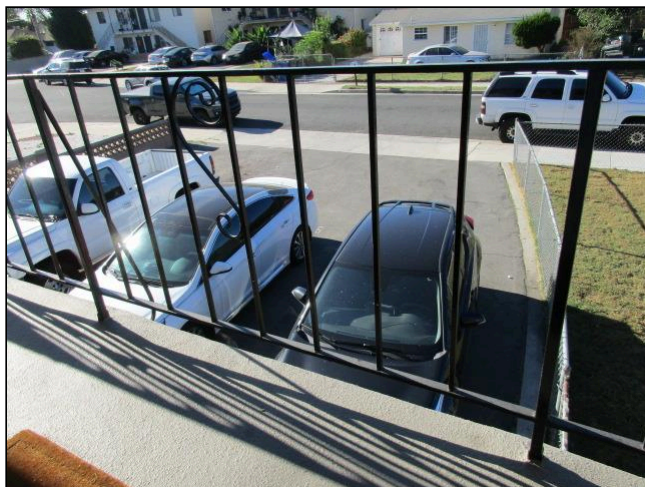
- 2 The front wrought iron railings at the steps and balcony surfaces have openings too far apart by today's safety standards. Spacing more than 4 inches apart could allow a child or pet to fall through. It is recommended that a qualified licensed contractor modify/alter the railings as needed.

Openings More Than 4"

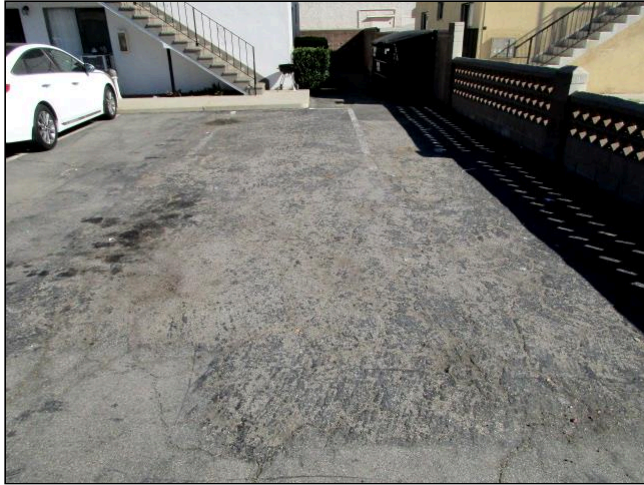
- 3 The asphalt drive is worn & deteriorated at the right side, unit D space. Have a qualified licensed paving contractor repair and seal as needed.

Worn, Deteriorated Drive

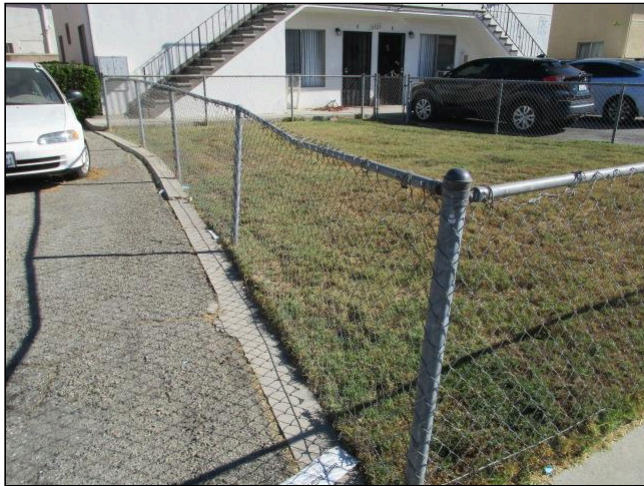
- 4 A section of the chainlink fencing at the left is damaged. A qualified licensed contractor should repair as needed.

Damaged Chainlink

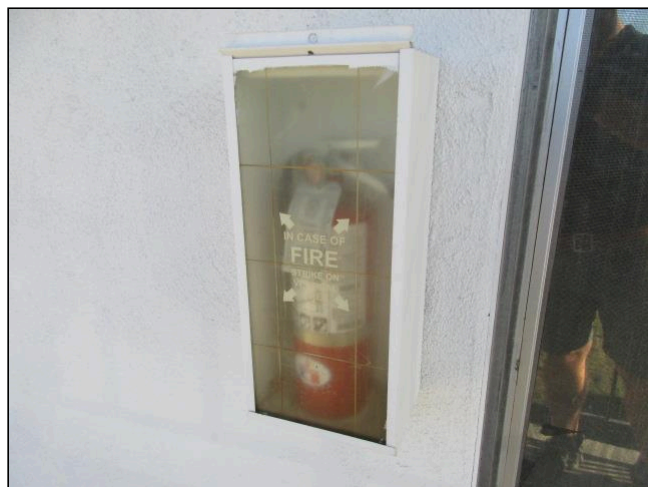
- 6 The fire extinguisher certifications are expired at both the 1st & 2nd stories. Contact a certified fire extinguisher company for service.

Extinguisher Certifications Expired

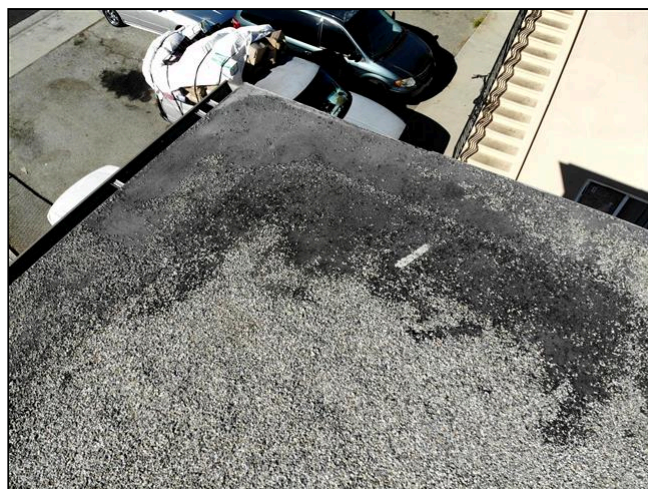
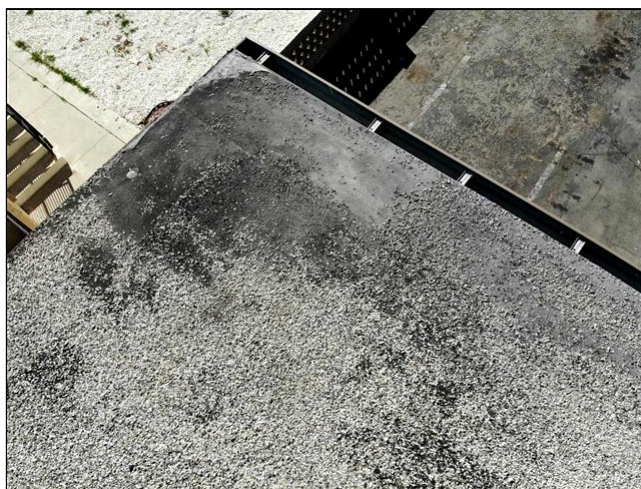
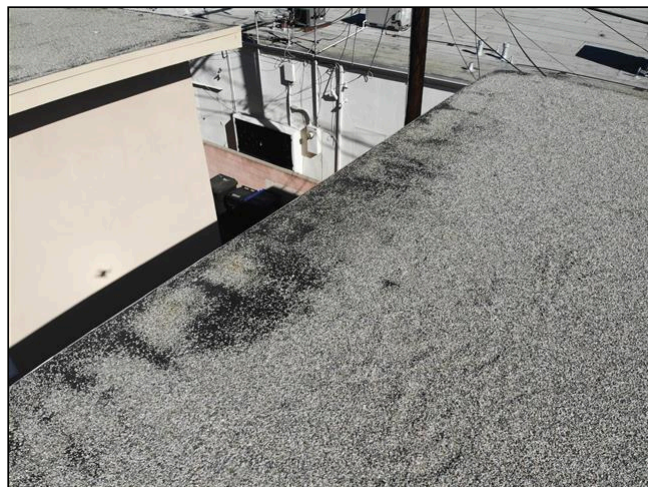
- 7 The built up roof covering is missing ballast the corners and edges, is cracked and appears to be nearing the end of it's expected useful life. Have a qualified licensed roofing contractor repair now to leaking during rains and anticipate future replacement.

Missing Ballast, Cracked Roofing

Missing Ballast

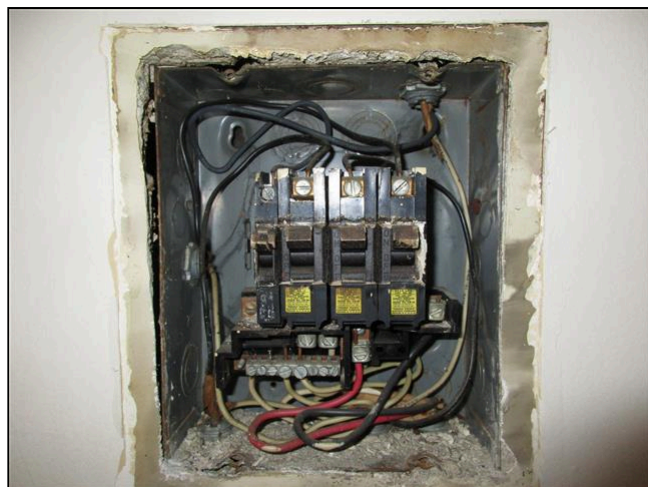
- 8 Each unit has a Federal Pacific Stablock panel and breakers installed. This brand of electrical equipment is known to be defective, to have loose connections and/or to have circuit breakers that may not trip during overload. This presents a potential electrical hazard. Contact a qualified licensed electrical contractor for evaluation and replacement as necessary.

Federal Pacific Stablock Panels & Breakers Present

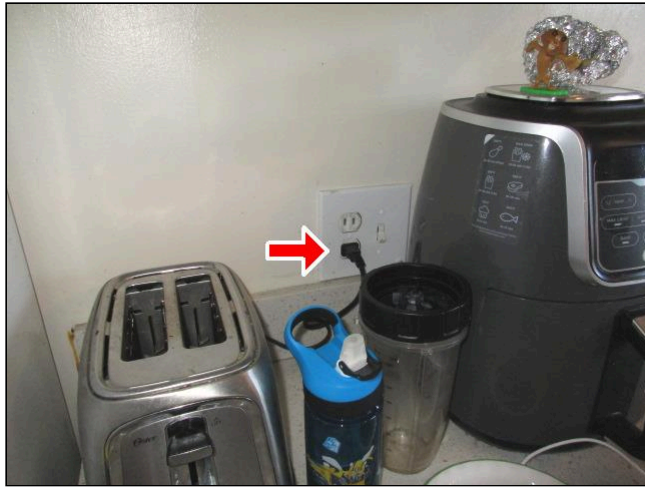
- 9 Upgrade *all* laundry area, bathrooms and kitchen counter top outlets to GFCI's (ground fault circuit interrupters). These may not have been required at the time of original construction but are recommended now, for safety.

Add Kitchen GFCI's

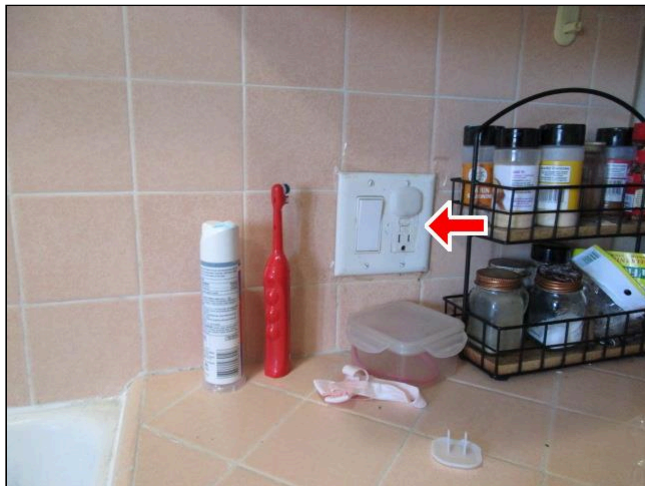
- 10** A GFCI (Ground Fault Circuit Interrupter) outlet at the unit C kitchen did not work or there is no power to the outlet. A qualified licensed electrical contractor should correct as needed.

GFCI Outlet Not Operational

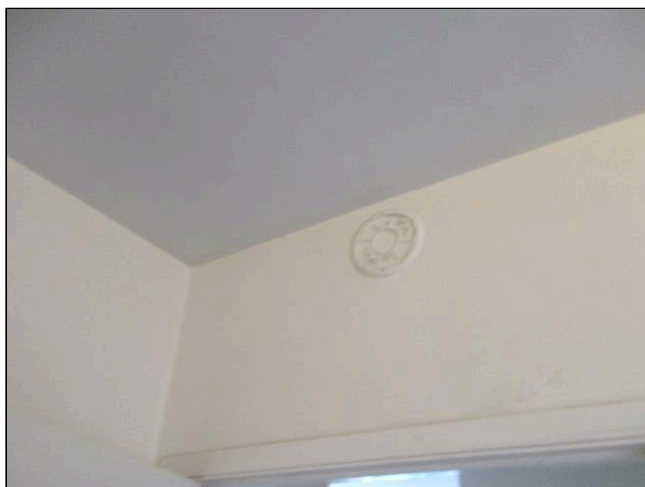
- 11** The smoke detectors are missing at the hallway and inside each bedroom of unit A and in the front bedroom of unit B. Without working smoke detectors you have no first alert to a possible fire. Install 10 year, tamper-proof smoke detectors for safety.

Add Smoke Detectors

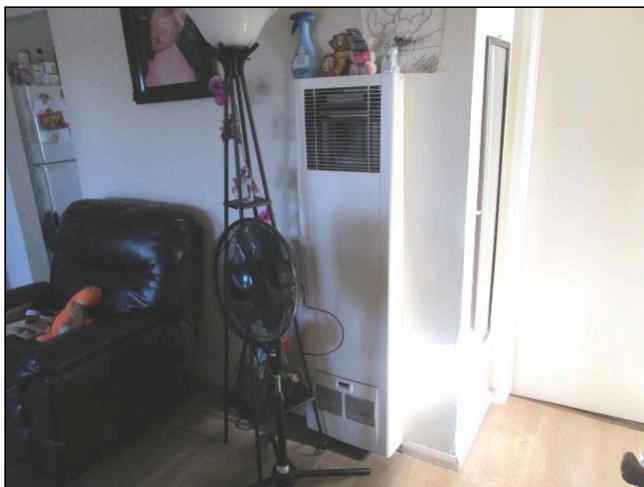
- 13** All gas fired wall furnaces were shut off at the time of inspection, not able to be tested/operated and the furnaces in units A, B & D are beyond their expected useful lives. Have the systems inspected and operated by a qualified licensed HVAC contractor or the gas company and anticipate repairs and replacement as necessary.

Old Wall Heater Shut Off, Unit D

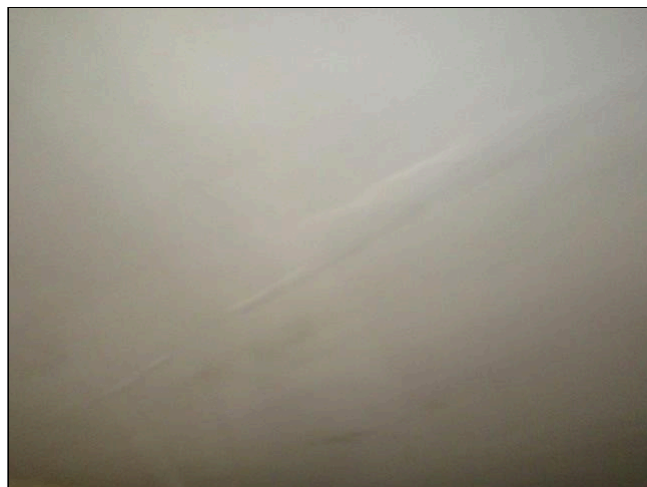
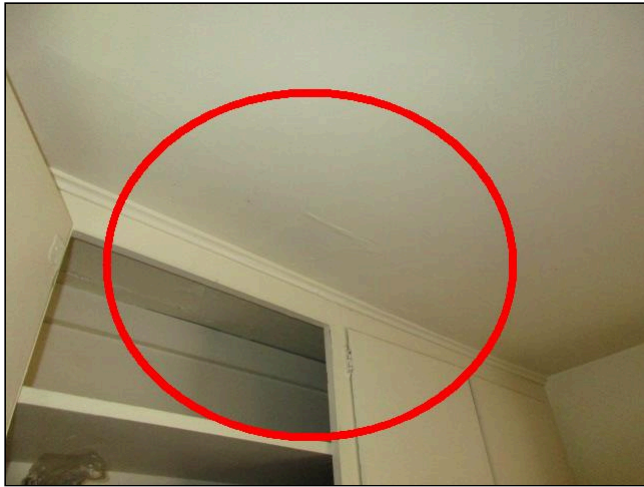
- 14** The plaster ceiling is damaged at the kitchen of unit B & living room of unit D. A moisture meter was used and it did not indicate excessive levels of moisture at the time of inspection. Have a qualified licensed contractor repair as needed.

Damaged Ceiling, Unit D

Damaged Ceiling, Unit B

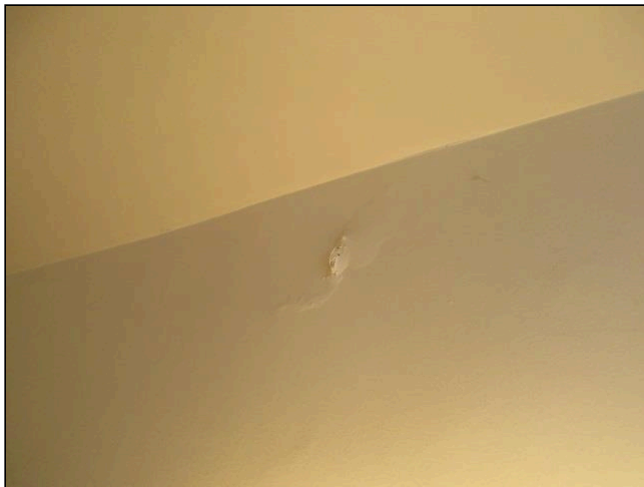
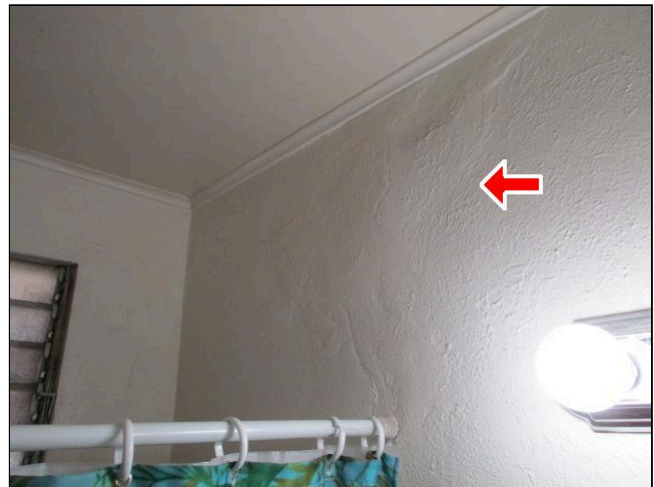
- 15** The plaster walls are damaged at the bathrooms of units A & B. A moisture meter was used and it did not indicate excessive levels of moisture at the time of inspection. Have a qualified licensed contractor repair as needed.

Damaged Wall, Unit A

Damaged Wall, Unit B

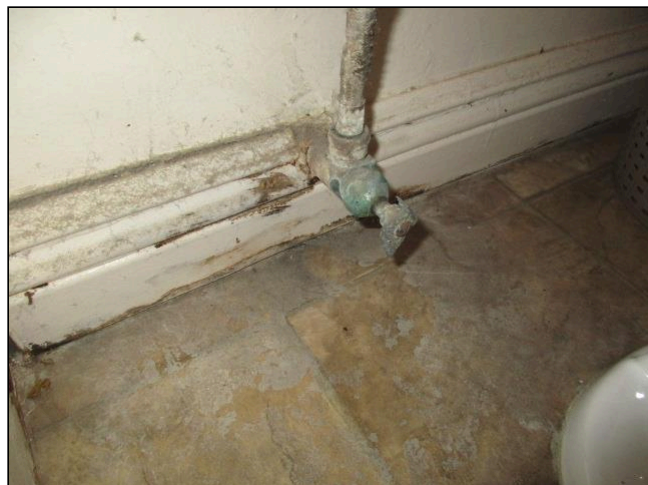
- 16** The baseboard mouldings are stained and damaged in the unit A bath. A moisture meter was used and it did not indicate excessive levels of moisture at the time of inspection. Have a qualified licensed contractor repair as needed.

Stained, Damaged Baseboards

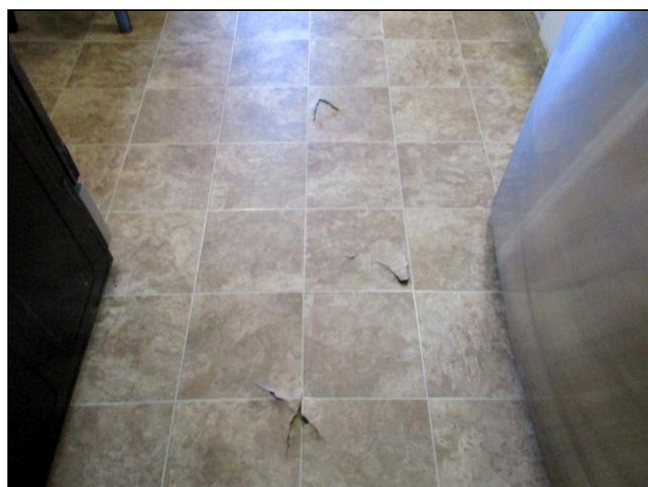
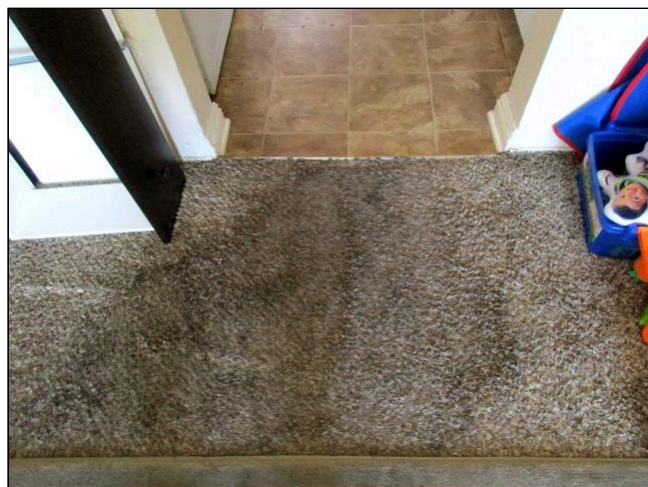
- 17 Various areas of the vinyl and carpet floors are stained and damaged throughout each unit. While this is cosmetic, the repair cost should be considered due to the amount of material needed for replacement.

Damaged Floor, Unit C Kitchen

Stained Carpet, Unit A

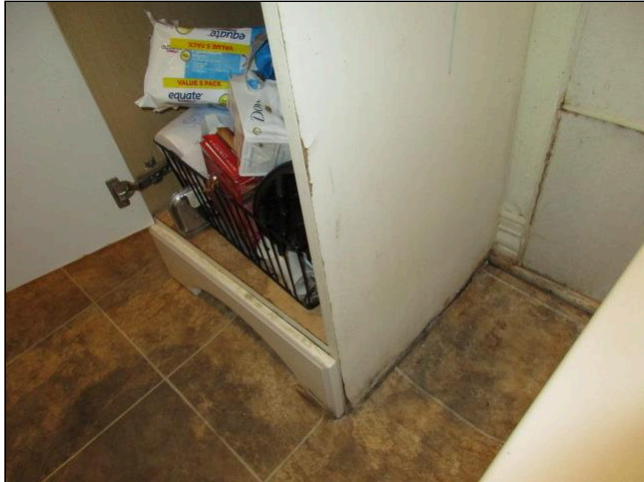
18 The bathroom vanity is damaged in the unit C bath. Repair or replace as necessary.

Damaged Vanity

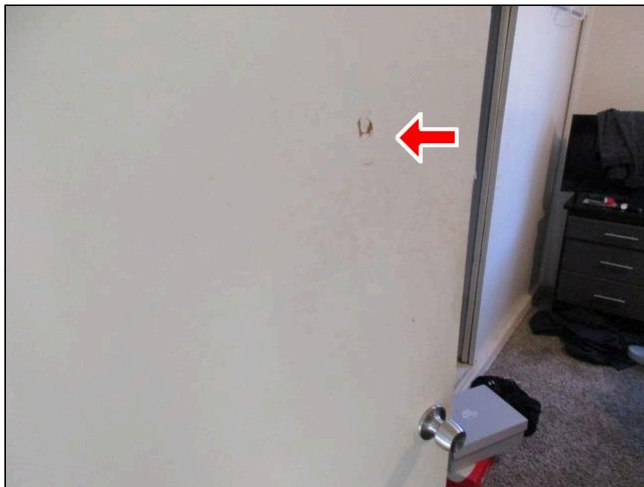
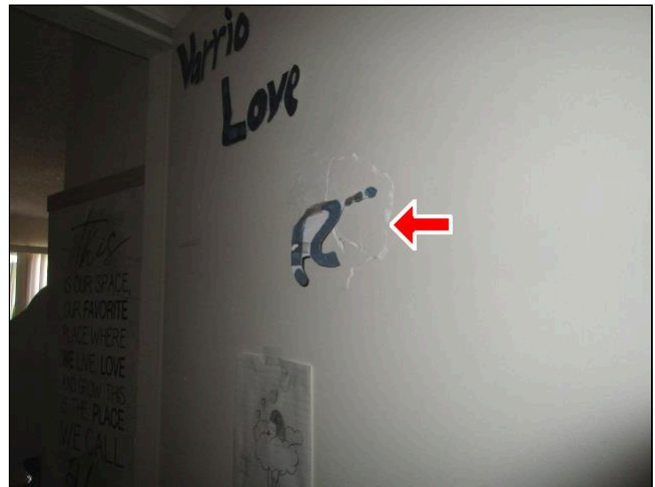
19 Interior doors are damaged at the rear bedroom of units B & D. Repair or replace as needed.

Damaged Door, Unit D

Damaged Door, Unit B

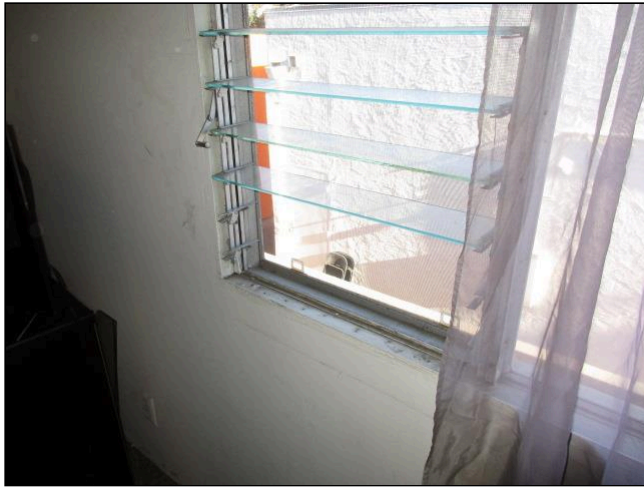
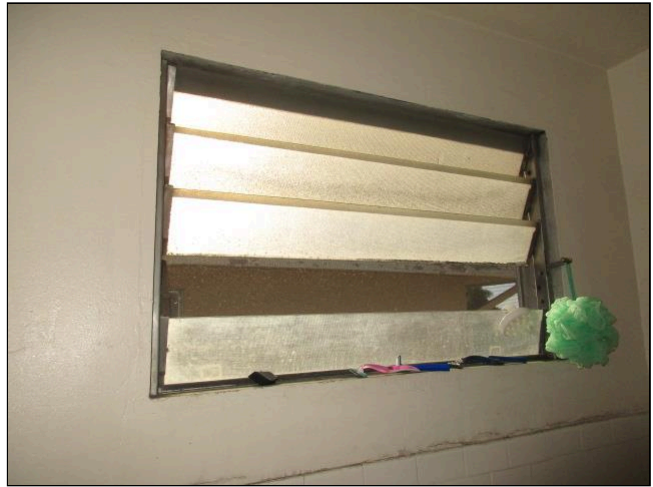
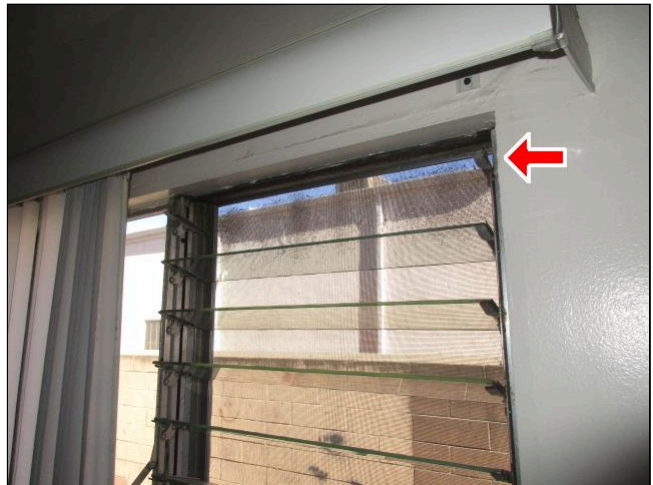
20 Jalousie windows are missing, loose and/or chipped glass panels in the kitchen of unit A, kitchen of unit B and the living room, bathroom and rear bedroom of unit D. Have a qualified licensed window contractor

Missing Panels, Unit D Rear Bedroom

Missing Panel, Unit D Bath

Missing Panel, Unit A

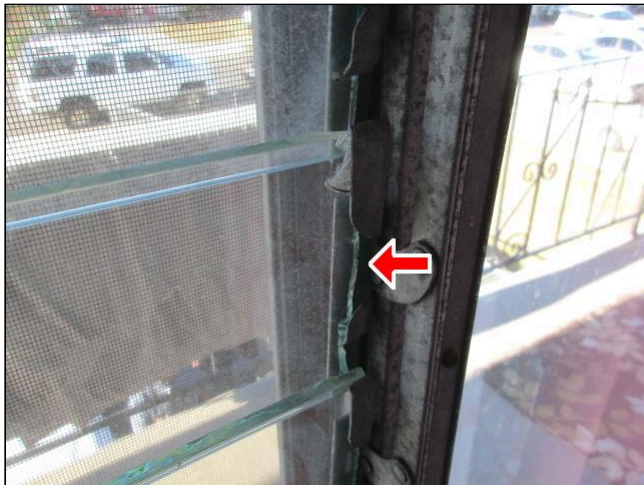
Chipped Glass, Unit D Living Room

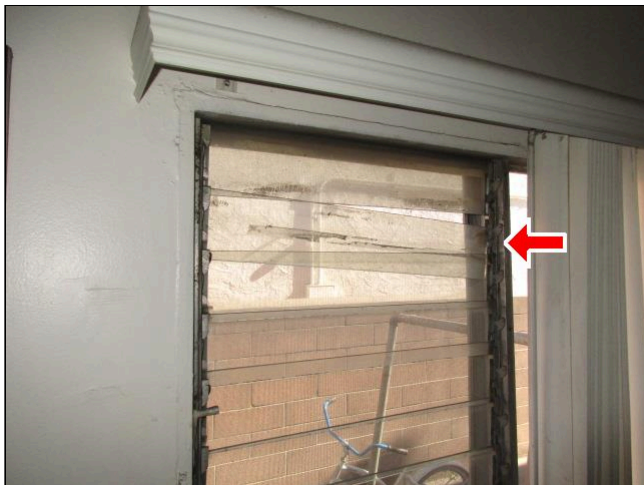
Loose Panel, Unit B Kitchen

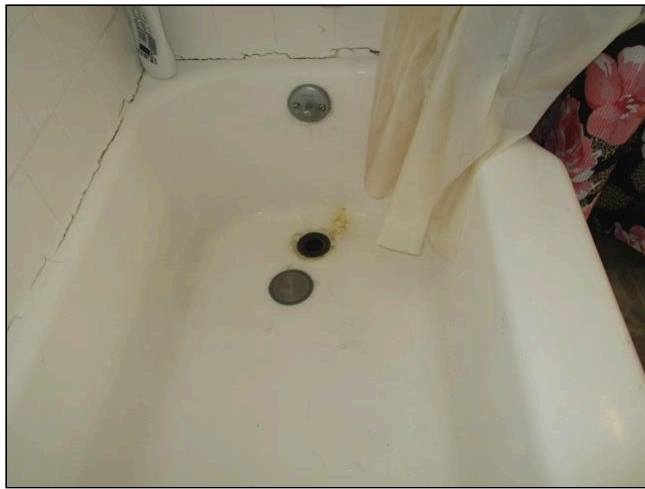
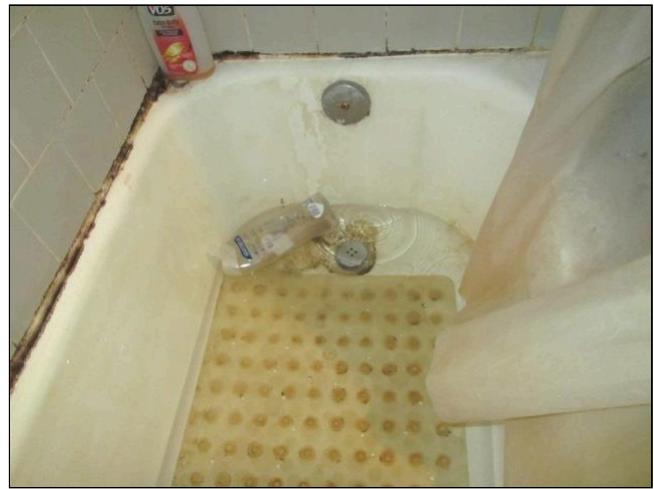
- 21** The tubs are slow draining in the bathrooms of units B & D. The cause of a slow drain can vary from a simple cleaning at the stopper valve or at the trap. I am unable to determine the cause of the slow

drain. A qualified licensed plumber should repair as needed.

Slow Draining Tub, Unit D

Slow Draining Tub, Unit B

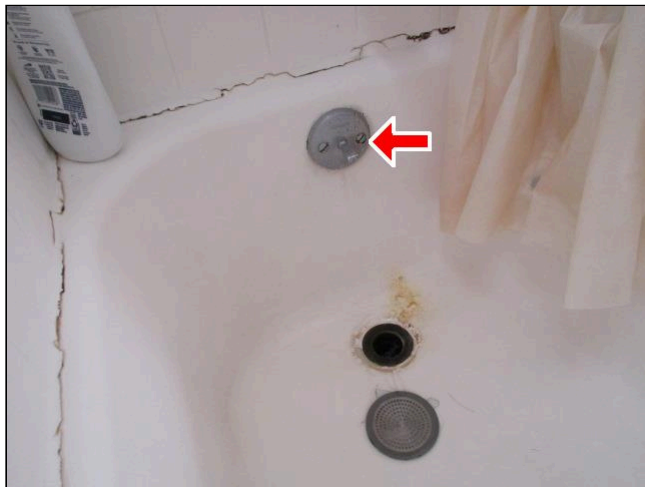
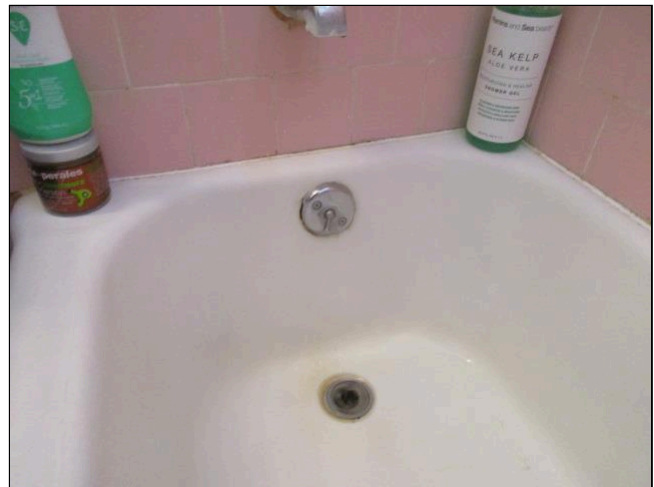
22 The tub stoppers do not work in the baths of units A & D. A qualified licensed plumber should repair as needed.

Stopper Not Operational, Unit D

Stopper Not Operational, Unit A

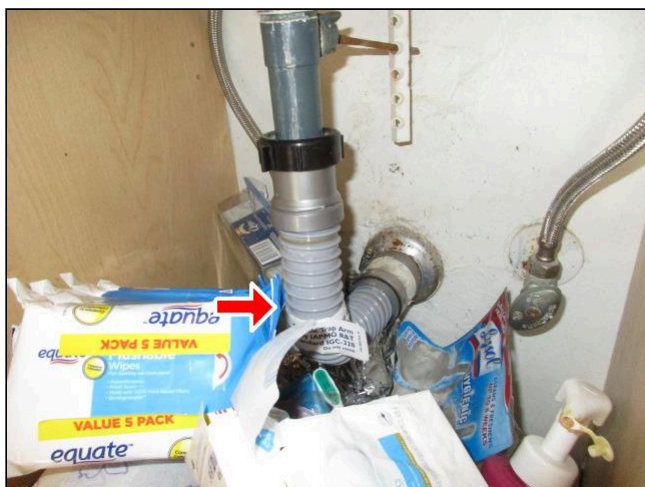
23 The sink drain has been repaired improperly at the unit C bath and without a P trap. This flexible, ribbed material will encourage clogs and bacteria growth. A qualified licensed plumber should repair with rigid, UPC approved material as needed.

Improper Drain Repair

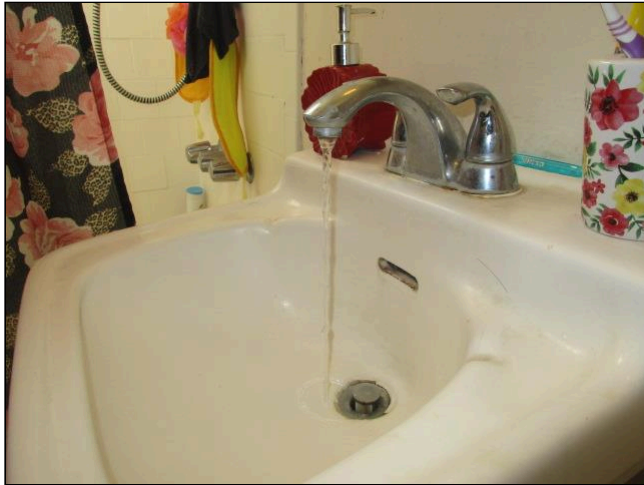
- 24** The volume of water is poor when operating multiple fixtures simultaneously in each unit. This is likely caused by the old galvanized steel service & supply piping present which is typically corroded inside. A qualified licensed plumber should correct as needed.

Low Water Volume

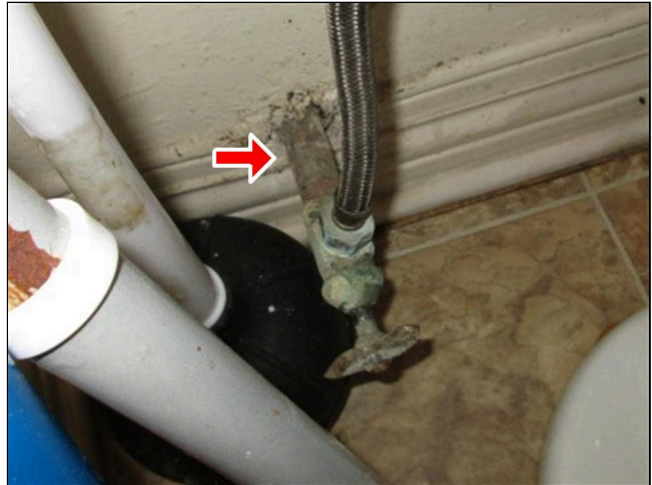
Old Galvanized Steel Piping In Use

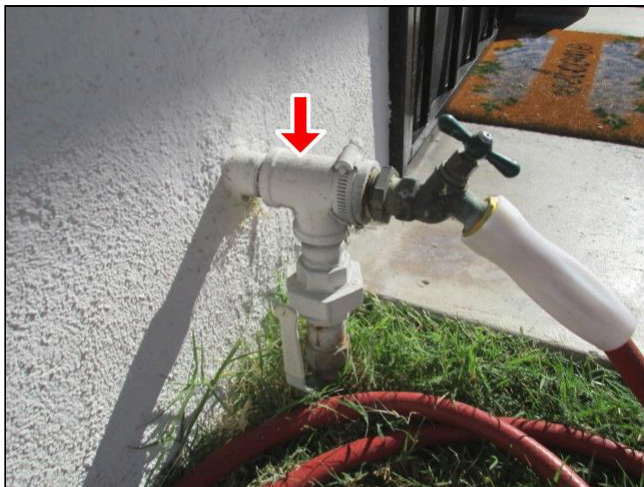
Old Galvanized Steel Piping In Use

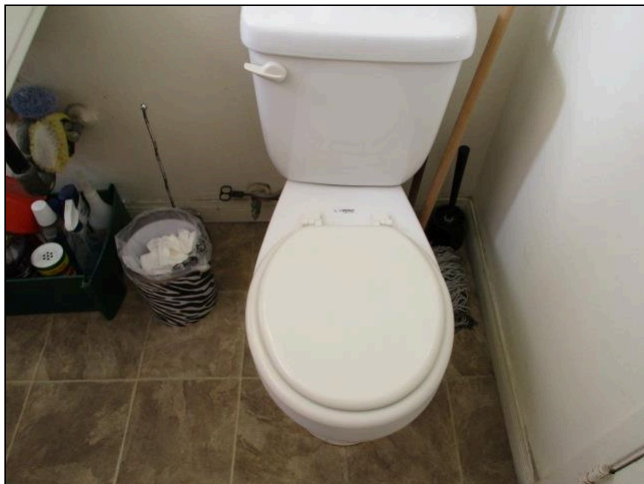
- 25** The toilet base is loose at the floor flange in the unit D bath. This can allow leaking and damage to surrounding materials. A qualified licensed plumber should replace the wax ring seal and re-secure the toilet to the floor flange.

Loose Toilet

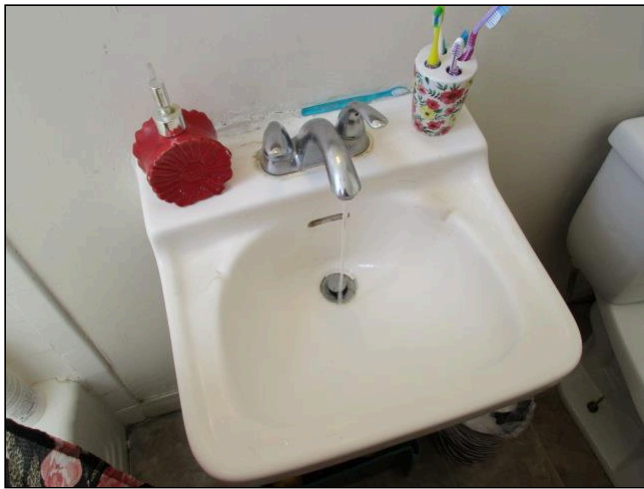
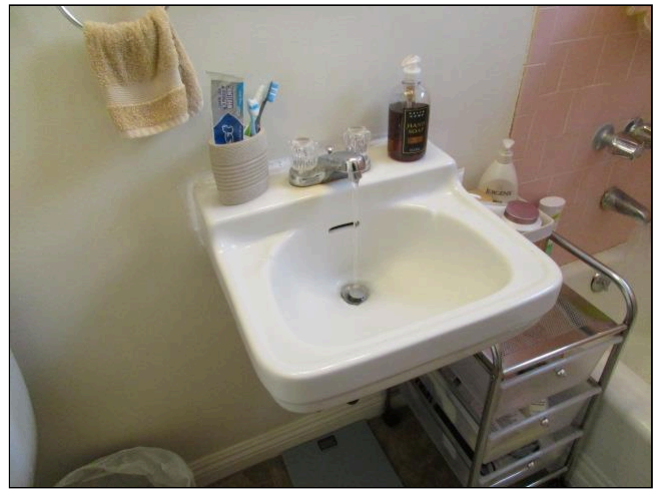
- 26** The wall mounted sinks are loose in the bathrooms of units A & D. The sinks should be re-mounted by

a qualified licensed contractor.

Loose Sink, Unit D

Loose Sink, Unit A

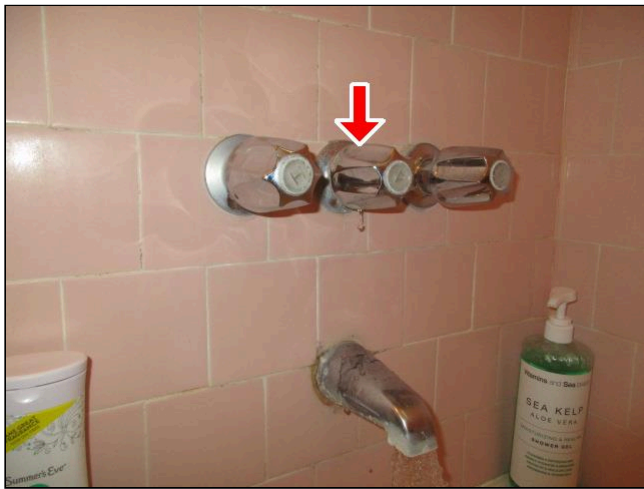
- 27** The tub spout diverter faucet leaks during operation in the unit A bath. A qualified licensed plumber should repair as needed.

Leaking Faucet

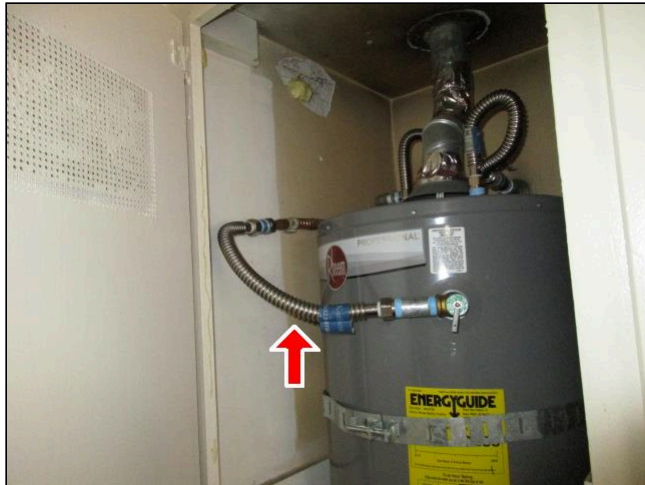
- 28** The existing piping for the T&P (temperature & pressure) relief valves on the water heaters in units A & C are not correctly installed with a downward slope to drain to the ground or exterior. A qualified licensed plumber should repair as needed.

Piping Incorrectly Installed Upward, Unit C

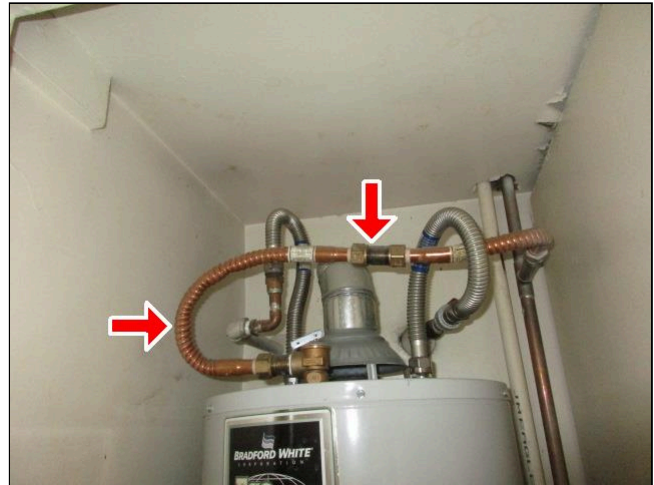
Piping Incorrectly Installed Upward, Unit A

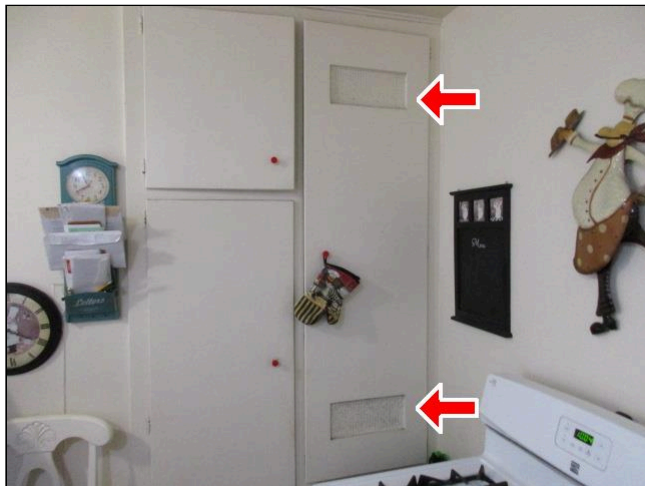
29 Combustion air vents in the water heater closet doors are sealed over with paint in all units. Open the vent screens to allow for proper combustion air to the water heaters, for safety.

Vents Covered, Typical

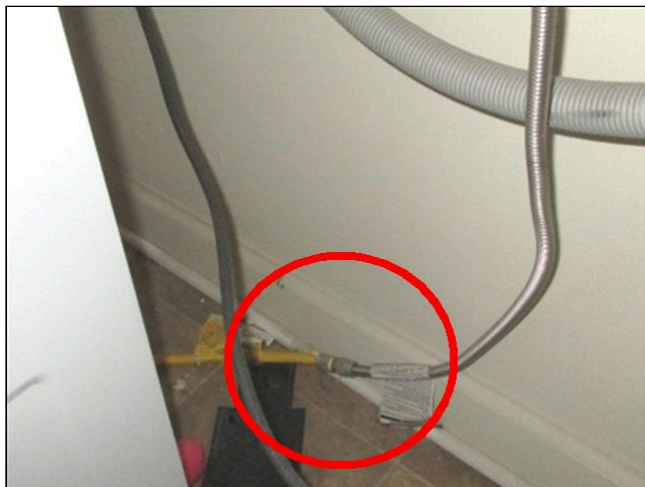
30 Two flexible gas connectors have been joined together for the clothes dryer in the unit C kitchen. This type of connection has a high propensity to leak and considered unsafe. Repairs by a qualified licensed plumber are recommended.

Flex Connectors Joined Together

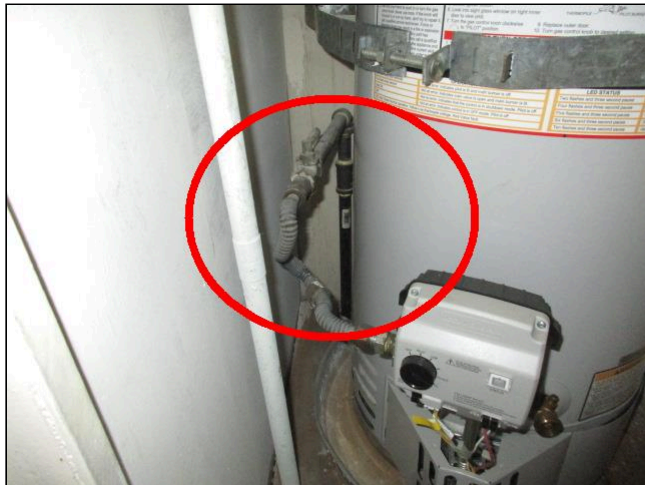
- 31** There are no visible sediment traps on the gas supply piping for any of the wall furnaces and water heaters. This may not have been a requirement at the time of installation, however today's standards typically require installation when replacement of the appliance occurs. Also, most manufacturers' require a sediment trap in their specifications to prevent contaminants and/or moisture from entering the gas control unit for the appliances. Have a qualified licensed HVAC contractor install, as needed.

Add Sediment Traps, Water Heaters, Typical

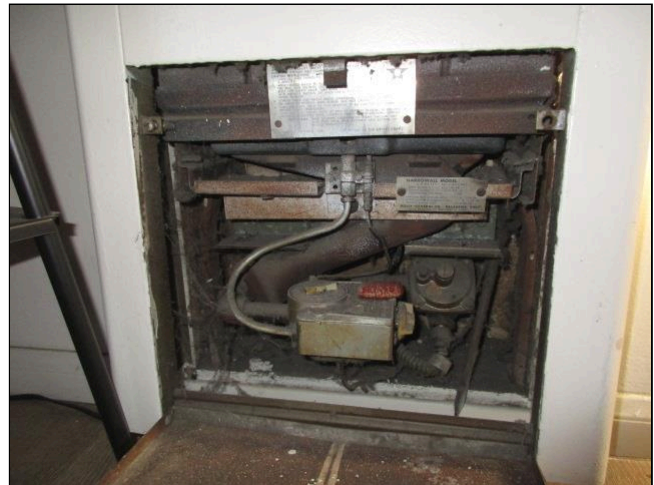
Add Sediment Traps, Wall Furnaces, Typical

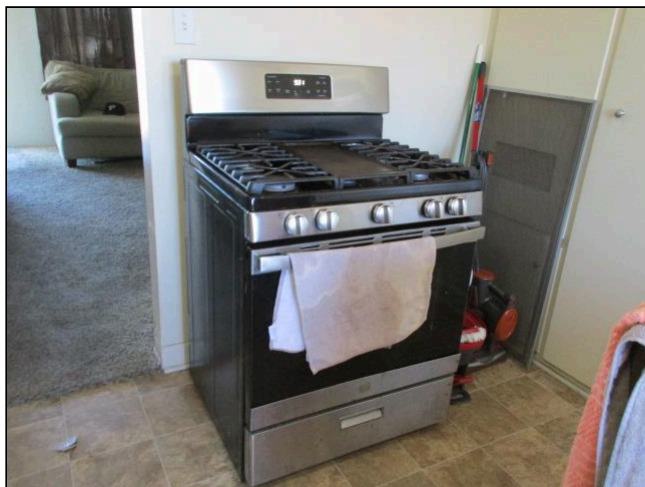
- 32** The ovens are missing an anti-tip bracket behind in each unit. This helps prevent the oven from tipping over should something heavy be placed on the open door. Install an anti-tip bracket in each unit.

Add Anti-Tip Brackets

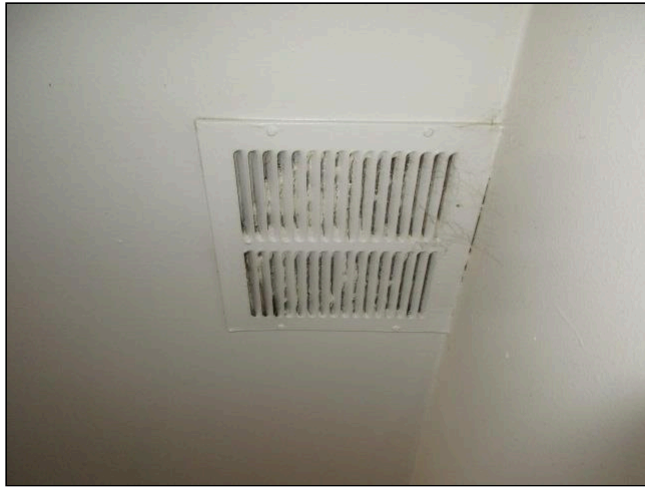
- 33** The kitchen gravity vent openings have been covered over are not functional in units __ & D. Open the gravity vents for improved ventilation as needed.

Gravity Vent Covered, Unit D

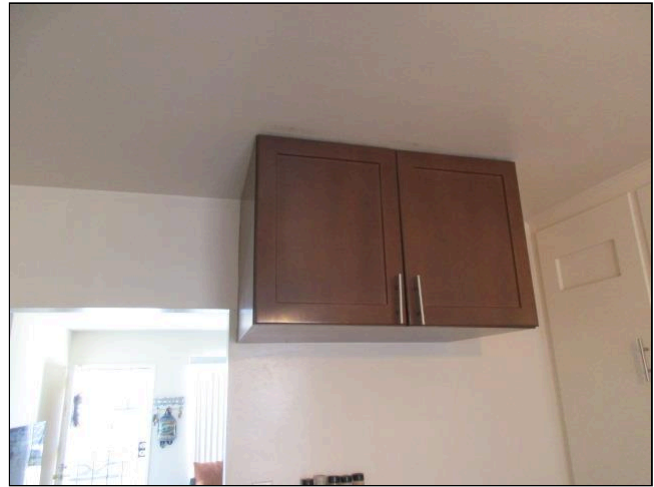
Gravity Vent Covered, Unit A

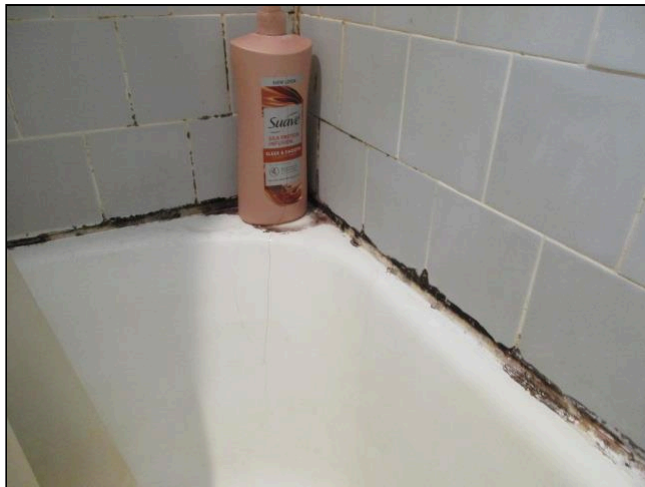
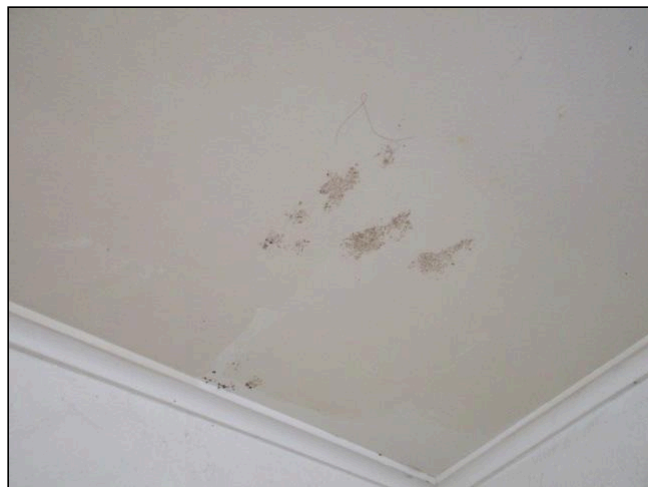
- 34** Suspected mold/fungus/mildew-like staining or substance was observed on the ceiling and grout & caulking of the shower surround in the bathroom of unit B. Analysis and testing for molds/fungus/mildew substances is not part of this general home inspection. I recommend evaluation and remediation by a qualified licensed contractor/hygienist/specialist in this field, as needed.

Suspected Mold/Fungus/Mildew, Unit B Bath

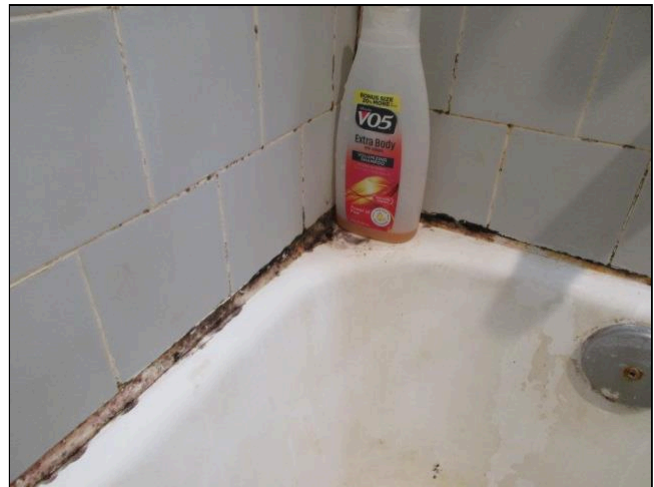
Suspected Mold/Fungus/Mildew, Unit B Bath

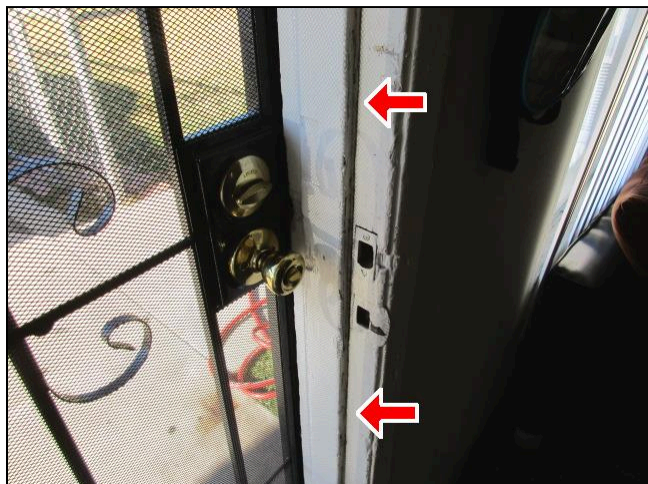
The front entry doors are in need of new weather-stripping and door sweeps in each unit. Without correction, this can allow some heat loss in winter and loss of cool air in summer. Install as needed.

Add Weather Stripping

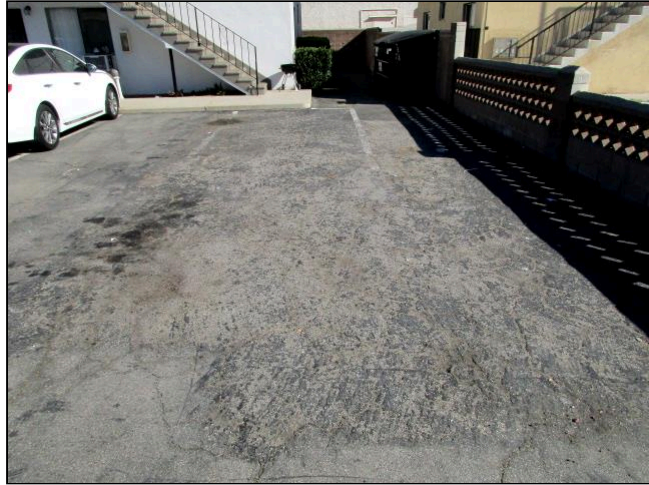
The asphalt drive is worn & deteriorated at the right side, unit D space. Have a qualified licensed paving contractor repair and seal as needed.

Worn, Deteriorated Drive

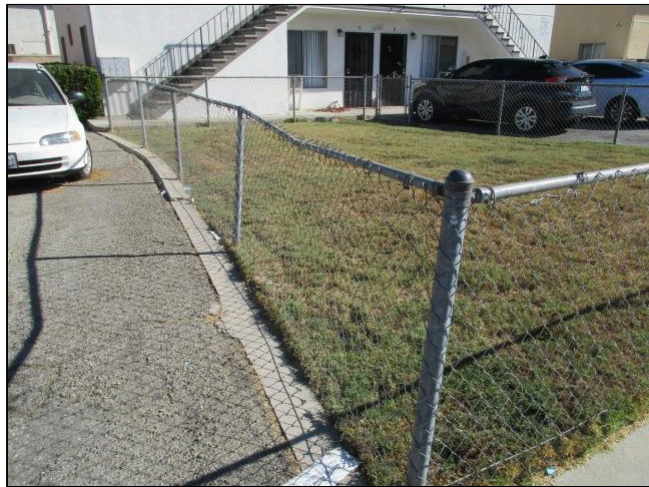
A section of the chainlink fencing at the left is damaged. A qualified licensed contractor should repair as needed.

Damaged Chainlink

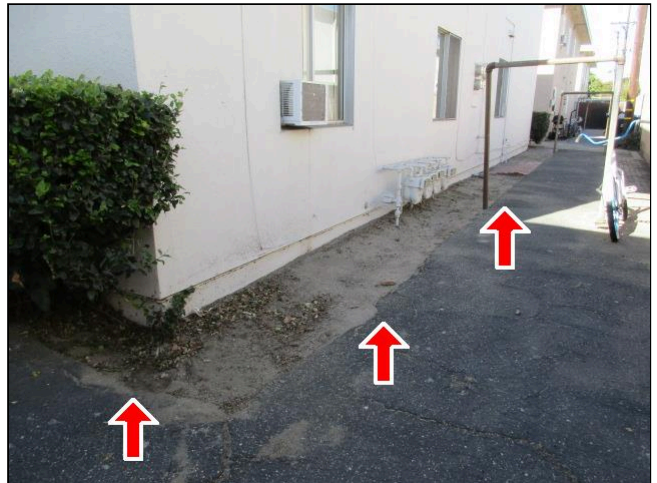
Poor Drainage Possible

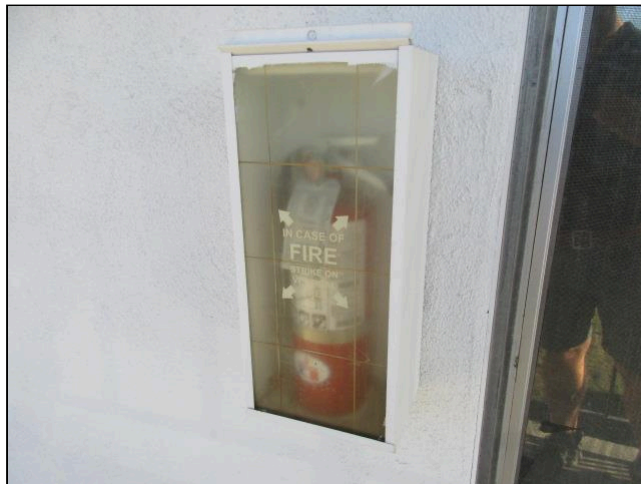
The fire extinguisher certifications are expired at both the 1st & 2nd stories. Contact a certified fire extinguisher company for service.

Extinguisher Certifications Expired

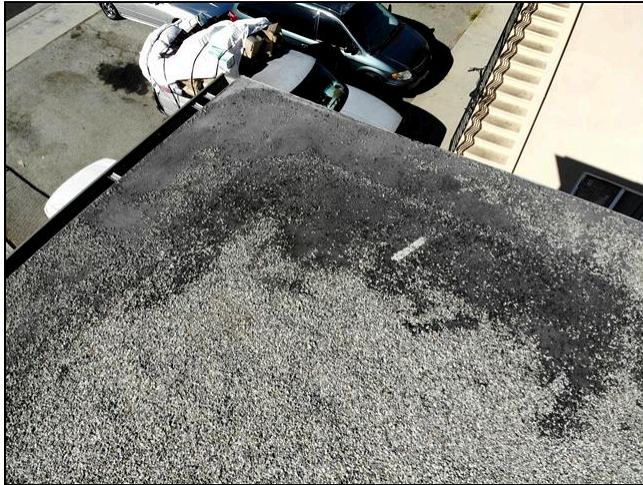
The built up roof covering is missing ballast the corners and edges, is cracked and appears to be nearing the end of it's expected useful life. Have a qualified licensed roofing contractor repair now to leaking during rains and anticipate future replacement.

Missing Ballast, Cracked Roofing

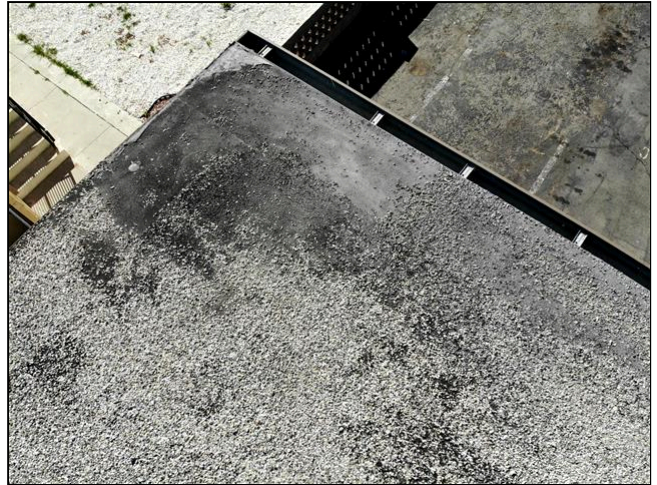
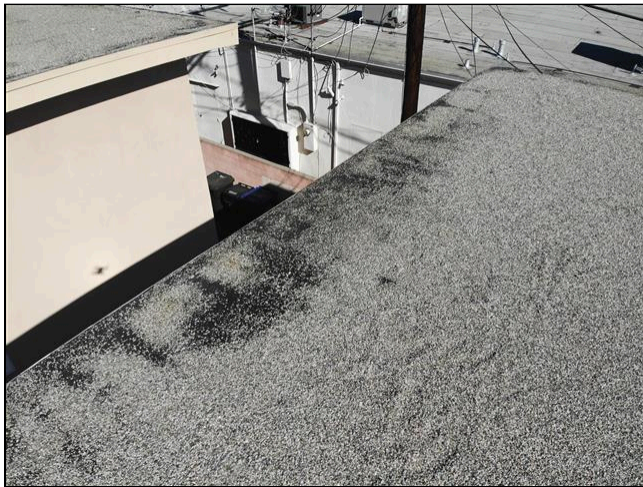
Missing Ballast, Cracked Roofing

Missing Ballast

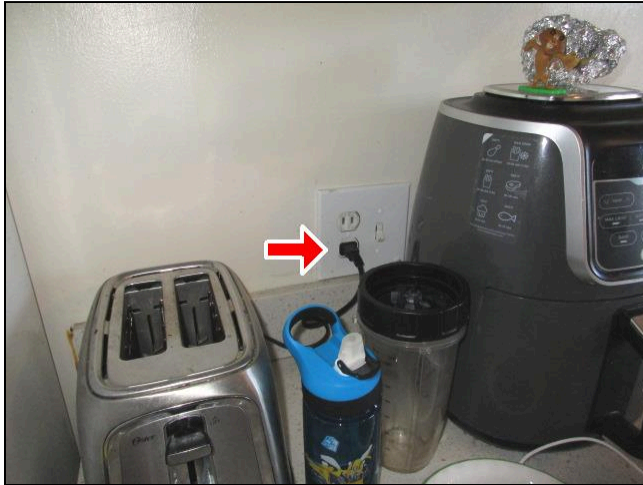
Upgrade *all* laundry area, bathrooms and kitchen counter top outlets to GFCI's (ground fault circuit interrupters). These may not have been required at the time of original construction but are recommended now, for safety.

Add Kitchen GFCI's

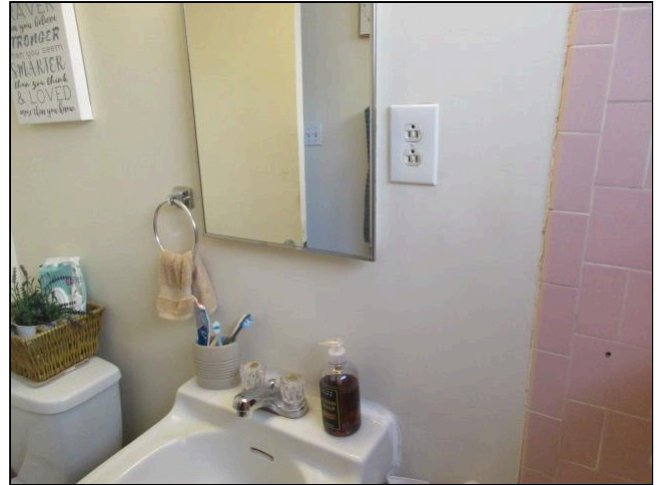
Add Bathroom GFCI's

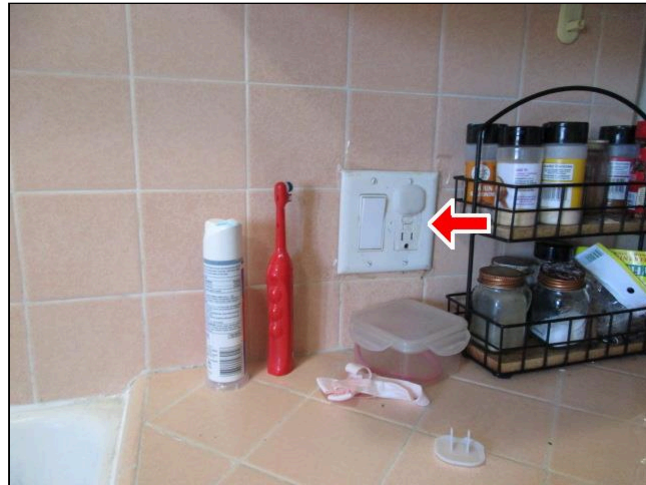
A GFCI (Ground Fault Circuit Interrupter) outlet at the unit C kitchen did not work or there is no power to the outlet. A qualified licensed electrical contractor should correct as needed.

GFCI Outlet Not Operational
