Inspection Report

Property Address:
8721 Lyndora St
Downey CA 90242

Inspection Industries, LLC

Date: 10/31/2023	Time: 09:00 AM	Report ID: 8721Dora
Property: 8721 Lyndora St Downey CA 90242	Customer: Barbara Santa Cruz	Real Estate Professional:

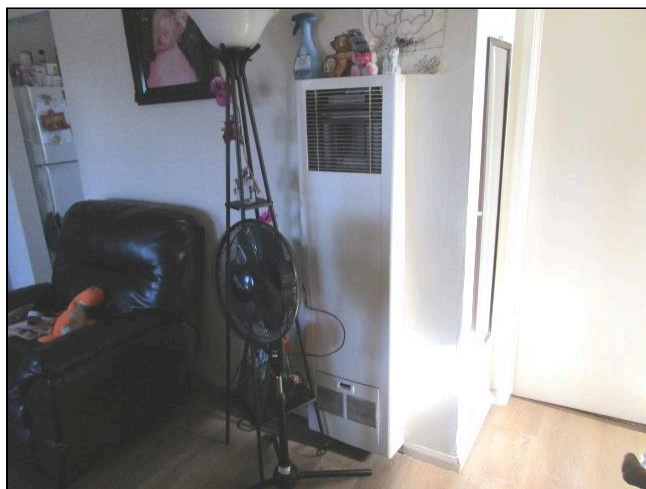
All gas fired wall furnaces were shut off at the time of inspection, not able to be tested/operated and the furnaces in units A, B & D are beyond their expected useful lives. Have the systems inspected and operated by a qualified licensed HVAC contractor or the gas company and anticipate repairs and replacement as necessary.

Old Wall Heater Shut Off, Unit D

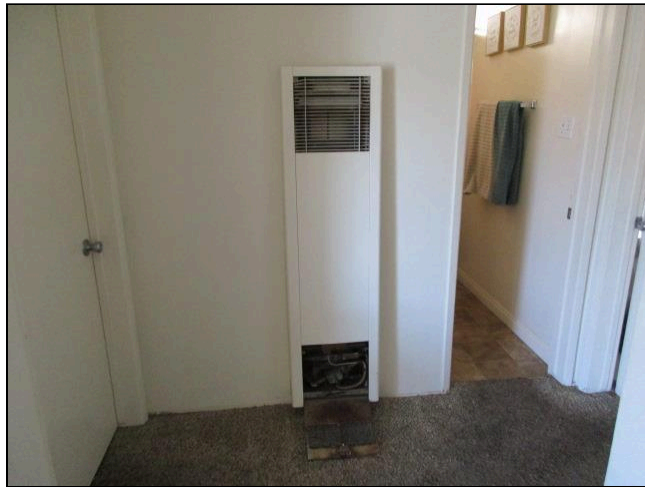
Old Water Heater Shut Off, Unit A

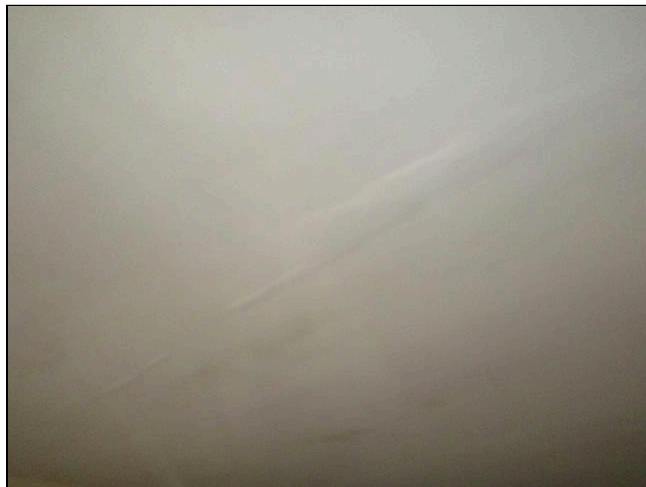
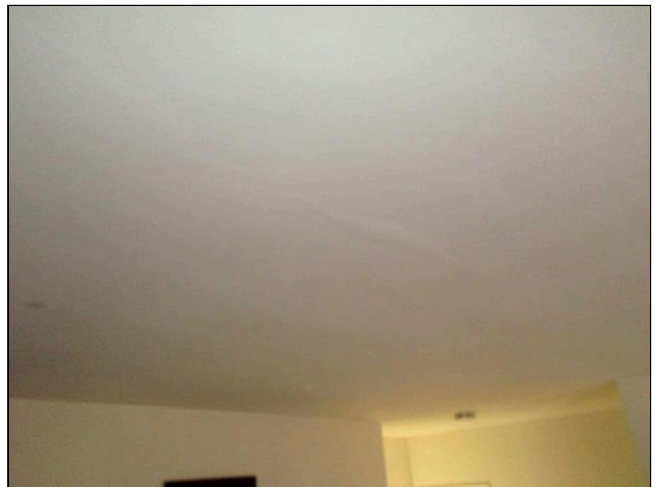
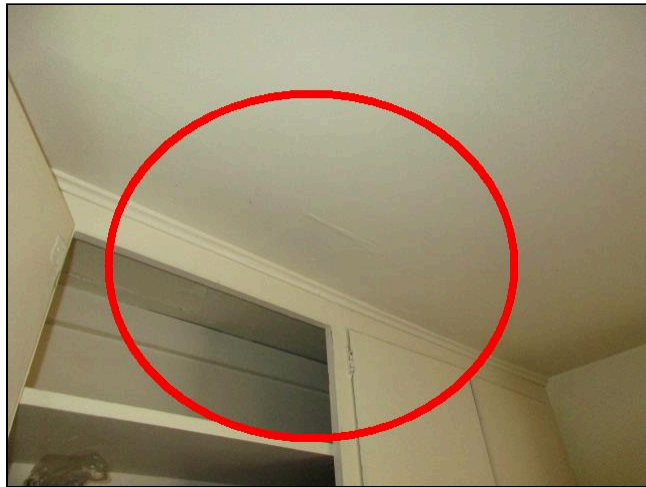
The plaster ceiling is damaged at the kitchen of unit B & living room of unit D. A moisture meter was used and it did not indicate excessive levels of moisture at the time of inspection. Have a qualified licensed contractor repair as needed.

Damaged Ceiling, Unit D

Damaged Ceiling, Unit B

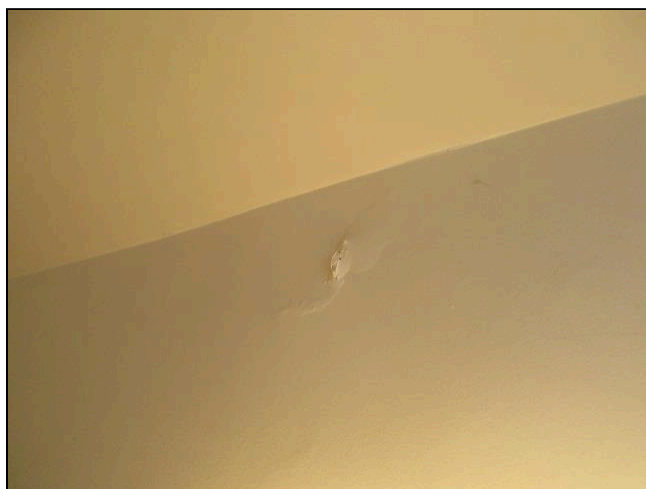
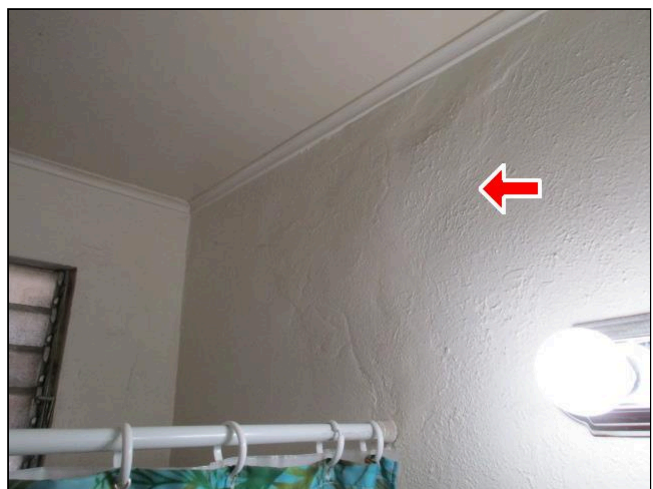
The plaster walls are damaged at the bathrooms of units A & B. A moisture meter was used and it did not indicate excessive levels of moisture at the time of inspection. Have a qualified licensed contractor repair as needed.

Damaged Wall, Unit A

Damaged Wall, Unit B

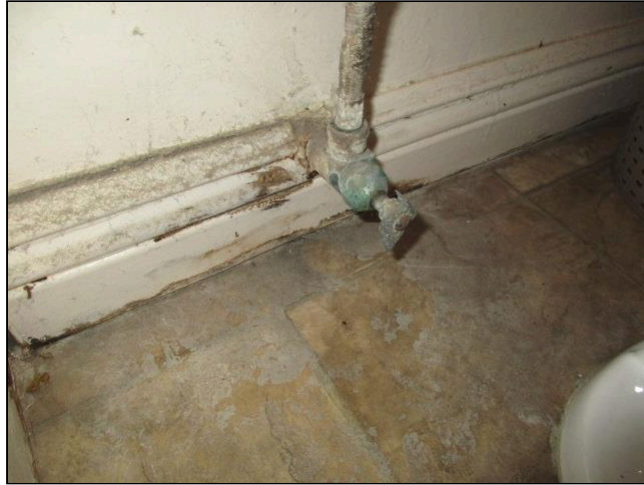
The baseboard mouldings are stained and damaged in the unit A bath. A moisture meter was used and it did not indicate excessive levels of moisture at the time of inspection. Have a qualified licensed contractor repair as needed.

Stained, Damaged Baseboards

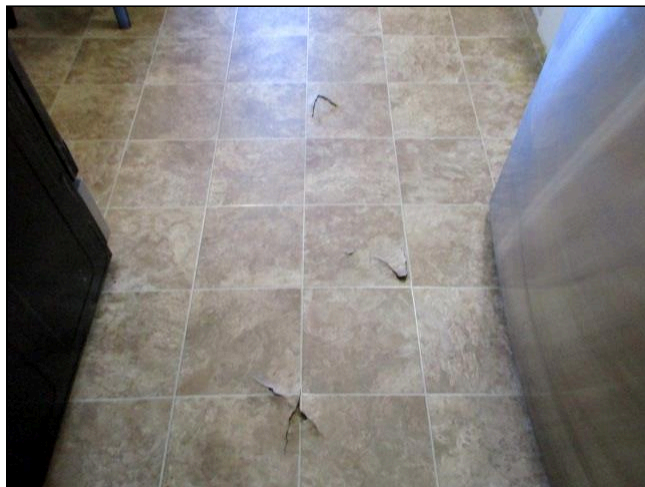
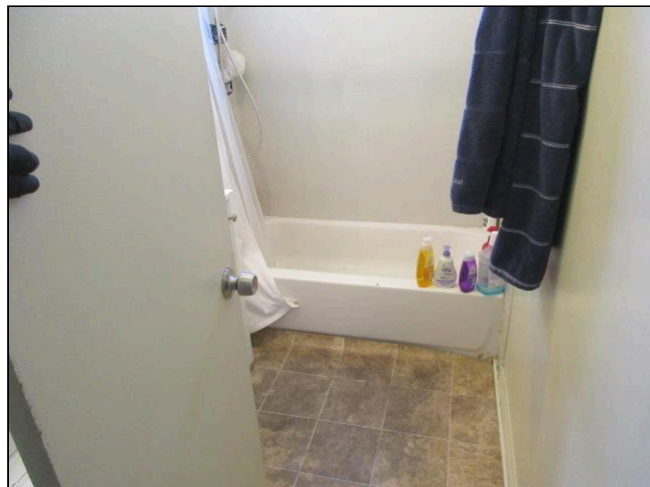
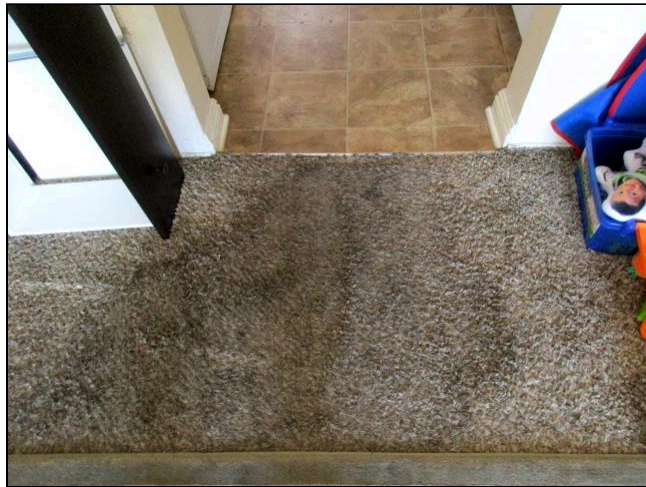
Various areas of the vinyl and carpet floors are stained and damaged throughout each unit. While this is cosmetic, the repair cost should be considered due to the amount of material needed for replacement.

Damaged Floor, Unit C Kitchen

Stained Floor, Unit C

Stained Carpet, Unit A

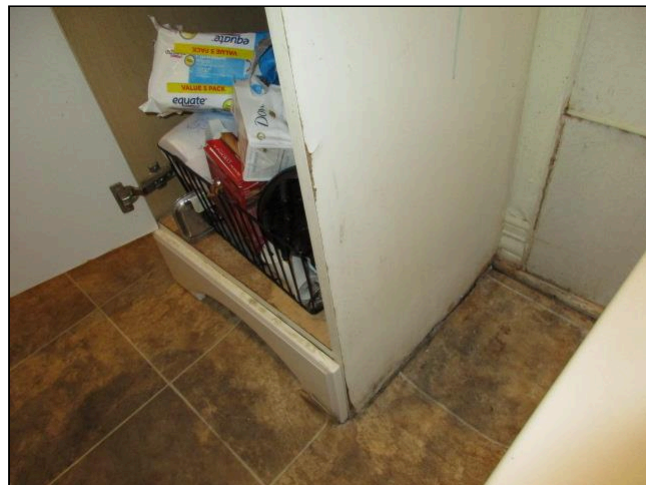
The bathroom vanity is damaged in the unit C bath. Repair or replace as necessary.

Damaged Vanity

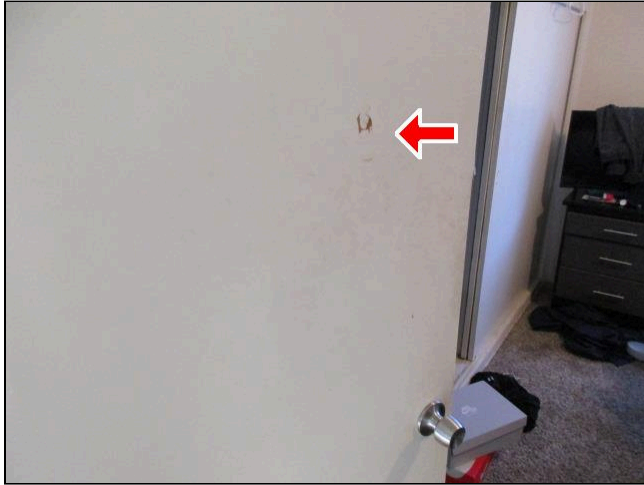
Interior doors are damaged at the rear bedroom of units B & D. Repair or replace as needed.

Damaged Door, Unit D

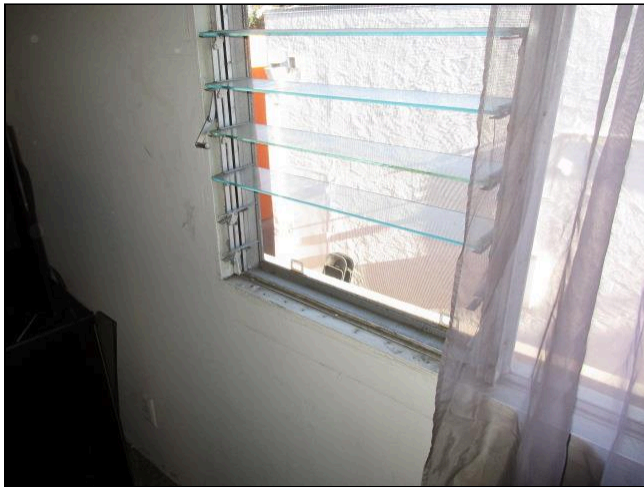
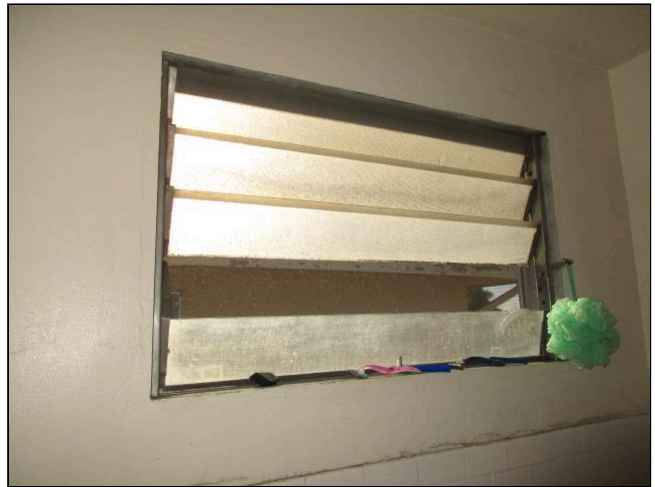
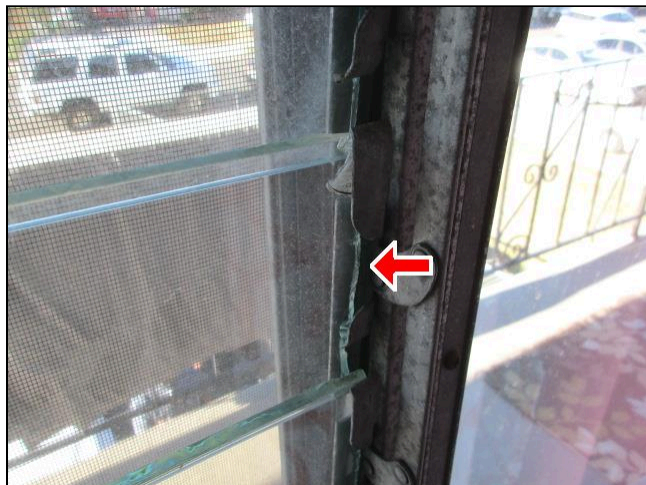
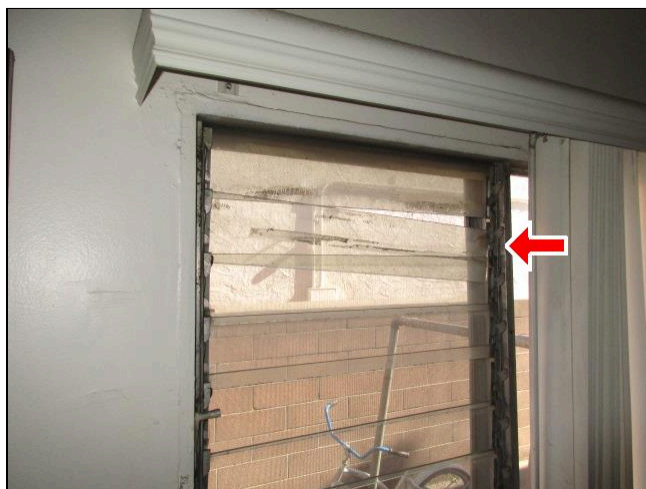
Jalousie windows are missing, loose and/or chipped glass panels in the kitchen of unit A, kitchen of unit B and the living room, bathroom and rear bedroom of unit D. Have a qualified licensed window contractor

Missing Panels, Unit D Rear Bedroom

Missing Panel, Unit D Bath

Chipped Glass, Unit D Living Room

Loose Panel, Unit B Kitchen

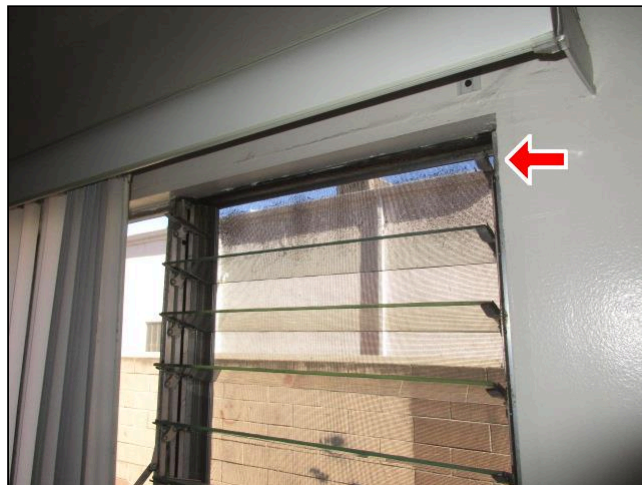
Missing Panel, Unit A

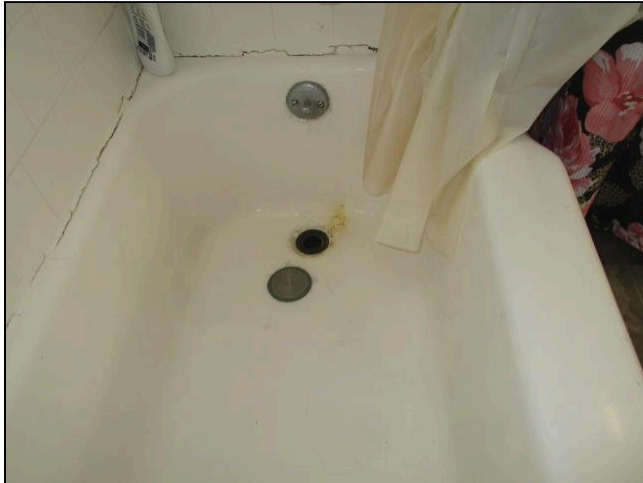
The tubs are slow draining in the bathrooms of units B & D. The cause of a slow drain can vary from a simple cleaning at the stopper valve or at the trap. I am unable to determine the cause of the slow drain. A qualified licensed plumber should repair as needed.

Slow Draining Tub, Unit D

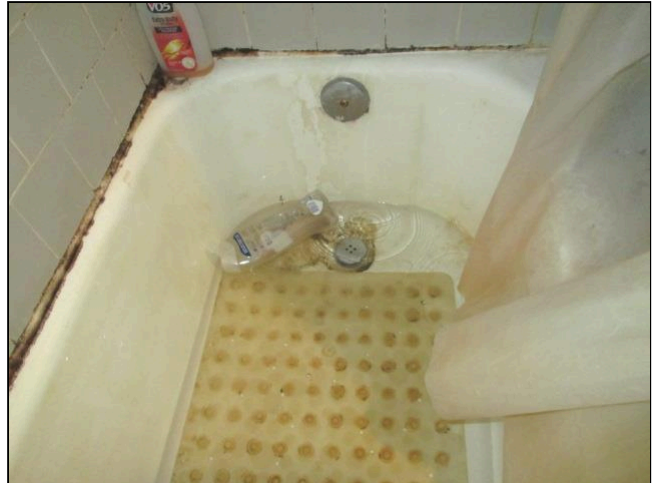
Slow Draining Tub, Unit B

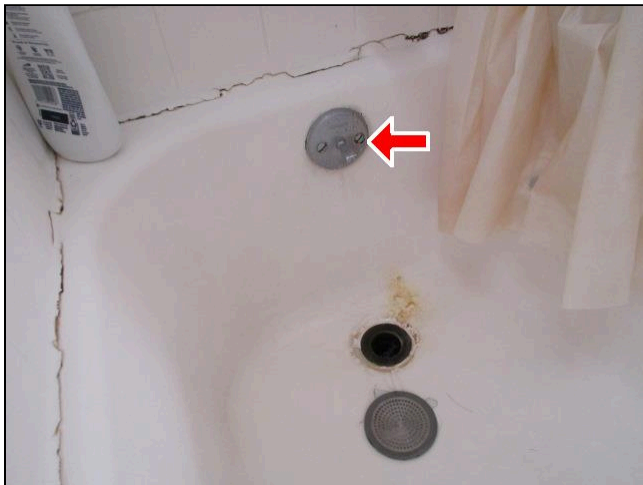
The tub stoppers do not work in the baths of units A & D. A qualified licensed plumber should repair as needed.

Stopper Not Operational, Unit D

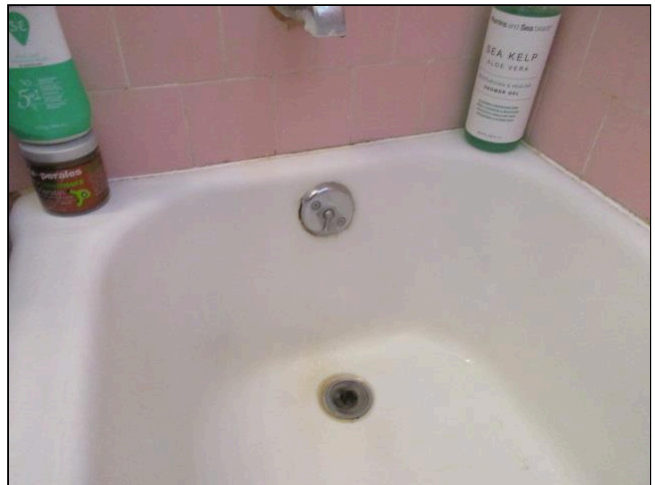
Stopper Not Operational, Unit A

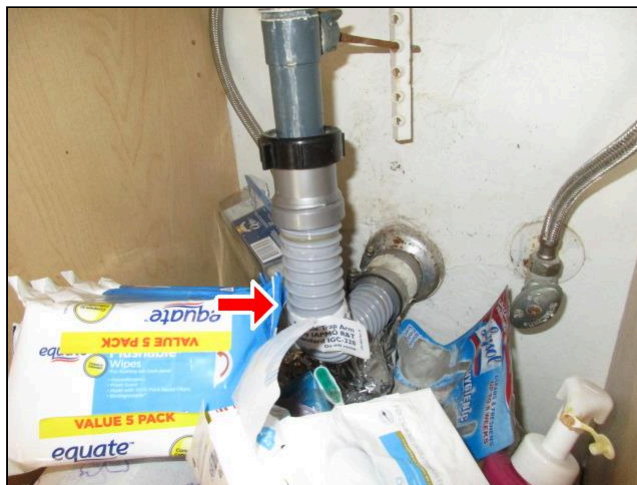
The sink drain has been repaired improperly at the unit C bath and without a P trap. This flexible, ribbed material will encourage clogs and bacteria growth. A qualified licensed plumber should repair with rigid, UPC approved material as needed.

Improper Drain Repair

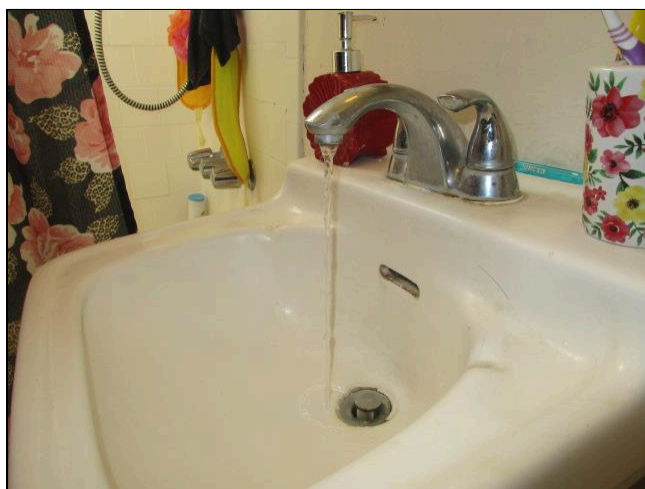
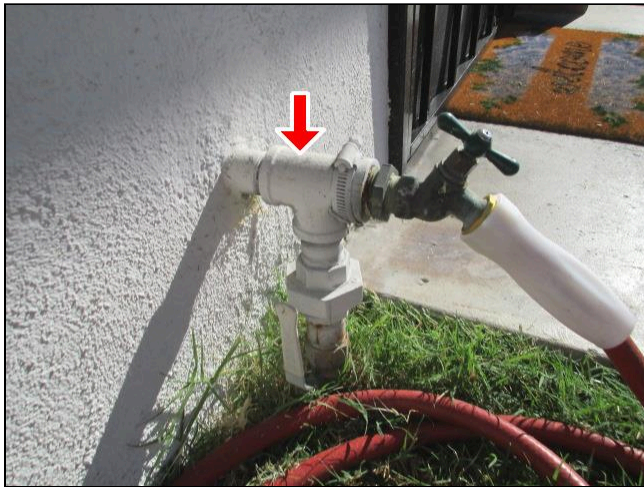
The volume of water is poor when operating multiple fixtures simultaneously in each unit. This is likely caused by the old galvanized steel service & supply piping present which is typically corroded inside. A qualified licensed plumber should correct as needed.

Low Water Volume

Old Galvanized Steel Piping In Use

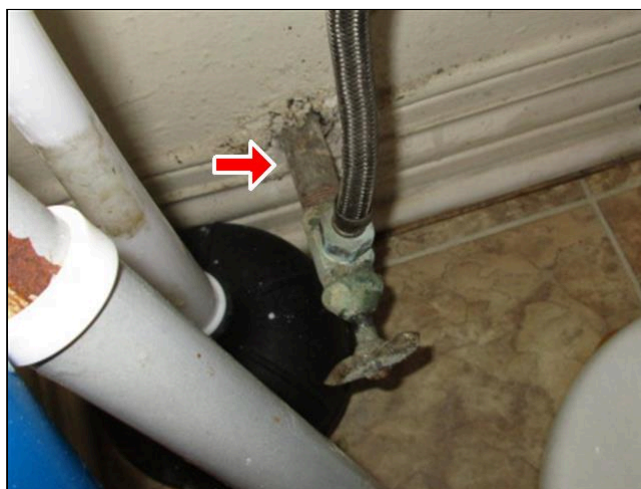
Old Galvanized Steel Piping In Use

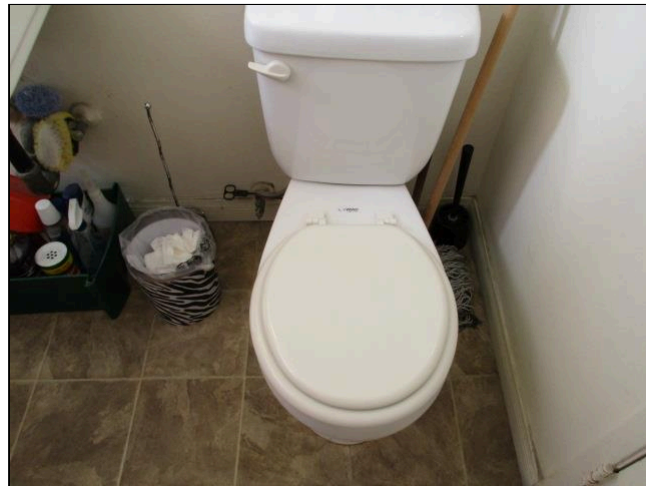
The toilet base is loose at the floor flange in the unit D bath. This can allow leaking and damage to surrounding materials. A qualified licensed plumber should replace the wax ring seal and re-secure the toilet to the floor flange.

Loose Toilet

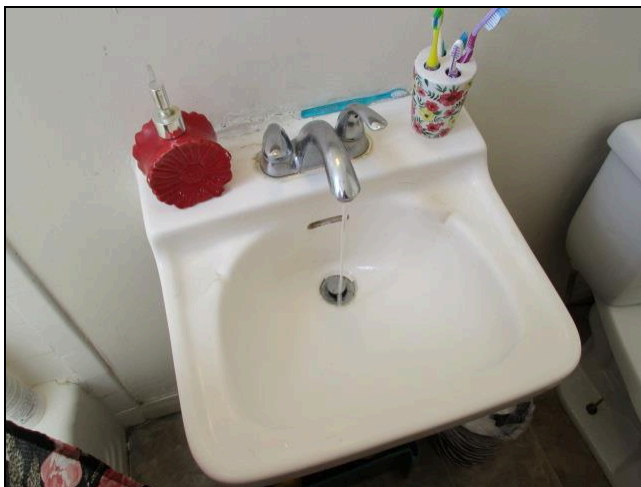
The wall mounted sinks are loose in the bathrooms of units A & D. The sinks should be re-mounted by a qualified licensed contractor.

Loose Sink, Unit D

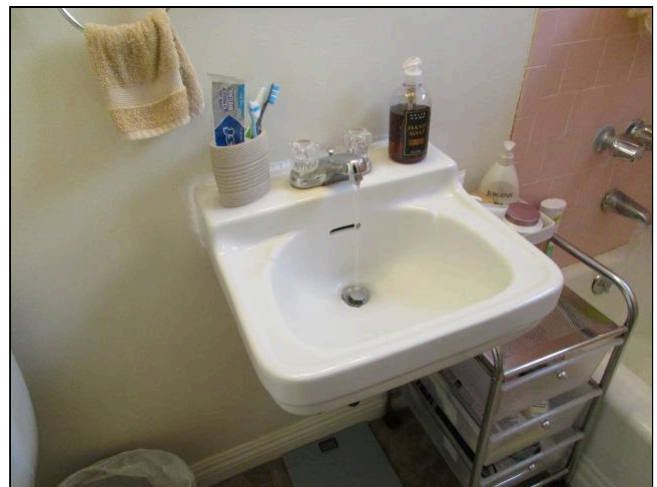
Loose Sink, Unit A

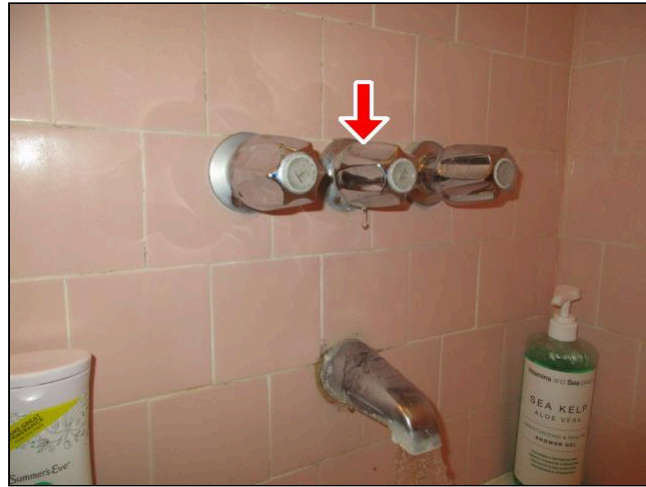
The tub spout diverter faucet leaks during operation in the unit A bath. A qualified licensed plumber should repair as needed.

Leaking Faucet

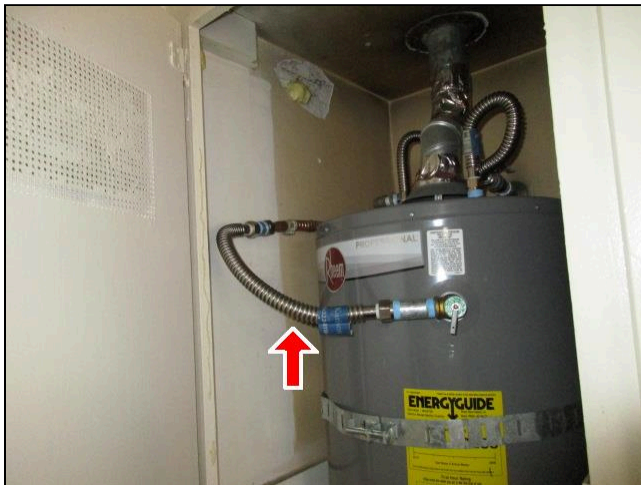
The existing piping for the T&P (temperature & pressure) relief valves on the water heaters in units A & C are not correctly installed with a downward slope to drain to the ground or exterior. A qualified licensed plumber should repair as needed.

Piping Incorrectly Installed Upward, Unit C

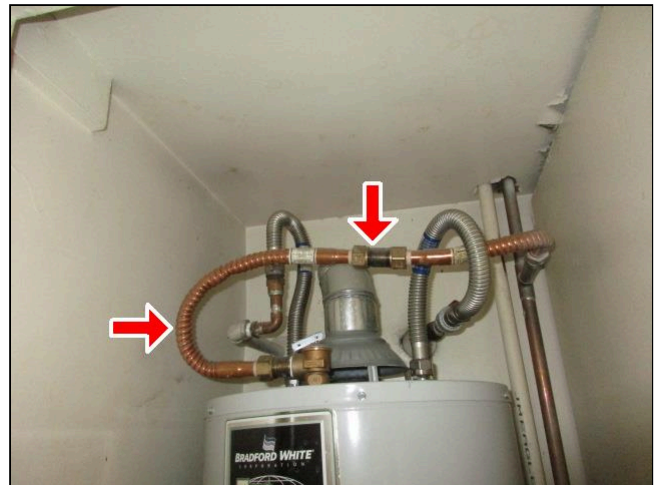
Piping Incorrectly Installed Upward, Unit A

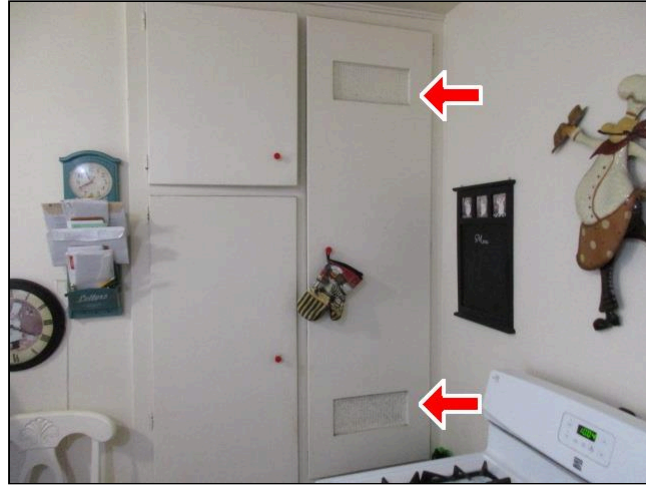
Combustion air vents in the water heater closet doors are sealed over with paint in all units. Open the vent screens to allow for proper combustion air to the water heaters, for safety.

Vents Covered, Typical

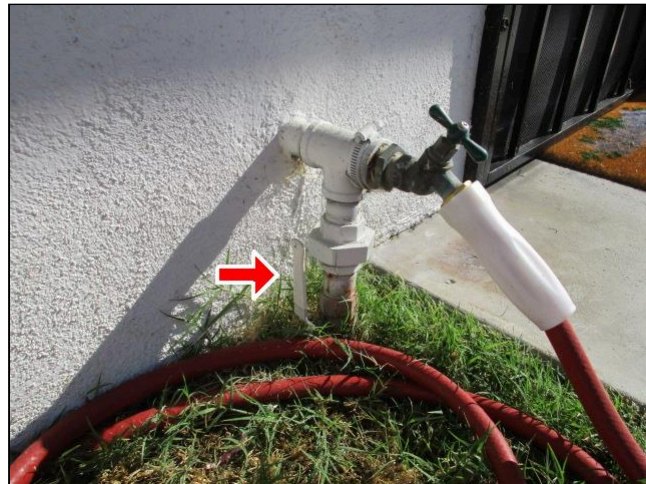
Water Shut Off Valve

The main water shut off is the lever located at the front exterior of unit A.

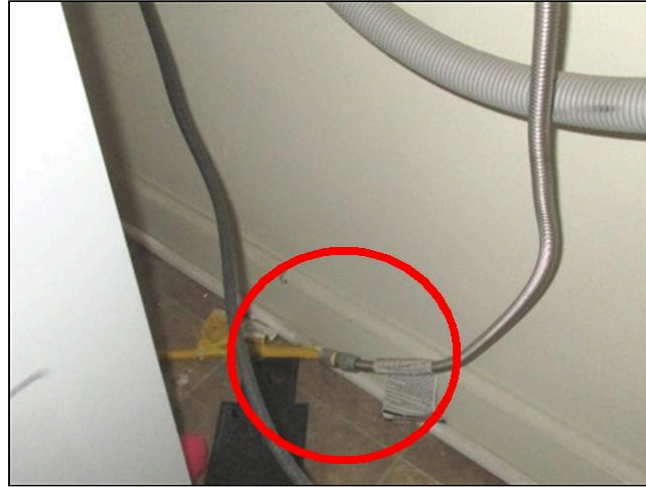
Two flexible gas connectors have been joined together for the clothes dryer in the unit C kitchen. This type of connection has a high propensity to leak and considered unsafe. Repairs by a qualified licensed plumber are recommended.

Flex Connectors Joined Together

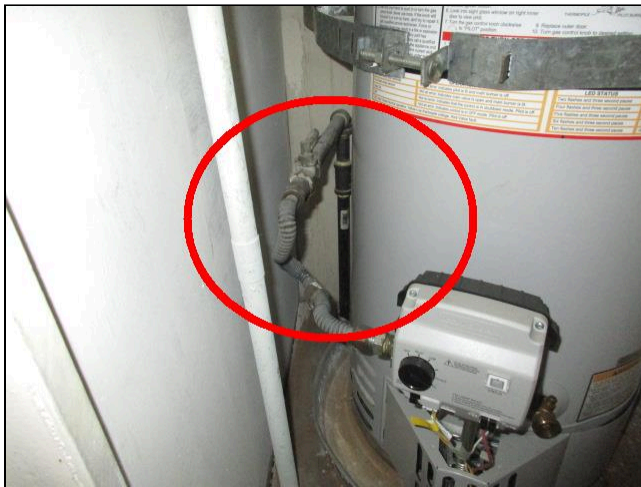
There are no visible sediment traps on the gas supply piping for any of the wall furnaces and water heaters. This may not have been a requirement at the time of installation, however today's standards typically require installation when replacement of the appliance occurs. Also, most manufacturers' require a sediment trap in their specifications to prevent contaminants and/or moisture from entering the gas control unit for the appliances. Have a qualified licensed HVAC contractor install, as needed.

Add Sediment Traps, Water Heaters, Typical

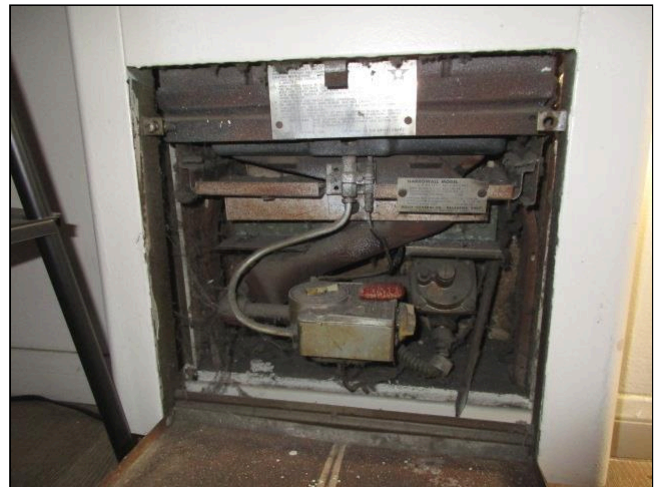
Add Sediment Traps, Wall Furnaces, Typical

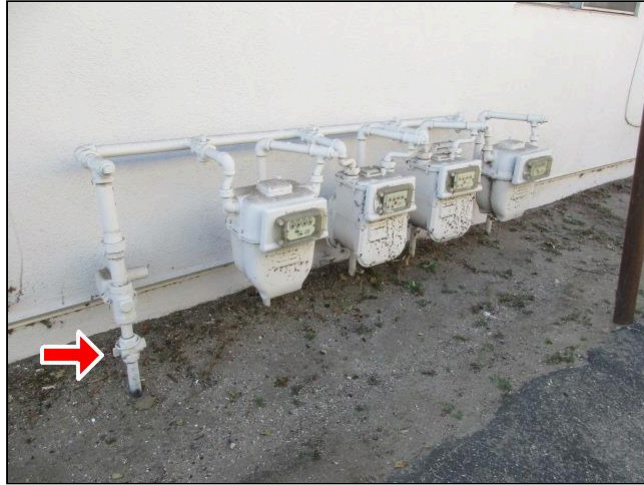
Main Gas Shut Off Valve

The main gas shut off is located at the gas meter bank, at the rear side of the building.

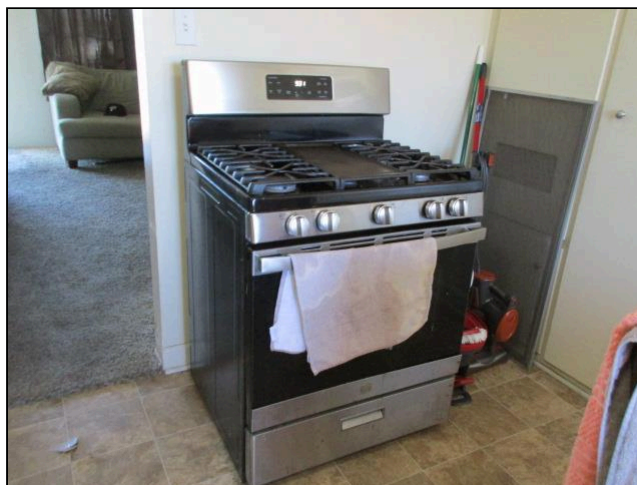
The ovens are missing an anti-tip bracket behind in each unit. This helps prevent the oven from tipping over should something heavy be placed on the open door. Install an anti-tip bracket in each unit.

Add Anti-Tip Brackets

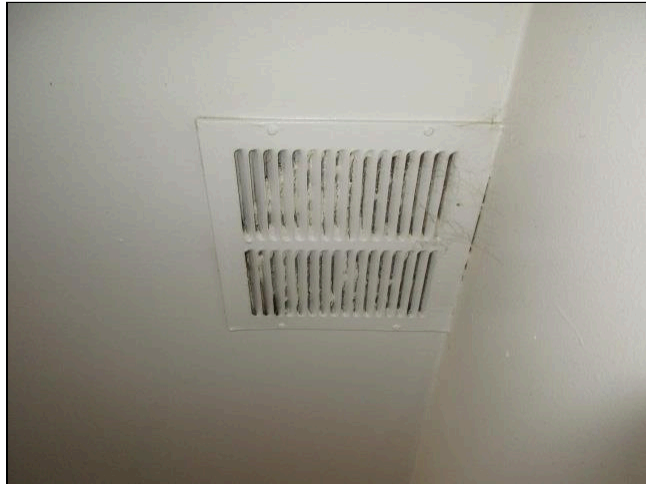
The kitchen gravity vent openings have been covered over are not functional in units __ & D.
 Open the gravity vents for improved ventilation as needed.

Gravity Vent Covered, Unit D

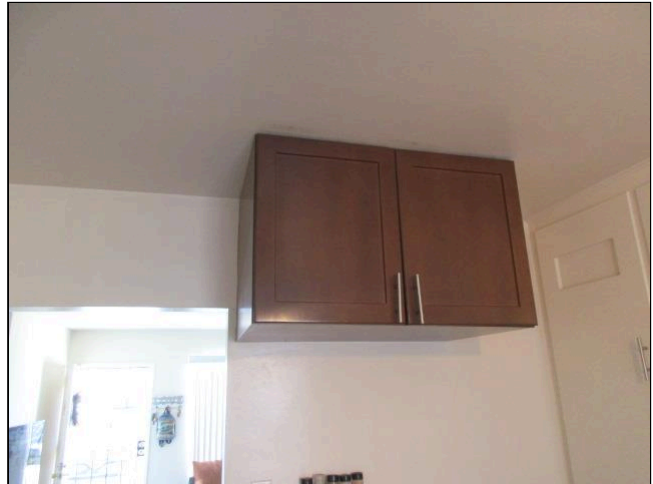
Gravity Vent Covered, Unit A

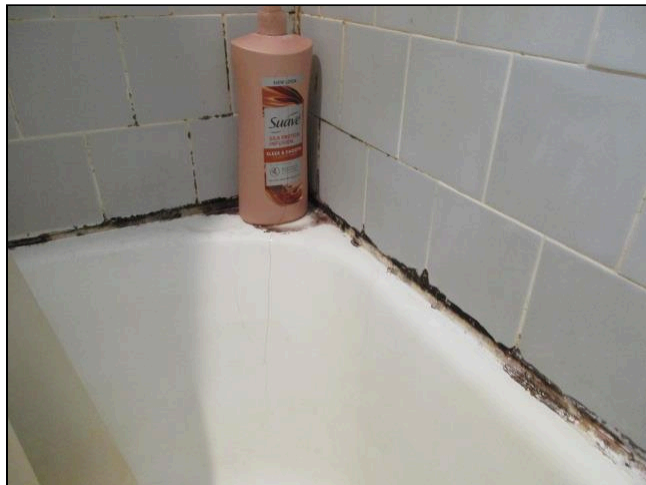
Suspected mold/fungus/mildew-like staining or substance was observed on the ceiling and grout & caulking of the shower surround in the bathroom of unit B. Analysis and testing for molds/ fungus/mildew substances is not part of this general home inspection. I recommend evaluation and remediation by a qualified licensed contractor/hygienist/specialist in this field, as needed.

Suspected Mold/Fungus/Mildew, Unit B Bath

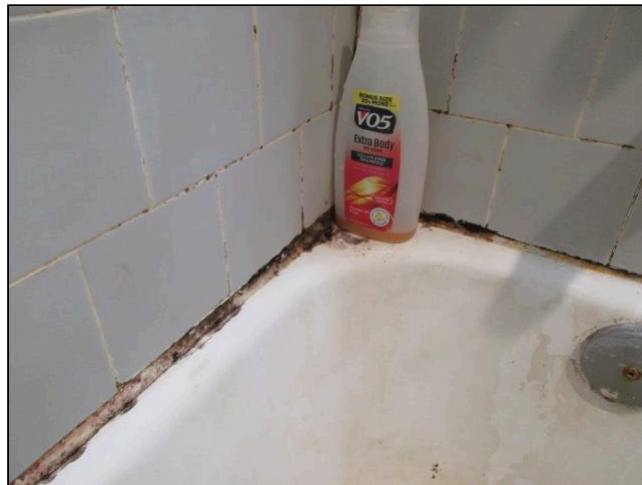
Suspected Mold/Fungus/Mildew, Unit B Bath

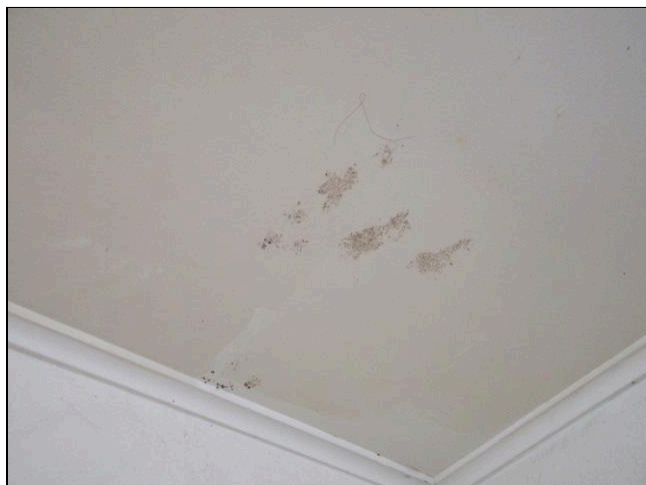
Suspected Mold/Fungus/Mildew, Unit B Bath
