Home Inspection Report

2827 South Fairview

Santa Ana, Ca 92704

Inspected On Fri, Feb 11, 2022 at 1:00 PM

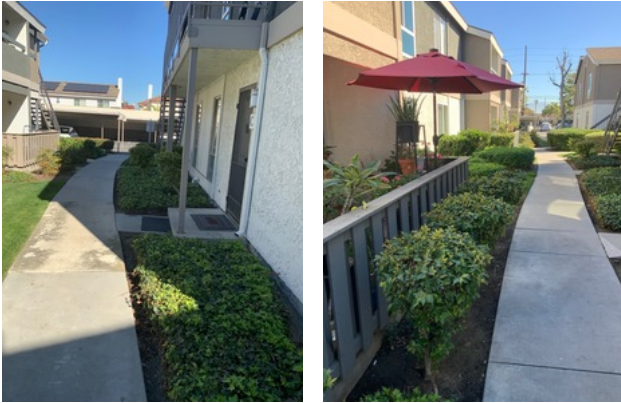
Mostly level, Sloped away from structure

Condition: Satisfactory

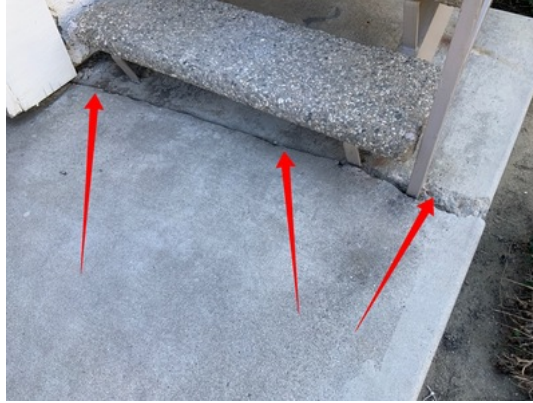
Comment 1

Condition: Further Evaluation Required

Portion of front step/stoop has a large crack. Recommend further evaluation by licensed contractor and HOA.

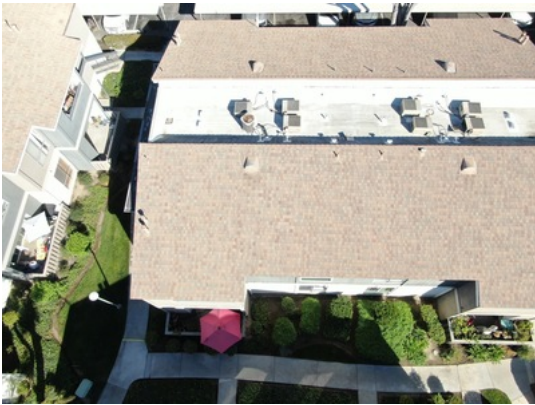
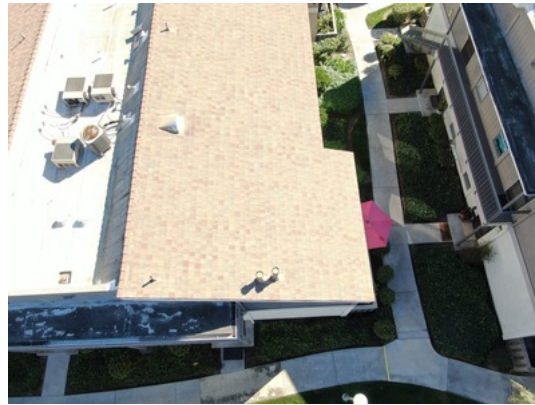
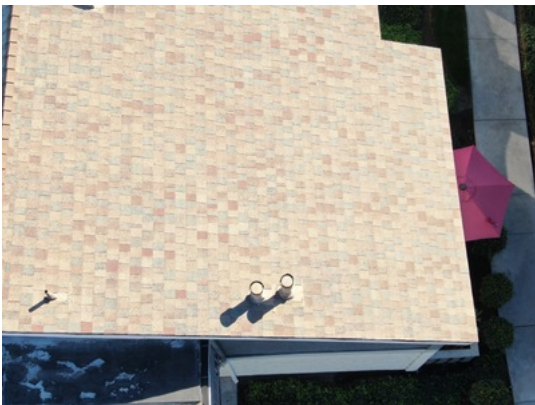
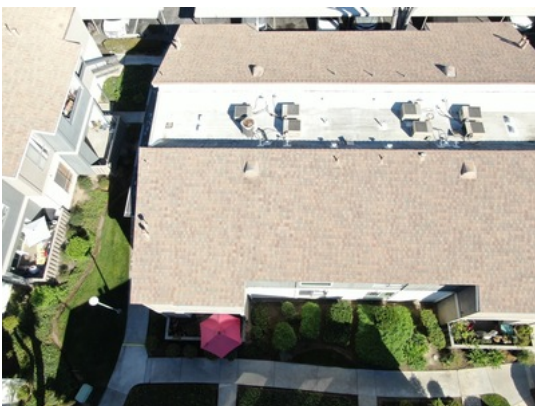
3 Tab Shingle, Roll Roofing

Condition: Satisfactory

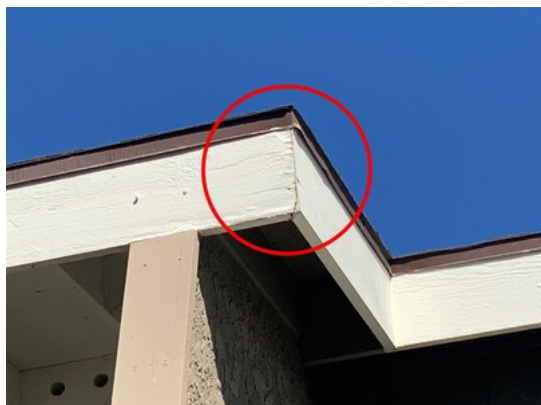
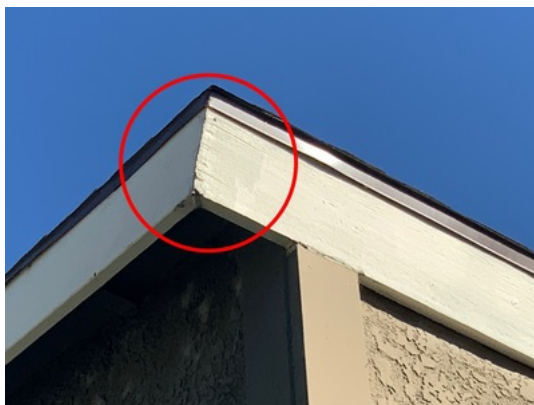
Comment 2

Some areas of trim showing signs of possible dry rot and/or termite damage. Recommend further evaluation by licensed contractor and pest control specialist and HOA.

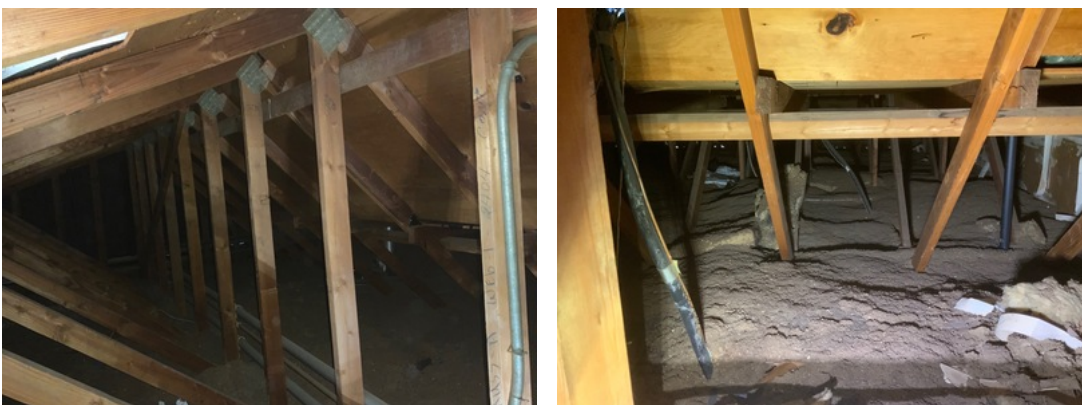
Wood Trusses

Condition: Satisfactory

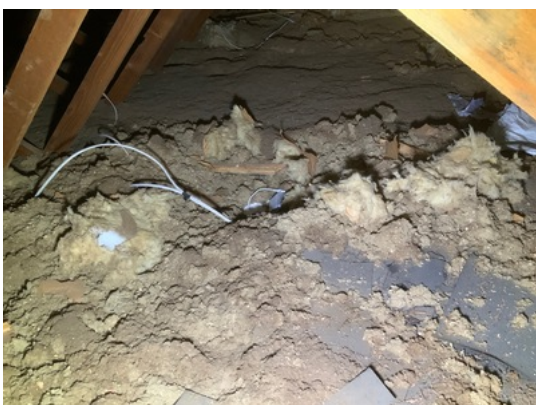
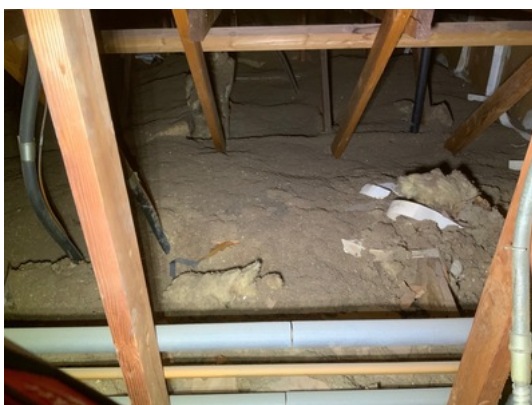
Blown In Cellulose

Condition: Satisfactory

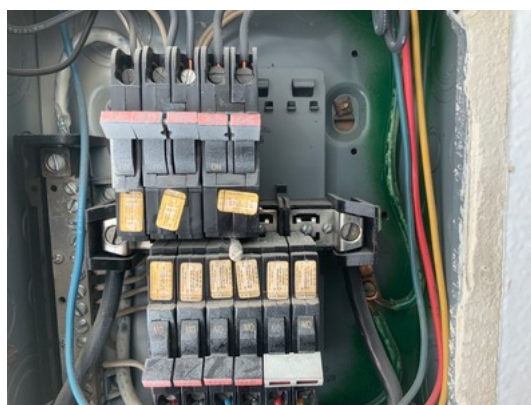
**Comment 3
Deficiency**

Presence of Federal Pacific Electric Company sub-panel, which has been banned from use as it does not meet current standards and represents a fire hazard.

Recommend further evaluation by licensed electrician.

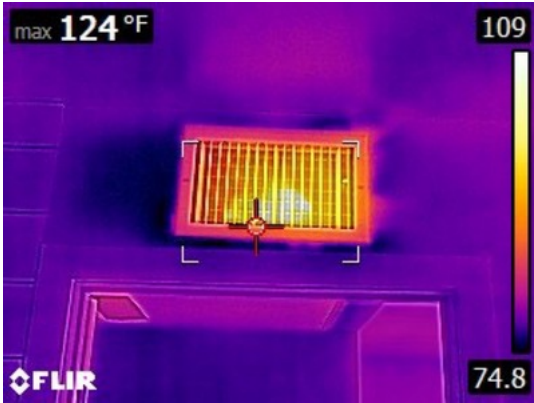
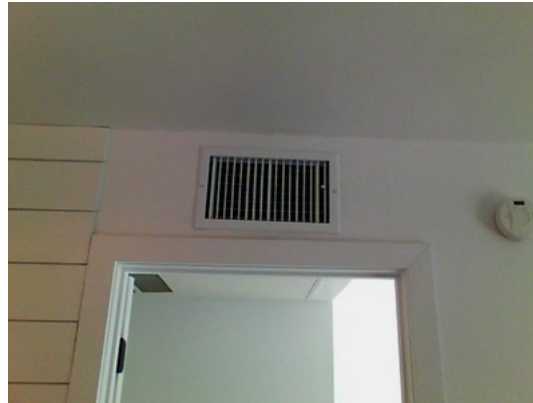
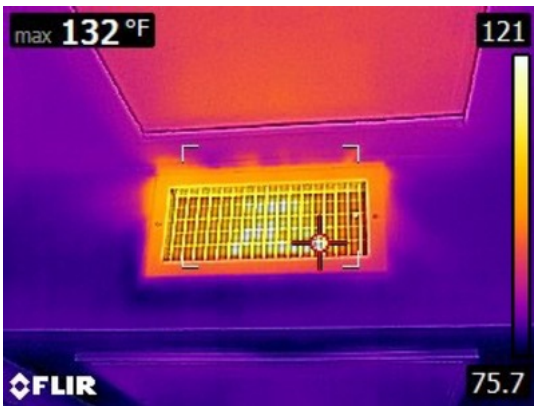
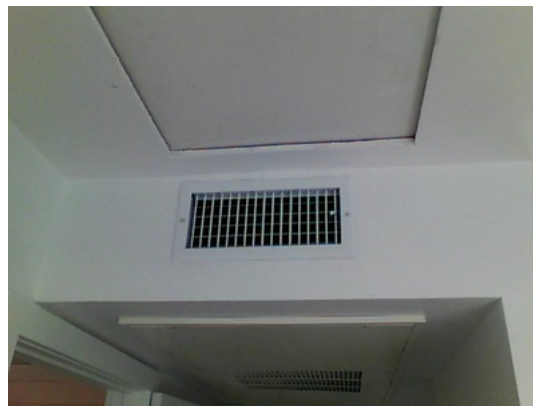
**Comment 4
Information**

Unable to visually inspect heater due to presence of large “2 person” access cover.

Heater appears to be functioning properly at time of inspection as shown by IR imaging pictures.

Furnaces over 10 years old should be checked, cleaned and serviced yearly by a licensed contractor.

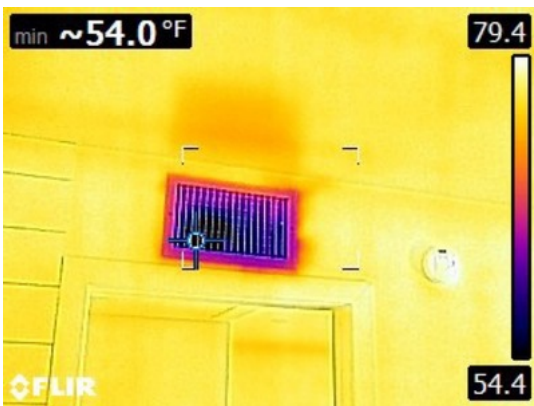
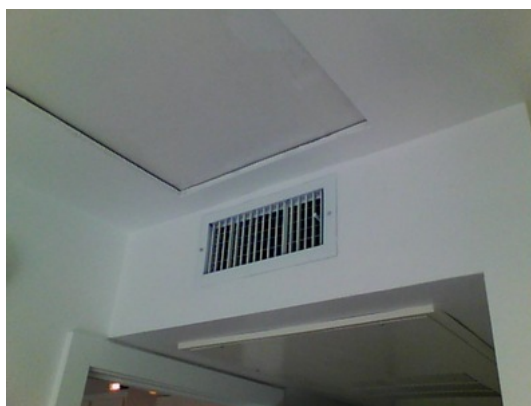
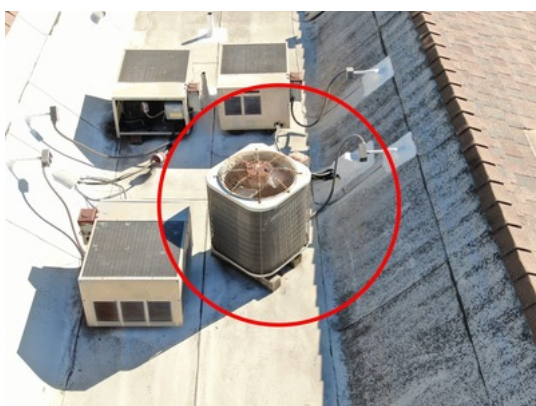
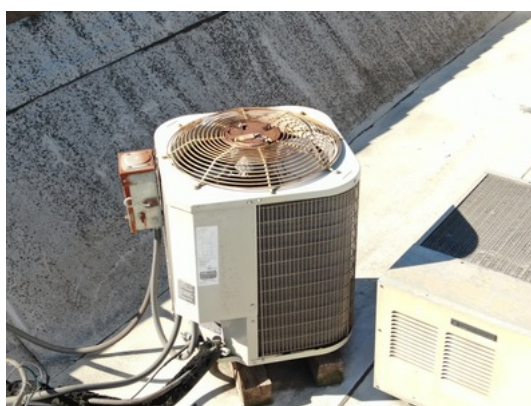
Split System

Condition: Satisfactory

54

Air conditioners over 10 years old and heat pumps over 5 years old should be checked, cleaned and serviced yearly by a licensed contractor.

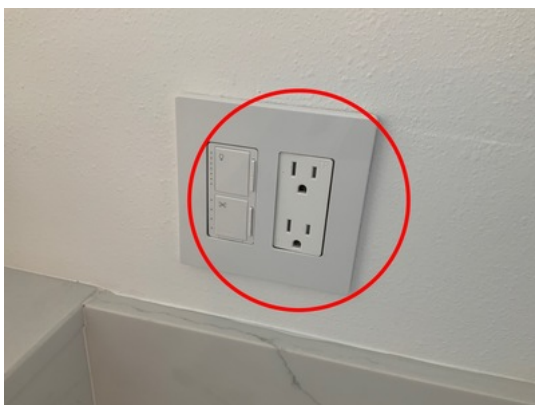
**Comment 7
Deficiency**

Missing GFCI's in kitchen area, which does not meet current standards. Recommend further evaluation by licensed electrician.

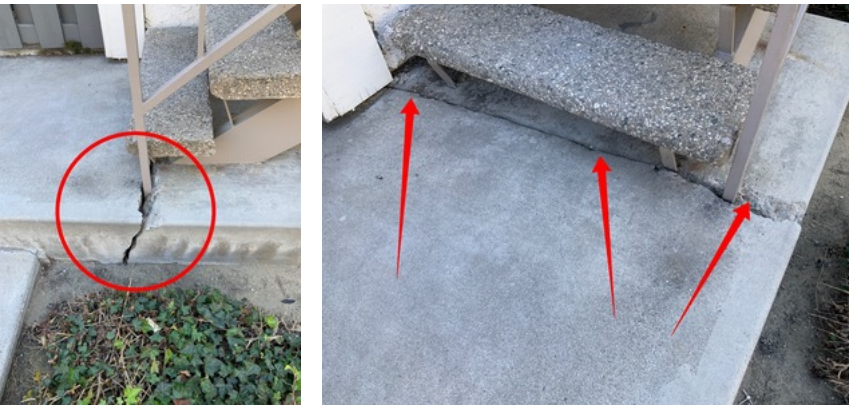
Site: Steps/stoops

Portion of front step/stoop has a large crack. Recommend further evaluation by licensed contractor and HOA.

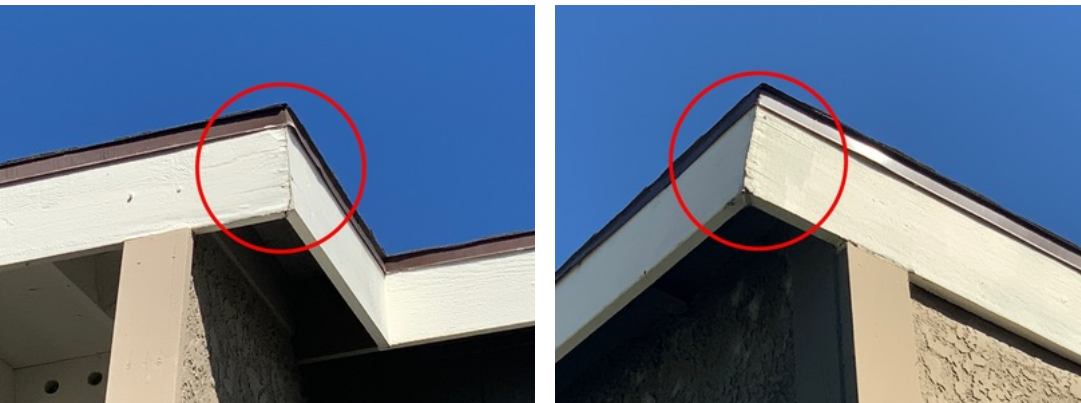
Roofing: Soffit and Fascia

Some areas of trim showing signs of possible dry rot and/or termite damage. Recommend further evaluation by licensed contractor and pest control specialist and HOA.

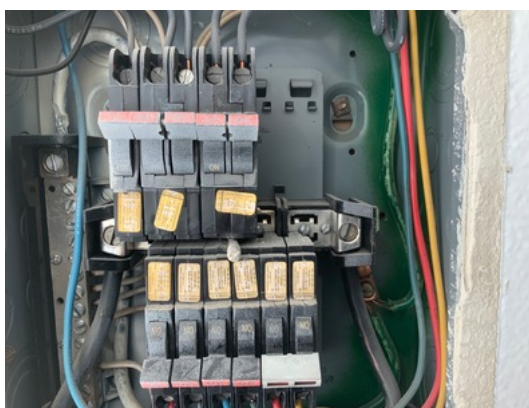
Sub Panel

Presence of Federal Pacific Electric Company sub-panel, which has been banned from use as it does not meet current standards and represents a fire hazard.

Recommend further evaluation by licensed electrician.

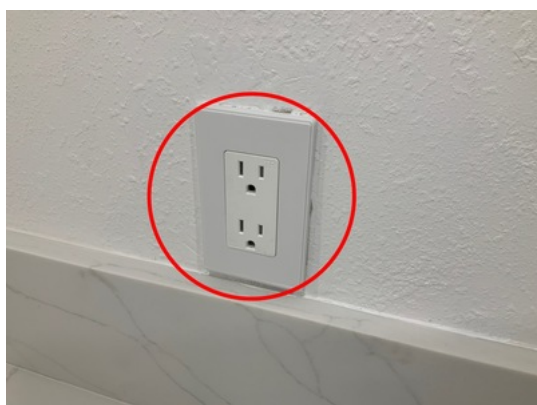
Master Bathroom: GFCI Protection

No GFCI outlets in bathroom near sink, which is required per current standards. Recommend further evaluation by licensed electrician.

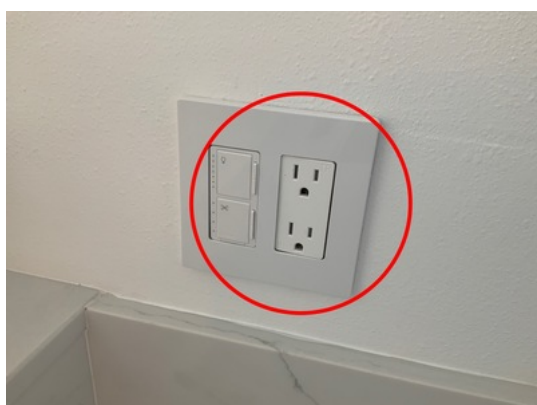
Kitchen

Missing GFCI's in kitchen area, which does not meet current standards. Recommend further evaluation by licensed electrician.
