# ELITE GROUP

1821 Harper Ave, Hermosa Beach, CA 90254  
Inspection prepared for: Michelle Lau  
Real Estate Agent: Michelle Lau - Estates Royale/ Glorias Co.

Date of Inspection: 4/8/2022 Time: 9:00 AM  
Age of Home: 1976 Size: 1810  
Weather: Sunny  
Order ID: 281093

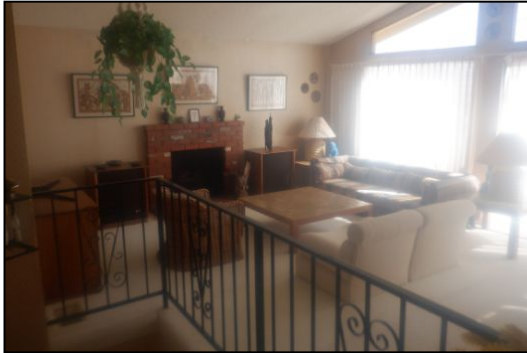
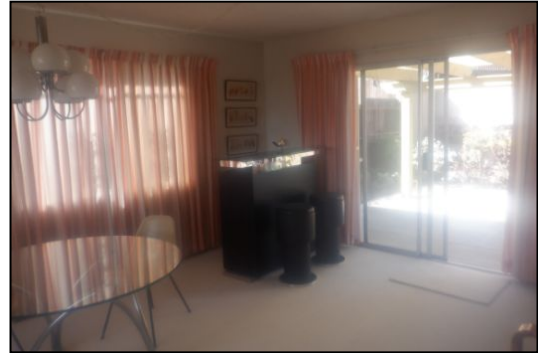
### 1. Wall Conditions

Small cracks/holes/chipped/dirty areas/cosmetic blemishes observed - typical for age of structure • Stains/blistered areas present - tested dry with moisture meter at time of inspection

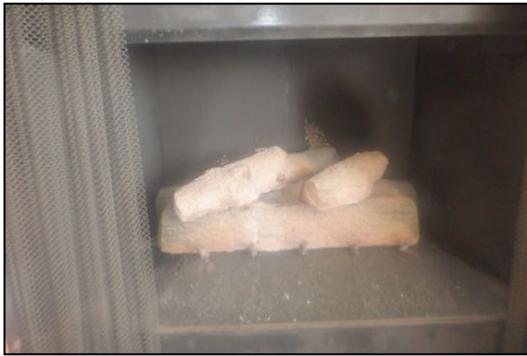
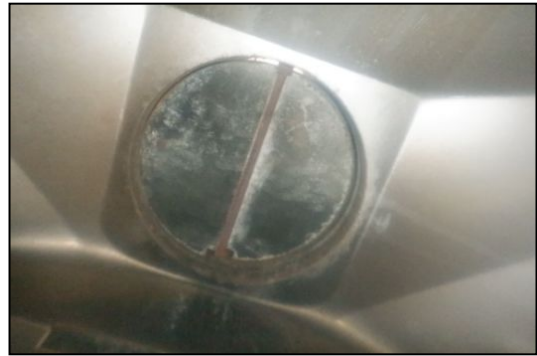
Damper was tested and operated at the time of the inspection • Damper was worn/rusted/dirty - recommend cleaning • Gas log lighter present • **No damper stop clamp - required for cosmetic gas logs, fire-glass or other cosmetic fire system that uses gas at the primary fuel**

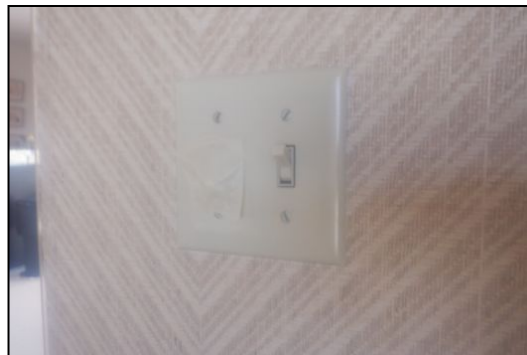
### 11. Electrical

A representative number of receptacles and switches were tested and found to be operational at time of inspection • Some switches have unknown function - not inspected, inquire with seller regarding operation

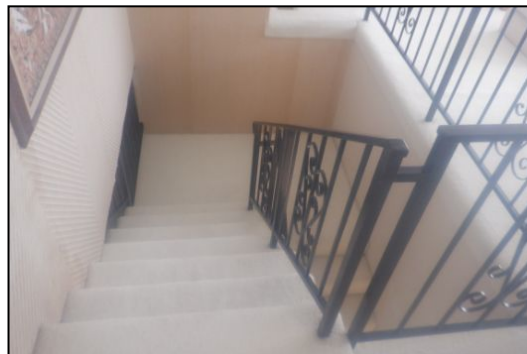
### 12. Stairs & Handrails

Functional at time of inspection

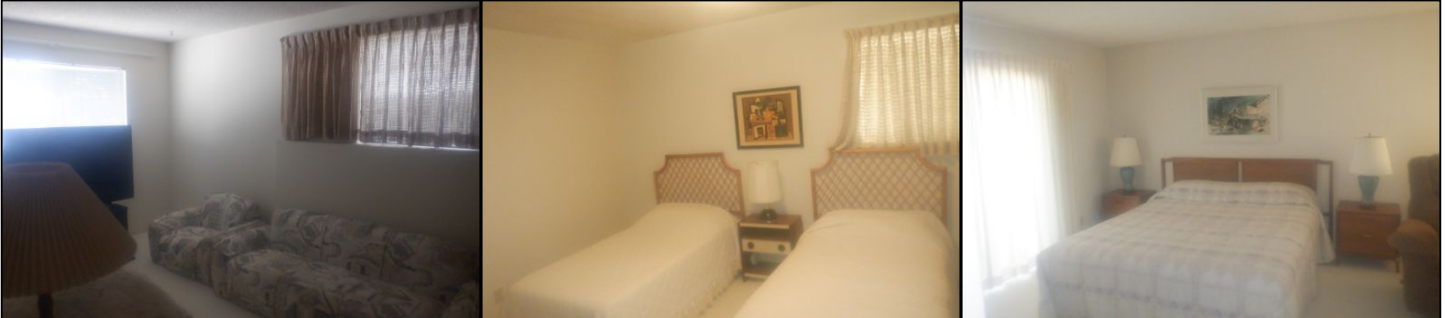
### 2. Wall Conditions

Small cracks/holes/chipped/dirty areas/cosmetic blemishes observed - typical for age of structure

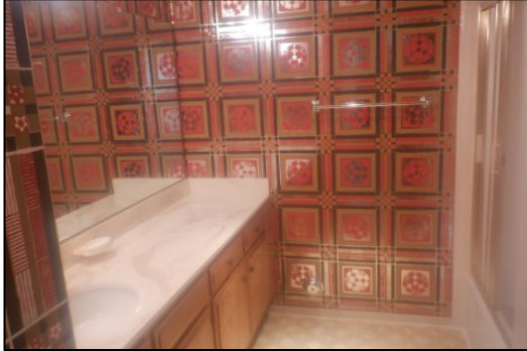
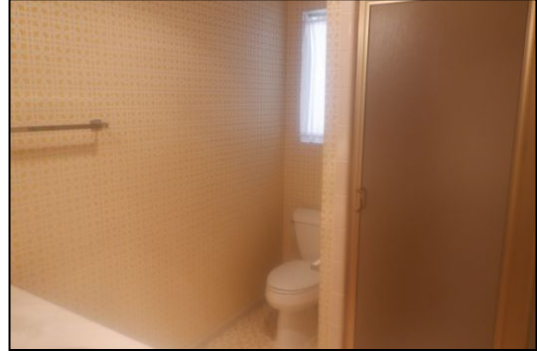
### 2. Wall Conditions

Small cracks/holes/chipped/dirty areas/cosmetic blemishes observed - typical for age of structure

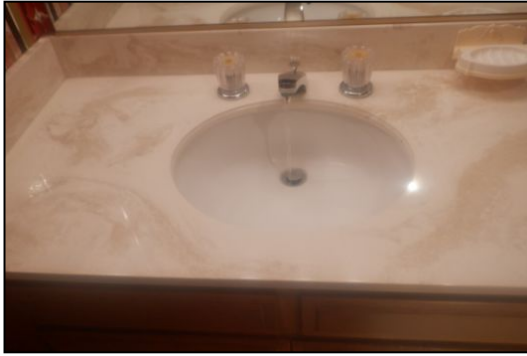
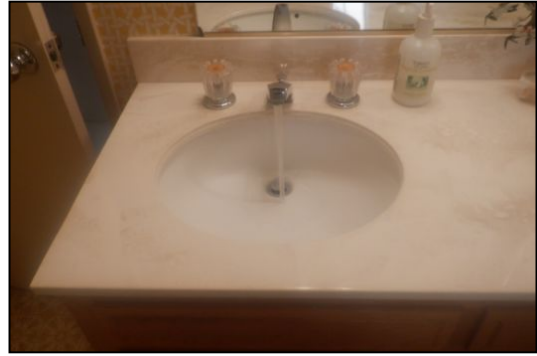
### 9. Sinks

Fixture operated at the time of the inspection • Worn fixture/sink - typical for the age

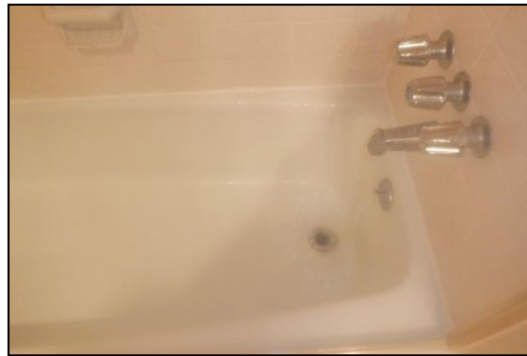
## 11. Bath Tubs

Fixture was tested and operating at the time of the inspection • Fixture was in a worn/older condition at the time of the inspection - typical for age

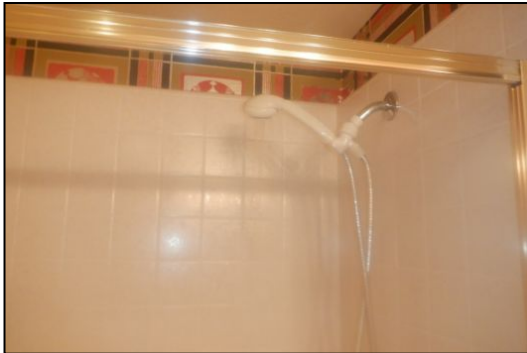
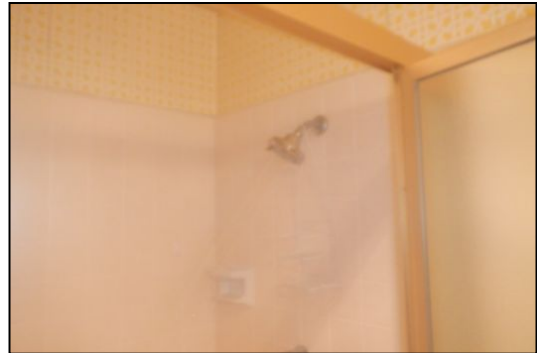
## 12. Showers

Fixture was tested and operating at time of inspection via normal fixture controls • Fixture was in a worn and older condition - typical for the age

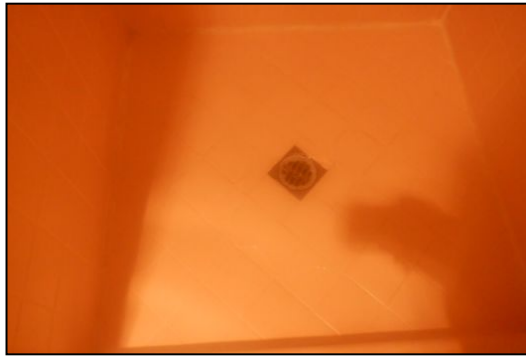
## 13. Shower Walls

The shower pan and shower walls are not waterproof tested for leaks. The Home Inspector cannot determine if shower walls or shower pans leak through or behind tile, fiberglass or other solid surface materials. The Inspector cannot see behind walls, floors or ceilings. We strongly recommend that you have all shower pans water tested for leaks. Cracking/missing grout, degraded or missing caulking may lead to leaks and should be immediately addressed in all cases and discoveries. • Tile and grout present • Wall materials in a worn/stained-faded/old condition - typical for age - recommend routine grout and sealer maintenance • Shower pan is in a worn/stained/older condition - typical for the age - recommend routine grout and sealer maintenance

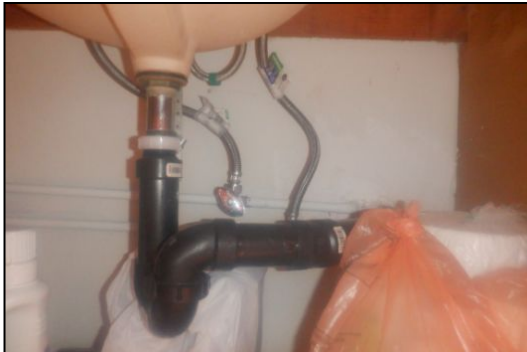
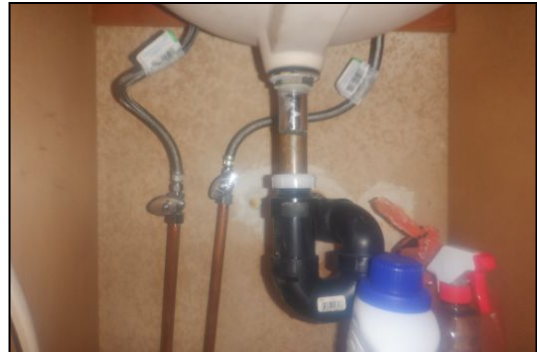
#### 17. Plumbing

Operational at time of inspection via normal fixture controls with no major visible defects

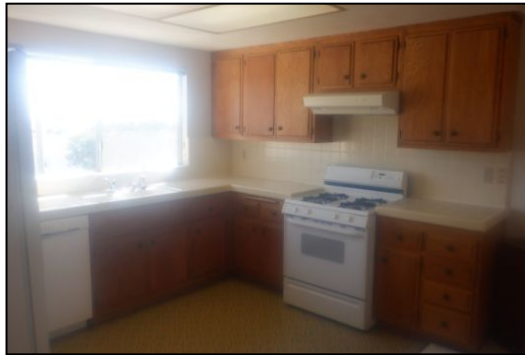
### 1. Wall Conditions

Appliances present and are not moved for inspection - limited inspection of walls, floors, cabinet areas covered by appliances • Small cracks/holes/chipped/dirty areas/cosmetic blemishes observed - typical for age of structure

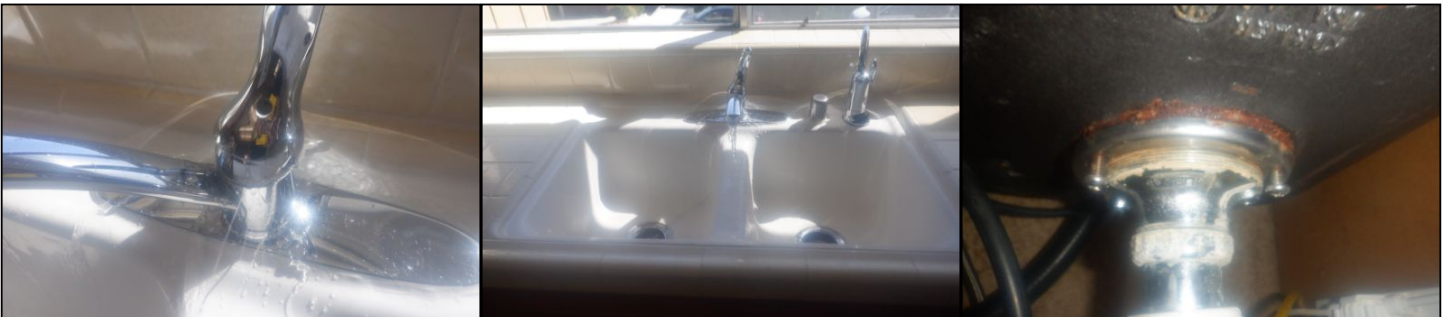
### 7. Sinks

Fixture operated at the time of the inspection • Worn fixture/sink - typical for the age • **Fixture leaks when operating - needs to be serviced** • **Hot water does not operate properly - needs to be serviced** • **Sink corroded/rusted at underside - needs to be serviced**

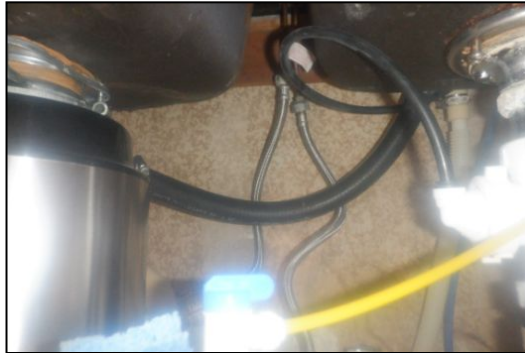
### 14. Plumbing

Angle stops/hoses/drain pipes are worn/older - recommend upgrading these areas with new fixtures

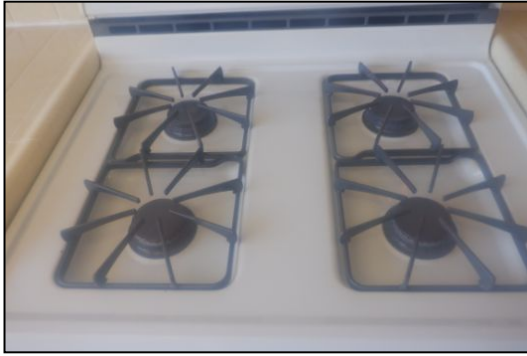
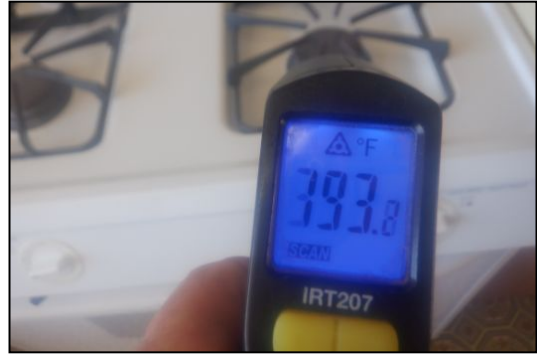
### 15. Ranges

The range or cooktop has a limited inspection, the Inspector cannot predict the remaining life of the unit nor determine the BTUs output by each burner or if/how well the burners will cook food. For gas units - gas leaks cannot be detected with this inspection - a full evaluation by the Gas Company of all gas supplied appliances is recommended beyond this inspection. • Gas supplied unit • Tested and operational at time of inspection via normal controls • **Left front element/burner not operating - needs to be serviced**

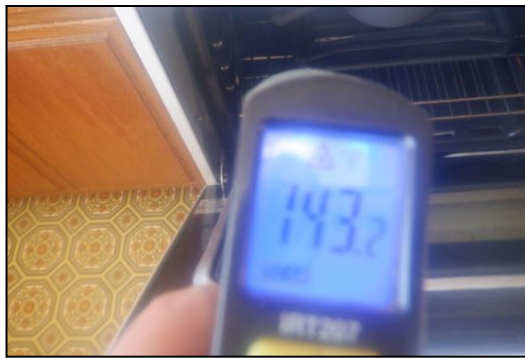
## 16. Ovens

The "Bake" feature is the only feature operated during a home inspection; convection, browning, rotisserie, warming drawers and other features are not tested during the oven inspection. Ovens are tested for basic heating element functionality. The oven cannot be tested to each incremental temperature setting or determine if adequate cooking temperatures can be achieved, nor if temperatures are calibrated with oven settings. We cannot determine if or how well the oven cooks food nor can we predict the remaining life left for the unit. For gas units - gas leaks cannot be detected with this inspection - a full evaluation by the Gas Company of all gas supplied appliances is recommended beyond this inspection. • Gas supplied unit • Tested and operational at time of inspection via normal controls

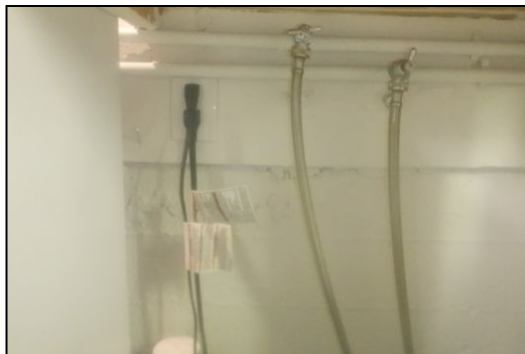
### 8. Plumbing

Visible fixtures were worn/old - typical wear for age

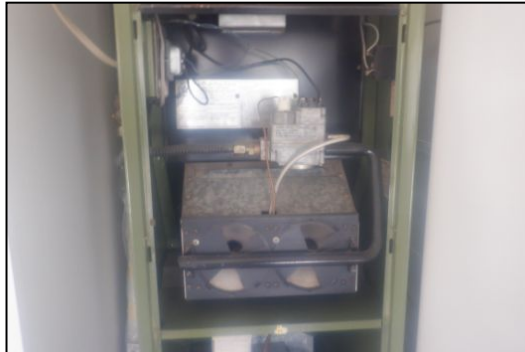
**Type:** Gas fired forced hot air

Operated at time of inspection • Visible areas of unit are worn and older - we recommend that you budget for a replacement and more efficient unit - recommend seasonal service and maintenance to extend the life of the unit

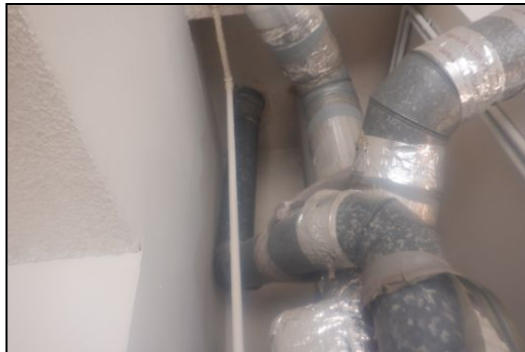
### 2. Venting

The visible areas of the vent are worn/older - typical for the age of the material, recommend upgrading

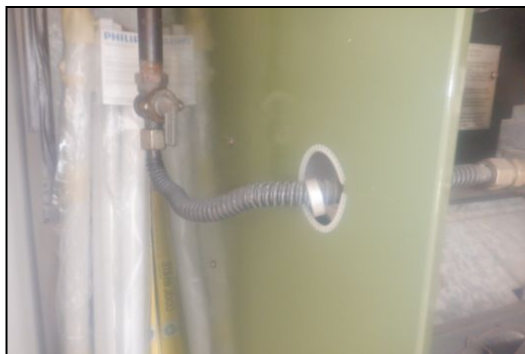
### 4. Gas Supply Valves and Pipes

**Flexible connector through sheet metal cabinet - needs to be serviced**

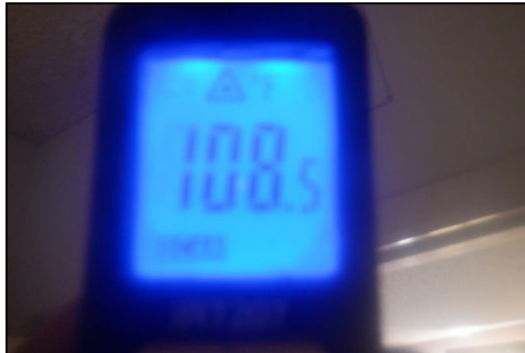
### 8. Registers

Heater Temperature at Registers: 100 degrees • Temperature at Air Return:75 degrees

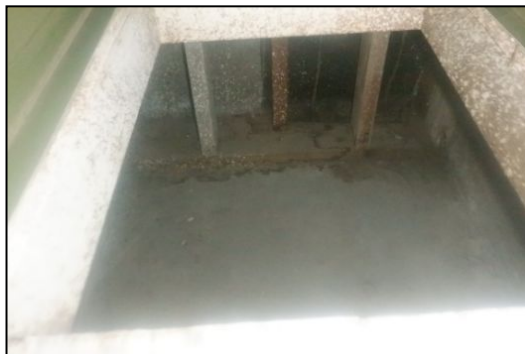
### 10. Platforms/Bases

Visible areas are worn/dirty - recommend cleaning the base areas and sealing the base of the unit as part of the preventative maintenance

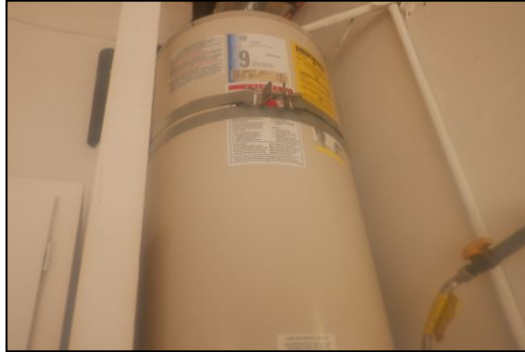
Operated at the time of the inspection - Gas unit • The unit is worn/older - consult a plumber for general maintenance recommendations to extend the life of the unit

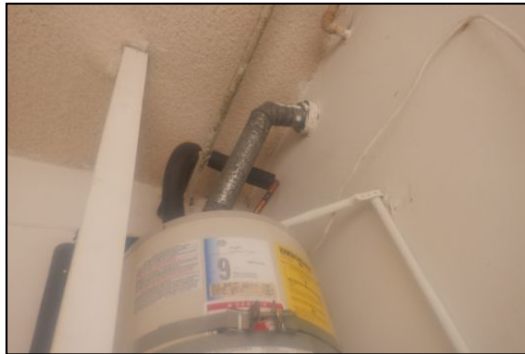
**Material type:** Copper • Insulated lines - plumbing is not fully visible

Normal wear at time of inspection - no major visible defects or leaks found at the time of the inspection

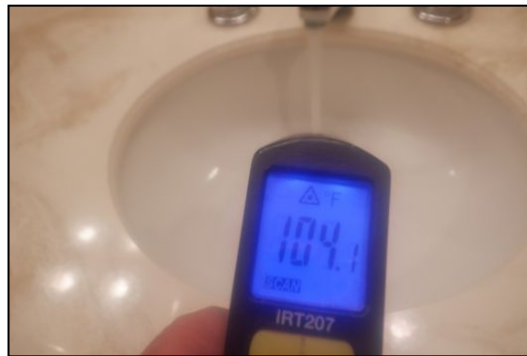
100 F (Average or approximate)

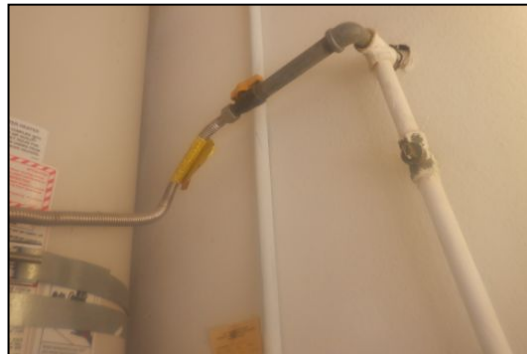
Normal wear at time of inspection - no major visible defects

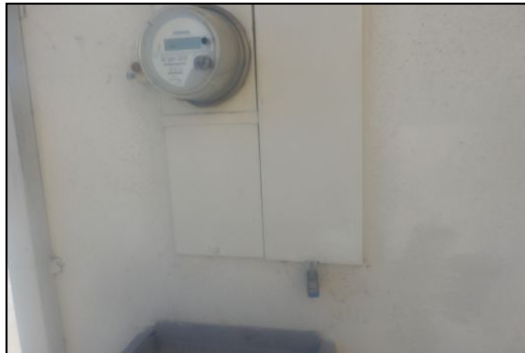
Not accessible due to locked panel - not opened or inspected • Recommend further evaluation by licensed electrician

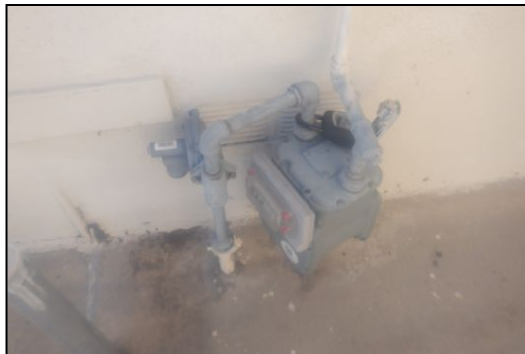
• Valve has normal wear for age at the time of inspection - no major visible defects • No seismic safety valve present - recommend installation for increased safety

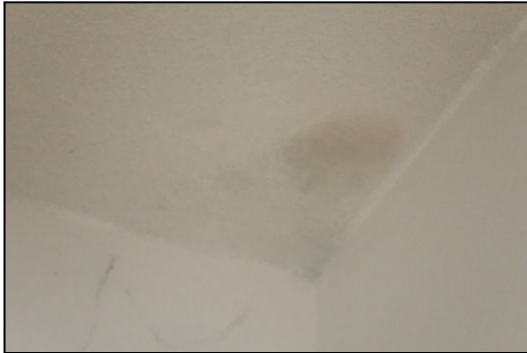
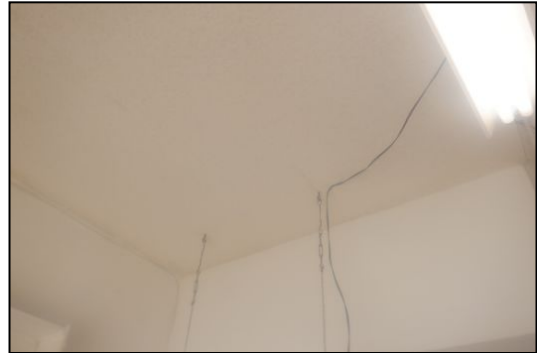
Drywall present – no visible access to view rafters (see firewall notes for additional information) • **Stains present – not accessible for moisture testing – monitor for possible moisture intrusion**

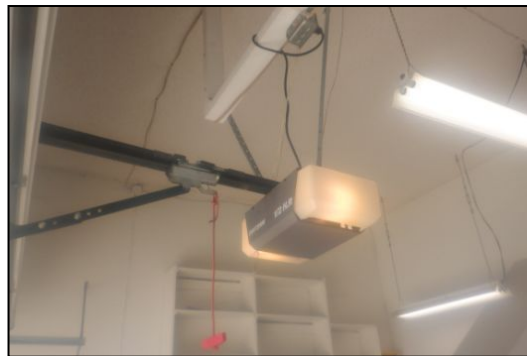
Opener(s) were tested using the normal wall button on the day of the inspection (remote controls are not tested)

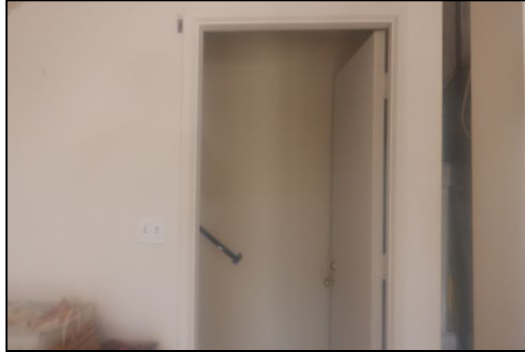
## 8. Fire Doors

Operated at the time of inspection • **Door did not properly self-close and latch - needs to be serviced** • **Door is not a fire rated - needs to be replaced with a fire rated door**

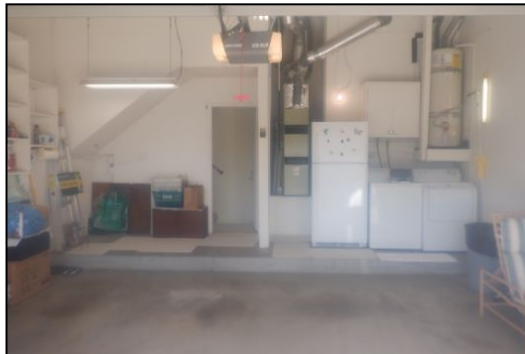
Small cracks/holes/chipped/dirty areas/cosmetic blemishes observed - typical for age of structure

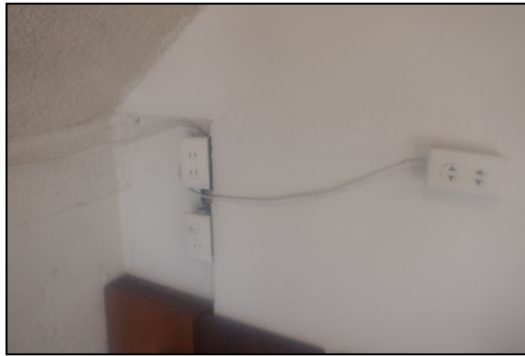
A representative number of receptacles and switches were tested and found to be operational at time of inspection • **Ungrounded outlets present - typical for the age of the structure - consider upgrading electrical services** • **Exposed non-metallic wire (romex/cloth) below eight feet - needs to be serviced** • **Recommend licensed electrician to further evaluate**

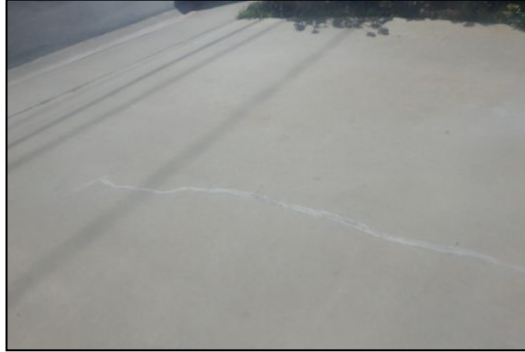
Worn with common cracks/chips - typical for age of material

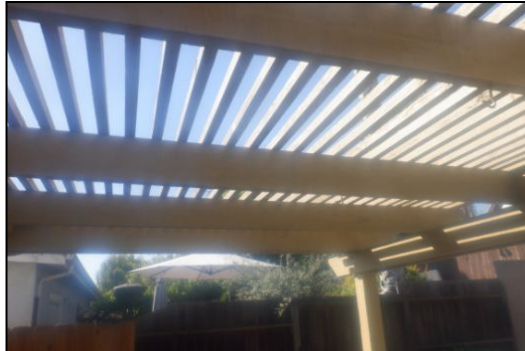
### 2. Patio and Porch Roofs

**Constructed of:** Shade type wood • Same as main structure - porch

See main roof page for porch/patio areas • Worn/weathered materials - typical for age

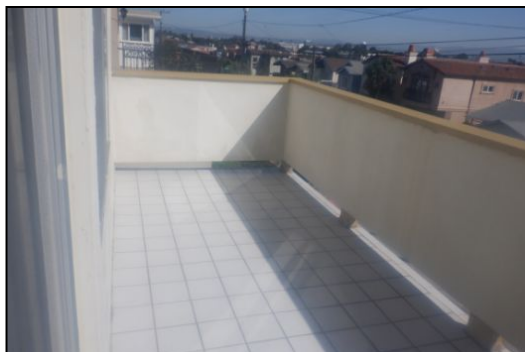
Wood railings present - consult termite report for all exterior wood • Normal wear on the day of the inspection - no major visible defects

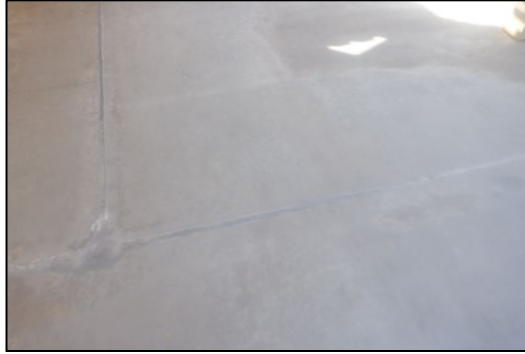
## 5. Patio and Porch Decks

Worn with common cracks/chips - typical for age of material

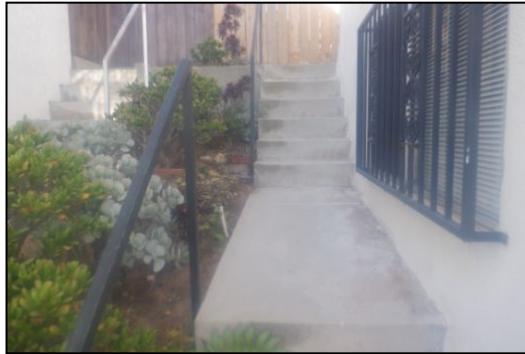
## 6. Stairs & Handrails

Stairs are worn/weathered - typical for the age of the materials

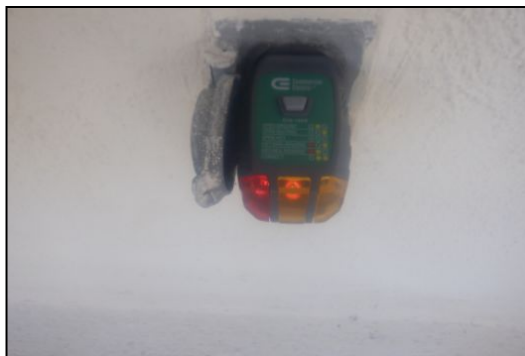
## 7. Exterior Electrical

All visible fixtures/switches/outlets were found to be in normal operating condition at the time of the inspection • Some light(s) did not function (some may be on sensors or timers) - check bulbs first, then consult an electrician to further evaluate as needed • **Outlet hot wired in reverse with neutral - needs to be serviced**

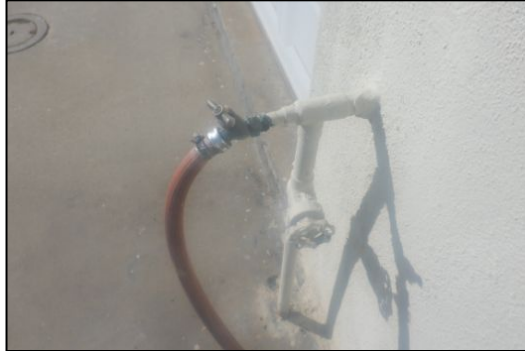
**Type of plumbing:** Galvanized water piping present - recommend complete water distribution system evaluation beyond the scope of this inspection due to age/type • Unknown mix of plumbing types - percentage is not determinable - consult a plumber for further evaluation if needed  
Main valve appears to have normal wear at the time of inspection - no major visible defects

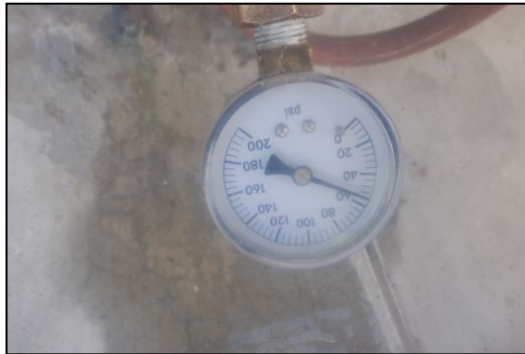
## 11. Water Pressure

Approximate pounds per square inch: 55

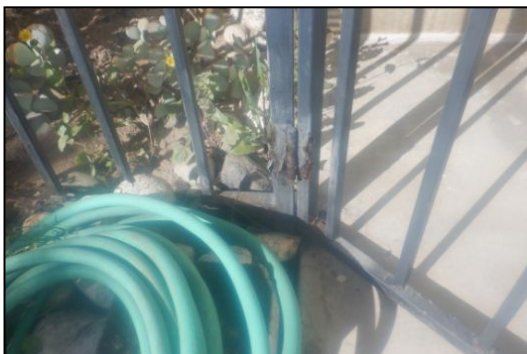
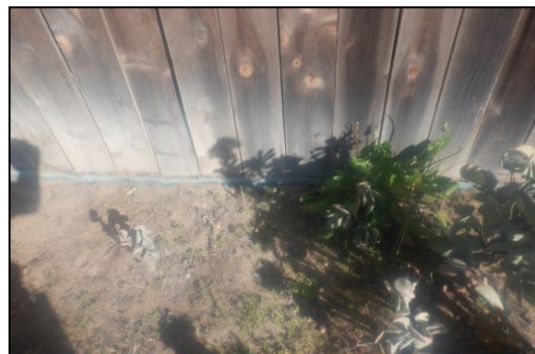
- **Rust/rust damage at metal fence materials - needs to be serviced**

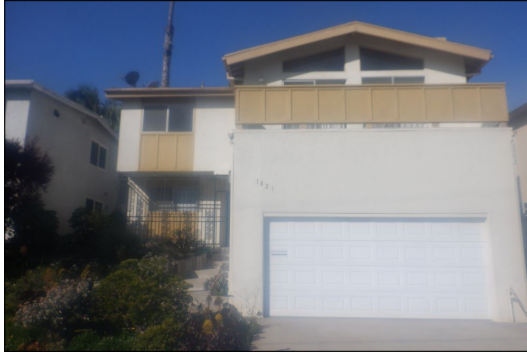
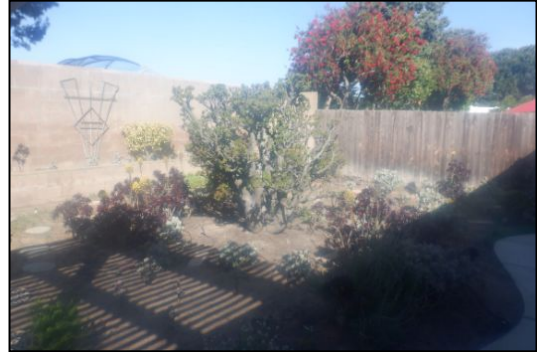
No drains visible at the property at the time of the inspection, drains are recommended to divert water away from structure

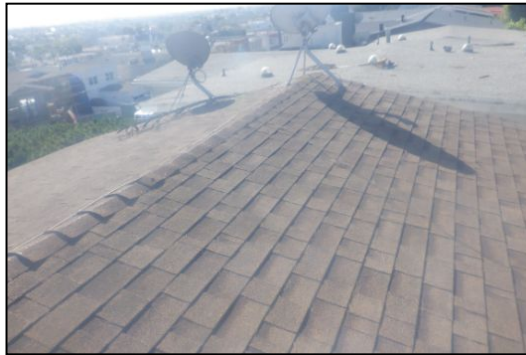
Worn and weathered materials present - typical for age and weather exposure - roof needs maintenance

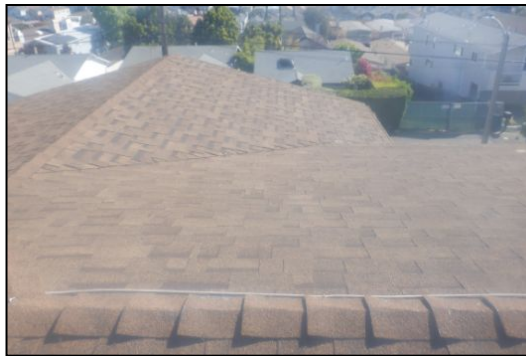
### 2. Flashings

Worn/weathered/rusted/bent - typical for age - recommend seasonal mastic maintenance to prevent moisture intrusion

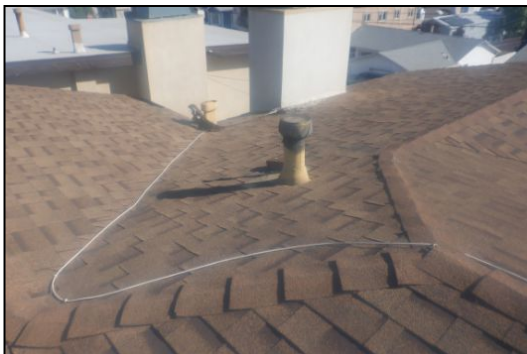
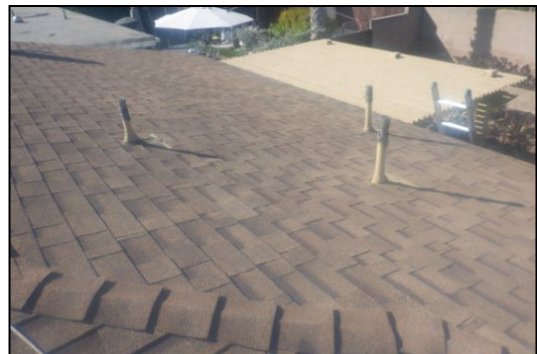
Worn/weathered cap(s) – recommend seasonal maintenance to ensure that caps do not become loose or develop other defects

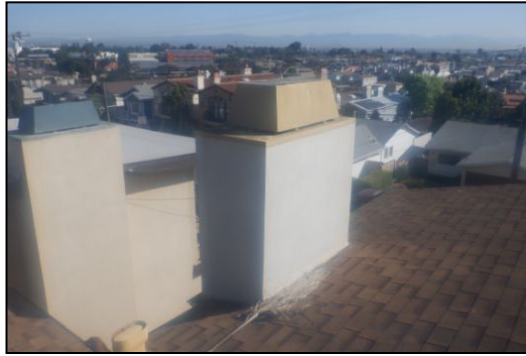
**5. Chimneys**

Worn/weathered chimney – recommend seasonal maintenance and care
