Property Inspection Report

6128 Hawarden, Riverside, CA 92506
Inspection prepared for: Latasha Mason
Real Estate Agent: Gustavo Rodriguez - Rise Mortgage & Real Estate

Date of Inspection: 8/8/2024 Time: 4:00 p.m. Size: 3,121 Sq Ft
Weather: Sunny & clear. Temperature: 91°F

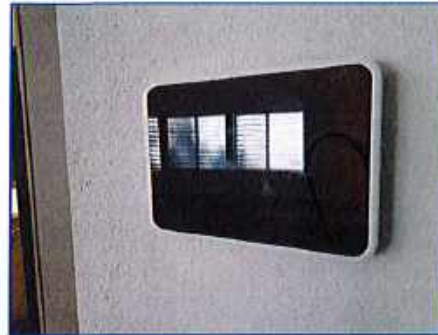
- Appeared functional, at time of inspection.
- UPGRADE: Some outlets were original and/or out dated throughout the house. Suggest replacing, upgrade and installing new outlets with TRR protection by a licensed electrician to enhance child safety, where and if necessary.
- No major system safety or function concerns noted at time of inspection.
- A low voltage alarm system is installed. Due to the specialized nature of these systems, I suggest that you review this system with the seller. As per our Inspection Agreement, this system is beyond the scope of this report and was not inspected.

• 2-prong outlets - The home contained outdated, ungrounded 2-prong electrical outlets. Although this condition may have been commonly considered safe or acceptable at the time the home was originally constructed, as general knowledge of safe building practices has improved with the passage of time, building standards have changed to reflect current understanding. Consider updating the existing condition to meet generally-accepted current standards.

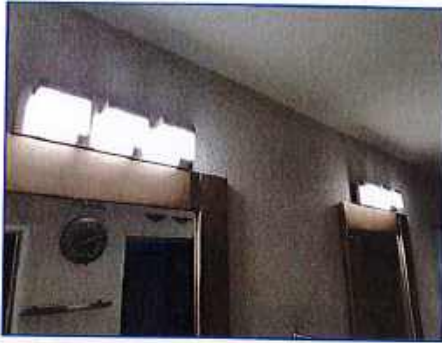
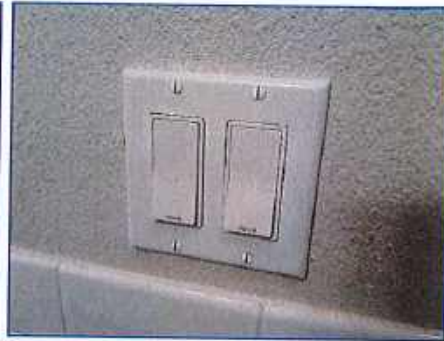
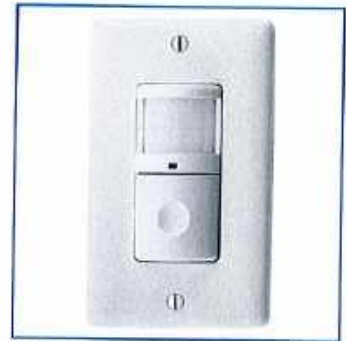
Inoperable - bathroom near the laundry room

- Appeared functional, at time of inspection.
- No occupancy/motion sensors installed at time of inspection. I recommend having them installed by a licensed electrician if necessary.
- Outlets are connected to a **GFCI** noted.
- Reset for the **GFCI** is in the hall bath.
- **2-prong outlets** - The home contained outdated, ungrounded 2-prong electrical outlets. Although this condition may have been commonly considered safe or acceptable at the time the home was originally constructed, as general knowledge of safe building practices has improved with the passage of time, building standards have changed to reflect current understanding. Consider updating the existing condition to meet generally-accepted current standards.
- ****GFCI OUTLET****
- **GFCI** apparently inoperable. See photo
- **GFCI** reset button would not reset. Recommend further review by a licensed electrician.

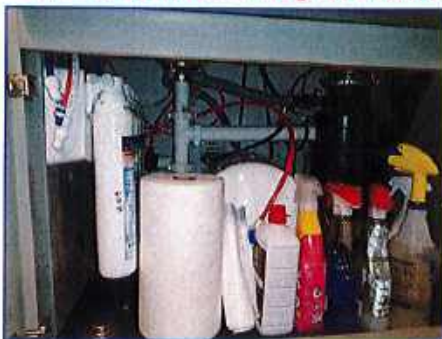
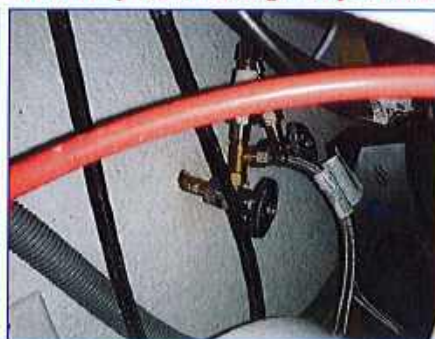
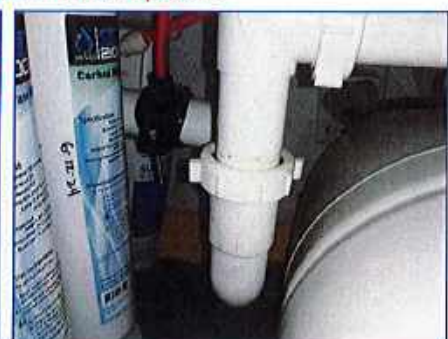
- Appeared functional, at time of inspection. Drains were tested, no leaking and no indication of stoppages at time of inspection.
- *** Garbage Disposal ***
- Operated - appeared functional at time of inspection.
- *** Garbage Disposal ***
- The unit makes irregular noise. This may be a foreign object stuck in the disposal.

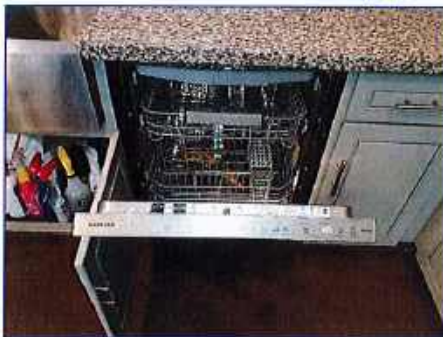
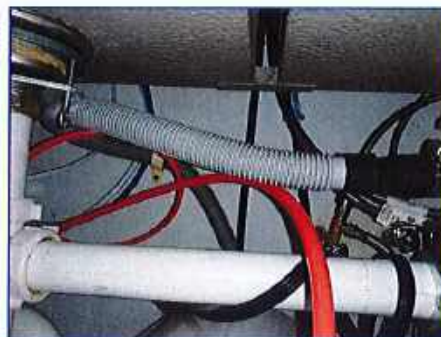
• No **air gap** noted at dishwasher drain line. In the event of a sewer backup, this device prevents sewer matter or waste water from entering into dishwasher and causing damage to the appliance. No loop in drain line noted. Suggest that the dishwasher drain line should drain upstream of the trap as necessary. Typically, there would be a "high loop" in the rear of the dishwasher unit but the home inspector can determine the presence of one due to accessibility. If buyers have any concerns, I recommend having a qualified plumber install an **air gap** to prevent possible contamination or confirm that the drain line is draining upstream, as necessary. For further information, [click here Air gap](#)

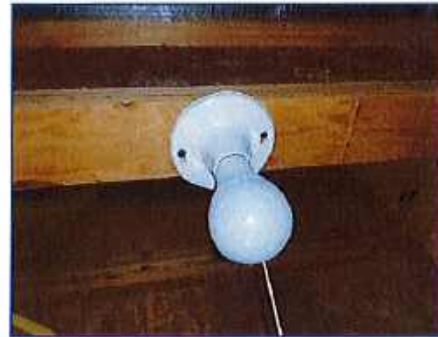
- Appeared functional and in serviceable condition, at time of inspection.
- Could not access all areas
- Attic light fixture is apparently inoperable or burnt out. Replace and check for operation
- Switch covers missing
- Missing outlet covers were found, make sure they are replaced. This is a **DIY** repair and does not require a contractor

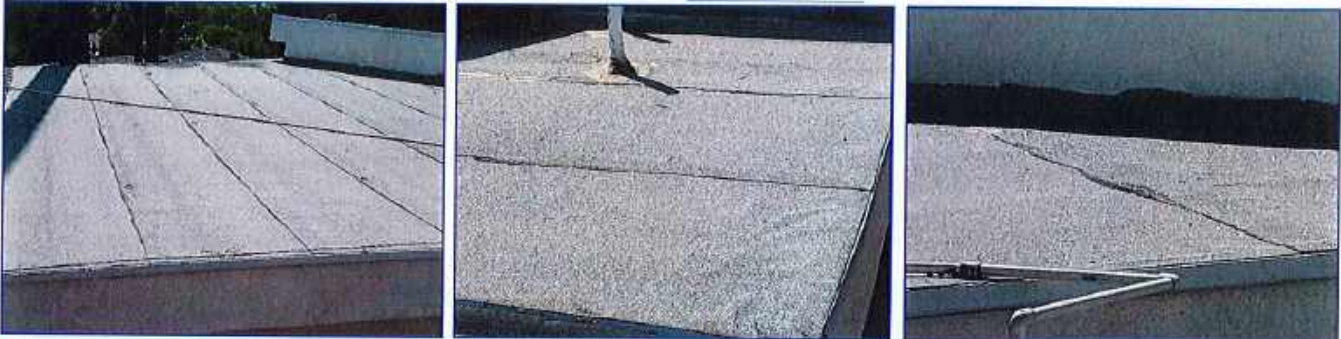
- Roof coverings appeared in serviceable condition at time of inspection.
- Uneven areas observed. Normal wear
- Semi-flat roof area should be kept clean to avoid leaks
- Note that experts recommend that any roof over 10 years old receive a roof certification by a local roofing specialist. For more information, click here [Roof Certified](#)

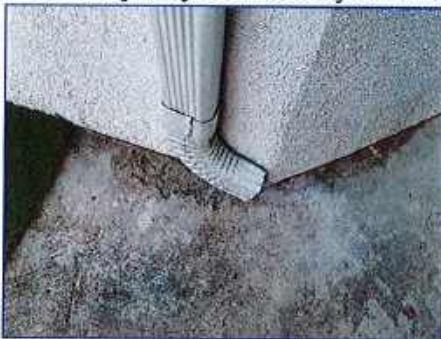
- Appeared in serviceable condition, at time of inspection.
- All the gutters should be evaluated for correct pitch in installation by a qualified installer.

- Make sure all downspouts are connected and routed to discharge away from the homes foundation, this will reduce the potential for water to seep into the foundation.

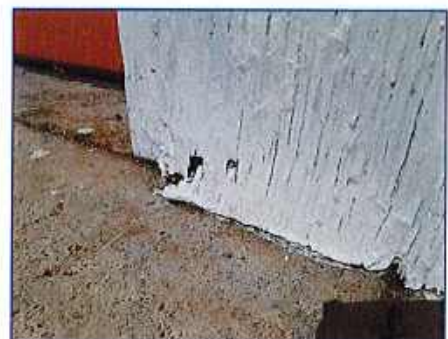
• Some wood deterioration noted at the garage area - exterior garage door frame base. Have repaired and inspected for wood-destroying insect damage.

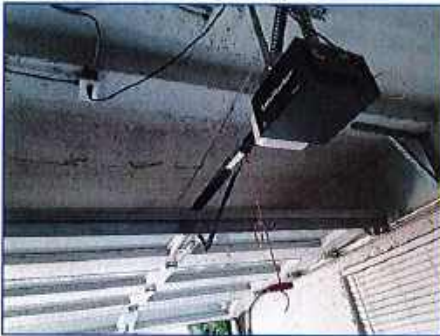
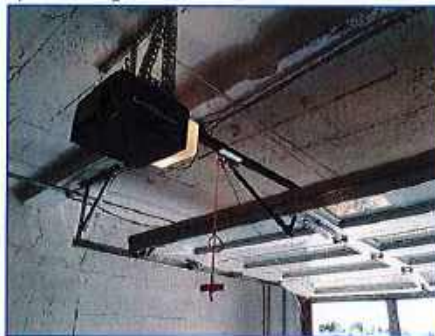
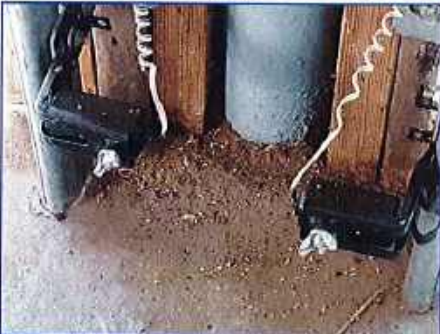
- ***Garage Door Opener***
- The garage door opener has safety features built-in noted
- Appeared functional and in serviceable at time of inspection.
- DEFERRED COST: The garage door opener is an older type noted. I recommend upgrading to a new modern unit with a battery backup installed by a licensed contractor if necessary.
- *** Safety/Photo Beam***
- Eye beam system present and operating. Tested functional at time of inspection.

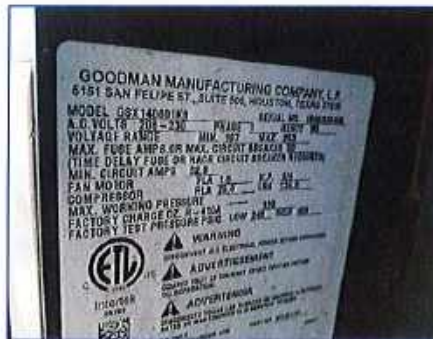
- **A/C** condenser unit not secured properly at the base. I recommend repairs by a licensed contractor.

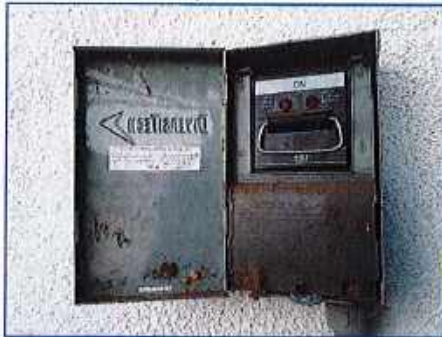
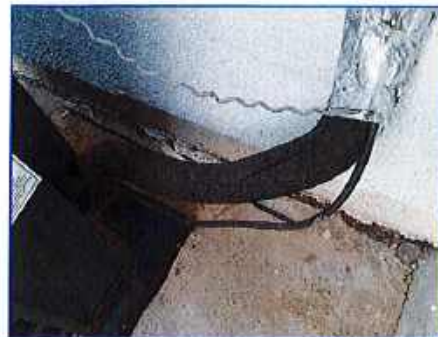
8. Disconnect Box & Refrigerant Lines

- *** Disconnect Box ***
- The disconnect box appeared functional and serviceable at time of inspection.
- *** Refrigerant Lines ***
- Refrigerant lines appeared in serviceable and functional condition at time of inspection.
- Recommend heat tape at connections

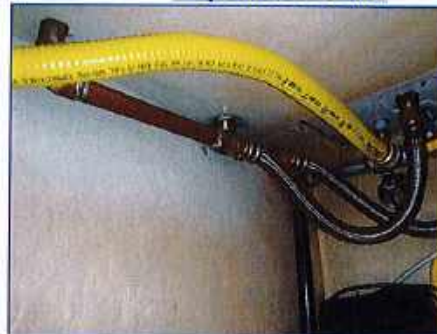
- **Expansion tank** not installed noted. This is designed for installation on potable water lines between the backflow preventer or pressure reducing valve and the water heater to protect against water thermal expansion. When system pressure increases, water enters the tank's polypropylene lined water chamber which expands a diaphragm into a pre-charged air chamber, keeping system pressure below the relief valve setting. Suggest consulting with a licensed plumber further details if necessary. For further information, click here [Expansion Tank](#)

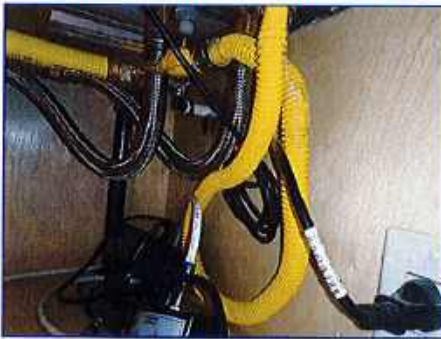
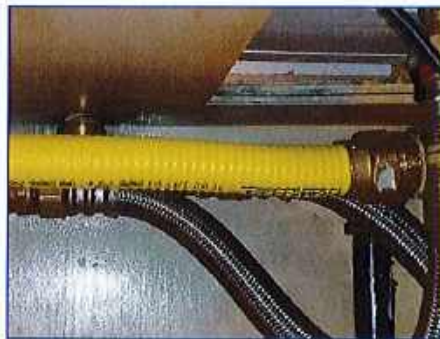
Page 45 Item: 4	Gas Shut off valve and Gas lines	<ul style="list-style-type: none"> • No sediment trap or drip leg noted. Recommend a licensed contractor for further evaluations and recommendations, if necessary.

- Gas shut off valves were present and functional.
- Updated gas line and gas shut off valve installed noted. Appeared in serviceable and in functional condition at time of inspection.
- **CSST** gas piping installed noted. Appears in functional and in serviceable condition at time of inspection. Manufacturers of yellow corrugated stainless steel tubing believe that yellow corrugated stainless steel tubing is safer if properly bonded and grounded as required by the manufacturer's installation instructions. Proper bonding and grounding of this product can only be determined by a licensed electrical contractor.
- **No sediment trap or drip leg noted. Recommend a licensed contractor for further evaluations and recommendations, if necessary.**

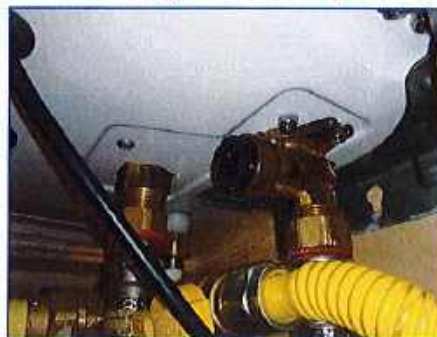
- **There is no TPR valve present on this water heater. This is a serious safety concern and needs to be corrected at once. I recommend contacting a licensed plumber to install a proper valve.**

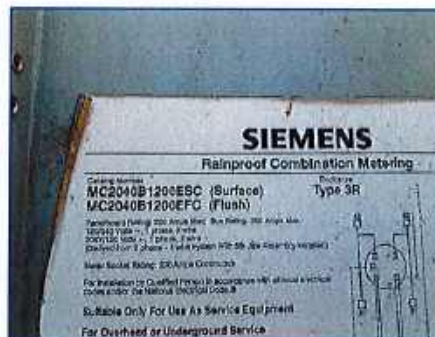
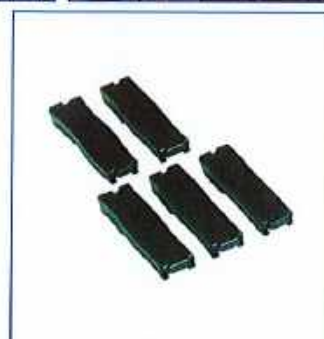
• **SHOCK HAZARD:** Open slots observed. Knockouts need snap-in caps inside panel box. Filler plates should be installed to keep exterior elements out of panel box and to avoid potential electrocution hazard. See photo

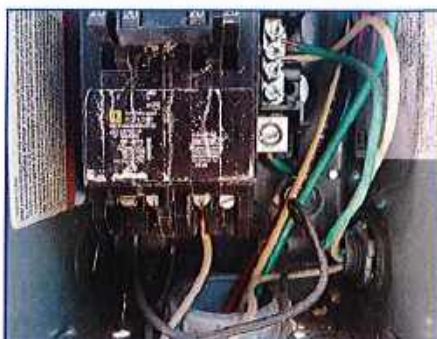
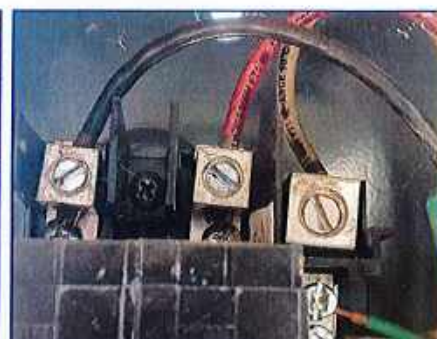
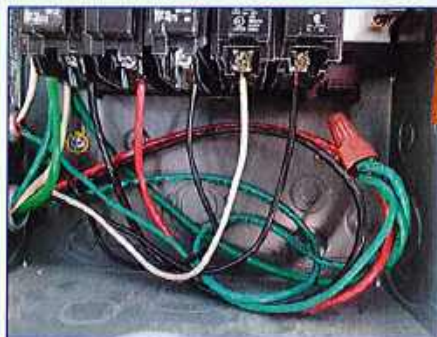
5. Sub Panel Breakers

- Appeared in functional condition at time of inspection.
- All of the circuit breakers appeared in the "ON" position and functional condition at time of inspection.
- Mixed or different name brand circuit breakers noted. This is typically not a concern. Consult with a licensed electrical contractor for further evaluations if necessary.
- No AFCI breakers installed noted.
- Grounding / Bonding questionable at panel box.
- Have electrician ensure that ground is continuous, see photo.
- Questionable wiring in panel box. Have licensed electrician evaluate.
- Burned or scorched wiring observed, recommend review by a licensed electrician.

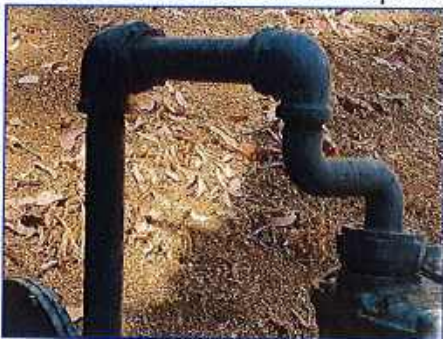
2. Gas Piping

- Gas piping has minor rust in areas noted. Recommend replacing by a licensed contractor if necessary
- Most of the piping is concealed and cannot be inspected. Could not access all areas

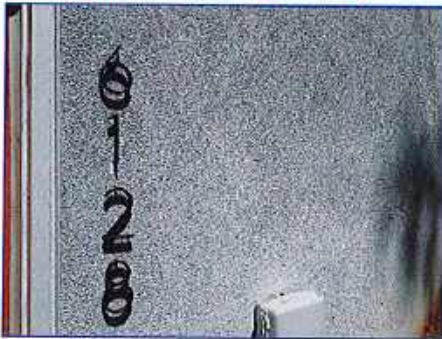
• Siding-Soil contact or proximity. This may provide entrance of moisture or insects to siding. Recommend grading soil so there is at least 6" of space (where practical) between the siding and the soil below and checking for any damaged trim and siding materials.

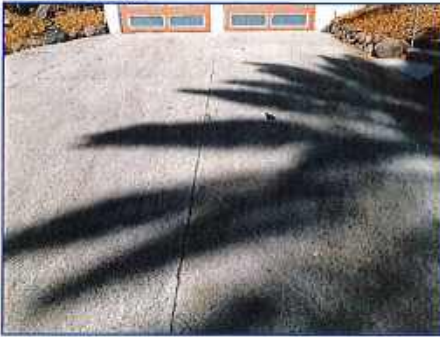
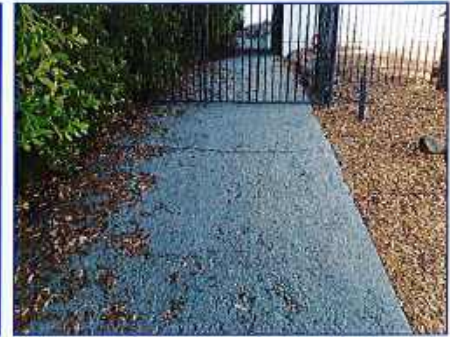
- There are numerous areas of damaged and heavy cracking on the concrete surfaces. Concrete replacement is expensive. Recommend a concrete specialist provide an estimate for repair and or replacing.

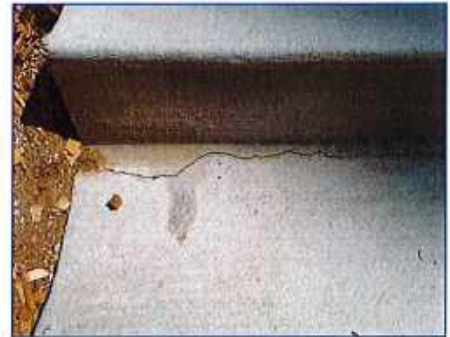
2. Steps or Stairs

- Appeared in serviceable condition, at time of inspection.
- IMPROVE: Typical cracking was observed at the concrete surfaces. Recommend sealing the cracks to prolong the life of the concrete.

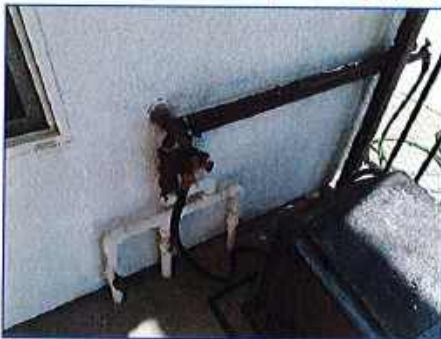
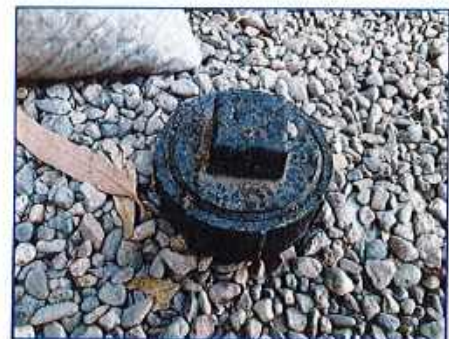
Location: Near the pool equipment area

Grounds		
Page 59 Item: 3	Exterior Plumbing	<ul style="list-style-type: none"> • Visible leaking is noted. Consult with a licensed plumbing contractor to determine and correct the cause of the issue. <p>Location: Near the pool equipment area</p>
Pool		
Page 62 Item: 2	Pool Slab, Coping & Skimmer Basket	<ul style="list-style-type: none"> • Pliable seal caulking or expansion joints missing in areas observed. Recommend sealing cracks/voids.
Raised Foundation		
Page 66 Item: 1	Ventilation	<ul style="list-style-type: none"> • Inadequate venting observed in crawlspace, suggest installing additional vents for proper moisture control. • No venting observed. Recommend contacting a qualified contractor to install venting.
Page 66 Item: 3	Access Panel	<ul style="list-style-type: none"> • The exterior crawlspace access was missing a proper cover. I recommend installing a cover with a screen to assist in ventilating the space.

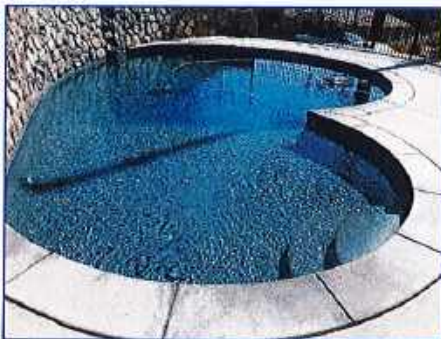
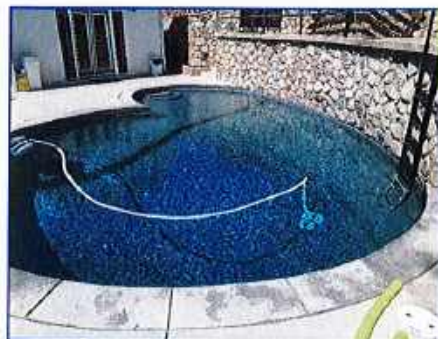
- Appeared serviceable, at time of inspection.
- Recommend contacting a qualified licensed pool service technician for evaluations, recommendations and monthly maintenance service.
- ** Tiling **
- Normal wear

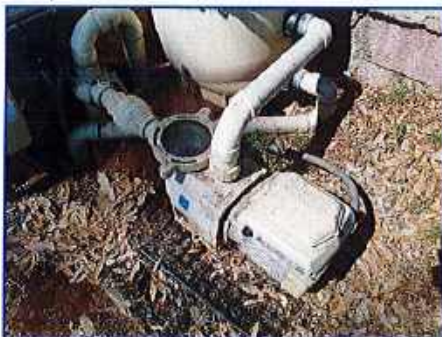
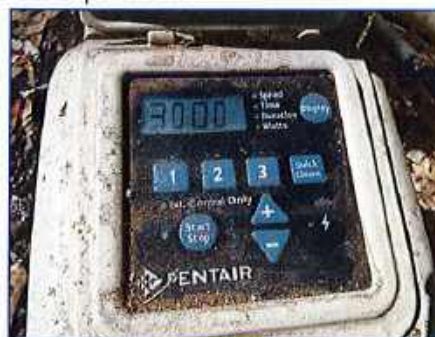
- Operated, tested functional and no visible leaking at time of inspection.

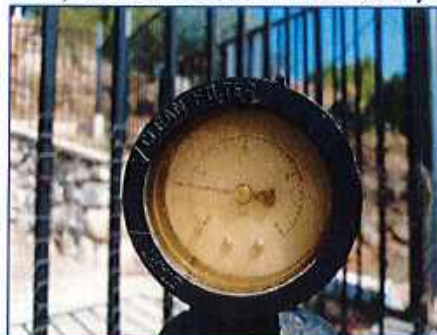
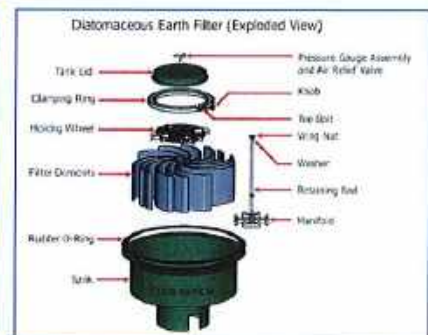
- **** Filter Housing ****
- Appears functional at time of inspection.
- **** Pressure Gauge ****
- Present on filter housing. Appeared functional at time of inspection.
- Lens cover appears to be faded and worn. Inspector could not fully inspect due to this condition. Recommend replacing by a licensed pool contractor if necessary.

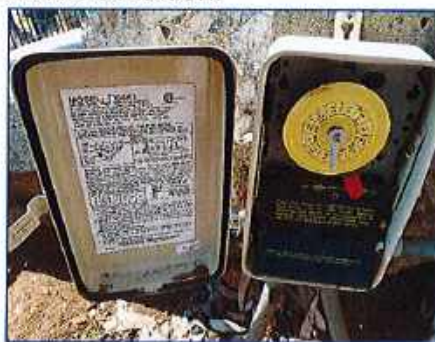
- Appears in satisfactory and functional condition.

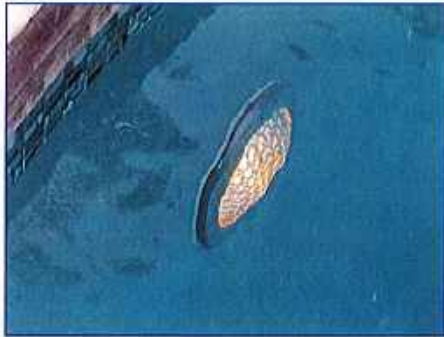
- Appeared functional at time of inspection.
- The pool light was verified that it was connected to the **GFCI** outlet and was tested functional. No concerns.

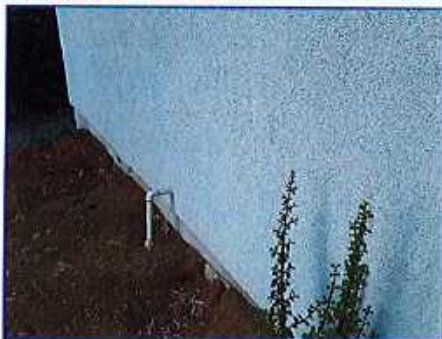
- Inadequate venting observed in crawlspace, suggest installing additional vents for proper moisture control.
- No venting observed. Recommend contacting a qualified contractor to install venting.

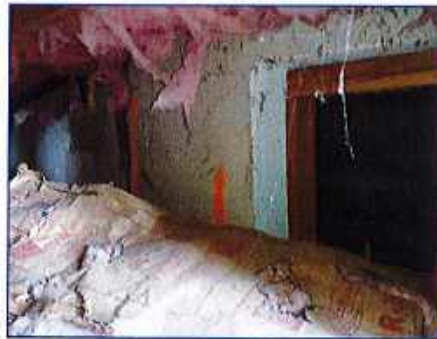
4. Foundation Walls

- Visible portions of foundation wall appeared to be in serviceable condition at the time of the inspection.
- Could not access all areas

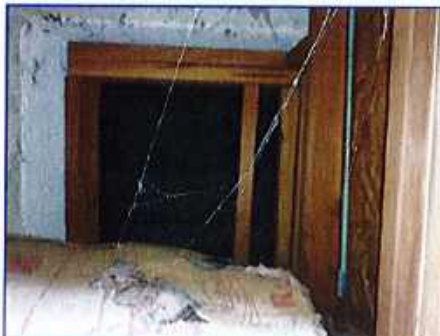
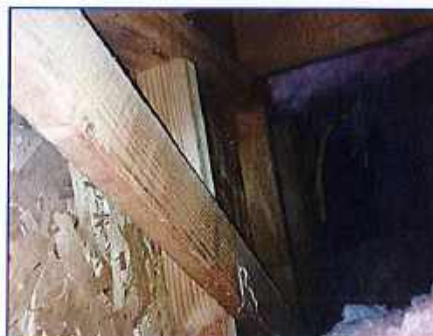
- Appeared in serviceable condition, in areas, at time of inspection.
- Could not access all areas

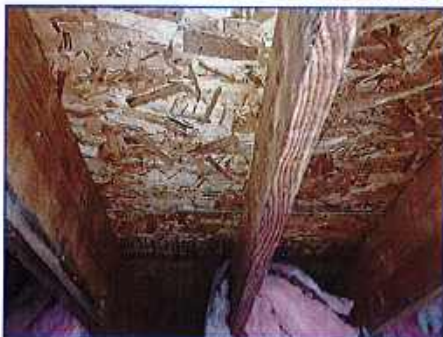
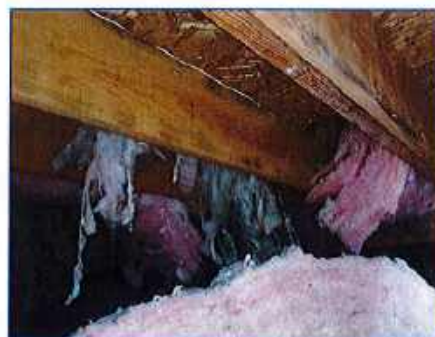
7. Sub Flooring

- 1x solid plank sheathing noted.
- Plywood sheathing sub floor in areas noted.

- Dimensional lumber wood Joists and trusses noted.

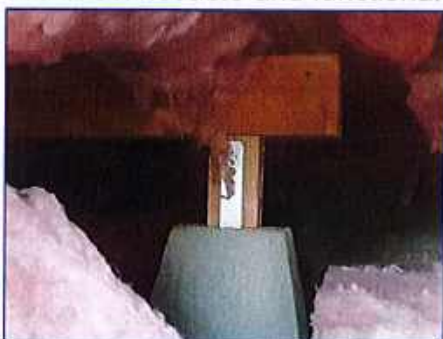
8. Support Pier and Girders

- Concrete piers noted

- Wood posts noted

- Appeared in serviceable and functional at time of inspection.

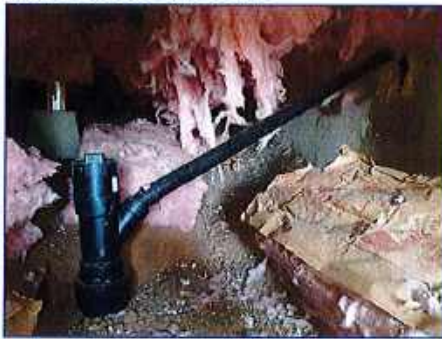
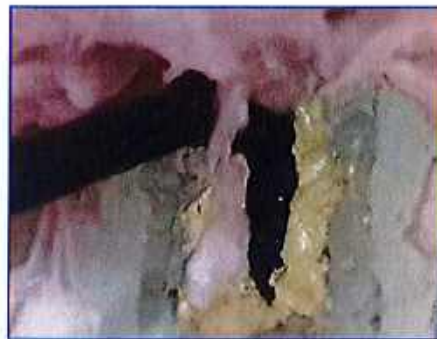
10. Foundation Supply Plumbing

- Acrylonitrile-Butadiene-Styrene "ABS" waste and vent pipes noted.

- Appears functional at time of inspection.
- Could not access all areas
