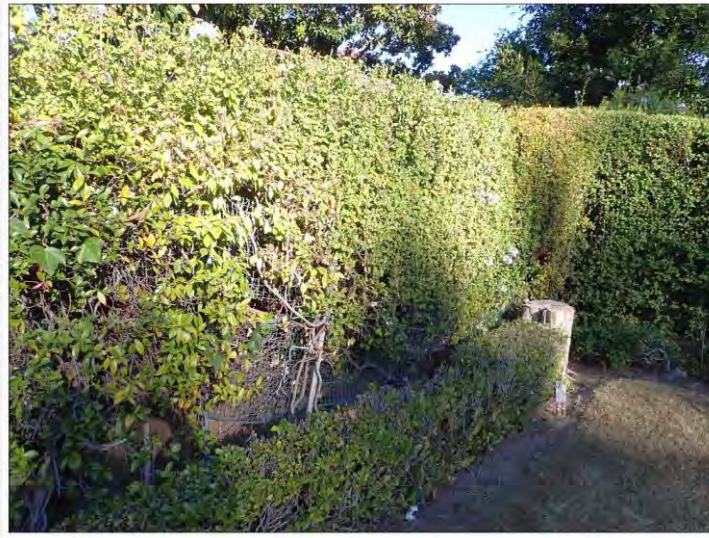
- 101 Driveway: Serviceable; brick/concrete.
-
- 102 Walks: Serviceable; brick/concrete.
-
- 103 Fences/Walls: Brick/wood. **Deteriorated, leaning and missing wood noted at rear right corner; suggest consulting with specialist for further review prior to close of escrow.**

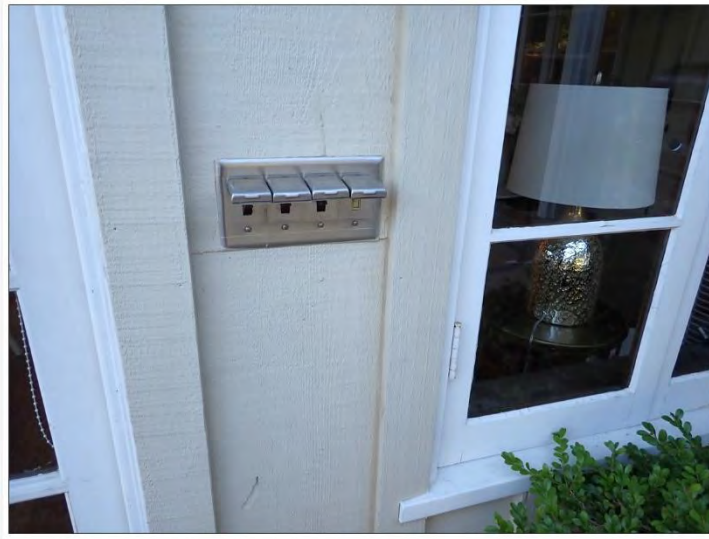
107 Electrical Fixtures: **Unable to determine function of four (4) switches noted at rear.**

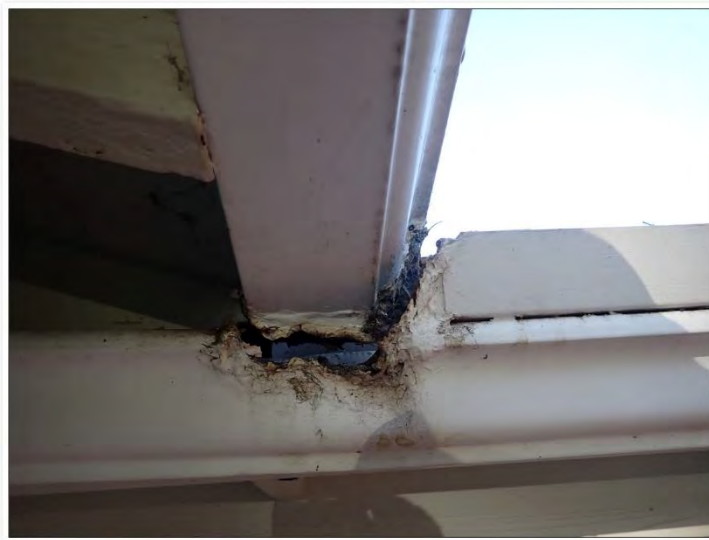
108 Gutters/Downspouts: Metal. **Front gutter noted is separated; we advise making necessary corrections.**

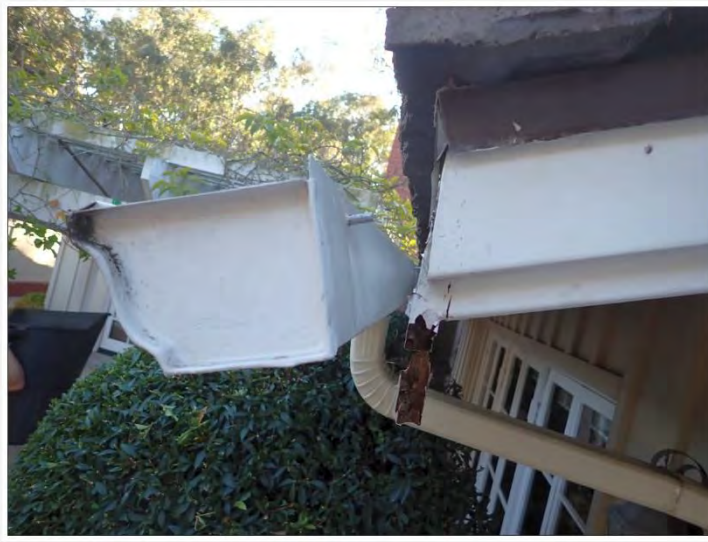
108 Gutters/Downspouts Cont'd: **Gutters noted are loose at various areas; we advise making necessary corrections.**

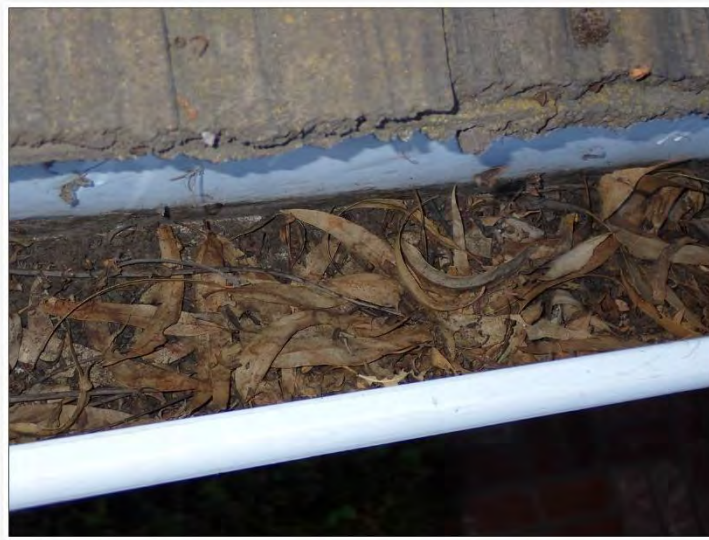
Suggest clearing all debris from gutters as part of routine maintenance to insure proper drainage.

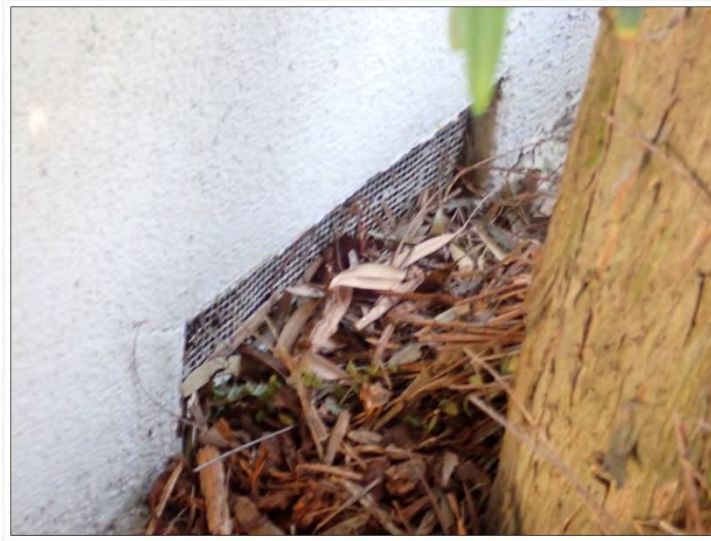
- 112 Chimneys: **LEFT:** Serviceable. A spark arrester is installed as a safety feature.
REAR: Serviceable. A spark arrester is installed as a safety feature.
-
- 112a Steps/Railing: Non-Applicable.
-
- 112b Hose Bib: Serviceable.
-
- 113 Lot grade/Drainage: Home is built on a flat lot. **Grade noted at front is up to vent for crawl area which may allow water intrusion under the home; we advise making necessary corrections.**

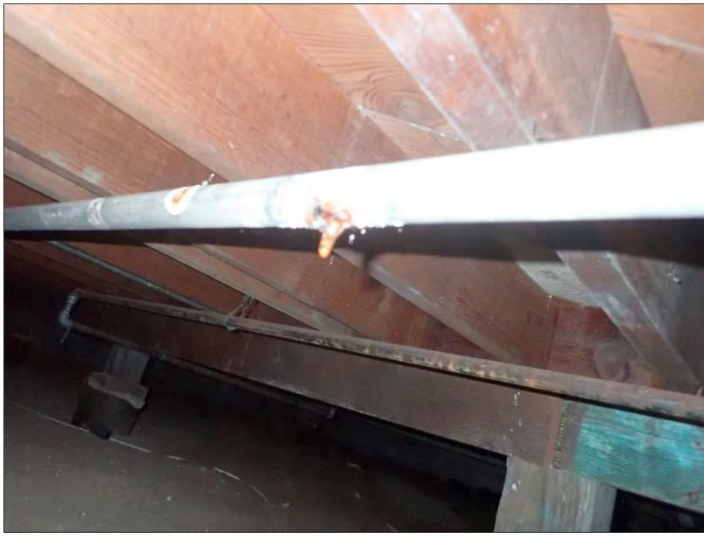
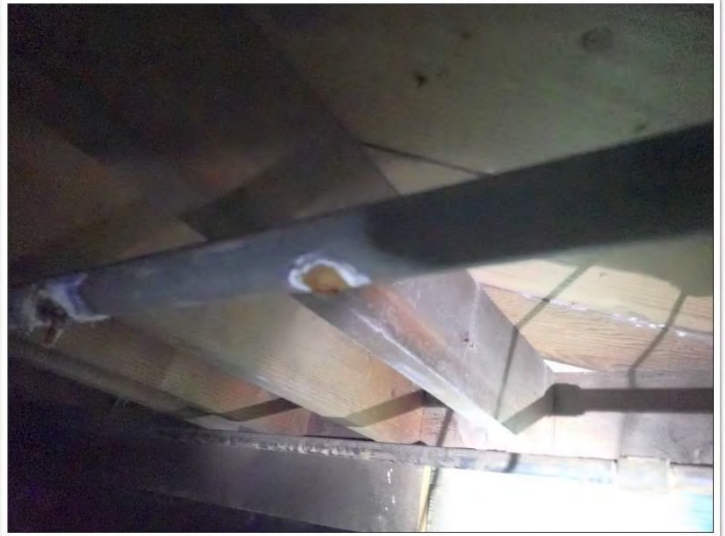
- 116 Sub-Floor: Accessible in family room closet. Plumbing leaking: **Leak noted at supply line under house; suggest consulting with specialist for further review prior to close of escrow.**

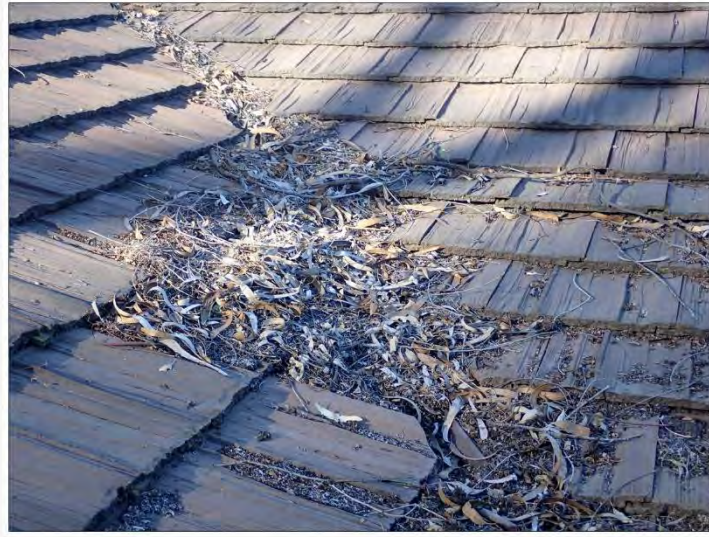
127 Roof Comments: **Debris observed on the roof at front and rear. Debris on roof/valleys limits view of roof and prevents the roof from draining or drying out properly. Debris in the valleys may cause water to dam and flashing(s) to leak. Advise periodic removal of debris as part of routine maintenance.**

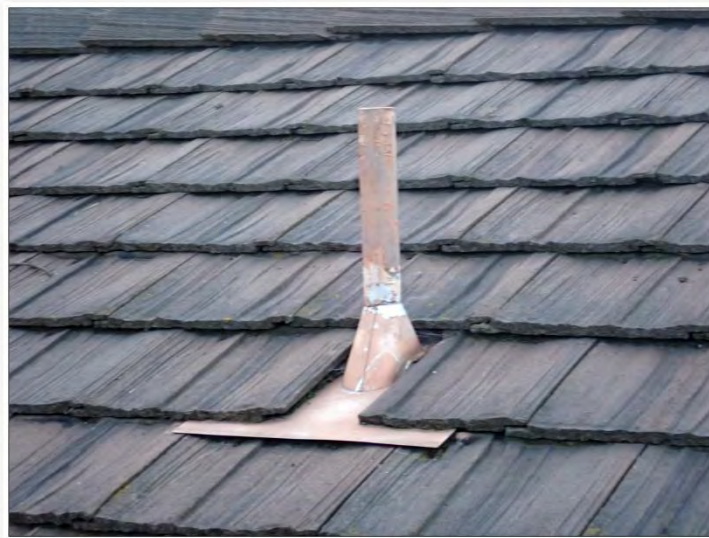
We advise resealing all through roof vents and projections as part of routine maintenance.

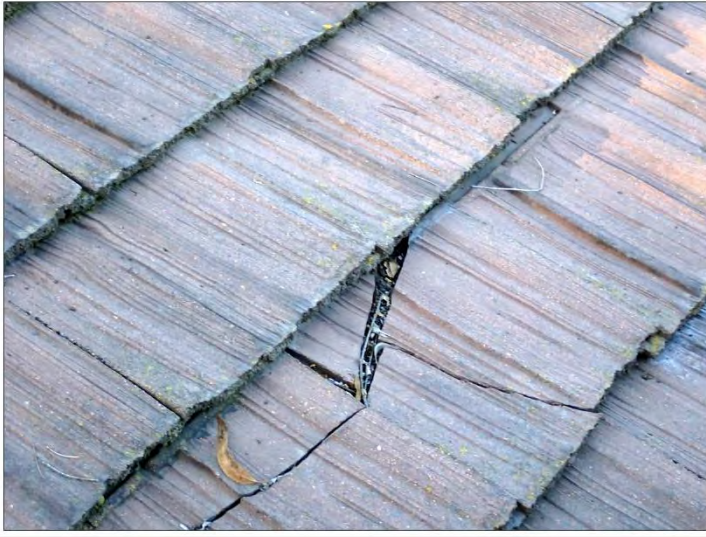
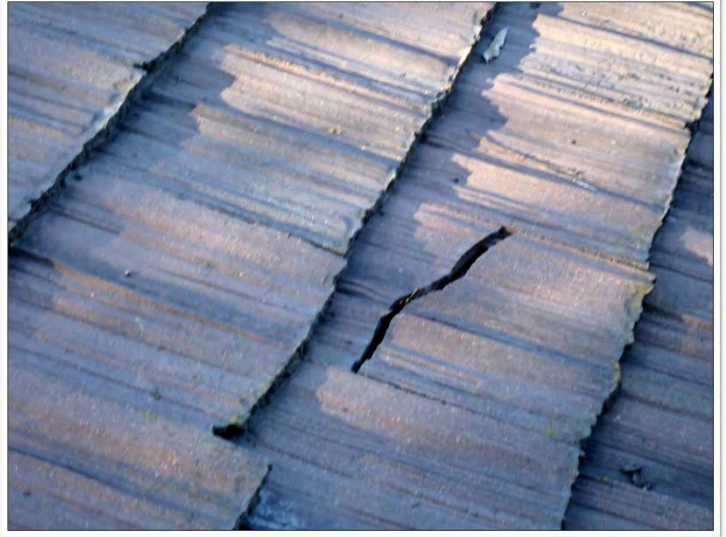
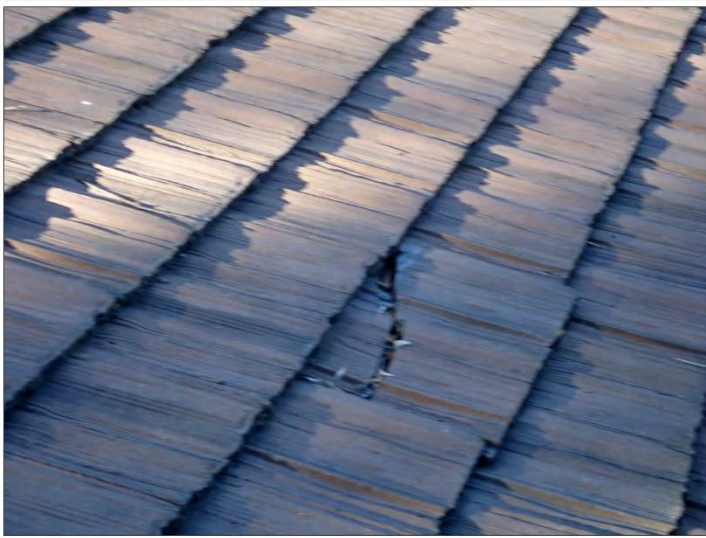
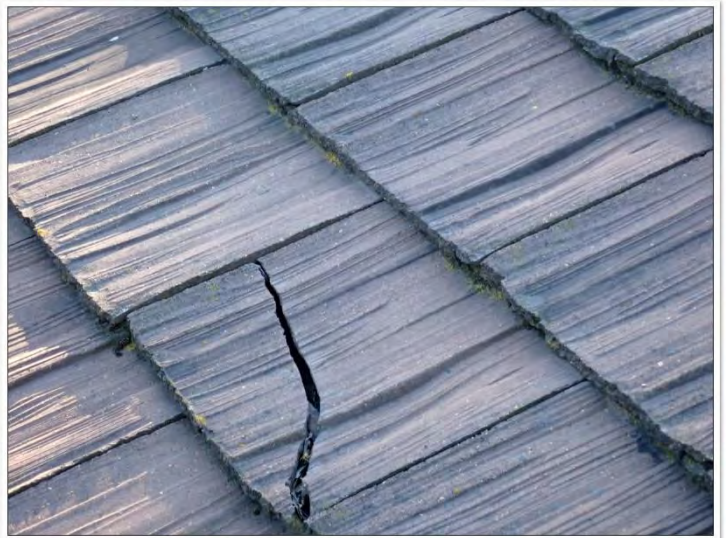
127 Roof Comments Cont'd: **Roof shows extensive wear and deterioration at various areas. We suggest consulting a roofing contractor for further review.**

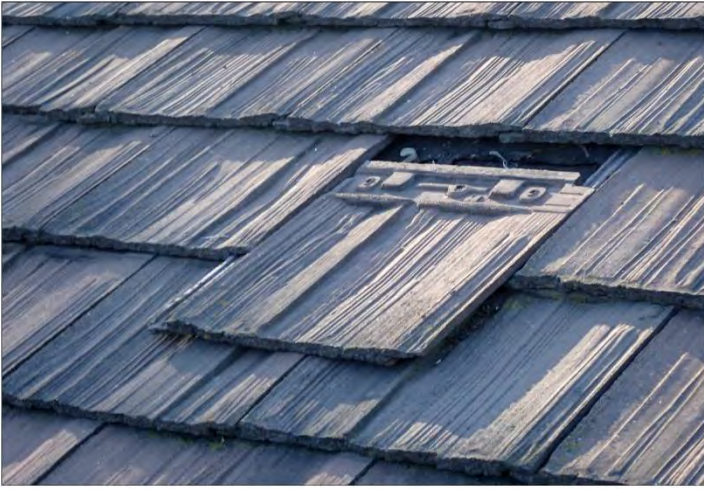
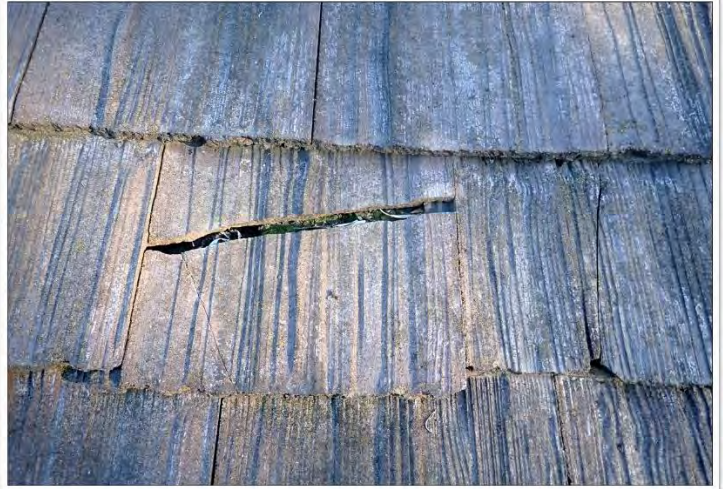
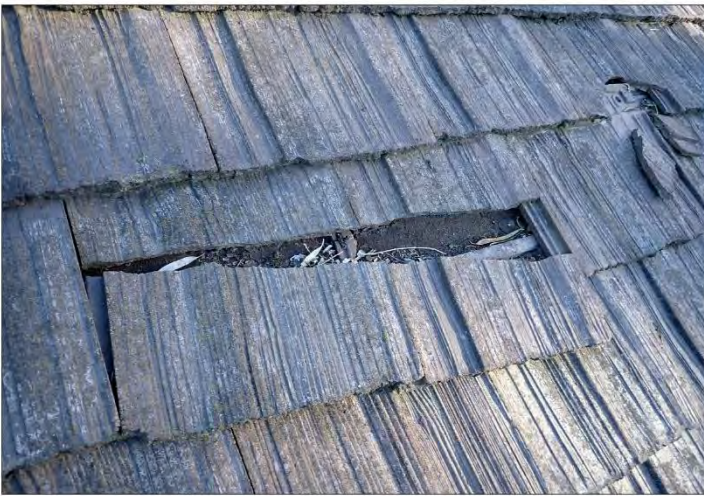
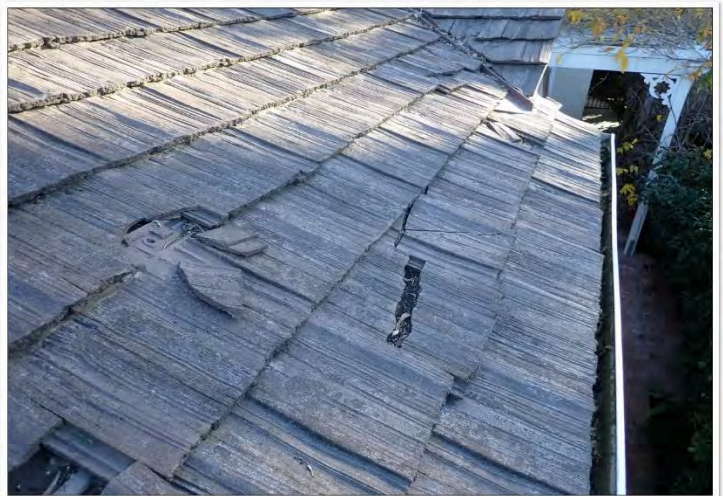
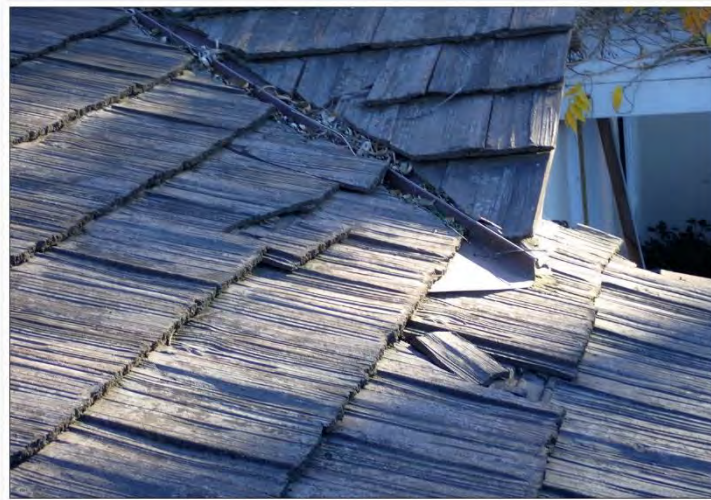
127 Roof Comments Cont'd: **Roof shows extensive wear and deterioration at various areas. We suggest consulting a roofing contractor for further review.**

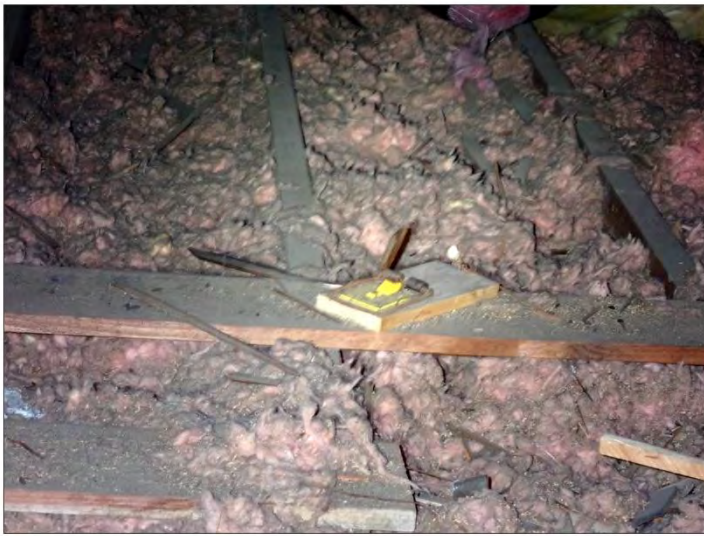
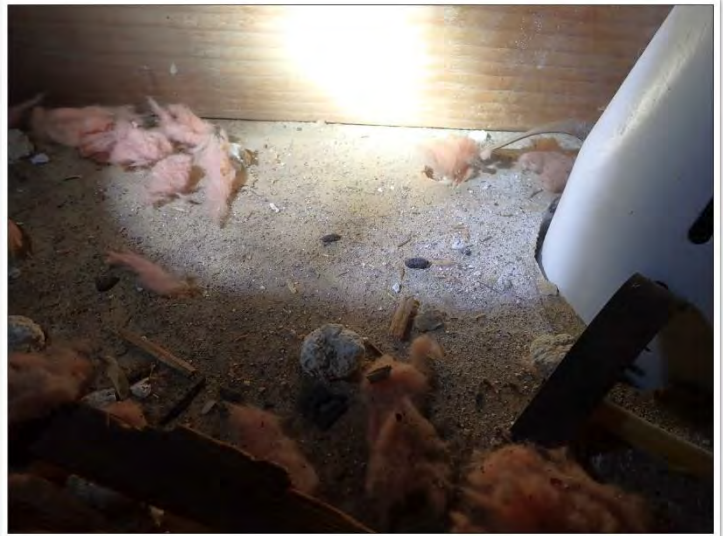
- 136 Hatch Location: Hall.
- 137 Accessible: Yes.
- 138 Sheathing: Serviceable; plywood.
- 139 Evidence of Leaking: No.
- 140 Insulation: Yes, where visible approximate thickness is 2-4 inches.
- 141 Ventilation: Appears to be adequate.
- 142 Attic Comments: **Evidence of animals/pests noted in attic space. Animals/pests may chew and/or damage electrical wiring and other components. We advise consulting with a pest exterminator for a complete review and for removal of any animals/pests.**

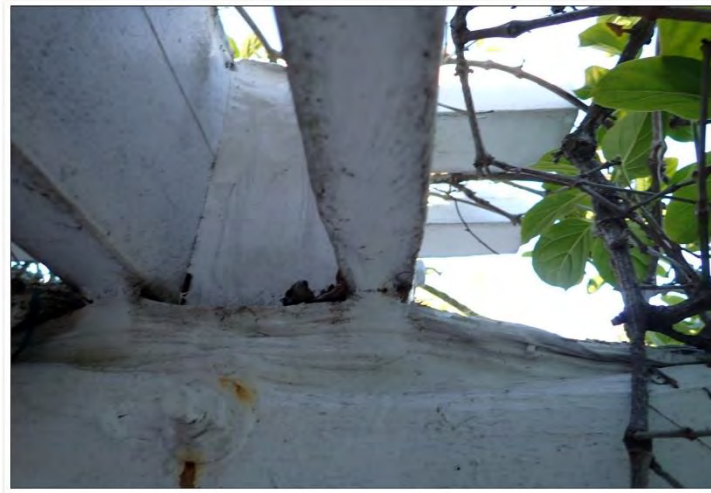
201 Cover: Wood. **Deteriorated wood noted at some areas.**

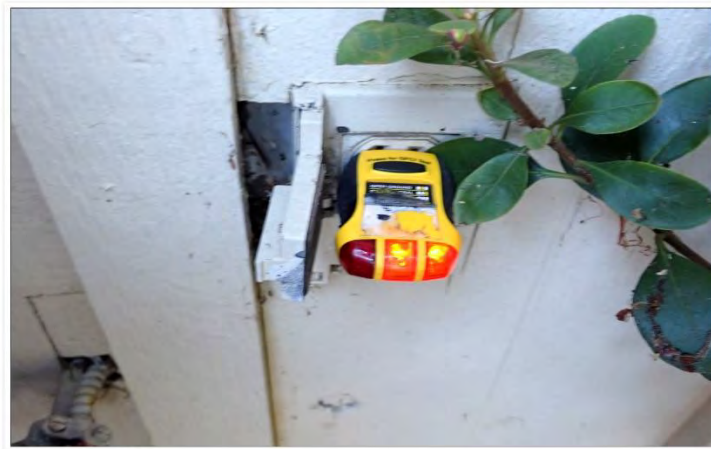
203 Electrical: **There is no ground fault interrupter noted in this area which may not have been standard at the time of construction. However, today's standards require ground fault interrupters at all areas within five feet of running water and external outlets. We suggest installing a ground fault interrupter in this area as a safety upgrade.**

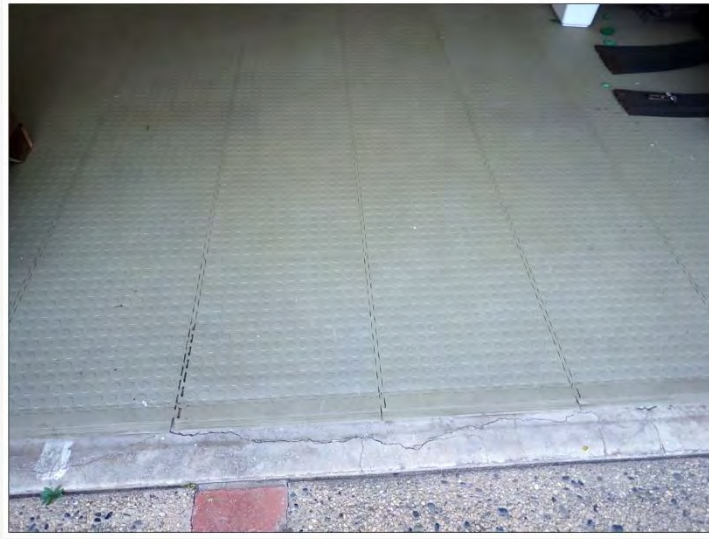
303 Slab: Concrete. **Unable to inspect floor of garage noted covered with a rubberized covering; suggest checking prior to close of escrow.**

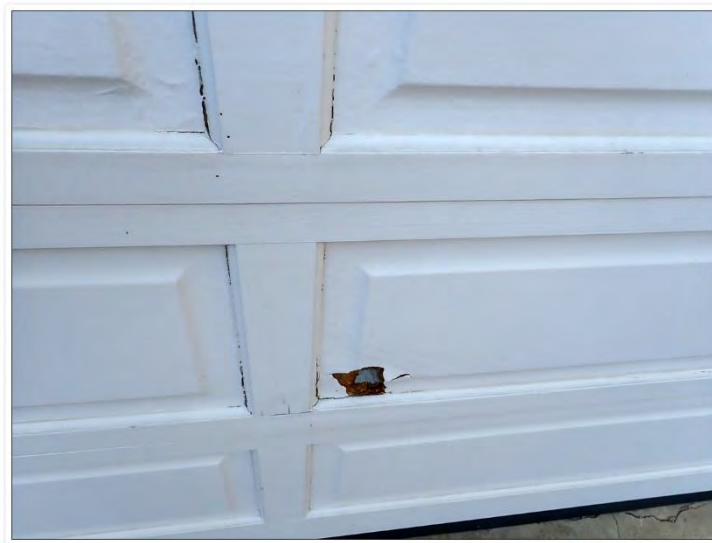
304 Overhead Door: Wood. **Chipped and deteriorated wood noted at some areas; suggest consulting with specialist for further review prior to close of escrow.**

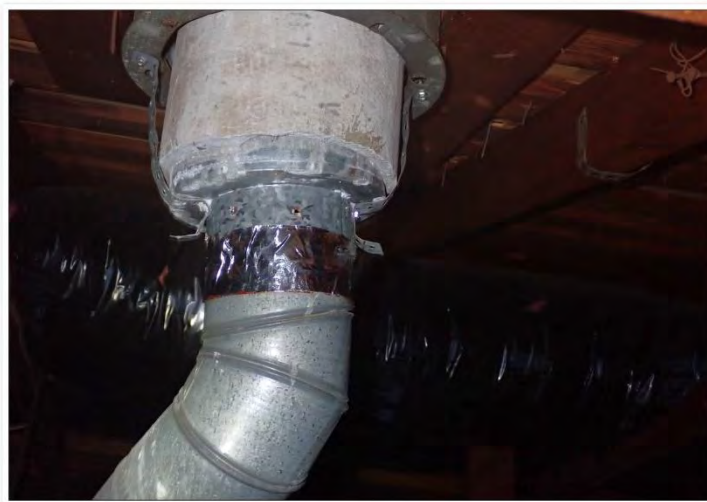
401a Venting: **A newer furnace has been installed to the existing ceramic pipe, which may cause moisture to drop onto the furnace. When a furnace is installed today, a double wall pipe is required for the flue. If concerned we suggest consulting with the local building department for further review.**

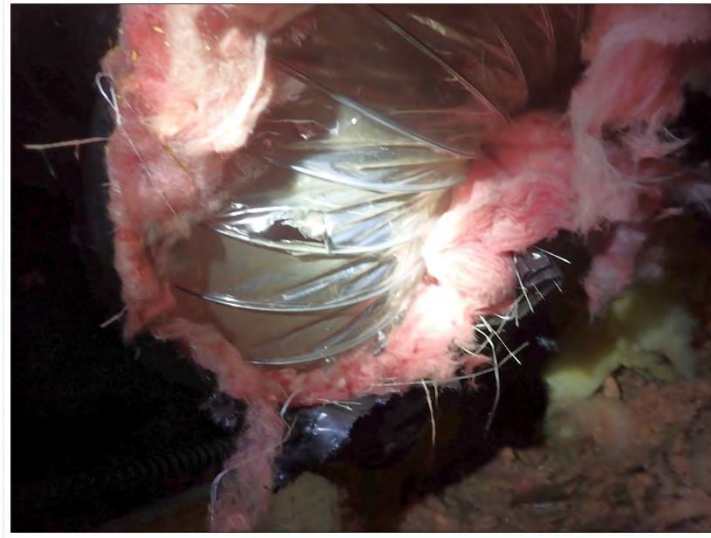
404 Ducting: **Holes noted in ducting in attic; we advise making necessary corrections.**

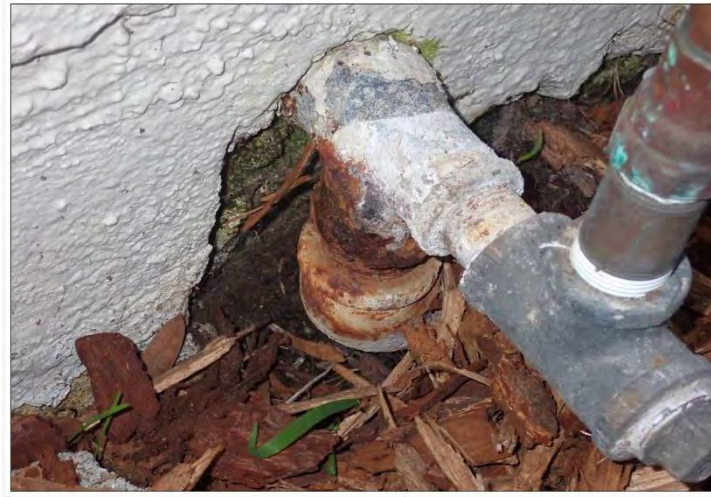
Excessive corrosion noted at front supply line; no evidence of leakage at time of inspection; suggest consulting with specialist for further review prior to close of escrow.

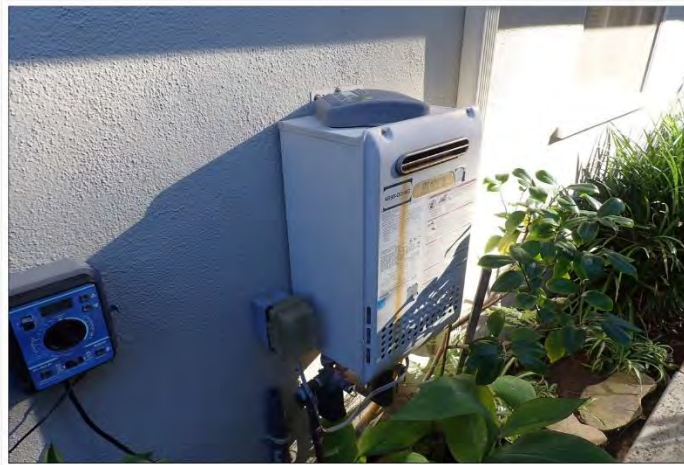
Unable to determine if water heater is raised high enough; suggest consulting with specialist for further review prior to close of escrow.

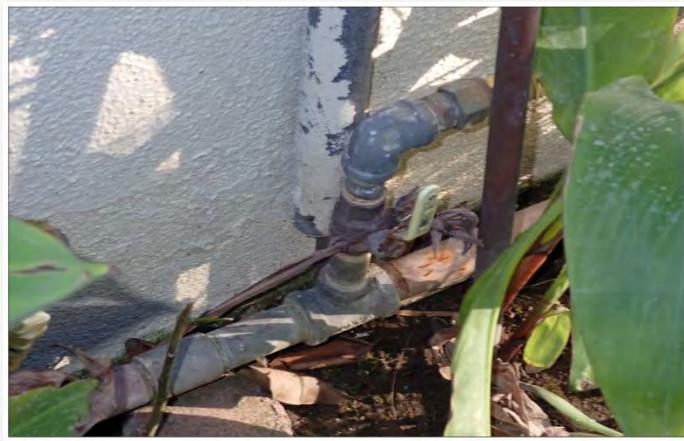
Gas line noted is loose; suggest securing as a safety upgrade.

Water heater shares gas line with other gas items; suggest consulting with specialist for further review prior to close of escrow.

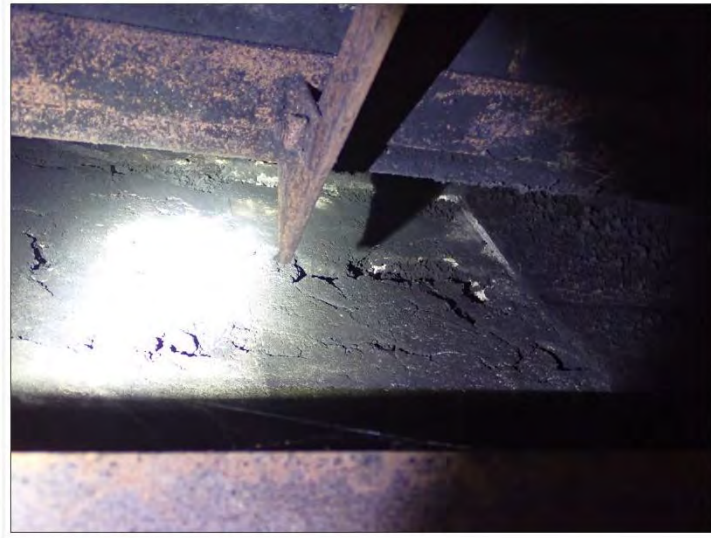
- 411 Fireplace #1: Located in living room. Burns wood and gas. Gas jet provided.
- Chipped concrete and breast plate.**
- Dirty fireplace noted; suggest cleaning as necessary.**

- Suggest adding a c-clamp to the fireplace damper as a safety upgrade, so that fireplace damper does not close completely during use.**

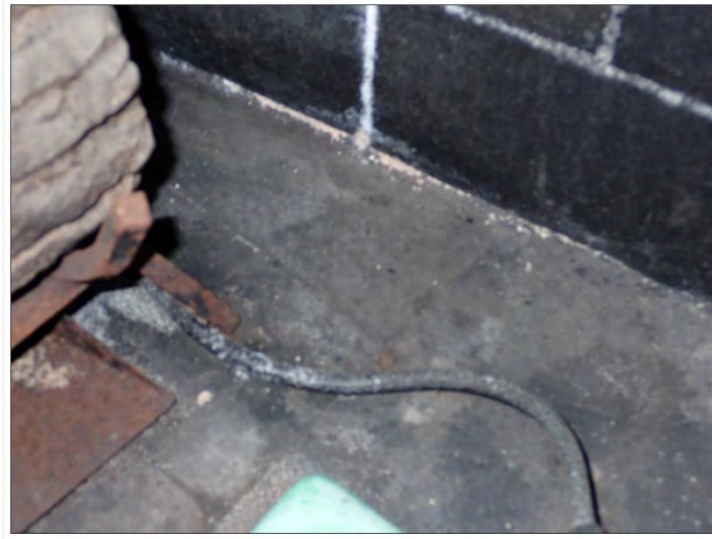
411 Fireplace #1 Cont'd: **Suggest replacing rigid gas line with flexible gas line as a safety upgrade.**

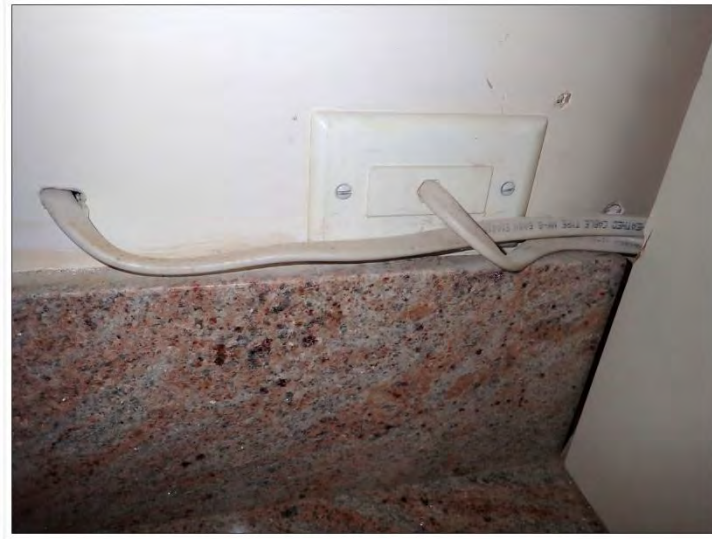
Rear left and right ground fault interrupters provided for safety is inoperable. Exposed Romex wiring noted at right side. This may be a safety concern if used where it could be subject to physical damage. Client may wish to encase as a safety upgrade.

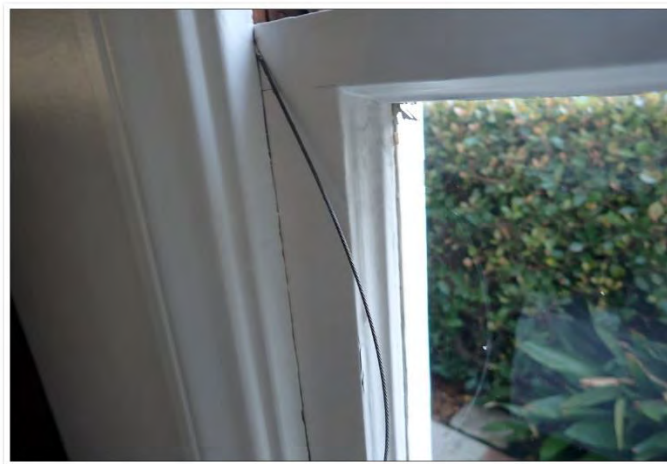
901 Floor:	Serviceable.
902 Walls:	Serviceable.
903 Ceiling:	Serviceable.
904 Doors:	Non-Applicable.
905 Windows:	Unable to open front left window; appears to be painted shut. Broken sash wire/cord noted on rear left window at time of inspection, this is a potential safety concern. Adjustments and/or repairs may be needed for safe and proper operation.

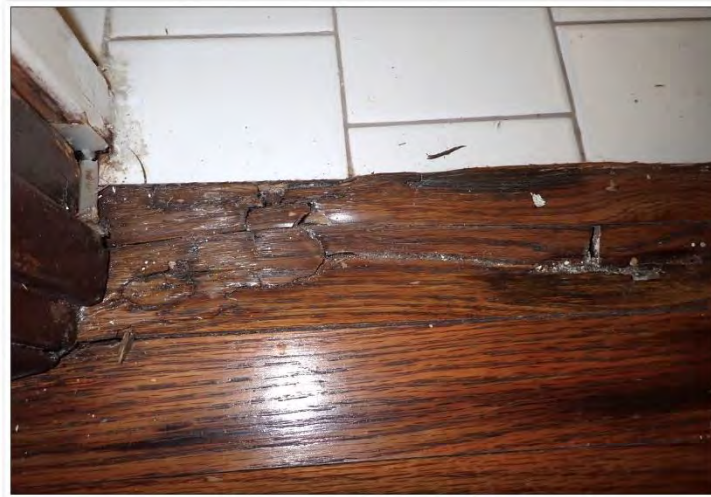
1301 Floor: **Floor is deteriorated noted by bathroom door; we advise making necessary corrections.**

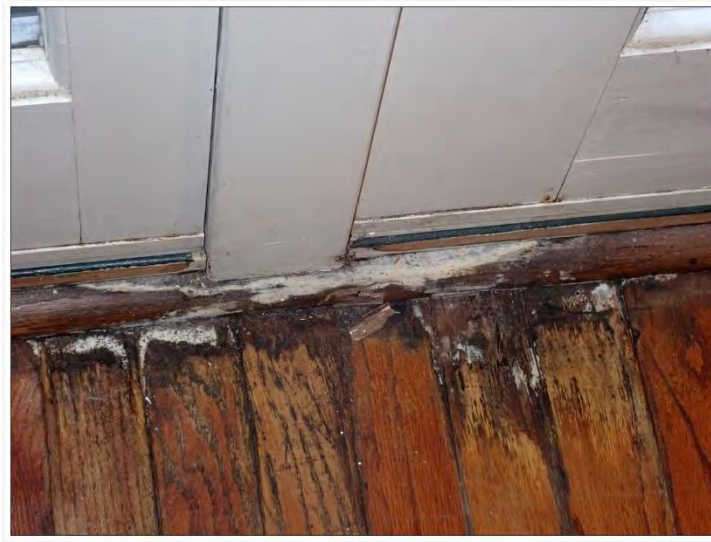
Water damage and deteriorated wood noted by left door; suggest consulting with specialist for further review prior to close of escrow.
