# WOOD DESTROYING PESTS AND ORGANISMS INSPECTION REPORT

| 8740 | El Camino Real | Atascadero | 93422 | 05/20/2025 | 1 of 8 |

**Report #: 110743**

| General Description:<br>Two story; Multi family residence; Composition shingle roof; Wood exterior; Vacant. | Inspection Tag Posted:<br><b>WATER HEATER CLOSET</b> |

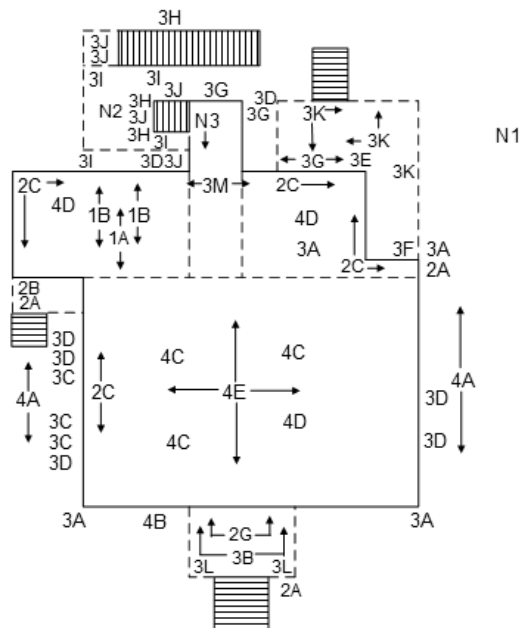
Diagram not to scale  
Finding locations approximate

| Finding: | 1A | Evidence of Subterranean Termite infestation was found at the substructure and indicates an infestation in the soil below the structure. |
| Finding: | 1B | Subterranean Termite damage was noted at the substructure framing. |

| Finding: | 2A | Evidence of Drywood Termite infestation was found at the exterior and appears to extend into inaccessible areas of the structure. |

Finding: 2B Drywood Termite damage was found at the door frame.  
Recommendation: Remove and replace the damaged portion of the door frame as needed.  
Price: \$204.00

Finding: 2C Evidence of Drywood Termite infestation was found at the substructure.  
Recommendation: Refer to item 2A for recommendation. Cost included in item 2A.  
Price: Included as noted in recommendation.

Finding: 3A Fungus damage was found at the second level fascia of the eave area.  
Recommendation: Replace the fungus damaged portions of the second level fascia as needed.

Finding: 3B Fungus damage has occurred to the second level deck soffit due to leakage at the waterproof coating at the posts.  
Recommendation: Remove and replace the damaged portions of the second level deck soffit as needed to eliminate the fungus infection. Make necessary corrections to the waterproof coating at the posts to eliminate the excessive moisture condition.  
Price: Price on request

Finding: 3C Fungus damage was found at the second level exterior wood trim.  
Recommendation: Replace the damaged portions of the second level trim as necessary.  
Price: \$714.00

Finding: 3D Fungus damage was found at the exterior wood trim.  
Recommendation: Replace the damaged portions of the trim as necessary.  
Price: \$918.00

Finding: 3E Fungus damage was found at the fascia of the eave area.  
Recommendation: Replace the fungus damaged portions of fascia as needed.  
Price: \$209.00

Finding: 3F Fungus damage was found at the exterior door frame.  
Recommendation: Replace the damaged portions of the door frame as necessary.

Finding: 3G Fungus damage was found at the wood siding.  
Recommendation: Remove and replace the damaged portions of the wood siding. Efforts will be made to match existing siding material type. Replacement materials may not match existing type. Additional costs may apply if damage extends into inaccessible wood members.

Finding: 3H Fungus damage was found in the second level deck handrail.  
Recommendation: Replace the fungus damaged portions of the second level handrail as needed.

Finding: 3I Fungus damage was found at the base of the second level porch post.  
Recommendation: Remove and replace the fungus damaged second level post.

Finding: 3J Fungus damage was found at the second level deck support bracing.  
Recommendation: Remove and replace the damaged portions of the second level deck support bracing as needed to eliminate the fungus infection and damage.

Finding: 3K Fungus infection and damage were found at the wood members of the first level deck.  
Recommendation: Remove and replace the damaged portions of wood members of the deck as needed to eliminate the fungus infection. In areas where VERY MINOR fungus growth is present, but no detectable deterioration has occurred, scrape away the surface growth with a wire brush and chemically treat the wood members with disodium octaborate tetrahydrate or copper naphthenate for elimination of infection. Repair includes replacement of wood members with similar materials (unless improper materials were originally used). Note: Price quoted above does not include complete replacement of the wood deck. Additional damages are often discovered when concealed surfaces of wood members are exposed during the course of repairs. If additional damage is discovered, findings and costs will be submitted on a supplemental report.

Finding: 3L Fungus damage has occurred to the first level deck due to leakage at the waterproof coating at the posts.  
Recommendation: Remove and replace the damaged portions of the first level deck as needed to eliminate the fungus infection. Make necessary corrections to the waterproof coating at the posts to eliminate the excessive moisture condition.

Finding: 3M Fungus damage was found at the substructure framing and sheer panel.  
Recommendation: Remove and replace the damaged portions of the substructure framing and sheer panel as needed to eliminate the fungus infection and damage.

Finding: 4A An excessive moisture condition exists at the siding/joints.  
Recommendation: Seal the siding at the joints to eliminate the excessive moisture condition.  
Price: \$588.00

Finding: 4B An excessive moisture condition exists due to plumbing leakage at the exterior leaking into the substructure.  
Recommendation: Contact a licensed plumber to correct the excessive moisture condition.  
Price: No Bid offered at this time. Owner should contact appropriate tradesman to complete recommended corrections.

Finding: 4C Earth to wood contact exists at the pier posts.  
Recommendation: Lower the adjacent soil grade as necessary to eliminate the earth to wood contact.  
Price: \$179.00

Finding: 4D Loose cellulose debris (wood scraps/paper) were found in the substructure area. This may lead to Subterranean termite infestation.  
Recommendation: Remove and dispose of all loose cellulose debris from under the dwelling of such size that it will not pass through an ordinary garden rake.  
Price: \$202.00

Finding: 4E Evidence of excessive moisture was noted at the substructure wood members and indicates that the substructure ventilation is inadequate. Condensation of moisture may lead to infestation, infection and damage.  
Recommendation: Install ventilation to the substructure area as needed to eliminate the excessive moisture condition and to comply with local building code.
