# THE COMPANY

Home Inspection Group

8275 Sutterhome Pl, Rancho Cucamonga, CA 91730

Date of Inspection: 9/13/2025 Time: 1:00 PM

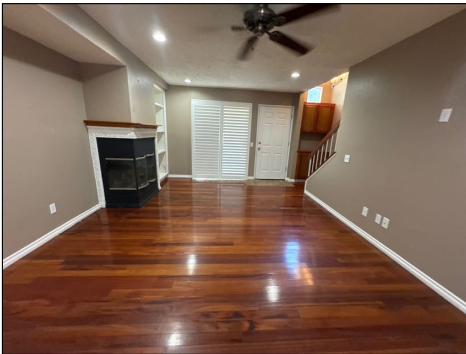
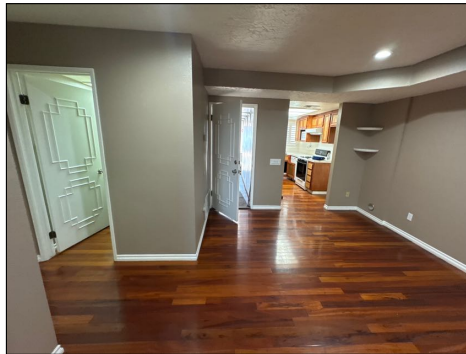
## 1. Wall Conditions

Small cracks/chipped/dirty areas/cosmetic blemishes observed – typical for age of structure • No moisture present when tested with a moisture meter

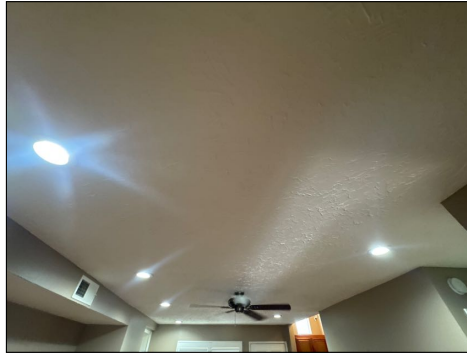
## 2. Ceiling Conditions

Small cracks/cosmetic blemishes observed – typical for age of structure

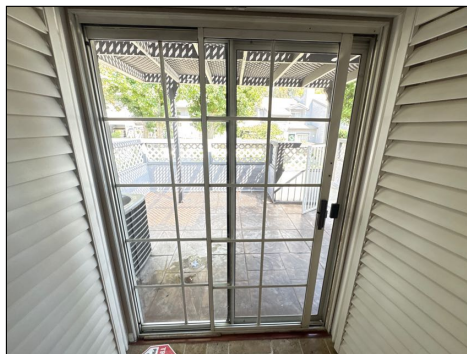
### 7. Sliding Glass Doors

Slider operated at the time of the inspection • Worn door with loose/worn hardware/frames/rollers/tracks – typical for age • Single pane • Tempered glass label observed • Recommend service/lubrication and general maintenance to extend the life of the slider

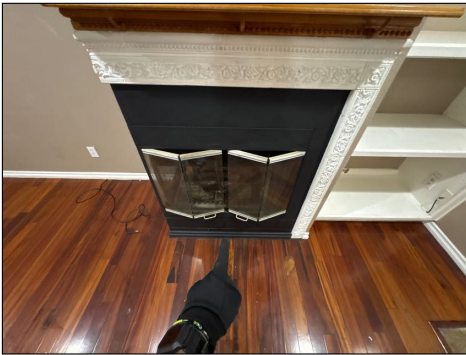
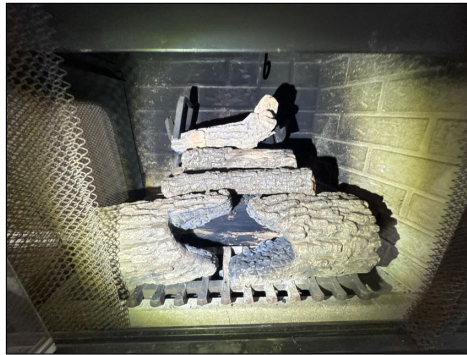
The fireplace is visually inspected only, the fireplace is not lit to test flame color or condition. The internal cavity of the fireplace is not inspected. It is recommended that you have an internal inspection of the chimney and a Gas Company evaluation of the fireplace prior to operating the fireplace. • Damper stop clamp was present at the time of the inspection • Small cracks/worn areas present – typical for age • Recommend fire caulk/sealing any holes/gaps/cracks • Damper was worn/rusted/dirty – recommend cleaning • Glass/screen door operated at the time of the inspection • Gas log lighter present • Gas valve tested and operated at the time of the inspection • **Hearth is missing – service recommended**

| <b>Interior</b> | | |
|---|---|---|
| Page 10 Item: 9 | Fireplaces | • Hearth is missing – service recommended |

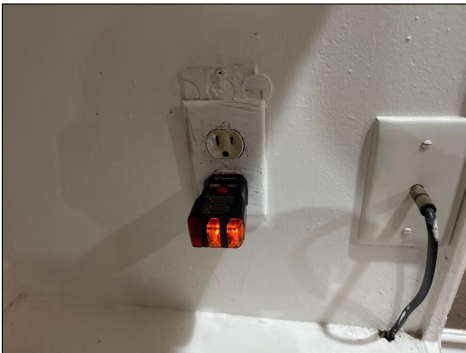
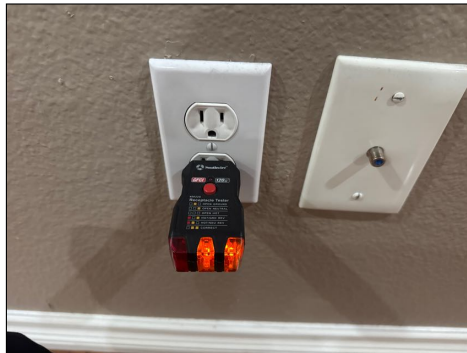
## 10. Electrical

A representative number of receptacles and switches were tested and found to be operational at time of inspection • Loose/worn outlets/switches – typical for age consider upgrading • **Outlet hot wired in reverse with neutral – service recommended**

Outlet hot wired in reverse with neutral – service recommended- see picture for location

| <b>Interior</b> | | |
|---|---|---|
| Page 10 Item: 10 | Electrical | • Outlet hot wired in reverse with neutral – service recommended |

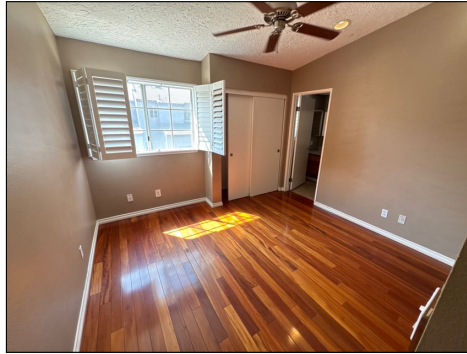
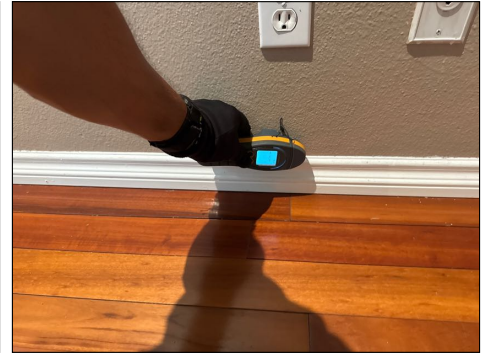
## 1. Wall Conditions

Small cracks/chipped/dirty areas/cosmetic blemishes observed – typical for age of structure • No moisture present when tested with a moisture meter

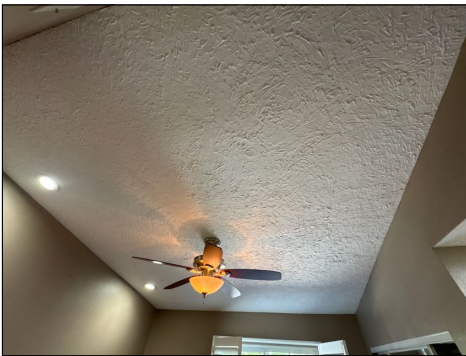
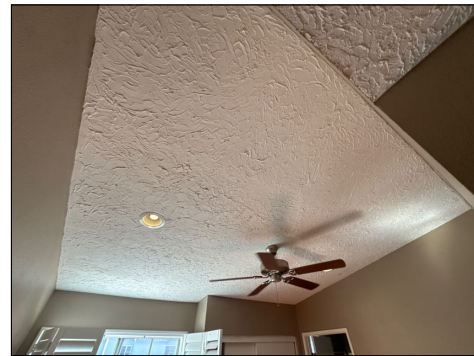
## 2. Ceiling Conditions

Small cracks/chipped/dirty areas/cosmetic blemishes observed – typical for age of structure

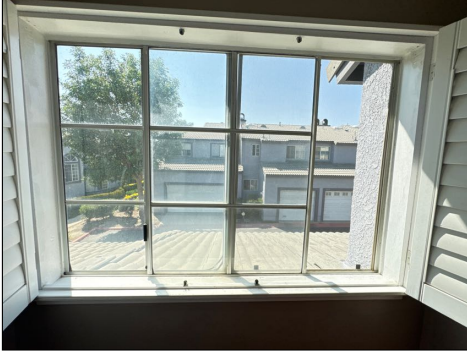
## 5. Window Conditions

Accessible windows were tested and operated at time of inspection • Visible/accessible windows have worn frames/hardware/sills/tracks – typical for age • Recommend general window maintenance/lubrication and weather tight service • Small cracks/worn areas/chipped paint observed around sill or frame • Damaged window seals – service recommended

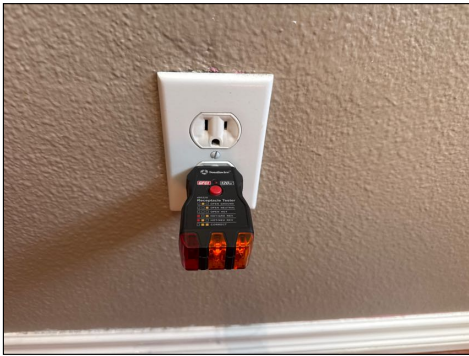
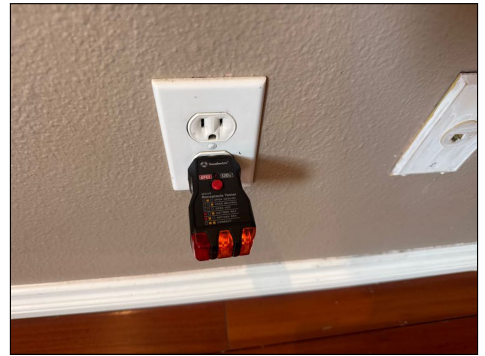
## 8. Electrical

A representative number of receptacles and switches were tested and found to be operational at time of inspection • Loose/worn outlets/switches – typical for age consider upgrading

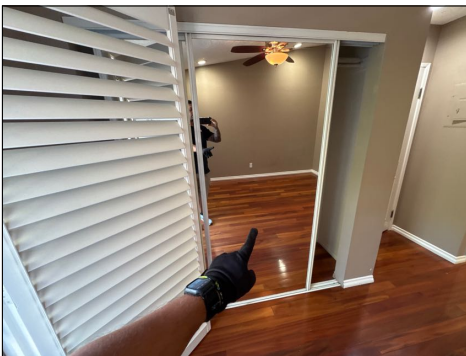
## 9. Closets

Worn closets with loose/worn hardware – typical for age • Bypass doors difficult to operate/rollers missing/damaged – service recommended

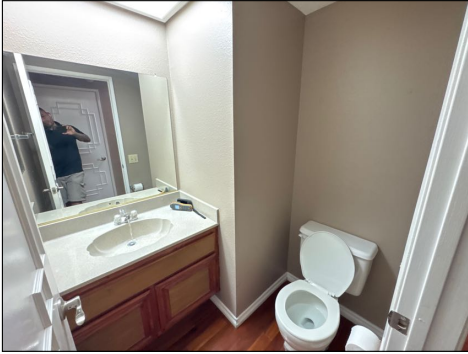
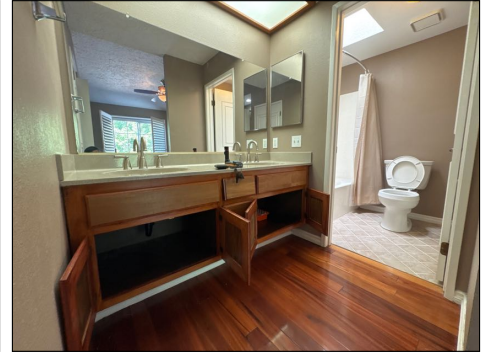
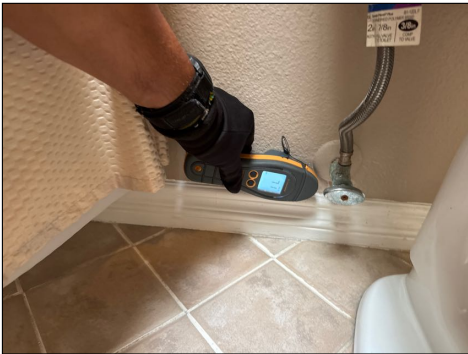
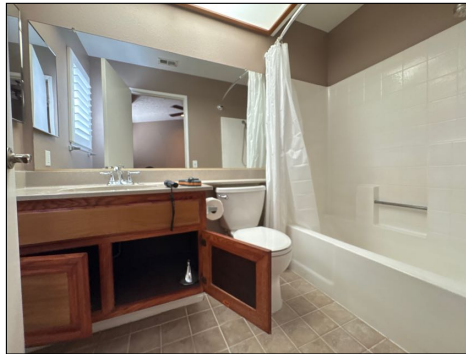
## 1. Wall Conditions

Cosmetic blemishes observed – typical for age of structure • No moisture present when tested with a moisture meter • No visible microbial growth/irregular staining found at the time of the inspection

No moisture present when tested with a moisture meter

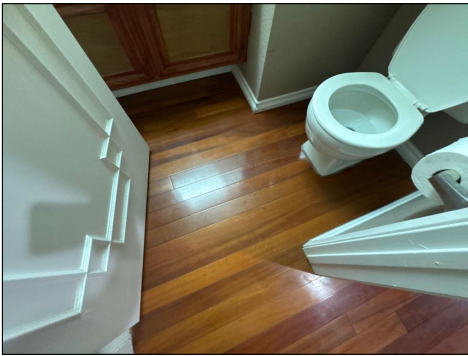
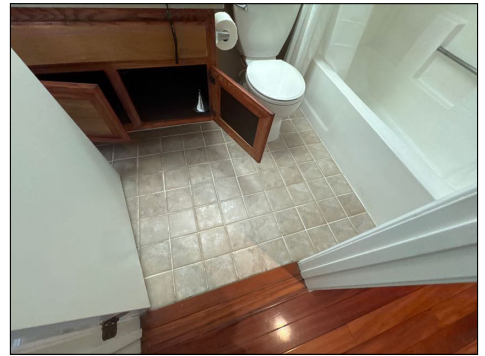
## 3. Floor Conditions

Scratched/worn areas – typical for age and use • Recommend grout and sealer maintenance

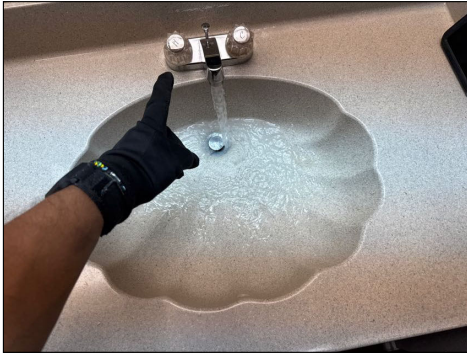
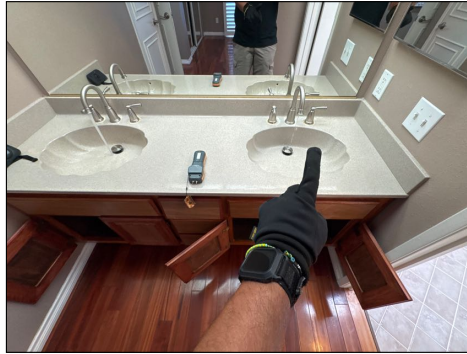
## 9. Sinks

Fixture operated at the time of the inspection • Loose/worn fixture – needs minor maintenance • **Drain stopper not operating properly – service recommended- guest**

| <b>Interior</b> | | |
|---|---|---|
| Page 18 Item: 9 | Sinks | • Drain stopper not operating properly – service recommended-guest |

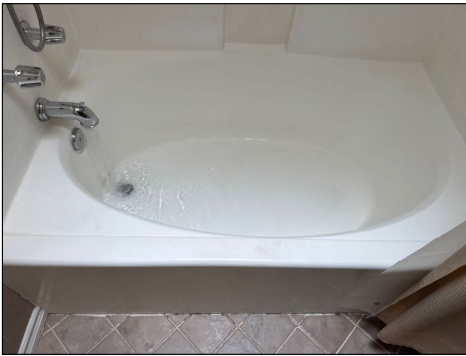
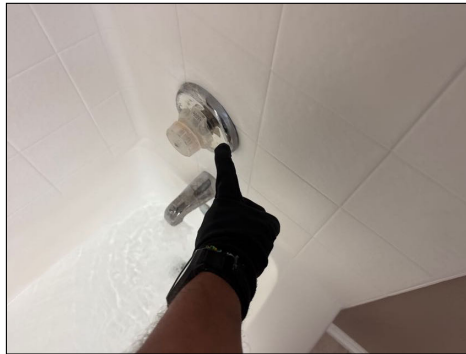
## 11. Bath Tubs

Fixture was tested and operating at the time of the inspection • Fixture was in a worn/older condition at the time of the inspection – typical for age • Recommend upgrading fixtures • Recommend Licensed Plumber for further evaluation • Tub is worn/older/stained/scratched/chipped – typical for the age • **Tub fixture is seized/stuck in position – service recommended- guest • Tub fixture leaks when operated – service recommended- primary**

| <b>Interior</b> | | |
|---|---|---|
| Page 18 Item: 11 | Bath Tubs | • Tub fixture is seized/stuck in position – service recommended-guest<br>• Tub fixture leaks when operated – service recommended-primary |

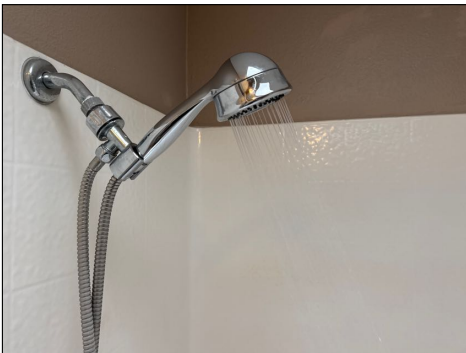
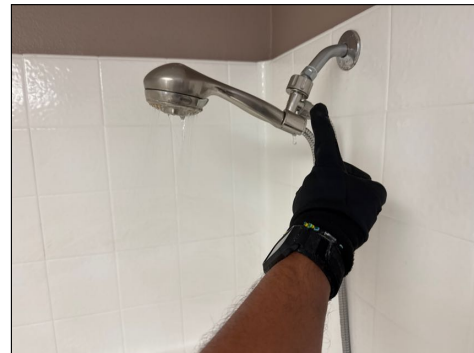
## 12. Showers

Fixture was tested and operating at time of inspection via normal fixture controls • Fixture was in a worn and older condition – typical for the age

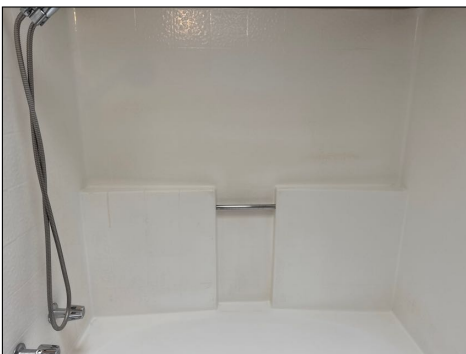
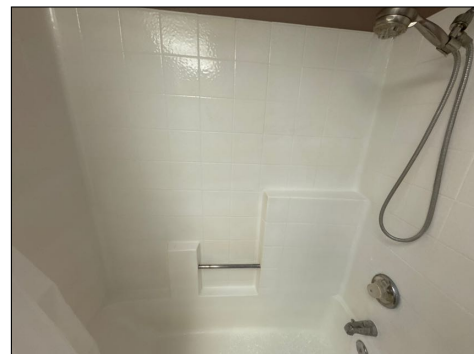
## 13. Shower Walls

Fiberglass surround present • Wall materials in a worn/stained-faded/old condition – typical for age – recommend routine grout and sealer maintenance

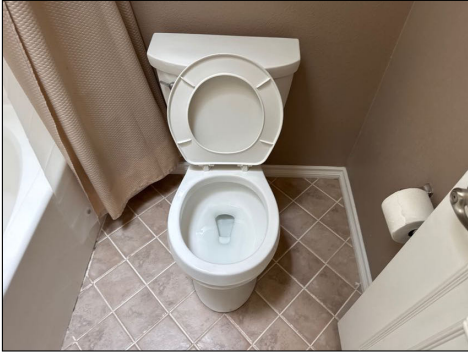
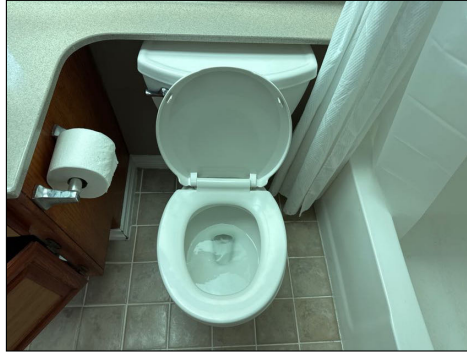
## 14. Toilets

Tested and operational at time of inspection via normal fixture controls, flush test performed • Toilet is in a worn and older condition at the time of the inspection – typical for age • No visible leaking at the time of inspection and flush testing • Water shutoff under toilet corroded – service recommended

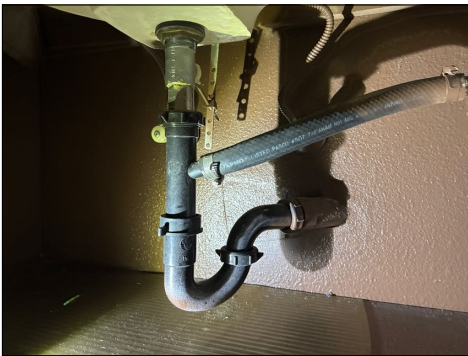
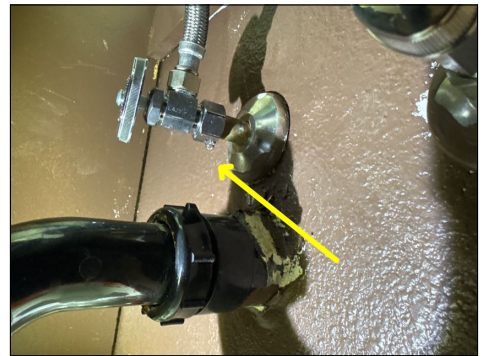
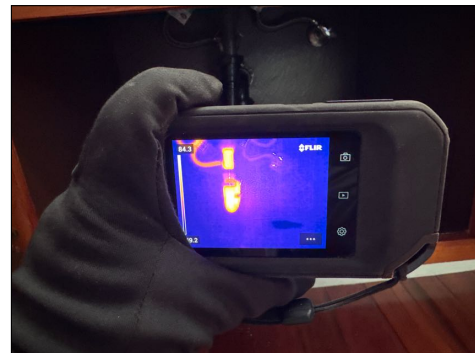
Operational at time of inspection via normal fixture controls with no major visible defects • Angle stops/hoses/drain pipes are worn/older – recommend upgrading these areas with new fixtures • **Shutoffs under sink leaking– service recommended- both sides primary**

Angle stops/hoses/drain pipes are worn/older – recommend upgrading these areas with new fixtures

Shutoffs under sink leaking– service recommended- both sides primary

| <b>Interior</b> | | |
|---|---|---|
| Page 20 Item: 15 | Plumbing | • Shutoffs under sink leaking– service recommended- both sides primary |

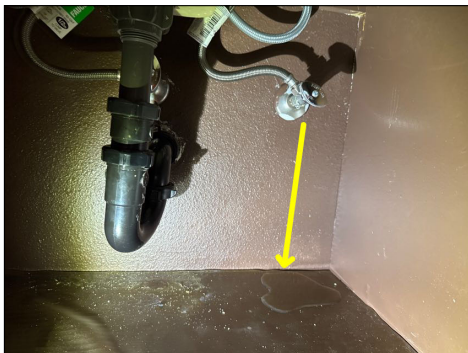
Shutoffs under sink leaking– service recommended- both sides primary

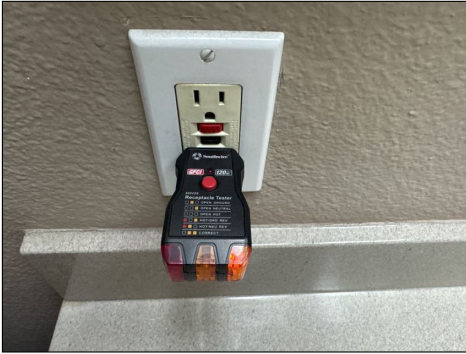
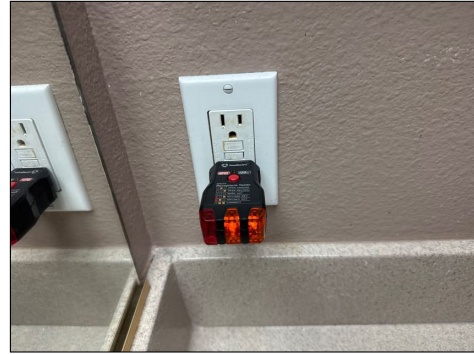
## 17. GFCIs

Tested and operational at time of inspection via normal control

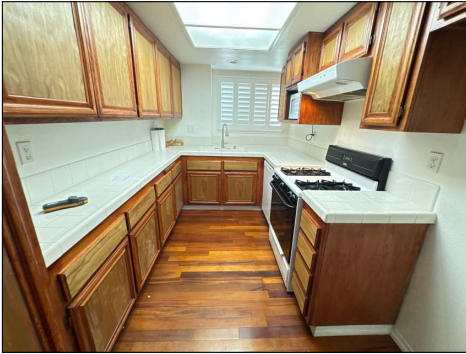
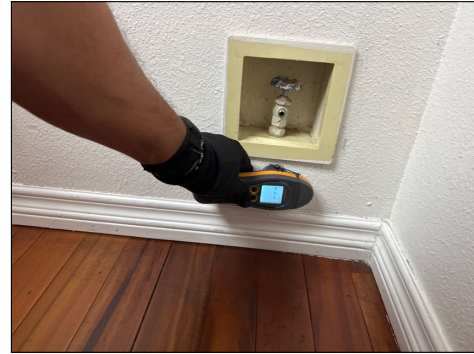
## 1. Wall Conditions

Appliances present and are not moved for inspection – limited inspection of walls, floors, cabinet areas covered by appliances • Cosmetic blemishes observed – typical for age of structure • No moisture present when tested with a moisture meter • No visible microbial growth/irregular staining found at the time of the inspection

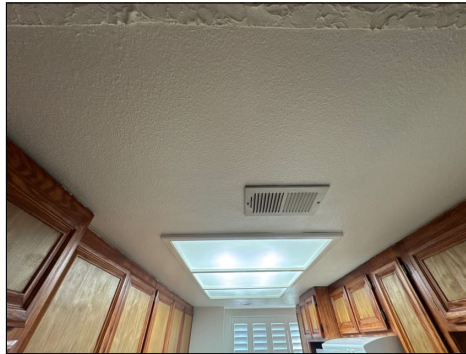
## 2. Ceiling Conditions

No major visible defects observed at the time of inspection • No moisture present when tested with a moisture meter

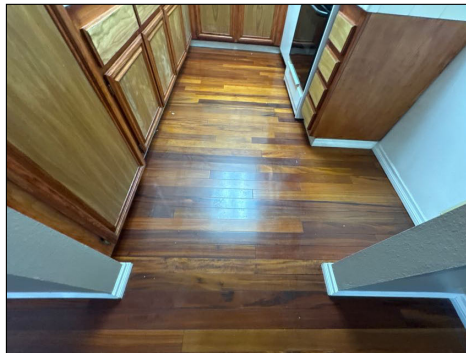
## 3. Floor Conditions

Scratched/worn areas – typical for age and use

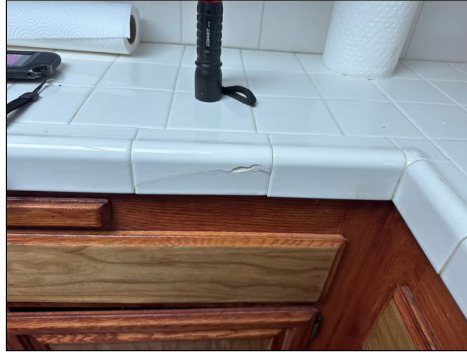
## 5. Counters

Counter is worn and has typical wear for age • Recommend grout/sealer/stone maintenance

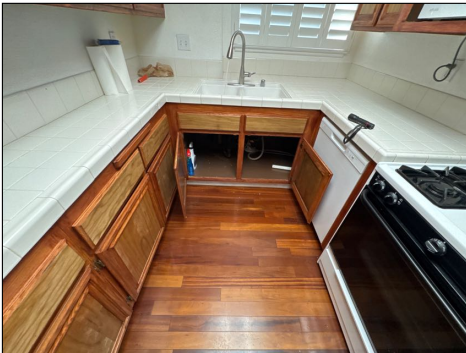
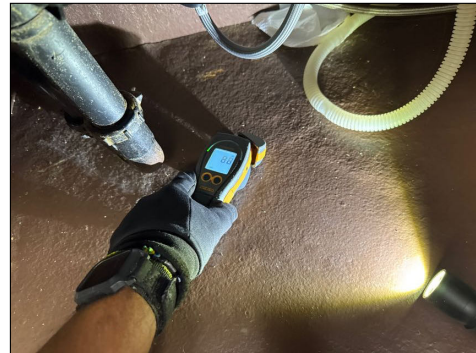
## 6. Cabinets

Worn cabinets with loose/worn hardware – typical for age

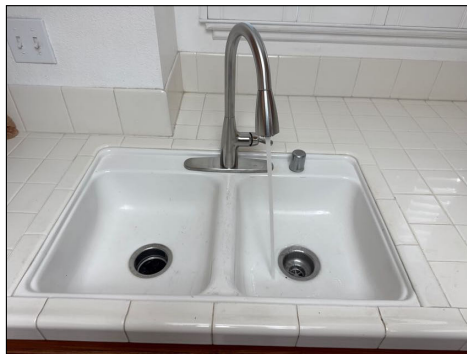
## 7. Sinks

Fixture operated at the time of the inspection • Normal wear at fixture/sink for age of material with no major visible defects

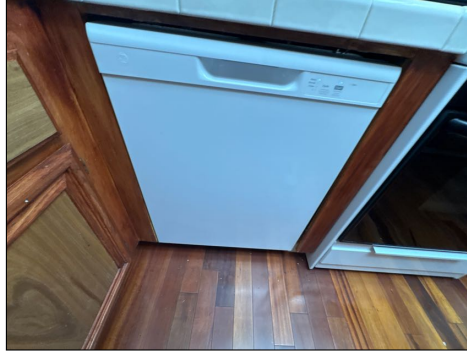
## 8. Dishwashers

The dishwasher inspection is limited and does not include an inspection of the water pump or any hoses inside or beneath the unit. The home inspector cannot predict the remaining life of the dishwasher or any parts within the dishwasher; nor can the home inspector tell you if or how well the dishwasher actually cleans or dries dishes. This inspection allows for one fill and one drain cycle only, the Inspector does not run the dishwasher for any full cycles. • Tested and operational (one fill and drain cycle only, not full cycle) at time of inspection via normal controls • Dishwasher has normal wear for age with no major visible defects • Drained properly during inspection • No visible leaks found at the time of the inspection

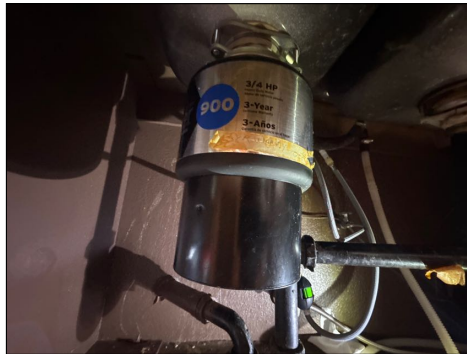
## 9. Garbage Disposals

The garbage disposal has a limited inspection, the Inspector cannot predict the remaining life of the garbage disposal nor determine how well the garbage disposal disposes of food or other items. The sharpness or adequacies of the internal blades is not determined during the home inspection. • Tested and operational at time of inspection via normal controls • Worn/older unit – typical wear for age and use • No visible leaks at the time of the inspection

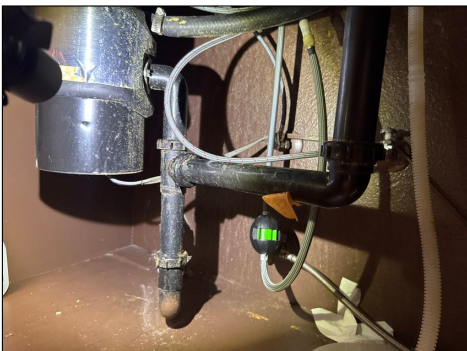
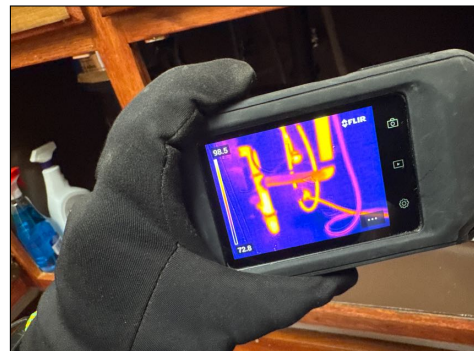
## 10. Plumbing

Operational at time of inspection via normal fixture controls with no major visible defects • Angle stops/hoses/drain pipes are in a normal condition for their age – no major visible defects • No visible leaks found at the time of the inspection after running water at fixtures

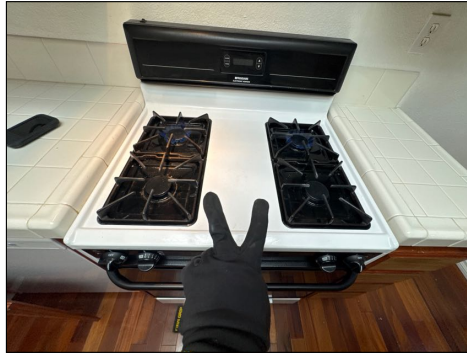
## 11. Ranges

The range or cooktop has a limited inspection, the Inspector cannot predict the remaining life of the unit nor determine the BTUs output by each burner or if/how well the burners will cook food. For gas units – gas leaks cannot be detected with this inspection – a full evaluation by the Gas Company of all gas supplied appliances is recommended beyond this inspection. • Gas supplied unit • Tested and operational at time of inspection via normal controls • Worn/older unit – replacement/repairs/maintenance will be required in the near future • **Front element/burners not operating – service recommended**

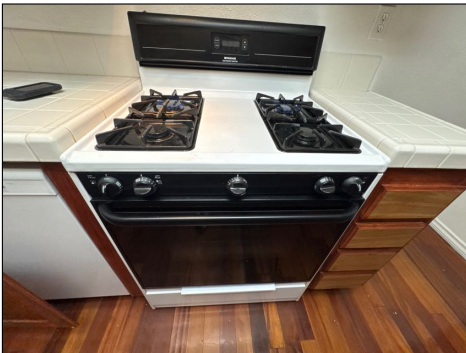
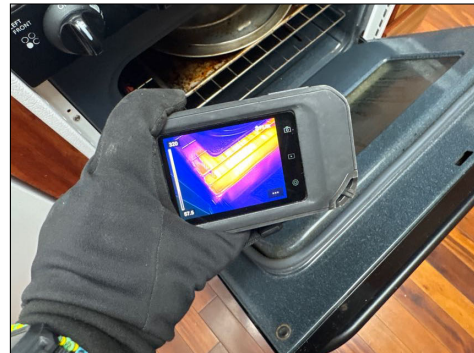
## 12. Ovens

The "Bake" feature is the only feature operated during a home inspection; convection, browning, rotisserie, warming drawers and other features are not tested during the oven inspection. Ovens are tested for basic heating element functionality. The oven cannot be tested to each incremental temperature setting or determine if adequate cooking temperatures can be achieved, nor if temperatures are calibrated with oven settings. We cannot determine if or how well the oven cooks food nor can we predict the remaining life left for the unit. For gas units – gas leaks cannot be detected with this inspection – a full evaluation by the Gas Company of all gas supplied appliances is recommended beyond this inspection. • Gas supplied unit • Tested and operational at time of inspection via normal controls • Worn/older unit – replacement/repairs/maintenance will be required in the near future

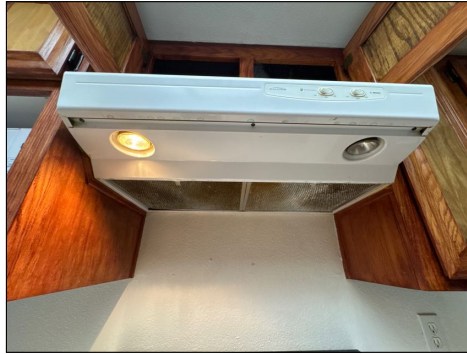
Hood with fan

The exhaust fan/vent is tested using the normal controls only. No smoke testing or other testing is done to determine the CFMs or how well the unit evacuates air. The home inspector cannot predict the remaining life left in the unit. • Tested and operational at time of inspection via normal controls • Worn/older unit – typical wear for age and use • Worn/dirty filters, recommend cleaning or replacing

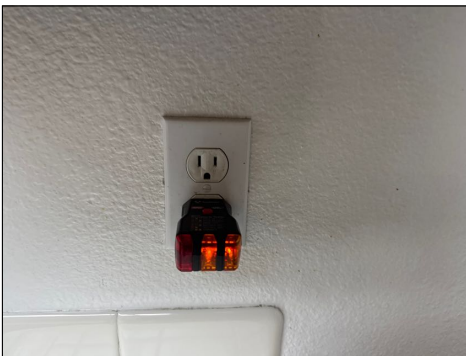
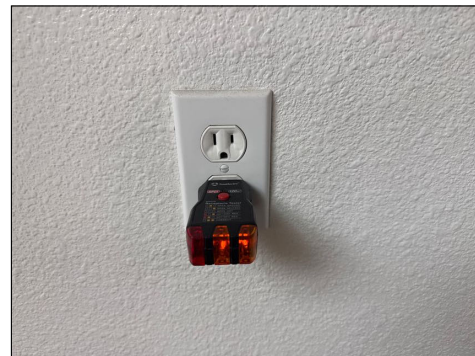
## 15. Electrical

A representative number of receptacles and switches were tested and found to be operational at time of inspection • Loose/worn outlets/switches – typical for age consider upgrading

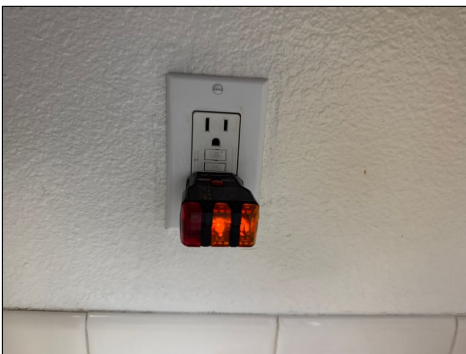
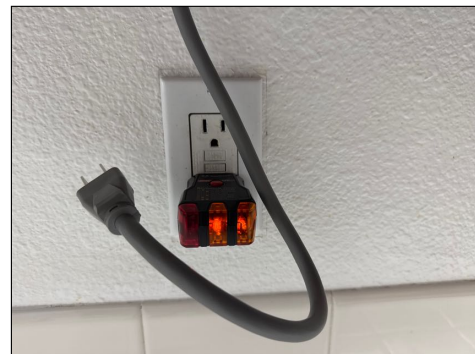
## 16. GFCIs

Recommend upgrading all receptacle to **GFCI** protection within 6 feet of all potential wet locations, unless the receptacle is on a circuit dedicated for a specific appliance. • Tested and operational at time of inspection via normal control

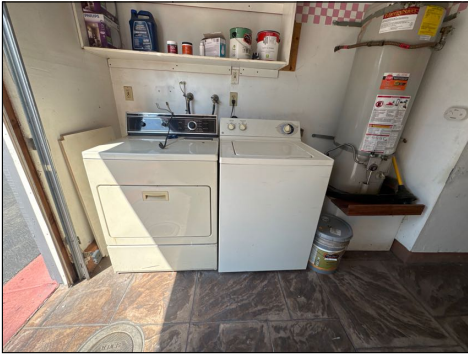
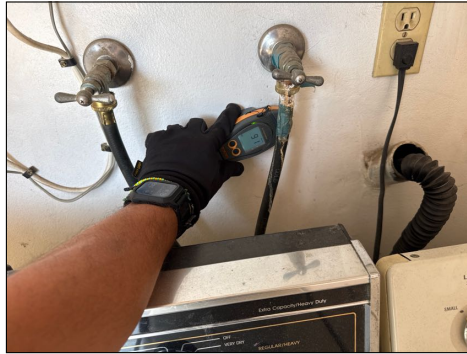
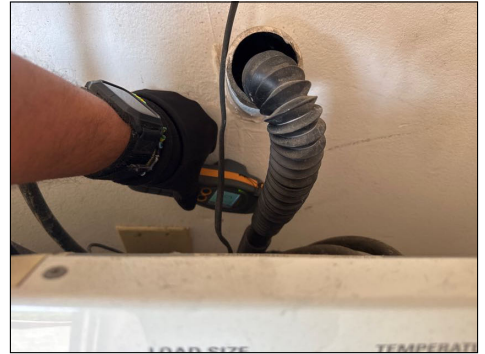
## 2. Wall Conditions

Small cracks/holes/chipped/dirty areas/cosmetic blemishes observed – typical for age of structure • No moisture present when tested with a moisture meter • No visible microbial growth/irregular staining found at the time of the inspection

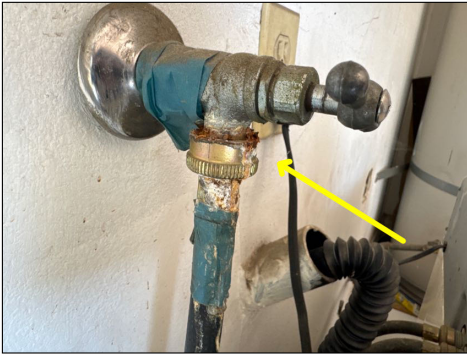
## 4. Plumbing

Angle stops/valves/hoses are worn/older – recommend upgrading these areas with new fixtures • No visible leaks at time of inspection • **Supplies corroded – service recommended**

Supplies corroded – service recommended

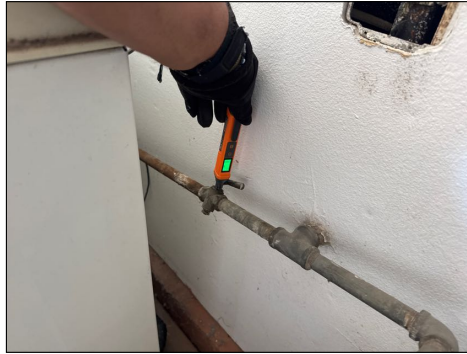
## 5. Gas Valve

The inspector does not check for gas leaks, consult the Gas Company to evaluate all gas areas prior to occupancy • Worn valve – recommend upgrading to newer style valve

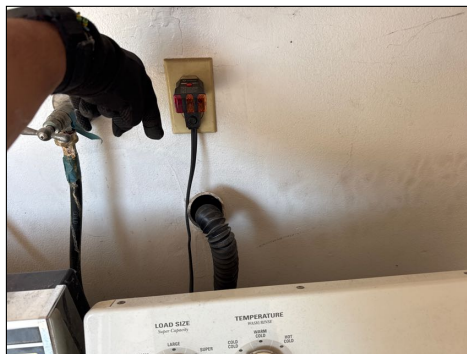
## 7. GFCIs

Recommend upgrading all receptacle to GFCI protection within 6 feet of all potential wet locations, unless the receptacles are on a dedicated circuit for appliances. • None installed recommend upgrade for increased safety

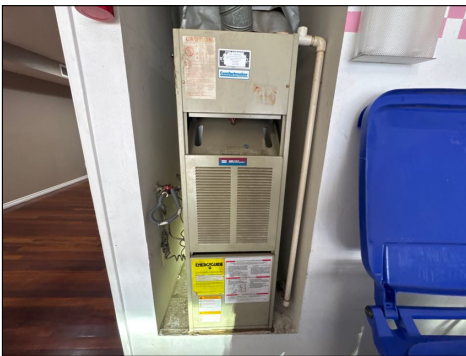
Operated at time of inspection • Unit is old, original and appears to be nearing end of useful life – will likely need replacement soon • Dirty/dusty unit – recommend cleaning/servicing unit prior to regular use

Unit is old, original and appears to be nearing end of useful life – will likely need replacement soon

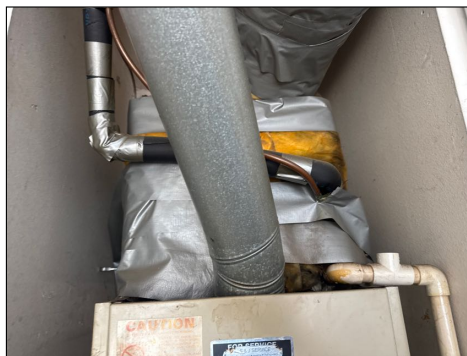
## 2. A/C Evaporator Coil Box

The visible areas of the coil box are worn/dirty and typical for the age of the older unit

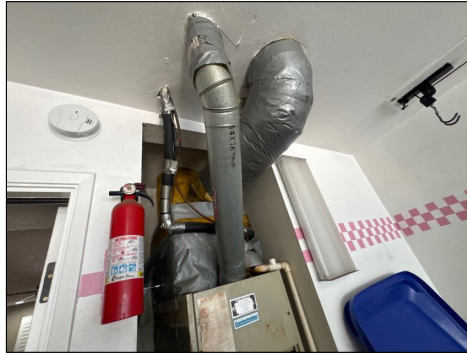
## 3. Venting

The visible areas of the vent are worn/older – typical for the age of the material, recommend upgrading

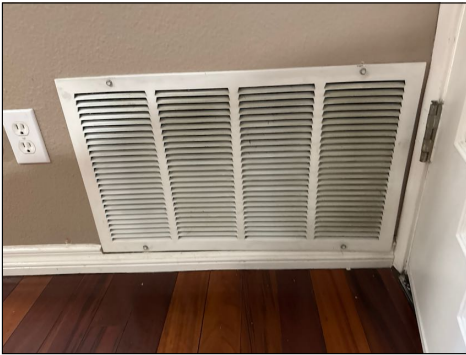
## 4. Air Supply

Recommend seasonal service and maintenance to ensure that all areas are sealed/cleaned/dry and functioning normally at all times • Air return chamber is dirty – recommend cleaning

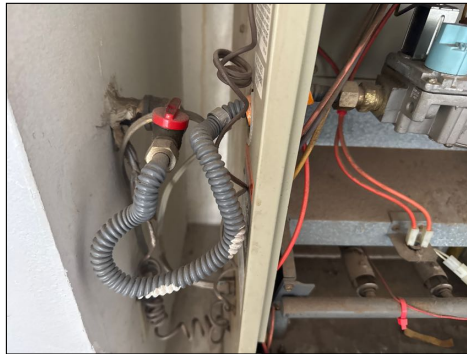
## 5. Gas Supply Valves and Pipes

Worn valve, consider upgrading to newer style valve • Older type of flex line is present – we recommend that you upgrade to a new teflon coated flex line • Flexible connector through sheet metal cabinet – service recommended • No sediment trap at gas supply – may have not been required at time of original installation, but is recommended

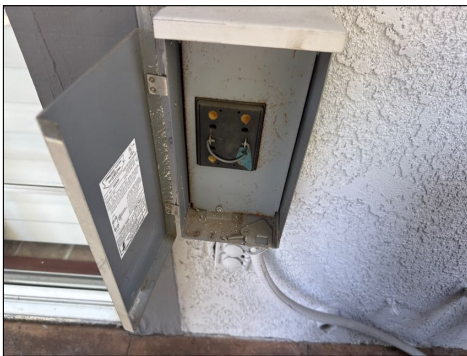
## 6. Electrical

Operating properly at the time of the inspection – no major visible defects • **Improper sized breaker serving outdoor compressor unit – service recommended**

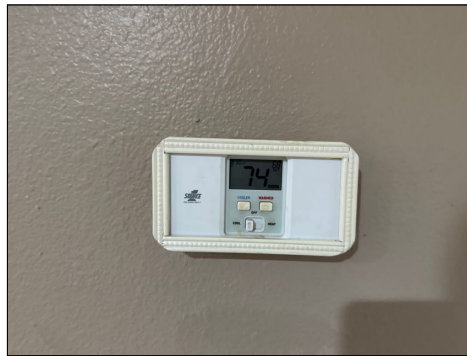
## 7. Thermostats

Digital type present – functional day of the inspection

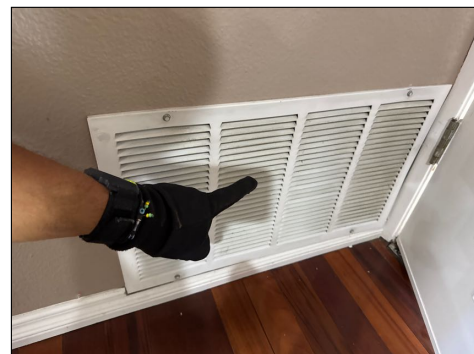
We recommend that the filters be changed or cleaned every 3 to 6 months depending on the usage of the heating and air conditioning systems • Filter is worn/dirty and will likely need changing soon

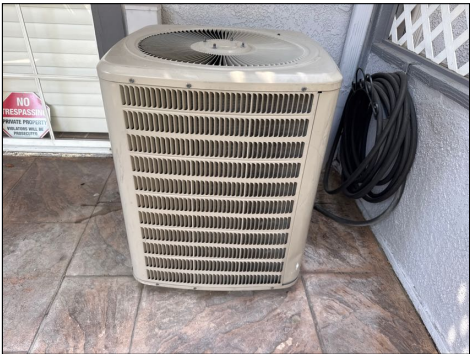
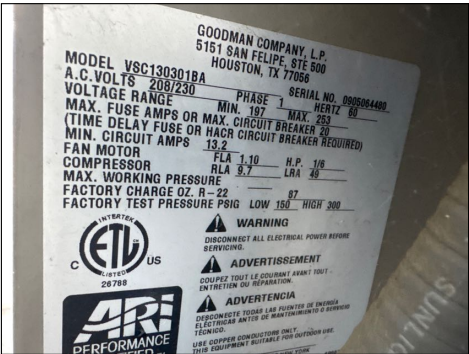
## 13. Air Conditioning Compressors

Operated at the time of inspection • Visible areas of unit are worn and weathered – recommend seasonal service and maintenance to extend the life of the unit • Recommend regular service/maintenance to extend the life of the unit(s)

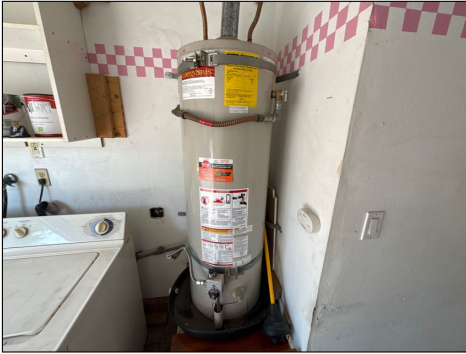
## 1. Water Heaters Condition

Operated at the time of the inspection – Gas unit • **Unit old and appears to be nearing end of useful life – we recommend that you budget for a replacement**

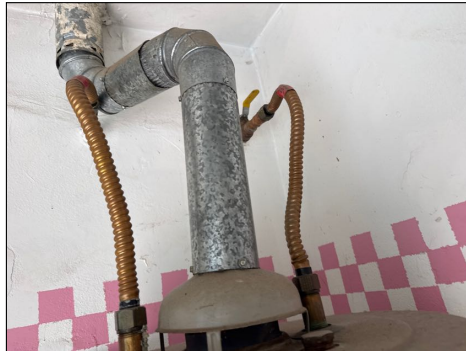
## 2. Venting

Normal wear day of the inspection – no major visible defects • Recommend sealing all connections at venting

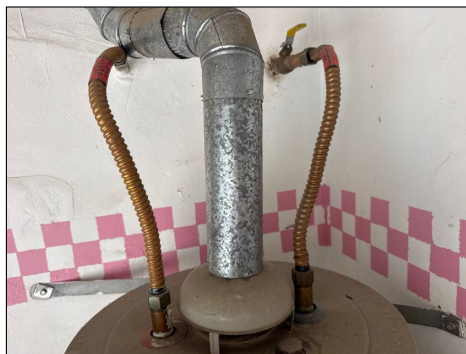
## 3. Plumbing

Worn valve/piping/connections – typical for age – no visible leaks found at the time of the inspection

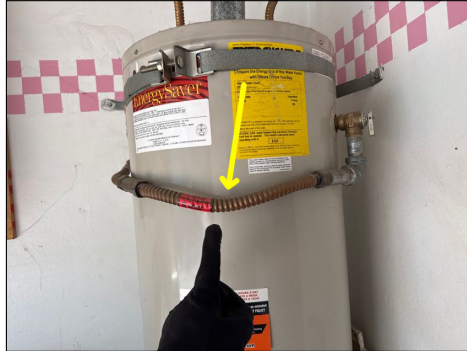
Worn piping – typical for age • **Not properly sloped to drain – service recommended**

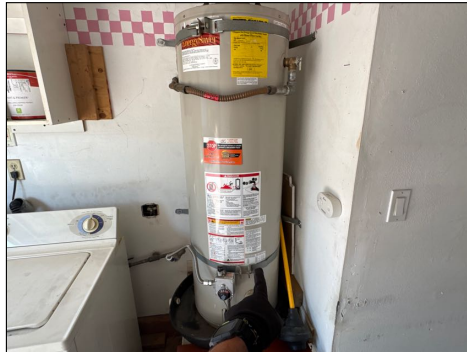
## 7. Strapping

Standard metal type straps present – normal wear on the day of the inspection – no major visible defects • Lower strap too close to gas control valve – minimum 4-inch clear required – service recommended

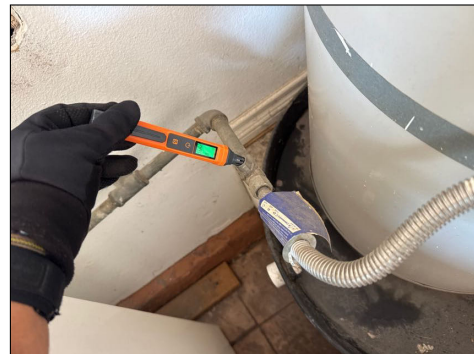
Worn valve, consider upgrading to newer style valve • No sediment trap at gas supply – may have not been required at time of original installation, but is recommended

**No sediment trap at gas supply – may have not been required at time of original installation, but is recommended**      **Worn valve, consider upgrading to newer style valve**

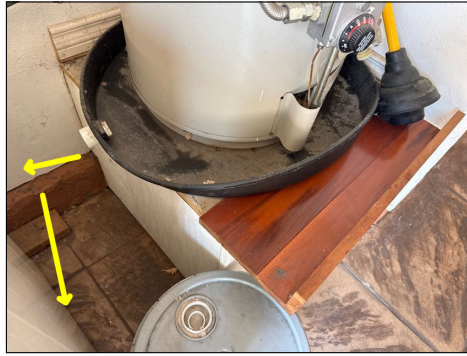
## 10. Platforms/Bases

Worn/dirty – recommend cleaning • Catch pan present – No drain connected to protection pan under water heater – service recommended

**Catch pan present – No drain connected to protection pan under water heater – service recommended**

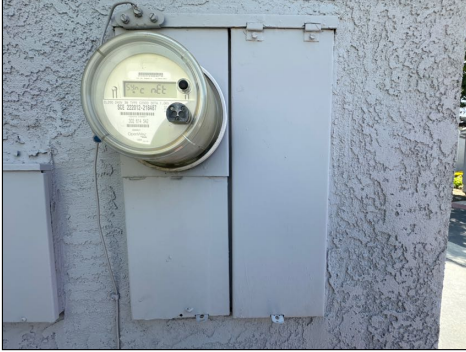
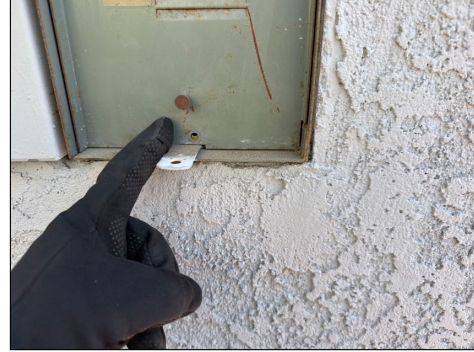
Worn/weathered panel – typical for age and weather exposure

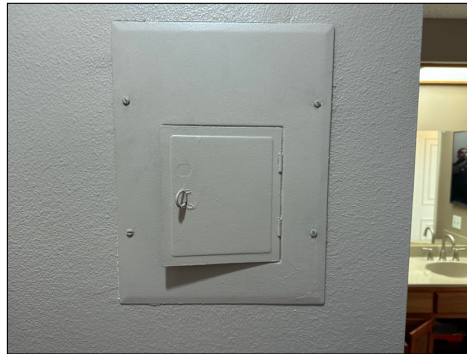
## 2. Sub Panels

Worn/older panel present – typical condition for age

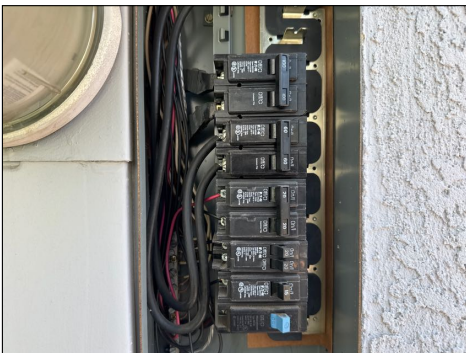
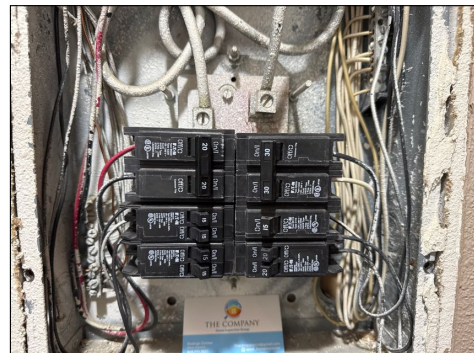
## 3. Panel Wiring

Wiring type: copper and multi-strand aluminum at 240-Volt circuits • Wiring method: non-metallic sheathed cable (romex) • Grounded panel – main ground/bonding wire observed and appears to be normal for the age of the panel • Visible wiring has normal wear for age with no major visible defects at the time of the inspection

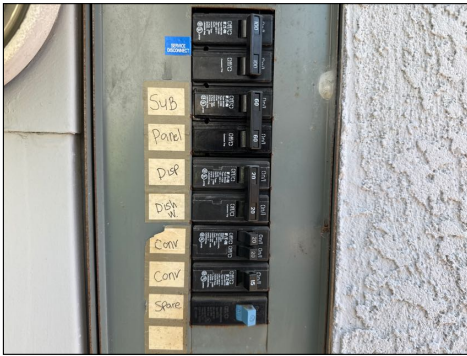
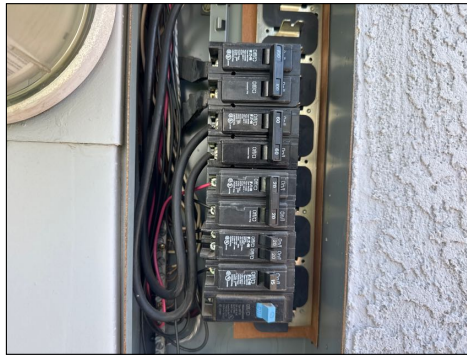
## 4. Breakers

Number of breakers in off position: • Number of unused breakers: • Labels are present on panel cover – the inspector does not check for accuracy of labels • Loose/worn breakers – typical for age

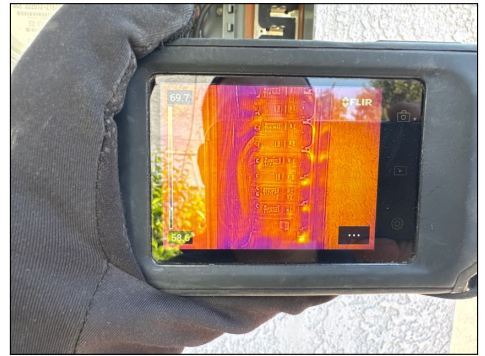
**Thermal Image View – Normal temperature readings with no visible signs of overheating at time of inspection**

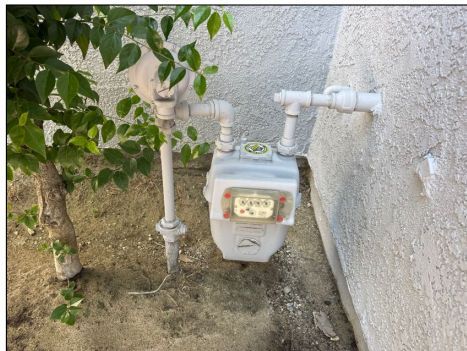
- Worn valve – typical for age • Recommend gas valve wrench be placed near valve for optimal preparedness • Minor rusting – typical for exterior weathering – recommend rust treatment • No seismic safety valve present – recommend installation for increased safety

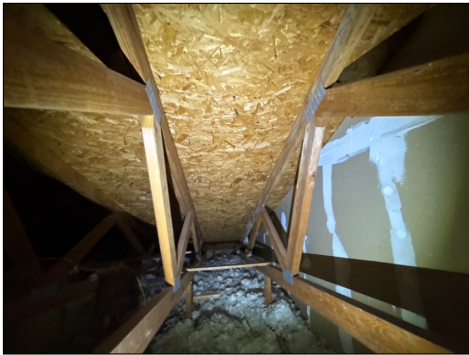
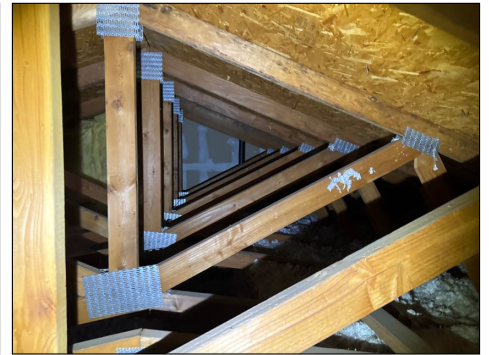
Conventional framing present, normal wear at time of inspection – no major visible defects • Cracking small at wood members – typical for age

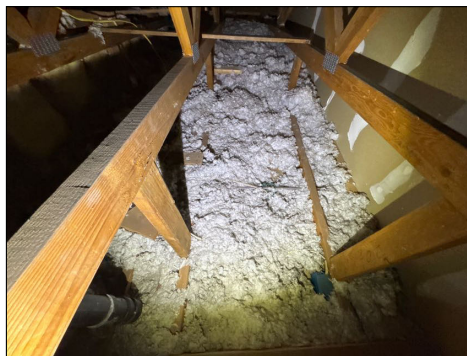
## 3. Insulation

**Material type:** Loose fill

**Approximate depth:** 8-10 inches

No visible signs of rodents at this inspection – we recommend pest services seasonally as needed • All visible insulation is worn/older/dirty – typical for the age of the structure

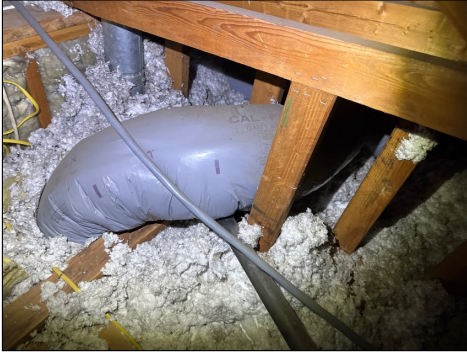
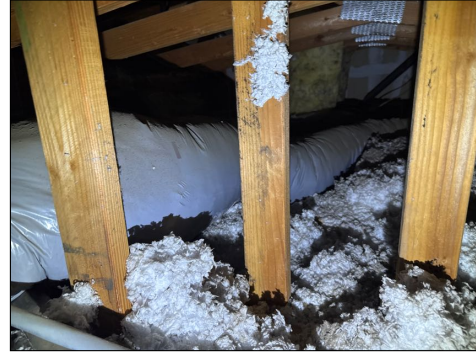
## 7. Duct Work

Older/worn ducts present – recommend routine maintenance and cleaning to extend the life of the existing ducts • Some areas not visible due to access hindrances or limitations

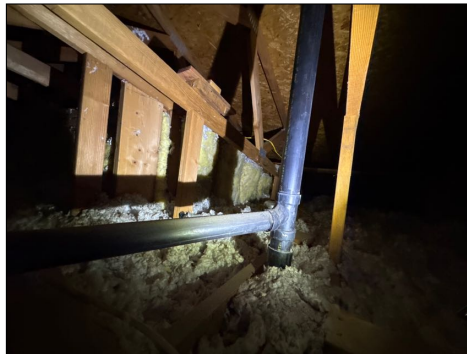
## 9. Plumbing

Vents only – no other plumbing/piping is visible for inspection

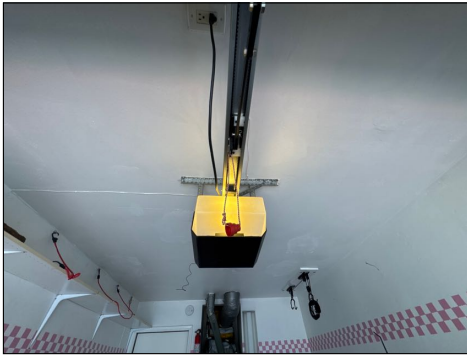
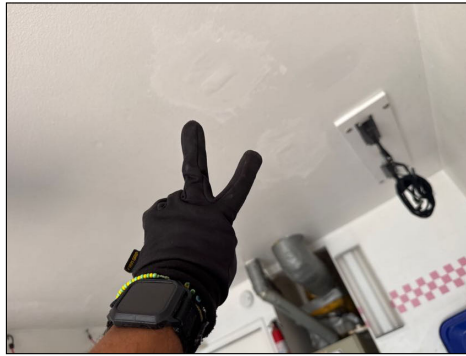
## 2. Rafters & Ceilings

Drywall present – no visible access to view rafters (see firewall notes for additional information) • Patched areas observed – inquire with seller regarding reason for repairs • **Evidence of a plumbing leak from above – tested positive for moisture at time of inspection – recommend further evaluation**

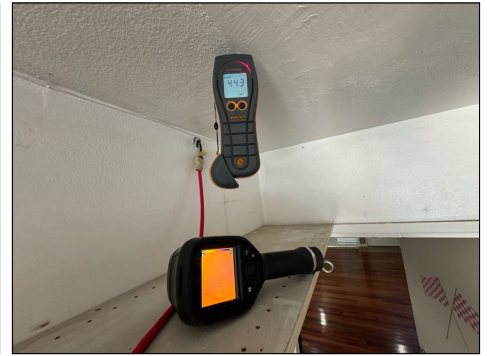
**Evidence of a plumbing leak from above – tested positive for moisture at time of inspection – recommend further evaluation**

| <b>Interior</b> | | |
|---|---|---|
| Page 42 Item: 2 | Rafters & Ceilings | • Evidence of a plumbing leak from above – tested positive for moisture at time of inspection – recommend further evaluation |

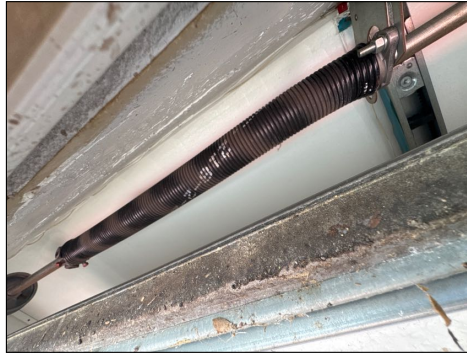
## 4. Hardware/Springs

Garage doors require periodic maintenance and is recommended to ensure that all hardware is properly lubricated and secured • Normal wear at time of inspection – no major visible defects

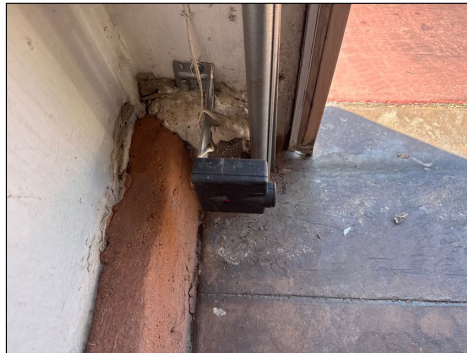
## 6. Garage Doors Reverse Safety Status

Light beam was tested; the inspector interrupted the beam during closing, the door stopped and reversed back open on the day of the inspection

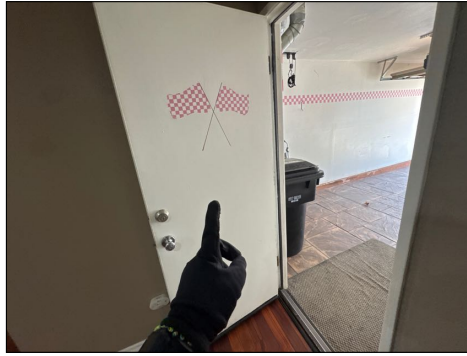
## 7. Fire Doors

Normal wear at time of inspection – no major visible defects • Maintain air tight seals at all times • **Door did not properly self-close and latch – service recommended**

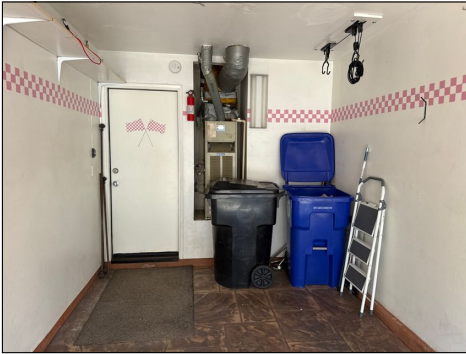
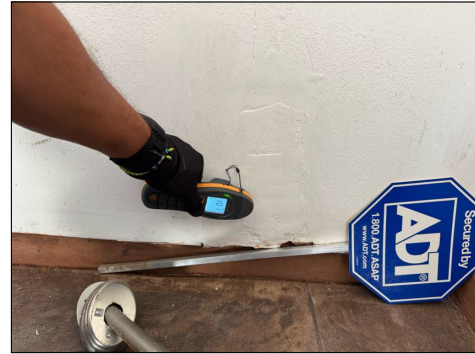
## 8. Firewalls

Small cracks/holes/chipped/dirty areas/cosmetic blemishes observed – typical for age of structure • Recommend sealing any holes/gaps/cracks/loose tape – all areas of the firewall should be properly sealed with the correct fire-rated materials • Patched areas – consult seller for past repairs • No moisture present when tested with a moisture meter • No visible microbial growth/irregular staining found at the time of the inspection

**No moisture present when tested with a moisture meter**

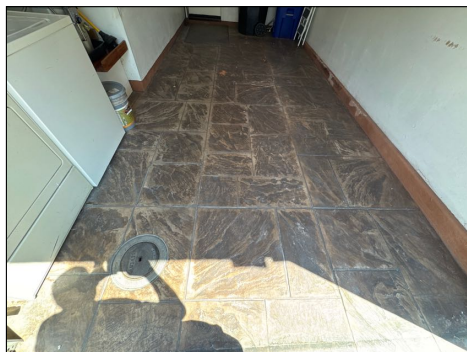
## 11. Slab

Small cracks/chipped areas – typical for the age of the materials

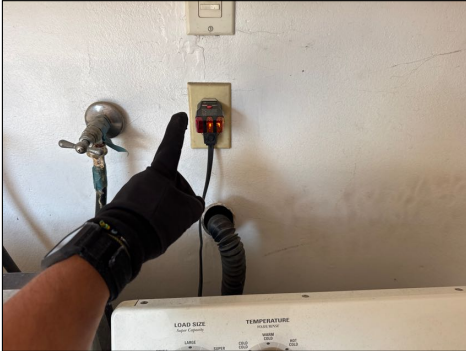
## 12. Electrical

A representative number of receptacles and switches were tested and found to be operational at time of inspection • Loose/worn outlets/switches – typical for age consider upgrading • Loose outlets – service recommended • **Outlet hot wired in reverse with neutral – service recommended**
