# THE COMPANY

Home Inspection Group

8275 Sutterhome Pl, Rancho Cucamonga, CA 91730

Date of Inspection: 9/13/2025 Time: 1:00 PM

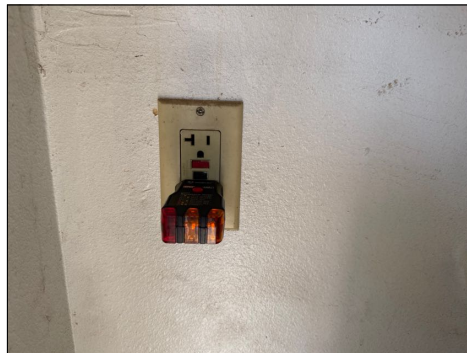
## 13. GFCIs

Recommend upgrading all accessible receptacles below 8 feet to GFCI protection within 6 feet of all potential wet locations or where potential ungrounded power tools could be used, unless these outlets are on dedicated circuits meant for appliances. • Tested and operational at time of inspection via normal control

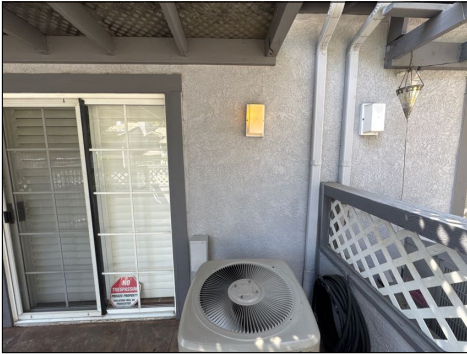
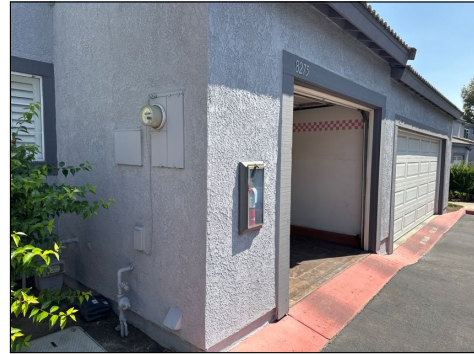
- Recommend sealing any holes/gaps or cracks to prevent moisture or pest entry • Stucco requires periodic seasonal maintenance, consult an exterior finish contractor for maintenance tips/schedules/suggestions

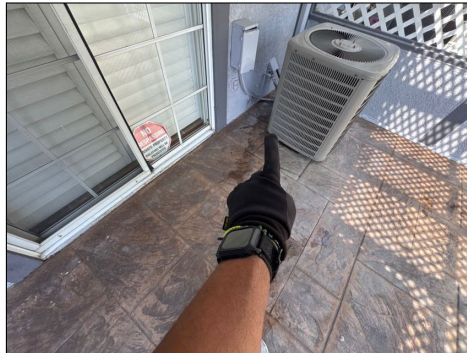
Worn/weathered areas – typical for the age

- Weep screeds encapsulated in concrete – service recommended

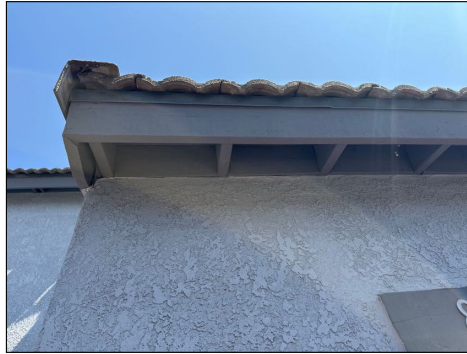
## 4. Eaves & Fascia

Common area – consult Home Owner's Association • Consult the Termite Report for all wood areas at the structure

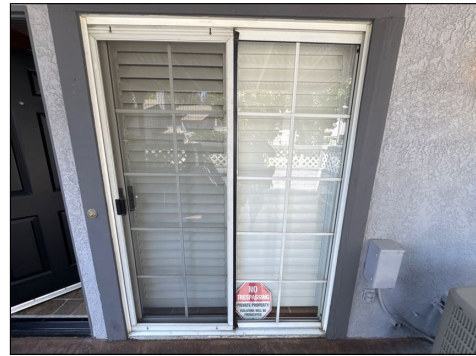
## 6. Exterior Doors

Exterior doors require seasonal maintenance to extend lifespan and maintain weather tight seals • See interior section for more information • All visible and accessible doors were tested during this inspection • Worn/weathered – recommend weather tight service/maintenance • Maintain weather tight seals at all doors

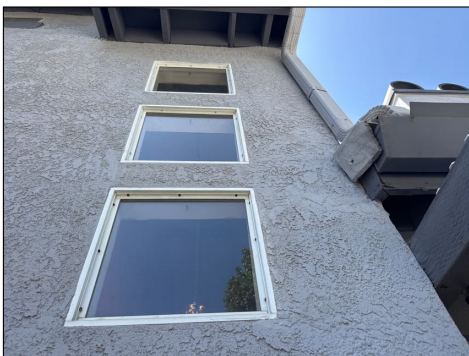
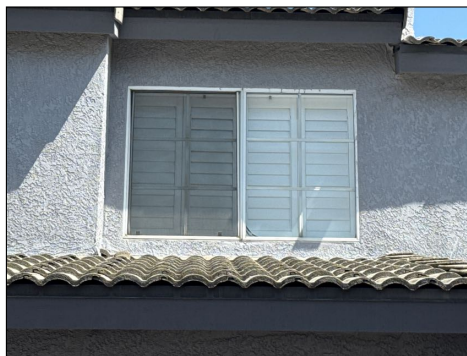
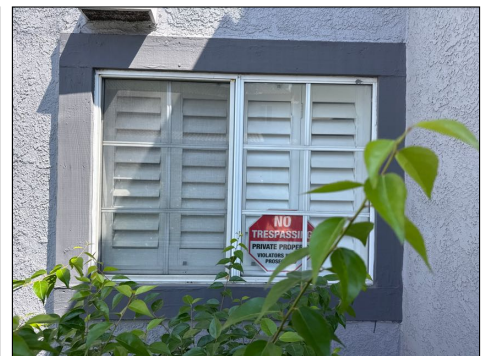
## 7. Exterior Windows

Exterior windows require seasonal maintenance to extend lifespan and maintain weather tight seals • See interior section for additional information – some exterior window areas may not be visible due to height/limited access/vegetation/etc. • Worn windows/screens – typical for age • Recommend weather tight service/maintenance

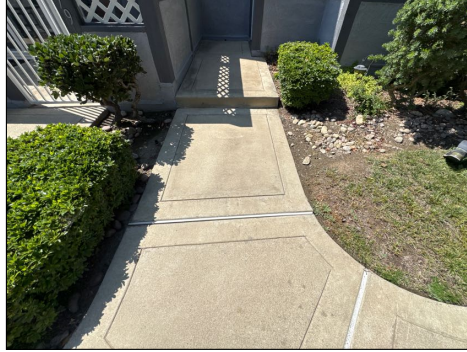
Common area – likely maintained by Home Owner's Association – not inspected – consult HOA • Worn with common cracks/chips – typical for age of material

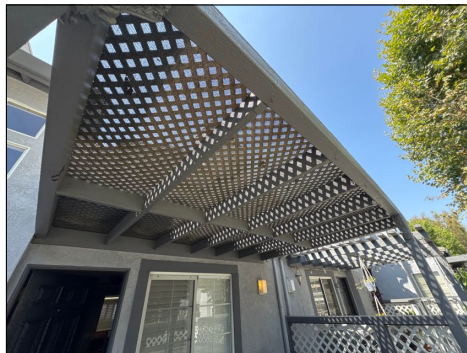
## 2. Patio and Porch Roofs

**Constructed of:** Shade type wood

Normal wear at time of inspection – no major visible defects • Consult the Termite Report for all exterior wood conditions

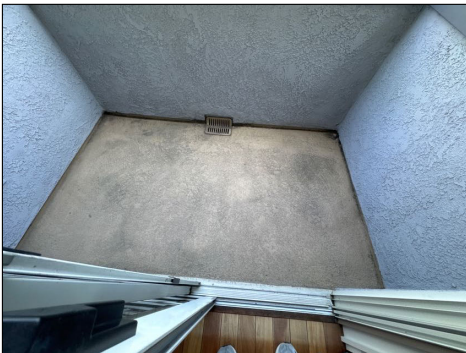
## 3. Balconies

Stained/small cracks and worn – will require re – waterproofing in the near future

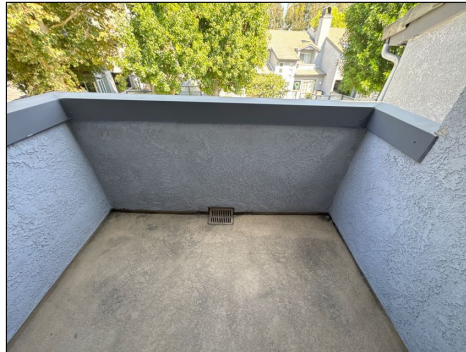
## 4. Balcony and Deck Railing

Common area – likely maintained by Home Owner's Association – consult HOA • Normal wear on the day of the inspection – no major visible defects

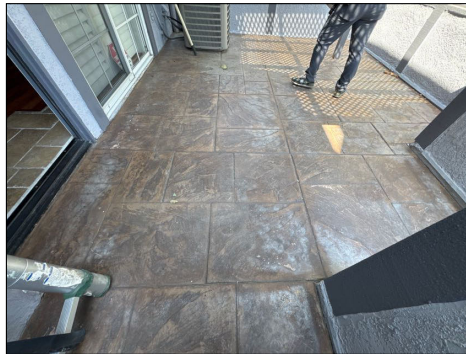
## 5. Patio and Porch Decks

Worn with common cracks/chips – typical for age of material

- Recommend grout and sealer maintenance on all exterior tile/stone areas

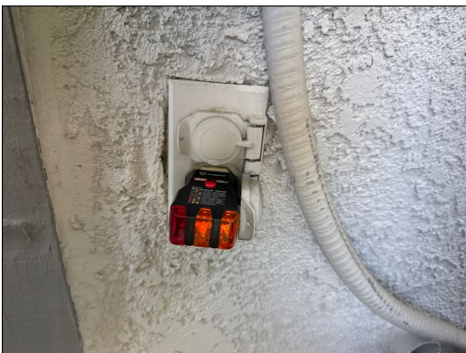
## 6. Exterior Electrical

Accessible lights/switches/outlets were tested on the day of the inspection

- The visible and tested fixtures/switches/outlets were in a loose/worn condition – typical for age
- Electrical fixtures need to be caulked/sealed to wall attachments to help prevent moisture entry

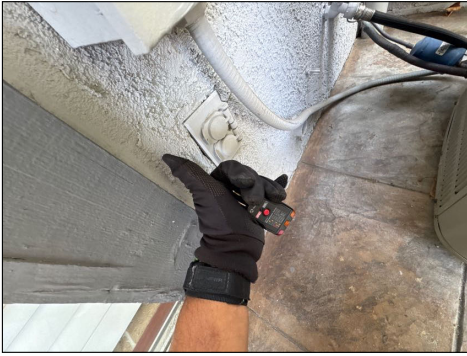
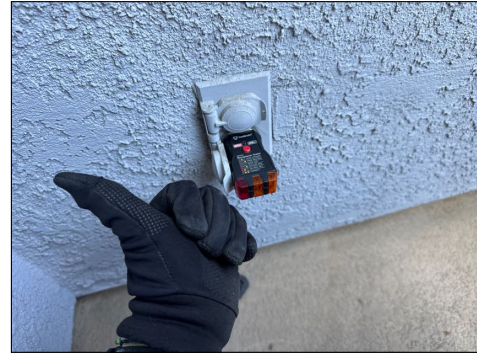
## 7. GFCIs

Standard outlets present with GFCI labeled stickers – Inspector cannot test standard outlets for GFCI nor can the inspector trace outlet link to GFCI – consult the seller where master GFCI is located.

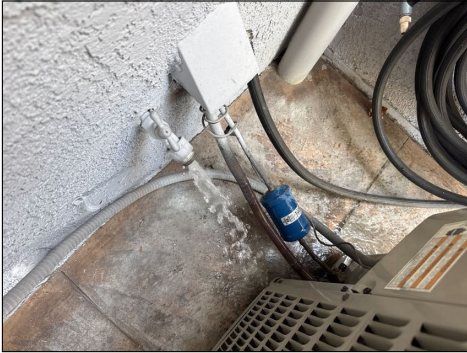
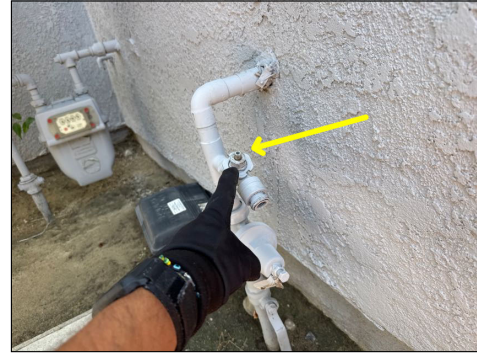
## 8. Exterior Plumbing and Faucets

Accessible exterior faucets operated/worn at time of inspection via normal fixture controls

- Hose bibb missing handle – service recommended
- We recommend adding anti-siphon/backflow preventers (if not already present) on all exterior hose bibs for optimum potable water protection

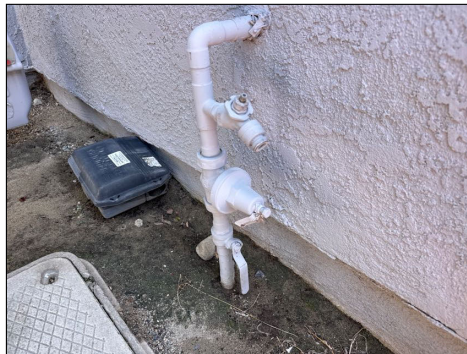
## 9. Main Water Valve

**Type of plumbing:** Copper 100% (approximate)

No visible leaking found at the main valve area at the time of the inspection • Main ball valve is worn – typical for age

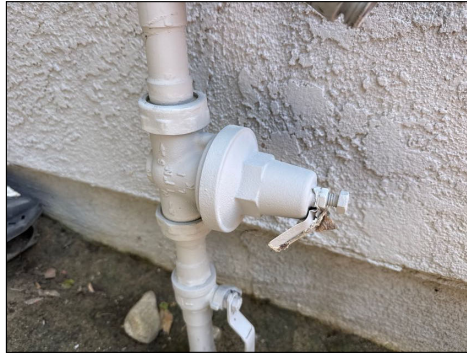
## 11. Pressure Regulator

None installed – a pressure regulator is recommended to allow for water pressure adjustments as needed

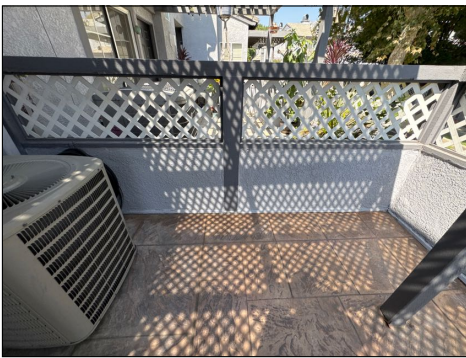
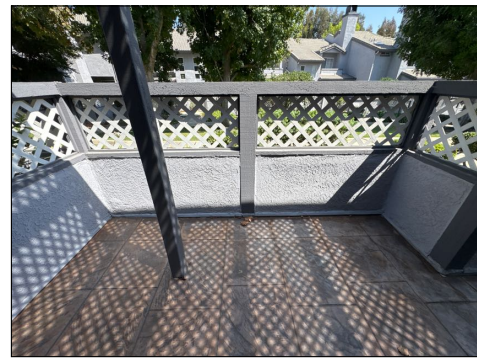
## 12. Fencing and Walls

Common area – likely maintained by Home Owner's Association – consult HOA • Visible fencing/wall areas are worn and weathered – typical for the age of the materials

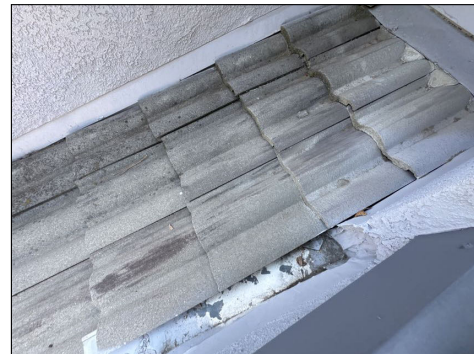
## 1. Condition

**Constructed of:** Concrete tile

Common area/roof – Maintained by Homeowner's Association – Not Inspected

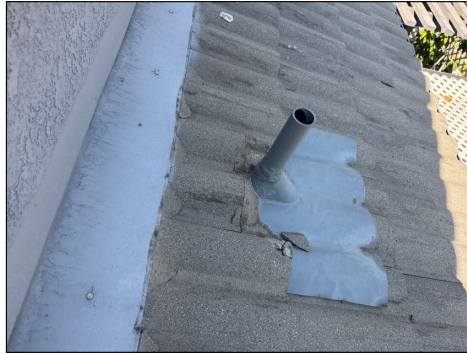
## 4. Vents and Vent Caps

Common area/roof – Maintained by Homeowner's Association – Not Inspected
