# WOOD DESTROYING PESTS AND ORGANISMS INSPECTION REPORT

Building No. 426	Street Weymouth Way	City Chico	ZIP 95973	Date of Inspection 02/20/2025	Number of Pages 4
---------------------	------------------------	---------------	--------------	----------------------------------	----------------------

Report # : 42414

GENERAL DESCRIPTION: Single family residence; furnished, attached garage	Inspection Tag Posted: Garage
	Other Tags Posted: None noted

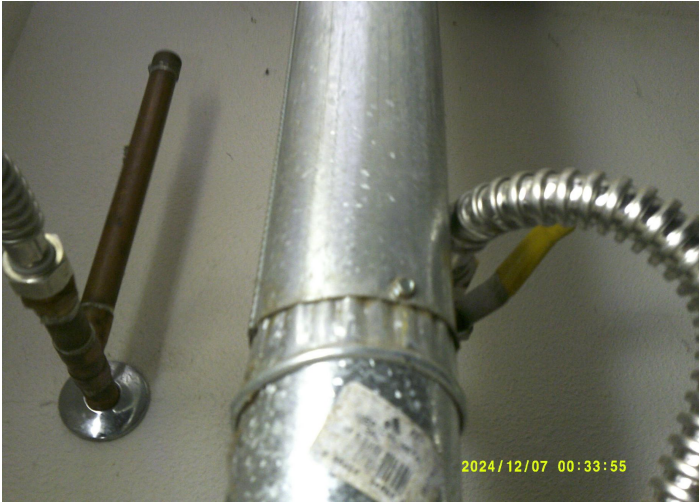
8A

FINDING: Stains were noted at the water heater vent pipe.

RECOMMENDATION: The owner should engage the services of a licensed contractor to check for leaks and make repairs as needed.

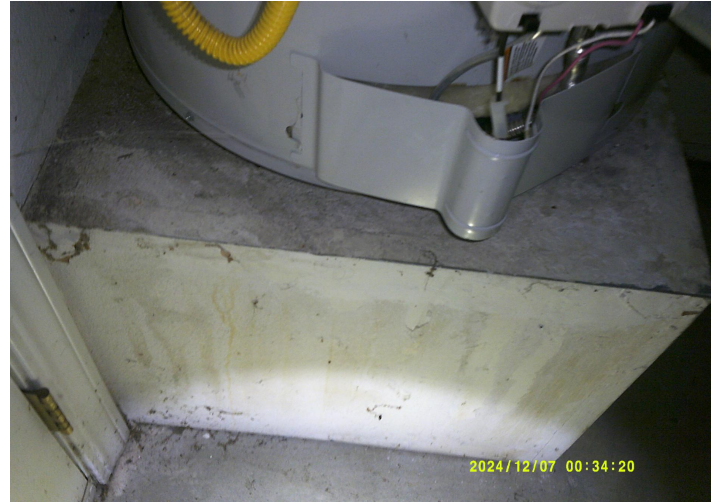
8B

FINDING: Stains were noted at the water heater platform and adjacent walls. Unable to determine if stains are active or passive.

RECOMMENDATION: Interested parties should engage the services of a licensed plumber to check for leaks and to perform any corrective work needed.

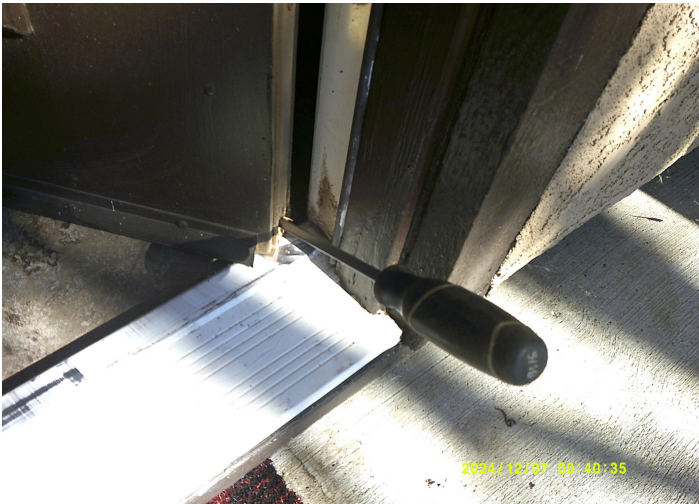
11A

FINDING: Fungus damage noted at the front door jambs and trim. Damage may extend into inaccessible areas.

RECOMMENDATION: Remove the fungus damaged portions of the door jambs and trim. Call for a reinspection of the inaccessible areas. The inaccessible areas will be inspected for a fee if made accessible by the interested parties at his/her expense. A supplemental report will be filed at such time. No opinion is rendered concerning the conditions in the area at this time. Replace with new material.

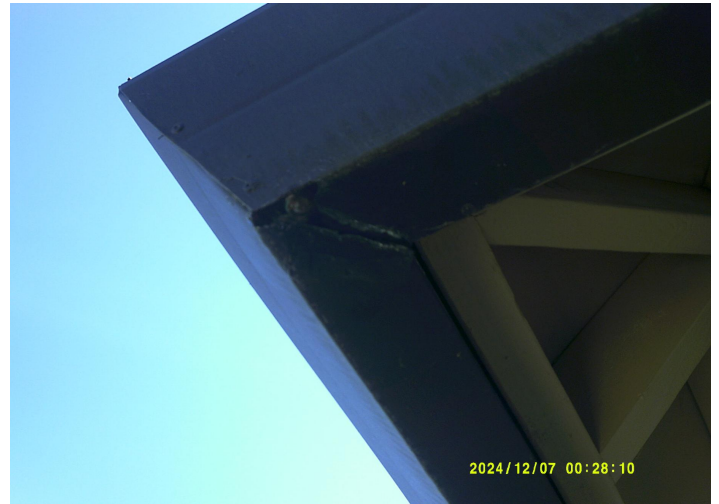
11B

FINDING: Leaking gutter seams were noted.

RECOMMENDATION: Seal the leaking gutter seams as needed to help prevent moisture-related problems in this area.
