WOOD DESTROYING PESTS AND ORGANISMS INSPECTION REPORT

| Building No. 6743 | Street County Road 19 | City Orland | ZIP 95963 | Date of Inspection 02/10/2023 | Number of Pages 3 |

| GENERAL DESCRIPTION: One story wood frame single family dwelling with a detached shop. | Inspection Tag Posted: Garage |

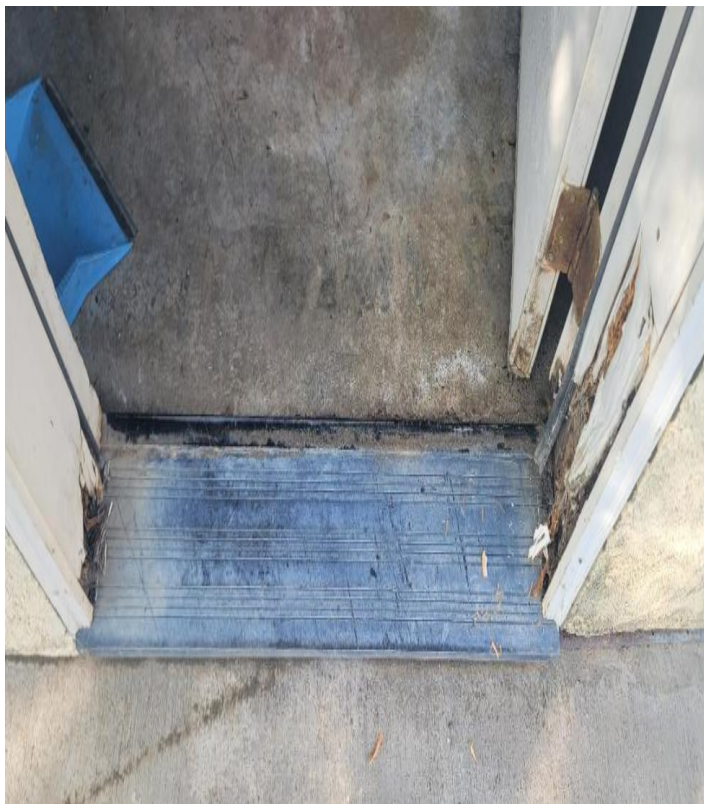
3B - Section I

FINDING: Fungus damage was found to the side door, door jambs, trim and frame on the detached shop.

3B - Damaged door, door jambs, frame and trim on the detached shop.

RECOMMENDATION: Remove the damaged door, jambs, trim and frame and replace with new material. Prime paint only. Re-use existing hardware.

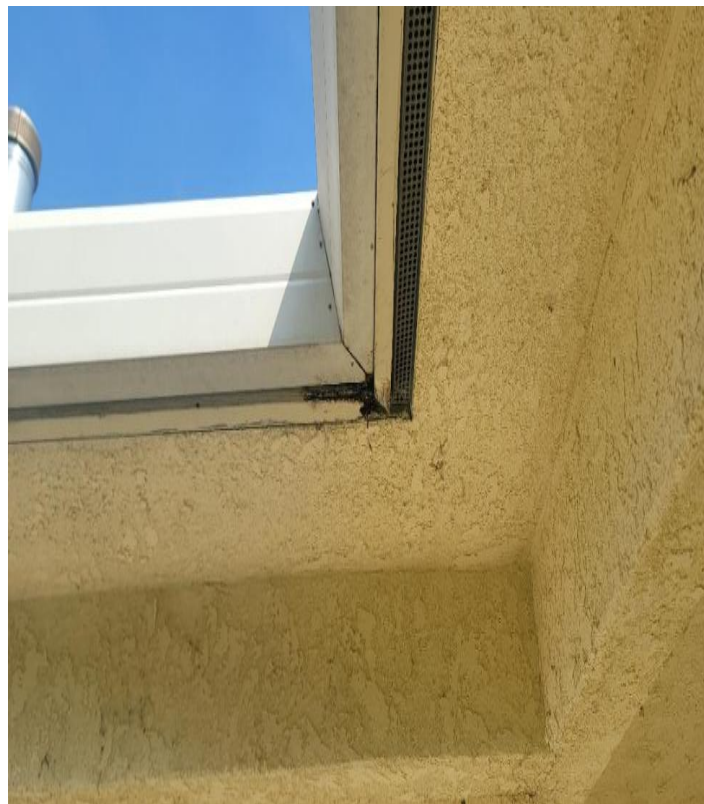
3C - Section I

FINDING: Fungus damage was found to roof fascia from leaking gutters. Several of the gutters around the structure were leaking and the wood members were stained.

3C - Damaged roof fascia from leaking gutters.

RECOMMENDATION: We recommend the owner/agent engage the services of a licensed roofing contractor to remove all damaged members and to replace with new appropriate material. Seal all gutters as needed.
