SUMMARY
6133 Centralia St, Lakewood, CA
90713
Debbie Moon
07/15/2024

Eric Harmon
NACHI-20061602
Crosswind Home inspection
7145149681
eric@crosswindhomeinspection.com

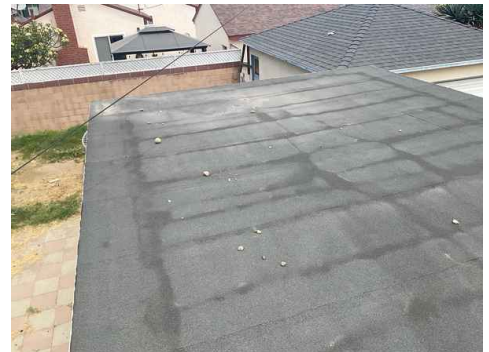
2.1.1 Roof Covering
PONDING

I observed indications of ponding in one or more areas of roof. Ponding or puddling of water concentrated in a particular area of the roof can lead to the deterioration and the roof leaking water. Recommend a qualified roofing contractor evaluate further and make any repairs deemed necessary.

Recommendation
Contact a qualified roofing professional.

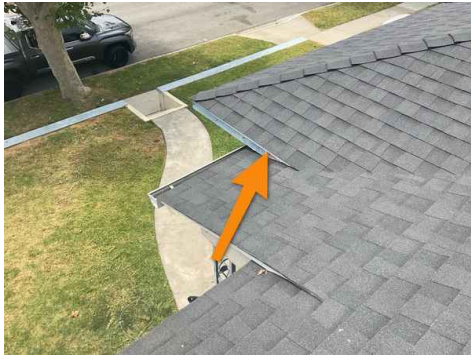
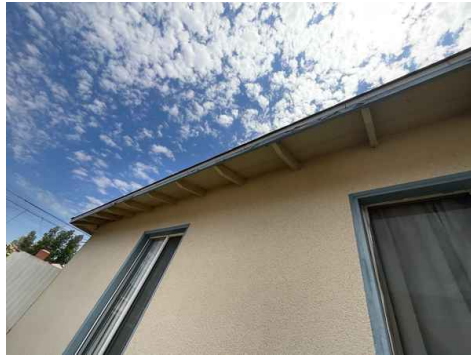
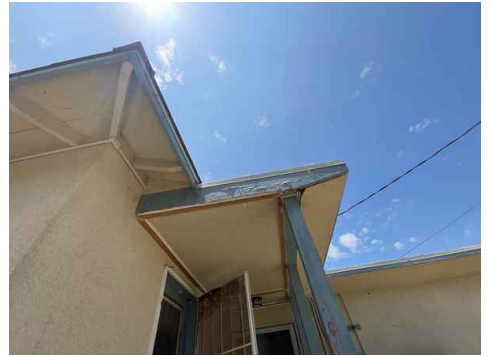
3.2.1 Eaves, Soffits & Fascia

PAINT SURFACE IN POOR CONDITION

I observed indications of paint or staining in poor condition. Flaking, cracking, and worn areas.

Correction and further evaluation is recommended.

Contact a qualified painting contractor.

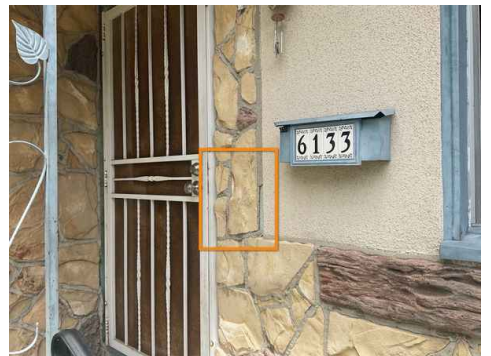
3.3.1 Wall-Covering, Flashing & Trim

DAMAGED WALL-COVERING MATERIAL

I observed indications of a defect at the exterior wall-covering material.

Correction and further evaluation is recommended.

Contact a qualified professional.

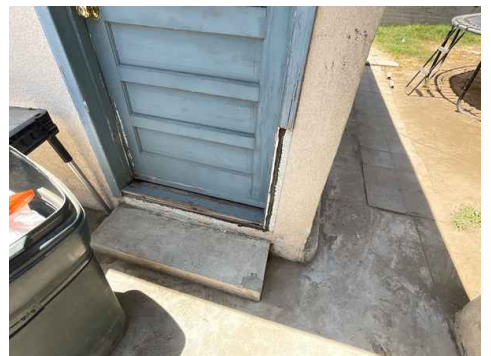
3.3.3 Wall-Covering, Flashing & Trim

MISSING EXTERIOR TRIM

I noted missing trim pieces in one or more locations around the exterior. missing trim pieces could lead to possible moisture intrusion over time. Recommend having a qualified contractor correct the deficiency.

Contact a qualified professional.

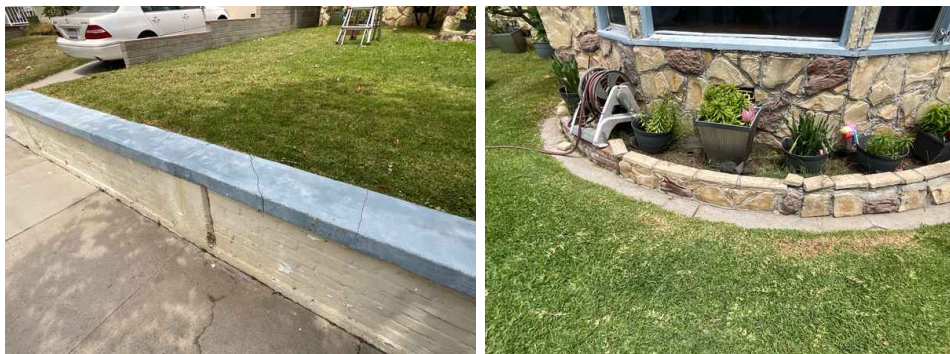
3.4.1 Vegetation, Surface Drainage, Retaining Walls & Grading

RETAINING WALL DAMAGE

I observed indication of damage at the retaining wall.

Correction and further evaluation is recommended.

Contact a qualified landscaping contractor

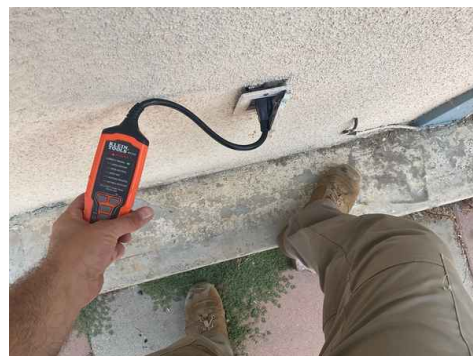
3.5.1 GFCIs & Electrical

GFCI DEFECT-WOULD NOT TRIP WHEN TESTED

I observed indications of a defect at a GFCI. The GFCI would not trip when tested, I recommend contacting a licensed electrician to repair.

Contact a qualified electrical contractor.

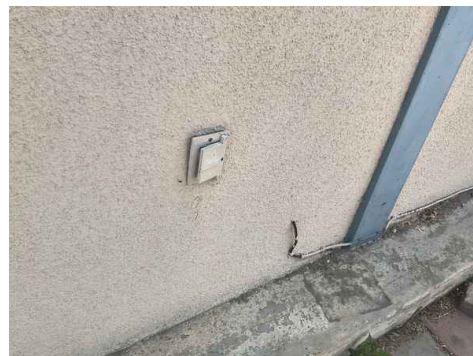
3.5.2 GFCIs & Electrical

LOOSE EXTERIOR RECEPTACLE

I observed a loose exterior receptacle. recommend securing.

Recommended DIY Project

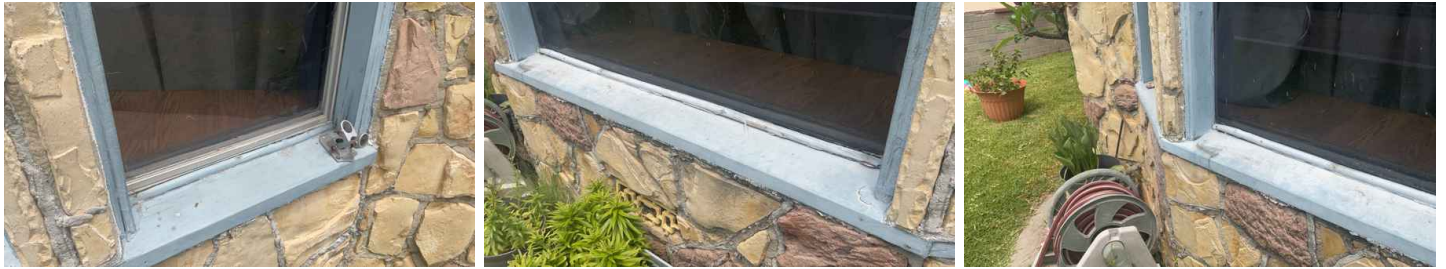
3.10.3 Windows

WOOD ROT AT WINDOW

I observed indications of wood rot at the window.

Correction and further evaluation is recommended.

Contact a qualified handyman.

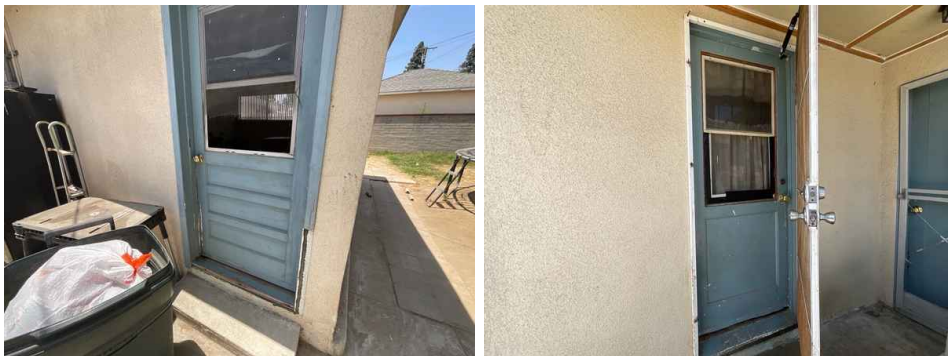
3.11.1 Exterior Doors

EXTERIOR DOOR DAMAGED

I noted some damage to an exterior door, recommend repair.

Contact a qualified professional.

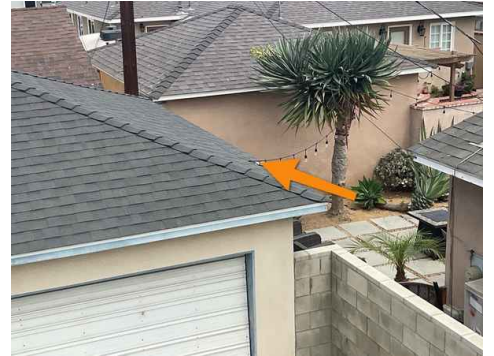
4.1.1 Roof Covering

EXPOSED FASTENERS

I observed indications of exposed fasteners at the roof-covering materials. Fasteners should not be exposed. Potential water entry points. Roof could leak. Further evaluation and correction is recommended.

Contact a qualified roofing professional.

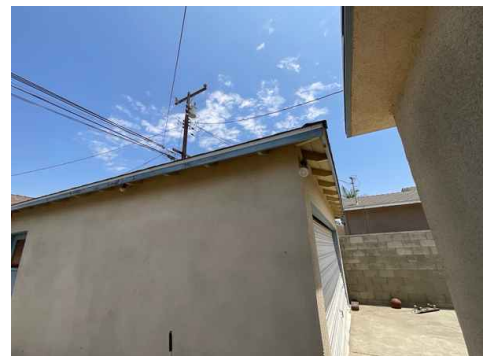
4.3.1 Gutters & Downspouts

GUTTERS MISSING

Gutters are necessary to properly collect rain water from the roof, control it, divert it, and discharge that water away from the house and its foundation. A missing gutter is a defect. This is a defect that should be corrected by a professional contractor.

Contact a qualified gutter contractor

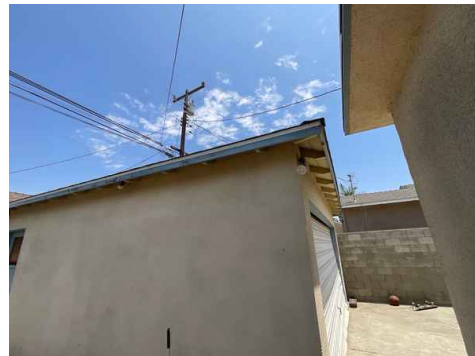
4.4.1 Eaves, Soffits & Fascia

PAINT SURFACE IN POOR CONDITION

I observed indications of paint or staining in poor condition. Flaking, cracking, and worn areas.

Correction and further evaluation is recommended.

Contact a qualified painting contractor.

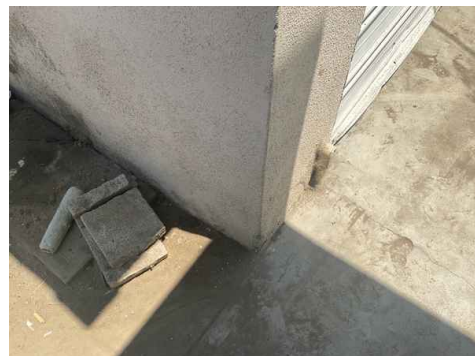
4.5.1 Wall-Covering, Flashing & Trim

DAMAGED WALL-COVERING MATERIAL

I observed indications of a defect at the exterior wall-covering material.

Correction and further evaluation is recommended.

Contact a qualified professional.

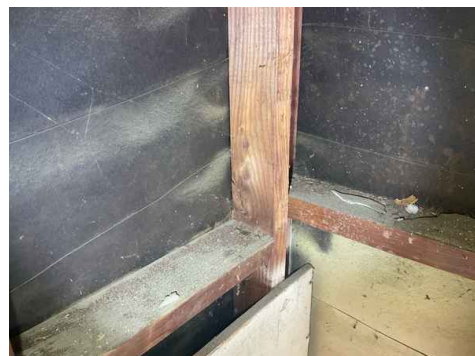
4.6.1 Ceiling & Walls in Garage

POSSIBLE WDO DAMAGE

I noted what appeared to be damage caused by wood destroying organisms, I recommend further review by a pest control contractor.

Contact a qualified professional.

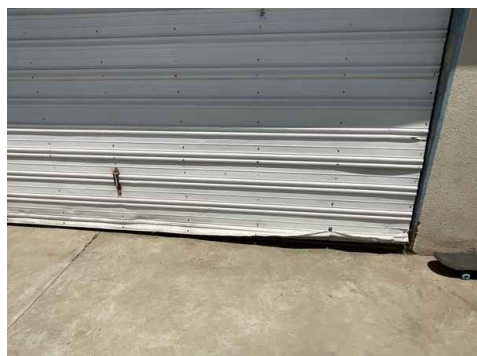
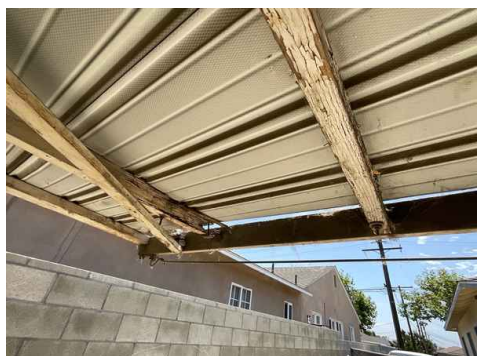
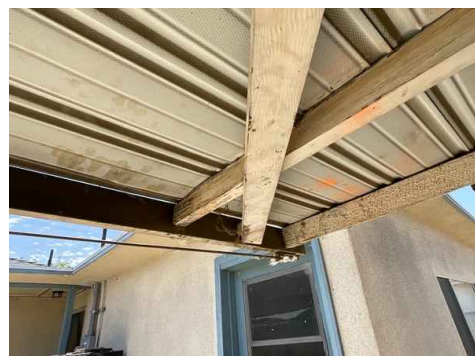
4.9.1 Garage Vehicle Door Opener

DEFECT AT DOOR PANEL

I observed indications of a defect at the garage door panel.

Contact a qualified garage door contractor.

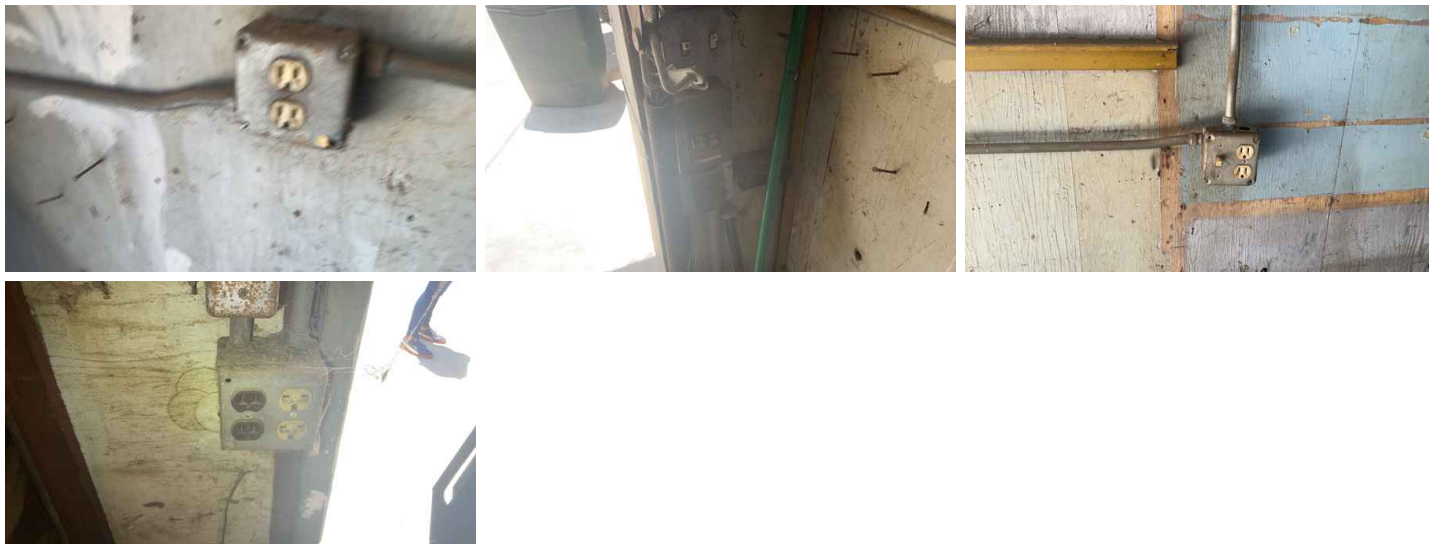
4.10.1 Electric in the Garage

MISSING GFCI-PROTECTION IN GARAGE

I observed a receptacle in the attached garage without GFCI (or ground fault circuit interrupter) protection.

GFCI protection is required for all 15- and 20-amp receptacles, including outlets for refrigerators, garage door openers, and washing machines.

Contact a qualified electrical contractor.

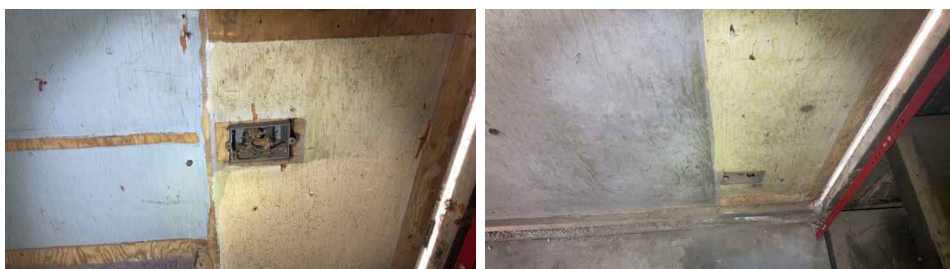
4.10.2 Electric in the Garage

MISSING RECEPTACLE COVER PLATE

I observed a receptacle that was missing its cover plate, this is a shock hazard. Recommend correction.

Contact a qualified electrical contractor.

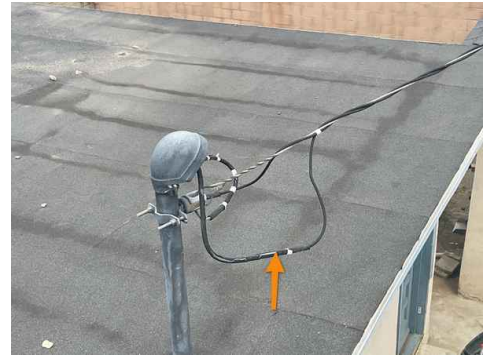
5.1.1 Service Head, Gooseneck & Drip Loops

SERVICE ENTRANCE CONDUCTOR SHEATHING DETERIORATING

I noted the outermost layer of the service entrance conductor sheathing has deteriorated from sunlight. While not a huge deal right now, may, eventually turn into an issue down the road. I recommend further investigation by an electrician.

Contact a qualified electrical contractor.

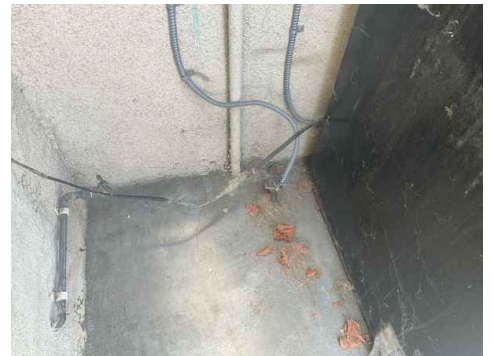
5.6.1 Service Grounding & Bonding

GROUND ROD NOT FLUSH

I observed indications that the grounding rod is not flush with or below grade level.

Contact a qualified electrical contractor.

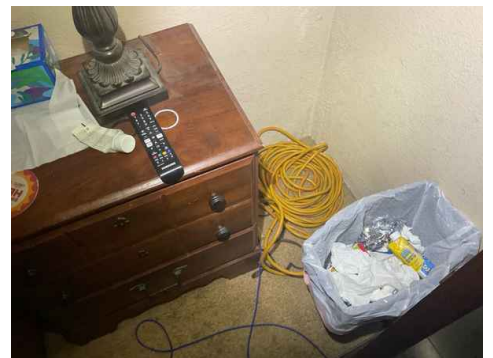
5.9.1 Electrical Defects

EXTENSION CORD USED AS PERMANENT WIRING

I noted an extension cord that was being used as permanent wiring.

Contact a qualified professional.

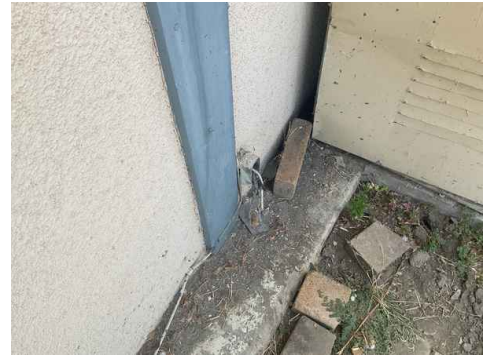
5.9.2 Electrical Defects

EXPOSED WIRING

I noted exposed wires, recommend further evaluation and correction by a licensed electrician.

Contact a qualified professional.

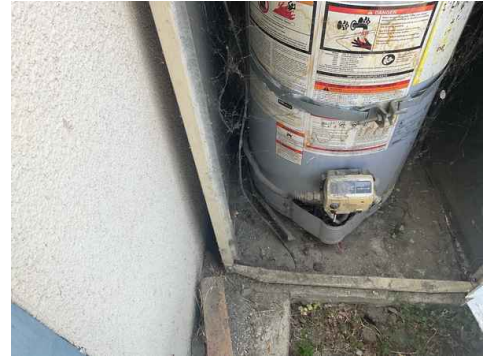
6.4.1 Hot Water Source

MISSING SEDEMENT TRAP

The gas feed line should have a sediment trap before the shutoff valve, recommend correction by a licensed plumber.

**Sediment Trap**

Contact a qualified professional.

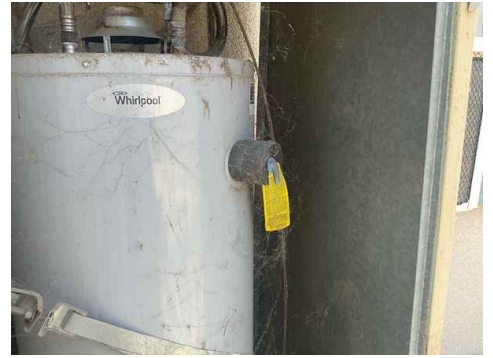
6.4.2 Hot Water Source

DEFECT AT TPR VALVE DISCHARGE

I observed a defect at the TPR (temperature, pressure, and relief) valve. The discharge pipe that serves a temperature pressure relief valve must:

- Not be connected to the drainage system.
- Discharge through an air gap located in the same room as the water heater.
- Not be smaller than the diameter of the outlet of the valve.
- Serve a single relief device.
- Discharge to the floor.
- Discharge in a manner that does not cause personal injury or structural damage.
- Discharge to a termination point that is readily observable.
- Not be trapped.
- Be installed so as to flow by gravity.
- Terminate no more than 6 inches above the floor or flood level rim of the waste receptor. And not less than 2 times the discharge pipe diameter.
- Not have valves or tee fittings.
- Be constructed of materials listed or rated for such use.
- Be one nominal size larger than the size of the relief valve outlet, where the relief valve discharge piping is installed with insert fittings.

Contact a qualified plumbing contractor.

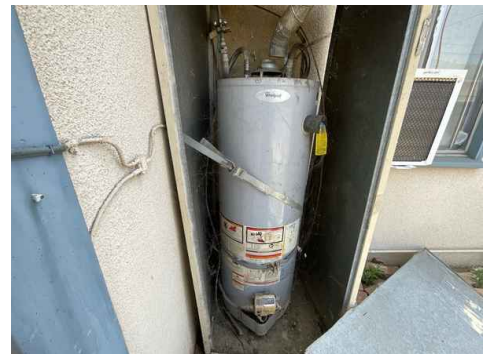
6.4.3 Hot Water Source

POOR BRACING

I observed inadequate seismic bracing at the water heater, recommend securing. There should be two seismic straps utilized and they should be snug to the heater tank.

Contact a qualified professional.

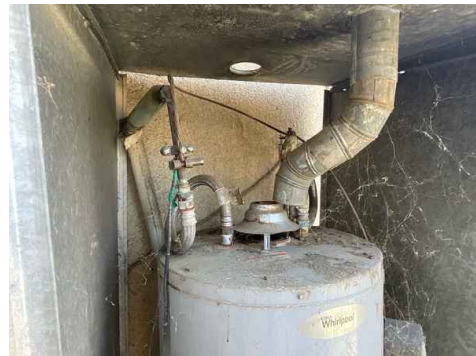
6.4.4 Hot Water Source

WATER HEATER FLUE IMPROPER

The water heater flue was not installed correctly, recommend further review and correction by a licensed plumber.

Recommendation
Contact a qualified professional.

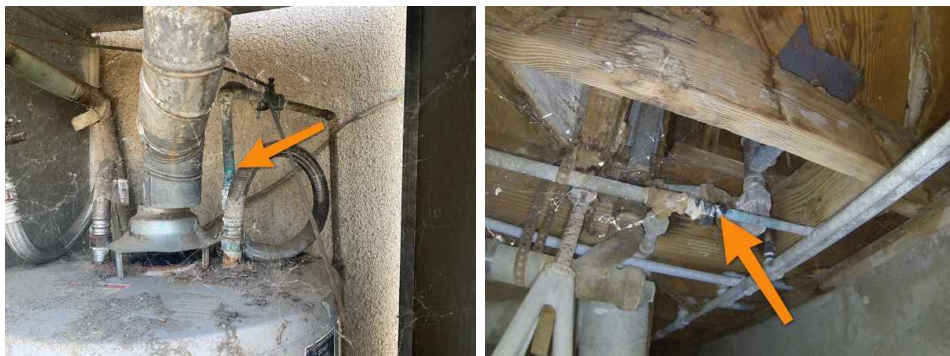
6.6.1 Water Supply & Distribution Systems

SUPPLY LINE CORROSION

I noted some corrosion on a water supply line, this can contribute to leaks. Recommend further evaluation and correction. By a qualified plumber.

Recommendation
Contact a qualified professional.

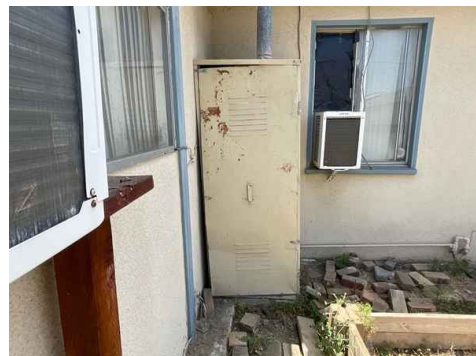
6.6.2 Water Supply & Distribution Systems
PLUMBING ACCESS DOOR DOES NOT FIT PROPERLY

I noted the plumbing access door does not fit properly, recommend correction.

Recommendation
Contact a qualified professional.

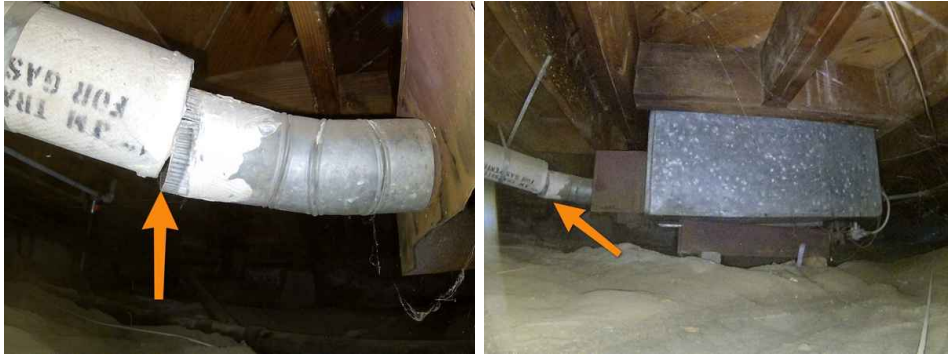
7.1.1 Heating System Information

DISCONNECTED EXHAUST FLUE

I noted an exhaust flue for a furnace was disconnected. Recommend review and correction by s heating contractor.

Recommendation
Contact a qualified professional.

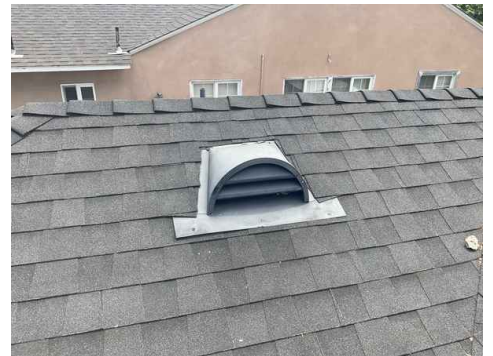
8.3.1 Ventilation in Attic

EXPOSED FASTENER AT VENT FLASHING

I noted exposed fasteners at one or more attic vent covers. This is a potential leak point. Recommend sealing the fasteners.

Recommendation
Contact a qualified professional.

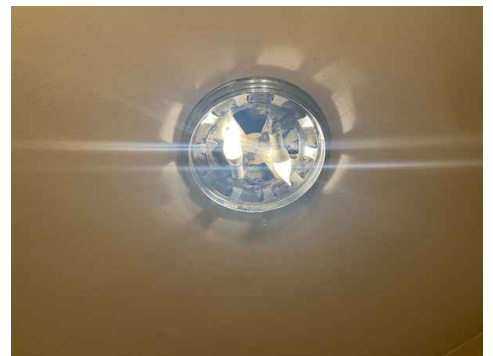
9.3.2 GFCI & Electric in Bathroom

BATHROOM LIGHT FIXTURE WAS DAMAGED

I observed a damaged bathroom light fixture, recommend correction to allow for proper operation.

Recommendation
Contact a qualified professional.

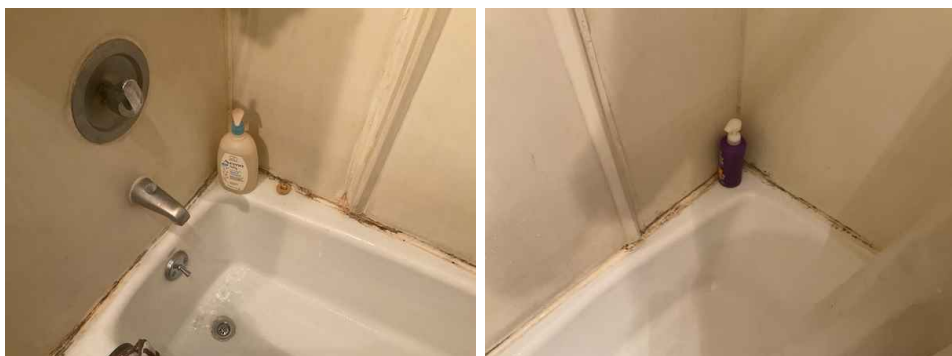
9.5.3 Cabinetry, Ceiling, Walls & Floor

APPARANT MOLD GROWTH IN BATHROOM.

I noted apparent mold growth in the bathroom. I recommend having the substance tested at an laboratory to confirm or deny the presence of microbial growth.

Recommendation
Contact a qualified mold remediation contractor

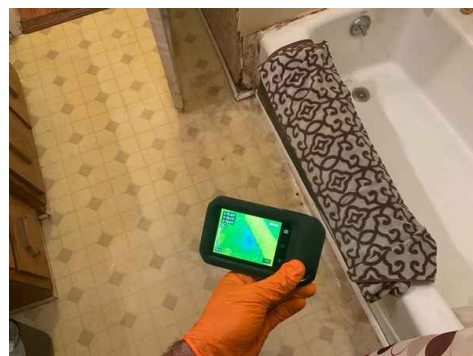
9.5.5 Cabinetry, Ceiling, Walls & Floor
MOISTURE DAMAGE-BATHROOM FLOOR

I noted indications of moisture damage at the bathroom floor, recommend repair as needed.

Recommendation
Contact a qualified professional.

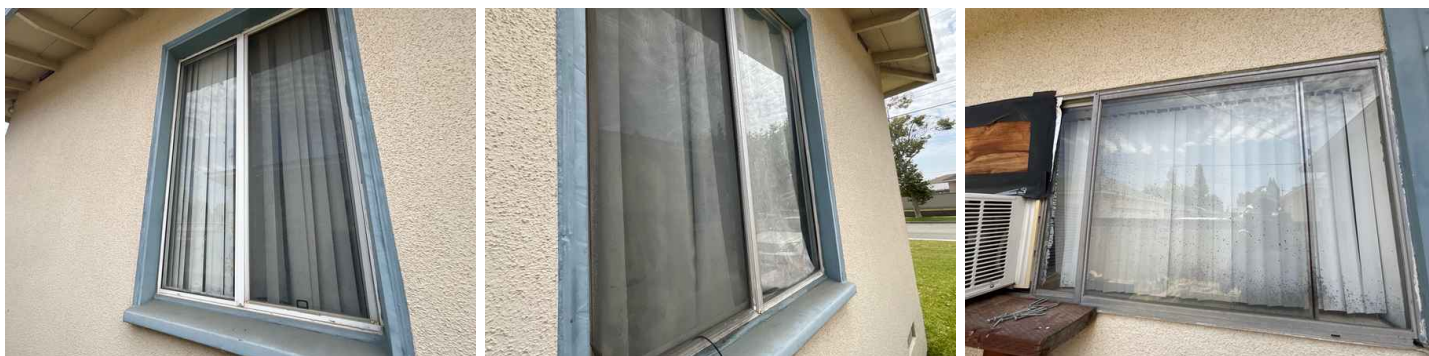
10.2.1 Windows

APPARENT MOLD GROWTH AT ONE OR MORE WINDOWS/ SKYLIGHTS

I observed apparent mold growth at one or more windows at the time of the. Inspection, I recommend testing the substance to either confirm or deny the presence of mold.

Recommendation
Contact a qualified professional.

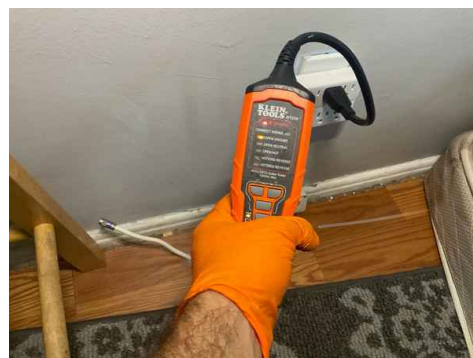
10.3.1 Switches, Fixtures & Receptacles
MISSING GROUND AT RECEPTACLE

I observed indications of a missing, open, or disconnected ground at a receptacle. Hazard.

Recommendation
Contact a qualified electrical contractor.

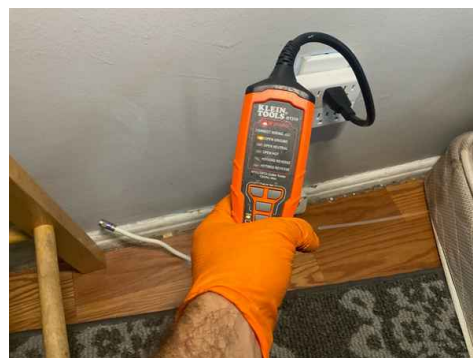
10.3.2 Switches, Fixtures & Receptacles
LOOSE RECEPTACLE

I observed indications of a loosely connected receptacle. Not secured to the wall. Defect.

Recommendation
Contact a qualified electrical contractor.

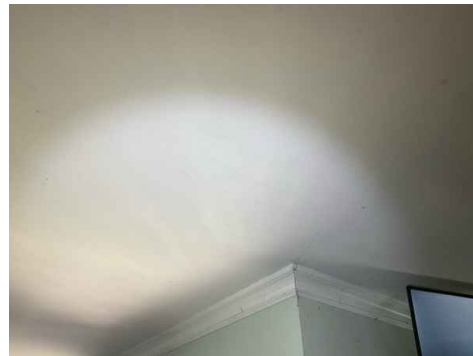
10.4.2 Floors, Walls, Ceilings

DRYWALL CRACKS

I observed minor drywall cracks, recommend repair by a drywall contractor

Recommendation
Contact a qualified professional.

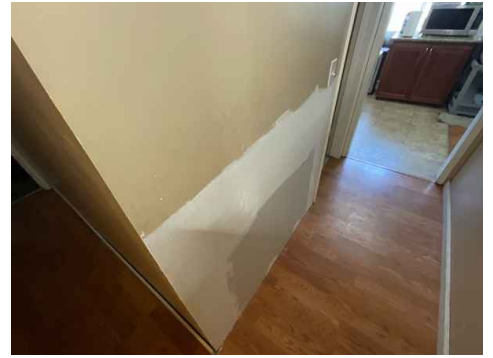
10.4.6 Floors, Walls, Ceilings

POOR PATCHING

Sub-standard drywall patching observed at time of inspection. Recommend re-patching.

Contact a qualified drywall contractor.

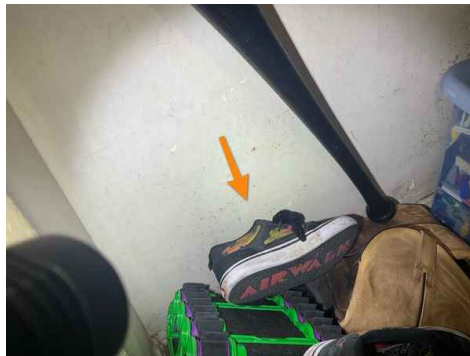
10.4.7 Floors, Walls, Ceilings

POSSIBLE MOLD

There was apparent mold growth noted. It is unknown if this is a safety hazard. Recommend having us sample the mold and analyzed by a lab to either confirm or deny the presence of actual mold.

Contact a qualified mold inspection professional.

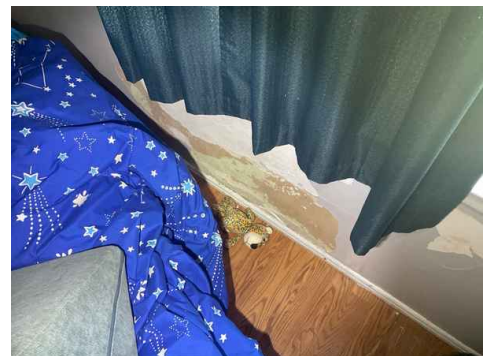
10.4.8 Floors, Walls, Ceilings

DAMAGED DRYWALL,

I noted damage to the drywall, recommend correction

Contact a qualified professional.

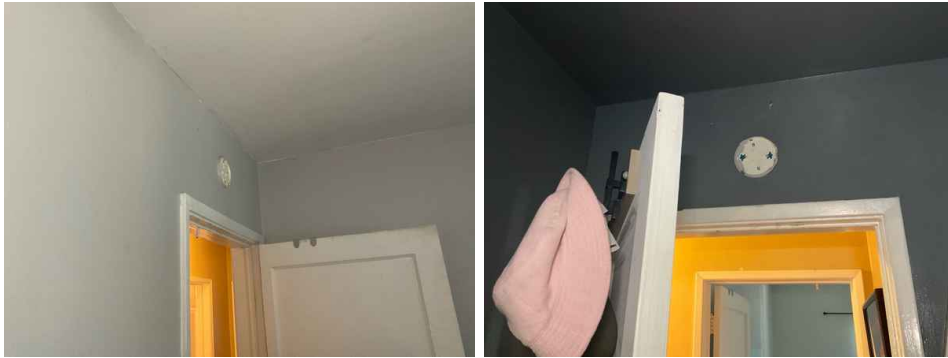
10.5.1 Presence of Smoke and CO Detectors

MISSING SMOKE DETECTOR

I observed indications of a missing smoke detector in an area required to keep people safe. Smoke detectors should be in every sleeping area, outside each sleeping area, and on every level of the home.

Contact a qualified professional.

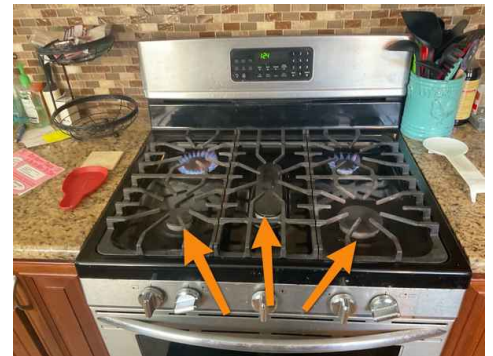
11.5.1 Range/Oven/Cooktop

BURNER NOT LIGHTING

I observed that one or more heating elements did not heat up when turned on.

Contact a qualified appliance repair professional.

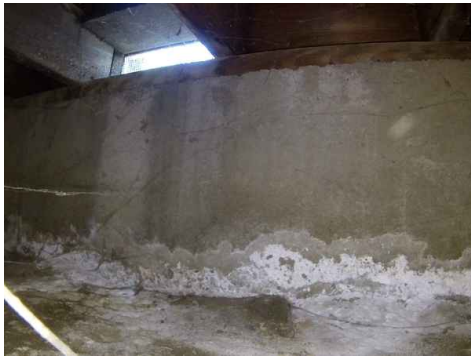
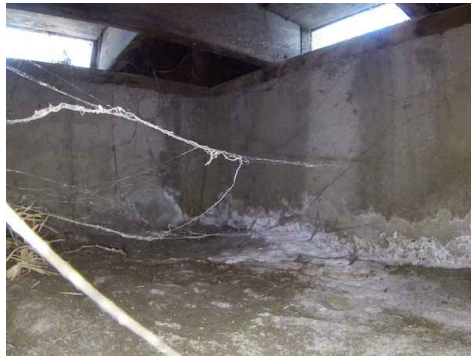
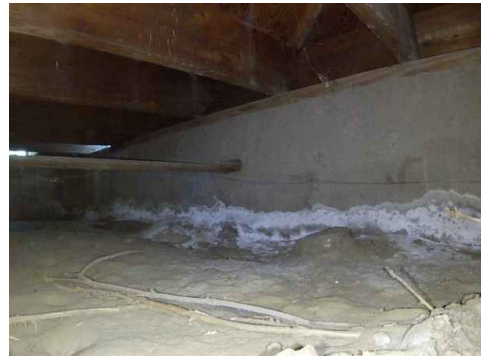
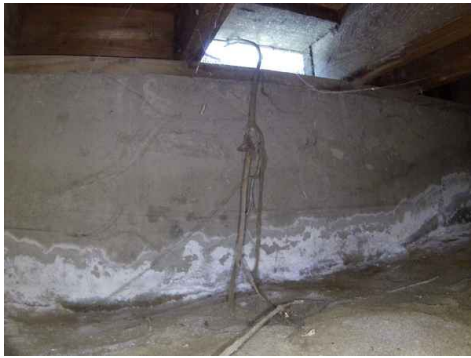
12.1.1 Under-Floor Crawlspace

EFFLORESCENCE OBSERVED

I observed efflorescence from the crawlspace.

Efflorescence is the white chalky powder that you might find on the surface of a concrete or brick wall. It can be a cosmetic issue, or it can be an indication of moisture intrusion that could lead to major structural and indoor air quality issues.

I noted the presence of efflorescence in the inspection report because it generally occurs where there is excess moisture, a condition that also encourages the growth of mold.

Contact a qualified professional.

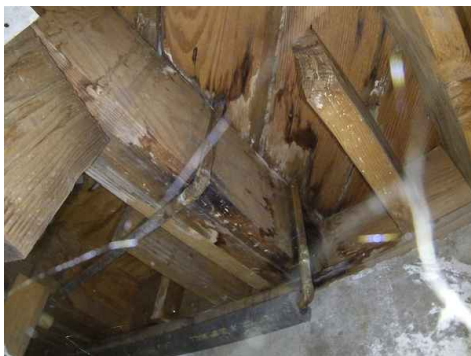
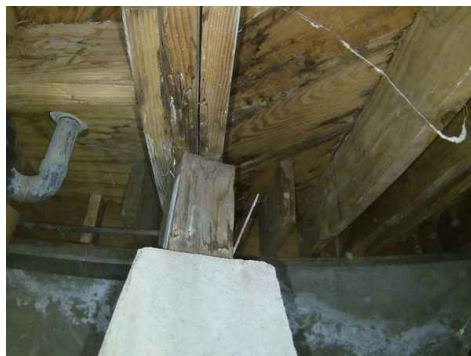
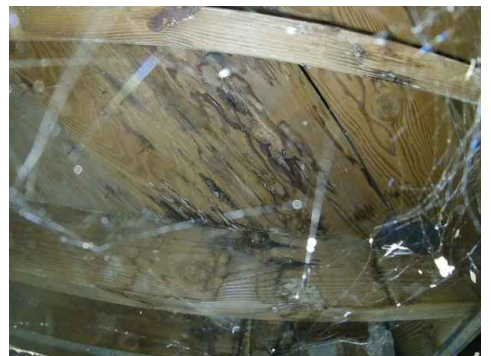
12.1.2 Under-Floor Crawlspace

PRIOR WATER PENETRATION OBSERVED

I observed indications that sometime in the past, there was water penetration or intrusion into the crawlspace.

Correction and further evaluation is recommended.

Recommend monitoring.

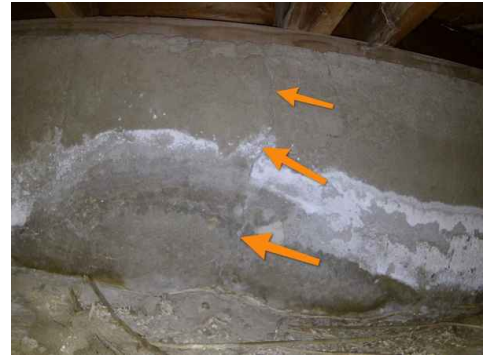
12.1.3 Under-Floor CrawlSpace

FOUNDATION CRACK-MODERATE

I noted a moderate foundation crack, cracks are indicative of foundation settling and building shifting. I recommend contacting a foundation contractor to further evaluate and repair.

Contact a qualified professional.

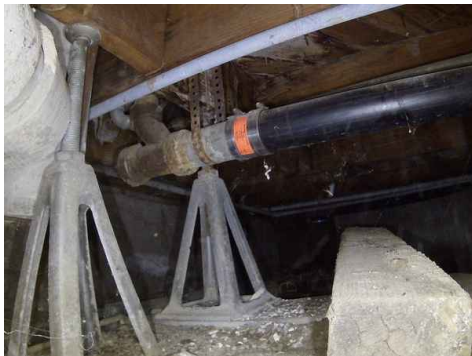
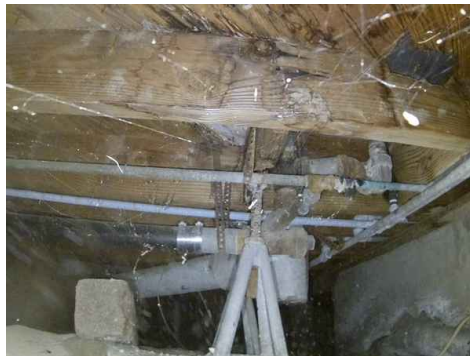
12.1.4 Under-Floor CrawlSpace

DAMAGED SUB FLOOR

Inspection Observed Moisture damage to some of the frame members and excess of wood rot and mold growth

Contact a qualified professional.

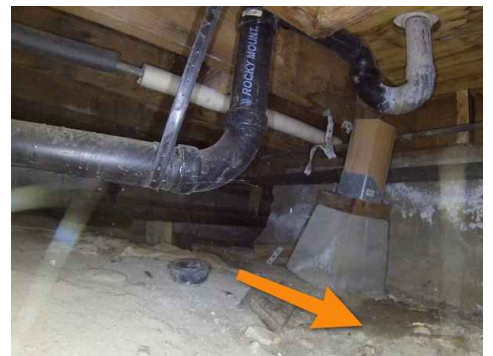
12.1.5 Under-Floor CrawlSpace

MOISTURE OBSERVED IN CRAWLSPACE

I noted moisture in the dirt of the crawl space. Moisture in the crawl space can contribute to a number of issues including wood decay, microbial growth, and foundation settling over time. I recommend the source of the moisture be determined and rectified to prevent damage to the home.

Contact a qualified professional.

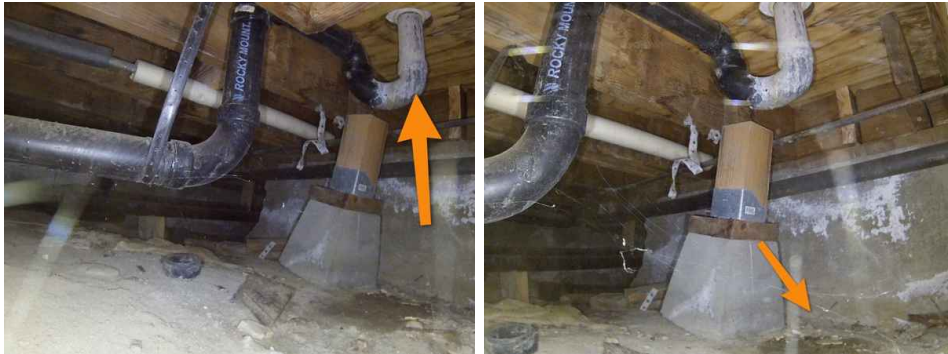
12.1.6 Under-Floor CrawlSpace

ACTIVE WATER PENETRATION OBSERVED

I observed indications of active water penetration into the crawlspace.

Correction and further evaluation is recommended.

Contact a qualified professional.

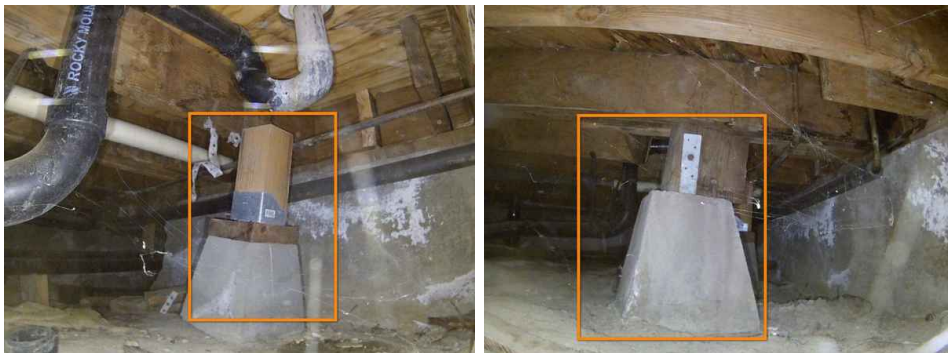
12.1.7 Under-Floor CrawlSpace

UNSUPPORTED PIER

I noted a pier that was shifting. Recommend repair.

Contact a qualified professional.

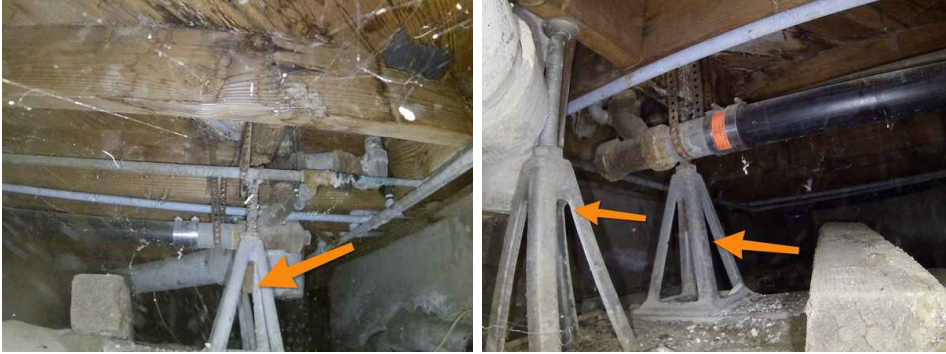
12.1.8 Under-Floor Crawlspace

IMPROPER SUPPORT USED

I observed improper support practices. I recommend contacting a foundation contractor for further evaluation and repair.

Contact a qualified professional.
