# *Advanced Inspection Services*

## Property Inspection Report

499 E Newlove APT K, Santa Maria, CA 93454  
Inspection prepared for: Thomas & Andrea Bouton  
Date of Inspection: 10/19/2026 Time: 8:00 AM  
Age of Home: 1984 Size: 1554 sqft  
Weather: Overcast  
Current repairs were noted at the time of inspection.

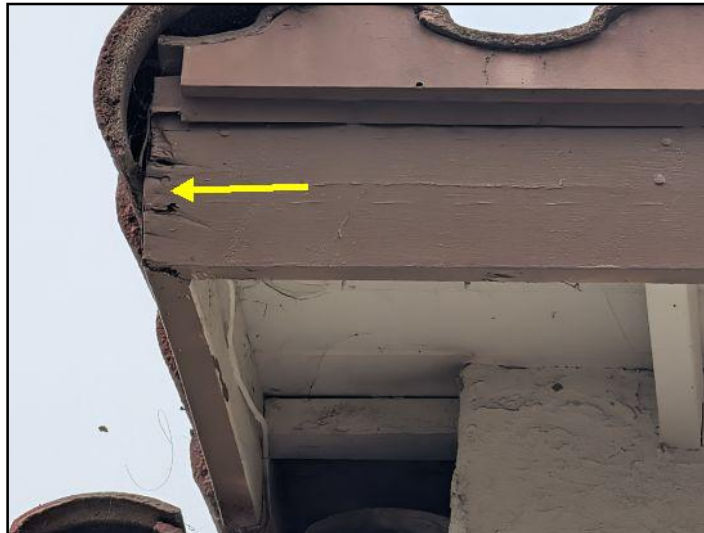
- Eaves and fascia are in generally good condition for the age of the property.
- Deteriorated paint and or wood noted at few small locations of exterior trim & eaves/fascia. \* (3)
- Moisture staining and/or wood damage noted at the rear eaves/fascia. (2) (3)

Moisture staining and/or wood damage noted at the rear eaves/fascia. (2) (3)

| Exterior components | | |
|---|---|---|
| Page 6 Item: 2 | Eaves/Fascia & Trim | • Moisture staining and/or wood damage noted at the rear eaves/fascia. (2) (3) |

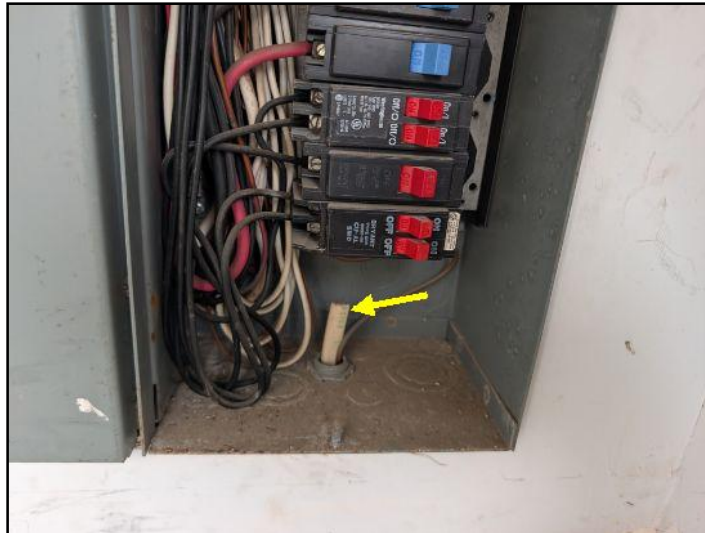
- All of the circuit breakers appeared serviceable.
- A cut wire that appears to be abandoned was noted in the main panel. \*

A cut wire that appears to be abandoned was noted in the main panel. \*

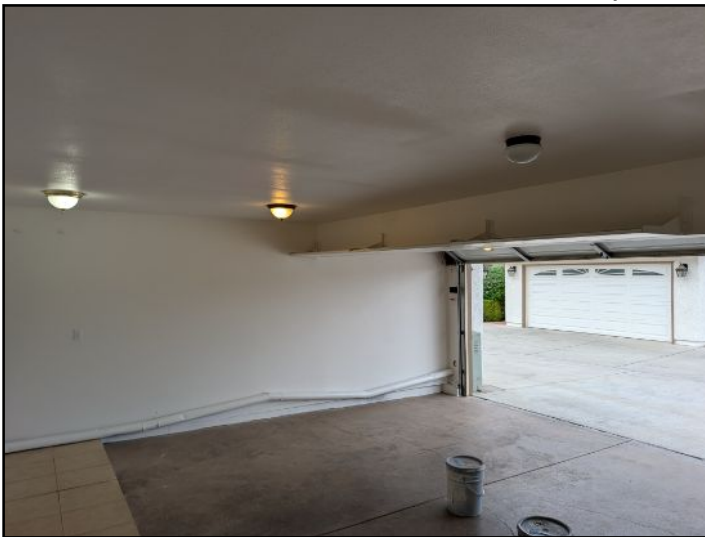
A garage light fixture is not operational or needs bulb replaced. (2)

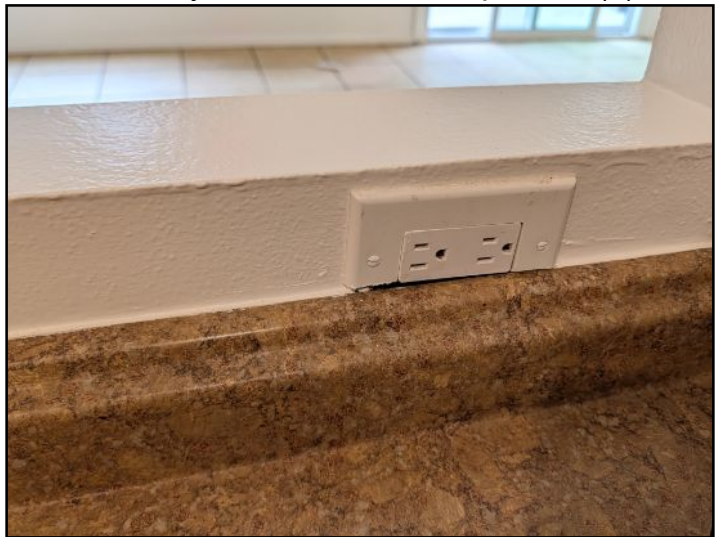
- The representative sample of switches and outlets tested appeared to be serviceable. The occupant's belongings prevented testing of some of the outlets and switches.
- A garage light fixture is not operational or needs bulb replaced. (2)
- One or more outlets in the primary bedroom is tied to the bathroom/Garage/Outdoor **GFCI** circuit.
- The kitchen vent fan appliance cord appear to be smaller gauge than what is typical. \*
- A loose ground connection was noted at the downstairs bathroom outlet. \*
- The older and/or loose outlets were noted at multiple locations. \*
- Outlet cover plates at the sink side countertop have been altered. The electrical boxes are partially obstructed by the laminate backsplash. \* (5)

Outlet cover plates at the sink side countertop have been altered. The electrical boxes are partially obstructed by the laminate backsplash. \* (5)

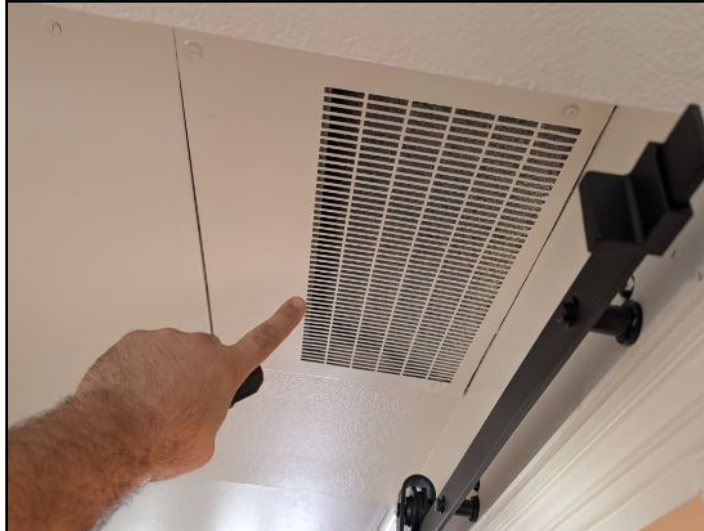
- Air filter present/appears serviceable.
- The furnace filter is dirty/painted. The filter is bent and allows incoming air to bypass the filter. \* (5)

The furnace filter is dirty/painted. The filter is bent and allows incoming air to bypass the filter. \* (5)

| Exterior components | | |
|---|---|---|
| Page 16 Item: 8 | Filters | • The furnace filter is dirty/painted. The filter is bent and allows incoming air to bypass the filter. * (5) |

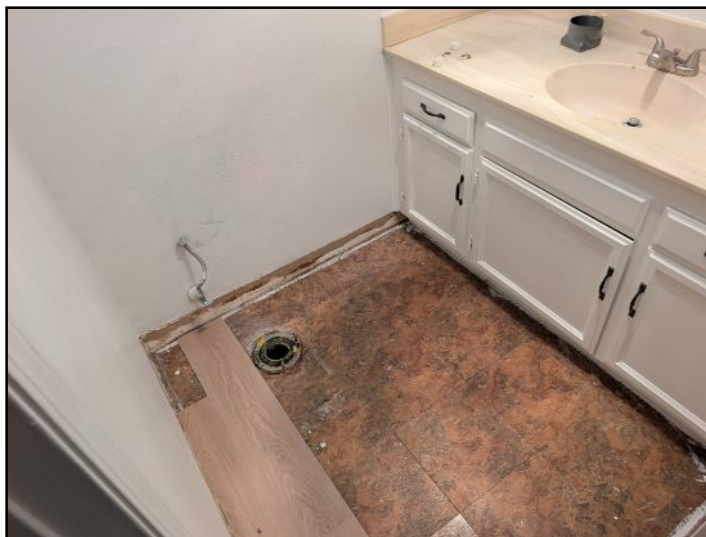
- Floor coverings appear serviceable.
- Uneven floor tiles and floor tiles that are hollow sounding were noted on multiple locations in the house and garage. \*
- Uneven floors noted at a few locations upstairs. \*
- Not fully visible
- The master bathroom floor was under repair at the time of inspection. The toilet and baseboards in the bathroom were not installed due to the flooring repairs. (2)

The master bathroom floor was under repair at the time of inspection. The toilet and baseboards in the bathroom were not installed due to the flooring repairs. (2)

| Exterior components | | |
|---|---|---|
| Page 17 Item: 3 | Floor Condition | • The master bathroom floor was under repair at the time of inspection. The toilet and baseboards in the bathroom were not installed due to the flooring repairs. (2) |

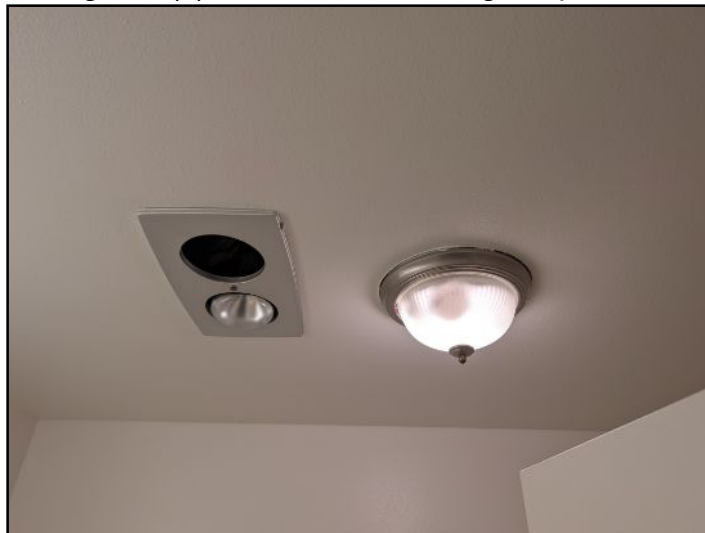
- The bath fan(s) are operational/in generally good condition for age of home.
- Missing bulb(s) noted at the heating lamps/fans. \*

Missing bulb(s) noted at the heating lamps/fans. \*

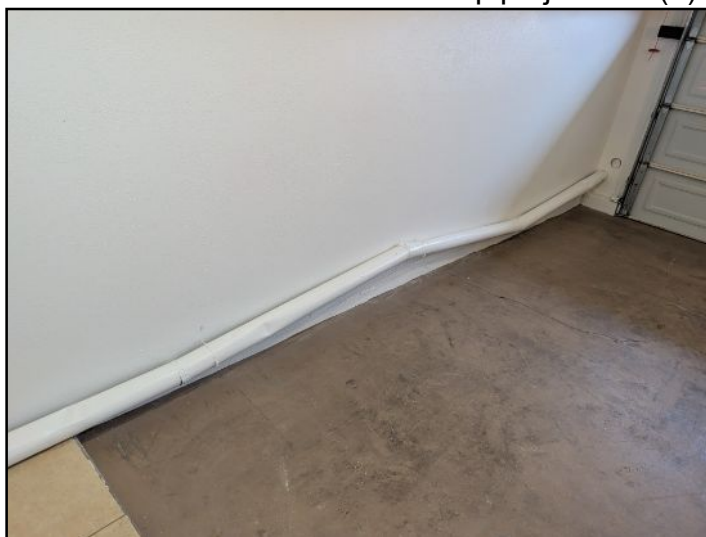
- Dryer vent appears serviceable; Not fully visible
- The dryer vent is poorly surface mounted on the garage wall. Poorly made connections were noted at the vent pipe joints. \* (5)

The dryer vent is poorly surface mounted on the garage wall. Poorly made connections were noted at the vent pipe joints. \* (5)

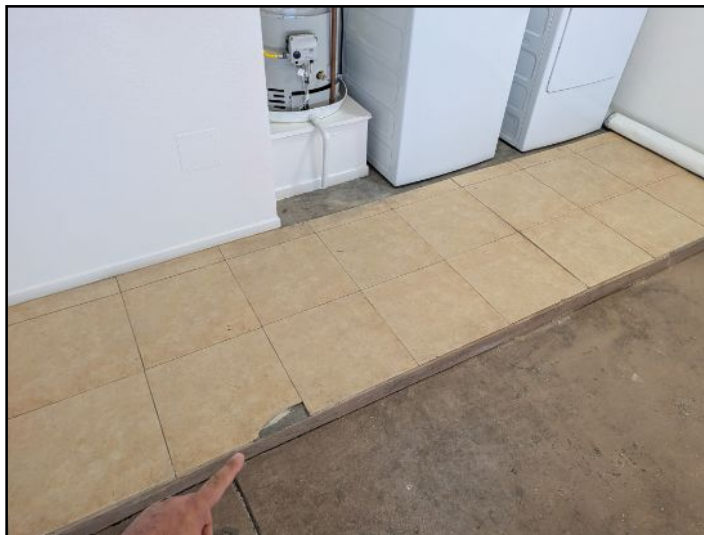
- Garage floor is in generally good condition for the age of the property.
- Common cracks noted at slab.
- **Cracked floor tile noted in garage. \* (5)**

Cracked floor tile noted in garage. \* (5)

| Exterior components | | |
|---|---|---|
| Page 26 Item: 1 | Floor Condition | • Cracked floor tile noted in garage. * (5) |

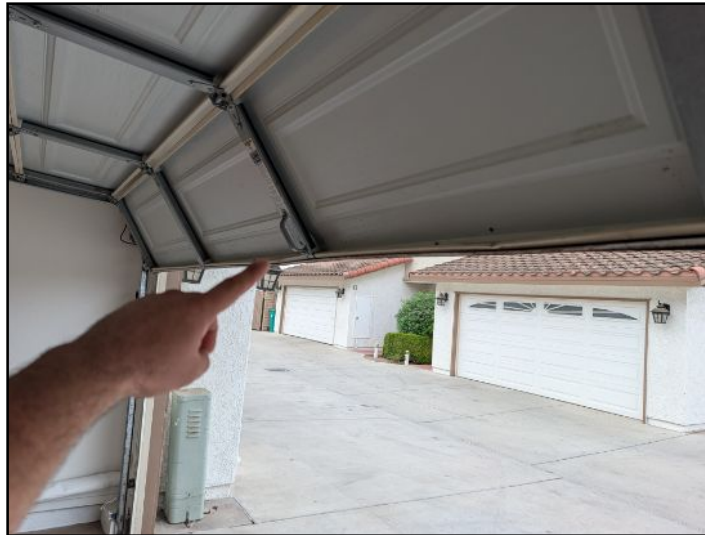
- Vehicle doors appear to be in generally good condition for age of the property.
- Damaged and/or warped panels noted at the garage vehicle door. \*

Damaged and/or warped panels noted at the garage vehicle door. \*
