Professional
Inspection Network

INSPECTION REPORT
3402 Liberty Blvd
South Gate CA 90280

INSPECTION DATE
📅 4/16/2024
🕒 12:30 PM

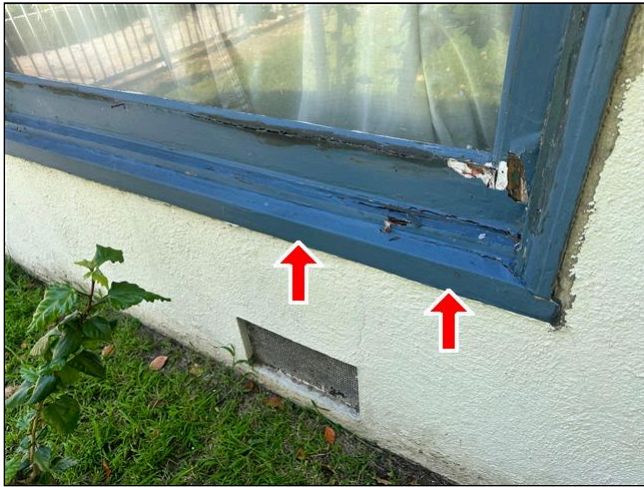
Item 1 - Item 1 (Picture) Exterior

- 1. (1) Repair or Replace:** There is wood deterioration observed at the front wall window frame. This deterioration can be caused by various factors such as moisture, pests, or age-related wear and tear. It is important to address this issue to prevent further damage. Due to the presence of wood deterioration, it is advisable to have a pest control company inspect the area for any signs of pest activity or infestation. Certain pests can cause significant damage to wood structures. A professional inspection will help determine if pests are present and if further treatment is necessary. It is recommended to hire a licensed contractor experienced in wood repairs and replacements. They will assess the extent of the wood deterioration and provide appropriate recommendations. Depending on the severity of the damage, the contractor may suggest repair techniques such as wood patching, reinforcement, or complete replacement of deteriorated wood components. Please be aware that this report is based on a visual inspection, and it is essential to consult a qualified professional, such as a licensed contractor and a pest control company, for a comprehensive assessment and appropriate repairs.

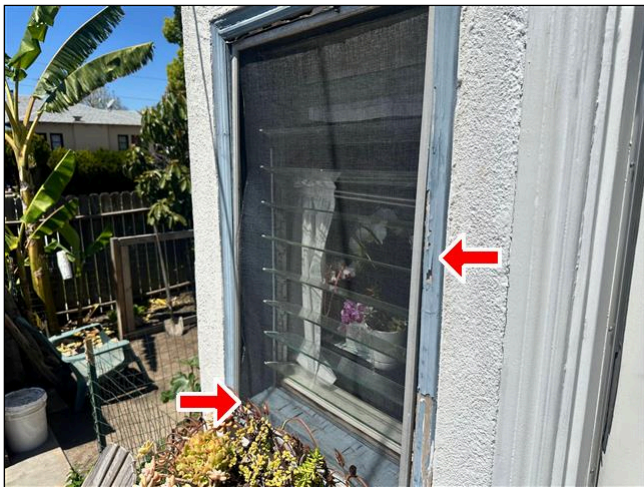
Item 2 - Item 1 (Picture) Exterior

2. (2) **Improve:** There is peeling paint at the exterior window frames in several locations. It is suggested that the exterior window frames be caulked and painted by a qualified professional to prevent rot and water intrusion.

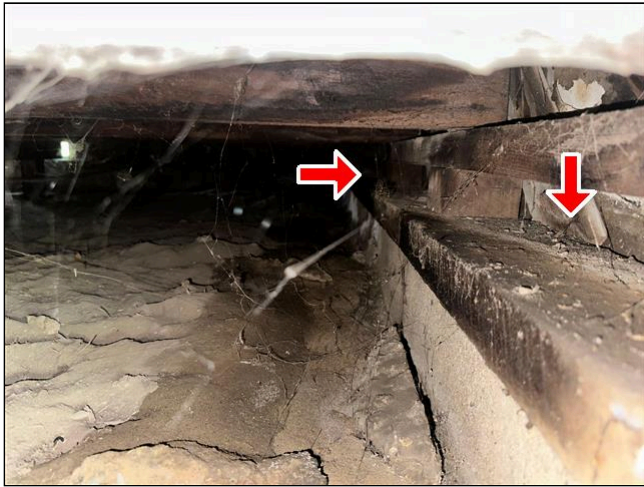
Item 3 - Item 1 (Picture) Structural Components

3. (1) **Safety Issue:** No anchor bolts were observed between the sill plate and the foundation walls. Given the age of the home, the installation of anchor bolts was not a requirement at the time of construction; however, their presence is considered best practice in contemporary building standards to enhance structural stability and safety. Without anchor bolts, the house is more susceptible to shifting or movement relative to the foundation during seismic events, which can lead to structural damage. Engage a structural engineer to assess the feasibility of retrofitting the foundation with anchor bolts. The engineer can provide specific recommendations based on the existing condition of the foundation and the structural requirements.

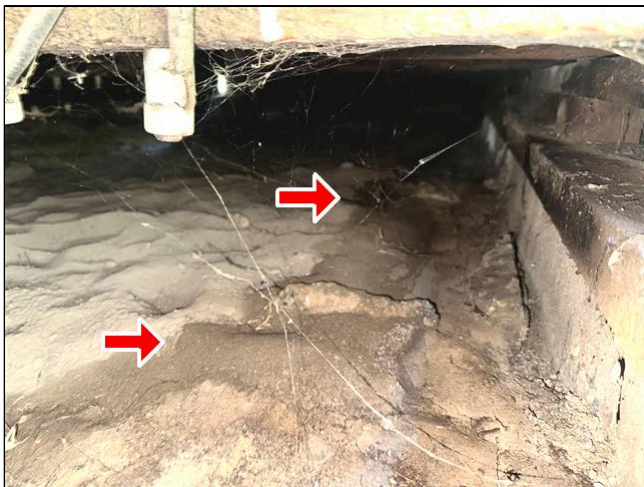
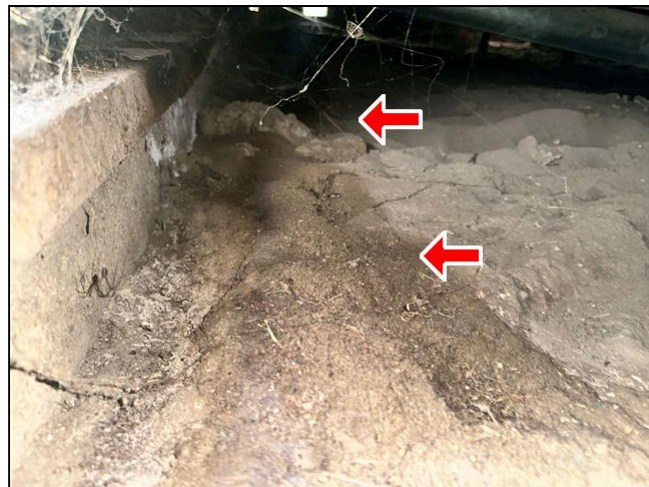
Item 4 - Item 1 (Picture) Structural Components

4. (2) **Improve/Monitor:** Visible signs of water intrusion in the crawlspace are present from damp soil was observed along the East wall of the home. Water intrusion can lead to more costly repairs and increase damage if not corrected. If the soil in the crawl space is wet due to poor exterior drainage, or current/past plumbing leaks, it can lead to a number of problems such as mold, mildew, and structural damage. If the cause is determined to be poor exterior drainage, a contractor or engineer may recommend installing additional drainage systems to divert water away from the foundation. It's important to address wet soil in a crawl space as soon as possible, as it can lead to significant structural and safety issues over time. A professional evaluation is crucial to identifying the underlying cause and determining the appropriate course of action to address it.

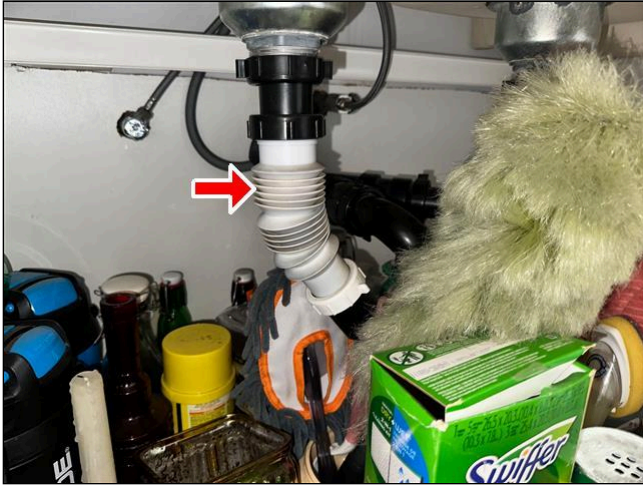
Item 5 - Item 1 (Picture) Plumbing System

5. (1) **Repair or Replace:** It is suggested that the accordion type drain at the kitchen sink be replaced with rigid type drain piping by a qualified professional.

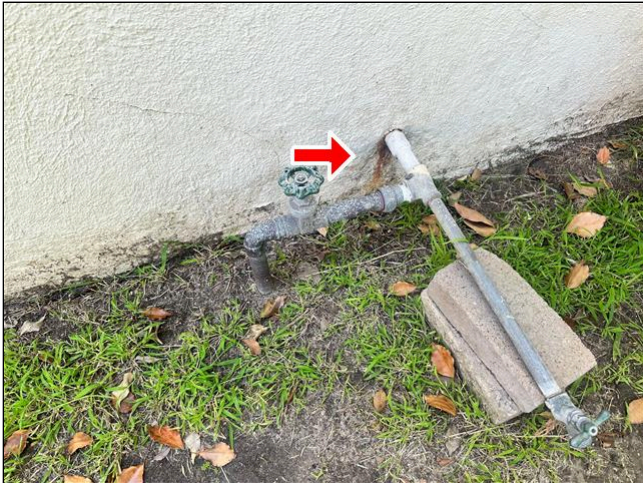
Item 6 - Item 1 (Picture) Plumbing System

6. (1) **Repair or Replace:** The main copper water supply pipe that attaches to the galvanized water supply pipe exhibits significant corrosion at the connection point. Additionally, it was noted that there is a lack of a dielectric union at the junction between the copper and galvanized pipes. The interaction between copper and galvanized steel can lead to accelerated corrosion due to galvanic action, potentially resulting in leaks and water damage over time. Corrosion can also compromise water quality, introducing metal residues and other contaminants into the household water supply. Engage a licensed plumber to install a dielectric union at the connection between the copper and galvanized pipes. This component is designed to prevent galvanic corrosion by providing electrical insulation between the two different metals. Have the plumber assess the extent of corrosion and damage. Replace any compromised sections of the pipe to ensure the integrity and reliability of the water supply system.

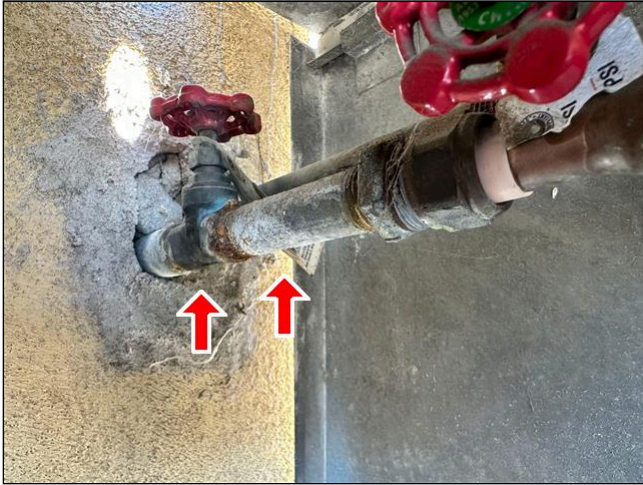
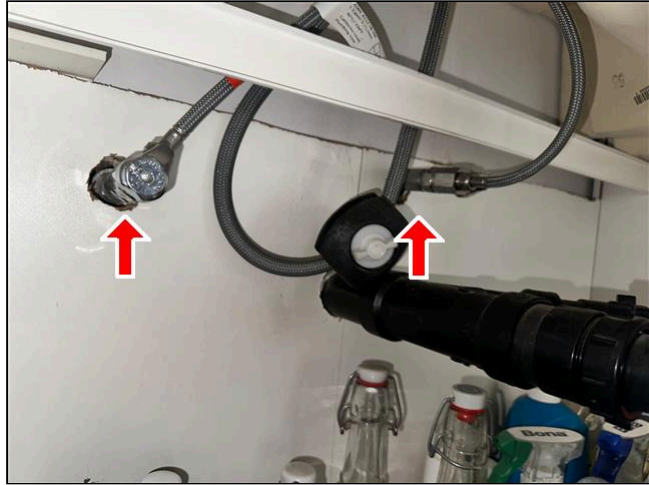
Item 7 - Item 1 (Picture) Plumbing System

7. (2) **Repair or Replace:** Galvanized steel pipes are used in the interior water supply, and generally have a finite life span. The quality of the plating, installation methods, water temperature, water quality and water usage all factor into the actual serviceable life. Scale builds up inside the pipe which eventually restricts the flow of water to the fixtures. Corrosion eats away at the inside of the pipes, eventually causing leaks. Thirty to forty years is the average life of galvanized pipes. Replacement of the galvanized steel supply pipes will eventually be required. Note: There is visible debris, and possible metal flakes, when water is run to the sinks in the home. The makeup of this debris is unknown.

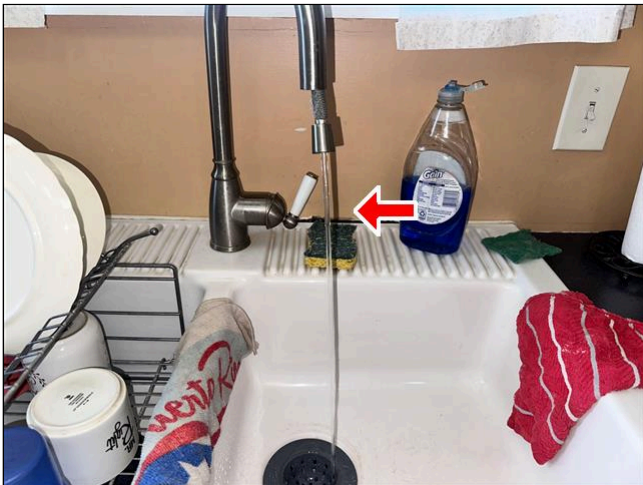
Item 8 - Item 1 (Picture) Plumbing System

8. (3) **Repair or Replace:** A drop in water flow was observed when multiple fixtures are operated simultaneously at the time of the inspection. The low water flow is due to the older galvanized water supply piping losing the required pipe diameter from corrosion on the interior of the piping. Although some copper tubing has been employed as part of the water supply system, it is suggested that all galvanized steel water supply pipes be replaced by a licensed contractor.

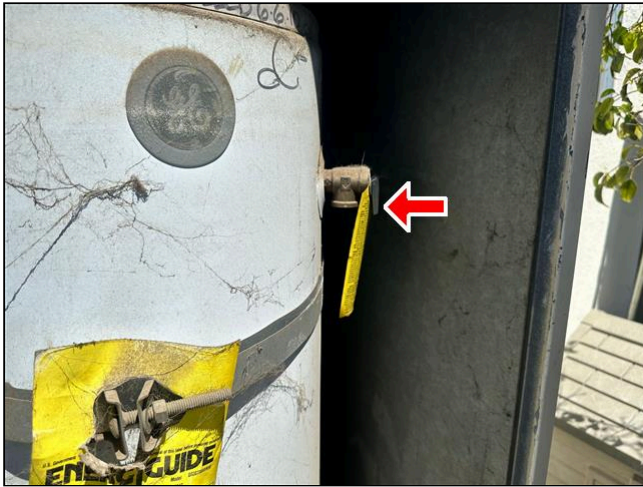
Item 9 - Item 1 (Picture) Plumbing System

9. (1) **Safety Issue:** The Temperature and Pressure Relief valve at the water heater needs a 3/4 pipe to extend within 6 to 24 inches of floor for safety. PVC is not approved for hot water use. Recommend repair by a qualified person.

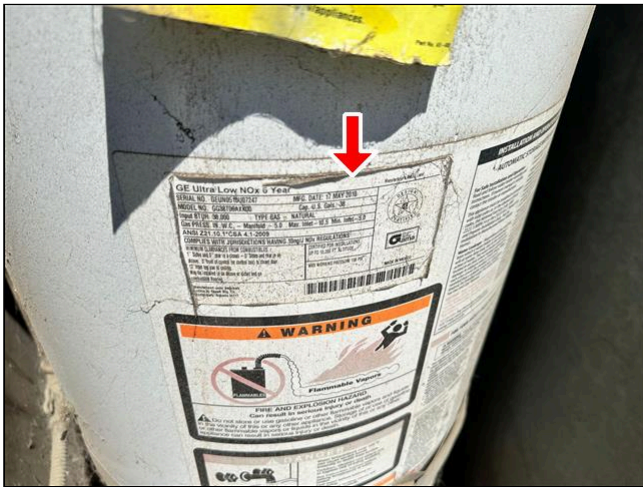
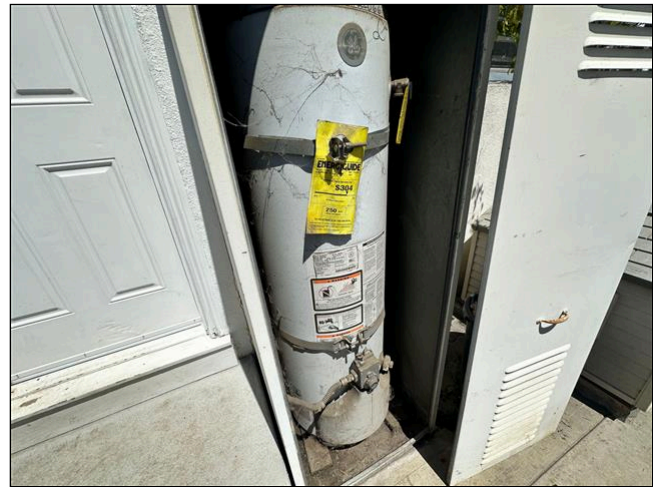
Item 10 - Item 1 (Picture) Plumbing System

- 10. (2) Repair/Replace/Monitor:** The water heater is an older unit. The water heater may be nearing the end of its service life. Typical life expectancy of water heaters is 7 to 12 years. The existing unit is 14 years old. It is difficult to determine when replacement will be necessary. Suggest replacement of the water heater by a licensed and qualified plumber.

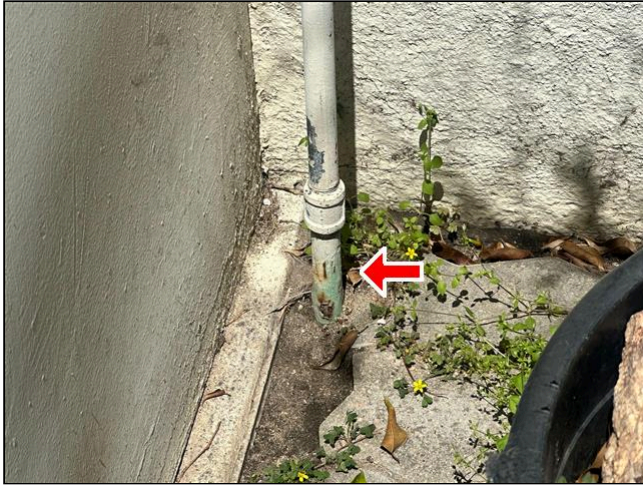
Item 11 - Item 1 (Picture) Plumbing System

- 11. (1) Safety Issue:** The gas supply pipe that runs through the ground at the rear exterior wall of the home was found to be corroded and rusted. This condition is observed on the exposed sections of the piping as it passes through the ground. Engage a licensed plumber or a certified gas fitter to conduct a thorough inspection of the entire gas supply line to assess the extent of the corrosion and determine the integrity of the pipe.

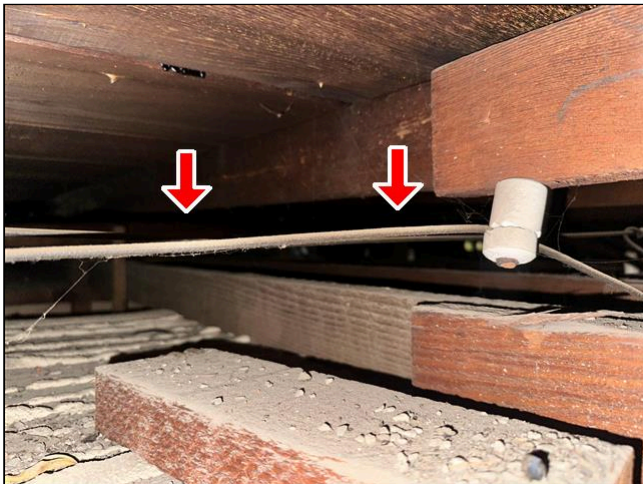
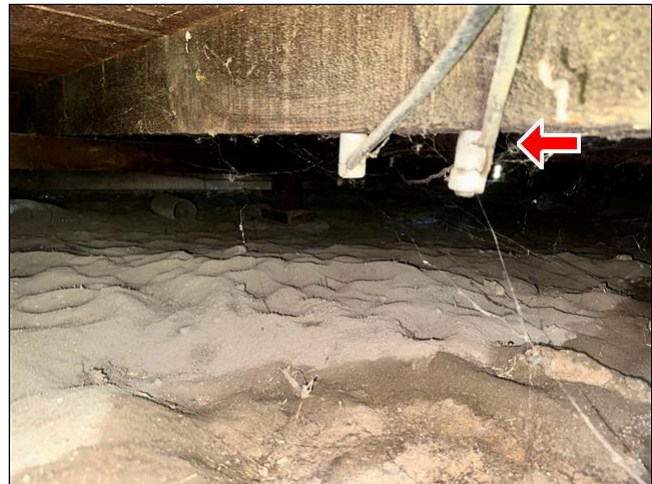
Item 12 - Item 1 (Picture) Electrical System

- 12. Safety Issue:** Older Knob and Tube wiring was observed at the attic space and crawl space of the home where visible. Extra care should be taken with this type of wiring. It is suggested that all Knob and Tube wiring be replaced with newer wiring by a licensed electrician due to the several safety concerns that the wiring poses. Knob and Tube wiring was observed at the attic space of the home. Knob and tube wiring, sometimes referred to as just K&T, is a type of electrical wiring seen in homes built in the late 1800s and early 1900s. It uses a system of copper conductors, which are run through tubes and held down with porcelain knobs. Unlike modern electrical systems, they have no ground wire. Also, the insulation can become brittle and make repairs difficult. Extra care should be taken with this type of wiring. A qualified electrician should inspect the Knob and Tube wiring to provide you with replacement options and costs.

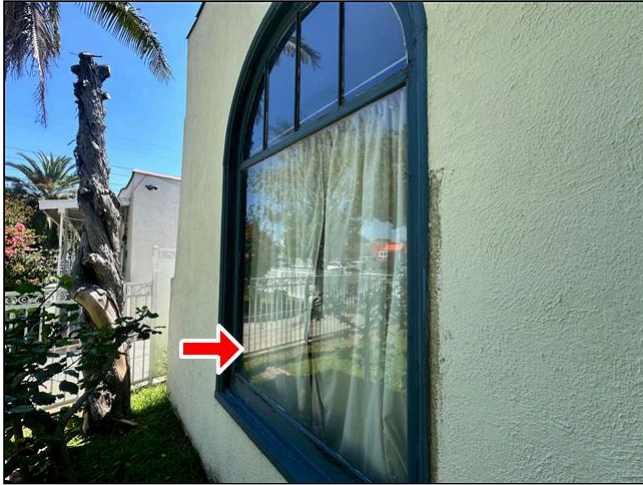
Item 17 - Item 1 (Picture) Interiors

17. **Safety Issue:** The window at the front wall of the home does not appear to be shatter proof/tempered glass. This is common in many older homes. The current building standards require that all glass located within 18-inches from a floor surface should be shatter proof/tempered glass. It is suggested that the windows be replaced or covered with a clear safety film to protect the occupants of the home.

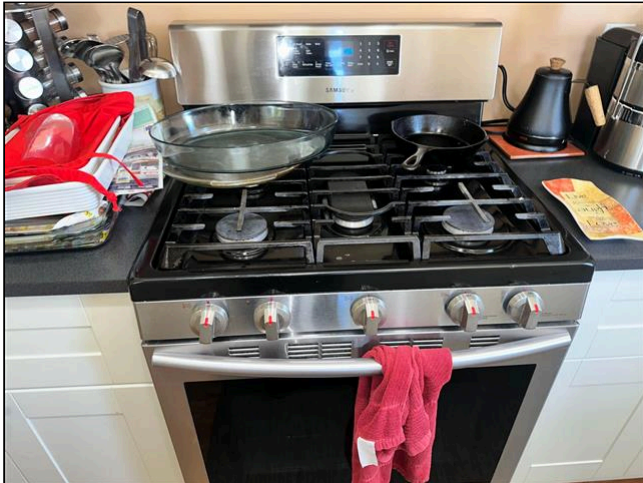
Item 18 - Item 1 (Picture) Appliances

- 18. Safety Issue:** The stove at the kitchen lacks an anti-tip bracket. An anti-tip bracket is an important safety feature that helps prevent the stove from tipping over, especially in situations where excessive weight or force is applied to the open oven door or if a child were to climb or hang on the stove. The absence of an anti-tip bracket increases the risk of the stove tipping over, which can result in serious accidents or injuries. It is recommended to have anti-tip brackets installed for each stove to enhance the safety of the property. It is advisable to consult with a qualified professional or appliance technician to properly install the appropriate anti-tip brackets for the stoves. They can ensure that the brackets are correctly attached to the stove and securely anchored to the floor or wall, following the manufacturer's guidelines and local building codes. Improving the safety features of the stoves by installing anti-tip brackets is an important step in preventing accidents and promoting the well-being of the occupants.

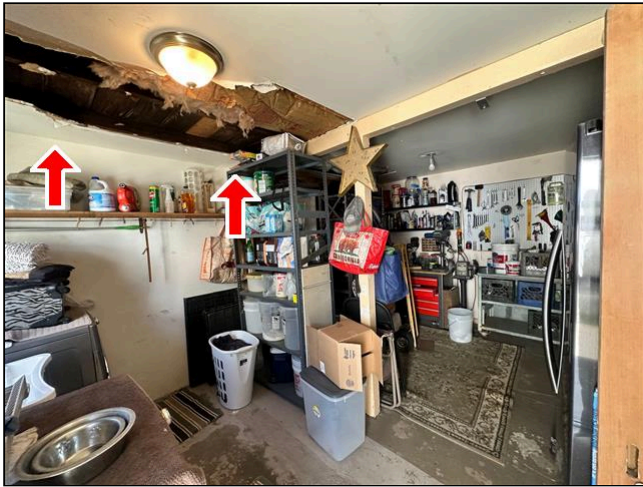
Item 19 - Item 1 (Picture) Garage

- 19. (1) Repair or Replace:** A section of the ceiling at the garage has been removed. It appears that it was damaged due to a past roof leak. Suggest replacement of the missing ceiling by a qualified professional.

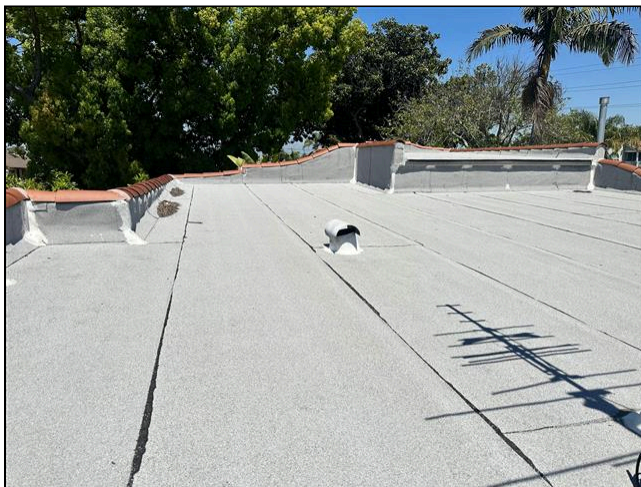
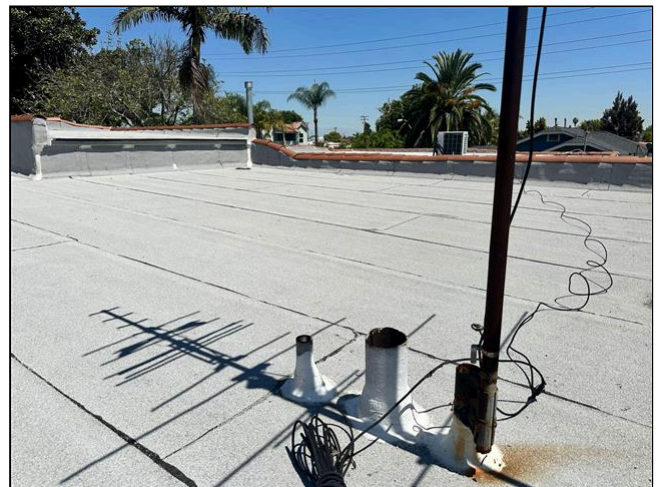
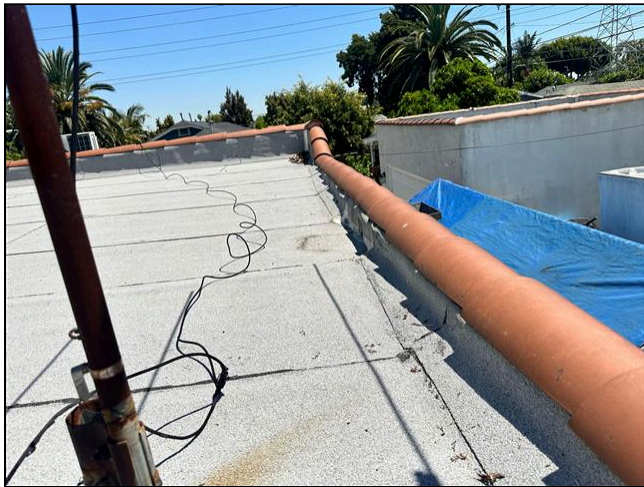
1.0 Item 1 (Picture) Roofing

Monitor: During the home inspection, it was observed that the composition roofing is currently in good condition. However, it is important to note that accurately determining the remaining serviceable lifespan of the roofing is challenging. To ensure the longevity and proper maintenance of the roof, periodic reviews by a licensed roof contractor are highly recommended. The composition shingle roofing of the property is currently in good condition, exhibiting no visible signs of significant damage or deterioration during the home inspection. However, it is important to note that accurately predicting the exact remaining serviceable lifespan of the roofing is difficult due to various factors such as weather conditions, installation quality, and maintenance history. As with any roof, it is advised to engage the services of a licensed roof contractor for periodic evaluations and necessary repairs. This proactive approach will help identify any potential issues or areas requiring attention and ensure the longevity and integrity of the roofing system.

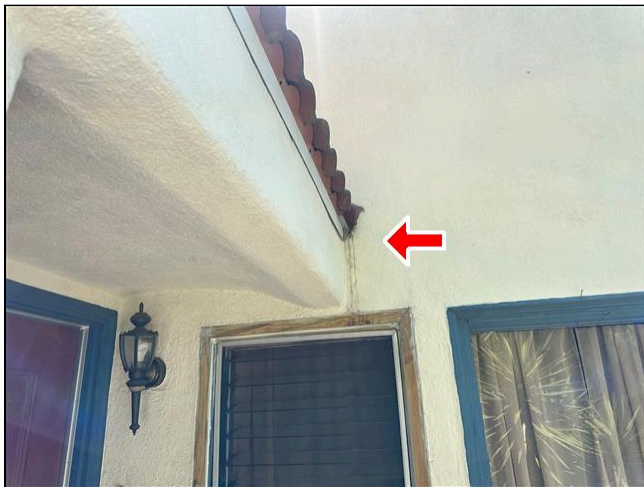
1.1 Item 1 (Picture) Roofing

Improve: The sloped areas of the roof terminate at the walls without the benefit of kick out flashing. It is suggested that a kickout flashing system be installed by a qualified roofing contractor. Kickout flashing, also known as diverter flashing, is a special type of flashing that diverts rainwater away from the cladding. When installed properly, they provide excellent protection against the penetration of water into the building envelope.

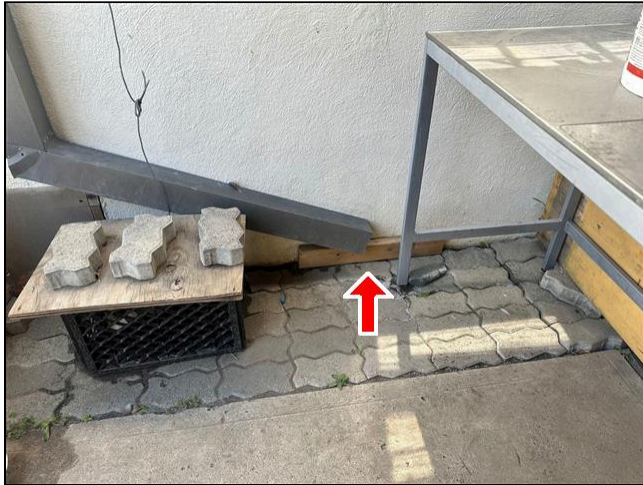
1.3 Item 1 (Picture) Roofing

Improve: The downspouts at the exterior walls of the home are not connected to the subsurface drains. Instead, they terminate at the exterior foundation walls. This configuration can lead to issues such as roof water pooling and over-saturating the soil around the foundation, which can potentially cause damage to the foundation over time. To address this concern, it is recommended to have the downspouts properly connected to the subsurface drains or directed away from the home by a qualified professional. This can help ensure that roof water is effectively directed away from the foundation, reducing the risk of water pooling and potential

foundation damage. A qualified professional, such as a drainage contractor or landscaper, can assess the current drainage system and provide recommendations for connecting the downspouts to the subsurface drains or redirecting them away from the home. This may involve installing additional piping, extending the downspouts, or implementing other appropriate drainage solutions based on the specific layout and needs of the property. Taking proactive measures to manage roof water and prevent water pooling around the foundation can help maintain the integrity of the home's foundation and minimize potential moisture-related issues in the future.

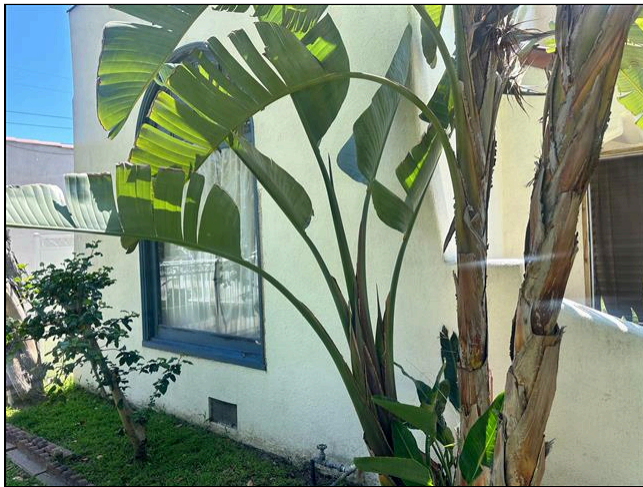
2.0 Item 1 (Picture) Exterior

(1) **Improve:** Trees, vegetation, and vines that are in contact with or in close proximity to the home should be removed or trimmed back to a safe distance. This is a crucial maintenance step to protect the structural integrity and safety of the home. Vegetation in direct contact with the house can lead to several issues. Trees and plants can retain moisture against the surfaces of the home, potentially leading to wood rot, mold growth, and deterioration of siding materials. Growing vines or large tree branches can exert physical force on siding, windows, and roofs, leading to damage over time. Vegetation close to the home can act as a bridge or attractant for pests, including insects and rodents, making it easier for them to access the house. Overgrown plants can obstruct pathways, windows, and potentially interfere with the home's ventilation systems. It is advisable to regularly inspect and maintain the landscaping around the home, ensuring that all trees, shrubs, and vines are kept at a safe distance. Professional landscaping services or an arborist can provide assistance in safely removing or trimming any problematic vegetation. Regular upkeep not only preserves the aesthetic appeal of the property but also plays a critical role in safeguarding the home against potential damage.

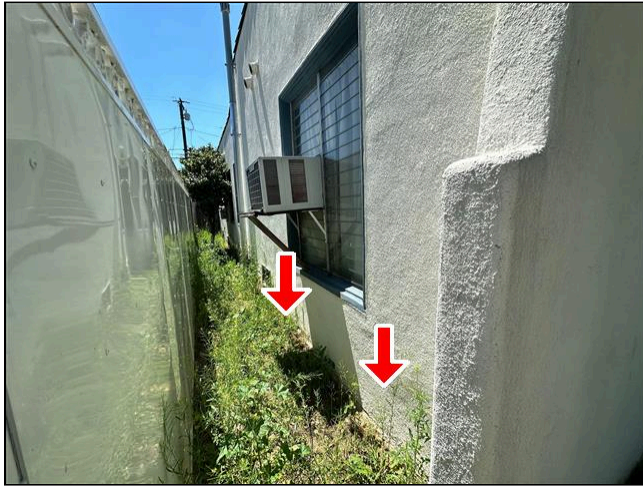
2.0 Item 2 (Picture) Exterior

(2) **Monitor:** The home was built in an era before weep screeds were installed at the bottom edge of the stucco siding, the stucco was extended into the soil. The stucco wicks water up out of the soil which causes the stucco to deteriorate from being moist for prolonged periods. We recommend minimizing moisture around the building to help protect the stucco and the foundation from moisture damage.

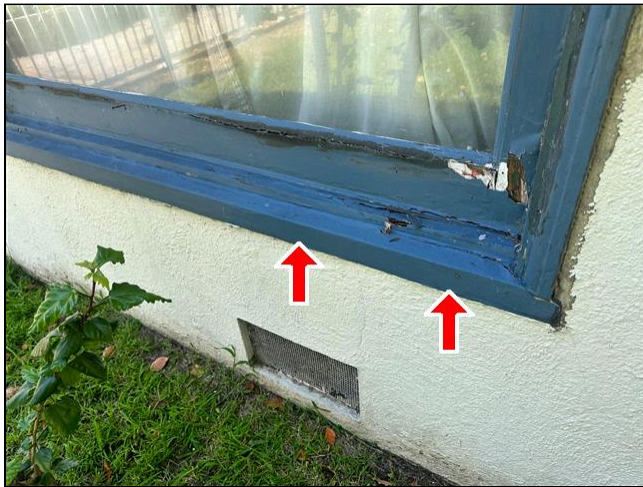
2.2 Item 1 (Picture) Exterior

(1) **Repair or Replace:** There is wood deterioration observed at the front wall window frame. This deterioration can be caused by various factors such as moisture, pests, or age-related wear and tear. It is important to address this issue to prevent further damage. Due to the presence of wood deterioration, it is advisable to have a pest control company inspect the area for any signs of pest activity or infestation. Certain pests can cause significant damage to wood structures. A professional inspection will help determine if pests are present and if further treatment is necessary. It is recommended to hire a licensed contractor experienced in wood repairs and replacements. They will assess the extent of the wood deterioration and provide appropriate recommendations. Depending on the severity of the damage, the contractor may suggest repair techniques such as wood patching, reinforcement, or complete replacement of deteriorated wood components. Please be aware that this report is based on a visual inspection, and it is essential to consult a qualified professional, such as a licensed contractor and a pest control company, for a comprehensive assessment and appropriate repairs.

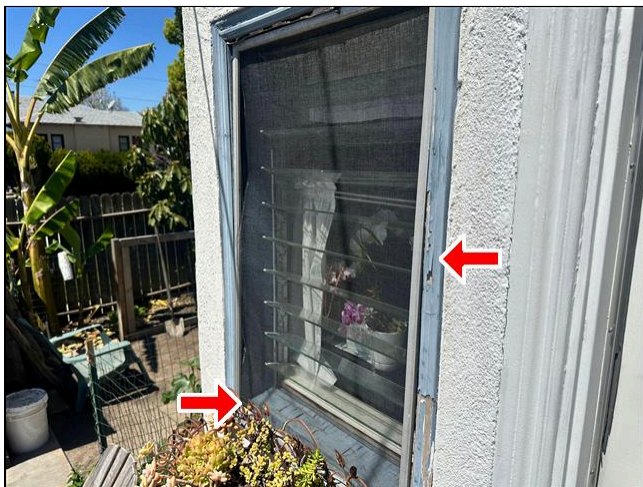
2.2 Item 2 (Picture) Exterior

(2) **Improve:** There is peeling paint at the exterior window frames in several locations. It is suggested that the exterior window frames be caulked and painted by a qualified professional to prevent rot and water intrusion.

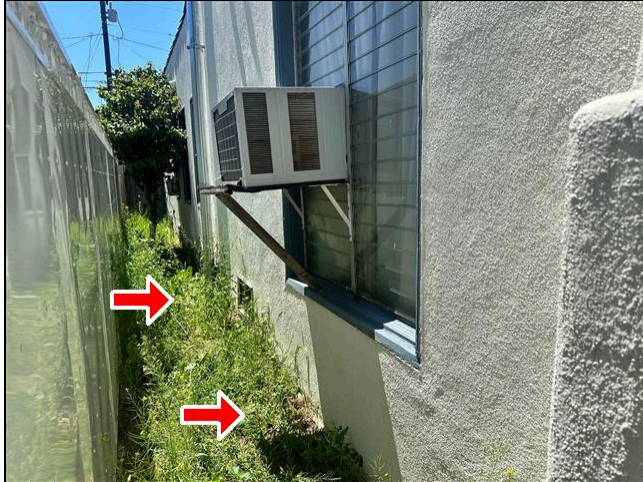
2.3 Item 1 (Picture) Exterior

Improve/Monitor: Low/neutral areas were observed at the grading which will cause water to pond during rain or extended irrigation. Standing water can be detrimental to the integrity of the foundation of the house. It is important to prevent or minimize standing water around the house. Recommend further evaluation by a qualified grading contractor to determine corrections needed.

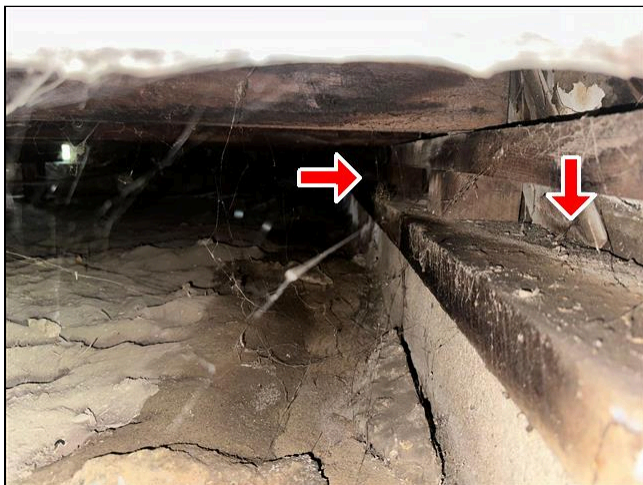
3.0 Item 1 (Picture) Structural Components

(1) **Safety Issue:** No anchor bolts were observed between the sill plate and the foundation walls. Given the age of the home, the installation of anchor bolts was not a requirement at the time of construction; however, their presence is considered best practice in contemporary building standards to enhance structural stability and safety. Without anchor bolts, the house is more susceptible to shifting or movement relative to the foundation during seismic events, which can lead to structural damage. Engage a structural engineer to assess the feasibility of retrofitting the foundation with anchor bolts. The engineer can provide specific recommendations based on the existing condition of the foundation and the structural requirements.

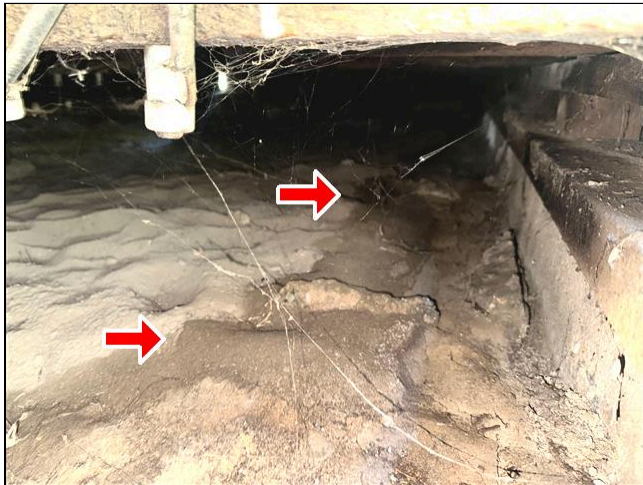
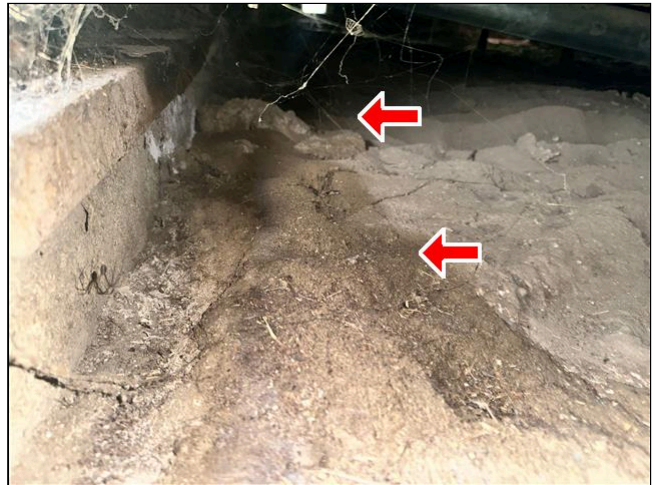
3.0 Item 2 (Picture) Structural Components

(2) **Improve/Monitor:** Visible signs of water intrusion in the crawlspace are present from damp soil was observed along the East wall of the home. Water intrusion can lead to more costly repairs and increase damage if not corrected. If the soil in the crawl space is wet due to poor exterior drainage, or current/past plumbing leaks, it can lead to a number of problems such as mold, mildew, and structural damage. If the cause is determined to be poor exterior drainage, a contractor or engineer may recommend installing additional drainage systems to divert water away from the foundation. It's important to address wet soil in a crawl space as soon as possible, as it can lead to significant structural and safety issues over time. A professional evaluation is crucial to identifying the underlying cause and determining the appropriate course of action to address it.

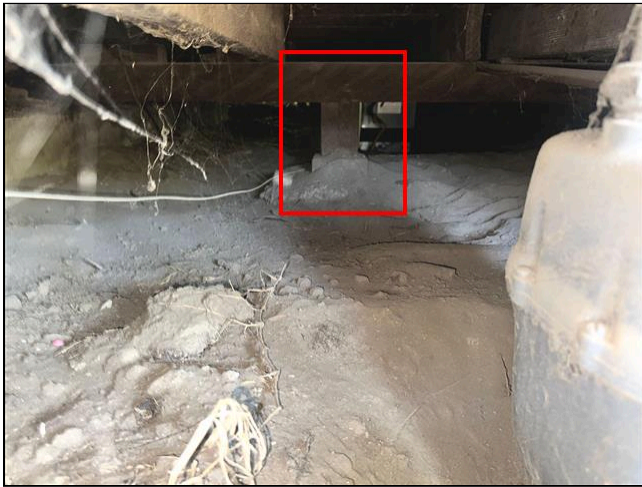
3.2 Item 1 (Picture) Structural Components

Improve: The girder and post connections in the structure do not comply with modern standard building practices regarding reinforcement. This deficiency raises concerns regarding the structural integrity and long-term stability of the building. The connections between the girders and posts, which are critical components in supporting the structure, have not been reinforced according to modern standard building practices. Reinforcement typically includes the use of metal brackets, fasteners, or other approved methods to enhance the connection's strength and stability. Engage the services of a qualified structural engineer who specializes in building construction and reinforcement methods. They can assess the specific connections, evaluate their structural adequacy, and provide recommendations for reinforcing the girder and post connections to meet modern standard building practices.

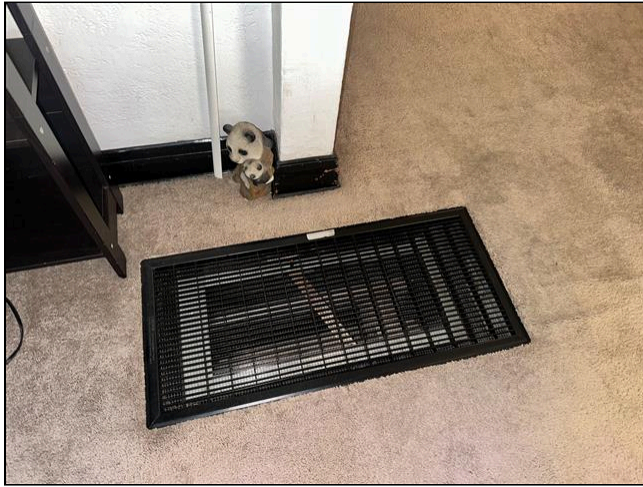
4.0 Item 1 (Picture) Heating/Central Air

Monitor: The floor furnace was operational and produced heat at time of inspection. However, due to the many components that are not visible (such as the heat exchanger and the entire length of the flue pipe), our inspection of the system is limited. Because of this, we recommend further evaluation be performed by the local gas company before the end of your contingency period.

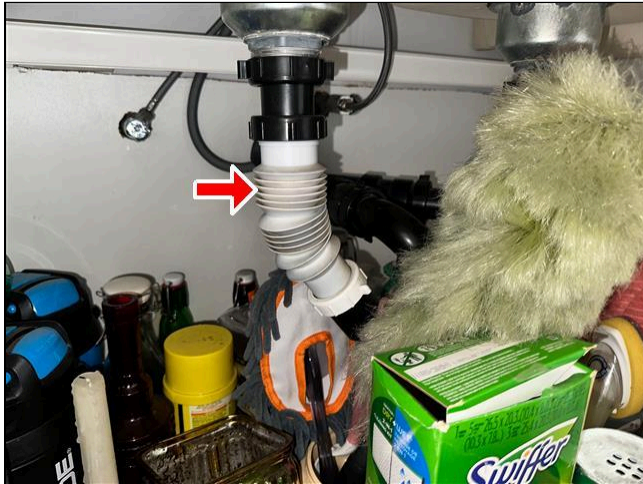
5.0 Item 1 (Picture) Plumbing System

(1) **Repair or Replace:** It is suggested that the accordion type drain at the kitchen sink be replaced with rigid type drain piping by a qualified professional.

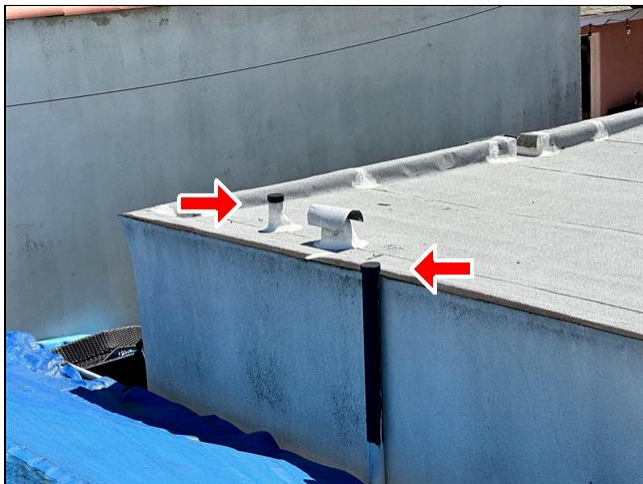
5.0 Item 2 (Picture) Plumbing System

(2) **Improve:** The vents for the plumbing fixtures at the garage have been capped. Suggest removal of the caps for the plumbing vents.

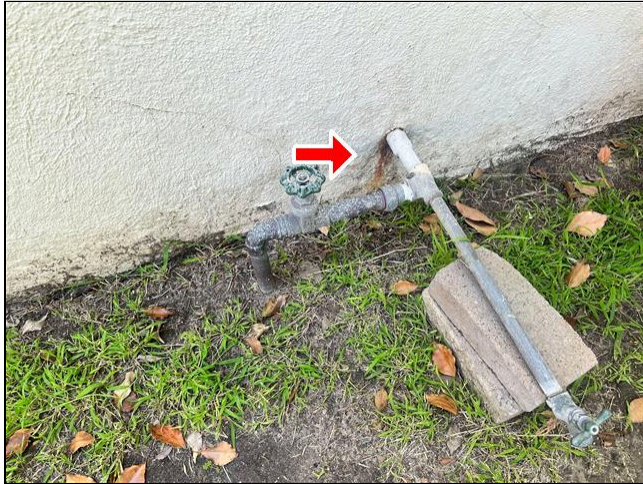
5.1 Item 1 (Picture) Plumbing System

compromise water quality, introducing metal residues and other contaminants into the household water supply. Engage a licensed plumber to install a dielectric union at the connection between the copper and galvanized pipes. This component is designed to prevent galvanic corrosion by providing electrical insulation between the two different metals. Have the plumber assess the extent of corrosion and damage. Replace any compromised sections of the pipe to ensure the integrity and reliability of the water supply system.

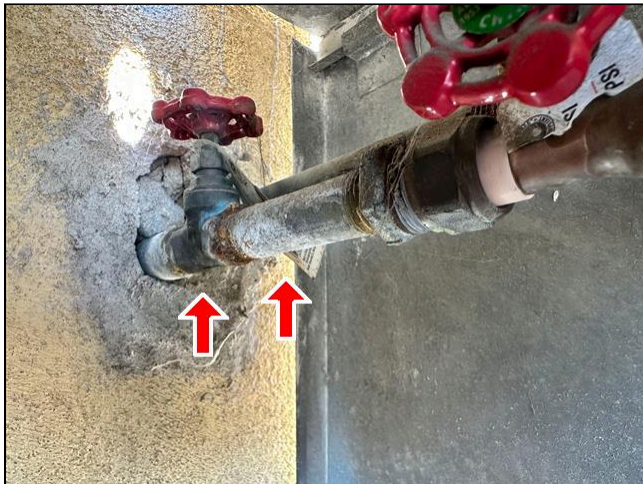
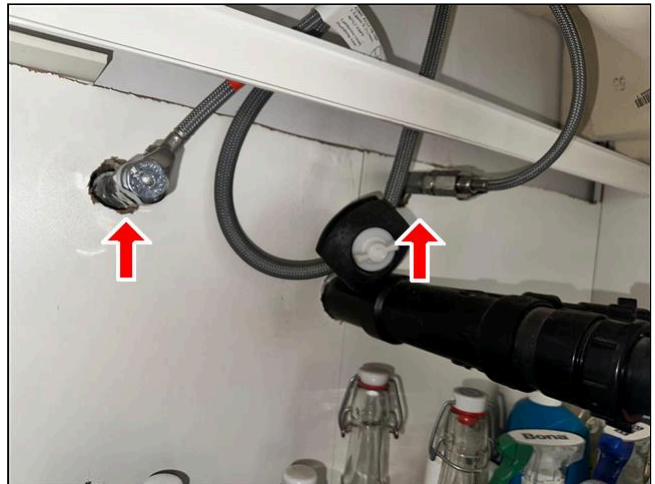
5.1 Item 2 (Picture) Plumbing System

(2) **Repair or Replace:** Galvanized steel pipes are used in the interior water supply, and generally have a finite life span. The quality of the plating, installation methods, water temperature, water quality and water usage all factor into the actual serviceable life. Scale builds up inside the pipe which eventually restricts the flow of water to the fixtures. Corrosion eats away at the inside of the pipes, eventually causing leaks. Thirty to forty years is the average life of galvanized pipes. Replacement of the galvanized steel supply pipes will eventually be required. Note: There is visible debris, and possible metal flakes, when water is run to the sinks in the home. The makeup of this debris is unknown.

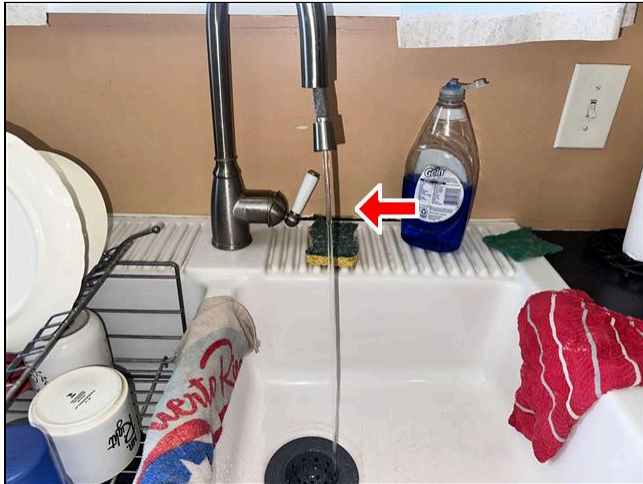
5.1 Item 4 (Picture) Plumbing System

Although some copper tubing has been employed as part of the water supply system, it is suggested that all galvanized steel water supply pipes be replaced by a licensed contractor.

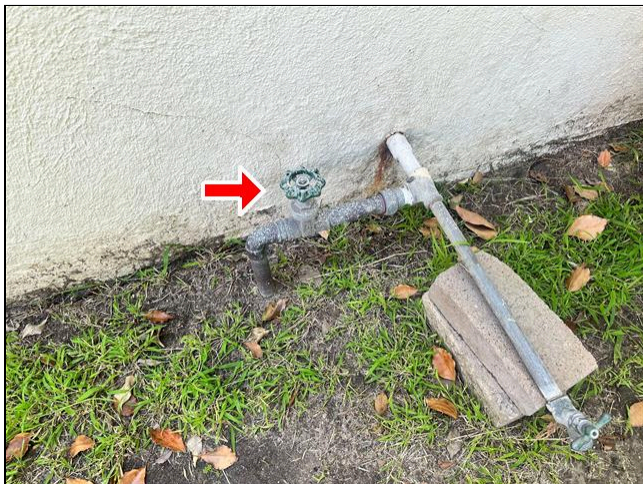
5.1 Item 5 (Picture) Plumbing System

(4) **Improve:** It is suggested that the older main water shut off valve at the front exterior wall of the home replaced with a quarter turn ball valve type by a licensed plumber.

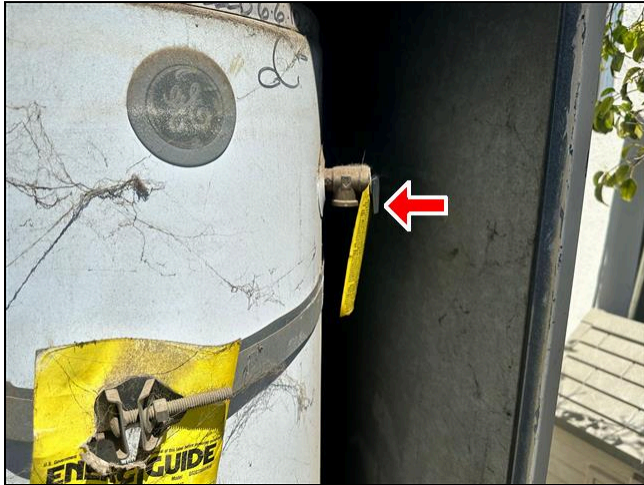
5.2 Item 1 (Picture) Plumbing System

(1) **Safety Issue:** The Temperature and Pressure Relief valve at the water heater needs a 3/4 pipe to extend within 6 to 24 inches of floor for safety. PVC is not approved for hot water use. Recommend repair by a qualified person.

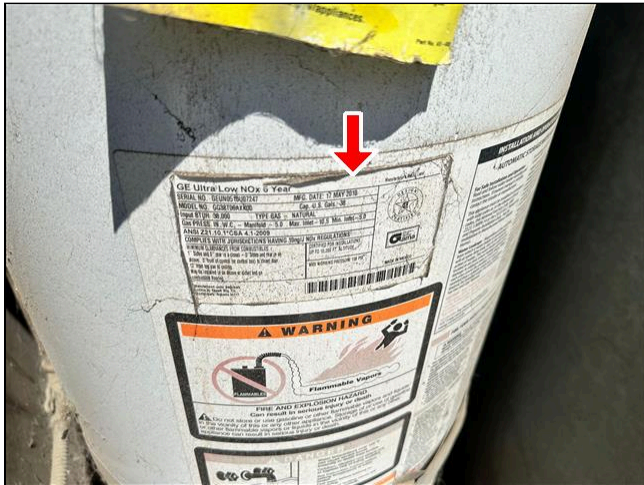
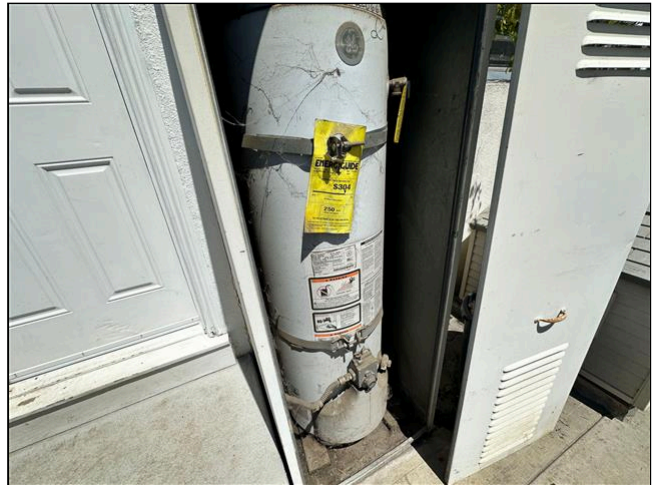
5.2 Item 2 (Picture) Plumbing System

(2) **Repair/Replace/Monitor:** The water heater is an older unit. The water heater may be nearing the end of its service life. Typical life expectancy of water heaters is 7 to 12 years. The existing unit is 14 years old. It is difficult to determine when replacement will be necessary. Suggest replacement of the water heater by a licensed and qualified plumber.

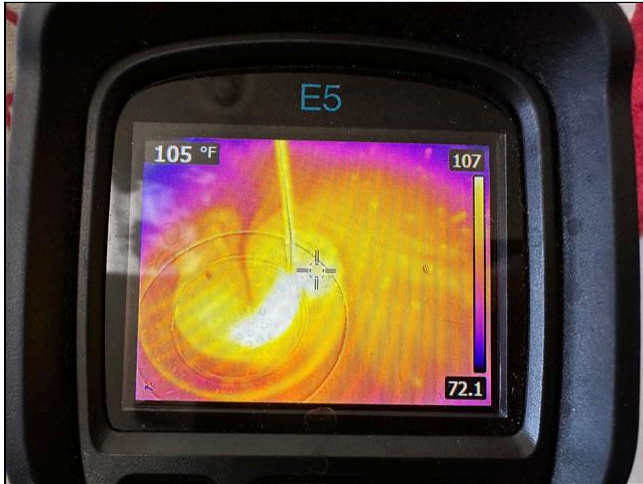
5.2 Item 4 (Picture) Plumbing System

(3) **Note/Monitor:** The water heater was operational and produced hot water at time of inspection.

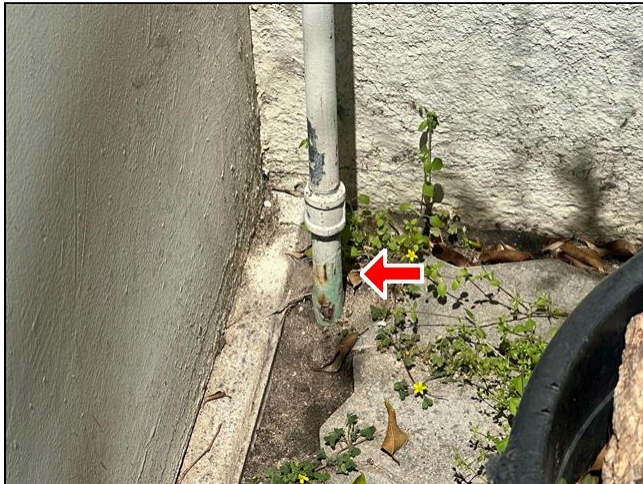
5.4 Item 1 (Picture) Plumbing System

(1) **Safety Issue:** The gas supply pipe that runs through the ground at the rear exterior wall of the home was found to be corroded and rusted. This condition is observed on the exposed sections of the piping as it passes through the ground. Engage a licensed plumber or a certified gas fitter to conduct a thorough inspection of the entire gas supply line to assess the extent of the corrosion and determine the integrity of the pipe.

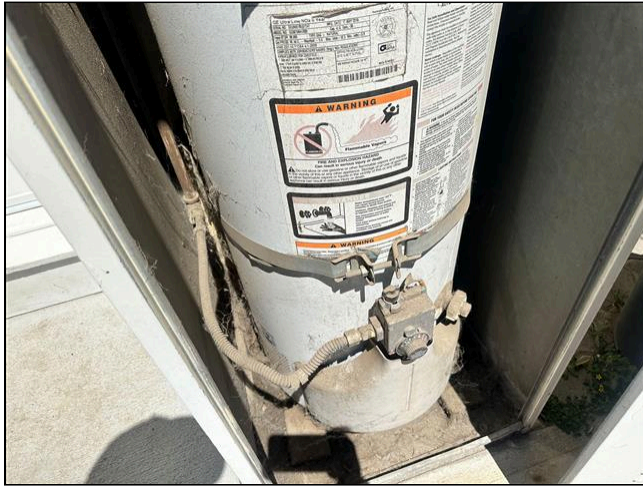
5.4 Item 2 (Picture) Plumbing System

your area. In many jurisdictions, including the United States, a sediment trap is commonly required for gas-fired appliances, including water heaters. It is recommended to have a qualified professional, such as a licensed plumber or gas technician, install the sediment trap according to the manufacturer's instructions and local code requirements to ensure proper operation and safety of the water heater.

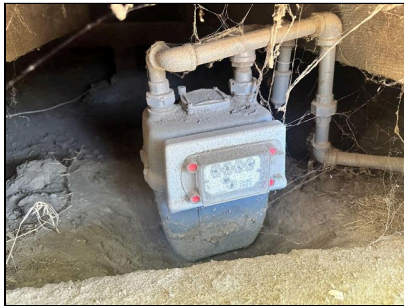
5.5 Item 2 (Picture) Plumbing System

(2) **Improve:** The main gas meter at the property lacks a seismic shut-off valve. It was observed that there is no seismic shut-off valve installed for the main gas meter. Seismic shut-off valves are designed to automatically shut off the gas supply in the event of a seismic event (earthquake), reducing the risk of gas leaks and associated hazards. To enhance the safety of the property, it is strongly recommended that a licensed plumber or qualified professional install a seismic shut-off valve for the main gas meter. This valve is an important safety feature, especially in regions prone to seismic activity, and can help prevent gas leaks and potential fire hazards during earthquakes. The installation of a seismic shut-off valve should be carried out in accordance with local building codes and regulations. Homeowners should consult with a licensed plumber or gas service provider to ensure compliance and proper installation.

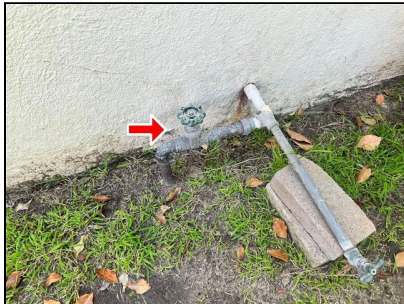
5.6 Item 1 (Picture) Plumbing System

Inspected: The main water shut off valve is located at the front wall of the home.

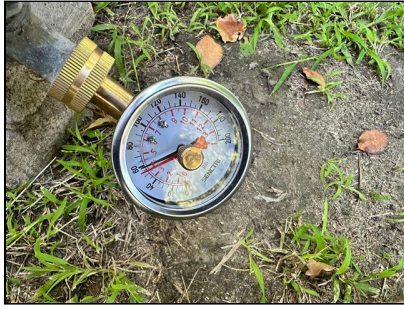
5.8 Item 1 (Picture) Plumbing System

Monitor: 60 PSI

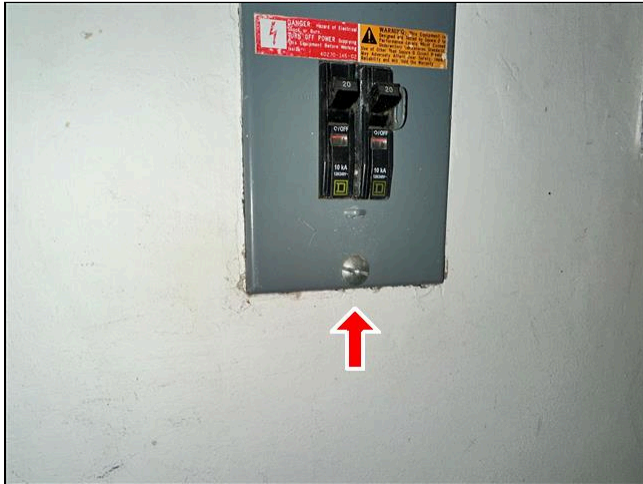
6.0 Item 1 (Picture) Electrical System

Monitor: Unable to remove the screw for the electrical subpanel during the inspection. Unable to remove the cover panel.
