Professional
Inspection Network

INSPECTION REPORT
3402 Liberty Blvd
South Gate CA 90280

INSPECTION DATE
📅 4/16/2024
🕒 12:30 PM

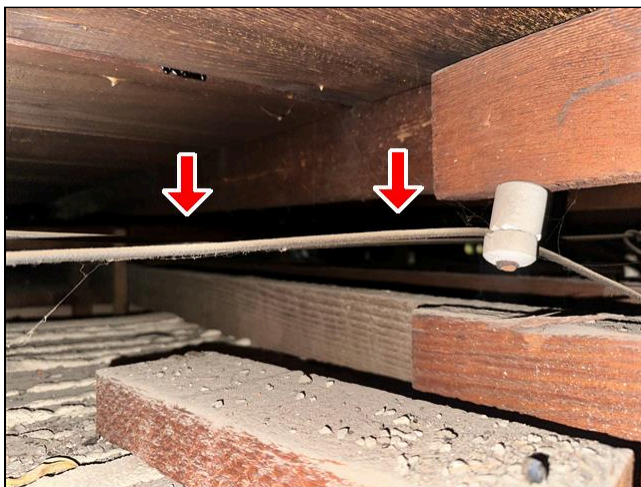
6.1 Item 1 (Picture) Electrical System

Safety Issue: Older Knob and Tube wiring was observed at the attic space and crawl space of the home where visible. Extra care should be taken with this type of wiring. It is suggested that all Knob and Tube wiring be replaced with newer wiring by a licensed electrician due to the several safety concerns that the wiring poses. Knob and Tube wiring was observed at the attic space of the home. Knob and tube wiring, sometimes referred to as just K&T, is a type of electrical wiring seen in homes built in the late 1800s and early 1900s. It uses a system of copper conductors, which are run through tubes and held down with porcelain knobs. Unlike modern electrical systems, they have no ground wire. Also, the insulation can become brittle and make repairs difficult. Extra care should be taken with this type of wiring. A qualified electrician should inspect the Knob and Tube wiring to provide you with replacement options and costs.

- 12. Safety Issue:** Older Knob and Tube wiring was observed at the attic space and crawl space of the home where visible. Extra care should be taken with this type of wiring. It is suggested that all Knob and Tube wiring be replaced with newer wiring by a licensed electrician due to the several safety concerns that the wiring poses. Knob and Tube wiring was observed at the attic space of the home. Knob and tube wiring, sometimes referred to as just K&T, is a type of electrical wiring seen in homes built in the late 1800s and early 1900s. It uses a system of copper conductors, which are run through tubes and held down with porcelain knobs. Unlike modern electrical systems, they have no ground wire. Also, the insulation can become brittle and make repairs difficult. Extra care should be taken with this type of wiring. A qualified electrician should inspect the Knob and Tube wiring to provide you with replacement options and costs.

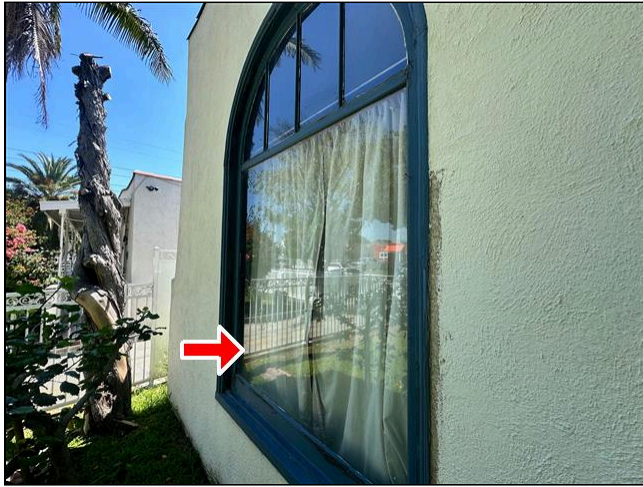
8.3 Item 1 (Picture) Interiors

Safety Issue: The window at the front wall of the home does not appear to be shatter proof/tempered glass. This is common in many older homes. The current building standards require that all glass located within 18-inches from a floor surface should be shatter proof/tempered glass. It is suggested that the windows be replaced or covered with a clear safety film to protect the occupants of the home.

17. **Safety Issue:** The window at the front wall of the home does not appear to be shatter proof/tempered glass. This is common in many older homes. The current building standards require that all glass located within 18-inches from a floor surface should be shatter proof/tempered glass. It is suggested that the windows be replaced or covered with a clear safety film to protect the occupants of the home.

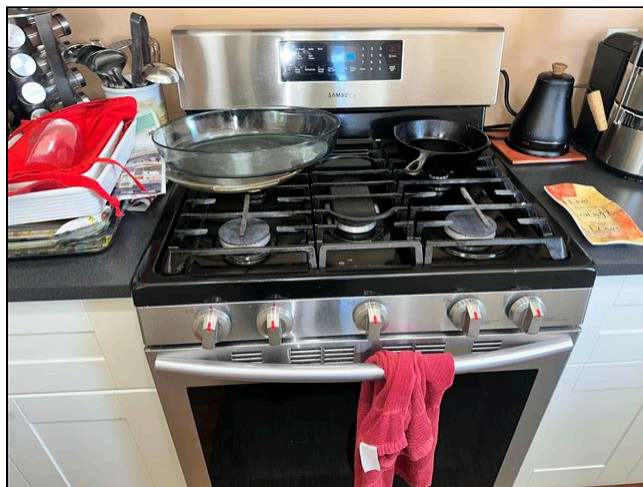
9.1 Item 1 (Picture) Appliances

Safety Issue: The stove at the kitchen lacks an anti-tip bracket. An anti-tip bracket is an important safety feature that helps prevent the stove from tipping over, especially in situations where excessive weight or force is applied to the open oven door or if a child were to climb or hang on the stove. The absence of an anti-tip bracket increases the risk of the stove tipping over, which can result in serious accidents or injuries. It is recommended to have anti-tip brackets installed for each stove to enhance the safety of the property. It is advisable to consult with a qualified professional or appliance technician to properly install the appropriate anti-tip brackets for the stoves. They can ensure that the brackets are correctly attached to the stove and securely anchored to the floor or wall, following the manufacturer's guidelines and local building codes. Improving the safety features of the stoves by installing anti-tip brackets is an important step in preventing accidents and promoting the well-being of the occupants.

- 18. Safety Issue:** The stove at the kitchen lacks an anti-tip bracket. An anti-tip bracket is an important safety feature that helps prevent the stove from tipping over, especially in situations where excessive weight or force is applied to the open oven door or if a child were to climb or hang on the stove. The absence of an anti-tip bracket increases the risk of the stove tipping over, which can result in serious accidents or injuries. It is recommended to have anti-tip brackets installed for each stove to enhance the safety of the property. It is advisable to consult with a qualified professional or appliance technician to properly install the appropriate anti-tip brackets for the stoves. They can ensure that the brackets are correctly attached to the stove and securely anchored to the floor or wall, following the manufacturer's guidelines and local building codes. Improving the safety features of the stoves by installing anti-tip brackets is an important step in preventing accidents and promoting the well-being of the occupants.

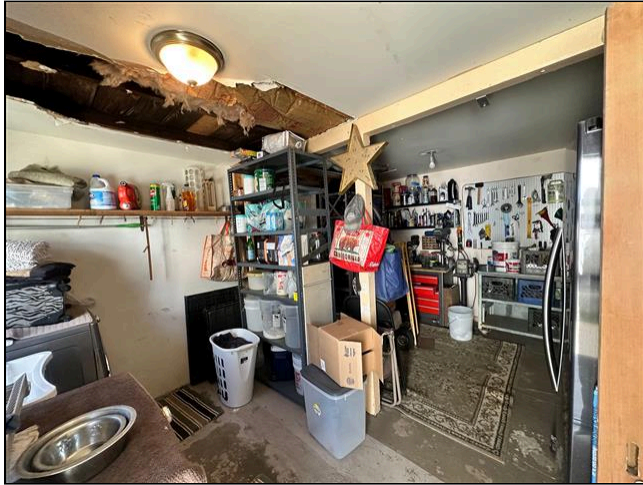
10.4 Item 2 (Picture) Garage

(2) **Monitor:** The occupants belongings at the garage prevents full view.

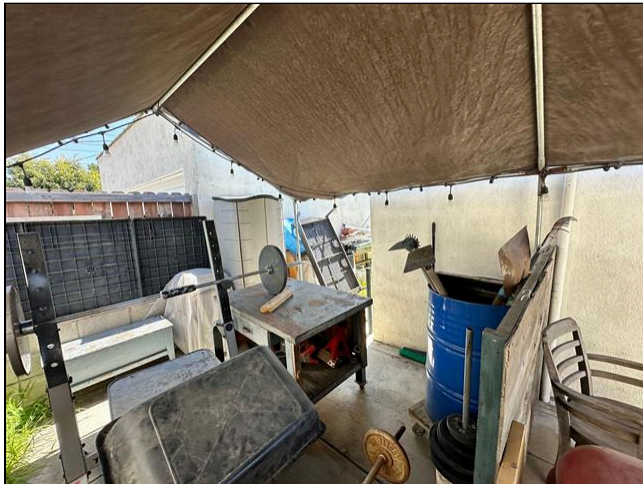
10.6 Item 1 (Picture) Garage

Monitor: Unable to access the rear exterior wall of the garage.
