**Service:** Full Home Inspection

**Prepared for:** Stella Chapman

Site Address: 1150 3rd Street, Gilroy, CA, 95020

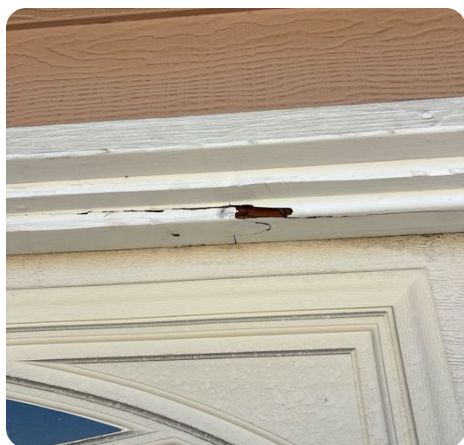
### 1 Minor Trim Damage

The area has minor trim damage. It is recommended to evaluate and repair the damaged trim to prevent further deterioration. A qualified carpenter can help repair the trim as needed.

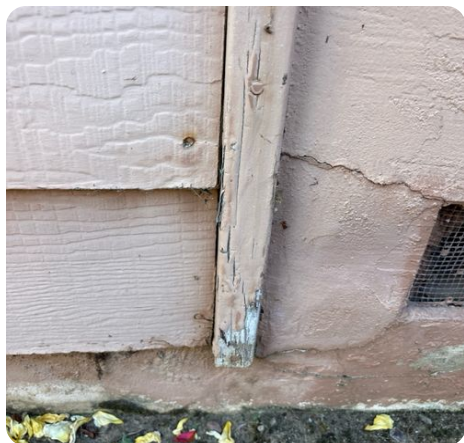
### 2 Chipping And Peeling Paint

The exterior of the structure has chipping and peeling paint. The inspector recommends further evaluation and repainting by a qualified painter who will properly prepare the surface, sand, apply primer and apply fresh coats of paint.

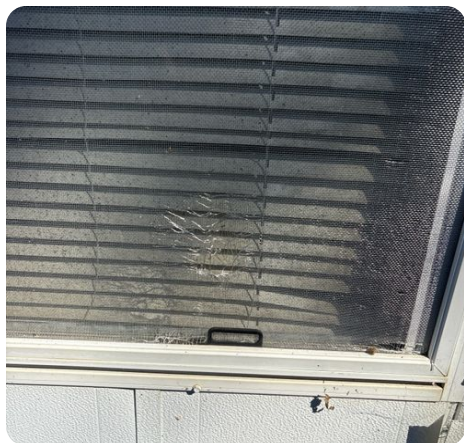
### 3 Damaged Window Screen

One or more of the window screens were damaged or not seated properly within the window frame. Repairing/replacing the damaged screens is recommended. Evaluation and repair by a qualified window professional is advised.

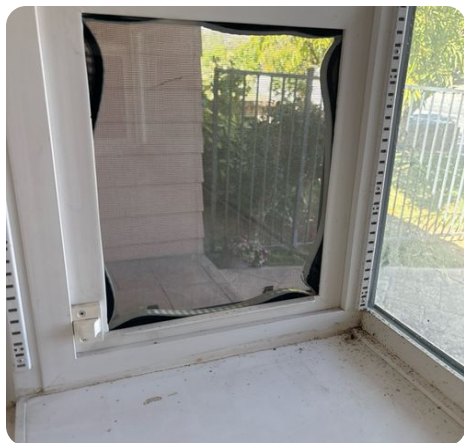
#### 4 Rubber Seal Displacement

The rubber seal between the window panes is displaced. This is a cosmetic issue however, this can lead to air and water leaks and reducing energy efficiency. It is recommended to repair or replace the rubber seal to ensure proper insulation and protection against the elements.

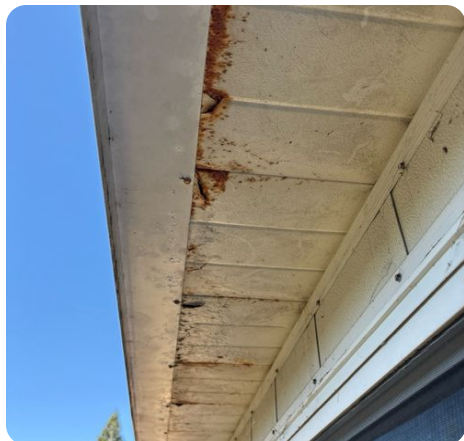
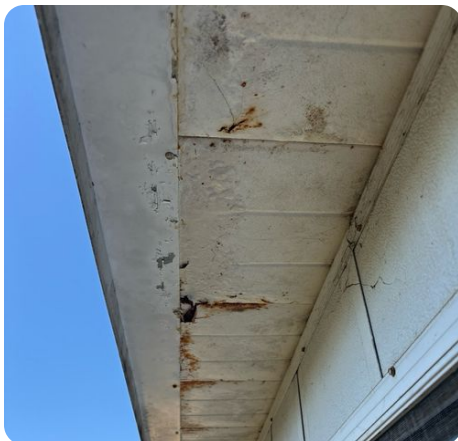
#### 5 Rust On Metal Roof Eaves

The metal roof eaves are showing signs of rust indicating possible leaks or elevated moisture levels. This issue can lead to structural deterioration if not addressed, affecting the integrity of the eaves over time. It is recommended to evaluate and repair the rusted areas to prevent further corrosion and maintain the functionality of the eaves. A qualified roofer should assess the extent of the rust and recommend appropriate treatment.

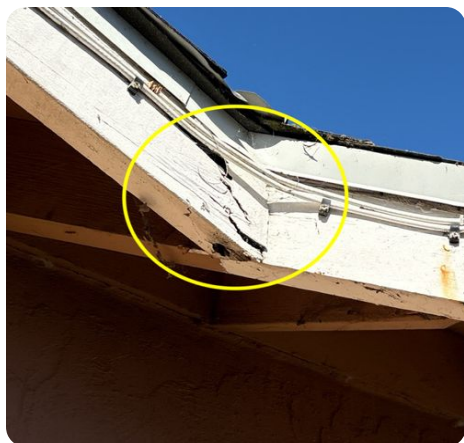
**6 Damaged Fascia Board**

The fascia boards on the exterior of the structure have moisture damaged. Refer to a recent pest report or contact a qualified contractor for proper repair.

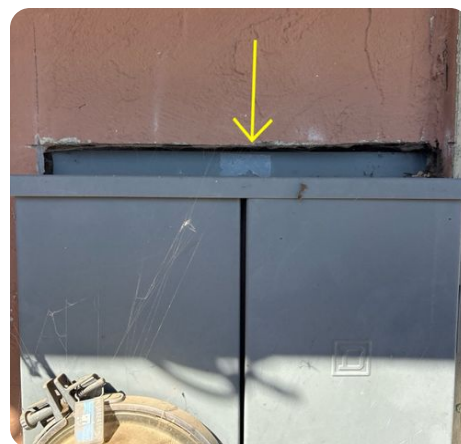
**7 Void Around Electrical Panel**

The void around the electrical panel should be filled to prevent potential entry points for pests or moisture infiltration. This issue can lead to safety hazards and should be addressed promptly. It is recommended to consult a qualified electrician to evaluate and seal the void effectively.

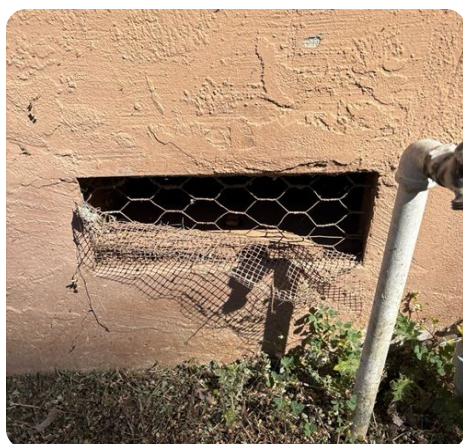
## 8 Damaged Vent Screen

There is a damaged vent screen at the structure which should be replaced/repaired. Tight vent screens should be provided to allow proper ventilation to the area, and to prevent pests from entering. Appropriate repairs are recommended.

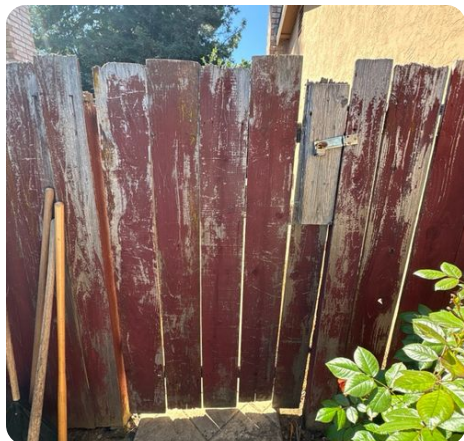
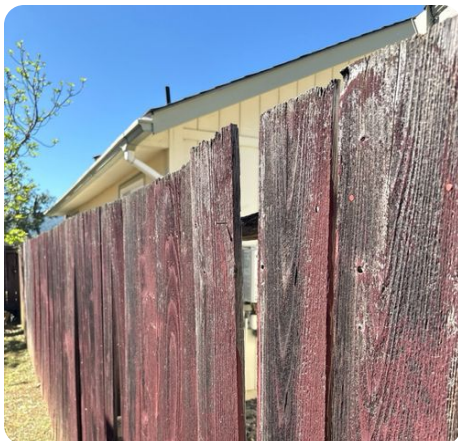
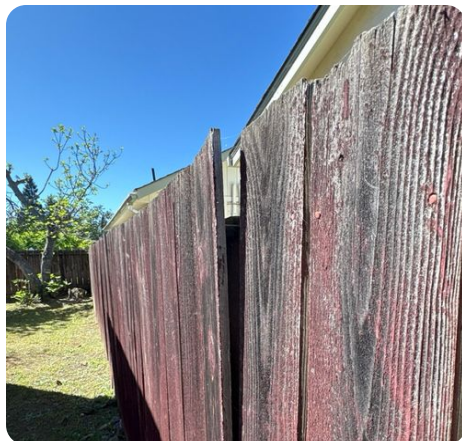
## 9 General Fence Damage Observed

Damage was observed on the property's fences, such as loose or missing boards, broken or leaning posts, and signs of rot or decay. To maintain the integrity and security of the fences, it is advisable to assess and fix the affected areas as required. If necessary, a qualified fence contractor should be reached out to for further assessment and repairs.

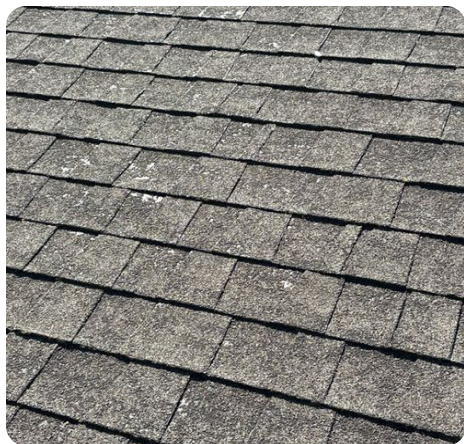
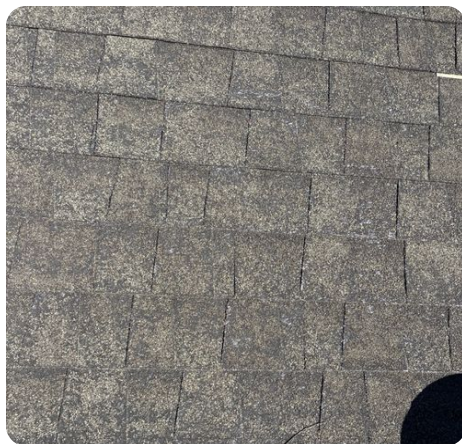
The roof covering is showing signs of granule loss and exposed fibers, indicating normal wear and aging. There appears to be serviceable life remaining. Further assessment and recommendations for future replacement by a qualified roofing company may be considered.

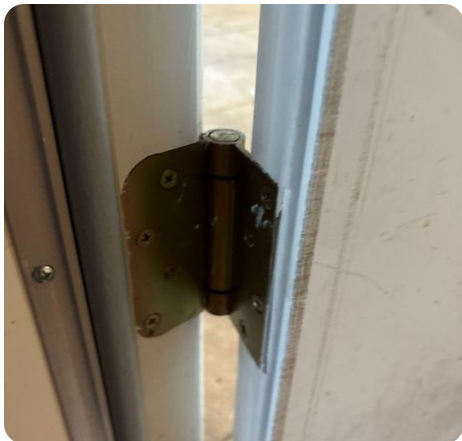
📍 Location: **Garage/House Door**

The spring hinge on the garage door to the structure is not adjusted to allow for automatic closure. Adjusting or replacing the spring-loaded hinge is recommended to provide the intended firewall safety function between the living area and the garage. It is suggested to contact a qualified professional for this maintenance.

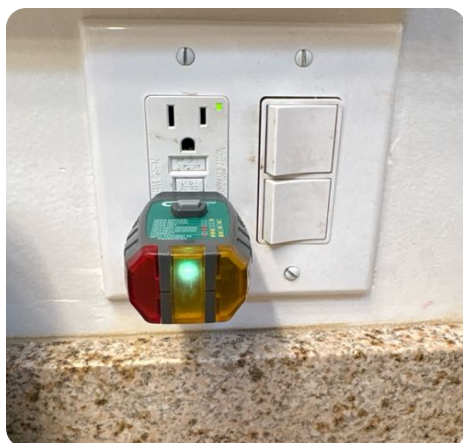
The GFCI receptacle is ungrounded, indicating it is not connected to the grounding system. While ungrounded GFCIs can offer some safety protection in older services, updating the wiring to include a ground is recommended to enhance overall safety. Grounding is crucial for electrical safety as it helps prevent electrical shocks. It is advised to contact a qualified electrician to discuss potential options for upgrading the service.

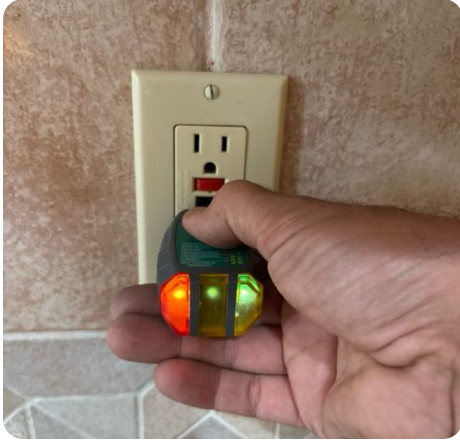
**18 GFCI Receptacle Failed Test**

The GFCI receptacle did not operate properly or 'trip' when tested. GFCI receptacles are designed to protect against electrical shock and should be in proper working condition. It is recommended to have a qualified electrician evaluate and repair or replace the receptacle.

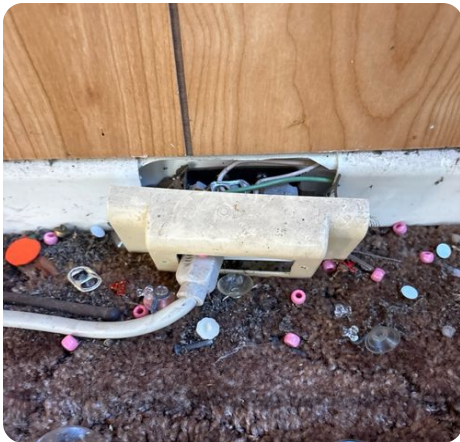
**19 Loose Outlet**

There is a loose outlet in the home which could lead to connectivity issues and pose a safety hazard. It is recommended to evaluate and repair the outlet as soon as possible. A qualified electrician should be contacted to properly address and fix the loose outlet to ensure safety and functionality.

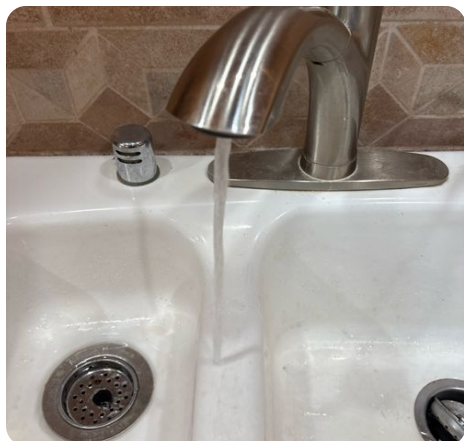
📍 Location: Kitchen

The water pressure is low, noticeable at faucets and fixtures. This may indicate a blocked supply line, a faulty pressure regulator, or an issue with the municipal water supply. Repair is suggested to restore normal water flow. Consider contacting a qualified plumber for further assessment and necessary repairs.

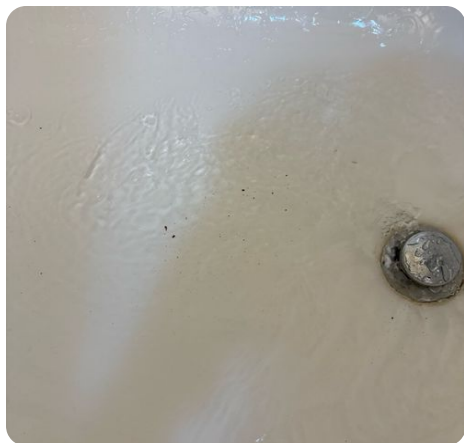
The presence of black sediment in the water supply can indicate the deterioration of pipes or the water heater lining. It is recommended to have a licensed plumber evaluate the water piping system to identify the source of the sediment and take appropriate measures to address it, such as cleaning or replacing affected components. Regularly flushing the water heater and conducting maintenance can help prevent further buildup of sediment. ALSO NOTED-The water pressure was low, noticeable at some of the interior fixtures. This could be due to clogged screens, clogged orifices and/or issues with the well system. Repair is suggested to restore normal water flow. Consider contacting a qualified plumber for further assessment.

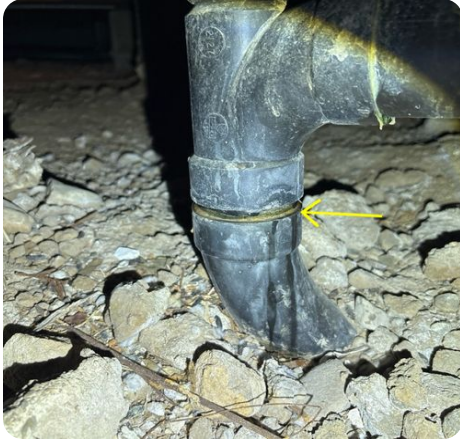
27 Waste Plumbing Leak

The waste plumbing system is experiencing leakage. Evaluate and repair the leak to prevent further issues. It is recommended to hire a licensed plumber for this repair to ensure it is properly fixed.

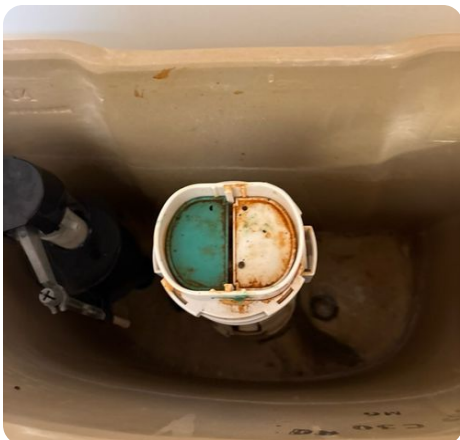
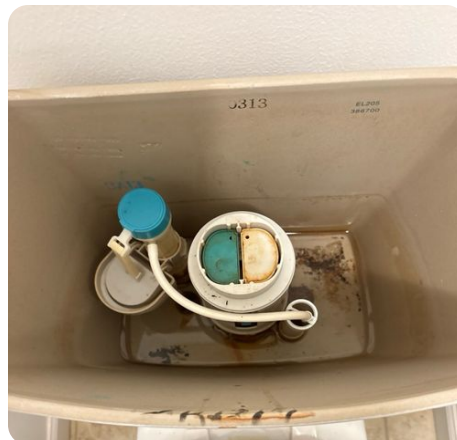
28 Defective Tank Valve In Toilet

The tank valve in the toilet is defective, leading to issues with flushing. This can result in inconsistent flushing or no flushing at all, causing inconvenience and disruption to normal usage. It is recommended to have a qualified plumber evaluate and repair the tank valve to ensure proper functioning of the toilet.

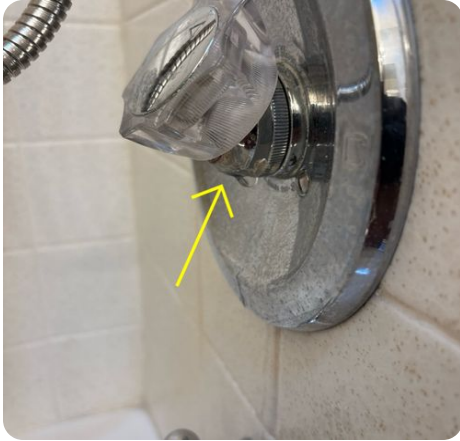
29 Tub Valve Leak

The tub valve is experiencing a leak when in the off position. It is recommended to evaluate and repair this leak to prevent further issues. Contact a licensed plumber to address this issue and ensure proper functioning of the tub valve.

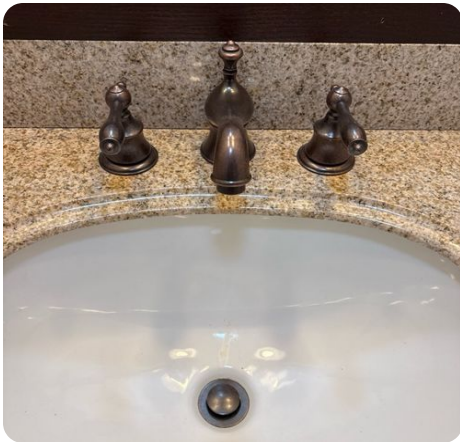
**30 Low Or No Flow At Vanity Faucet**

The issue is a low or no flow at the vanity faucet. This can be caused by a clogged aerator, issues with the water supply valves, or sediment buildup in the faucet. It is recommended to check and clean the aerator, inspect the water supply valves for any blockages, and consider flushing the faucet to remove sediment. If the problem persists, a licensed plumber should evaluate and repair the faucet to restore proper water flow.

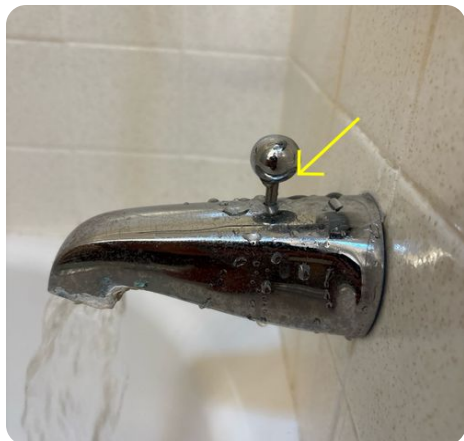
**31 Diverter Valve**

The diverter valve is in need of repair. A malfunctioning diverter valve can result in inadequate water flow or difficulty switching between fixtures. It is recommended to have a qualified plumber repair the fixture to ensure proper functioning and to avoid any water flow issues in the future.

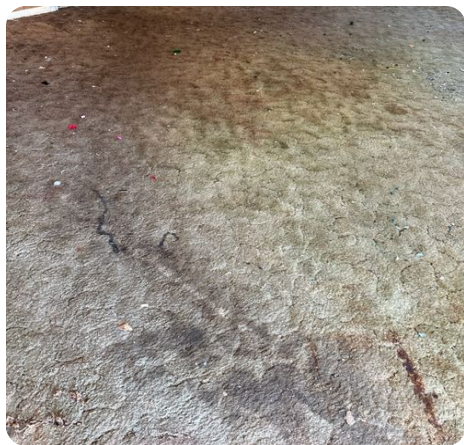
### 32 Carpet Stains And Damage

The carpet shows significant staining and damage. It is recommended to evaluate the extent of the damage and consider repairing or replacing the carpet to improve the overall appearance and comfort of the space.

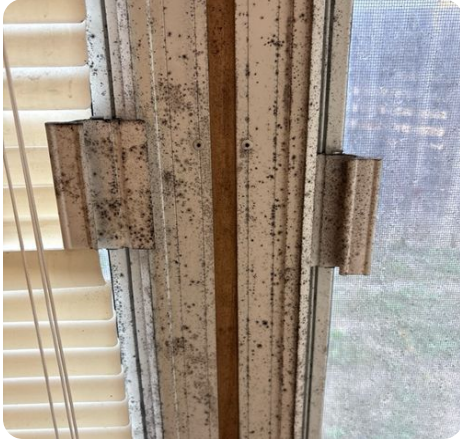
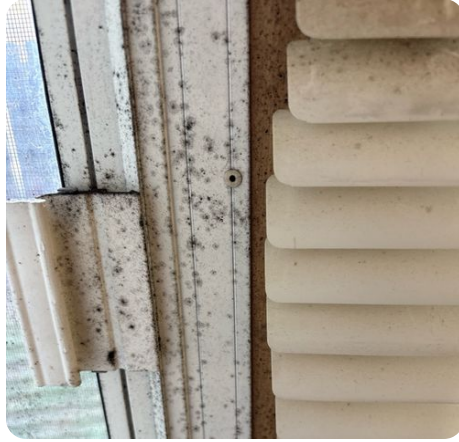
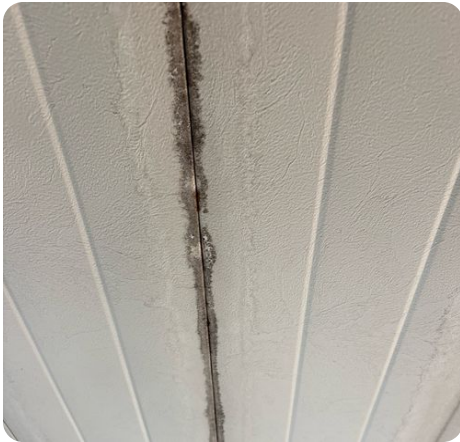
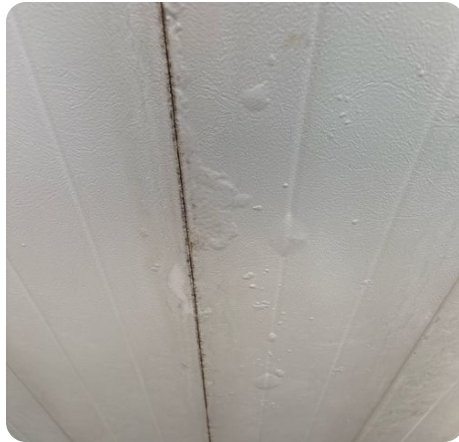
### 33 Microbial Stains Noted

The presence of possible microbial stains has been observed in the specified area. Testing by a lab would be needed to determine if it is microbial growth and what type. It is recommended to evaluate the extent of the issue and consider repair if necessary to prevent further growth and maintain a healthy indoor environment. A qualified mold remediation specialist should be contacted for further assessment and appropriate treatment.

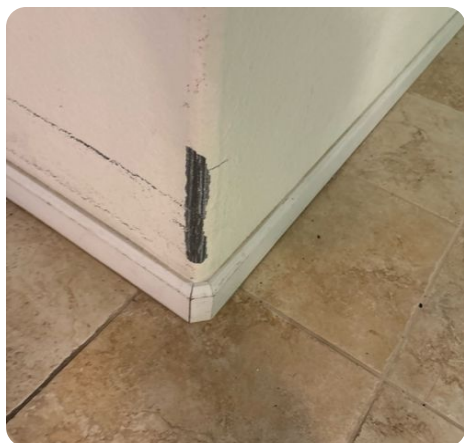
**35 Wall Damage**

The interior walls show signs of damage. It is recommended to evaluate the extent of the damage and repair to prevent further deterioration. A qualified contractor can assess the cause and make necessary repairs to restore the wall to its proper condition.

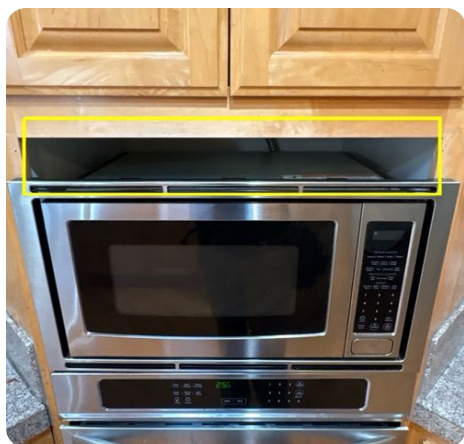
**37 Missing Cabinet Trim**

The cabinet trim is missing, which can detract from the overall aesthetic appeal of the cabinets. It is recommended to have a qualified specialist install the missing trim to provide a finished look.

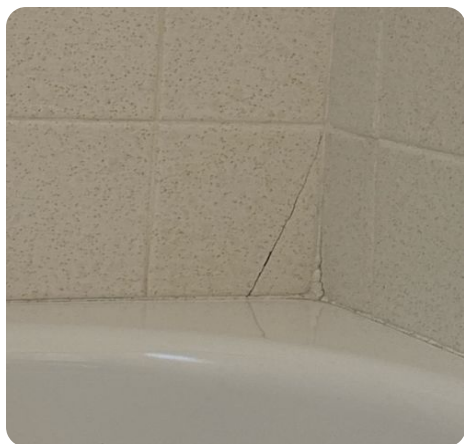
The shower tile is cracked on the step up at the entrance way. Repair by a tile specialist recommended. The inspector cannot determine if any water damage was present below the tile. A more invasive inspection would be needed to make this determination.

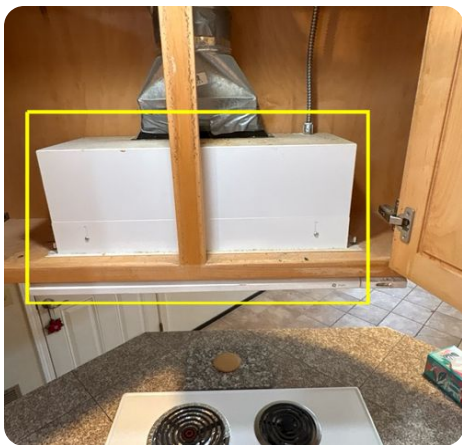
The stove exhaust at the cooktop did not function. Questioning the seller as to its operation and functionality is suggested. It is recommended to evaluate and repair the exhaust fan for intended use and ventilation in the event that smoke is produced from cooking. A qualified appliance specialist should be consulted for further evaluation and repair.

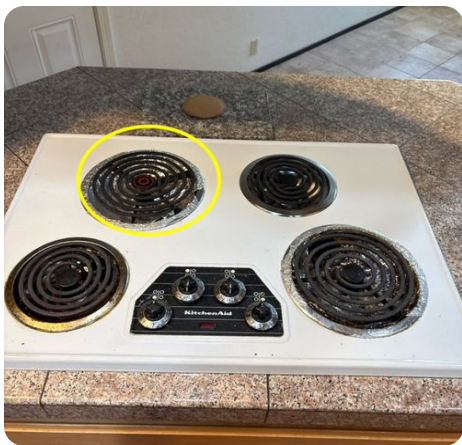
### 42 Non-Functioning Stove Top Burner

The stove top burner is not working properly. We recommend evaluating and repairing the burner to ensure all burners are functioning correctly. This issue can impact the cooking ability and efficiency of the stove. It is recommended to have a appliance repair technician inspect and repair the non-working burner.

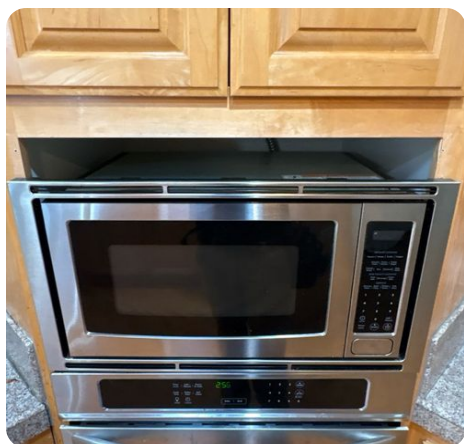
### 43 Not Functional

The microwave oven was not functional. It is recommended to have any necessary repairs done by a qualified professional and verify functionality before closing.

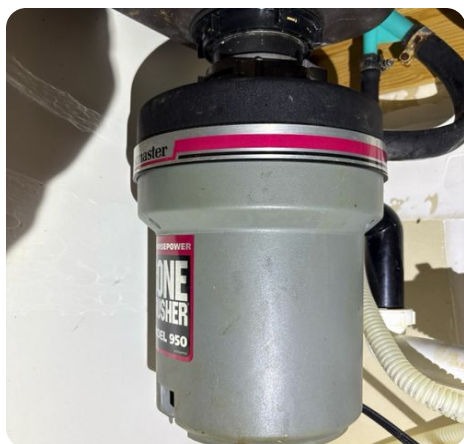
**44 Garbage Disposal Not Functional**

The garbage disposal was not functional at the time of the inspection. The unit may be jammed or need repairs. Contact a qualified professional to make needed repairs or replace the disposal.

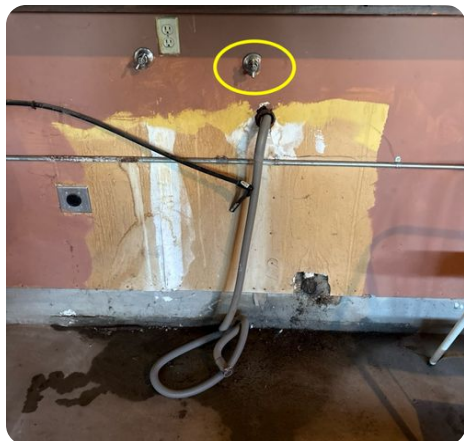
**45 Active Leak**

An active drip leak was observed at the clothes washer valves. Repair is recommended to prevent possible water damage.

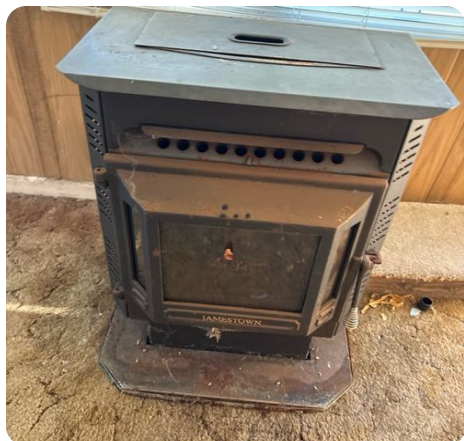
### 46 Pellet Stove Not Tested

The pellet stove was not tested. It is recommended to have a qualified technician evaluate the pellet stove to ensure it is functioning properly and safely before regular use. Regular maintenance and cleaning of the pellet stove are also recommended to prevent potential issues.

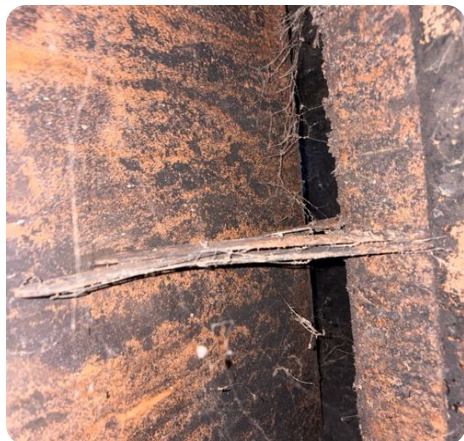
### 47 Chimney Flue Cleaning Recommended

The chimney flue should be cleaned. It is recommended to have a qualified chimney sweep clean the chimney flue to ensure proper ventilation and prevent any potential fire hazards. Regular cleaning also helps in maintaining the efficiency of the fireplace.

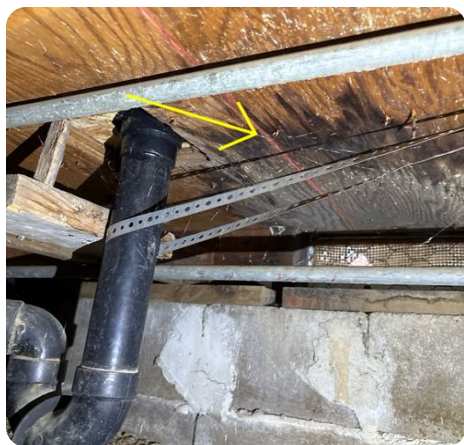
The presence of moisture stains on the floor structure indicates possible water intrusion. It is recommended to evaluate the source of the moisture and repair any leaks to prevent further damage to the structural integrity of the floor. Refer the recent pest inspection reports for further details and recommendations.

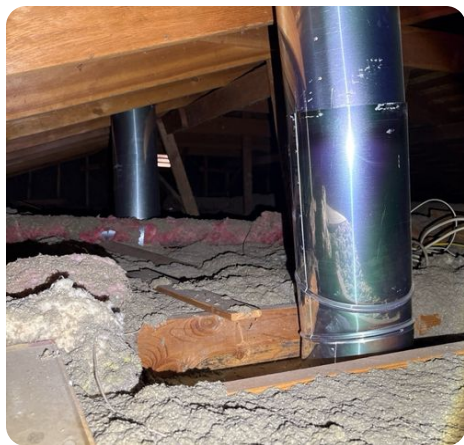
The insulation in the attic has settled and become matted, which can result in reduced energy efficiency. It is recommended to evaluate and repair by adding more insulation to ensure proper coverage and maximize the insulation's effectiveness. A qualified insulation contractor can assess and add more insulation as needed to improve energy efficiency.

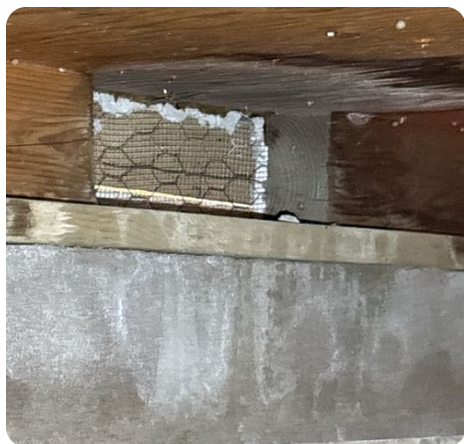
### 51 Crawl Space Ventilating Into Room Addition

The crawl space ventilating into the room addition is a concerning issue as it can lead to poor indoor air quality and potential health hazards. This situation can also cause temperature imbalances and moisture problems in the room addition. It is recommended to consult with a qualified HVAC professional to evaluate and repair the crawl space ventilation system to ensure proper ventilation and prevent further issues.

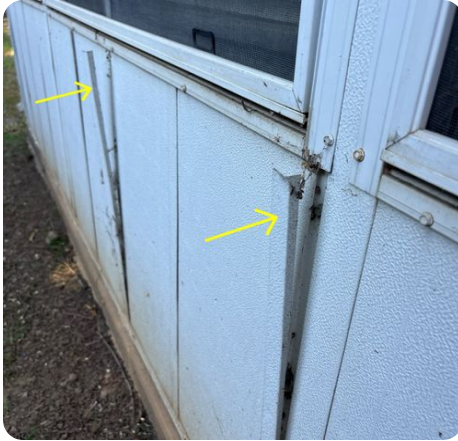
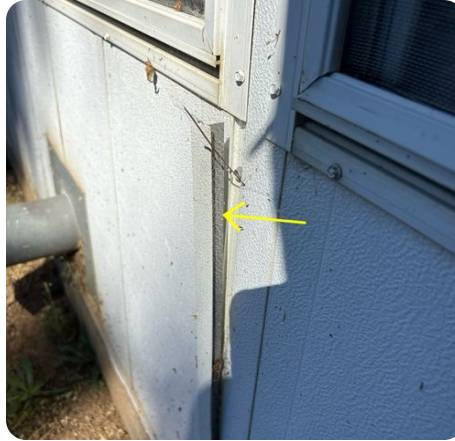
📍 Location: Back of Home

The metal trim on the exterior of the property is loose. This can lead to water penetration and further damage if not addressed. It is recommended to secure or repair the loose metal trim to prevent any potential issues in the future.

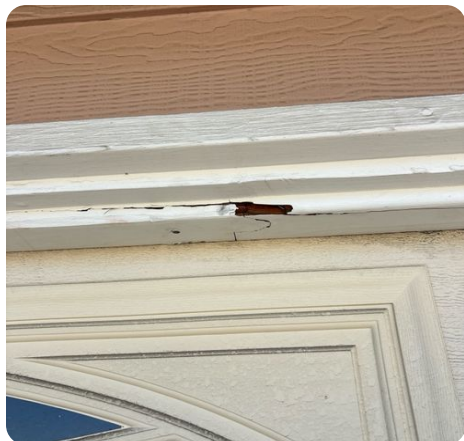
#### Minor Trim Damage

The area has minor trim damage. It is recommended to evaluate and repair the damaged trim to prevent further deterioration. A qualified carpenter can help repair the trim as needed.

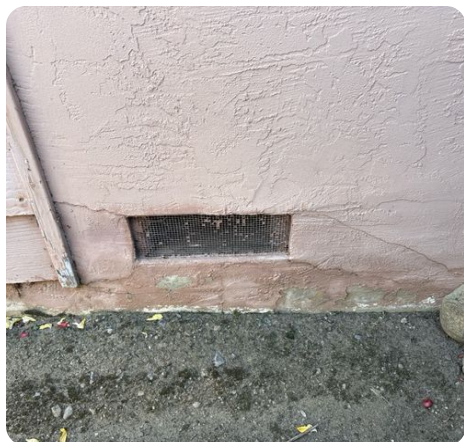
The stucco shows minor cracking. This is common with stucco applications and typically not a major concern. It is recommended to monitor the cracks for any widening or water penetration. If cracks become larger than 1/8th", further assessment and repair by a qualified professional should be considered.

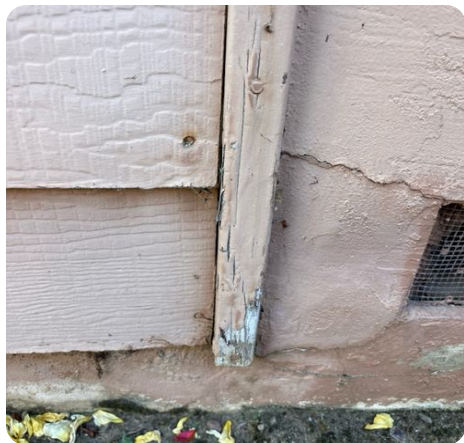
The exterior of the structure has chipping and peeling paint. The inspector recommends further evaluation and repainting by a qualified painter who will properly prepare the surface, sand, apply primer and apply fresh coats of paint.

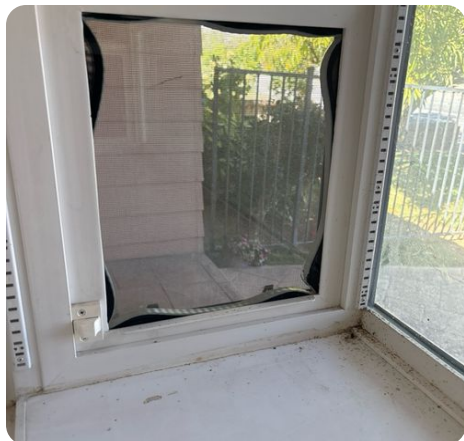
The rubber seal between the window panes is displaced. This is a cosmetic issue however, this can lead to air and water leaks and reducing energy efficiency. It is recommended to repair or replace the rubber seal to ensure proper insulation and protection against the elements.

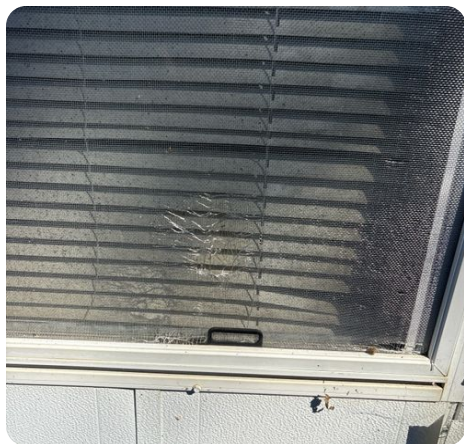
One or more of the window screens were damaged or not seated properly within the window frame. Repairing/replacing the damaged screens is recommended. Evaluation and repair by a qualified window professional is advised.

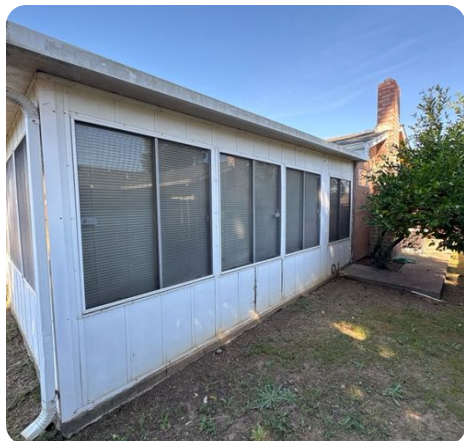
The windows in the home are single pane, which are less energy efficient and can lead to higher energy costs. Replacing the single pane windows with double or triple pane windows in the future should be considered in order to help improve energy efficiency and lower heating and cooling costs. Contacting a qualified window contractor for a cost estimate is recommended.

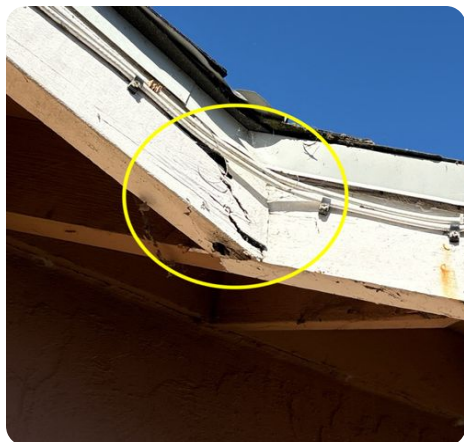
The fascia boards on the exterior of the structure have moisture damaged. Refer to a recent pest report or contact a qualified contractor for proper repair.

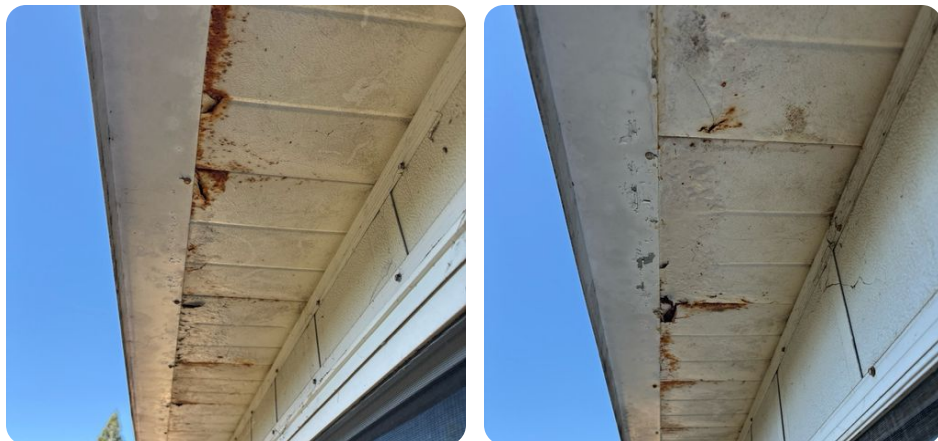
##### Rust On Metal Roof Eaves

The metal roof eaves are showing signs of rust indicating possible leaks or elevated moisture levels. This issue can lead to structural deterioration if not addressed, affecting the integrity of the eaves over time. It is recommended to evaluate and repair the rusted areas to prevent further corrosion and maintain the functionality of the eaves. A qualified roofer should assess the extent of the rust and recommend appropriate treatment.

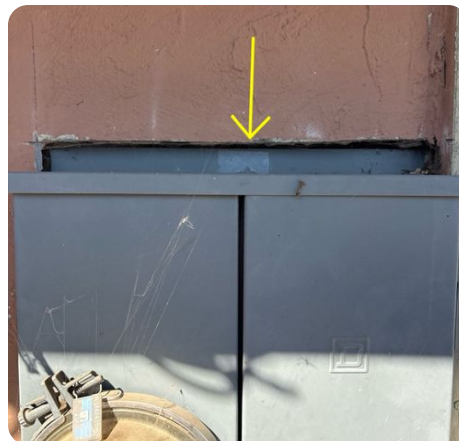
The void around the electrical panel should be filled to prevent potential entry points for pests or moisture infiltration. This issue can lead to safety hazards and should be addressed promptly. It is recommended to consult a qualified electrician to evaluate and seal the void effectively.

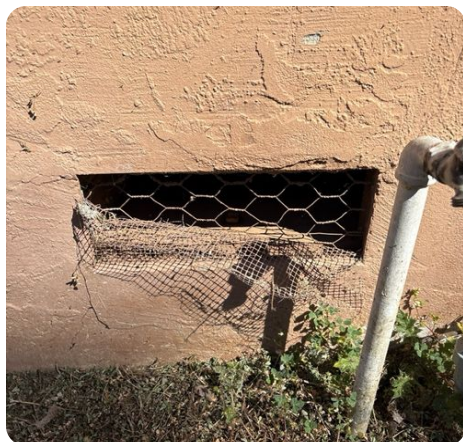
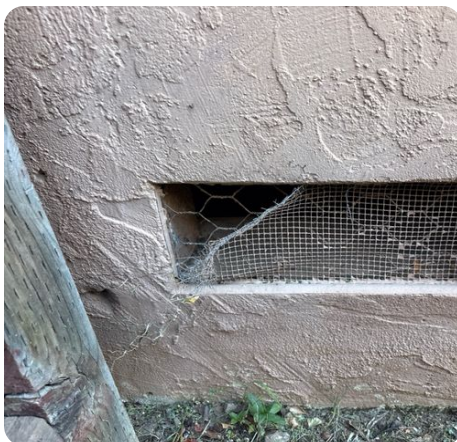
### Damaged Vent Screen

There is a damaged vent screen at the structure which should be replaced/repaired. Tight vent screens should be provided to allow proper ventilation to the area, and to prevent pests from entering. Appropriate repairs are recommended.

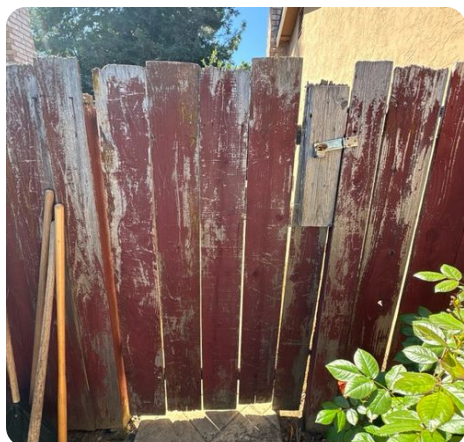
Damage was observed on the property's fences, such as loose or missing boards, broken or leaning posts, and signs of rot or decay. To maintain the integrity and security of the fences, it is advisable to assess and fix the affected areas as required. If necessary, a qualified fence contractor should be reached out to for further assessment and repairs.

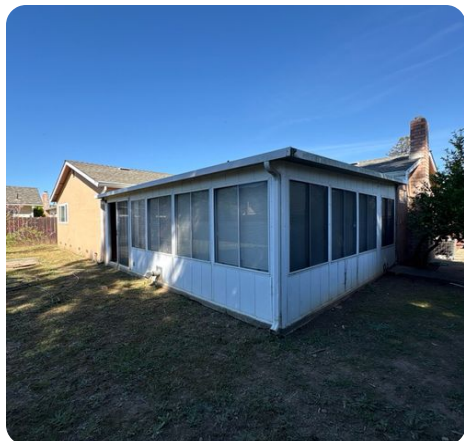
The inspector noted that the home includes a bonus room or addition. Determining whether this area was constructed with the proper permits and in compliance with local building codes is beyond the scope of this inspection. The inspector recommends that the client verify permit status and final approvals with the local building department to ensure the addition was completed according to applicable regulations and safety standards.

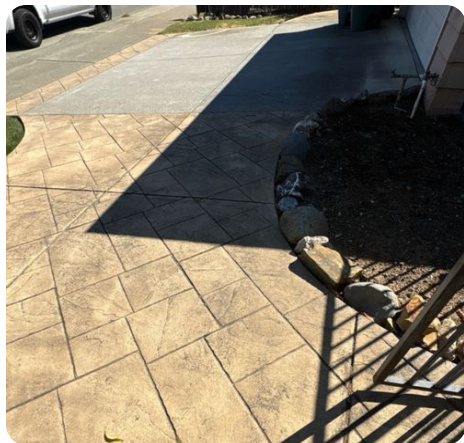
The inspection of the walkways and driveway included checking for cracks, uneven surfaces, and proper drainage to prevent standing water. Both the walkways and the driveway were found to be in serviceable condition.

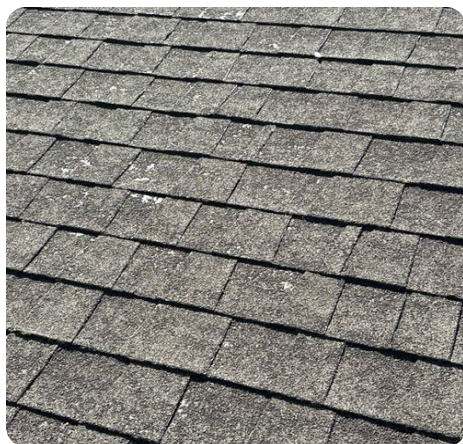
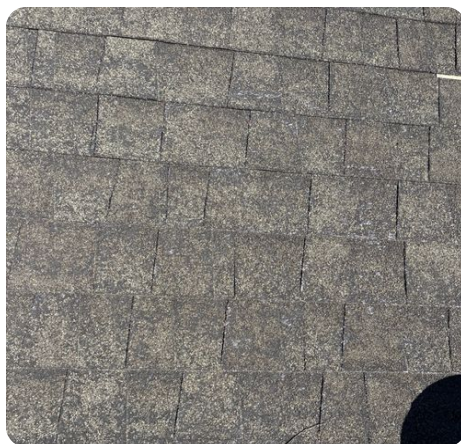
The roof covering is showing signs of granule loss and exposed fibers, indicating normal wear and aging. There appears to be serviceable life remaining. Further assessment and recommendations for future replacement by a qualified roofing company may be considered.

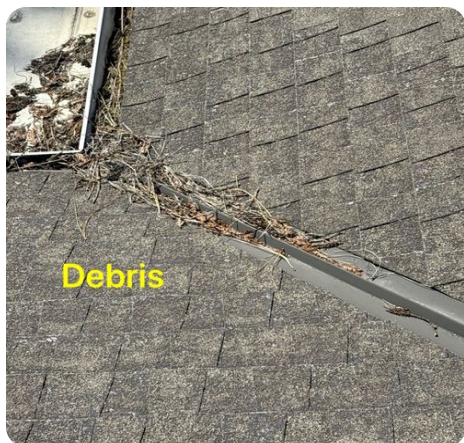
Any build-up, corrosion/rust or debris build-up in the valleys or flashing areas should be removed as needed. It is recommended to perform preventative maintenance of the flashings and valleys every 3-5 years to allow water to flow to the gutters and/or from the roof as intended. Contact a qualified roofing company for this maintenance.

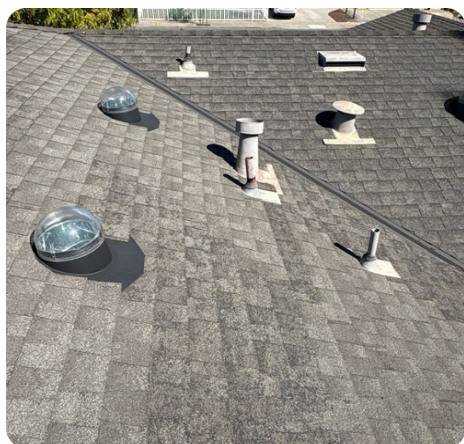
Periodic maintenance for roof vents and penetrations is recommended to ensure they remain in good condition and prevent potential leaks. It is advised to annually inspect for any signs of damage such as cracks or gaps and repair or replace any deteriorating components. Keeping these areas well-maintained can help prolong the life of your roof and prevent water infiltration.

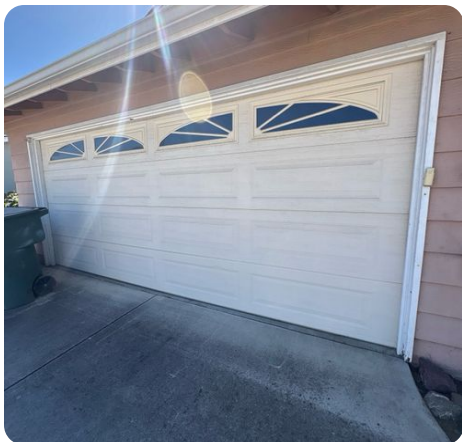
The garage vehicle door was evaluated. Periodic adjustment/maintenance of the doors and track may be needed to insure continued smooth operation.

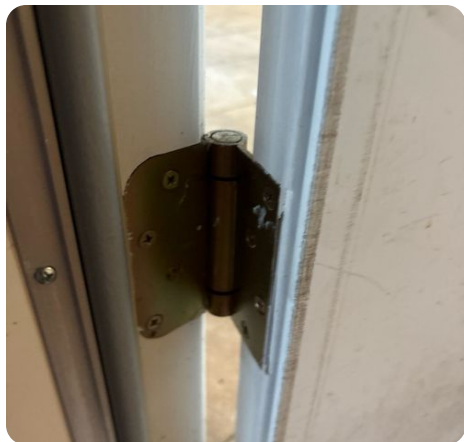
The spring hinge on the garage door to the structure is not adjusted to allow for automatic closure. Adjusting or replacing the spring-loaded hinge is recommended to provide the intended firewall safety function between the living area and the garage. It is suggested to contact a qualified professional for this maintenance.

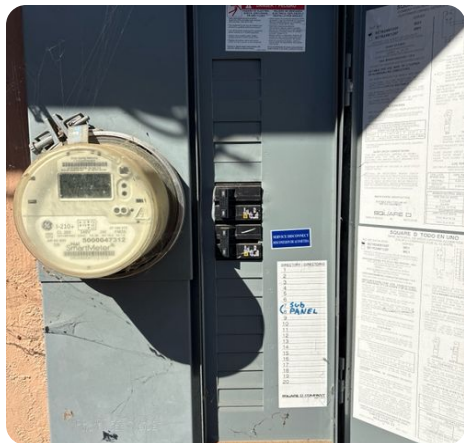
The interior components of the electrical service panels were evaluated during the inspection. It is recommended to conduct regular maintenance and/or evaluation on the electrical panels to ensure continued safe performance.

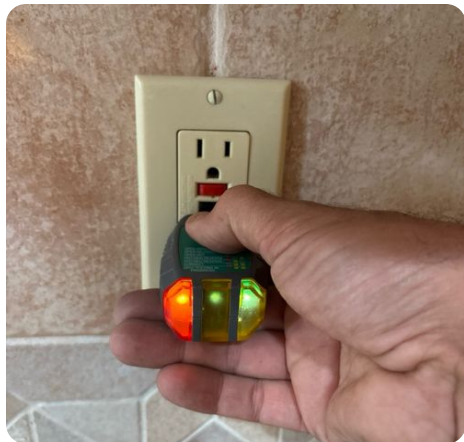
The GFCI receptacle did not operate properly or 'trip' when tested. GFCI receptacles are designed to protect against electrical shock and should be in proper working condition. It is recommended to have a qualified electrician evaluate and repair or replace the receptacle.

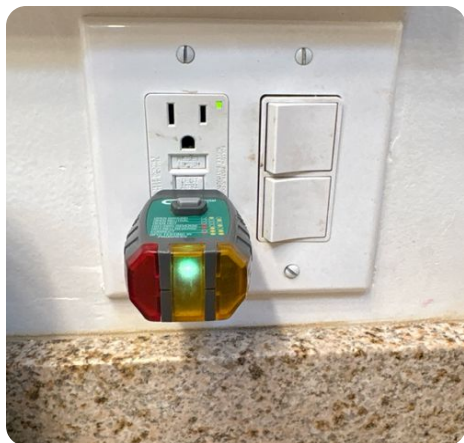
### GFCI Receptacle Ungrounded

The GFCI receptacle is ungrounded, indicating it is not connected to the grounding system. While ungrounded GFCIs can offer some safety protection in older services, updating the wiring to include a ground is recommended to enhance overall safety. Grounding is crucial for electrical safety as it helps prevent electrical shocks. It is advised to contact a qualified electrician to discuss potential options for upgrading the service.

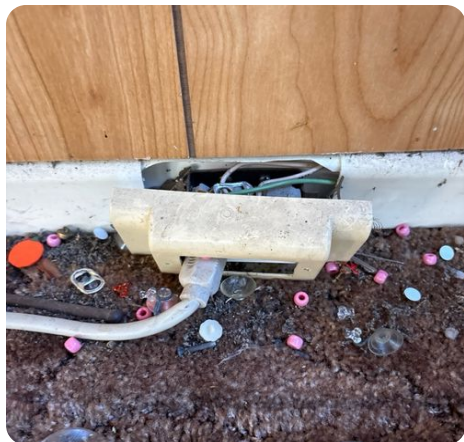
There is a loose outlet in the home which could lead to connectivity issues and pose a safety hazard. It is recommended to evaluate and repair the outlet as soon as possible. A qualified electrician should be contacted to properly address and fix the loose outlet to ensure safety and functionality.

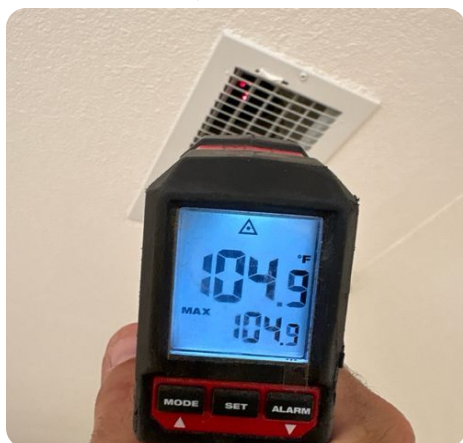
The heating system was operated and found to be in functional condition. Having the system serviced annually by a qualified HVAC contractor is recommended to help ensure continued functional operation.

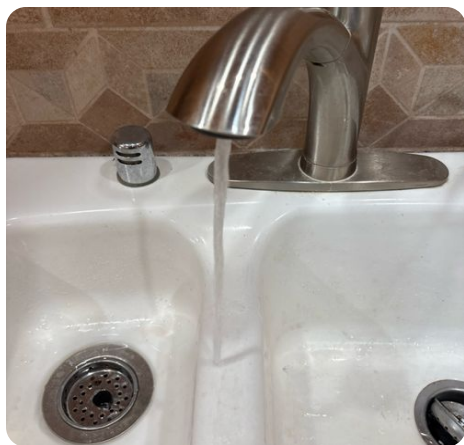
The water pressure is low, noticeable at faucets and fixtures. This may indicate a blocked supply line, a faulty pressure regulator, or an issue with the municipal water supply. Repair is suggested to restore normal water flow. Consider contacting a qualified plumber for further assessment and necessary repairs.

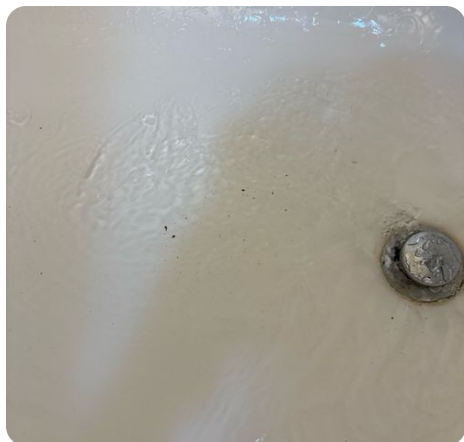
### Presence Of Black Sediment In Water

The presence of black sediment in the water supply can indicate the deterioration of pipes or the water heater lining. It is recommended to have a licensed plumber evaluate the water piping system to identify the source of the sediment and take appropriate measures to address it, such as cleaning or replacing affected components. Regularly flushing the water heater and conducting maintenance can help prevent further buildup of sediment. ALSO NOTED-The water pressure was low, noticeable at some of the interior fixtures. This could be due to clogged screens, clogged orifices and/or issues with the well system. Repair is suggested to restore normal water flow. Consider contacting a qualified plumber for further assessment.

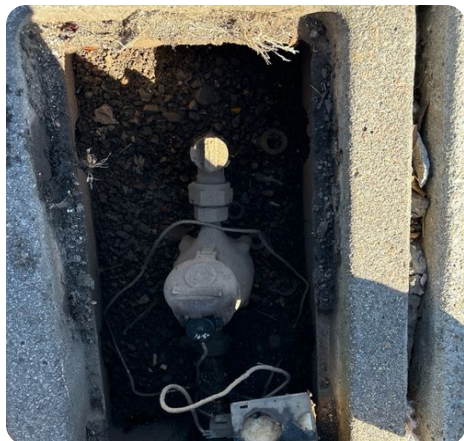
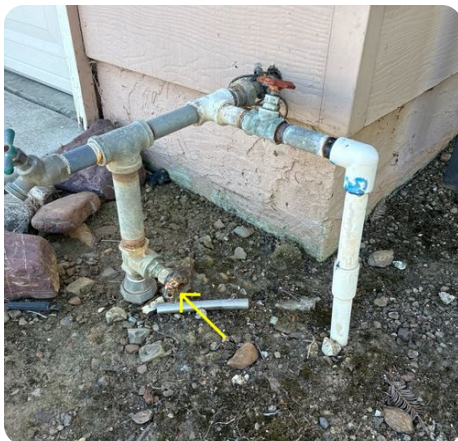
The water main shut-off valve was located and evaluated. It is important to know the location and condition of the shut-off valve in case of emergencies or repairs. We recommend testing the shut-off valve periodically to ensure proper functionality.

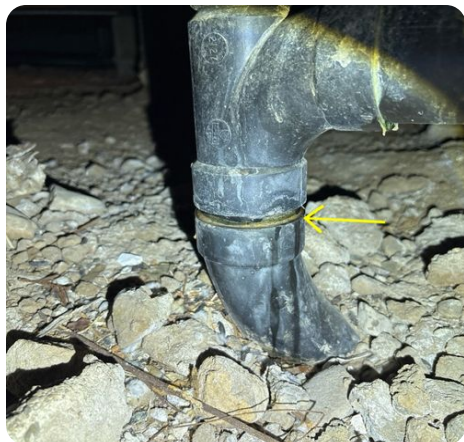
Location: Crawl Space

The waste plumbing system is experiencing leakage. Evaluate and repair the leak to prevent further issues. It is recommended to hire a licensed plumber for this repair to ensure it is properly fixed.

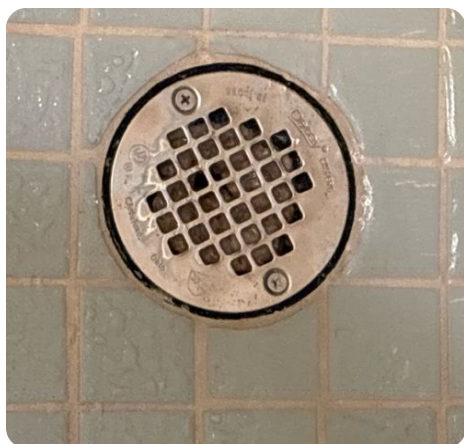
Debris was found in the shower drain. This blockage can lead to slow drainage or backups. It is recommended to have a qualified plumber remove the debris to prevent any further issues.

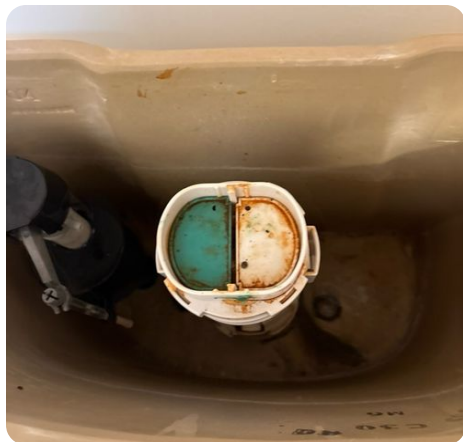
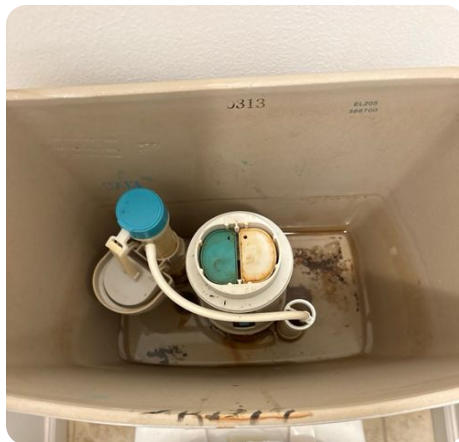
Location: Master Bathroom, Guest Bathroom

The tank valve in the toilet is defective, leading to issues with flushing. This can result in inconsistent flushing or no flushing at all, causing inconvenience and disruption to normal usage. It is recommended to have a qualified plumber evaluate and repair the tank valve to ensure proper functioning of the toilet.

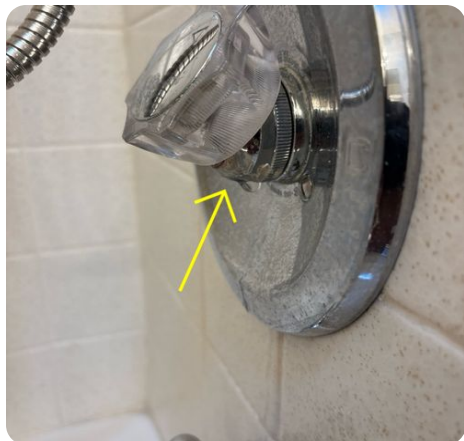
Location: Guest Bathroom

The tub valve is experiencing a leak when in the off position. It is recommended to evaluate and repair this leak to prevent further issues. Contact a licensed plumber to address this issue and ensure proper functioning of the tub valve.

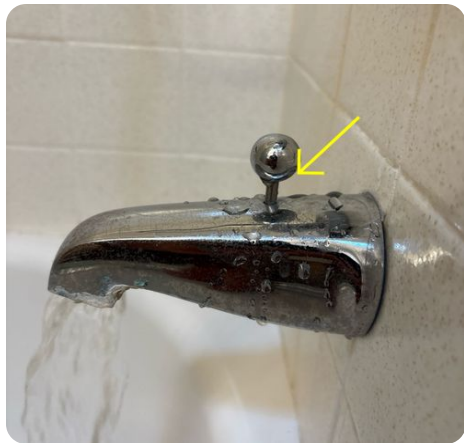
Location: **Guest Bathroom**

The diverter valve is in need of repair. A malfunctioning diverter valve can result in inadequate water flow or difficulty switching between fixtures. It is recommended to have a qualified plumber repair the fixture to ensure proper functioning and to avoid any water flow issues in the future.
