**Service:** Full Home Inspection

**Prepared for:** Stella Chapman

Site Address: 1150 3rd Street, Gilroy, CA, 95020

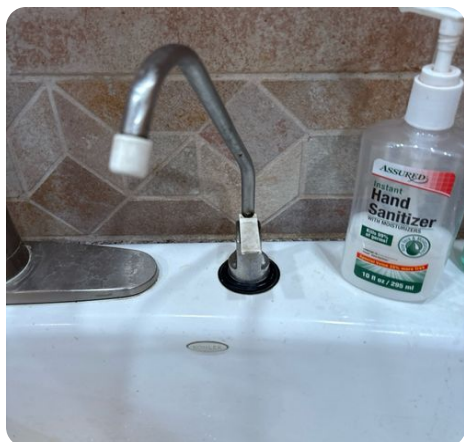
📍 Location: Kitchen

The filtered water faucet did not function when tested. Contact a qualified handy person or Plumber for further evaluation and repairs.

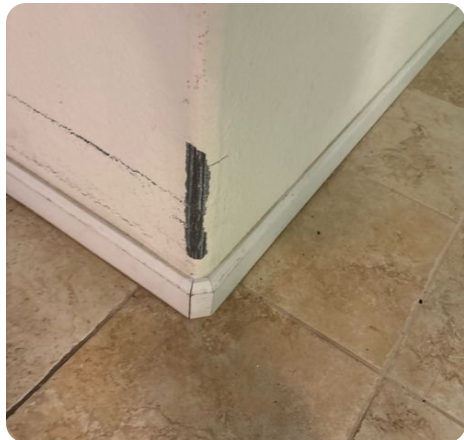
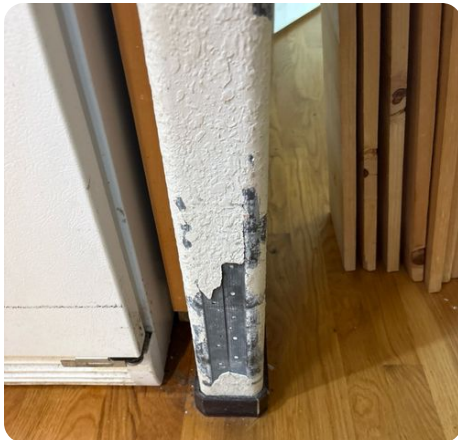
Location: Main Hall

The interior walls show signs of damage. It is recommended to evaluate the extent of the damage and repair to prevent further deterioration. A qualified contractor can assess the cause and make necessary repairs to restore the wall to its proper condition.

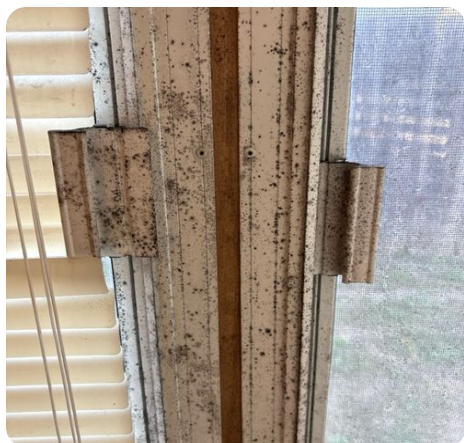
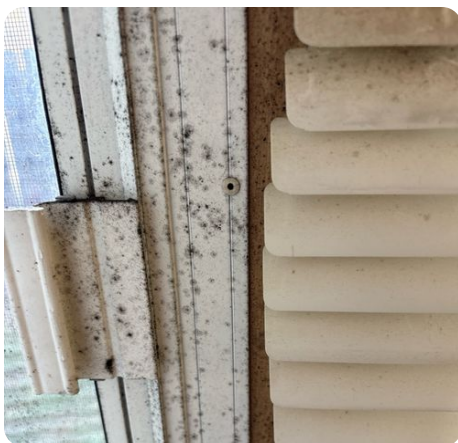
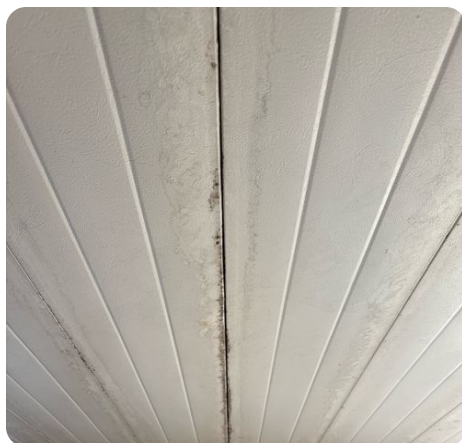
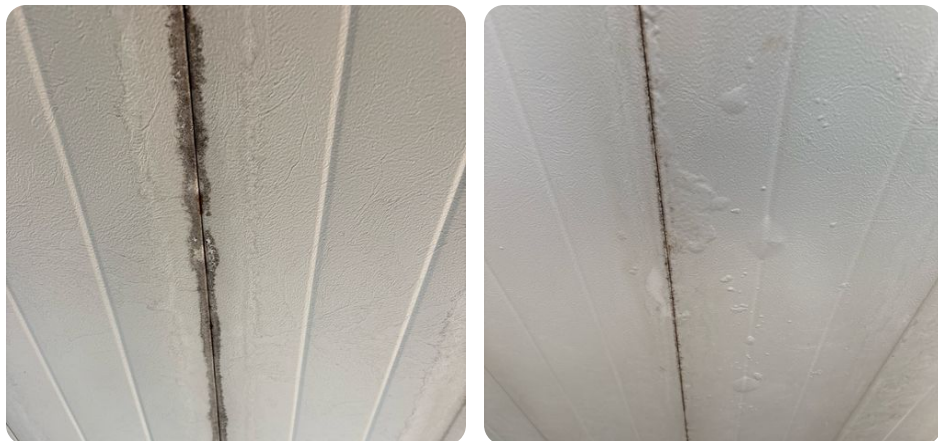
Location: Additional Room

The presence of possible microbial stains has been observed in the specified area. Testing by a lab would be needed to determine if it is microbial growth and what type. It is recommended to evaluate the extent of the issue and consider repair if necessary to prevent further growth and maintain a healthy indoor environment. A qualified mold remediation specialist should be contacted for further assessment and appropriate treatment.

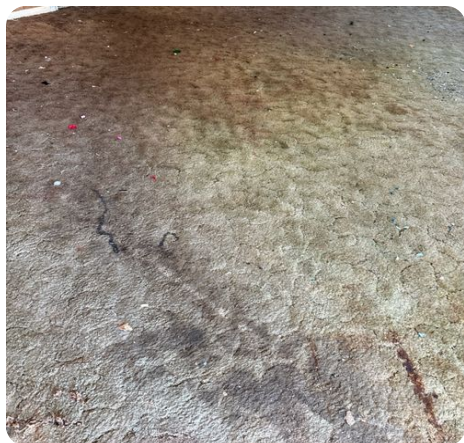
Location: Additional Room

The carpet shows significant staining and damage. It is recommended to evaluate the extent of the damage and consider repairing or replacing the carpet to improve the overall appearance and comfort of the space.

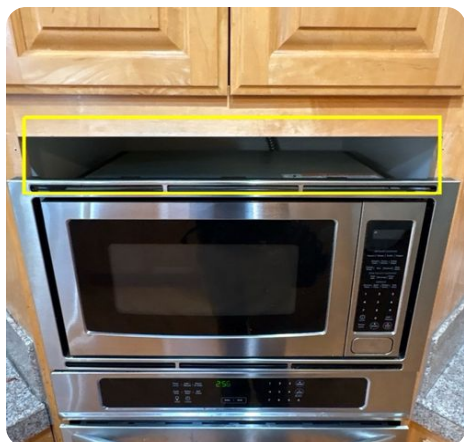
The cabinet trim is missing, which can detract from the overall aesthetic appeal of the cabinets. It is recommended to have a qualified specialist install the missing trim to provide a finished look.

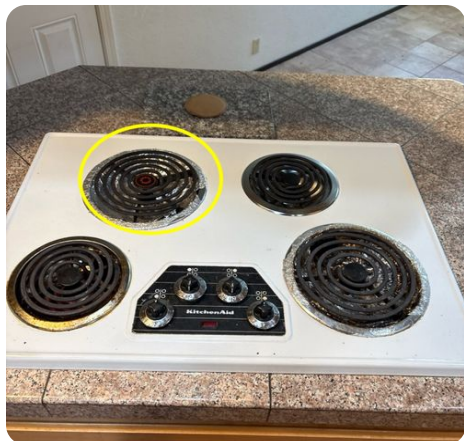
### Non-Functioning Stove Top Burner

The stove top burner is not working properly. We recommend evaluating and repairing the burner to ensure all burners are functioning correctly. This issue can impact the cooking ability and efficiency of the stove. It is recommended to have a appliance repair technician inspect and repair the non-working burner.

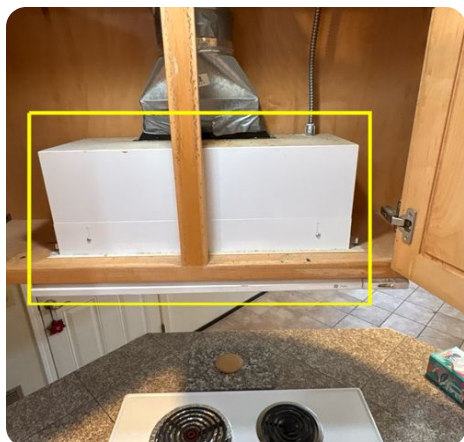
#### Stove Exhaust Not Functioning

The stove exhaust at the cooktop did not function. Questioning the seller as to its operation and functionality is suggested. It is recommended to evaluate and repair the exhaust fan for intended use and ventilation in the event that smoke is produced from cooking. A qualified appliance specialist should be consulted for further evaluation and repair.

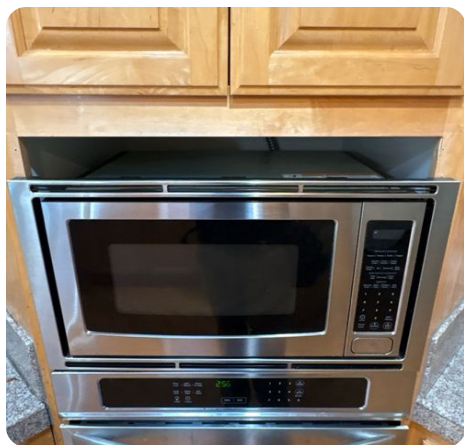
The microwave oven was not functional. It is recommended to have any necessary repairs done by a qualified professional and verify functionality before closing.

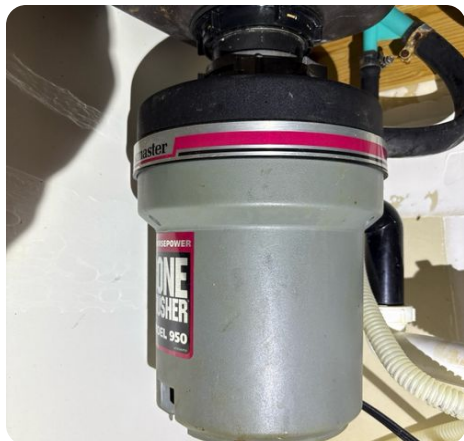
#### Garbage Disposal Not Functional

The garbage disposal was not functional at the time of the inspection. The unit may be jammed or need repairs. Contact a qualified professional to make needed repairs or replace the disposal.

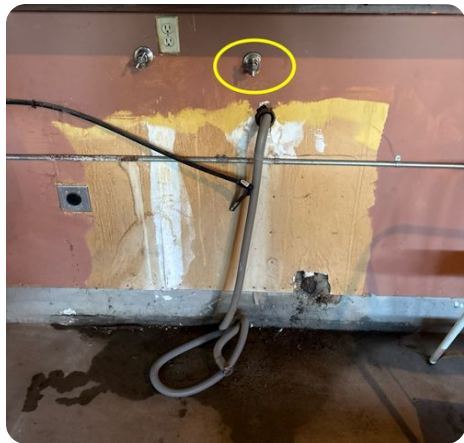
### Active Leak

An active drip leak was observed at the clothes washer valves. Repair is recommended to prevent possible water damage.

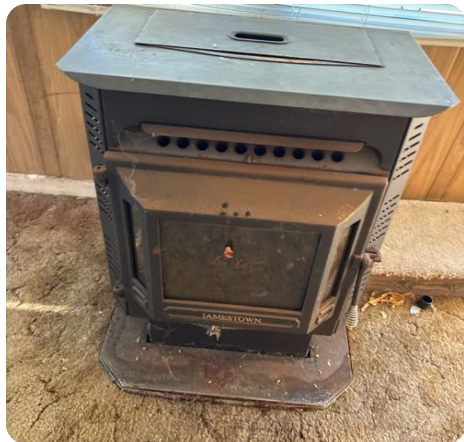
The pellet stove was not tested. It is recommended to have a qualified technician evaluate the pellet stove to ensure it is functioning properly and safely before regular use. Regular maintenance and cleaning of the pellet stove are also recommended to prevent potential issues.

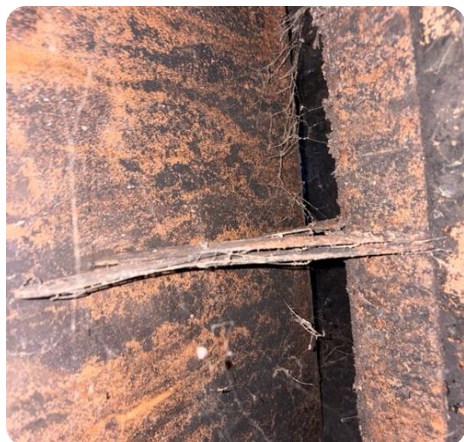
### Chimney Flue Cleaning Recommended

The chimney flue should be cleaned. It is recommended to have a qualified chimney sweep clean the chimney flue to ensure proper ventilation and prevent any potential fire hazards. Regular cleaning also helps in maintaining the efficiency of the fireplace.

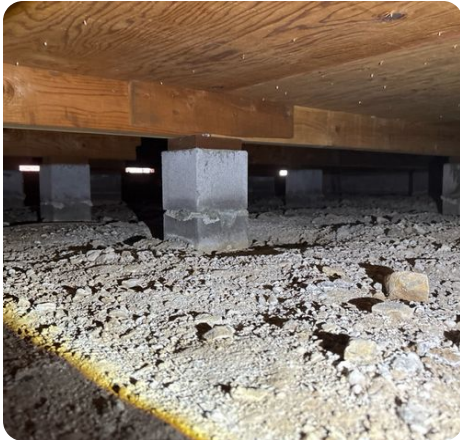
#### Raised Foundation

Raised foundations are a type of building foundation where the structure is supported by vertical concrete piers set into the ground and wooden post that support horizontal wooden beams placed on top to create a raised platform for the house, creating a crawl space underneath. This system is evaluated for conditions including stability, levelness, cracking, shifting and water intrusion. Regular monitoring of the foundation is recommended to maintain its current condition.

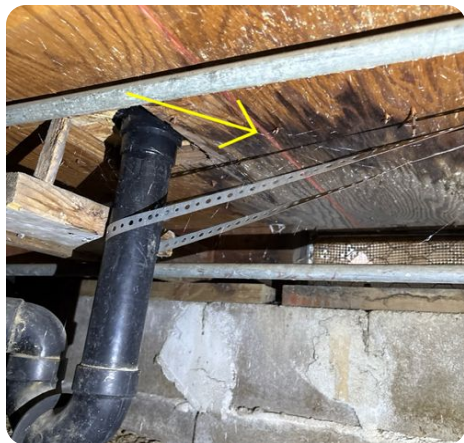
#### Moisture Stains On Floor Structure

📍 Location: Crawl Space

The presence of moisture stains on the floor structure indicates possible water intrusion. It is recommended to evaluate the source of the moisture and repair any leaks to prevent further damage to the structural integrity of the floor. Refer the recent pest inspection reports for further details and recommendations.

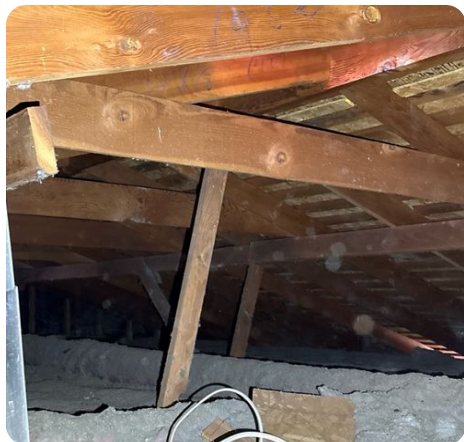
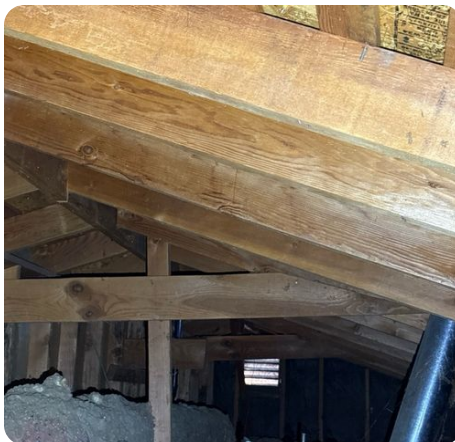
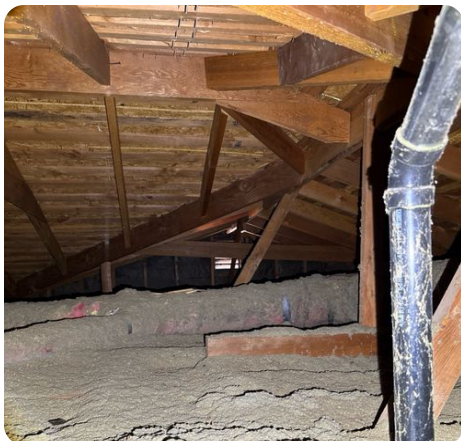
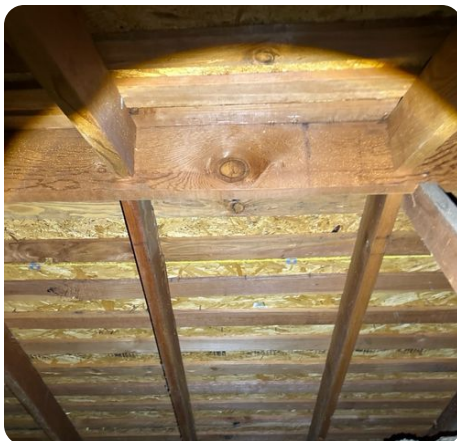
The visible/accessible roof structure and attic components were evaluated including trusses, rafters, and sheathing, were examined. The inspection focused on identifying signs of deflection, deterioration, or damage, such as water staining or wood decay. This report does not include calculations for determining the adequacy of the design of the roof support structure or the detection of "roof framing lift". Due to framing within the attic, not all areas were visible. Any areas not visible/accessible are considered outside the scope of this inspection.

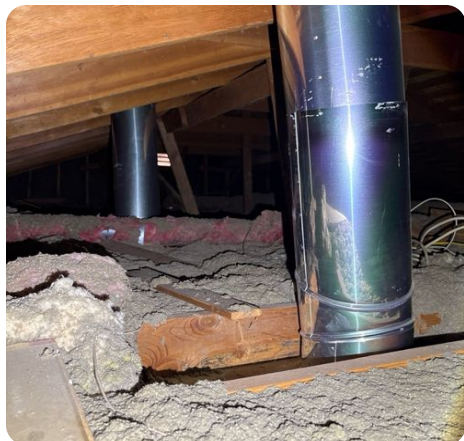
The insulation in the attic has settled and become matted, which can result in reduced energy efficiency. It is recommended to evaluate and repair by adding more insulation to ensure proper coverage and maximize the insulation's effectiveness. A qualified insulation contractor can assess and add more insulation as needed to improve energy efficiency.

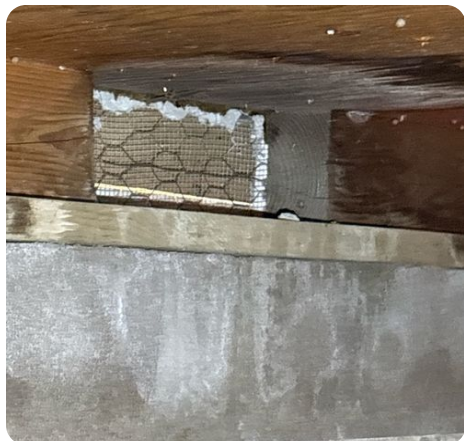
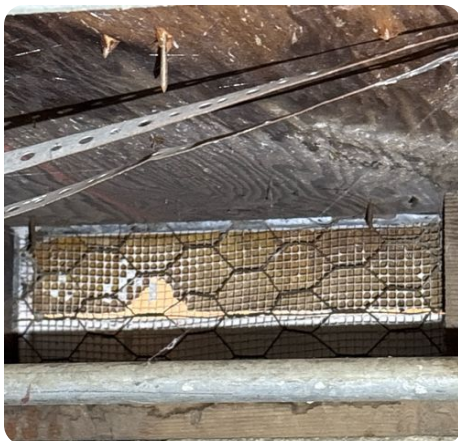
Location: Additional Room

The crawl space ventilating into the room addition is a concerning issue as it can lead to poor indoor air quality and potential health hazards. This situation can also cause temperature imbalances and moisture problems in the room addition. It is recommended to consult with a qualified HVAC professional to evaluate and repair the crawl space ventilation system to ensure proper ventilation and prevent further issues.

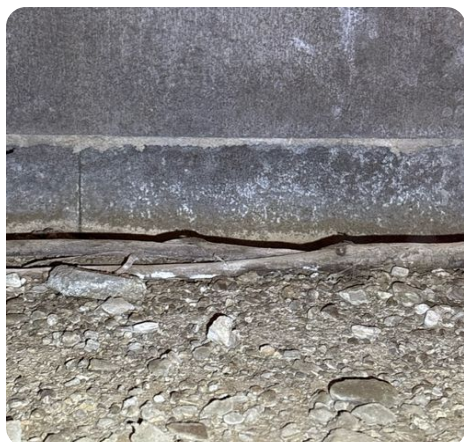
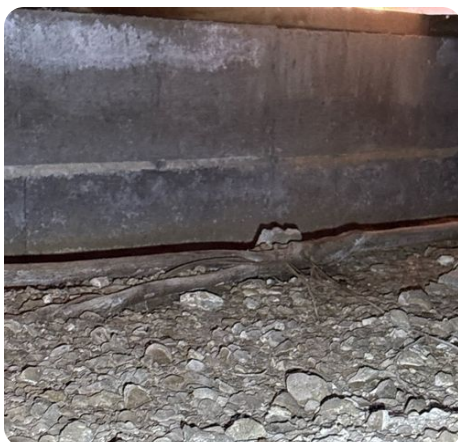
The presence of roots in the crawlspace can indicate potential issues with nearby trees or shrubs. Roots can cause damage to the foundation and interfere with the plumbing system. It is recommended to evaluate and address the root intrusion to prevent further structural damage. A qualified arborist or landscaping professional can assess the situation and recommend proper solutions.
