NORCAL INSPECTIONS PLUS

22975 Flournoy Ave  
Corning, CA 96021

Alberto Mendoza

JULY 21, 2025

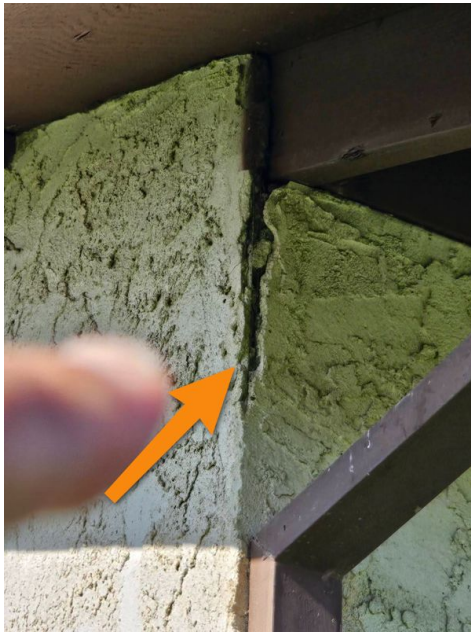
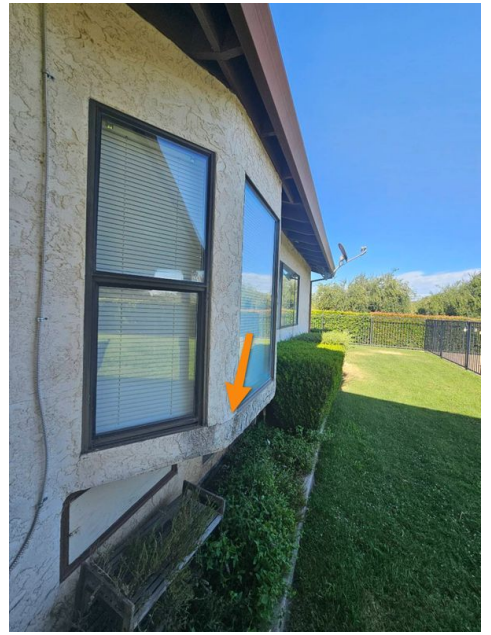
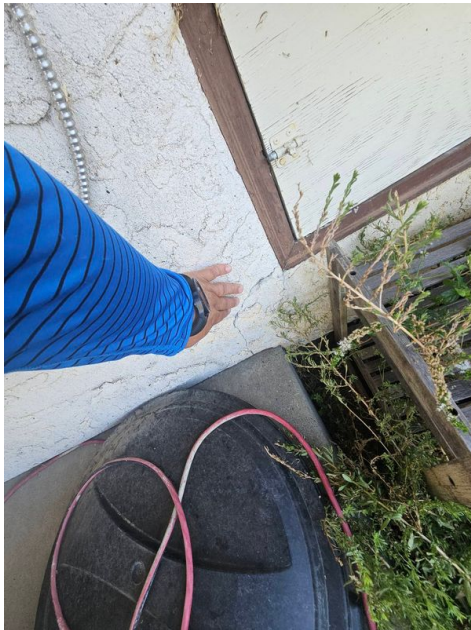
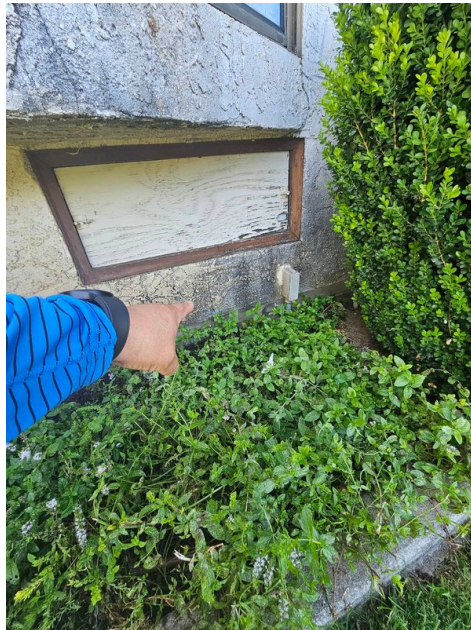
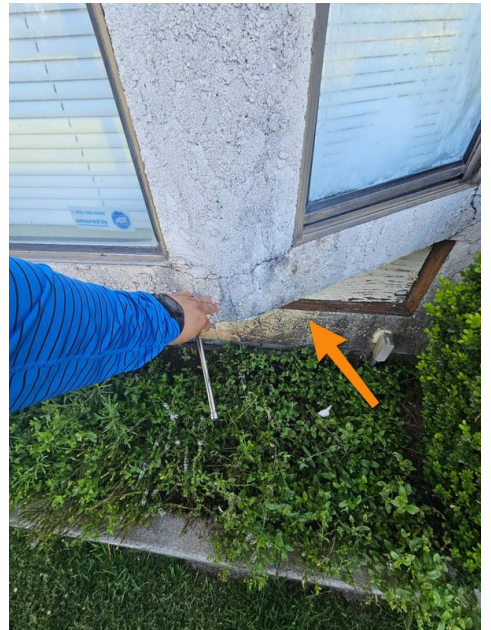
### **CRACKING - MAJOR AT MASONRY EXTERIOR**

I observed indications of major structural cracking at the time of my inspection of the exterior. Cracking was observed at one or more areas.

Monitoring the masonry walls of the house is needed. Although masonry can deform elastically over long periods of time to accommodate small amounts of movement, large movements normally cause cracking. Cracking can result from a variety of problems: differential settlement of the foundation; drying shrinkage; expansion and contraction due to ambient thermal and moisture variations; improper support over openings; the effects of freeze-thaw cycles; the corrosion of iron and steel wall reinforcement; differential movement between building materials; expansion of salts; and the bulging or leaning of walls.

Further evaluation is recommended.

Contact a stucco repair contractor

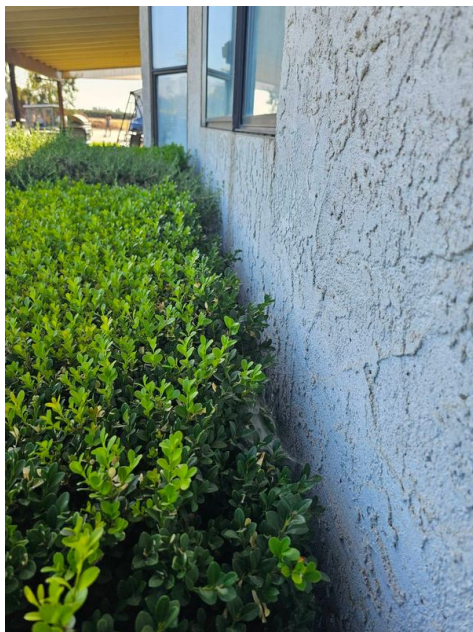
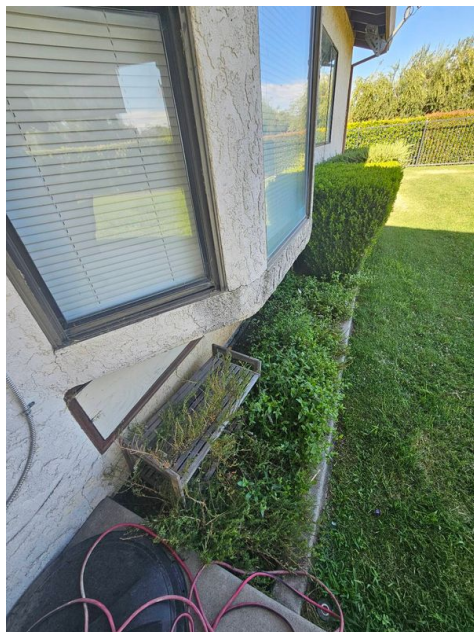
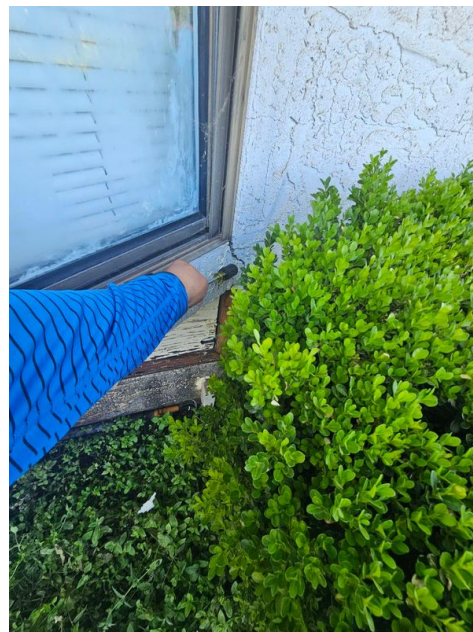
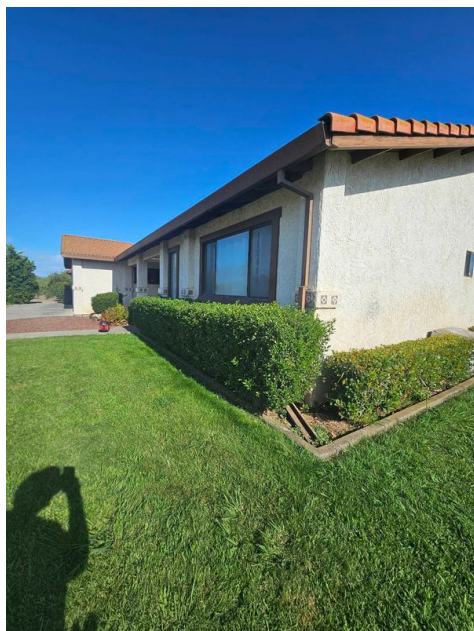
Major Defect**DENSE VEGETATION**

I observed dense vegetation around the house in areas. This condition limited and restricted my visual inspection. Dense vegetation and landscaping up against or near the house foundation and exterior walls may be prone to water penetration and insect infestation.

Trimming, pruning and some landscaping is recommended.

Recommended DIY Project

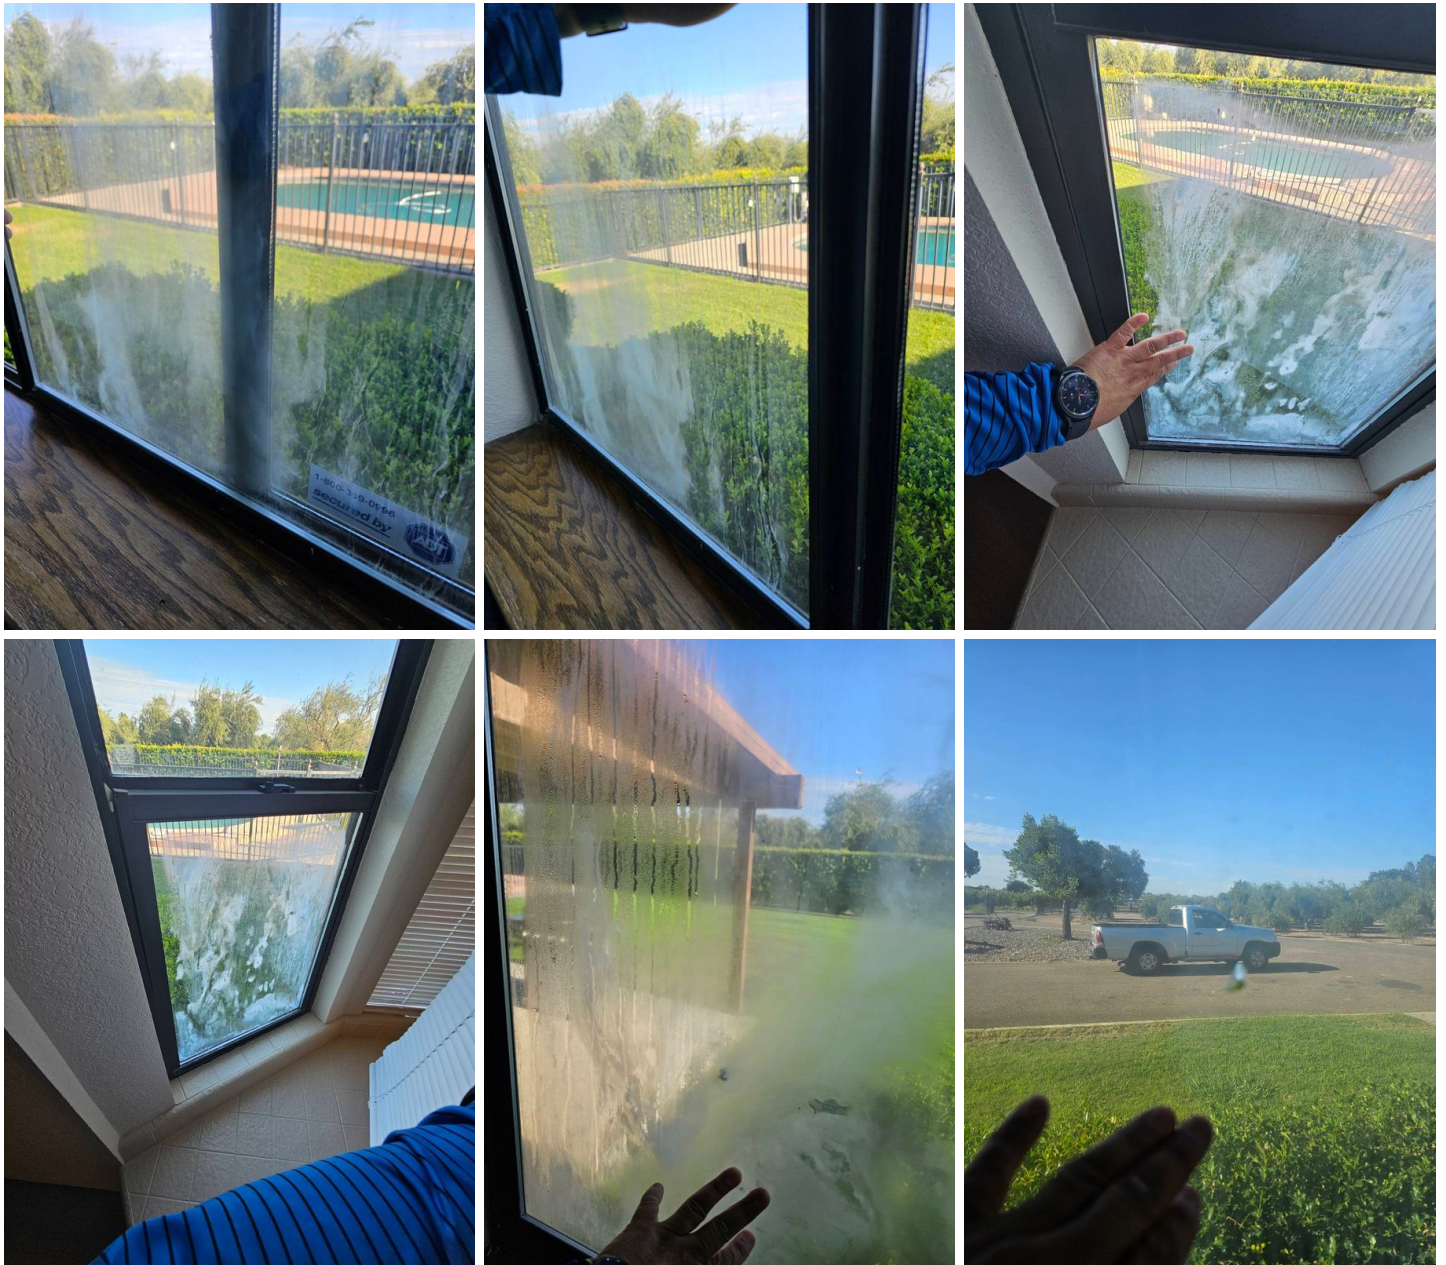
Major Defect**FOGGED WINDOWPANE**

I observed a fogged windowpane (a lost seal) at a window.

If multiple-pane windows appear misty or foggy, it means that the seal protecting the window assembly has failed, and condensation has formed in between the two panes of glass. Condensation in double-paned windows indicates that the glazing assembly has failed and needs repair or replacement. Visible condensation can damage glazing and is the main indication of sealant failure. Condensation is not always visible. If the failure is recent, a failed window may not be obvious, since condensation doesn't usually form until the window is heated by direct sunlight. Windows in the shade may show no evidence of failure, so it is nearly impossible to observe and report all failed double-paned windows.

Contact a qualified window repair/installation contractor.

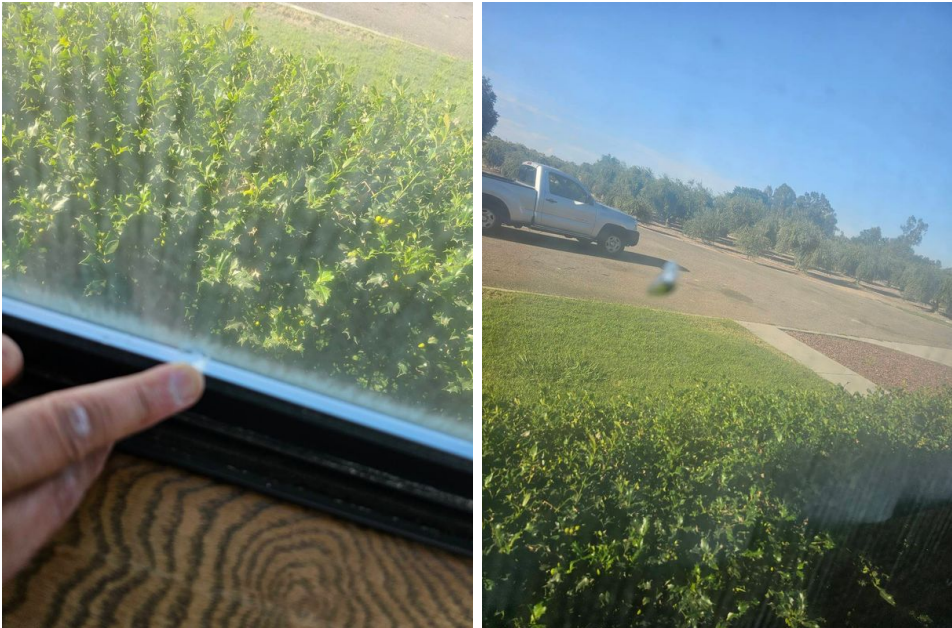
### CRACKED WINDOWPANE

I observed a cracked glass windowpane.

Correction and further evaluation is recommended.

Recommendation  
Contact a qualified window repair/installation contractor.

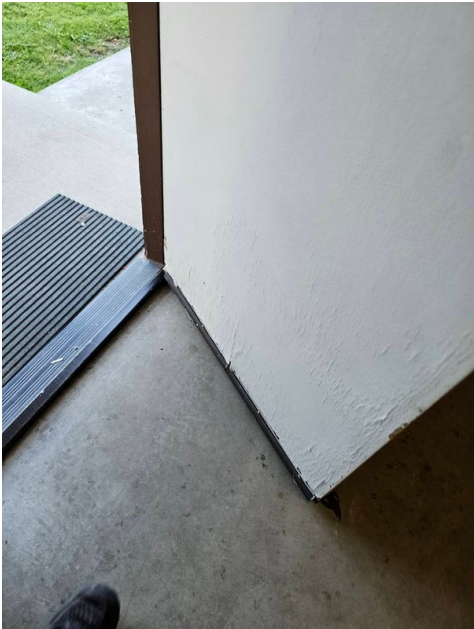
**WOOD ROT AT DOOR**

I observed wood rot at the exterior door.

Correction and further evaluation is recommended.

Recommendation  
Contact a qualified professional.

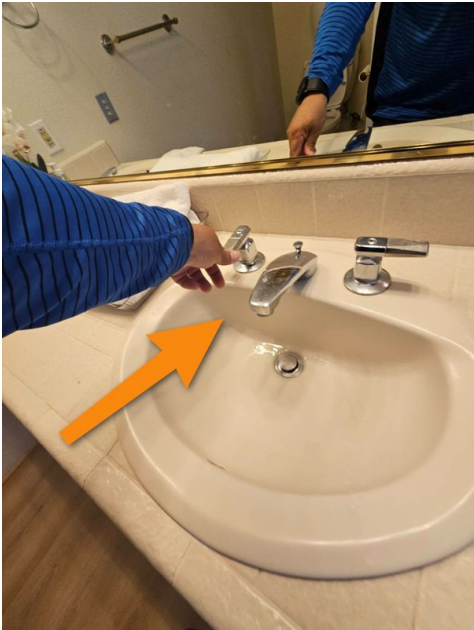
I observed that there was no running hot water at the fixture.

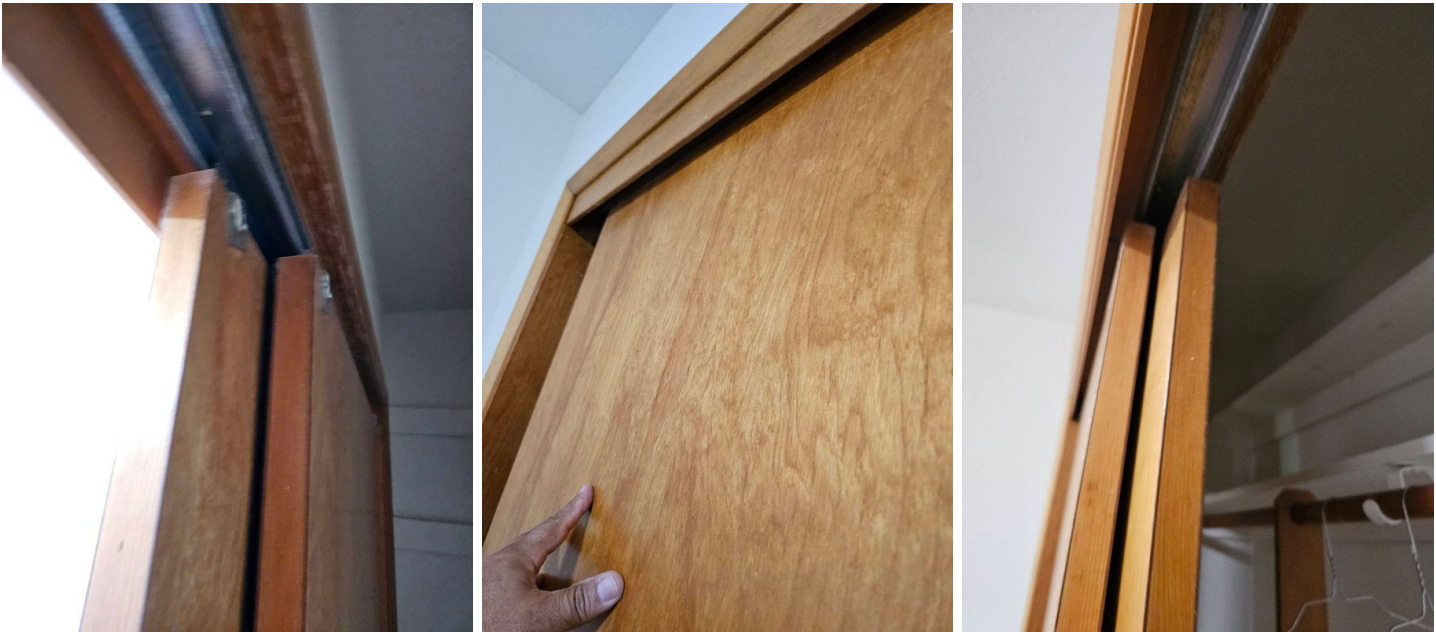
DAMAGED DOOR HARDWARE

I observed damage to the door hardware.

Contact a qualified door repair/installation contractor.

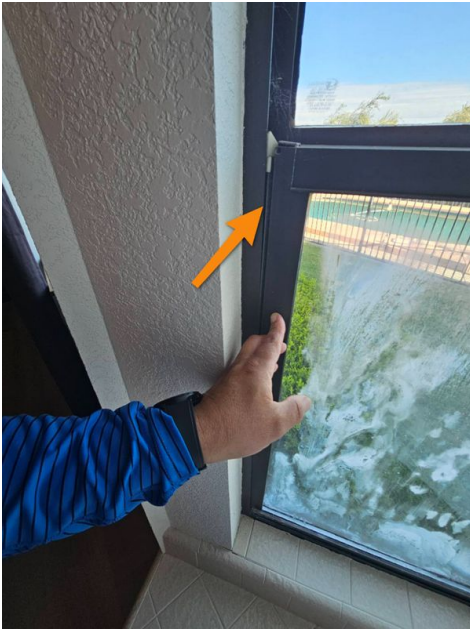
DAMAGED WINDOW

I observed damage to a window.

Contact a qualified window repair/installation contractor.

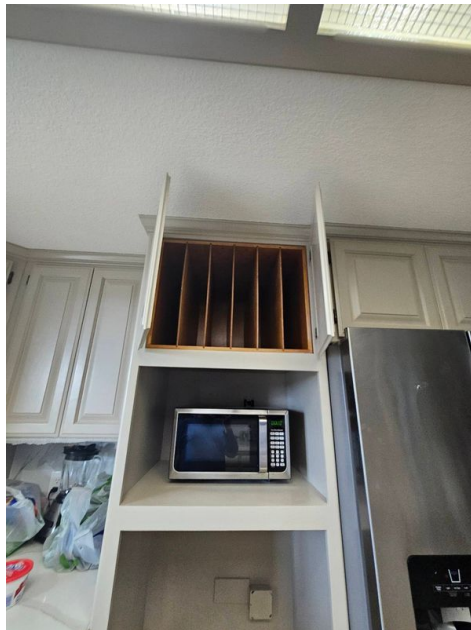
#### **COVER NOT IN PLACE**

I observed a receptacle with a cover (plate) that was not in place.

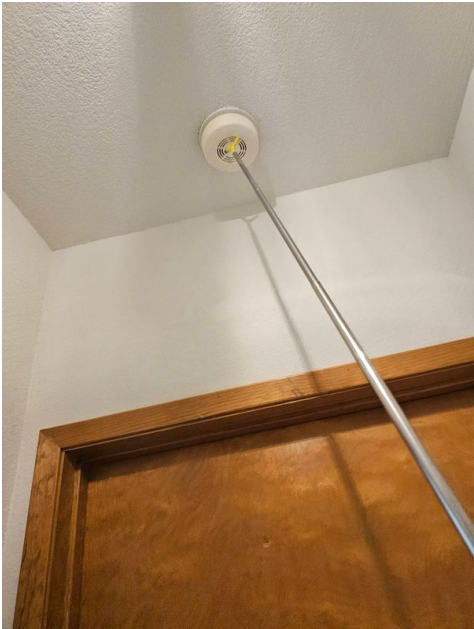
#### **SMOKE DETECTOR DID NOT TEST FUNCTIONAL**

I observed indications that a smoke detector did not test functional. I pushed the test button, but it did not test as expected.

Recommendation  
Contact a qualified professional.
