# Property Inspection Report

**Estate of Lloyd Freese**

**132 8th Street Manhattan Beach, CA 90266**

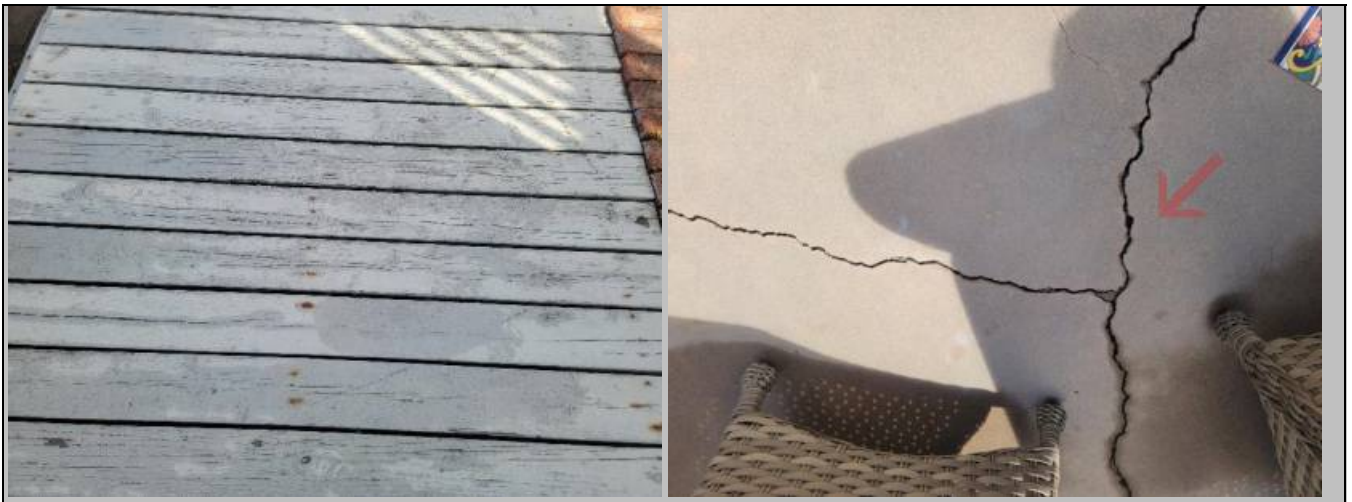
**MAINTENANCE:** Wood boards need sanding and paint.

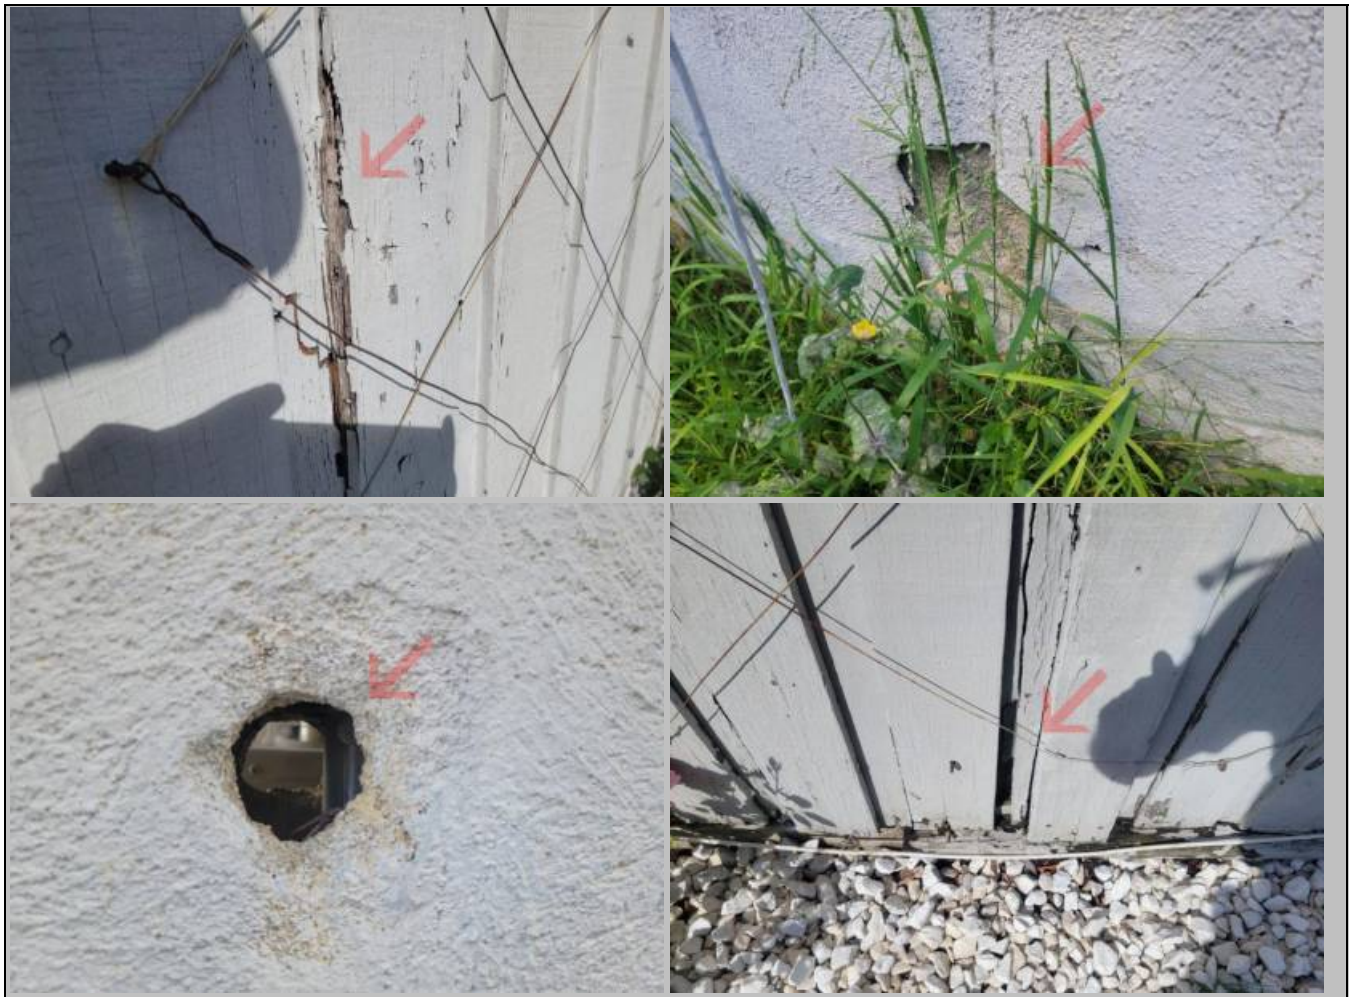
**MAINTENANCE:** Some cracked or damaged stucco viewed. We recommend repairs as needed at this time to protect against moisture intrusion and to enhance the structure's appearance.

**MAINTENANCE:** Some loose or peeling paint viewed. We recommend painting at this time to protect the siding from further deterioration and to enhance its appearance.

**DEFERRED:** Insect damage or rot viewed.

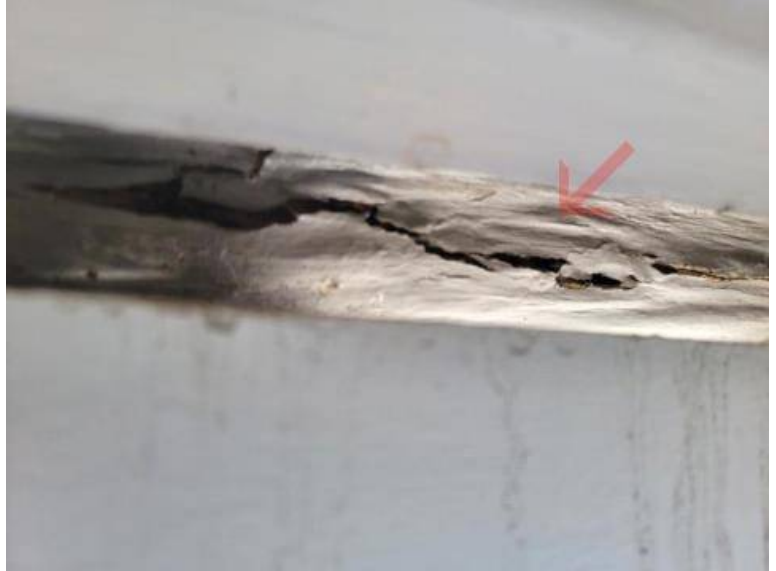
**SAFETY:** Cracked/broken pane at one or more windows. We suggest inspecting all windows prior to the close of this transaction.

**DEFERRED:** Wood rot viewed.

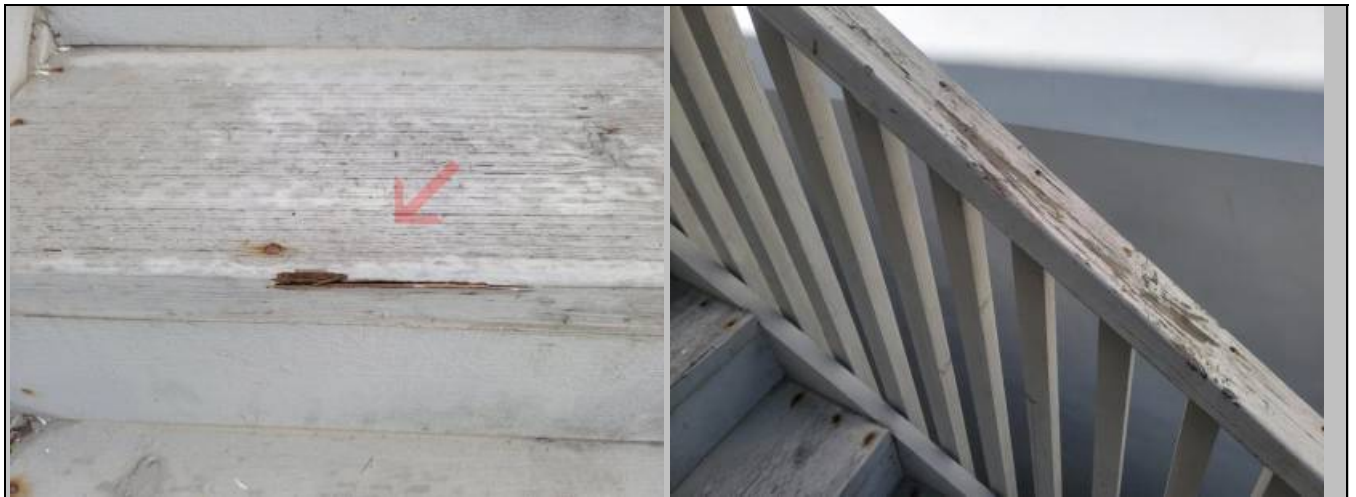
**DEFERRED:** Nails do not appear to be galvanized and are corroded.

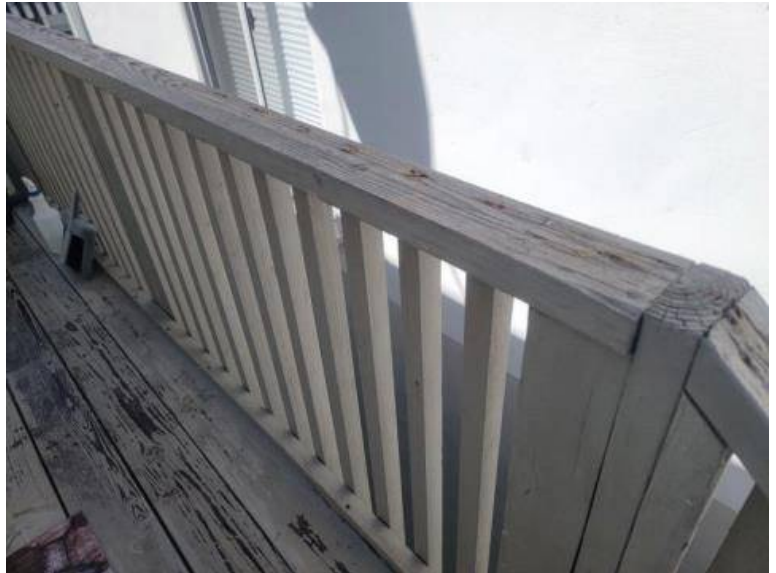
### 3.7 Guardrails

**SAFETY:** Railing appears to be too low. We recommend the minimum height of guardrails to be at least 42-inches above the walking surface with no opening greater than 4-inches where the walk-off height is greater than 30-inches.

**MAINTENANCE:** Peeling paint. Will need to sand and paint.

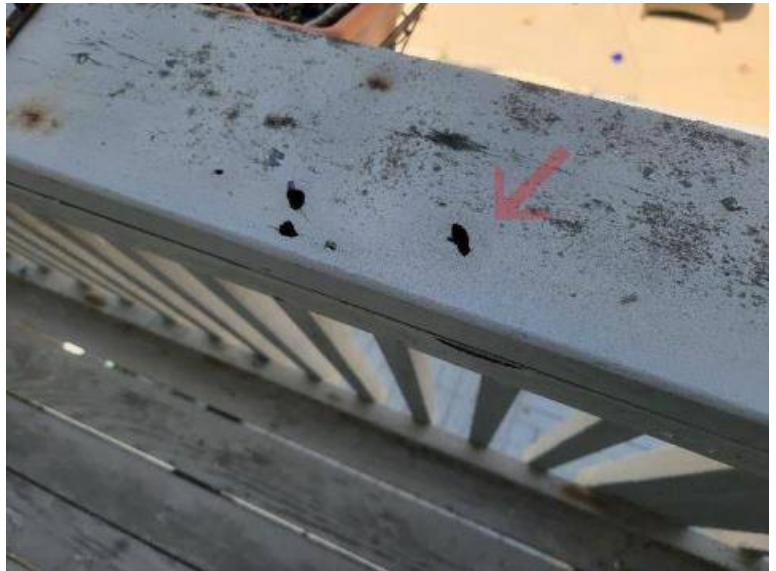
**SAFETY:** Railing appears to be too low. We recommend the minimum height of guardrails to be at least 42-inches above the walking surface with no opening greater than 4-inches where the walk-off height is greater than 30-inches.

**DEFERRED:** Wood rot viewed.

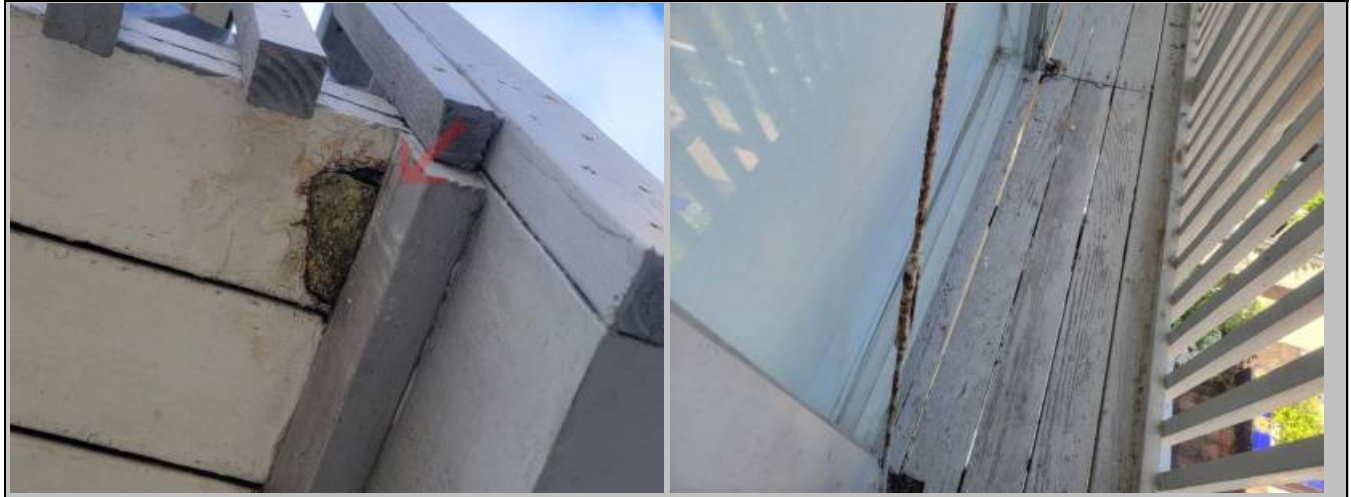
**DEFERRED:** Wood rot viewed.

**MAINTENANCE:** Peeling paint and cross brace is corroded/

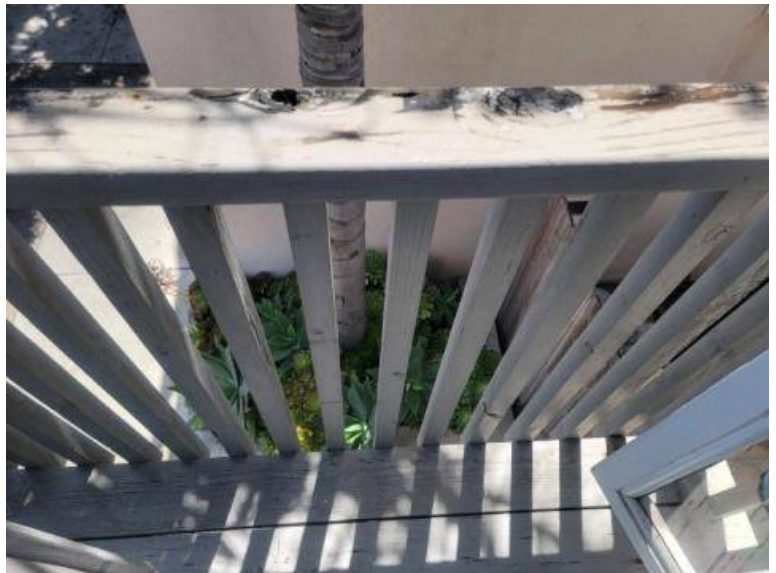
**SAFETY:** Railing appears to be too low. We recommend the minimum height of guardrails to be at least 42-inches above the walking surface with no opening greater than 4-inches where the walk-off height is greater than 30-inches.  
**MAINTENANCE:** Peeling paint.

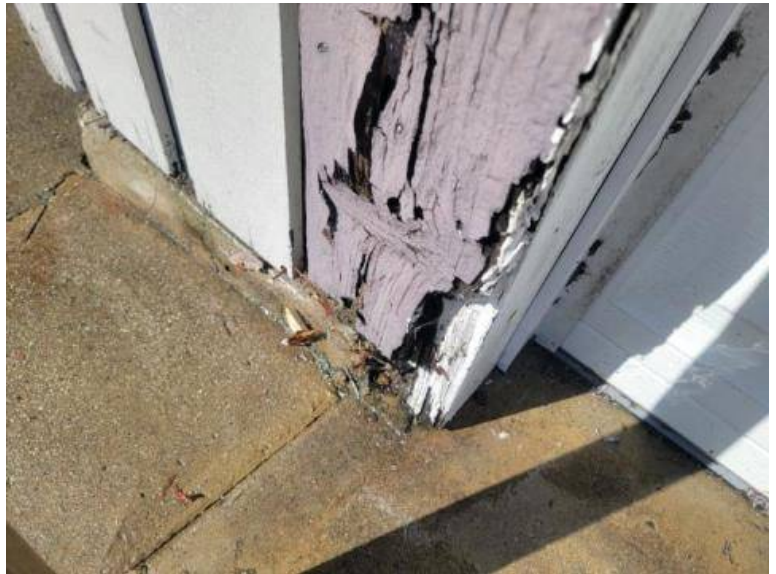
**DEFERRED:** Insect or moisture damage viewed at the jamb.

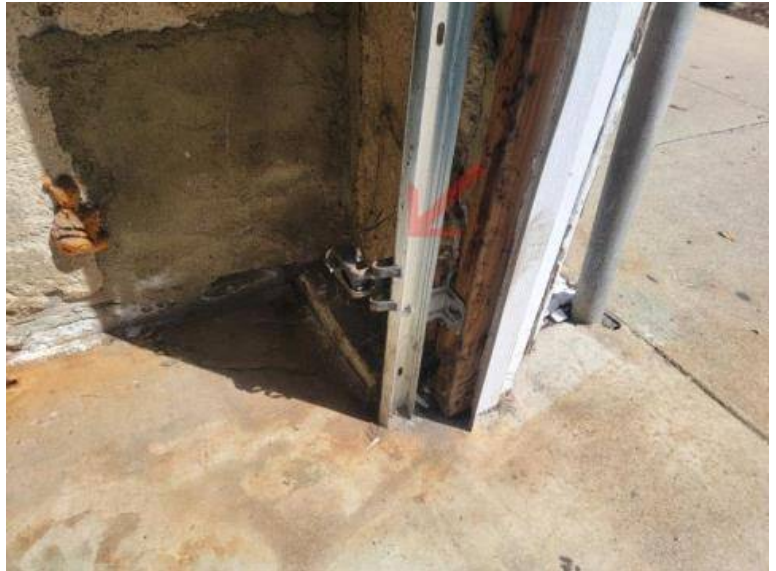
#### 4.2 Automatic operator

**SAFETY:** Electronic safety beams are poorly located. Beams should be installed approximately 6-inches off the floor. We recommend relocating them for enhanced safety.

**DEFERRED:** South door wouldn't close without holding button down, will need adjustment.

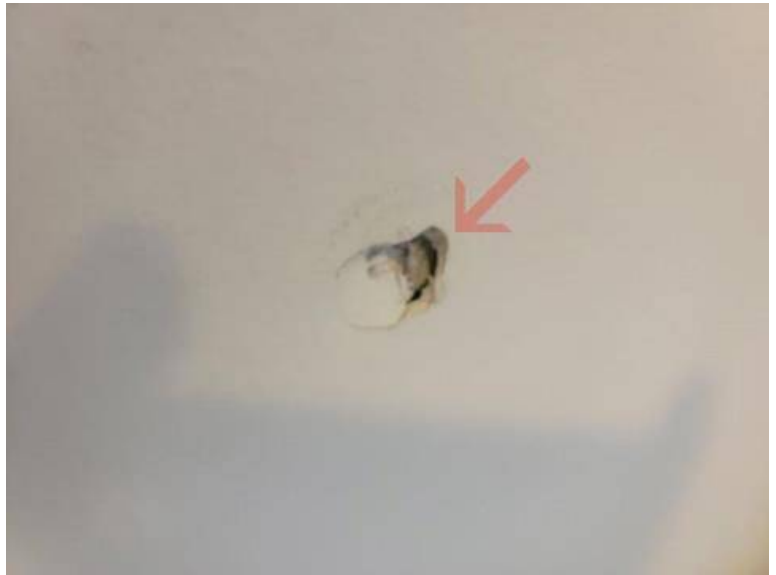
### 4.3 Fire door to interior

**SAFETY:** We recommend installing weather stripping and threshold as needed to provide a seal from garage fumes.

**DEFECTIVE:** No automatic closing hardware is installed as required for fire protection.

**SAFETY:** Deadbolt is not installed. We recommend installing a modern deadbolt that meets current security standards.

**MAINTENANCE:** No door stopper, damage to wall.

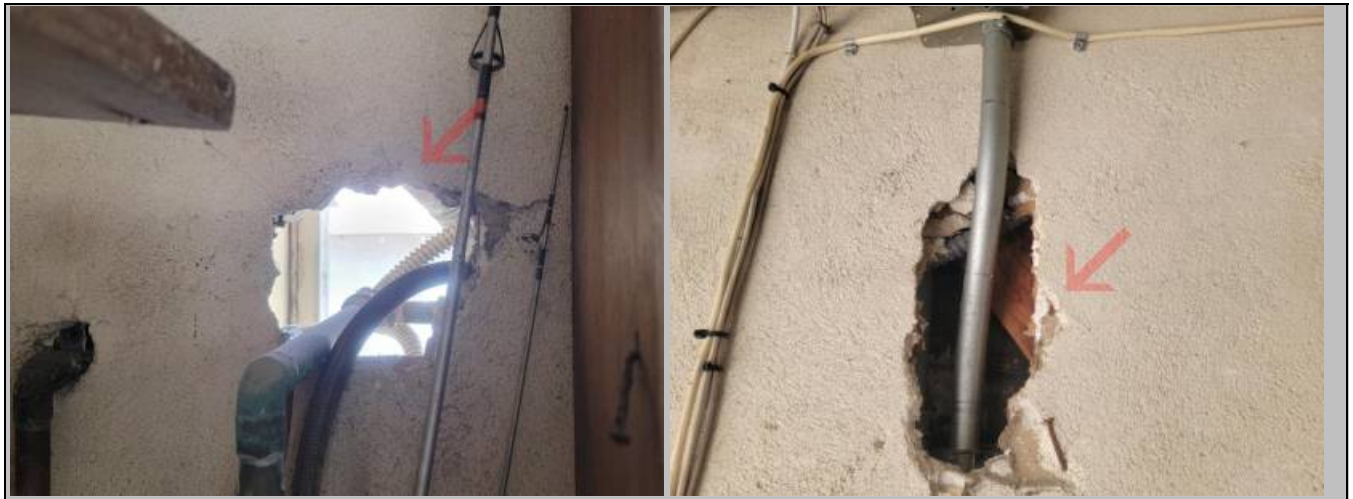
### 4.4 Walls and ceiling

**MAINTENANCE:** Some holes or damaged viewed.

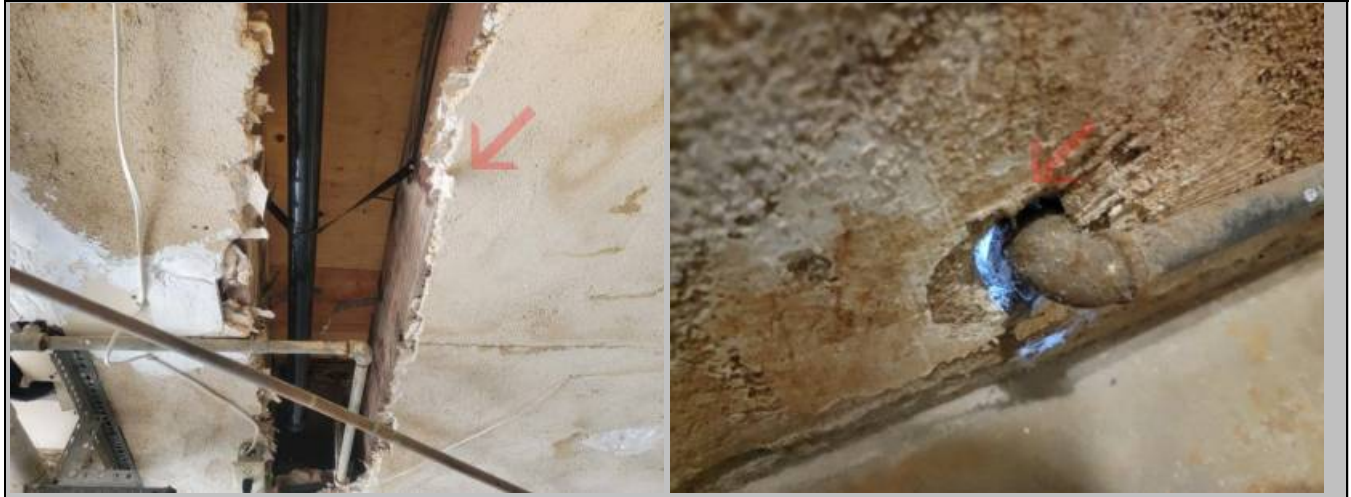
### 4.5 Fire separation

**DEFECTIVE:** Holes or other damage noted. Fire separation is designed to slow the spread of fire originating in the garage.

**DEFECTIVE:** Excessive annular space around pipe at one or more penetrations. Space around firewall penetrations should be tight to prevent the spread of fire.

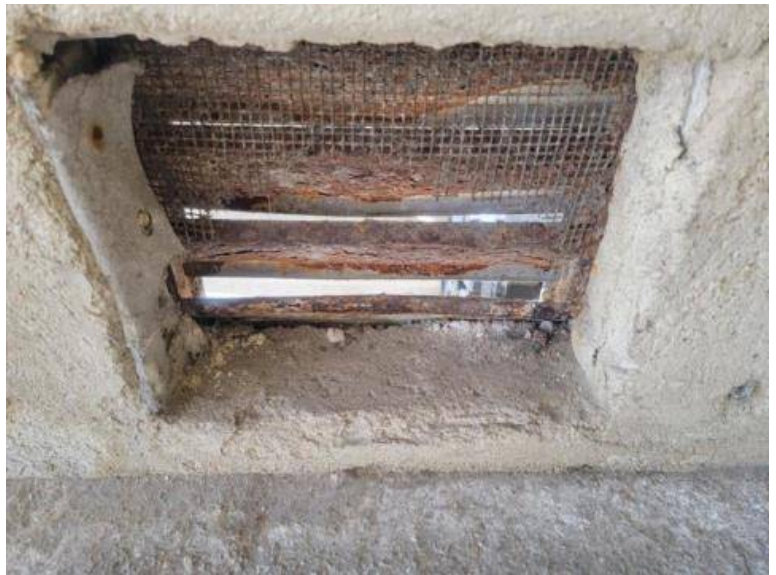
**4.6 Ventilation**

**DEFECTIVE:** Screens were , damaged. .  
We recommend maintaining screens in good repair for proper ventilation of possible combustible vapors and to prevent animal or rodent entry.

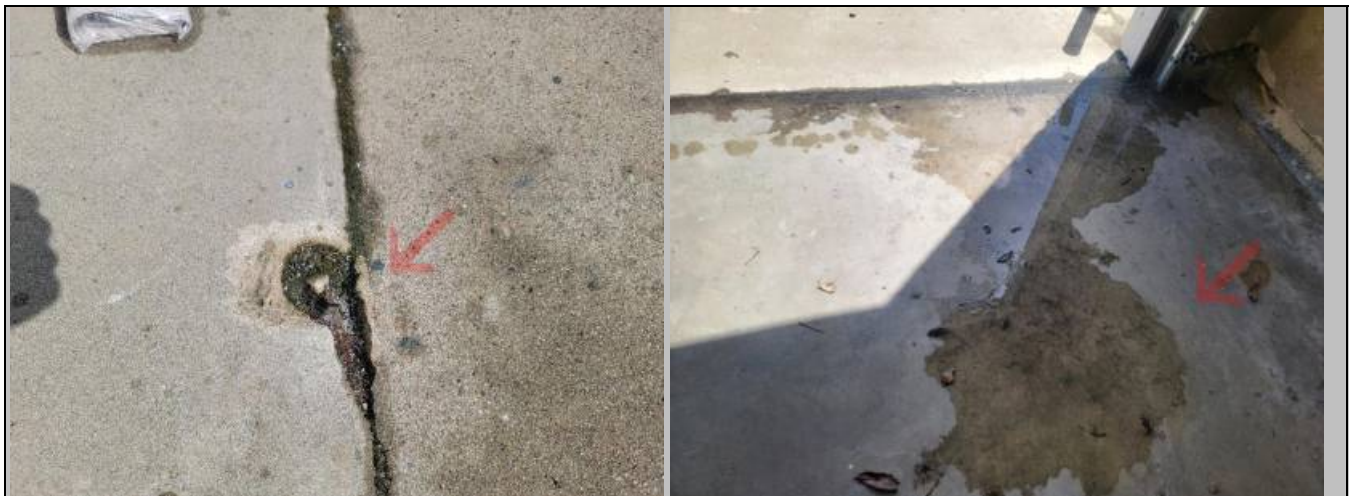
**4.7 Floor**

**DEFECTIVE:** Damaged concrete at entry  
**DEFERRED:** Water entering garage.

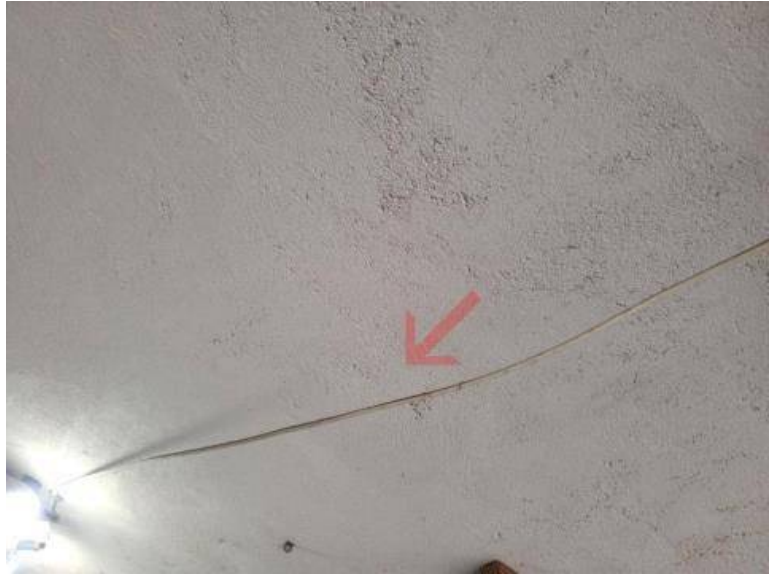
#### 4.8 Garage wiring observations

**DEFECTIVE:** Romex wiring is exposed to physical damage. This type of wiring is for use in concealed areas where it is not subject to physical damage.

**DEFECTIVE:** Unsecured wiring. Loose wiring can be accidentally disconnected creating a hazardous condition.

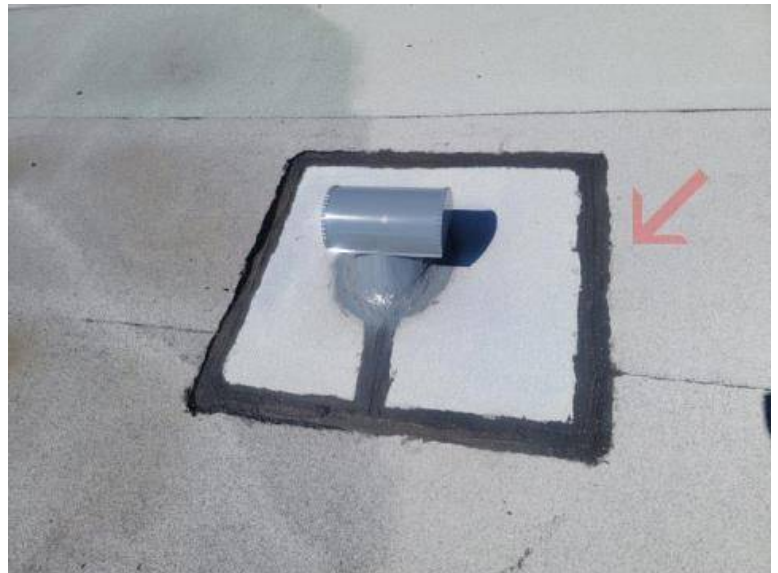
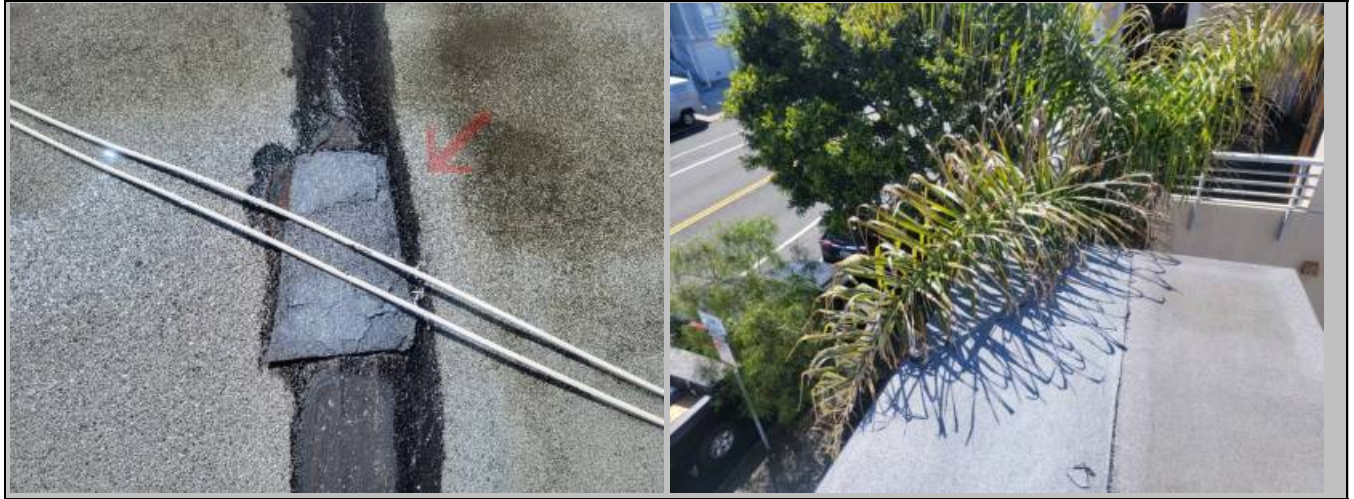
MAINTENANCE: Vegetation near or touching the roof surface. We recommend maintaining vegetation growth near the roof as needed to prevent damage to the roofing materials.

DEFERRED: Repairs/patching observed may indicate a history of leakage. We suggest asking the current owner to disclose any repairs or leaks, past or present.

DEFERRED: Spongy area(s). Spongy areas may indicate moisture damage to the sheathing. We recommend further evaluation by a licensed roofing contractor and a licensed structural pest control operator prior to the close of this transaction.

DEFECTIVE: Evidence of ponding. This condition can reduce the service life of the roof.

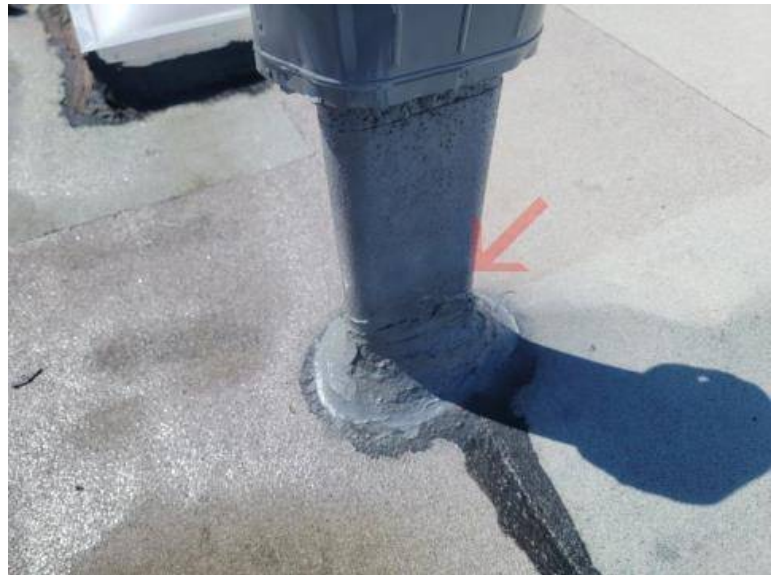
**5.4 Exposed flashings**

**DEFECTIVE:** Storm collar is missing. Gas flues should have a storm collar in lieu of roofers' mastic to guard against water intrusion.

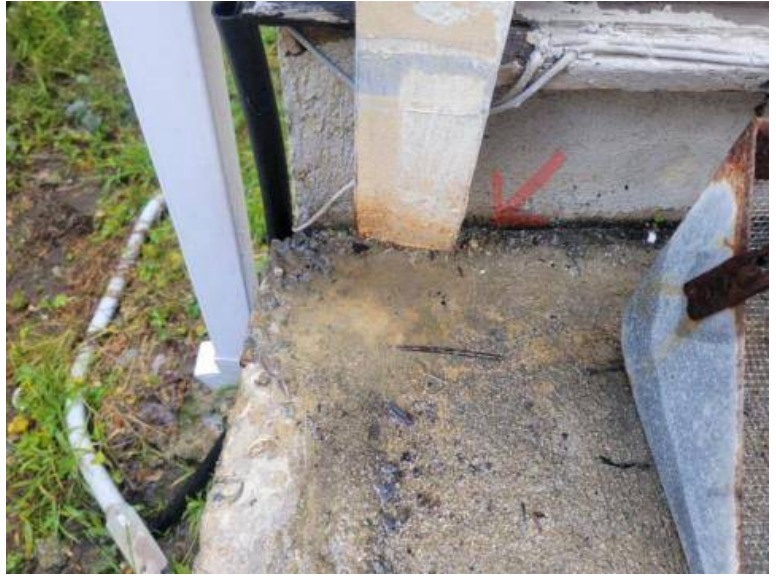
MAINTENANCE: We recommend installing rain gutters to control/divert roof runoff water away from the foundation.

MAINTENANCE: We recommend rerouting downspouts to divert water away from the foundation as needed.

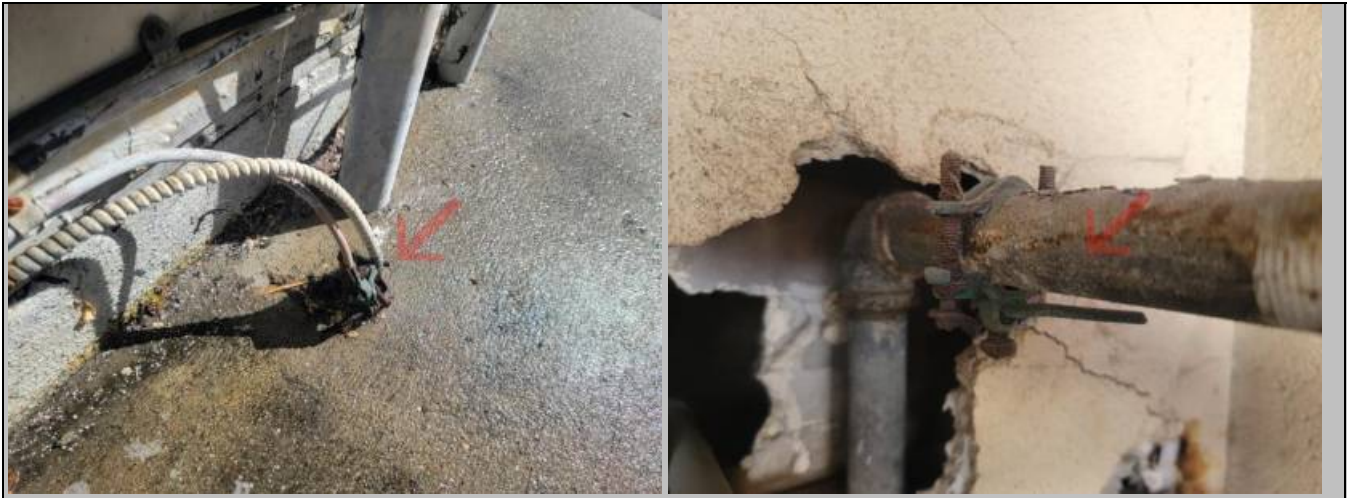
**DEFECTIVE:** Improperly located attachment. The service ground connection to the cold water pipe should be within 5' of where the building supply line enters the building.

**DEFECTIVE:** System ground was not switched to the copper water lines when the water system was re-piped. We strongly advise immediate correction by a licensed electrician of this potentially hazardous condition.

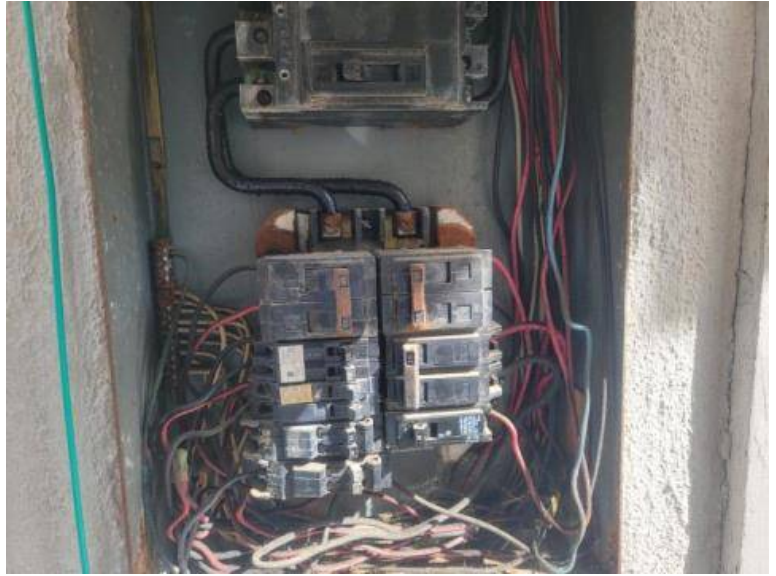
**SAFETY:** Circuit breakers are not adequately labeled for area/items served. We recommend permanently labeling each breaker for emergency needs.  
**DEFECTIVE:** Missing inner panel cover; live parts are exposed to accidental contact.

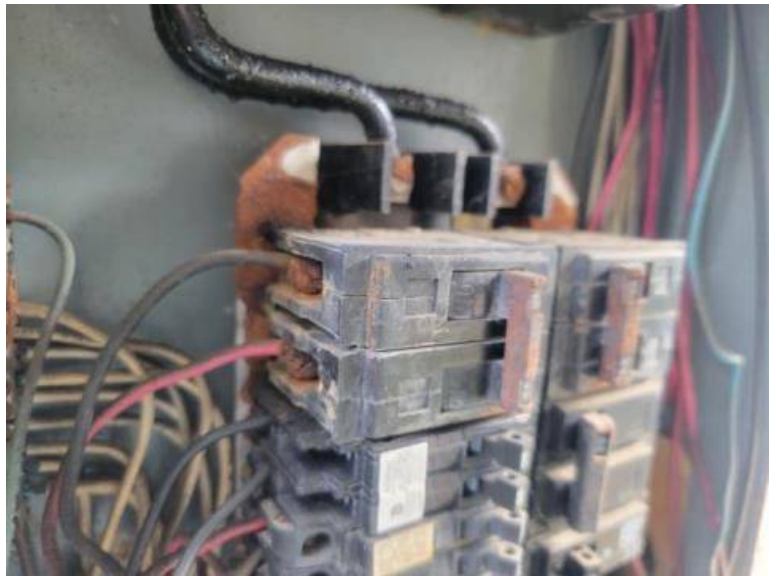
### 7.7 Panel, interior

**DEFECTIVE:** Corrosion observed within the electrical panel indicates moisture intrusion. We recommend further evaluation by a qualified licensed electrical contractor and correction as needed.

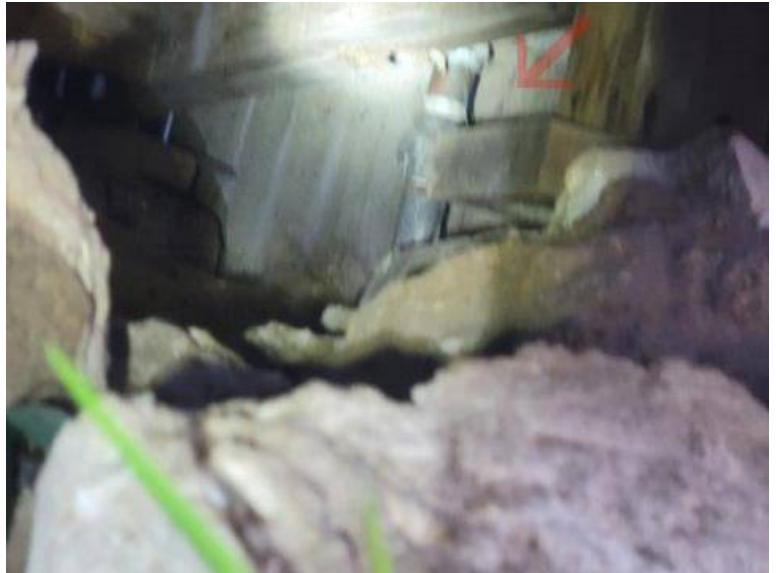
**DEFERRED:** It appears to be under front deck not accessible. Required to have accessible shutoff at house.

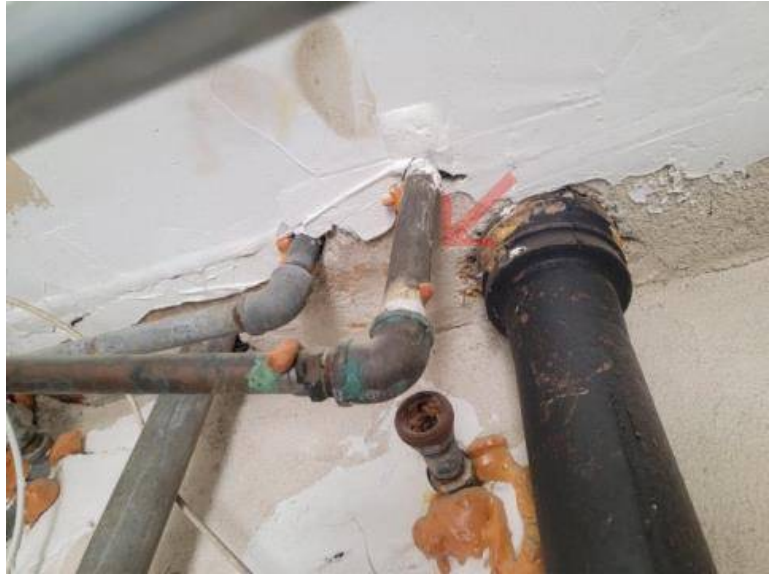
**DEFECTIVE:** Missing dielectric coupling at one or more locations. Where copper and galvanized pipes are connected together a dielectric coupling, or section of brass pipe must be used to control galvanic corrosion and premature leakage.

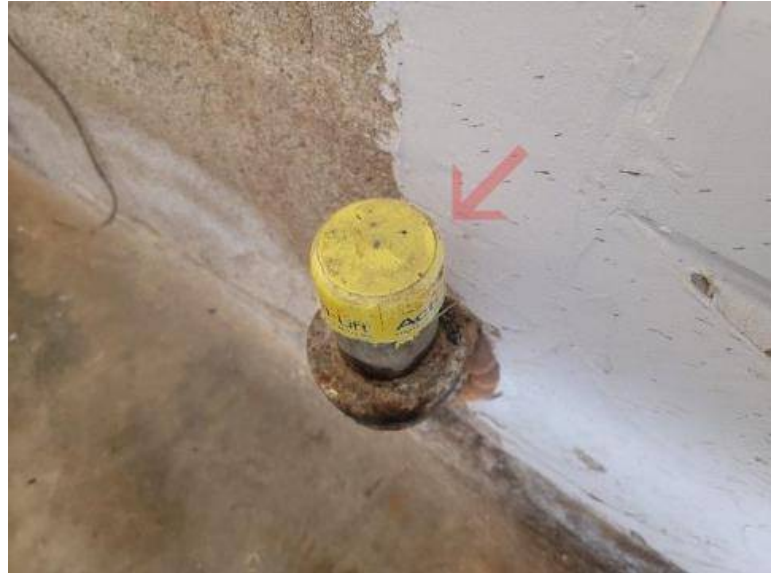
**DEFERRED:** Due to the age of this building we recommend having a video scan to determine the interior condition of the sewer line (service available by others). Repairs can be expensive and this is the best non-intrusive way to determine the sewer line condition.  
**DEFECTIVE:** Improper cap for Cleanout.

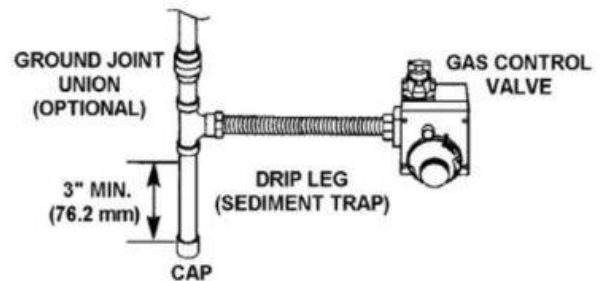
**DEFECTIVE:** No sediment trap on the gas line. Sediment traps protect the appliance from malfunctioning due to debris in the gas line. We recommend sediment traps at all gas water heaters.

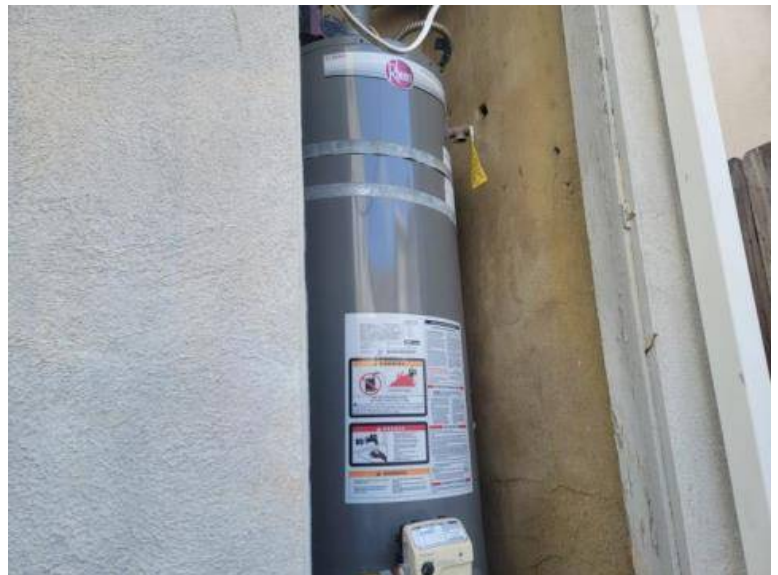
#### 9.5 Seismic bracing

**DEFECTIVE:** Not adequately braced, anchored or strapped to resist toppling or horizontal displacement due to earthquake motion. Minimum requirement for water heaters is two approved straps properly located at top and bottom 1/3 and anchored with minimum of 2-1/4" X 3" lag bolts per strap into the studs (or the structural equivalent where stud attachment is not an option).

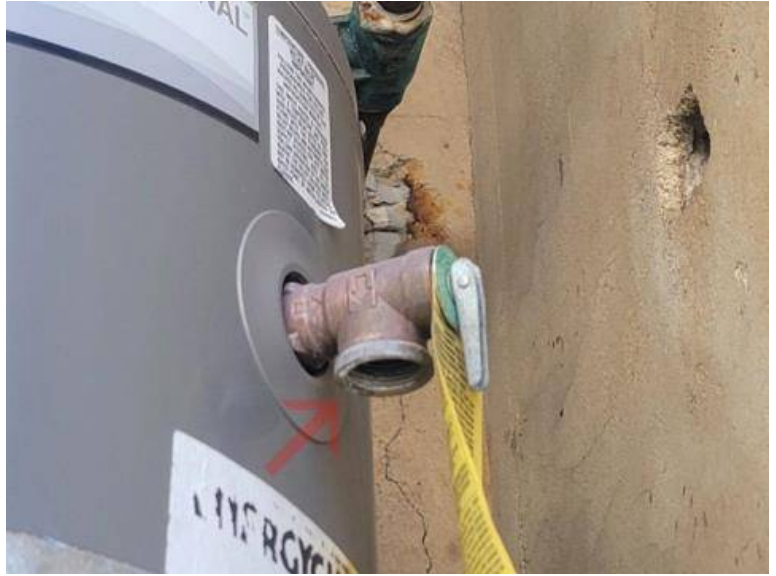
### 9.6 Safety relief valve

**DEFECTIVE:** No discharge line. An approved discharge line that terminates below the controls and at the exterior of the building or other approved location is required on safety valves.

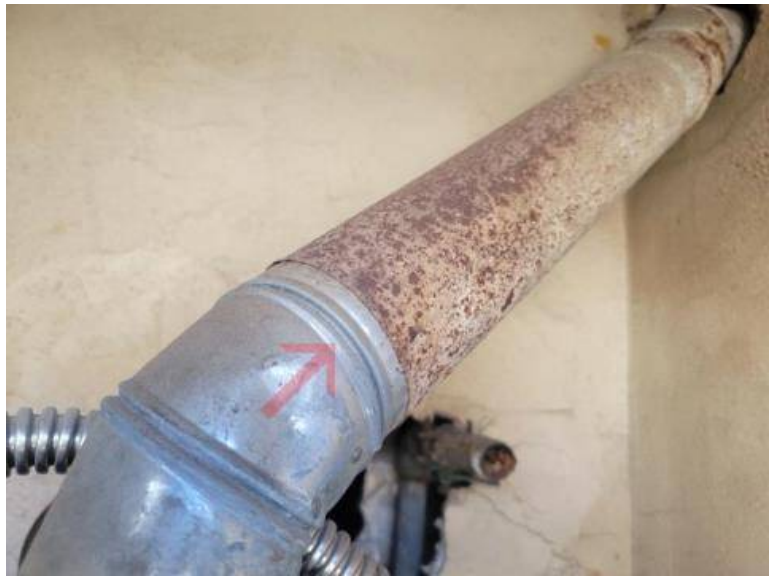
### 9.7 Vent system

**DEFECTIVE:** Sections of the connector pipe are not screwed together or the draft hood is not properly secured. Each joint of the vent connector pipe should be secured with three screws and the draft hood securely attached to the tank to prevent accidental displacement.

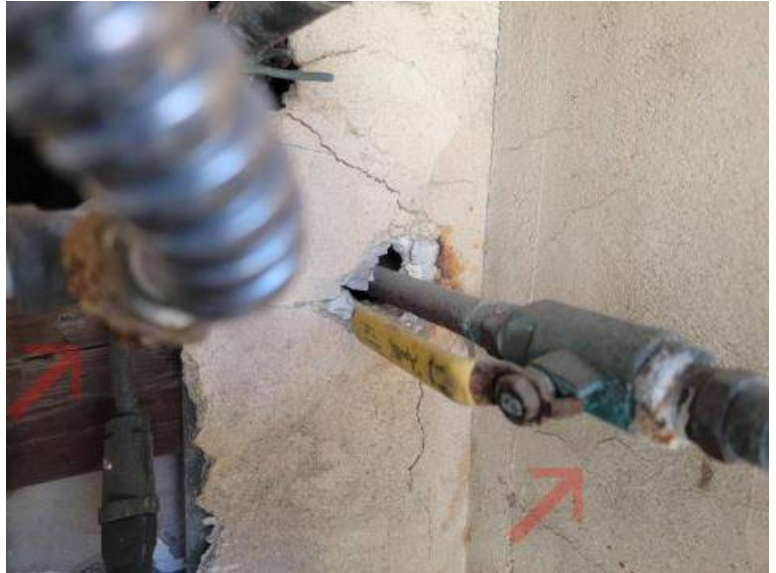
### 9.8 Water connections

**SAFETY:** Water and gas pipe bonding not viewed. We recommend bonding the water and gas lines together at the water heater to eliminate the potential for electric shock. This can be done with a few dollars worth of parts and a few minutes of labor by a licensed electrician.  
**MAINTENANCE:** Shutoff valve or connectors are corroded. We recommend replacing corroded components when observed as preventative maintenance.

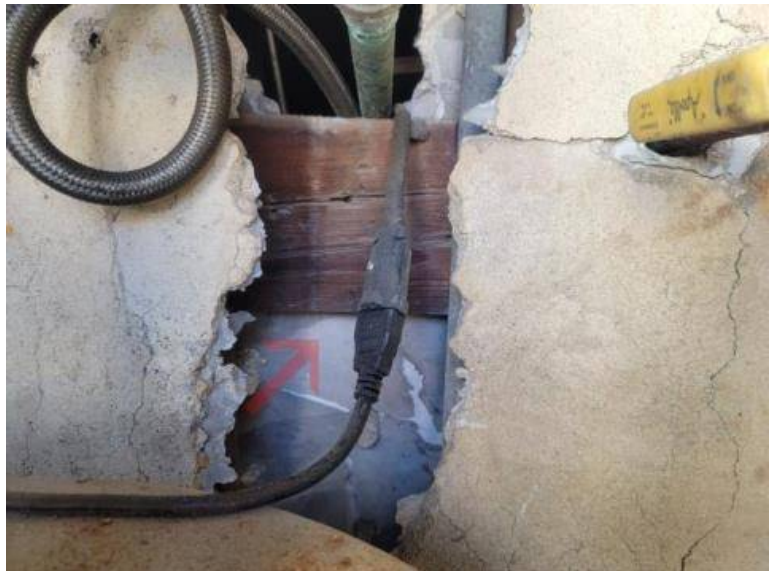
**DEFECTIVE:** Recirculation pump plugged into extension cord and should be plugged directly into receptacle.

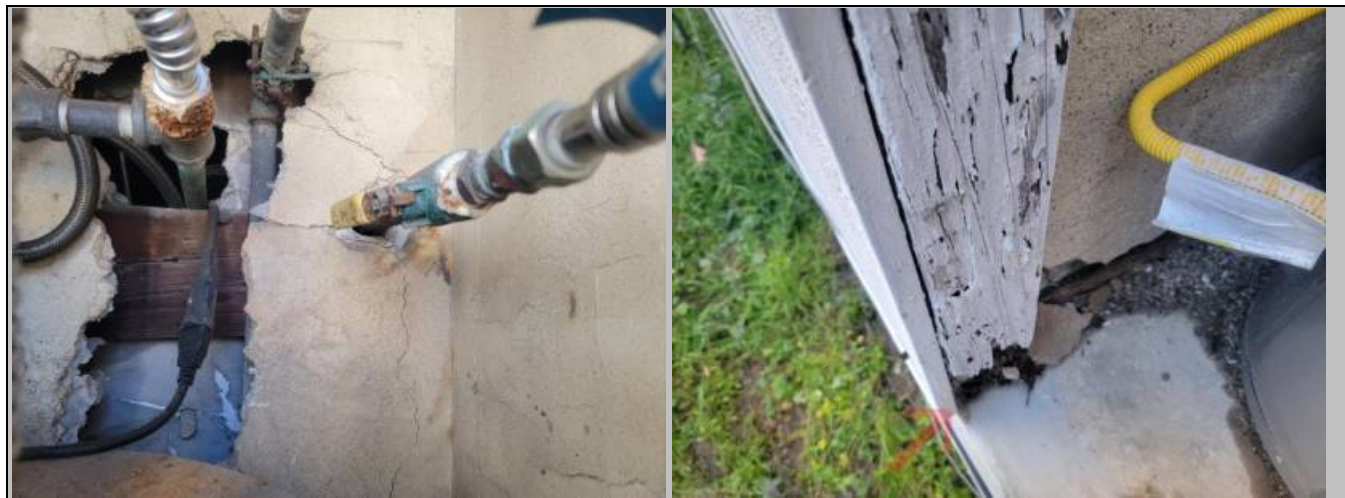
### 9.12 Enclosure

**DEFECTIVE:** Missing door

**MAINTENANCE:** Walls inside the enclosure are damaged.

**DEFERRED:** Rot viewed on trim.

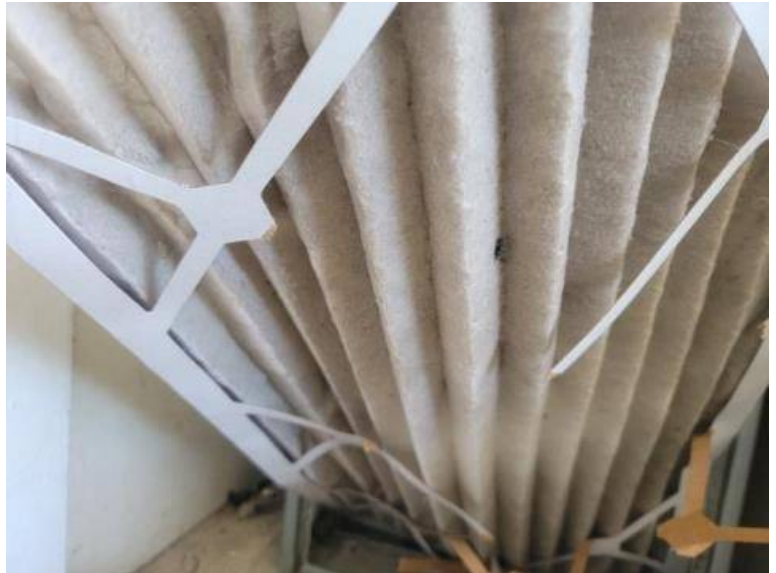
**MAINTENANCE:** Filter is dirty. Filters should be checked every two to three months and cleaned or changed as needed. We recommend cleaning or replacing filters when any dust can be observed for increased efficiency and energy conservation.

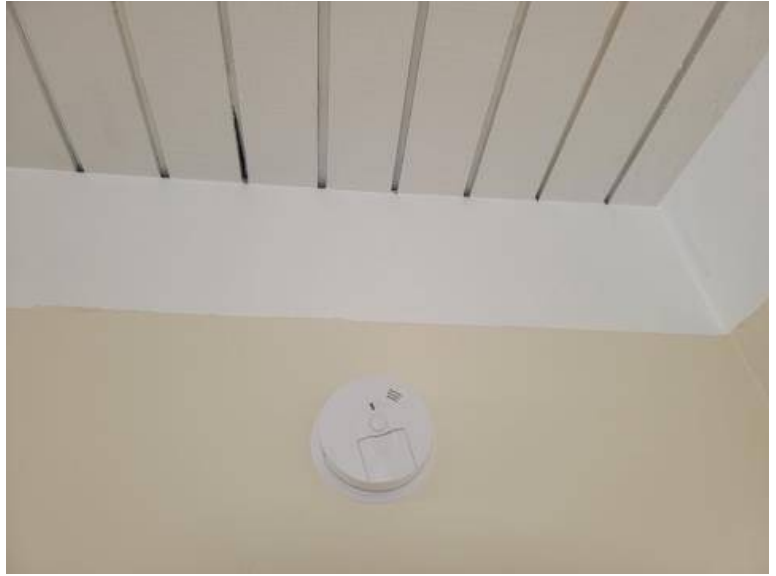
**DEFECTIVE:** Missing. A smoke alarm is required in rooms or hallways leading to sleeping rooms.

**SAFETY:** Older smoke alarms are estimated to have a 30% probability of failure within the first 10 years. Newer smoke alarms do better, but should be replaced after 10 years. Unless you know that the smoke alarms are new, replacing them when moving into a new residence with dual sensors smoke alarms with both photoelectric and ionization for optimal performance is recommended by the National Fire Protection Association.

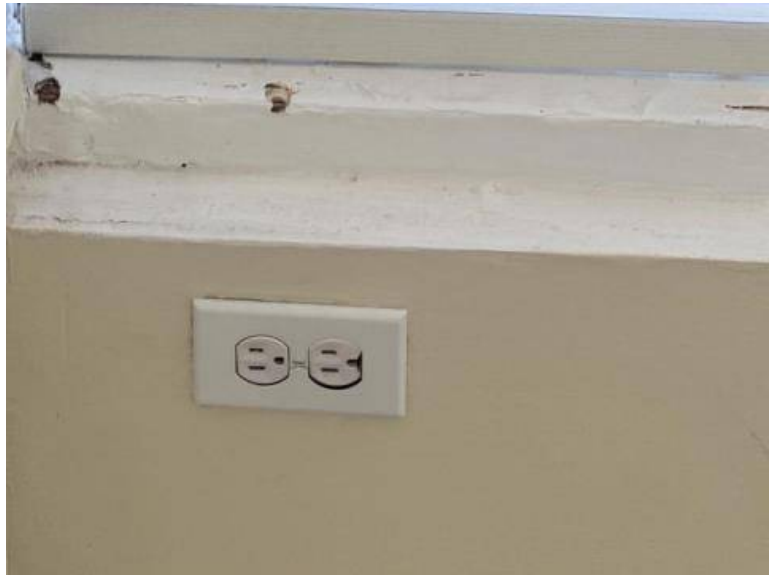
**DEFECTIVE:** Receptacle(s) sampled was dead in stairwell

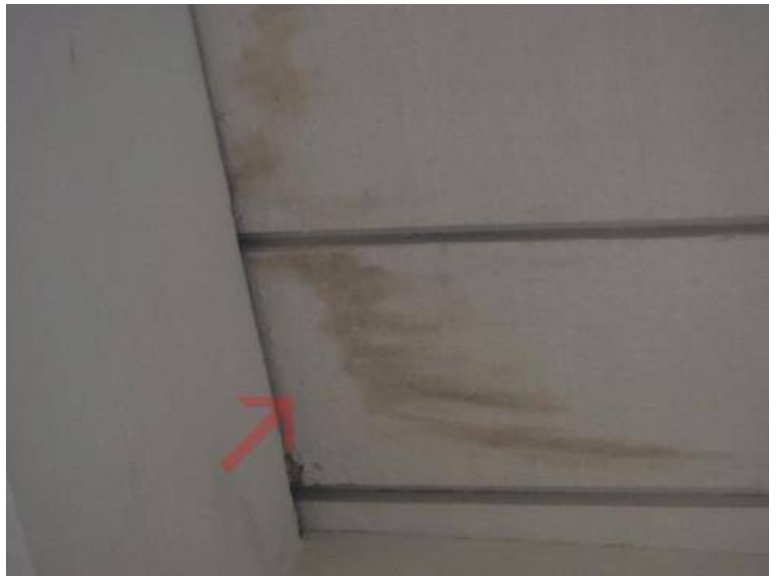
**DEFERRED:** Moisture stains noted on the, ceiling appeared dry at the time of our inspection and could be from a repaired or intermittent leak. We suggest asking the current owner for any knowledge or history of leakage.

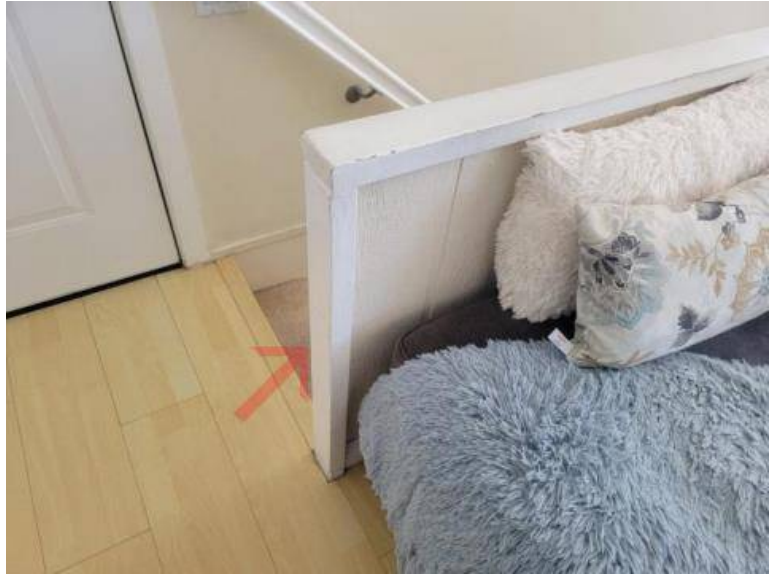
**SAFETY:** Railing appears to be too low. We recommend the minimum height of guardrails to be at least 42-inches above the walking surface with no opening greater than 4-inches where the walk-off height is greater than 30-inches.
