# Property Inspection Report

**Estate of Lloyd Freese**

**132 8th Street Manhattan Beach, CA 90266**

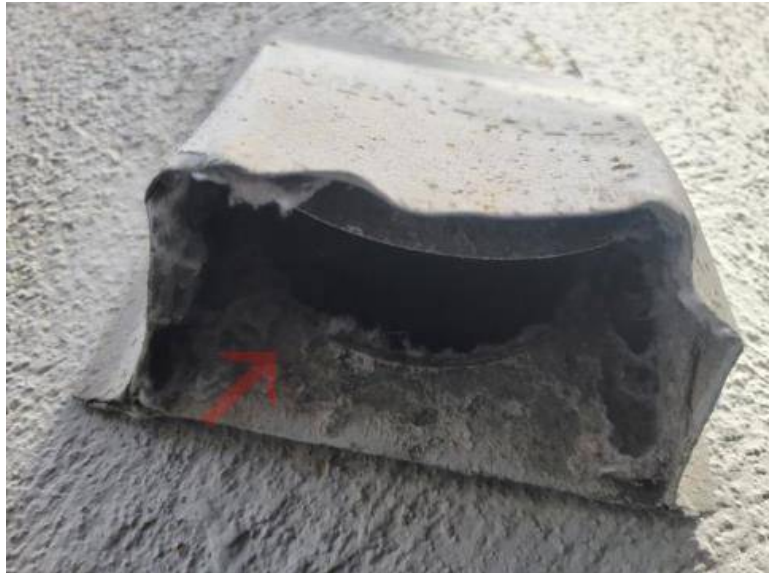
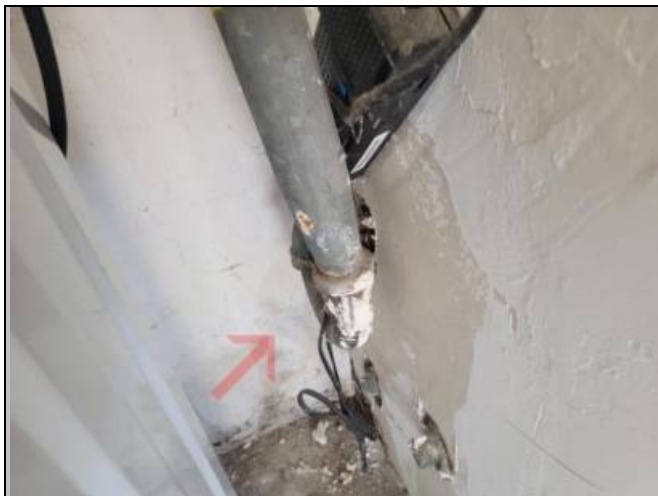
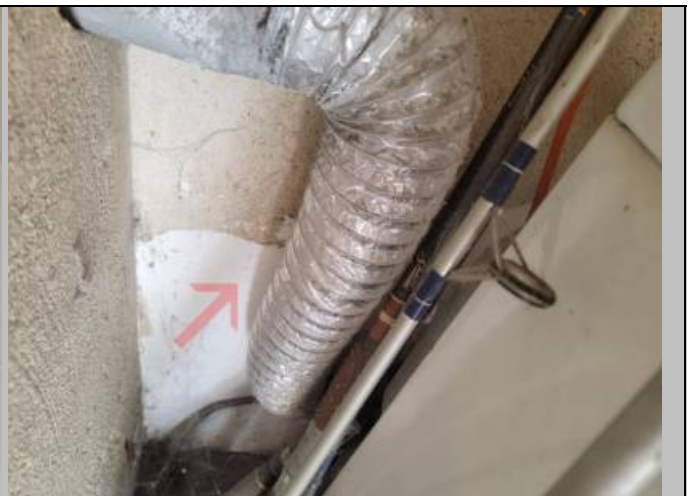
**DEFERRED:** Laundry trap and drain is undersized by today's standards and may need to be replaced for proper drainage.

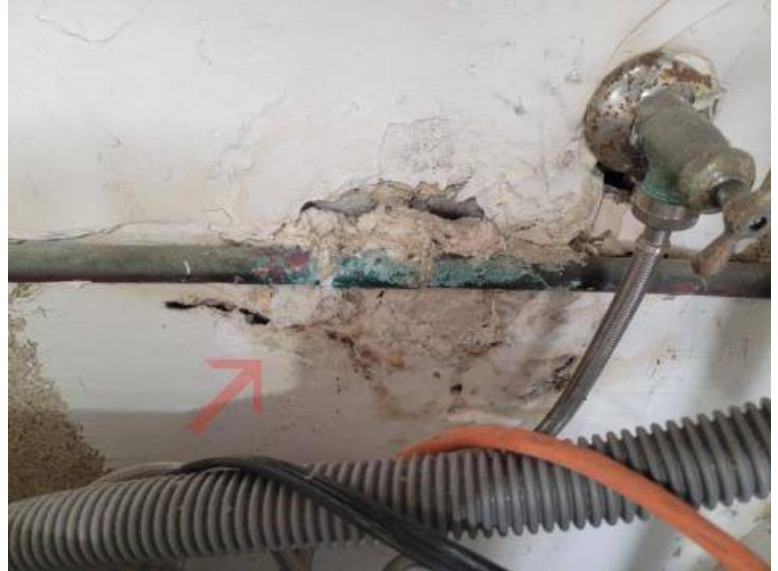
**MAINTENANCE:** Some holes or damaged viewed.

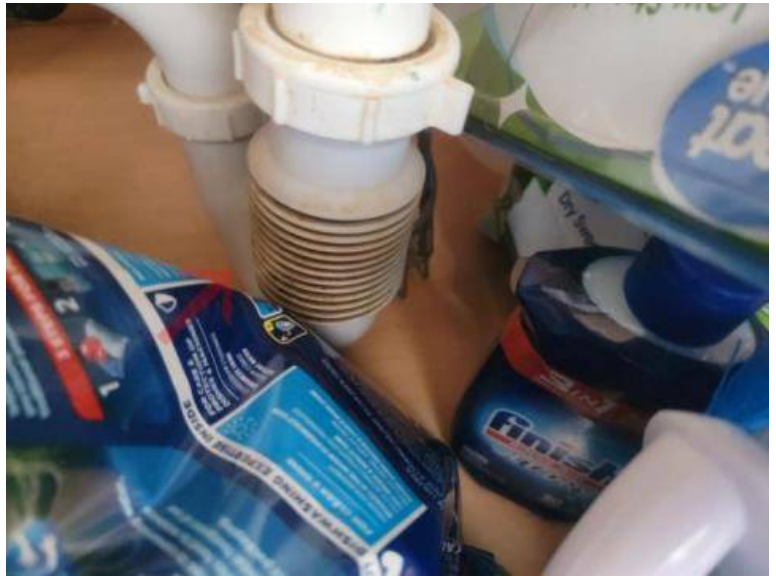
**DEFECTIVE:** Improper drain materials. Flexible tail pieces are not approved and will collect soap and bacteria. We recommend replacing them with an appropriate sanitary component.

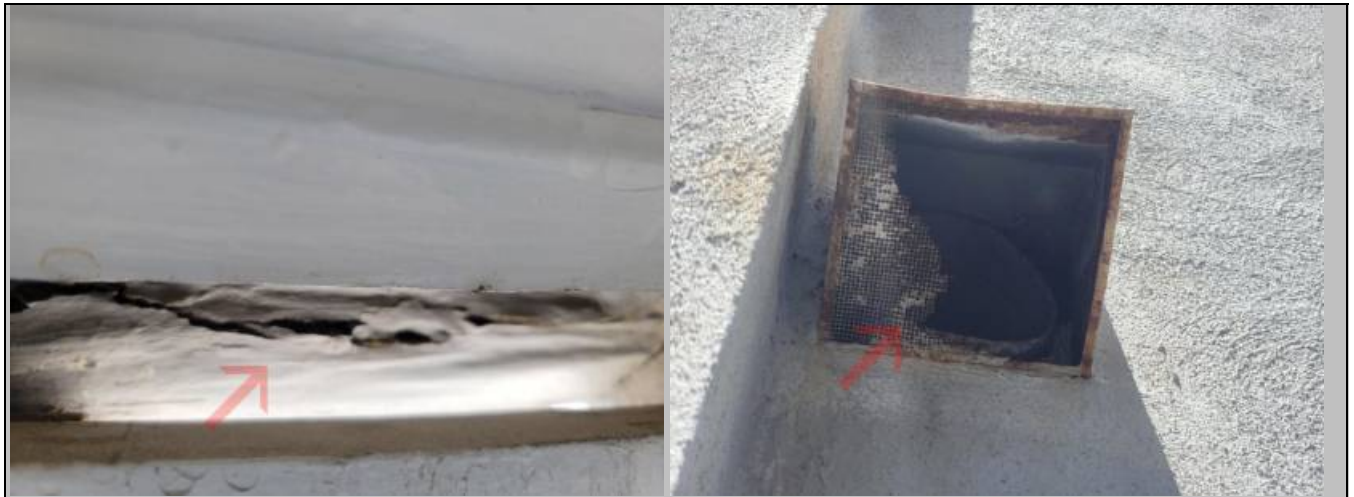
**DEFECTIVE:** Fan did not respond to user controls. You are now required to have exhaust fan even when you have a window.

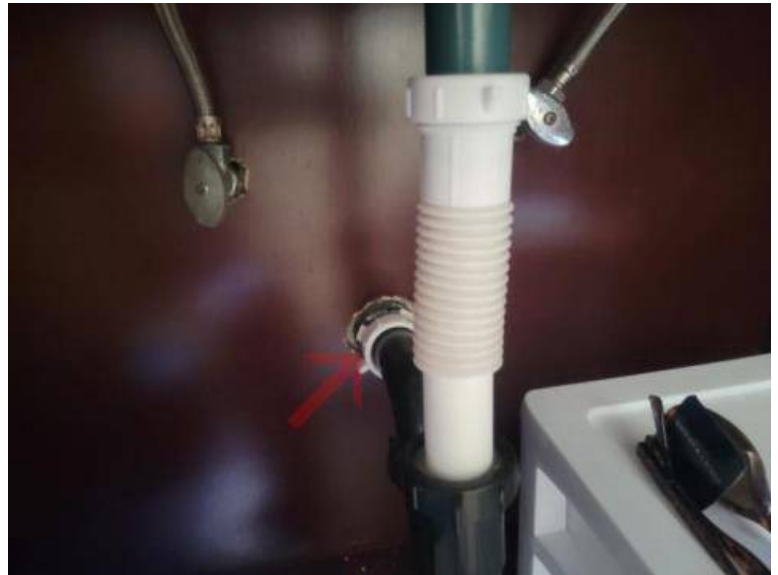
**DEFECTIVE:** Improper drain materials. Flexible tail pieces are not approved and will collect soap and bacteria. We recommend replacing them with an appropriate sanitary component.

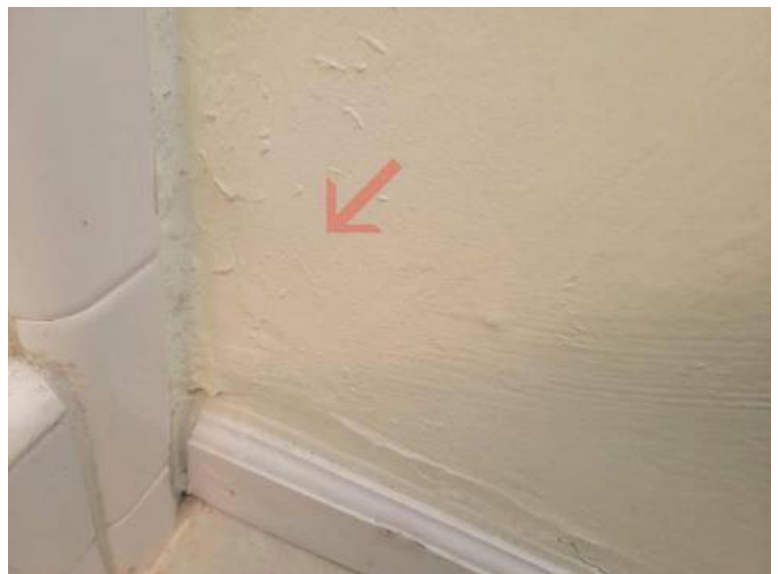
**14.11 Stall shower**  
**MAINTENANCE:** Faucet leaks at the handle.  
**MAINTENANCE:** Moisture damage at the wall or floor outside the shower. Possible concealed insect damage or wood rot. We recommend further evaluation by a licensed pest control operator.

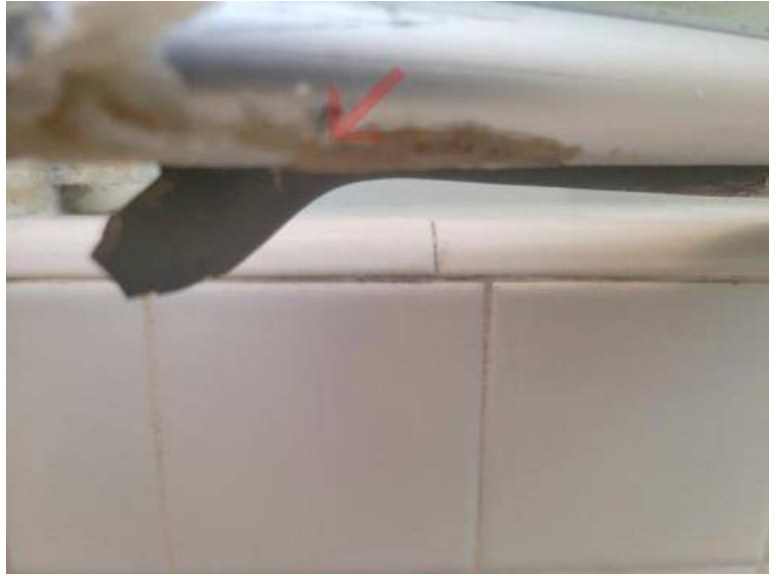
**14.12 Shower door/enclosure**

**MAINTENANCE:** Vinyl strip at the bottom of the door is damaged. This strip helps to prevent water from escaping. We recommend repair as needed at this time.

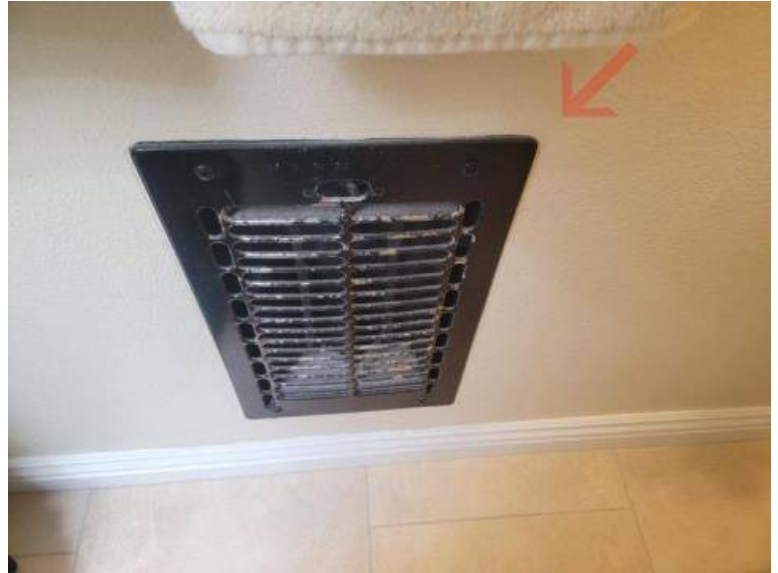
**SAFETY:** Towel bar is too close to the electric wall heater, which is a fire hazard. We recommend relocating the towel bar.
