SUMMARY
 555 W 104th Pl, Los Angeles, CA
 90044
 Lisa Williams
 August 17, 2024

Scott Knudson
 NACHI09070813
 Signature Property Inspections
 888-860-2688
info@signaturemore.com

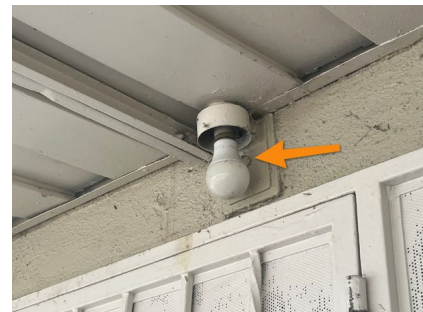
Left Side

4.5.1 Electrical
LIGHT FIXTURES - DETERIORATED

One or more light fixtures are damaged and/or deteriorated. A qualified electrician should evaluate and repair or replace light fixtures where necessary.

Recommendation
 Contact a qualified electrical contractor.

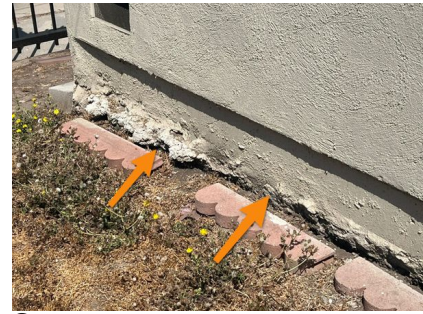
Garage

4.6.1 Foundation

FOOTING ABOVE GRADE

One or more sections of foundation footings are significantly above grade. Footings should be below grade so adequate lateral support is provided by the soil. Soil should be installed as necessary so footings are below grade.

Recommendation
Contact a qualified concrete contractor.

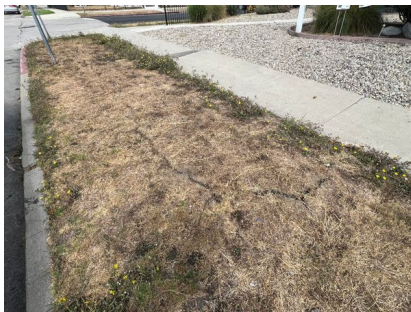
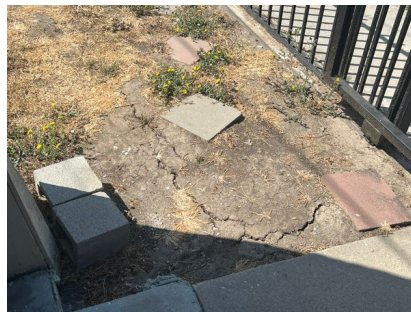
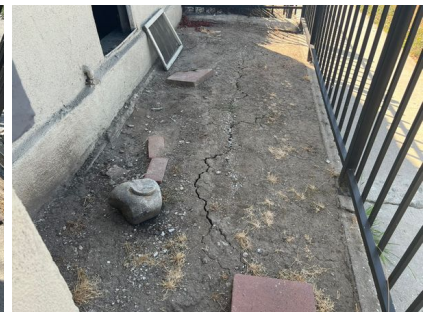
4.6.2 Foundation

POTENTIAL EXPANSIVE SOIL

The home was located in an area that is known to have deposits of expansive soils. Expansive soils are soils that increase to many times their original volume in response to increases in soil moisture levels, creating forces that can easily damage home foundations. The Inspector recommends that before the expiration of your Inspection inspection contingency deadline you ask to see any existing soil reports, or that you have soil testing performed by a soils (geotechnical) engineer, in order to determine the level of potential risk.

Recommendation
Contact a qualified structural engineer.

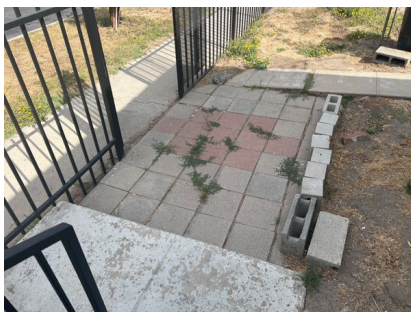
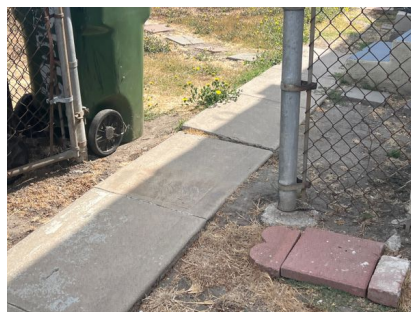
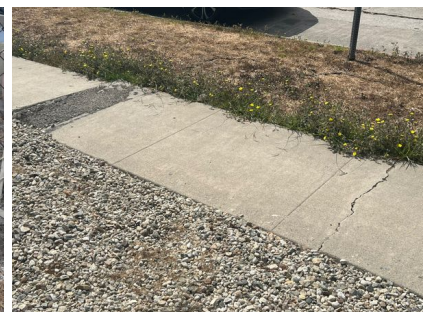
4.9.2 Walkways
TRIP HAZARD

Due to cracks, settlement, or heaving, one or more trip hazards were found in walkways or patio sections. A qualified contractor should evaluate, repair, or replace sidewalk or patio sections to eliminate trip hazards.

Recommendation
Contact a qualified concrete contractor.

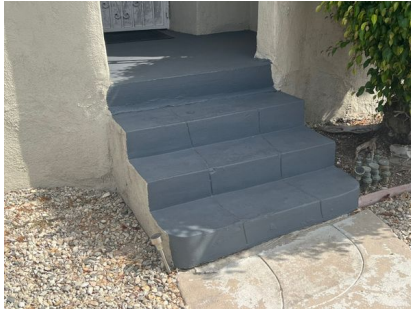
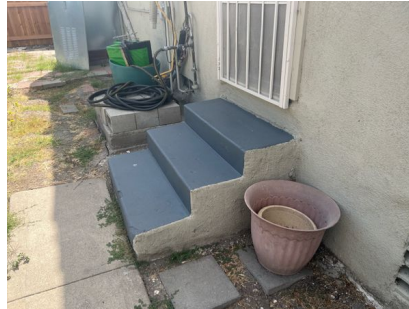
4.21.1 Handrails

MISSING

One or more flights of stairs with four (4) or more risers have no handrail installed. This is a safety hazard. A qualified contractor should install graspable handrails that your hand can completely encircle at stairs where missing, and as per standard building practices.

Contact a qualified professional.

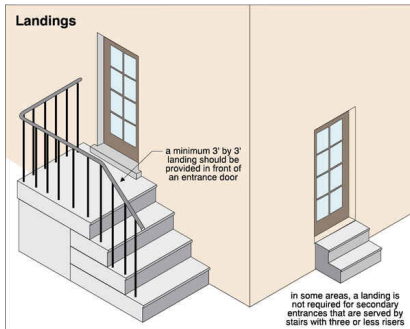
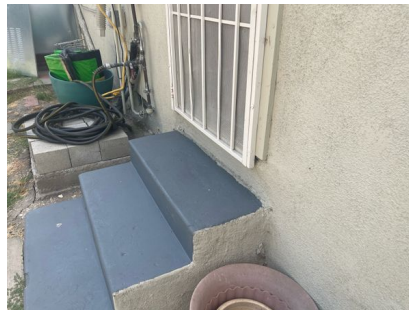
Outside Rear

4.23.1 Landings

NO LANDING AT TOP OF STAIRS

One or more doors swing outward over stairs without a landing area in front of the door. This a safety hazard, specifically in the case of someone tripping or falling when standing on the stairs and opening the door while someone else walks through the door as it is opened. A qualified contractor should evaluate and make repairs as necessary. For example, installing a door that opens in the other direction (away from the stairs).

Contact a qualified door repair/installation contractor.

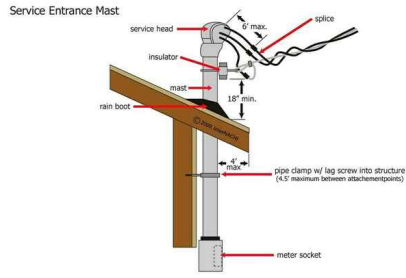
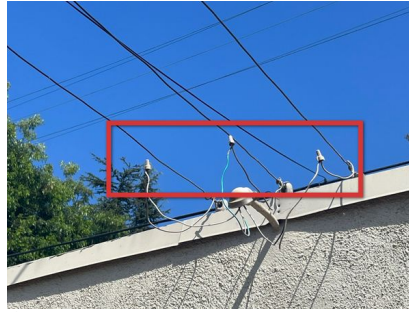
Garage

6.9.1 Service Entrance Wires

EXPOSED SPLICES

Spllices in the service conductors at the service masthead were exposed. The spllices should be covered with plastic insulators or tape to prevent exposed, energized wires. This is a potential shock hazard. Recommend that a licensed and qualified electrician repair per standard building practices.

Contact a qualified electrical contractor.

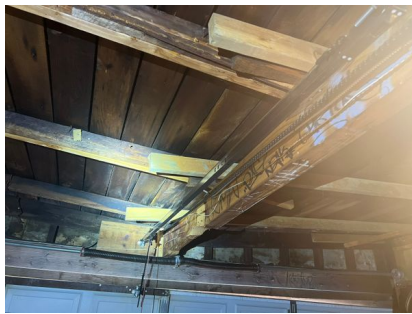
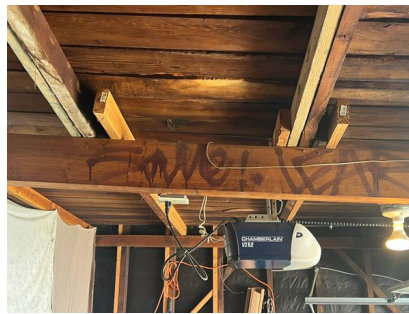
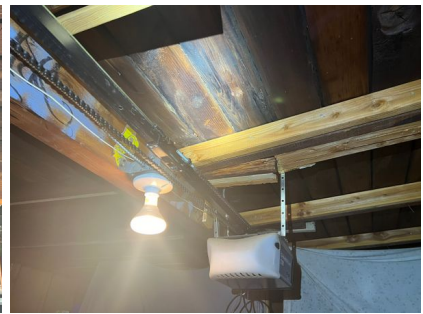
7.3.2 Interior / Walls / Ceiling

PRIOR CEILING/WALL REPAIRS NOTED

Prior ceiling and or wall repairs were noted in one or more areas. Recommend asking seller and or sellers agent for explanation of repairs.

Recommendation
Contact the seller for more info

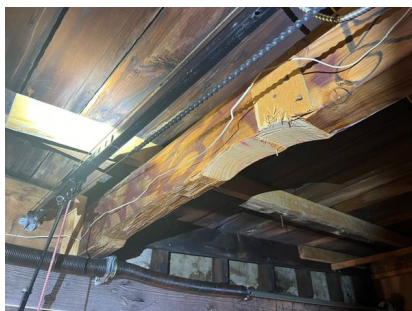
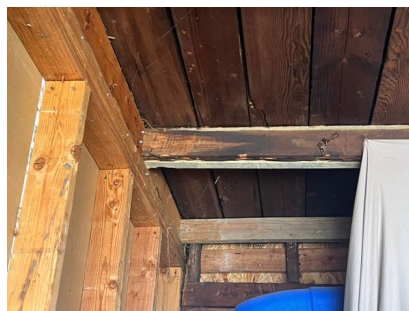
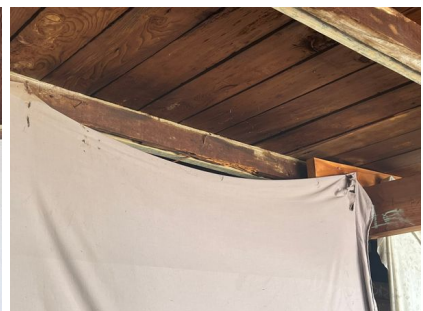
7.3.3 Interior / Walls / Ceiling

GARAGE JOIST/BEAM/RAFTER/TRUSS DAMAGE

Ceiling joist, rafter, truss and or beam in the garage is damaged. Recommend having a qualified professional repair and or replace.

Recommendation
Contact a qualified carpentry contractor

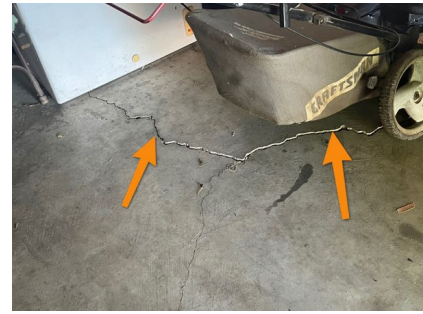
7.4.1 Floor
MODERATE CRACKS

Moderate cracks, heaving, and/or settlements were found in one or more sections of concrete slab floors. Uneven surfaces can pose a trip hazard. Recommend that a qualified contractor repair or replace concrete slab floors where necessary.

Recommendation
Contact a qualified concrete contractor.

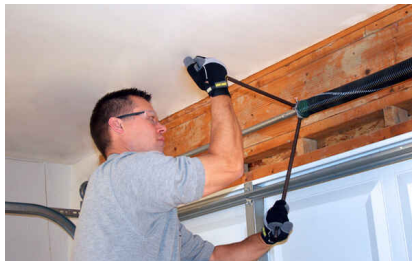
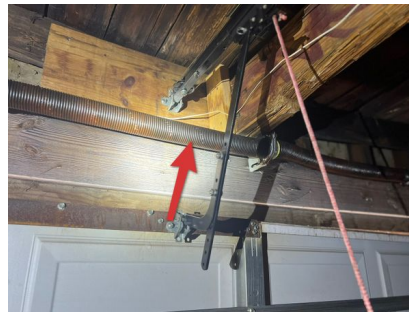
7.6.1 Vehicle Door **NOT BALANCED**

The vehicle door isn't balanced. The door won't stay in place when it's partially opened and falls to the ground instead. This is a safety hazard since the door may fall when open. A qualified contractor should evaluate and make repairs as necessary.

Recommendation
Contact a qualified garage door contractor.

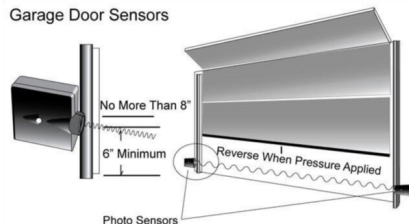
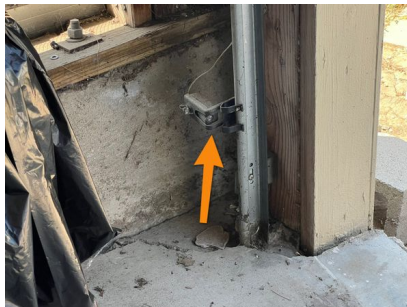
7.7.1 Automatic Door Opener **PHOTOELECTRIC SENSORS - TOO HIGH**

The photoelectric sensors that trigger the auto-reverse feature on one or more garage vehicle doors' automatic openers were higher than 8 inches from the floor. This is a potential safety hazard. A licensed and qualified person should relocate sensors 6 to 8 inches (dependent on the manufacturer) from the floor per standard building practices

Garage doors should have two safety devices. The electronic sensor causes the door to reverse motion when the photo sensor is broken. The pressure reverse should cause the door to reverse when the most minimum resistant pressure is applied during the door down motion.

Contact a qualified garage door contractor.

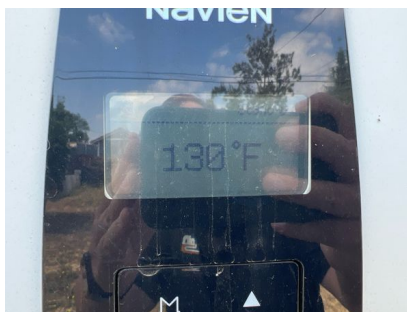
8.3.1 Gas Water Heater

TEMP > 120

The hot water temperature for the water heater is more significant than 120 degrees Fahrenheit. This is a safety hazard due to the risk of scalding. The thermostat should be adjusted so the water temperature doesn't exceed 120 degrees.

Contact a handyman or DIY project

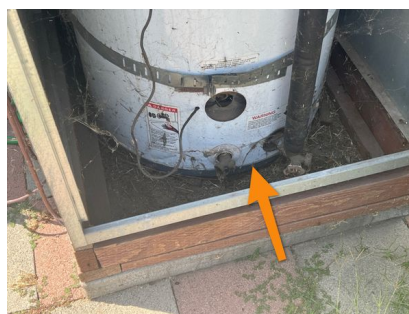
8.3.2 Gas Water Heater

NO INSULATED PAD

The water heater is installed in an unheated space and is not resting on an insulated pad. We recommend installing an insulated pad under the water heater for better energy efficiency.

Contact a qualified plumbing contractor.

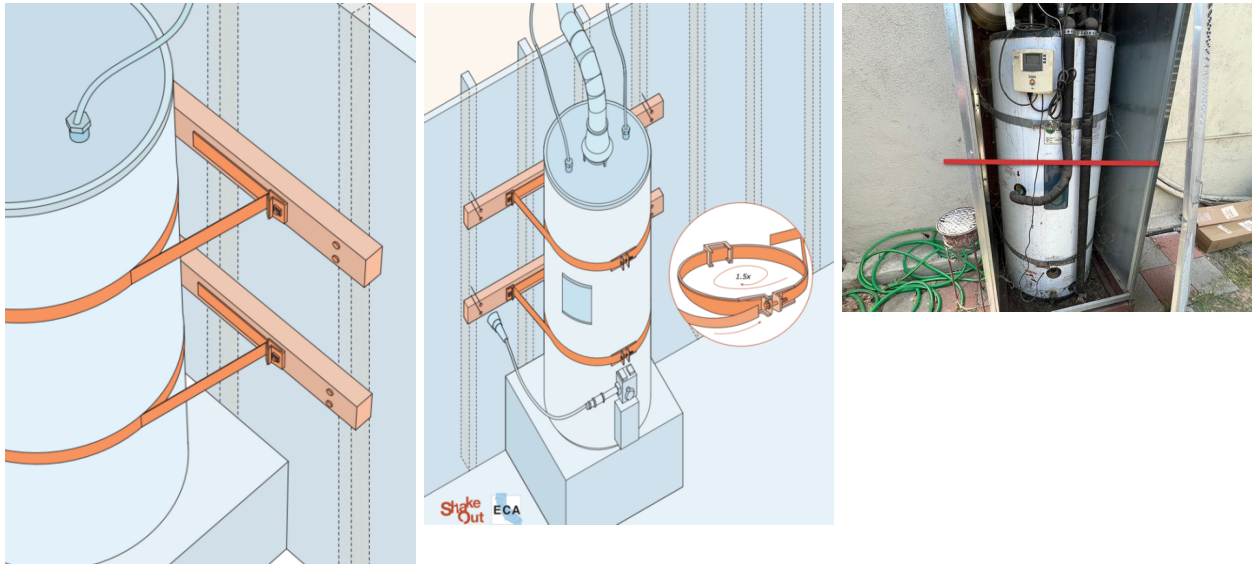
8.5.1 Seismic Straps

SUBSTANDARD BRACING

The water heater's seismic straps or struts are substandard. For example, they may allow significant movement or use improper fasteners. This is a potential safety hazard since movement can cause leaks in the gas supply lines or damaged wiring. Leaks may also occur in water supply pipes.

- There should be very little space between the water heater and the wall. If there are more than 1 or 2 inches, attach a wooden block to the wall studs with long lag screws. The purpose is to prevent the heater from tipping backward.

- Wrap the heavy-gauge metal strapping 1½ times around the tank. Start by placing the strapping at the back of the tank. Bring it to the front and back to the wall (see illustrations below).

- Secure this strapping to the wall studs or the woodblock using several 1/4" x 3" or longer lag screws with oversized washers. If you are securing it directly into concrete, use 1/4" expansion bolts in place of the screws.

- Replace all copper and metal piping with flexible natural gas and water line connectors.
- Three approved straps are required for 75-gallon tanks, and four approved straps for 100+ gallon tanks.

- A qualified contractor should evaluate and either repair existing straps or install new straps or struts as necessary and per standard building practices.

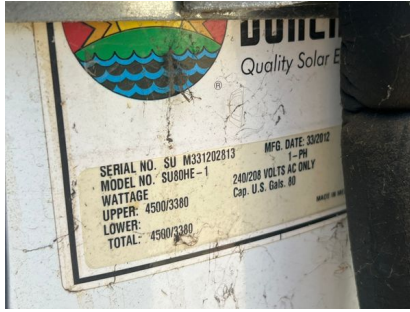
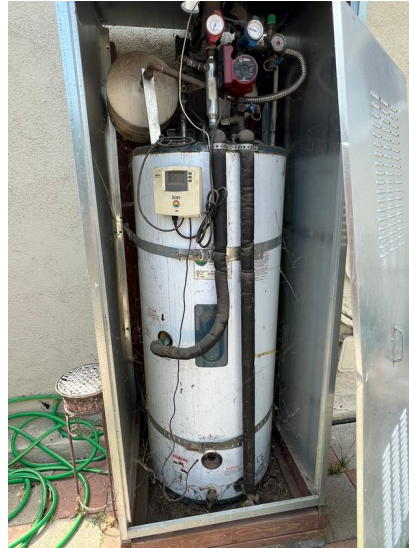
8.6.1 Age

8-12 YEARS OR OLDER

The estimated useful life for most water heaters is 8 to 12 years. This water heater appears at this age or older and may need replacing anytime. Recommend budgeting for a replacement soon.

Recommend monitoring.

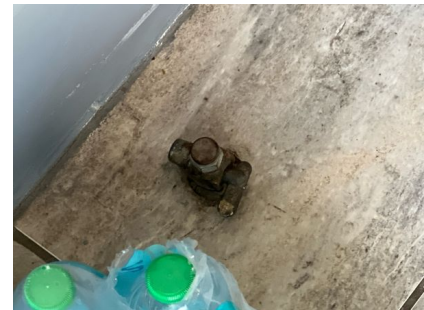
9.5.1 Plumbing **GAS LINE CAP MISSING**

One or more propane or natural gas supply terminations in the property were found unused (no appliance connected) with no cap installed on the gas shut-off valve(s). This situation can lead to gas flowing directly out of the termination if the shut-off valve is opened, posing a potential fire hazard. It is recommended that a qualified individual install caps on the terminations where they are missing according to standard building practices.

Recommendation
Contact a handyman or DIY project

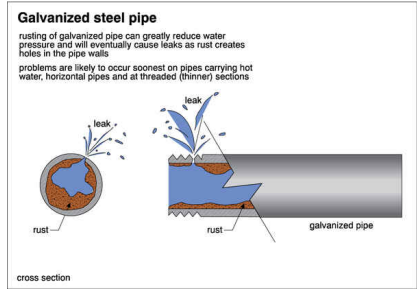
10.8.1 Galvanized Steel Supply

OLD, ADVISE, MONITOR

Some, most, or all of the water supply pipes in this structure are made of galvanized steel. Based on this structure's age, these pipes may be nearing or exceeded their estimated useful life of 40 to 60 years. Internal corrosion and rust can reduce these pipes' inside diameter over time, resulting in reduced flow and, eventually, leaks. The inspector performed a "functional flow test" during the inspection where multiple fixtures were run simultaneously and found the flow to be adequate. For example, the shower flow didn't decrease substantially when the toilet was flushed. Despite this, and because of their apparent age, these pipes may need replacing at any time.

Recommendation
Contact a qualified plumbing contractor.

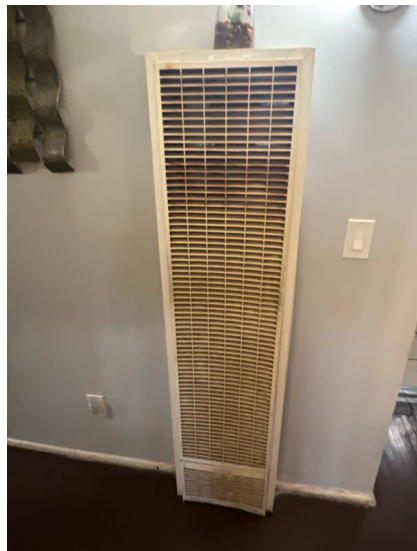
11.4.1 Gas Heat

NO RESPONSE - HEATER

The heater did not respond when its controls were operated. This system was not thoroughly evaluated. The client(s) should consult with the property owner(s) about how it operates and have a qualified heating and cooling contractor evaluate and make repairs if necessary.

Recommendation
Contact a qualified HVAC professional.

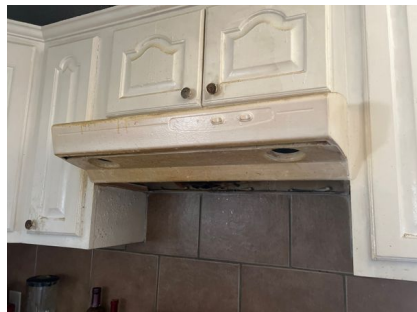
12.4.1 Exhaust Fan(s)

INOPERABLE

The range hood fan is inoperable. A qualified contractor should evaluate and repair or replace the fan or the range hood as necessary.

Recommendation
Contact a qualified appliance repair

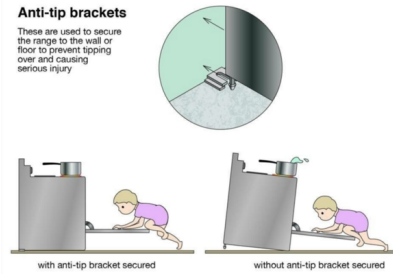
12.7.1 Range/Oven/Stove Top

NO ANTI-TIP BRACKET

The range is not equipped with an anti-tip bracket, which poses a safety risk as it can tip forward when weight is applied to the open door, potentially causing accidents, especially if small children climb on it or heavy objects are dropped. Anti-tip brackets have been a standard safety feature in all free-standing ranges since 1985. It is crucial to install an anti-tip bracket to prevent accidents and ensure the safety of occupants in the home.

Contact a qualified appliance repair

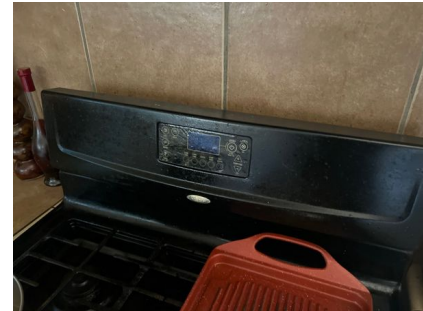
12.7.2 Range/Oven/Stove Top **DIGITAL DISPLAY DEFECTIVE**

The digital display on the oven is defective. The oven may be at or near the end of its useful life. A qualified appliance repair technician should evaluate and repair as necessary, or replace the oven.

Contact a qualified appliance repair

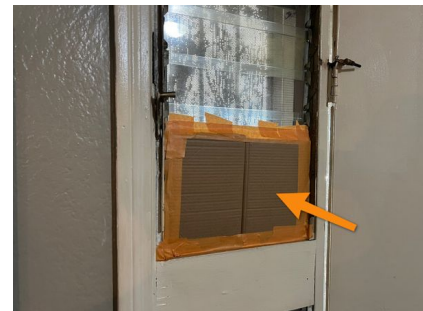
13.3.1 Windows **GLASS - BROKEN** DINING ROOM

Glass in one or more windows is broken. A qualified contractor should replace glass where necessary.

Contact a qualified window repair/installation contractor.

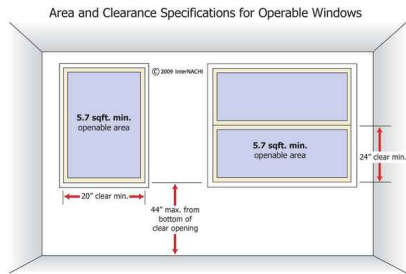
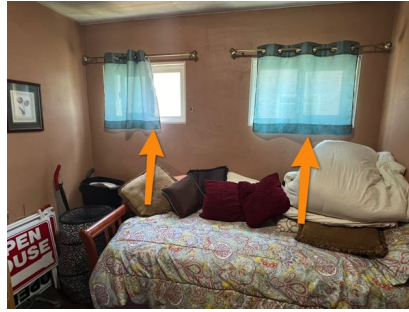
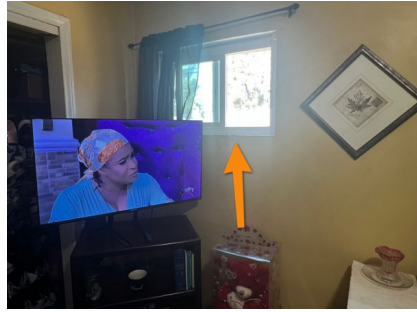
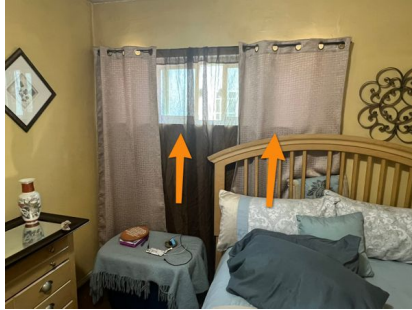
13.3.2 Windows **BEDROOM EGRESS - TOO HIGH**

One or more bedroom windows have inadequate egress in the event of a fire due to their being too high from the floor. Bedroom windows should have a maximum sill height of 44 inches from the floor. At a minimum, furniture such as a chair should be located immediately below the window to improve egress. Modifications, such as moving or replacing window(s), should be made as necessary to comply with these recommendations.

Contact a qualified window repair/installation contractor.

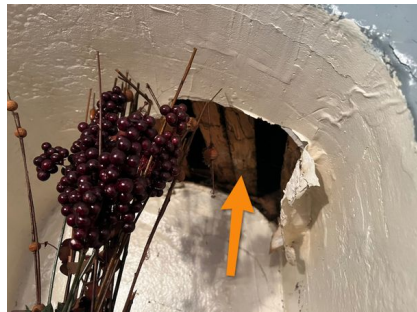
Living Room

13.15.1 Ceiling
CRACKS/DAMAGE

Cracks were found in ceilings in one or more areas. They do not appear to be a significant structural concern. Still, the client(s) may wish to repair these for aesthetic reasons or have them further evaluated if they have additional concerns.

Recommendation
Contact a qualified drywall contractor.

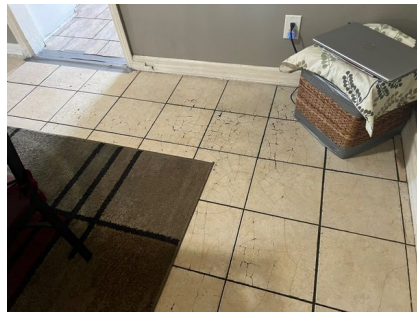
Dining Room

13.17.2 Floors
TILE, STONE AND GROUT - DETERIORATED

Tile, stone and/or grout flooring is damaged and/or deteriorated in one or more areas. A qualified contractor should evaluate and make repairs as necessary. For example, replacing broken tiles and deteriorated grout, and resealing grout.

Recommendation
Contact a qualified flooring contractor

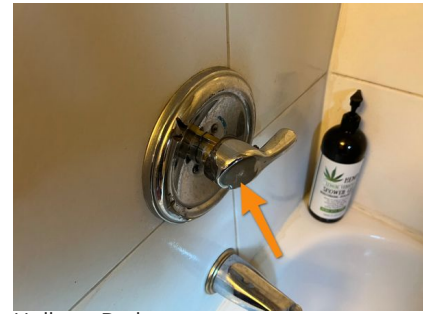
Hallway Bathroom

14.10.1 Faucets
LOOSE OR MISSING HANDLE

One or more faucet handles are loose or missing and should be repaired or replaced as necessary. A qualified plumber should evaluate and repair as necessary.

Recommendation
Contact a qualified plumbing contractor.

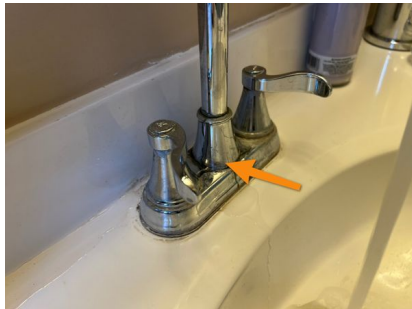
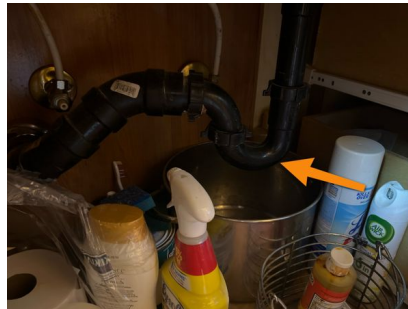
14.10.2 Faucets

LEAKS WHEN ON

One or more faucets leak by the handle(s) or at their base when turned on. A qualified plumber should evaluate and repair as necessary.

Recommendation
Contact a qualified plumbing contractor.

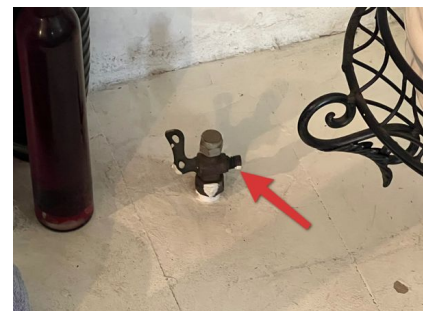
15.6.1 Gas

GAS LINE CAP MISSING

One or more propane or natural gas supply terminations were unused (no appliance connected), and no cap was installed on the gas shut-off valve(s). Gas can flow directly from the termination when the shut-off valve is opened. This is a potential fire hazard.

Recommend that a qualified person install missing caps per standard building practices.

Recommendation
Contact a qualified handyman.

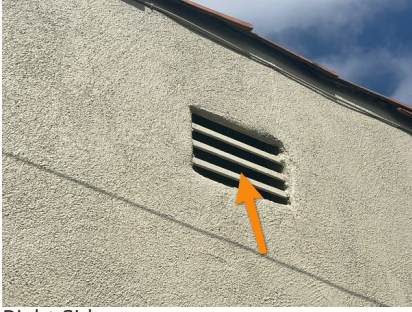
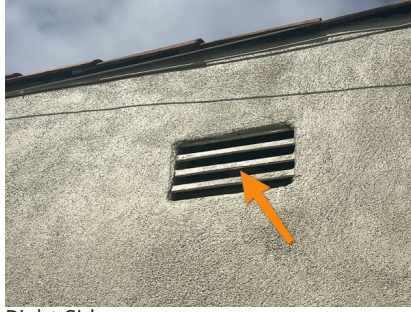
16.15.1 Vents

SCREENS DETERIORATED OR MISSING

Screens are missing and/or deteriorated at one or more soffit, gable, and/or ridge vents. Birds and vermin may enter the attic because of this. Screens should be replaced or repaired where necessary or installed where missing.

Recommendation
Contact a handyman or DIY project
