## SUMMARY

28701 Highridge Rd, Rolling Hills

Estates, CA 90274

Corey Galceran  
Certified Master Home Inspector-  
InterNACHI  
Tactical Inspections  
888-991-0822  
[support@tacinspect.com](mailto:support@tacinspect.com)

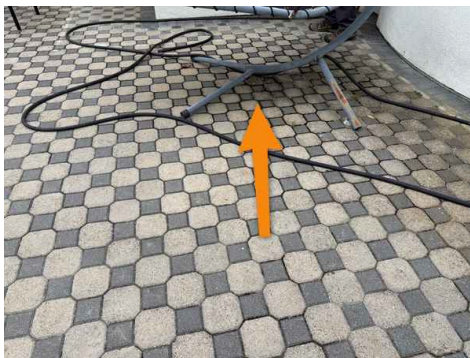
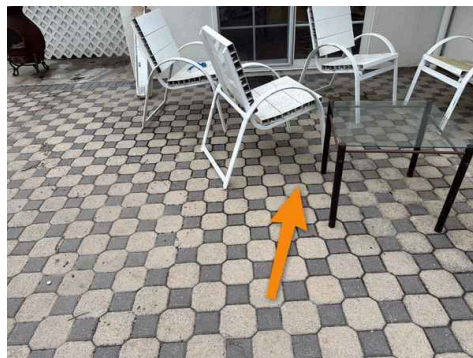
### 2.2.2 Walkways, Patios & Driveways

#### PONDING EVIDENCE

Ponding evidence in one or more locations - needs to be serviced

Contact a qualified professional.

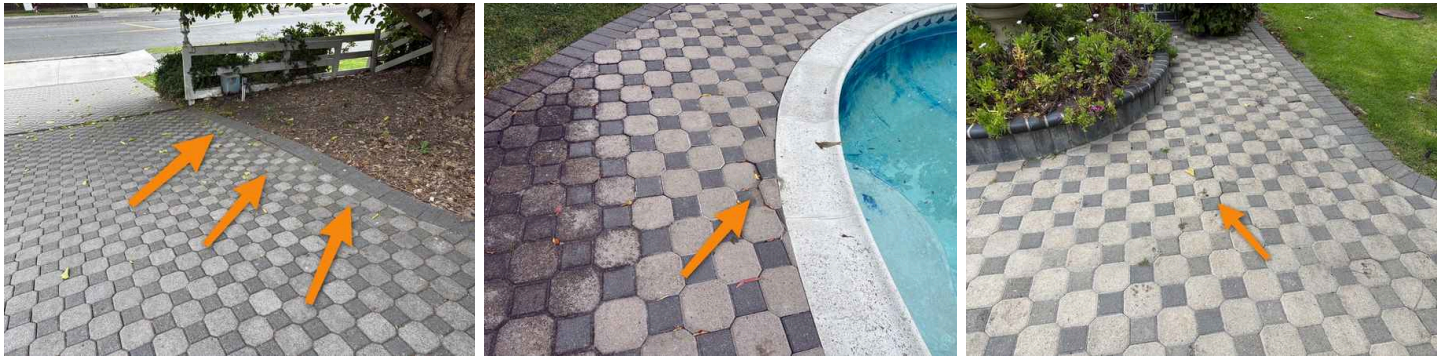
### 2.2.3 Walkways, Patios & Driveways

#### LOOSE SINKING PAVERS

One or more locations pavers are sinking needs to be serviced

Contact a qualified professional.

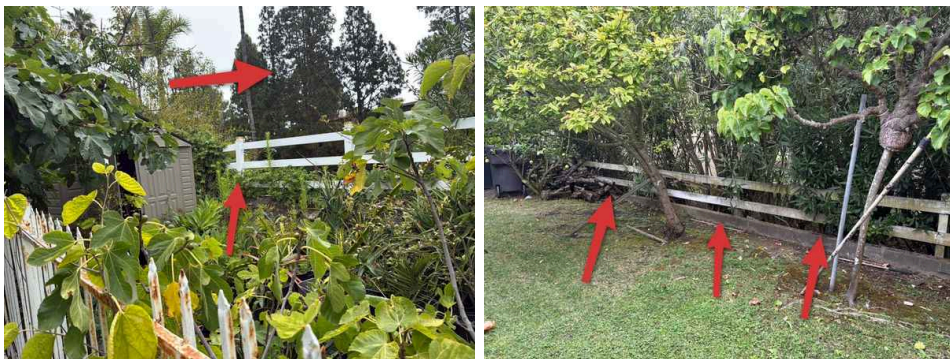
#### **LOOSE /LEANING FENCE**

One or more areas fence leaning observed - needs to be repaired

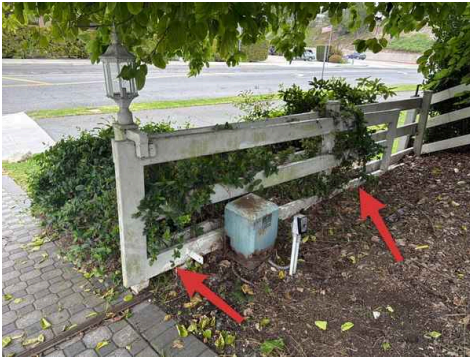
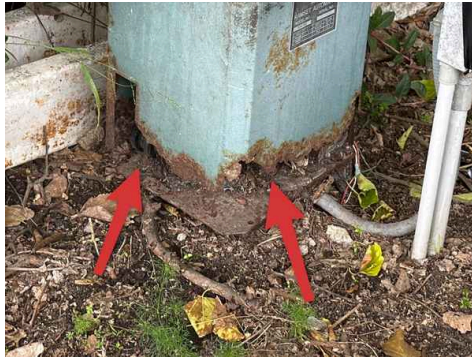
### 2.3.4 Property line fence/walls

#### **GATE DAMAGED**

Side gate is damaged. Does not close properly needs to be serviced.

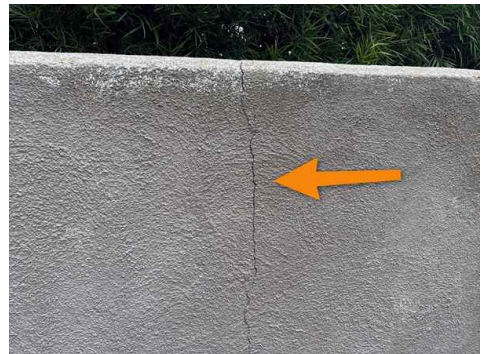
### 2.3.5 Property line fence/walls

#### **SMALL CRACKING**

Small cracking observed minor repairs needed

Contact a qualified professional.

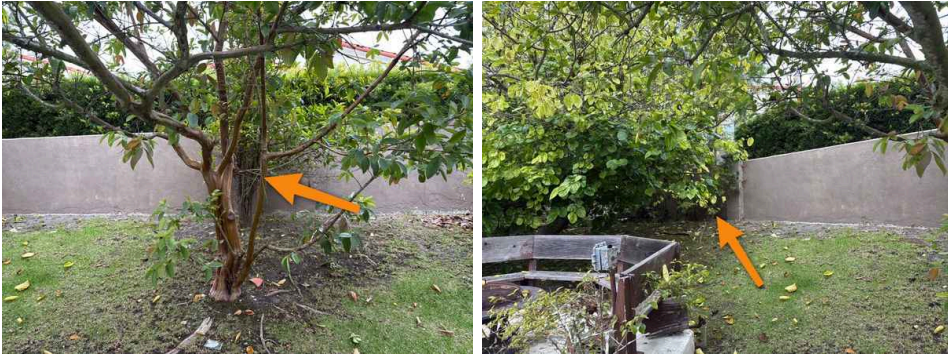
### 2.3.6 Property line fence/walls

#### **LARGE TREES NEAR BLOCK WALL**

Large trees near block walls may have potential for future damage to the wall

Contact a qualified professional.

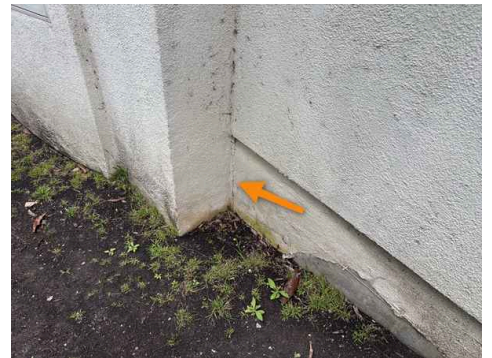
### 2.9.1 Siding, Flashing & Trim

#### **CRACKING - MINOR**

Siding showed cracking in one or more places. This is a result of temperature changes, and typical as homes with stucco age. Recommend monitoring.

Recommended DIY Project

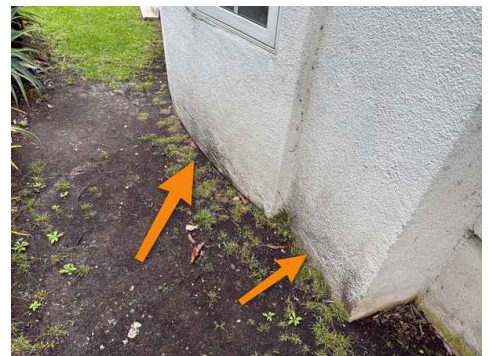
### 2.9.2 Siding, Flashing & Trim

#### **STAINING**

One or more locations visibly stained from rain draining off roof and splashing stucco - installing rain gutters will help eliminate these areas - needs to be serviced

Contact a qualified professional.

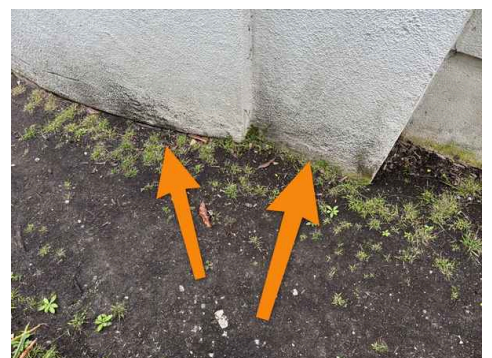
### 2.9.3 Siding, Flashing & Trim

#### **WEEP SCREED MINIMAL TO NO CLEARANCE TO GRADE**

Contact a qualified professional.

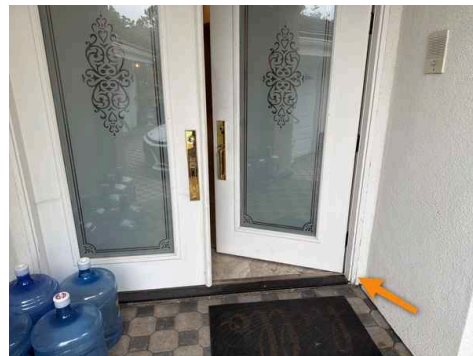
#### **WORN AND WEATHERED**

The exterior doors show significant signs of wear and weathering, including fading, cracking, and damage to the finish. It is recommended to refinish or replace the doors to restore their appearance and improve energy efficiency and security.

Contact a qualified professional.

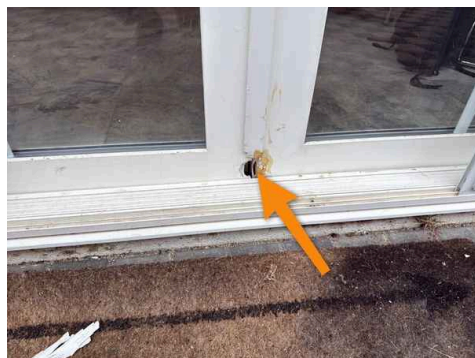
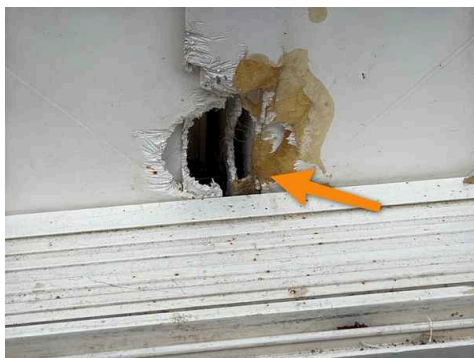
#### DOOR DAMAGED

One or more areas of the door are damaged and some rodent chewing has occurred at base of door. Recommend repair or replace.

Contact a qualified professional.

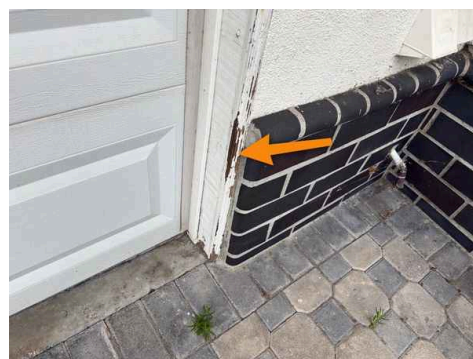
### 2.10.3 Exterior Doors

#### WOOD DETERIORATION

Wood deterioration at door jam. Check termite report for further servicing advice.

Contact a qualified professional.

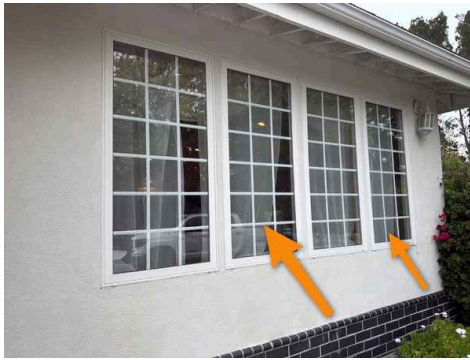
The windows show signs of inner condensation between the glass panes, indicating a potential failure of the seals. It is recommended to have the windows inspected and consider repair or replacement to prevent further moisture buildup and improve energy efficiency.

Contact a qualified professional.

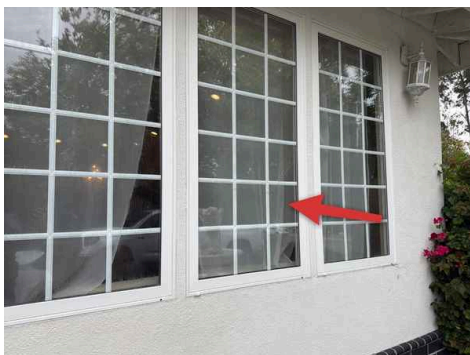
## 2.11.4 Windows

**BROKEN/CRACKED WINDOW**

Broken / cracked glass at one or more locations - needs to be serviced

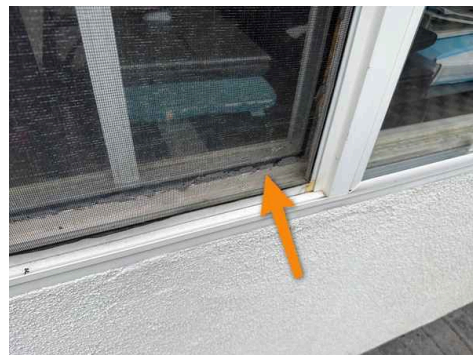
Window glazing deteriorated as part of normal wear and tear and in need of replacement glazing/reglazing.

Contact a qualified professional.

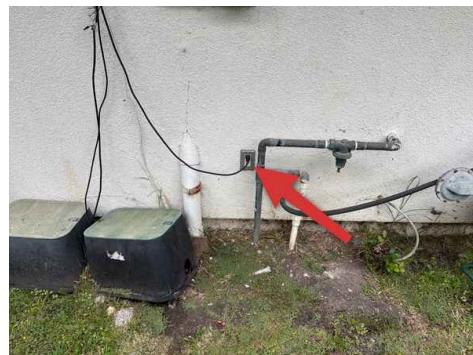
## 2.12.2 Switches / Receptacles

**COVER PLATE LOOSE / MISSING / DAMAGED**

A cover plate for a switch and/or a receptacle (outlet) were missing and/or damaged. These plates are intended to contain fire and prevent electric shock from occurring due to exposed wires. Recommend that a qualified person install cover plates where necessary.

Contact a handyman or DIY project

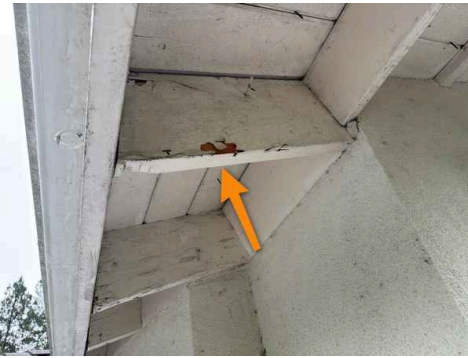
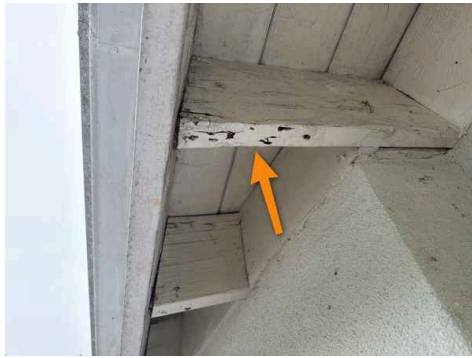
## 2.13.1 Eaves, Soffits &amp; Fascia

**RAFTER WOOD DETERIORATION**

The rafter wood in the eaves, soffits, and fascia shows signs of deterioration, including rotting and damage from moisture exposure. It is recommended to replace or repair the affected rafter wood to prevent further structural damage and maintain the integrity of the roof system. Check termite reports.

Contact a qualified professional.

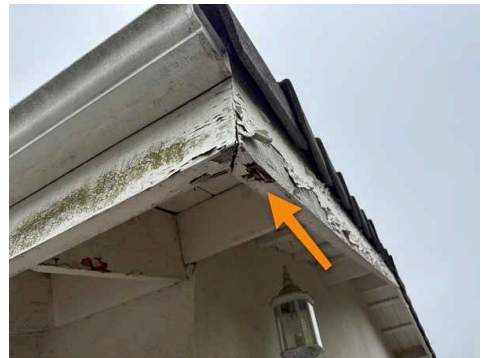
#### 2.13.2 Eaves, Soffits & Fascia

##### **FASCIA - DAMAGED**

One or more sections of the fascia are damaged. Recommend qualified roofer evaluate & repair.

Contact a qualified roofing professional.

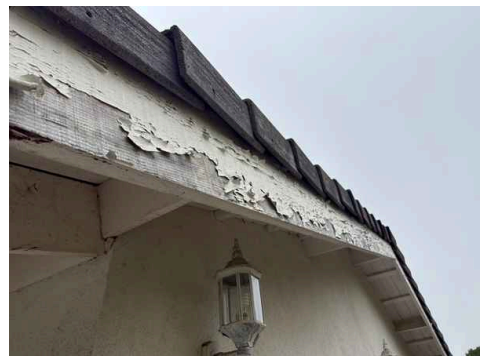
#### 2.13.3 Eaves, Soffits & Fascia

##### **PAINT/FINISH FAILING**

The paint or finish is failing. This can lead to deterioration and rot of the material. Recommend that the areas be properly prepared and painted / finished.

Contact a qualified painting contractor.

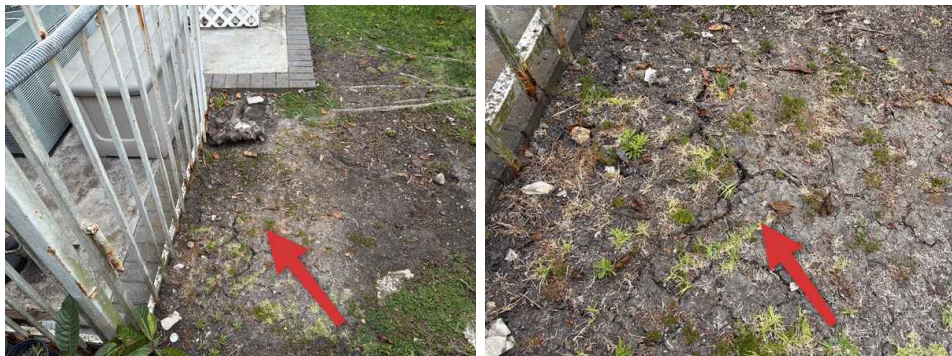
#### 2.14.1 Vegetation, Grading, Drainage & Retaining Walls

##### **EXPANSIVE SOIL**

Visible signs of expansive, soil on side yard and front yard due to moisture sitting and drying repeatedly- further evaluation needed

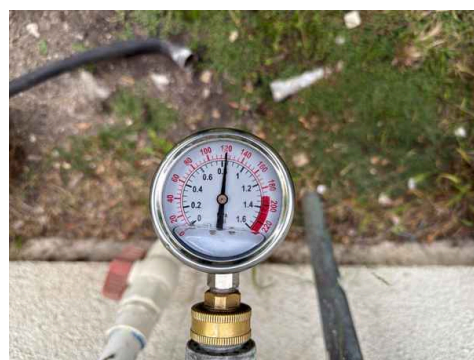
#### 2.16.1 Service / Main Line

##### **PUBLIC SUPPLY PRESSURE >80 PSI**

The public water supply pressure exceeds 80 psi, which is above the recommended limit and could put strain on plumbing fixtures and appliances. It is advised to install a pressure-reducing valve to maintain safe pressure levels and prevent potential damage to the plumbing system.

Contact a qualified plumbing contractor.

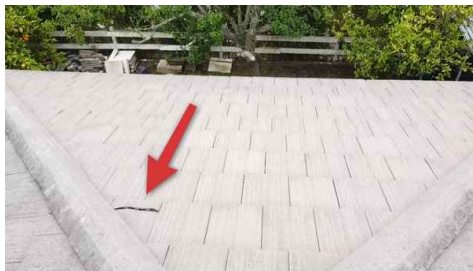
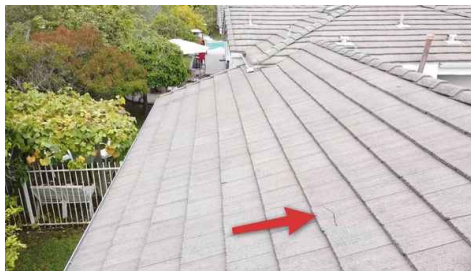
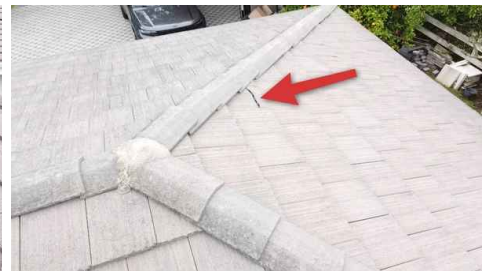
#### BROKEN TILE(S)

One or more broken tiles observed - needs to be repaired

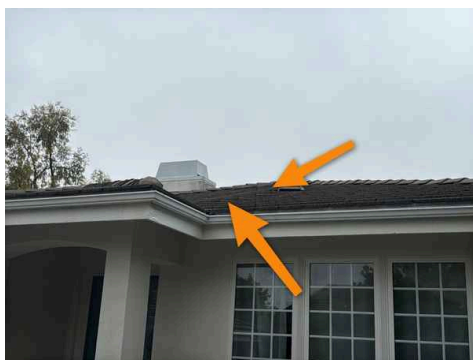
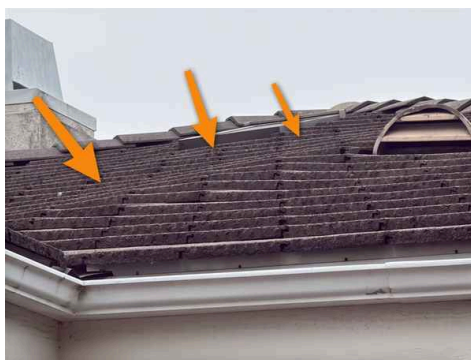
### 3.2.3 Coverings

#### DEFLECTION

Contact a qualified professional.

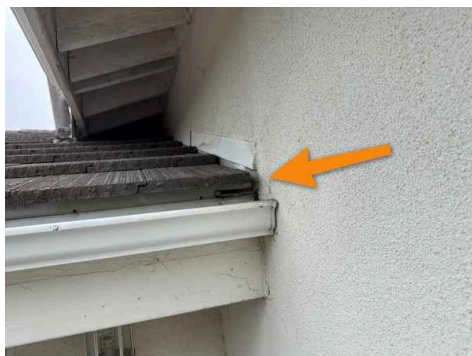
As an upgrade, recommend kickout flashing be installed to divert rain away from sidewall into gutter.

Contact a qualified professional.

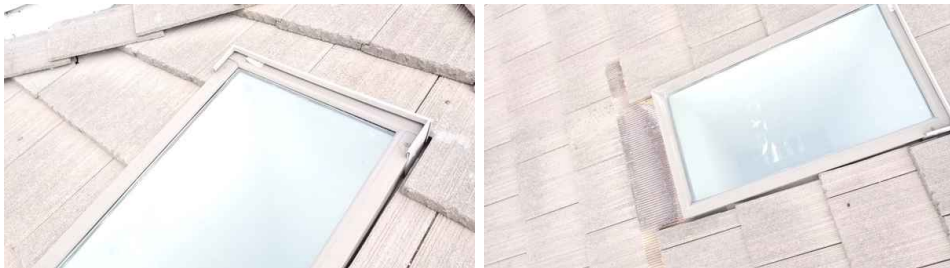
#### **WORN OLDER**

The skylight is worn and shows signs of aging, which may affect its ability to properly seal. This deficiency increases the risk of leaks, water infiltration, and reduced energy efficiency if not addressed or replaced.

Contact a qualified professional.

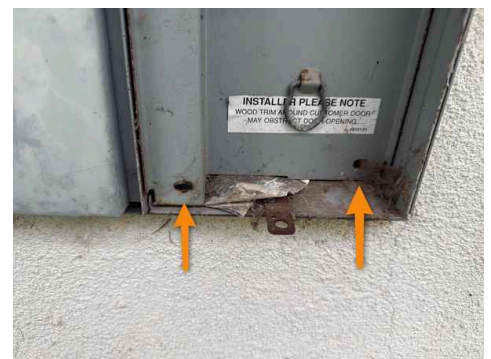
### 4.2.1 Panels

#### **MISSING SCREW FOR DEAD FRONT**

Recommend servicing for safety

Contact a qualified professional.

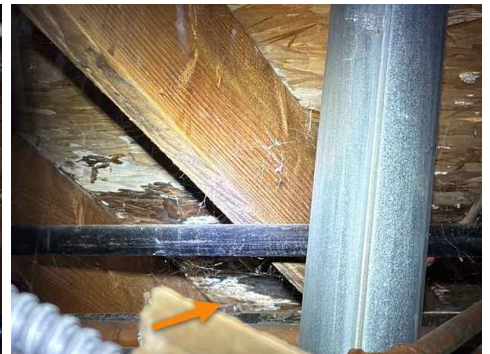
### 5.12.1 Attic access

#### **STAINING OBSERVED**

Contact a qualified professional.

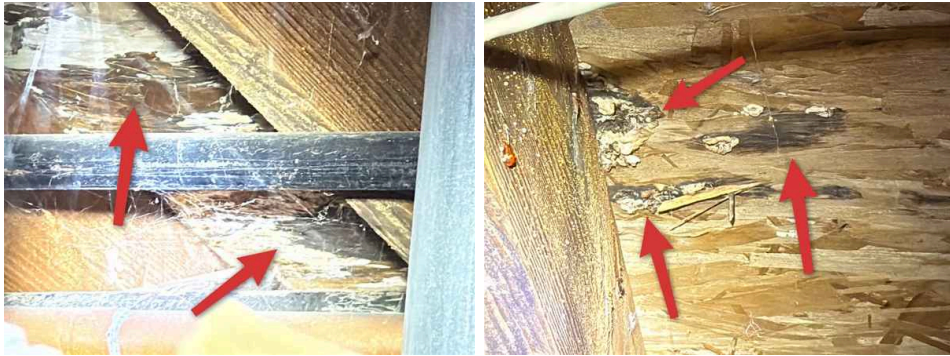
## 5.12.2 Attic access

**MICROBIAL GROWTH OBSERVED IN ATTIC SPACE IN GARAGE**

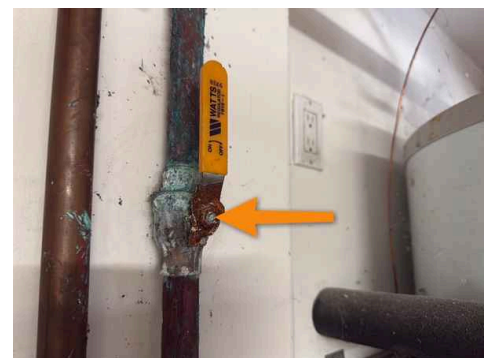
**CORRODED SHUT OFF VALVE**

Shut off valve corrosion visible needs to be serviced

Contact a qualified professional.

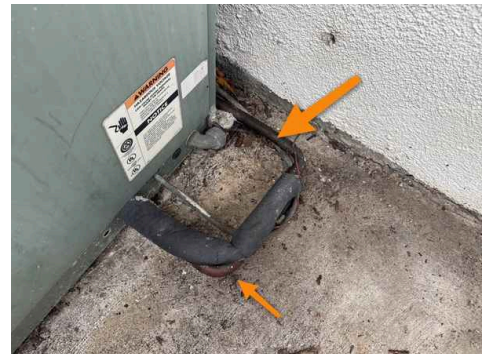
#### REFRIGERANT LINE MISSING INSULATION

Insulation missing at copper coolant line needs to be serviced

Contact a qualified professional.

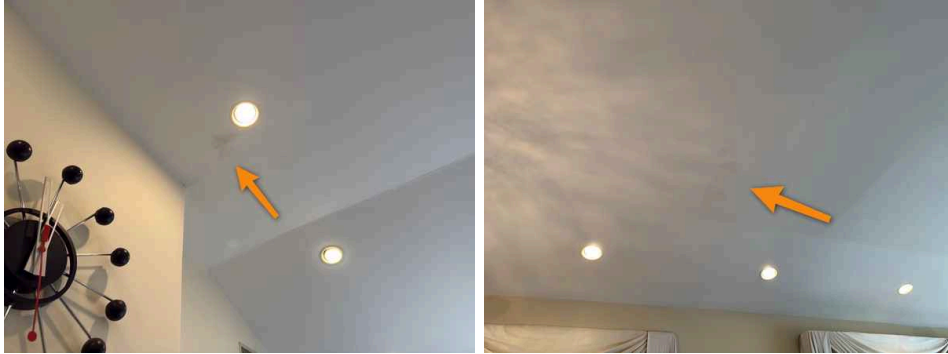
#### STAIN(S) ON CEILING

There is a stain on ceiling/wall that requires repair and paint. Source of staining should be determined.

Recommendation  
Contact a qualified professional.

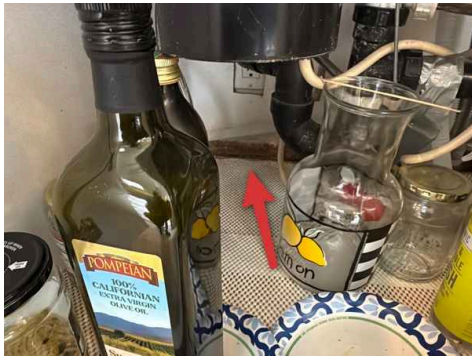
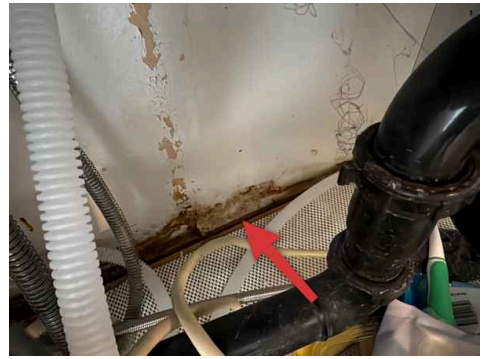
Microbial Growth was found in cabinet - needs to be serviced

Contact a qualified professional.

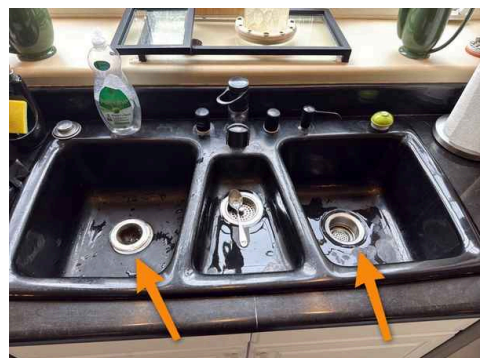
**\*\*Observation:\*\*** The kitchen sink drains slowly, indicating a partial clog or buildup in the plumbing. **\*\*Recommendation:\*\*** A licensed plumber should inspect and clear the drain to restore proper water flow and prevent further blockage.

Contact a qualified plumbing contractor.

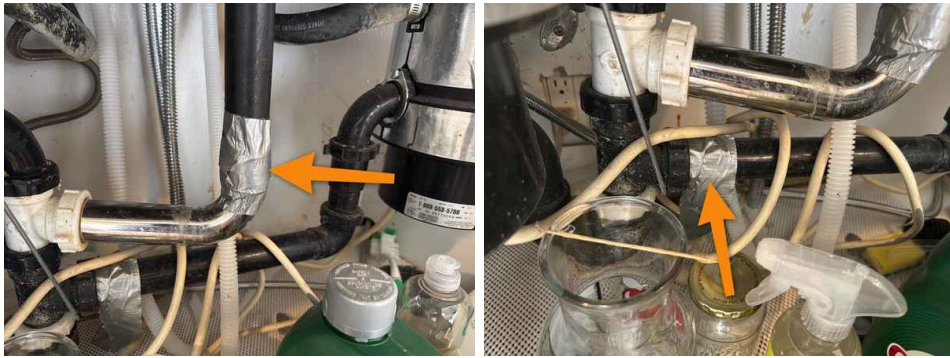
#### 9.7.1 Drain, Waste, & Vent Systems

##### IMPROPER CONNECTION

An improper connection was observed at a drain, waste or vent pipe. Recommend a qualified plumber evaluate and repair.

Contact a qualified plumbing contractor.

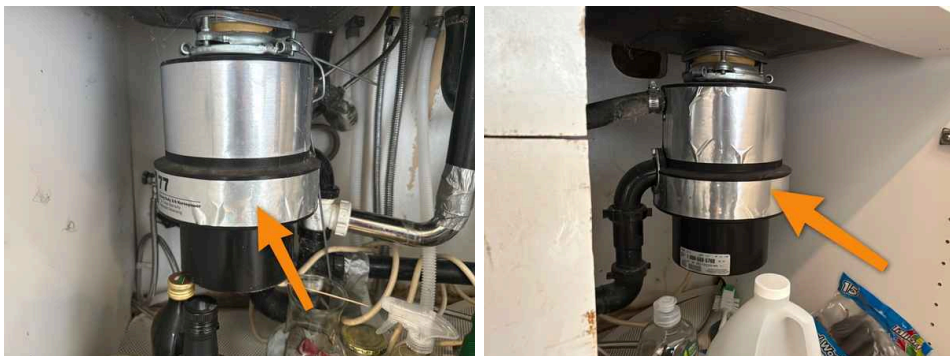
Garbage disposal was inoperable at the time of inspection. Recommend qualified handyman repair.

Contact a qualified handyman.

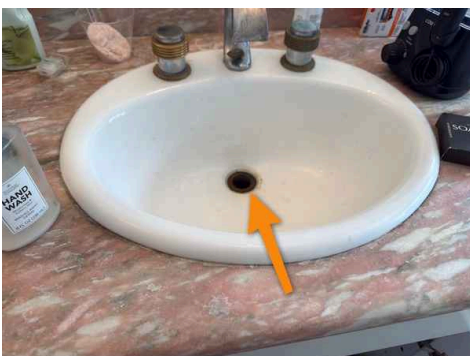
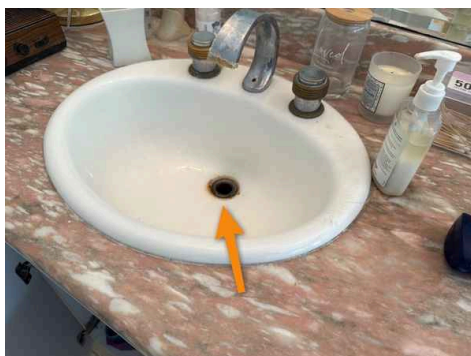
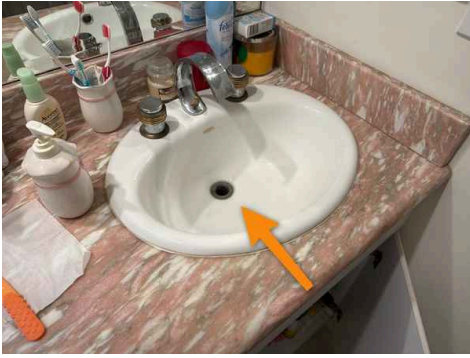
##### **DRAIN STOP MISSING OR DAMAGED**

Drain stop missing or damaged needs repair by certified professional

Contact a qualified professional.

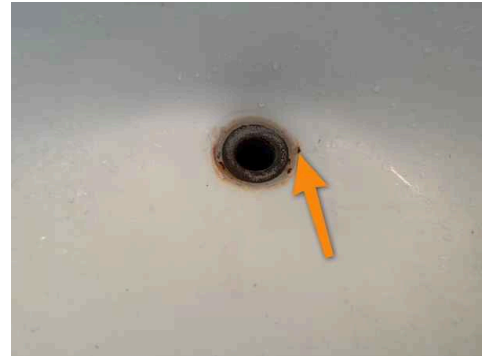
#### 11.7.5 Sinks / Fixtures

### **RUST OBSERVED UNDER SINK BASE**

Recommend servicing or replacing

Contact a qualified professional.

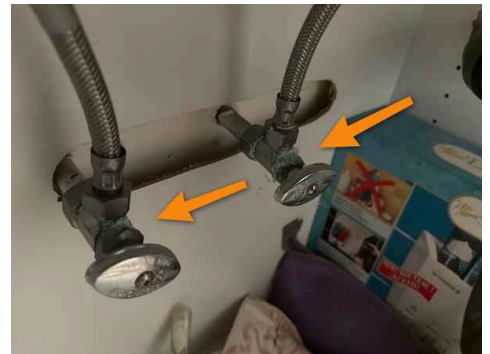
#### 11.8.1 Angle Stops (shutoff valves)

### **CORRODED ANGLE STOPS**

One or more angle stops, observed to have corrosion, which is a sign of a slow leak needs to be serviced- Jack and Jill right sink

Contact a qualified professional.

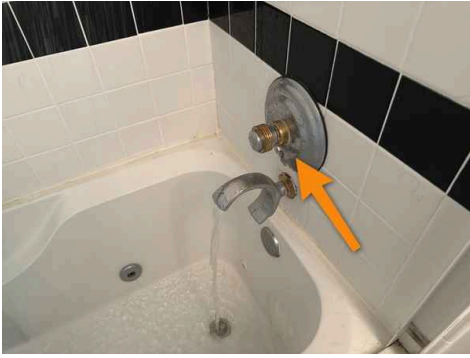
### **DIVERTER PULL DAMAGED**

The diverter pull was not functioning properly. Recommend repair.

Contact a qualified plumbing contractor.

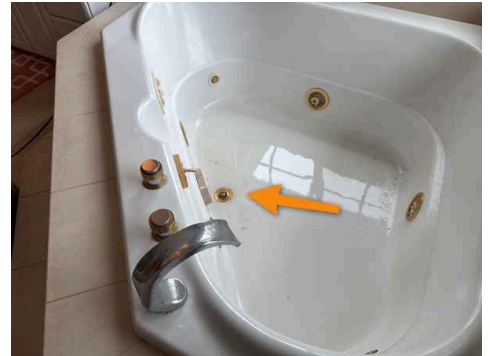
#### 11.10.2 Bathtub / Shower

### DRAINED SLOWLY / CLOGGED - BATHTUB

The bathtub drained slowly or was clogged. Recommend clearing drain and/or that a qualified plumber repair if necessary.

Contact a qualified plumbing contractor.

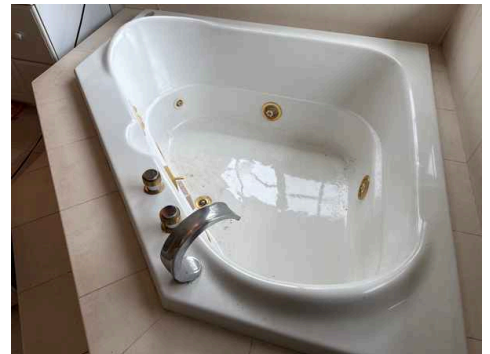
#### 11.10.3 Bathtub / Shower

### JETTED TUB JETS INOPERABLE

One or more jets in the jetted tub were not operating at time of inspection. Recommend qualified plumber evaluate and repair.

Contact a qualified plumbing contractor.

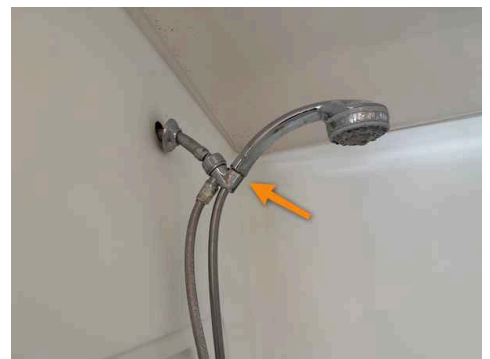
#### 11.10.4 Bathtub / Shower

### SHOWER HEAD DRIPS

The shower head was dripping when the shower was turned off. Recommend that a qualified person repair as necessary.

Contact a qualified plumbing contractor.

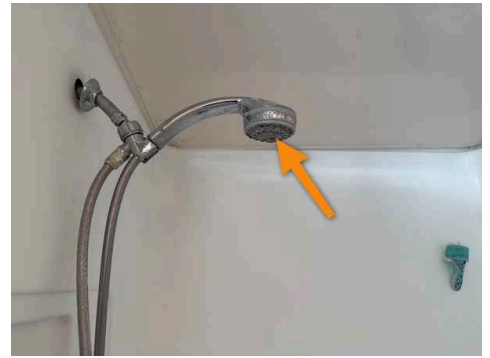
#### 11.10.5 Bathtub / Shower

### SHOWER HEAD CLOGGED

Shower head appeared to be clogged or had low flow. Recommend repair by a qualified person.

Contact a qualified plumbing contractor.

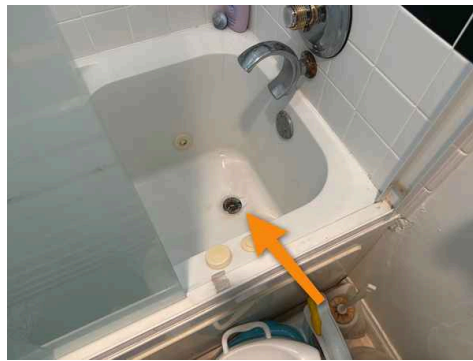
11.10.6 Bathtub / Shower

### **TUB DRAIN STOPPER MISSING/NOT OPERATIONAL**

Contact a qualified professional.

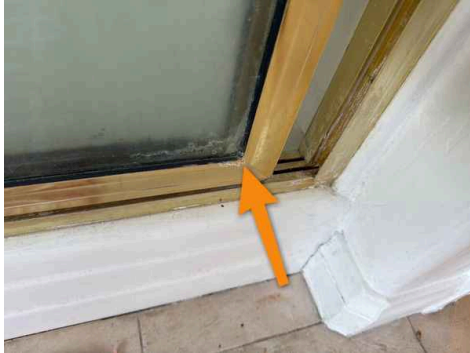
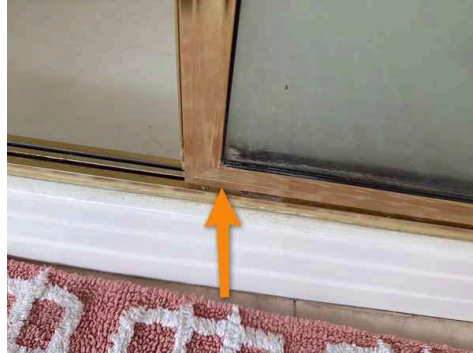
**CORROSION OBSERVED**

One or more locations of corrosion was observed, needs to be serviced

Contact a qualified professional.

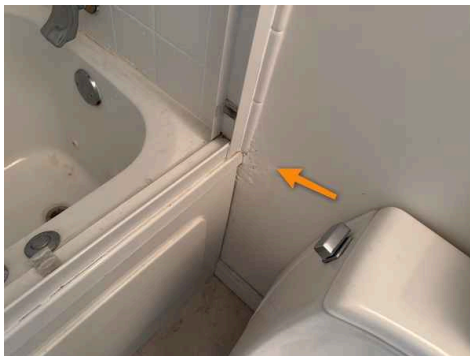
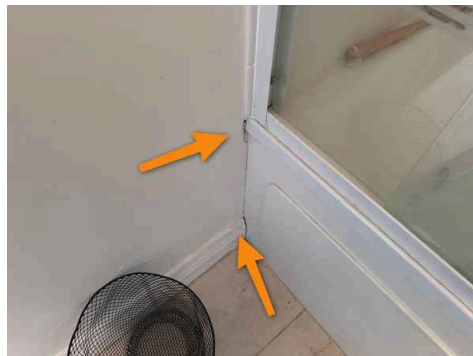
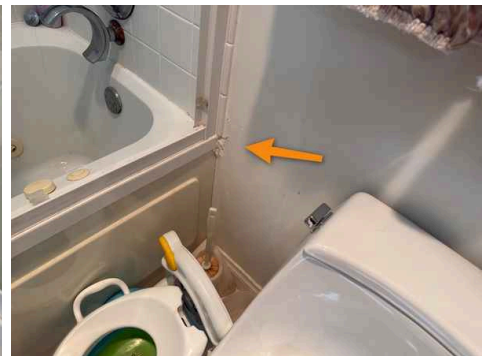
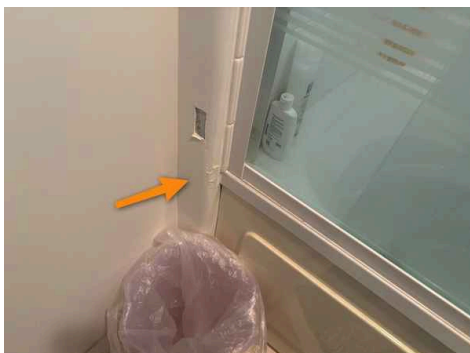
## 11.12.2 Shower Enclosure

**EVIDENCE OF PAST OR PRESENT LEAKAGE**

Shower enclosure moisture damage at baseboard recommend ceiling enclosure to prevent further damage. Tested dry of inspection.

Contact a qualified professional.

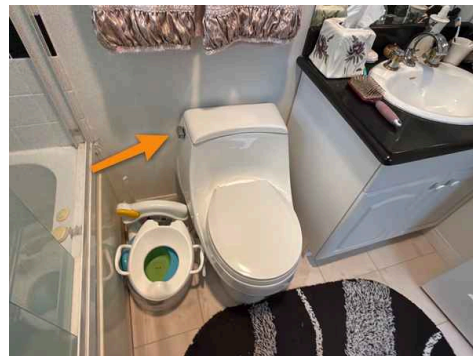
## 11.13.1 Toilet

**TOILET DID NOT FLUSH PROPERLY**

Toilet is not flushing properly needs to be serviced- unit 15 both bathrooms

Recommendation  
Contact a qualified professional.

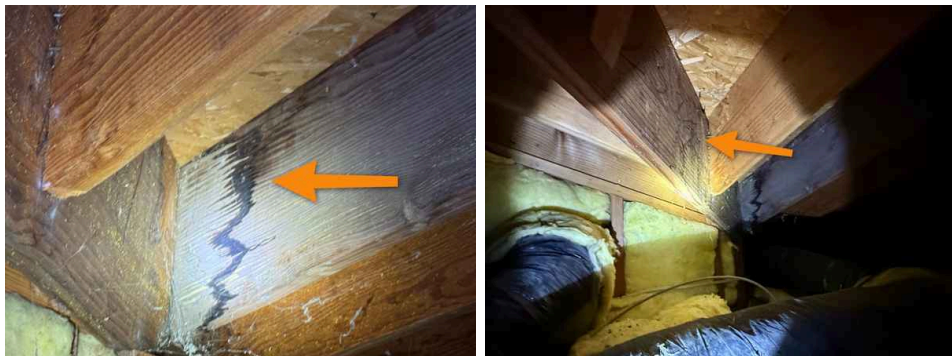
#### 12.2.1 Structure & Sheathing

### STAINS CAN'T DETERMINE

One or more dark stains were found in the attic. Due to their location and/or roof configuration, the inspector was not able to determine with thermal imaging or moisture meter if this is an active leak, or a prior leak. Client should consider their options such as having a qualified roofing contractor evaluate these areas prior to closing. In the absence of pouring rain, the inspector cannot guarantee the watertightness of the roof.

Recommendation  
Contact a qualified roofing professional.

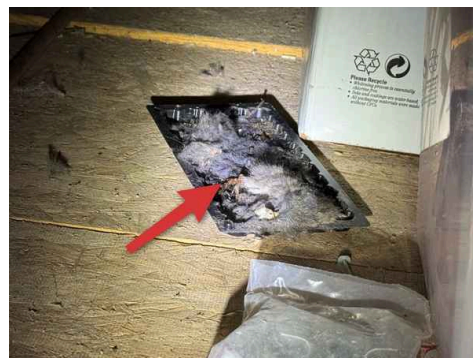
### RODENT ACTIVITY OBSERVED

Rodent activity observed contact pest control to further evaluate

Contact a qualified professional.

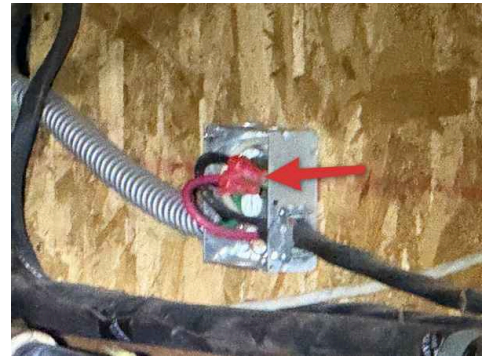
**JUNCTION BOX COVER PLATES LOOSE, MISSING OR BROKEN**

**\*\*Observation:\*\*** One or more junction box cover plates in the attic are loose, missing, or broken, exposing wiring and creating a potential electrical hazard. **\*\*Recommendation:\*\*** A licensed electrician should install or replace cover plates to ensure all electrical connections are properly enclosed for safety and code compliance.

Contact a qualified electrical contractor.

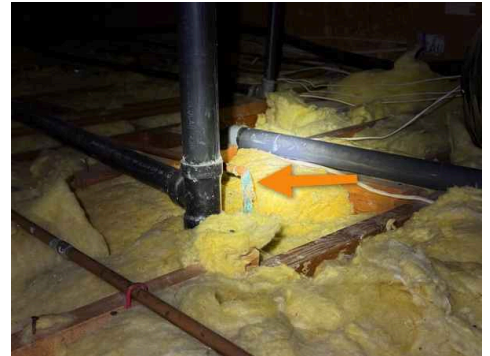
## 12.8.1 Plumbing

**CORROSION AT COPPER PLUMBING**

Corrosion at copper, plumbing further evaluation needed by licensed plumber

Contact a qualified professional.

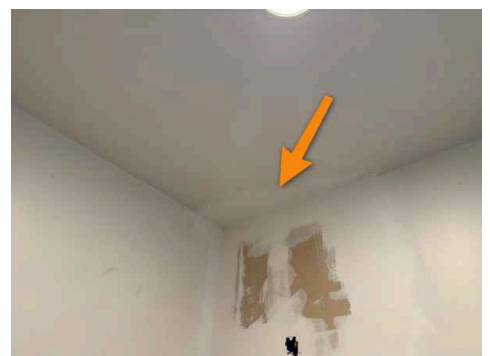
**MOISTURE INTRUSION**

Ceiling show signs of possible moisture intrusion. It is recommended to contact a qualified contractor to prevent further damage or growth of mold. A qualified contractor should find and evaluate the source of moisture intrusion.

Contact a qualified professional.

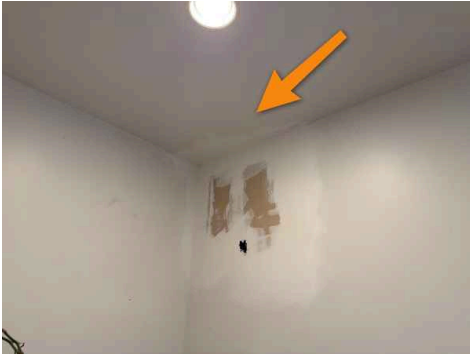
## 13.1.3 Ceilings

**PATCHING OBSERVED**

Inquire with seller as to why repairs were made

Contact a qualified professional.

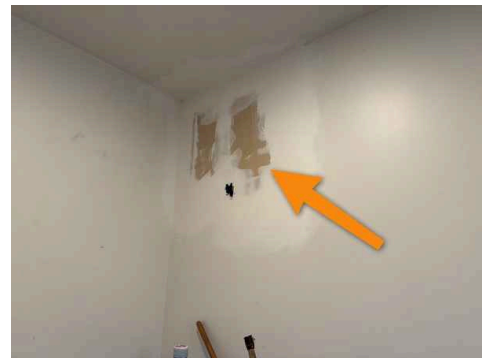
Sub-standard drywall patching observed at time of inspection.  
Recommend re-patching.

Contact a qualified drywall contractor.
