WOOD DESTROYING PESTS AND ORGANISMS INSPECTION REPORT

Building No. 414	Street Silver Lake	City Chico	ZIP 95973	Date of Inspection 01/28/2022	Number of Pages 5
---------------------	-----------------------	---------------	--------------	----------------------------------	----------------------

Report # : 39557
 Registration # : PR3779
 Escrow # :
 CORRECTED REPORT

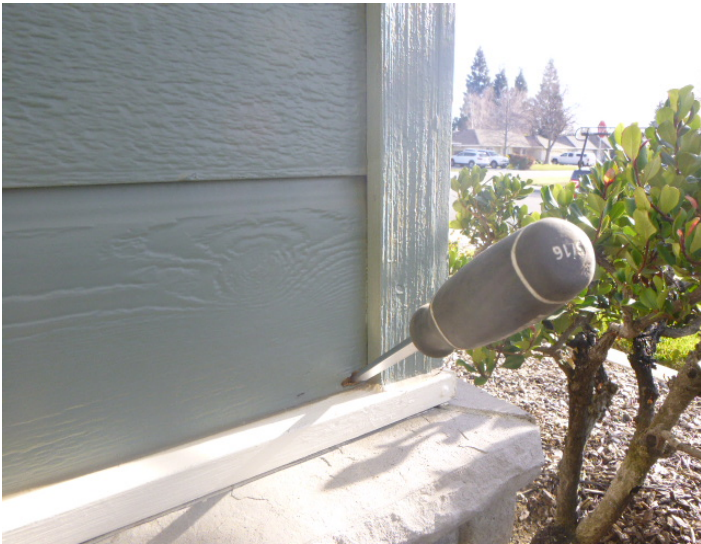
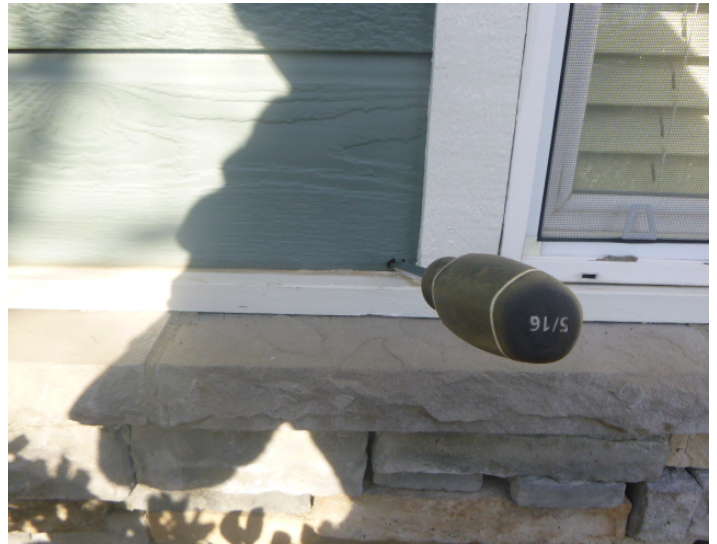
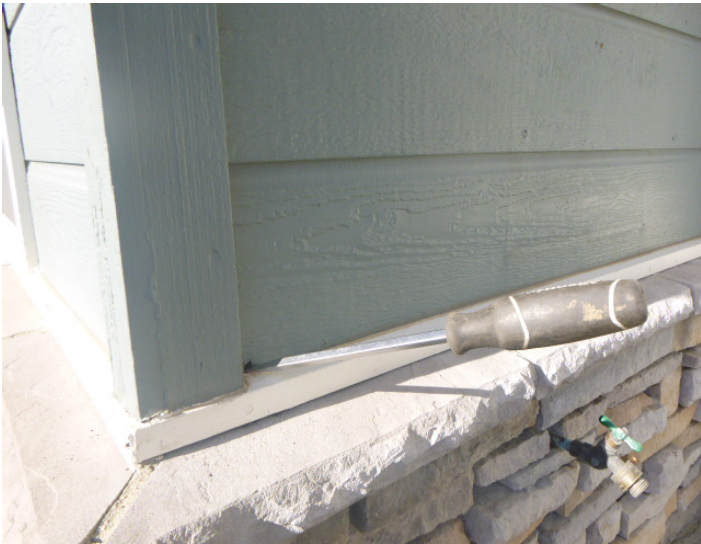
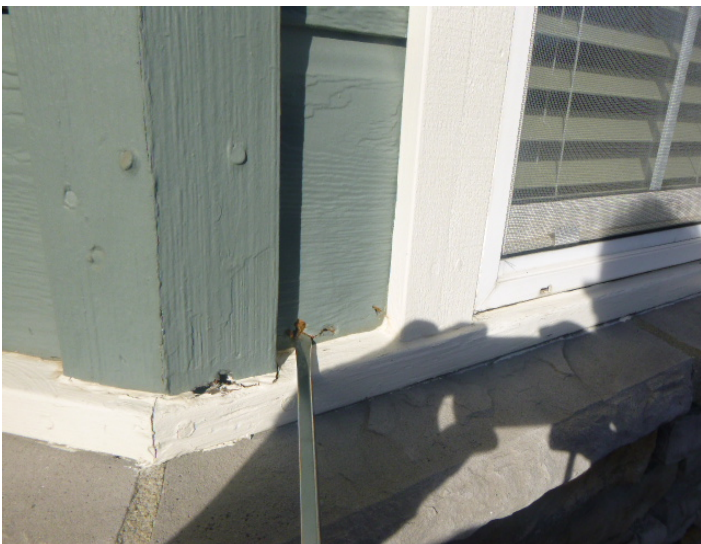
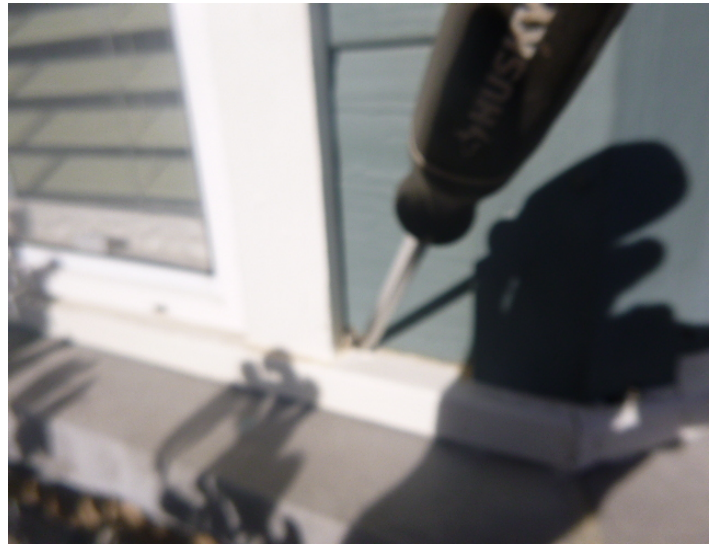
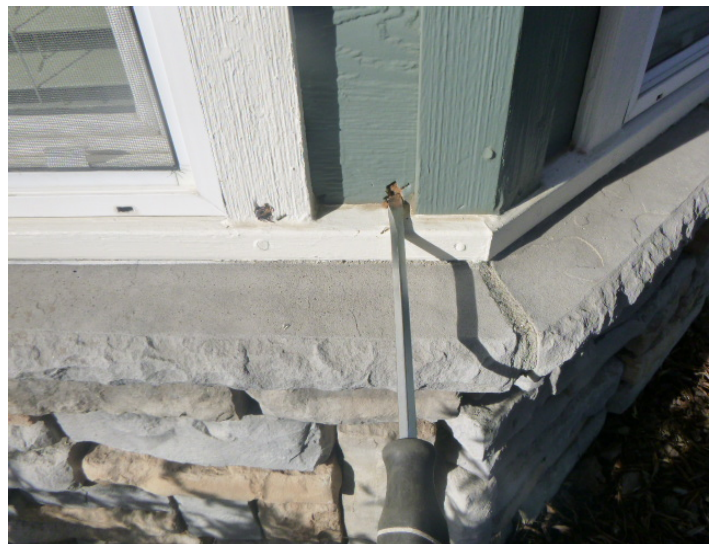
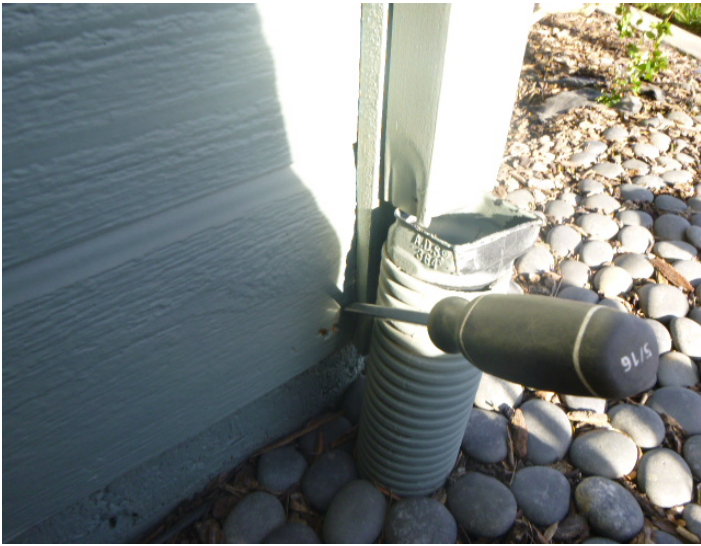
11A

FINDING: Fungus damage noted at the siding. Damage may extend into inaccessible areas.

RECOMMENDATION: Remove the fungus damaged portions of the siding. Call for a reinspection of the inaccessible areas. The inaccessible areas will be inspected for a fee if made accessible by the interested parties at his/her expense. A supplemental report will be filed at such time. No opinion is rendered concerning the conditions in the area at this time. Replace with new material.

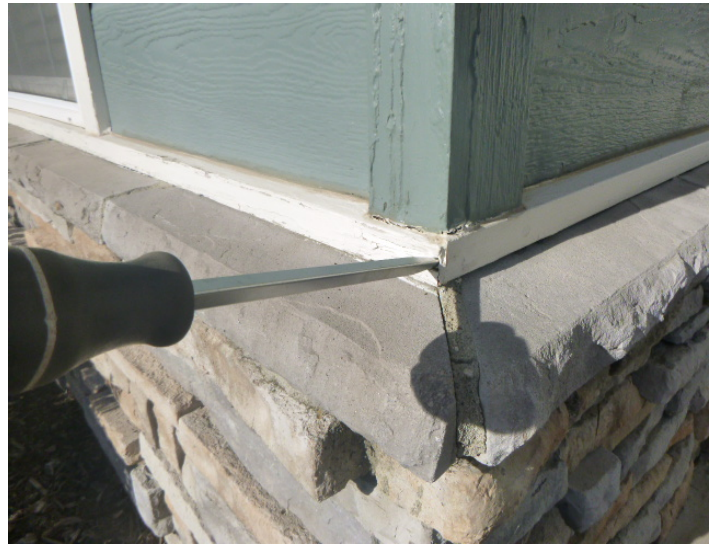
11B

FINDING: Fungus damage noted at the horizontal trim. Damage may extend into inaccessible areas.

RECOMMENDATION: Remove the fungus damaged portions of the horizontal trim. Call for a reinspection of the inaccessible areas. The inaccessible areas will be inspected for a fee if made accessible by the interested parties at his/her expense. A supplemental report will be filed at such time. No opinion is rendered concerning the conditions in the area at this time. Replace

with new material.

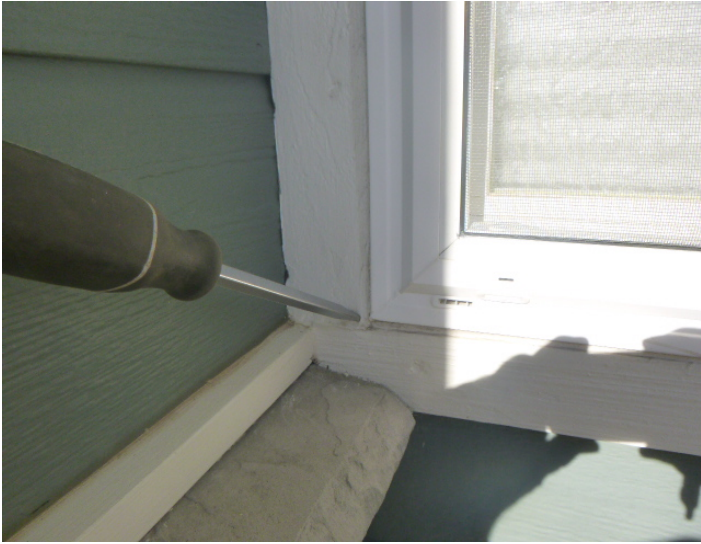
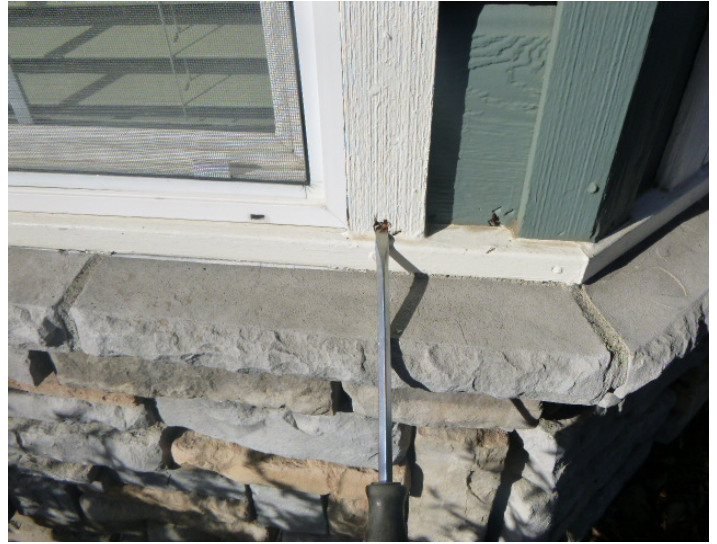
11C

FINDING: Fungus damage noted at the window trim. Damage may extend into inaccessible areas.

RECOMMENDATION: Remove the fungus damaged portions of the window trim. Call for a reinspection of the inaccessible areas. The inaccessible areas will be inspected for a fee if made accessible by the interested parties at his/her expense. A supplemental report will be filed at such time. No opinion is rendered concerning the conditions in the area at this time. Replace with new material.

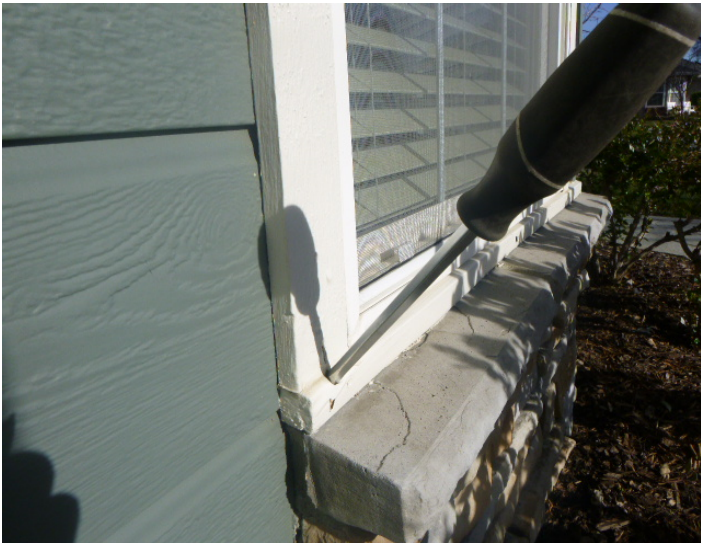
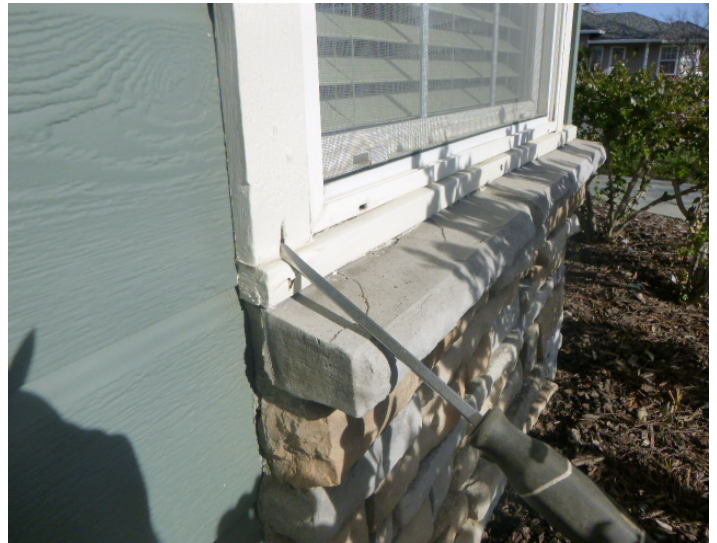
11D

FINDING: Fungus damage noted at the window sill, frames and trim. Damage may extend into inaccessible areas.

RECOMMENDATION: Remove the fungus damaged portions of the window sill, frames and trim. Call for a reinspection of the inaccessible areas. The inaccessible areas will be inspected for a fee if made accessible by the interested parties at his/her expense. A supplemental report will be filed at such time. No opinion is rendered concerning the conditions in the area at this time. Replace with new material.

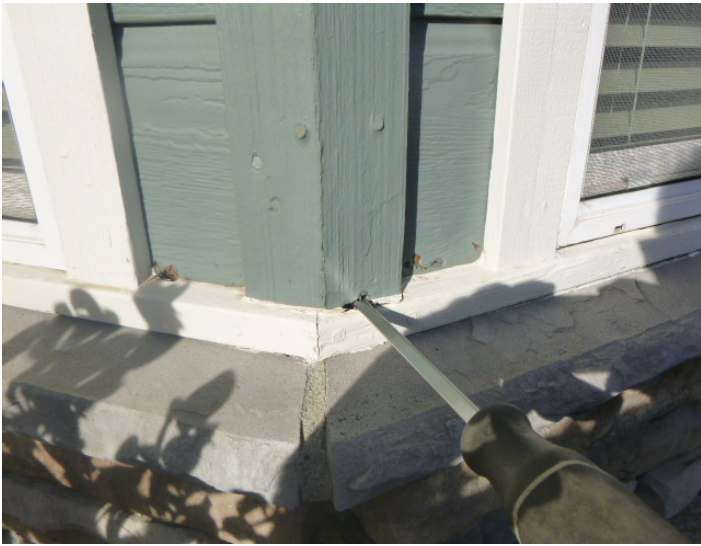
11E

FINDING: Fungus damage noted at the corner and horizontal trim. Damage may extend into inaccessible areas.

RECOMMENDATION: Remove the fungus damaged portions of the corner and horizontal trim. Call for a reinspection of the inaccessible areas. The inaccessible areas will be inspected for a fee if made accessible by the interested parties at his/her expense. A supplemental report will be filed at such time. No opinion is rendered concerning the conditions in the area at this time. Replace with new material.

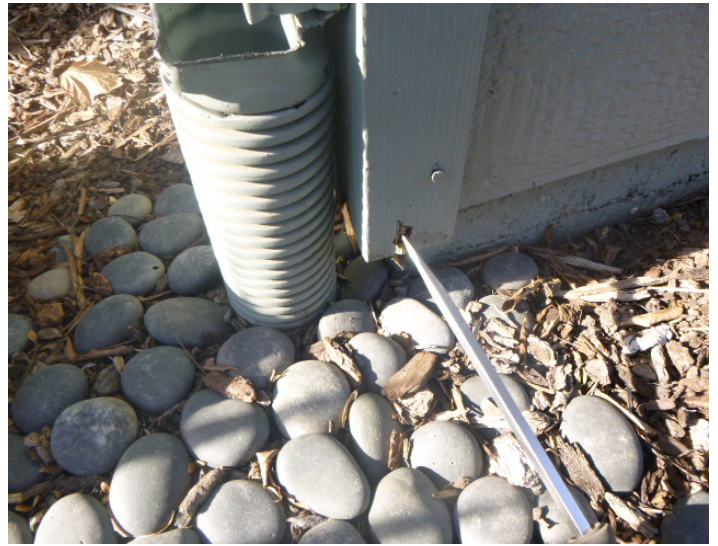
11F

FINDING: Fungus damage noted at the base of the corner trim. Damage may extend into inaccessible areas.

RECOMMENDATION: Remove the fungus damaged portions of the corner trim. Call for a reinspection of the inaccessible areas. The inaccessible areas will be inspected for a fee if made accessible by the interested parties at his/her expense. A supplemental report will be filed at such time. No opinion is rendered concerning the conditions in the area at this time. Replace with new material.

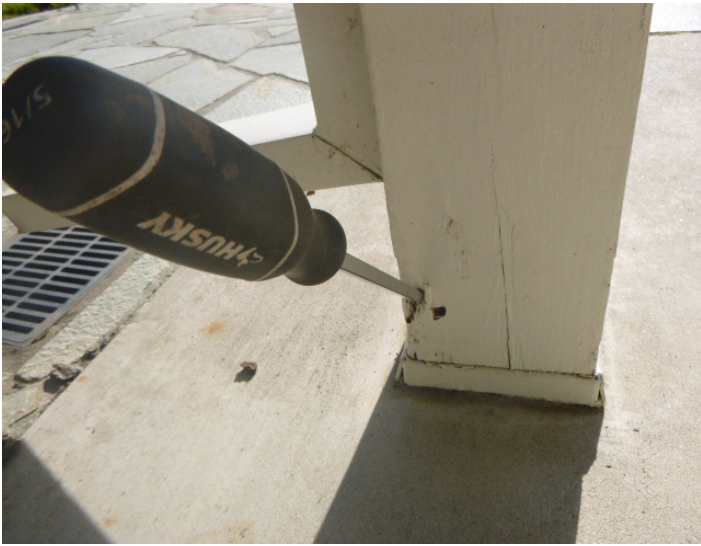
4A

FINDING: Fungus damage noted at the base of the front porch cover support posts.

RECOMMENDATION: Remove the fungus damaged portions of the support posts and replace with new material.
